MARINE ACCIDENT
INVESTIGATION BRANCH

SAFETY DIGEST

**Lessons from Marine
Accident Reports
1/2006**

No 1/2006

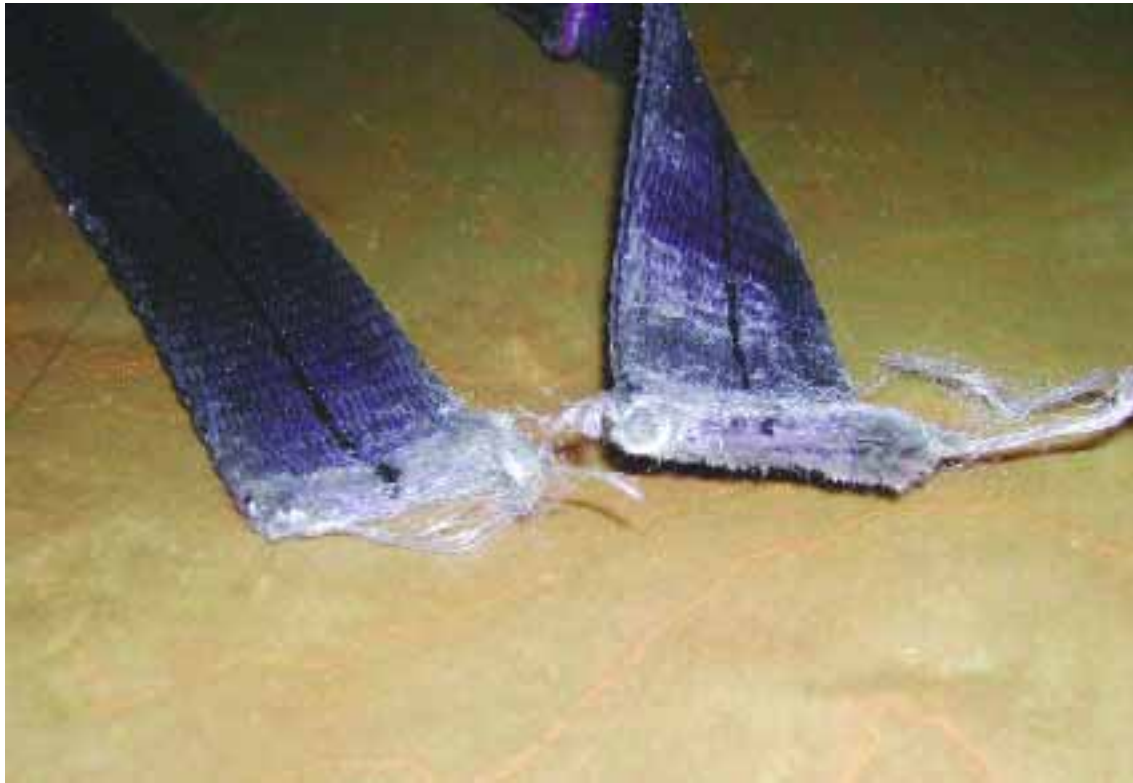
Figure 1: Parted fabric strop

Those involved in slinging the compressor did not seek advice from a competent person. Had they done so, it would have been clear that the SWL of the single strop was less than the weight of the compressor, and that it was incapable of taking the load. In addition, the strop was being chaffed by sharp edges on the compressor, making failure of the strop almost inevitable.

With luck on his side, the engineering rating escaped serious injury. The failure of the strop could so easily have resulted in a fatality. Safe Working Loads are recorded on all items of lifting equipment, and it is clear that these must be greater than the loads being lifted.

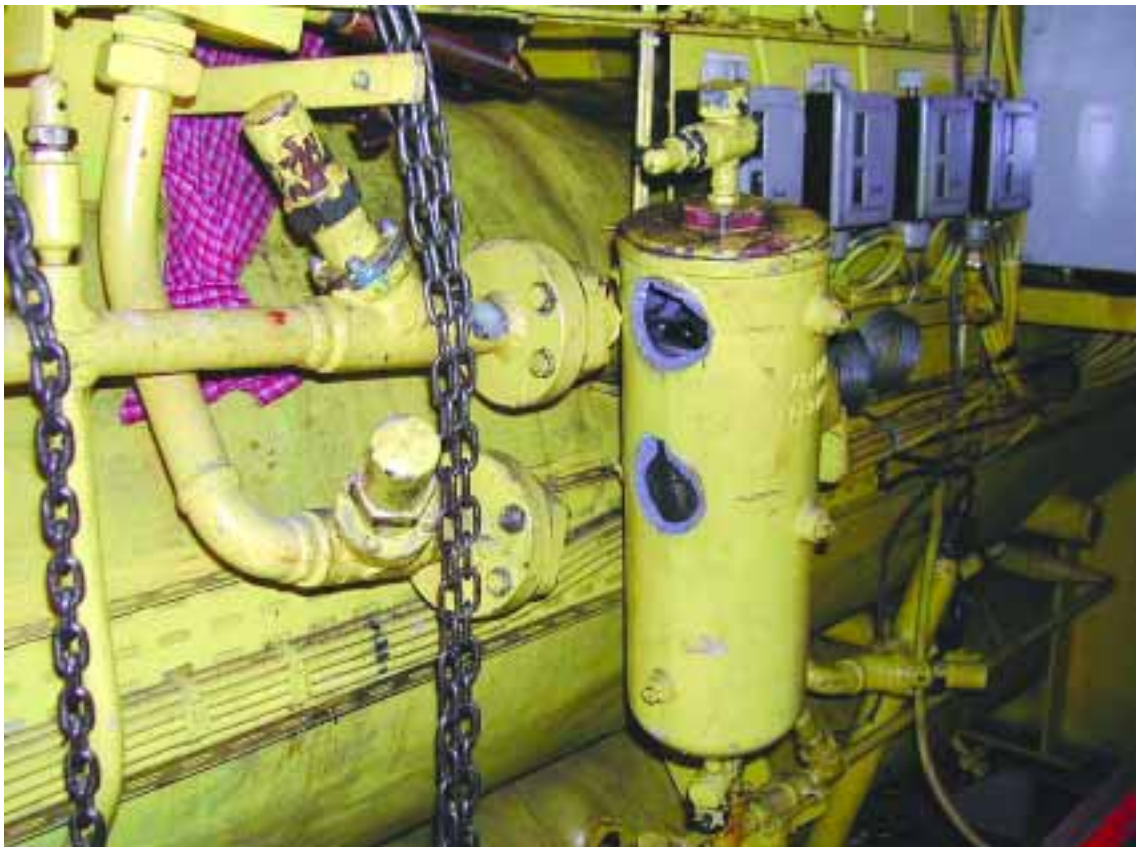
fell against the compressor oil filter, fracturing the inlet and outlet pipes (Figure 2). The compressor then fell to the floor plates and bounced onto a nearby rating. The rating suffered an open fracture of the leg, and had to be evacuated by helicopter to a nearby UK hospital.

Figure 2: Damage to the inlet and outlet pipes

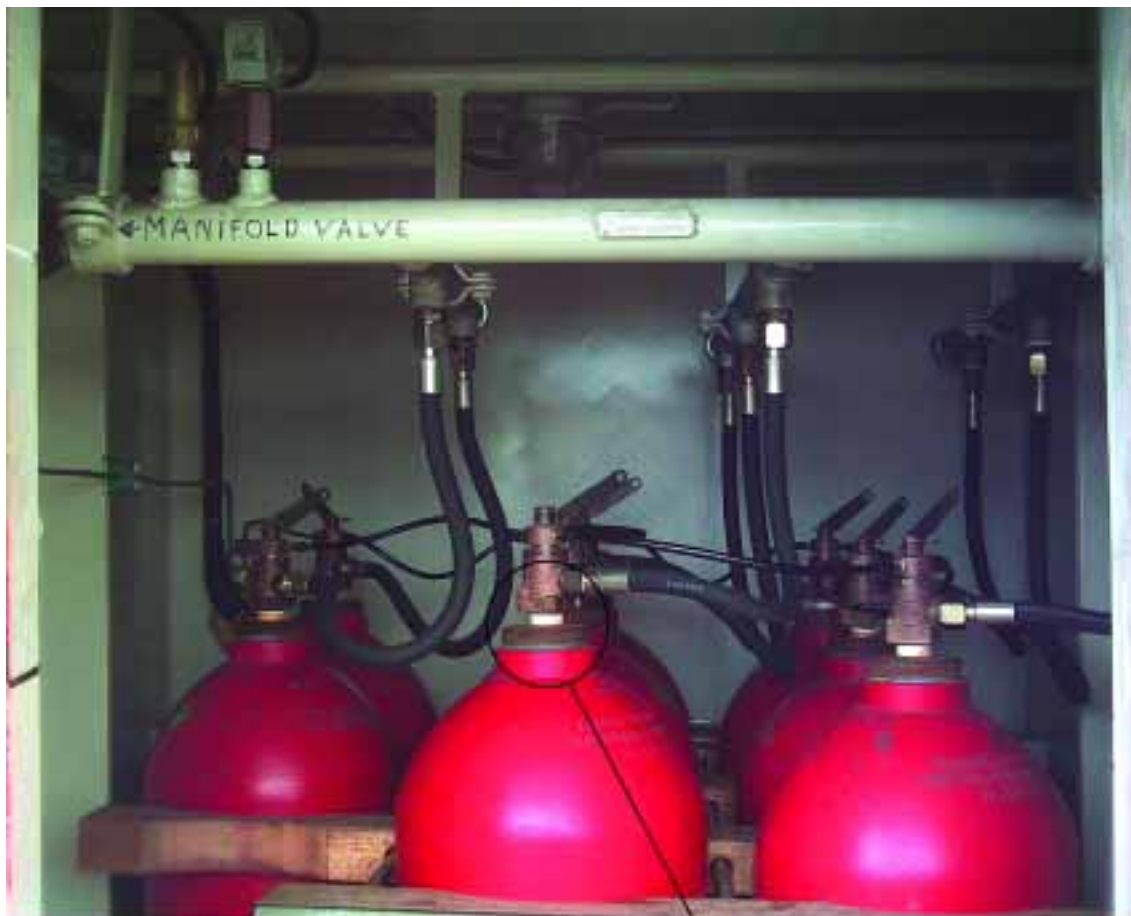
Figure 1

Believing he might have made a mistake in the procedure, he returned to the control box compartment. There, he found the CO₂ pilot bottle isolating valve – which controlled the gas supply to the main bottle activators – partially open. It appears that the chief engineer's coat sleeve might have inadvertently become caught on the isolating valve, causing the system to activate.

CO₂ storage bottle neck seal

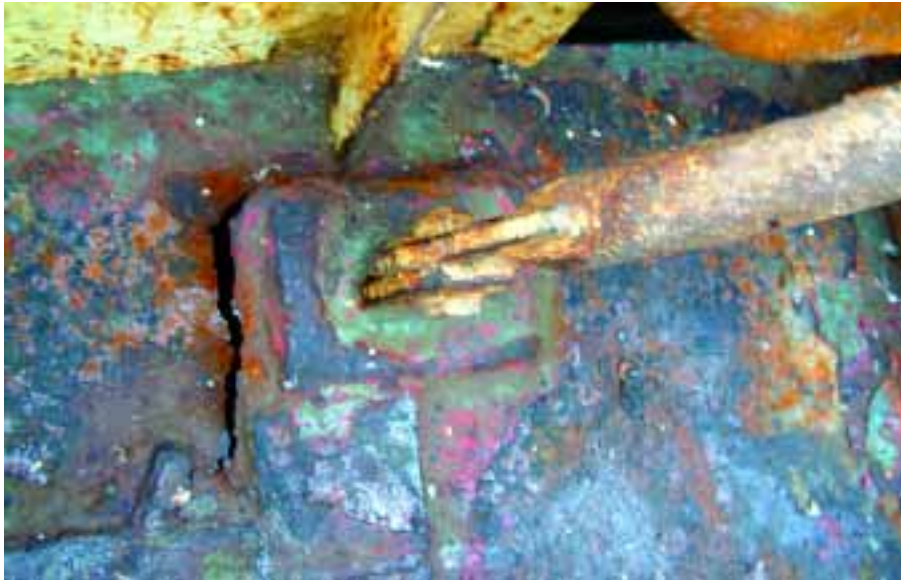
Figure 2: A frame supporting frame to deck split

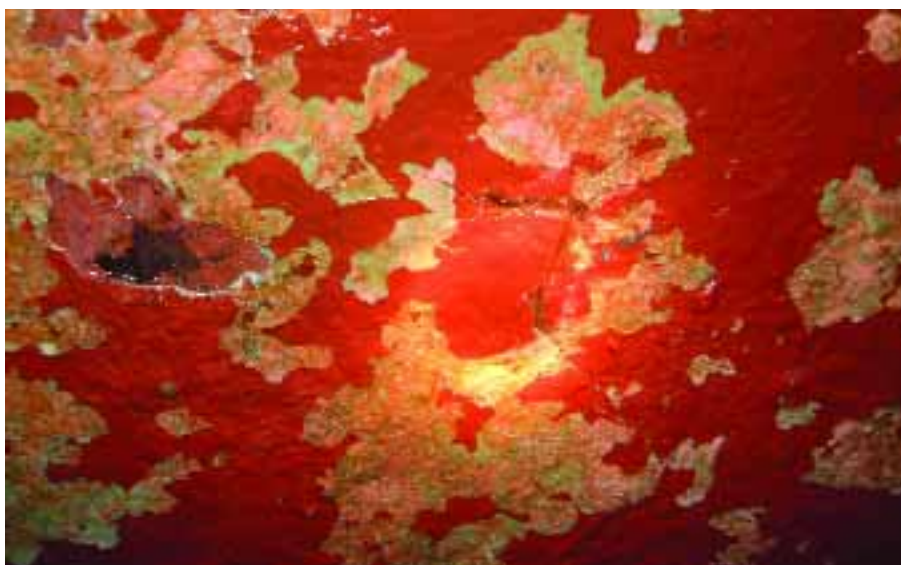
Figure 3: Vee split in hull

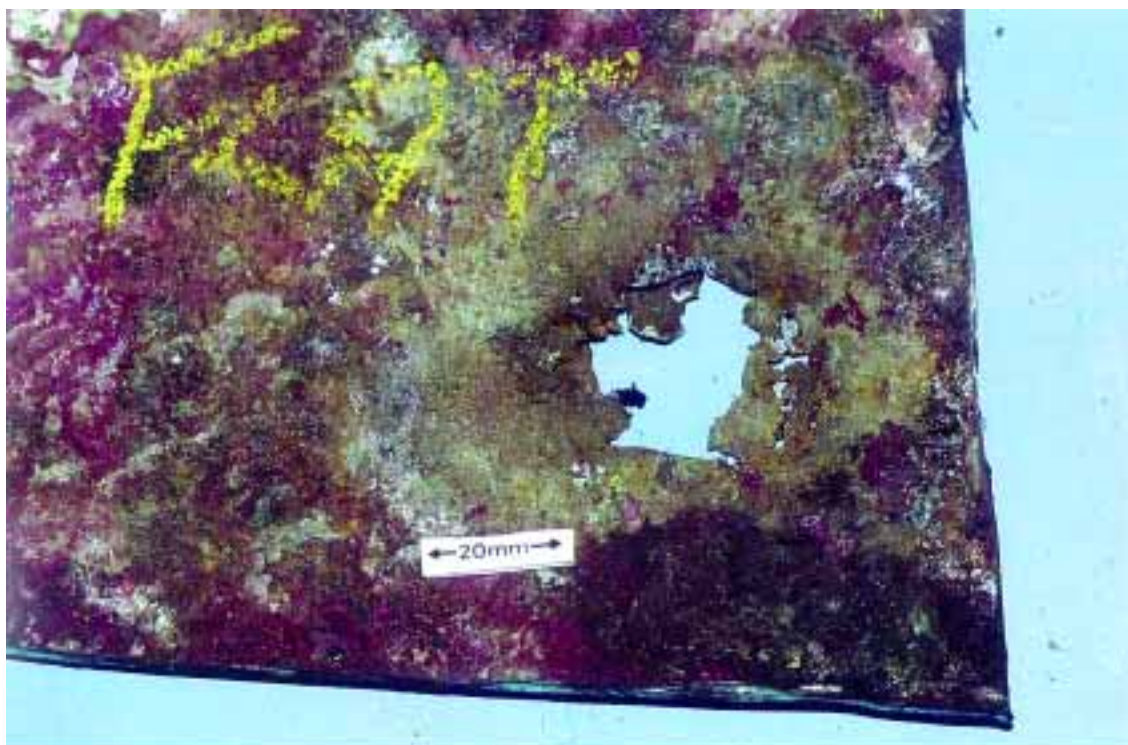
All the evidence indicates that the trawler began to take water in her steering compartment and her engine room, further reducing her limited stability. The flooding went undetected until the latter stages, when it is believed an attempt was made to pump out the bilges. During the process, the vessel was swamped by seas, downflooding occurred through the open steering gear compartment hatch and she sank rapidly by the stern. There was no time to transmit a "Mayday".

Figure 4: Steering compartment forward bulkhead hole

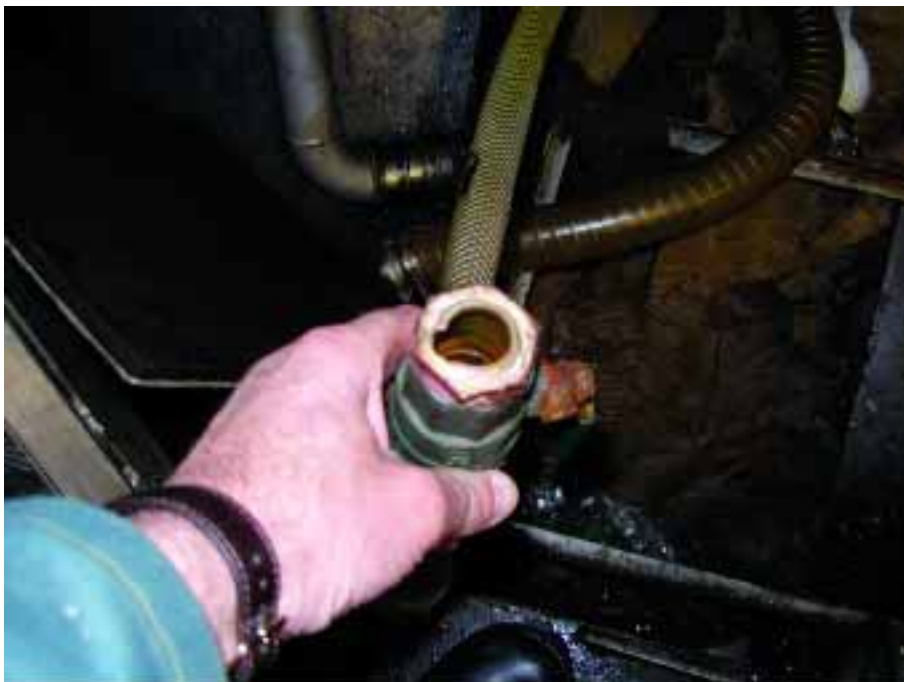
Sheared fitting after accident

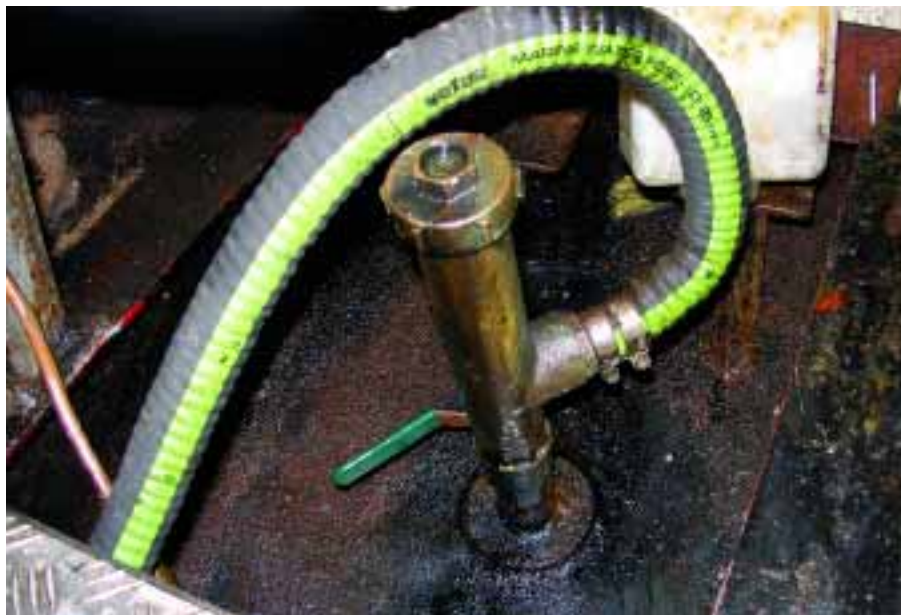
long and set at a convenient height for standing on; the vessel did not have non-return valves in her overboard discharges; no bilge alarm was fitted; holes were bored in the watertight toilet deck into the engine room to assist drainage when cleaning.

Similar sea water inlet before accident

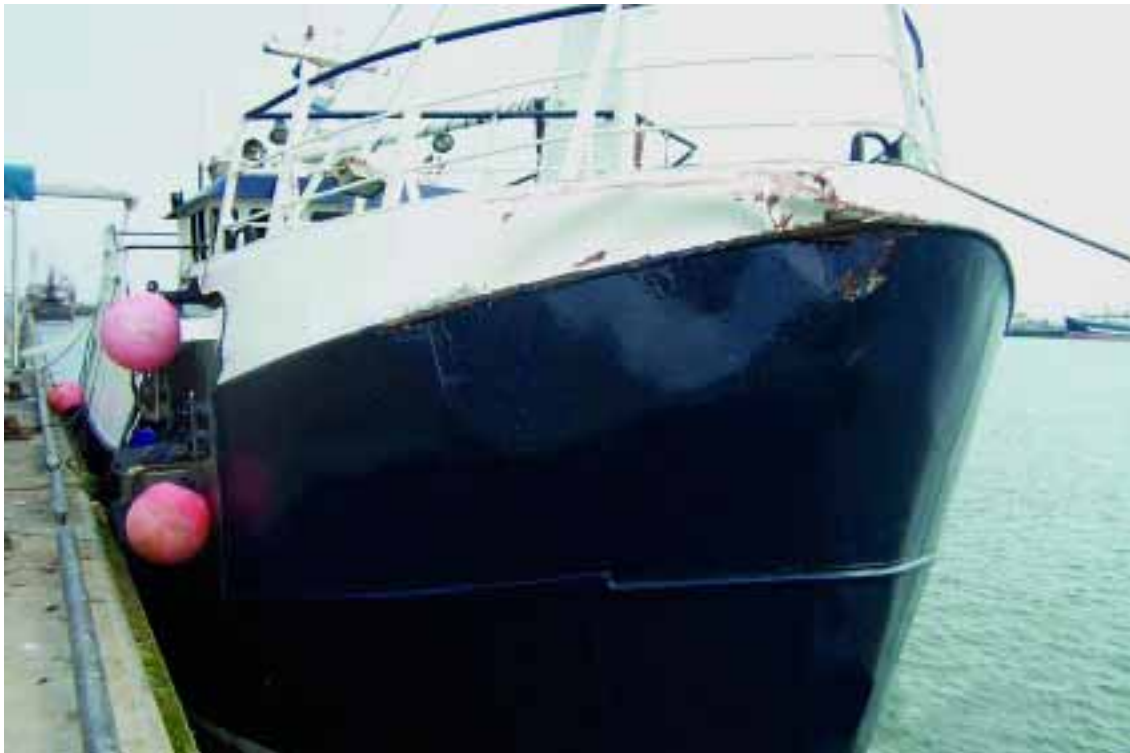
Damage to fishing vessel

When the crew mustered for work about 3 hours after the collision, the skipper was informed of the call made by the coastguard. He immediately turned on the deck working lights and saw that a davit arm was damaged. As this meant the vessel was unable to fish, the skipper decided to return to harbour. Fortunately, the damage to neither vessel was serious (Figures).

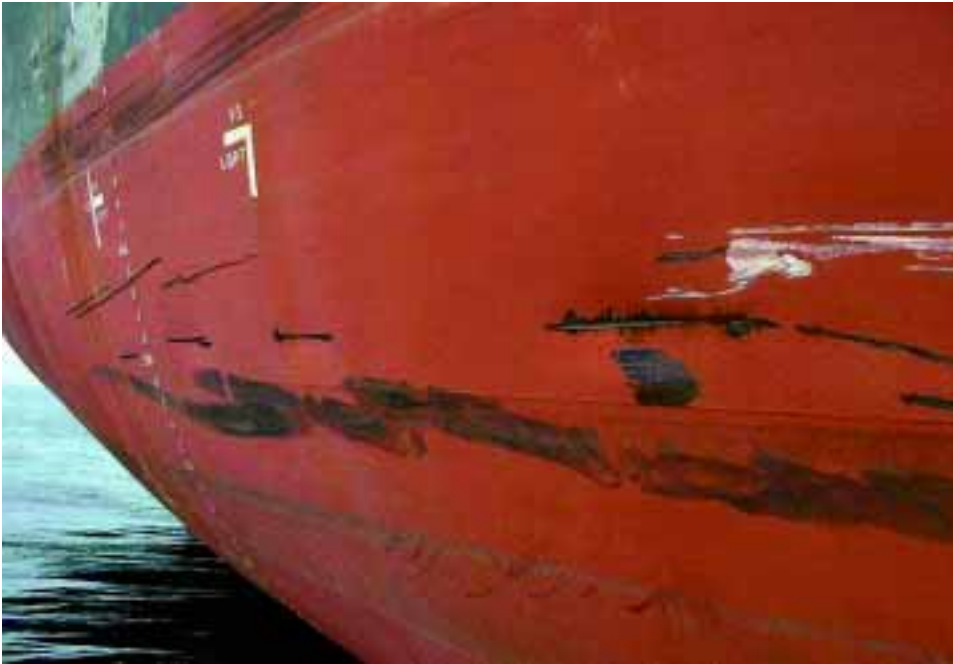
Shell plating damage on ore carrier

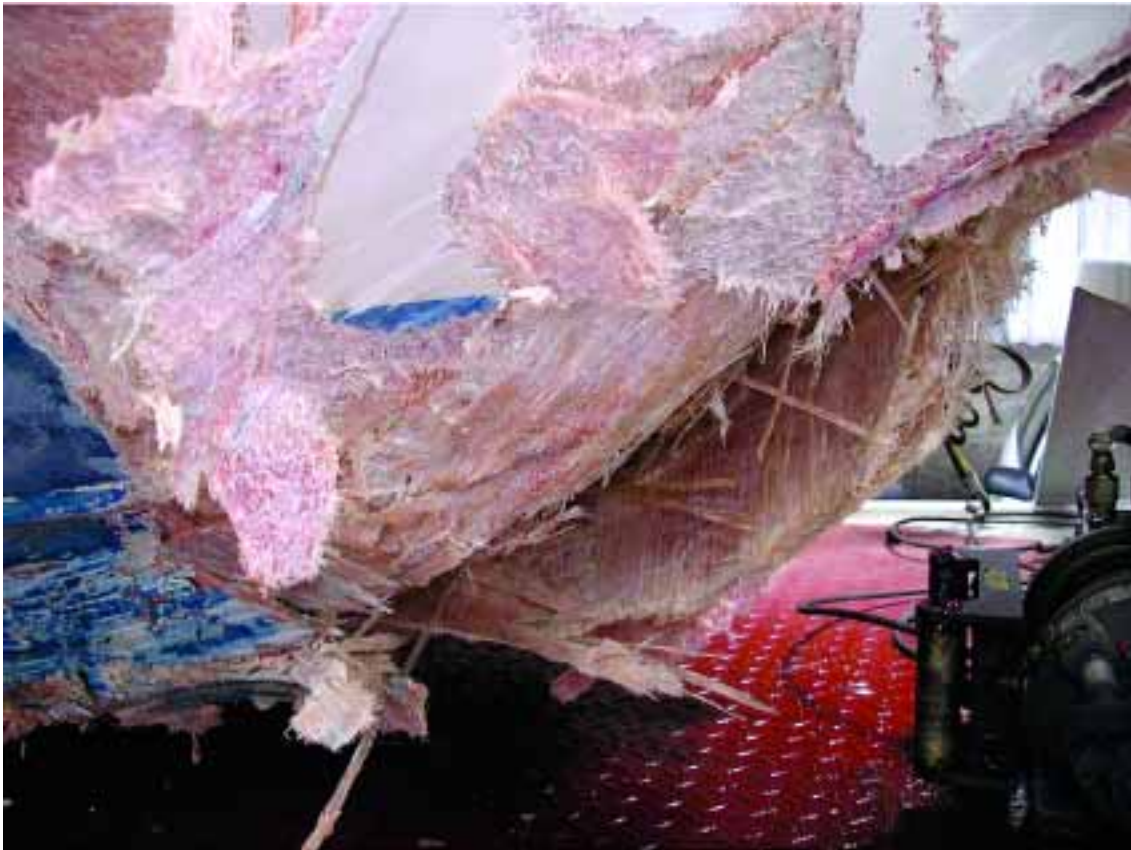
Damage to starboard forefoot and bow forward

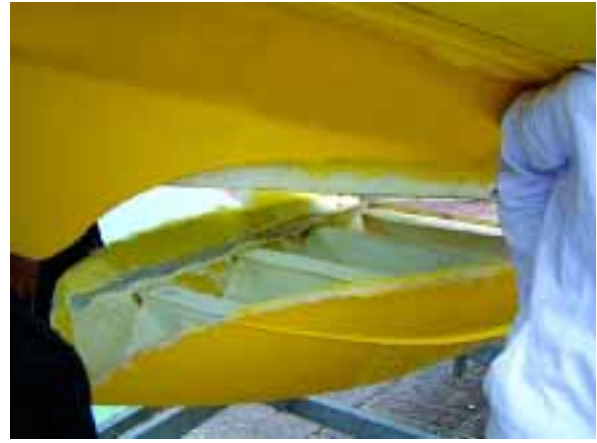
The skipper felt the RIB's handling characteristics change. The deck heaved slightly, there was a loud crack and the forward part of the hull momentarily adopted an angle of about 45 degrees from the horizontal. The front bench seat was torn from its deck mountings, plunging two of the children into the water (Figure 2). One female passenger also trapped her legs between the split sections of the marine ply deck before being pulled back by her husband. In the meantime, the skipper ran forward, the engines stopped as the kill cord was activated, and he dropped both his anchors and launched the lifeboat, although he was unsure how to do this. The RIB, although still afloat, had its bow section fully open to the sea, with port and starboard splits to the hull extending to over half the RIB's length (Figure 3).

Figure 3: Hull lifted to expose split

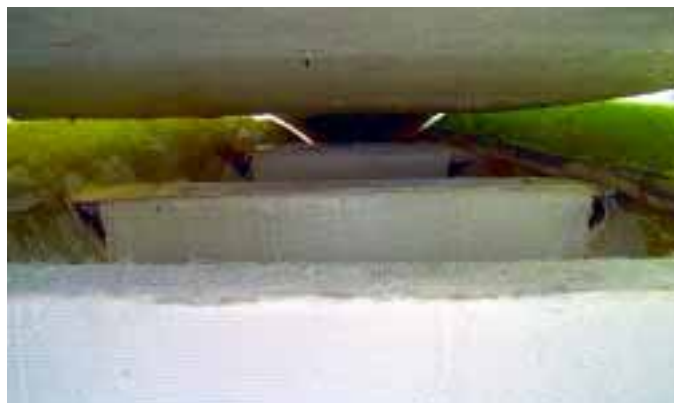
The subsequent investigation found that the RIB was supposedly built to the European Craft Directive's standards, but there was no documentation to support this claim. In particular, there was no specification for the hull structure or its construction to justify its designation to cope with 4 metre seas, the structure lacked longitudinal stiffness and was of extremely light construction (Figure 4). As

Figure 4: Construction
