MARINE ACCIDENT
INVESTIGATION BRANCH

SAFETY DIGEST

**Lessons from Marine
Accident Reports
3/2007**

No 3/2007

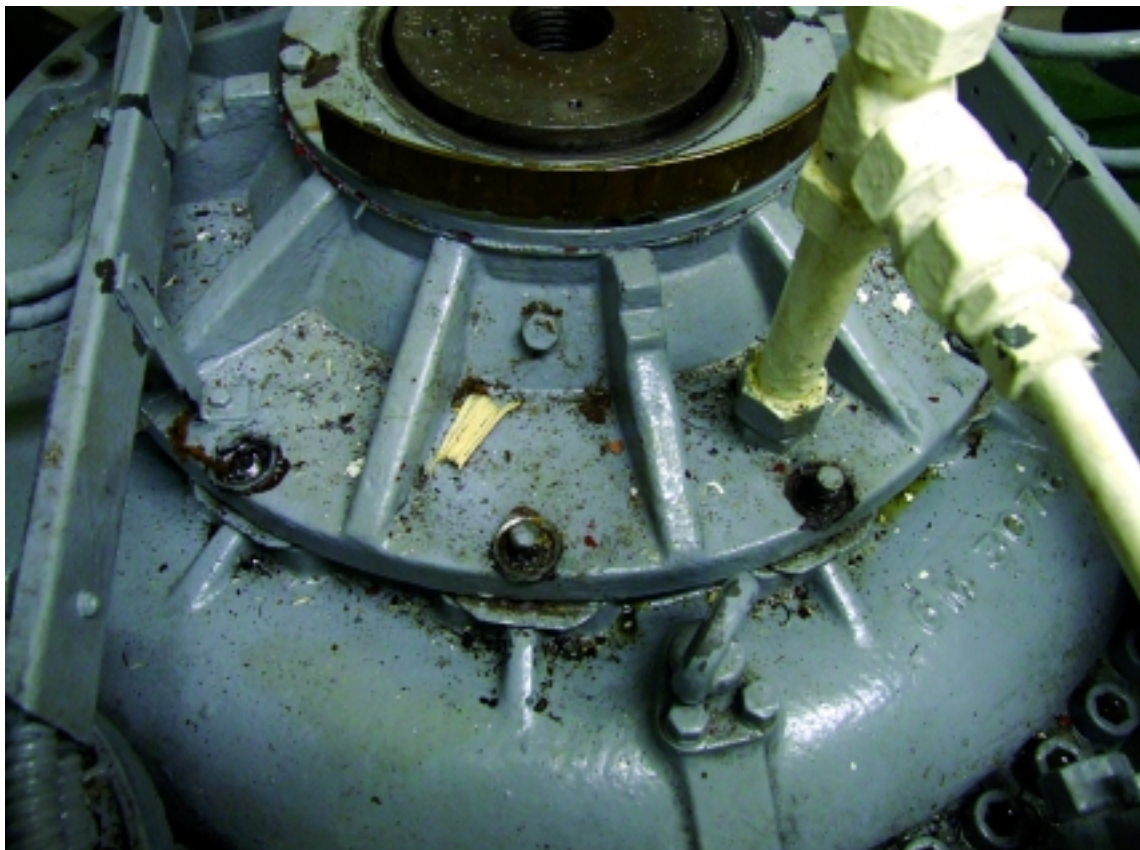
Figure 1: Damage to the vessel's steering gear

chief engineer reported to the master that the steering gear was badly damaged (Figure 1). The ship was now on a south easterly heading, and as she continued to be set to the north by the wind and the swell, her forward part made contact with a green lateral buoy marking the north side of the channel. Both anchors were then let go and the ship came to rest at about 1628.

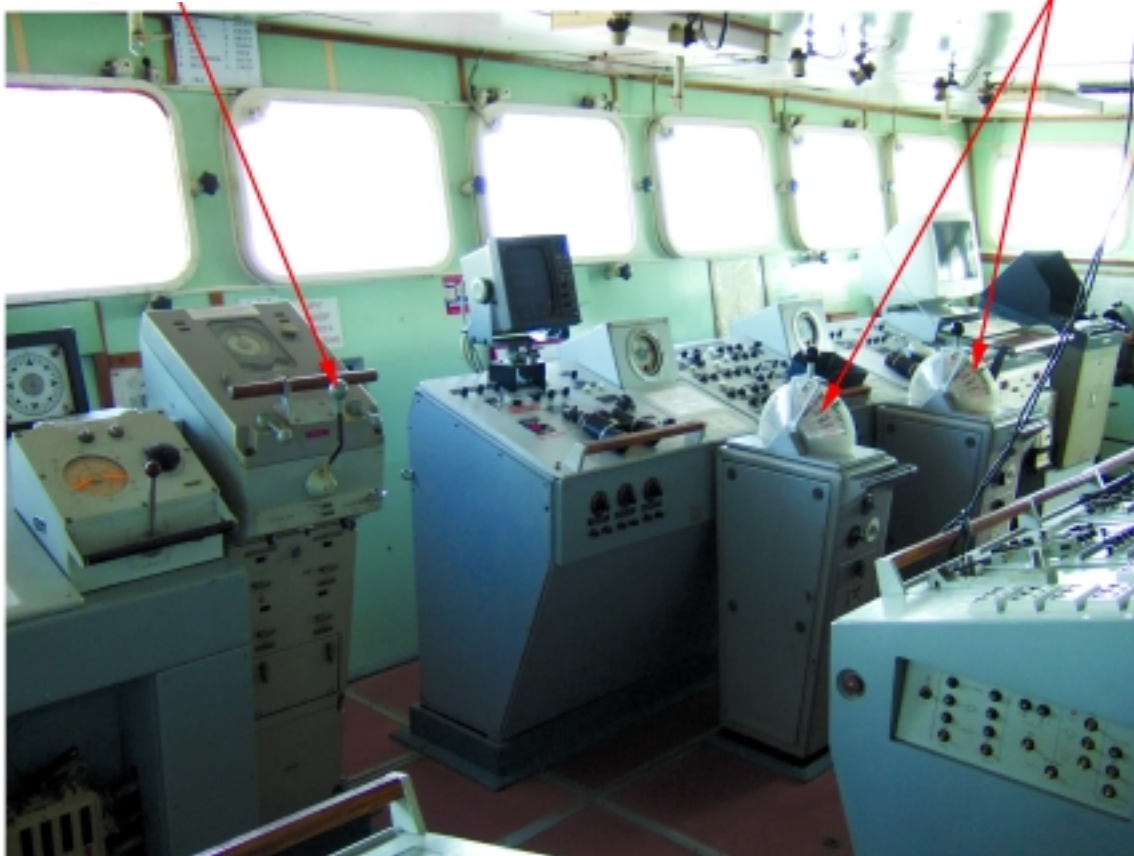
The bridge showing the telegraph and steering positions

1. The pilot had noted that the ship was fitted with twin shafts and a bow thruster, and considered that a ship with this arrangement would be very manoeuvrable. Unfortunately, the master/pilot exchange was short, and the particular manoeuvring characteristics of this ship were not passed on to the pilot. The pilot was not prepared for the ship's low power and poor turning ability.

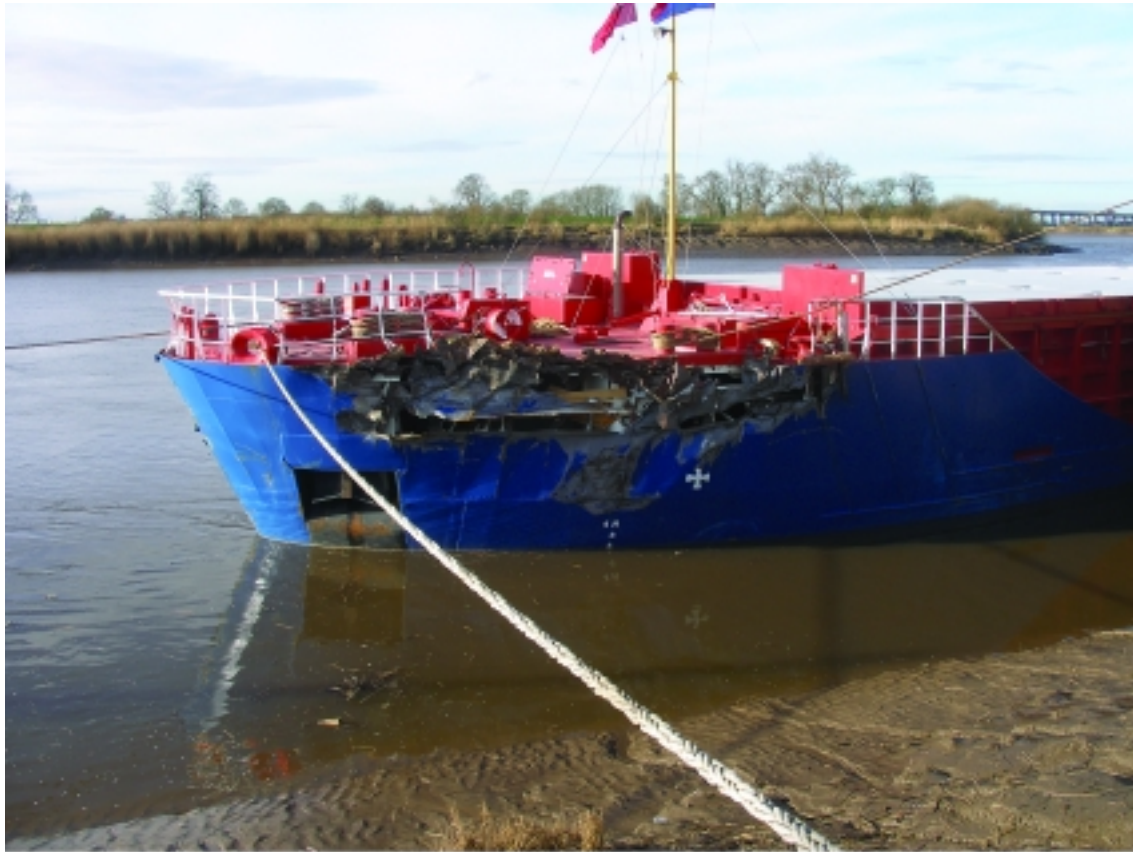
Damage to the vessel's bow

As the pilot neared the bend in the river, he reduced the vessel's speed from 10 knots over the ground, but did not check to confirm his new speed. His view from the wheelhouse was affected by the flood-lighting on the bridge, which coincidentally was in line with the vessel's very low wheelhouse windows and caused a "dazzle effect" as the ship neared the bridge; this was exacerbated by the reflection of the lights from the mirror-like surface of the river. The pilot misjudged the vessel's position, and by the time this became apparent to him it was too late to take corrective action to prevent her from hitting the bridge, causing substantial damage to the cargo vessel and bridge supports. Fortunately no one was injured.

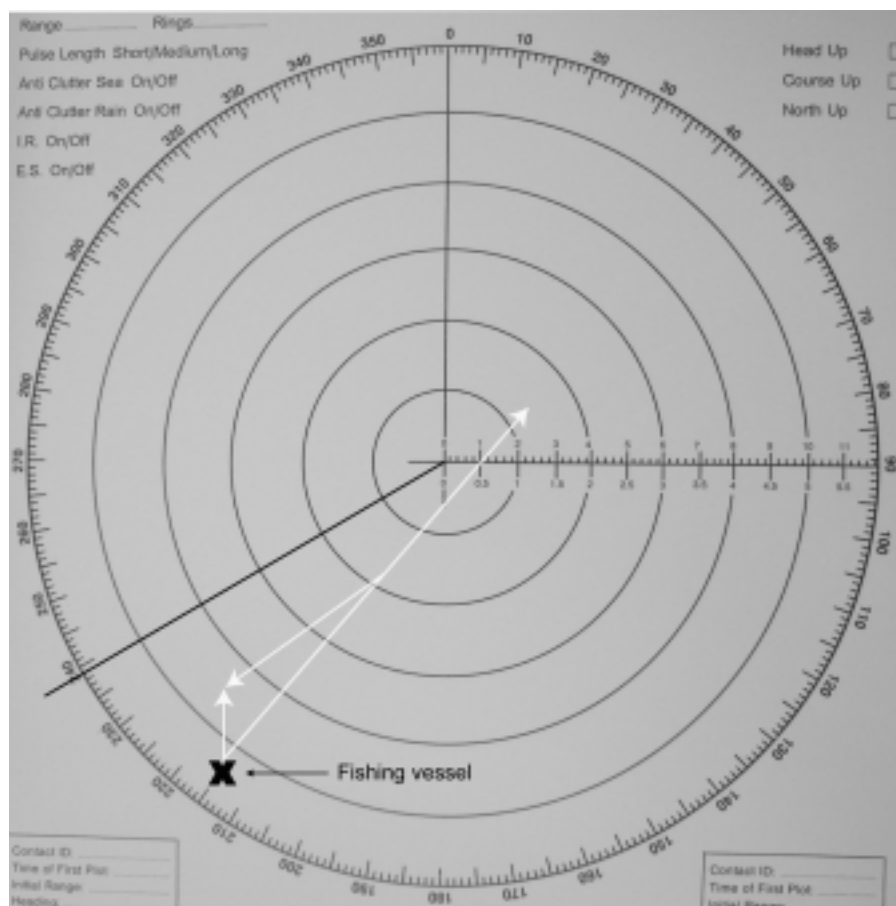
The fishing vessel was initially sighted on the port bow, and the radar trails indicated that it would pass about 3 cables astern of the coastal tanker, so no plot was initiated. Soon after that, the OOW adjusted the vessel's course (4°) to port to allow her to pass clear of a wreck which lay close by the course line. This change of course was sufficient to change the CPA to zero, but he did not look again at the fishing vessel's target (see plot below).

Plot A: Radar as viewed on the tanker

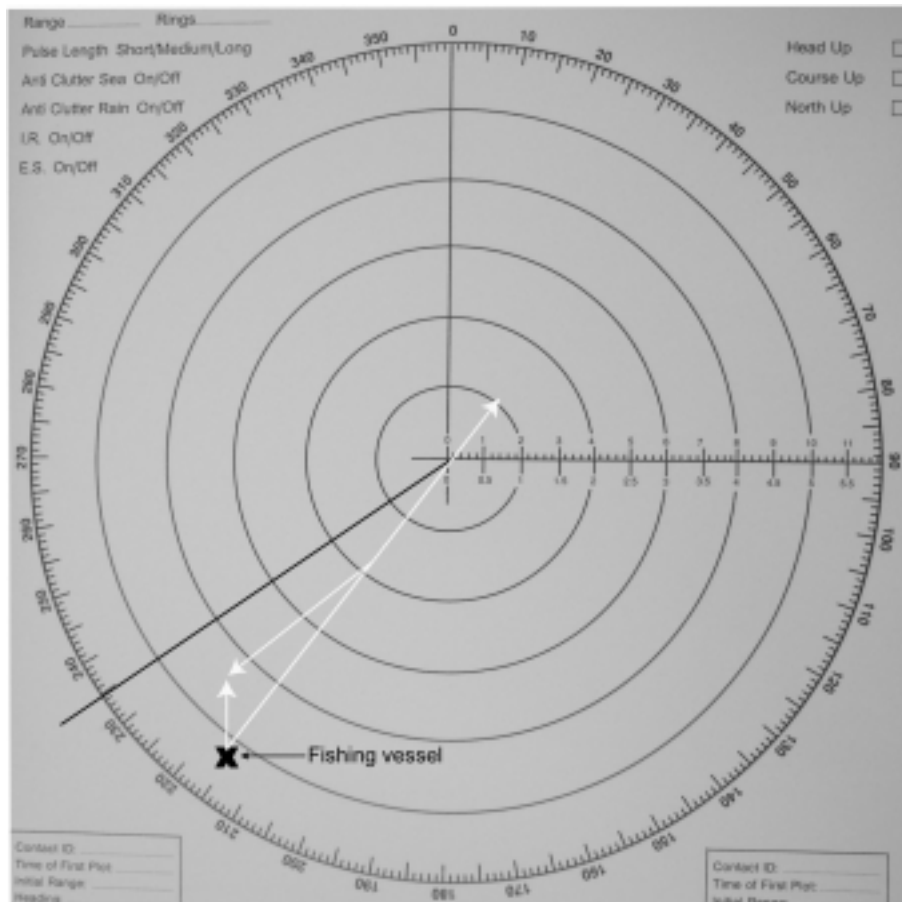
Plot B: Radar plot after alteration of course

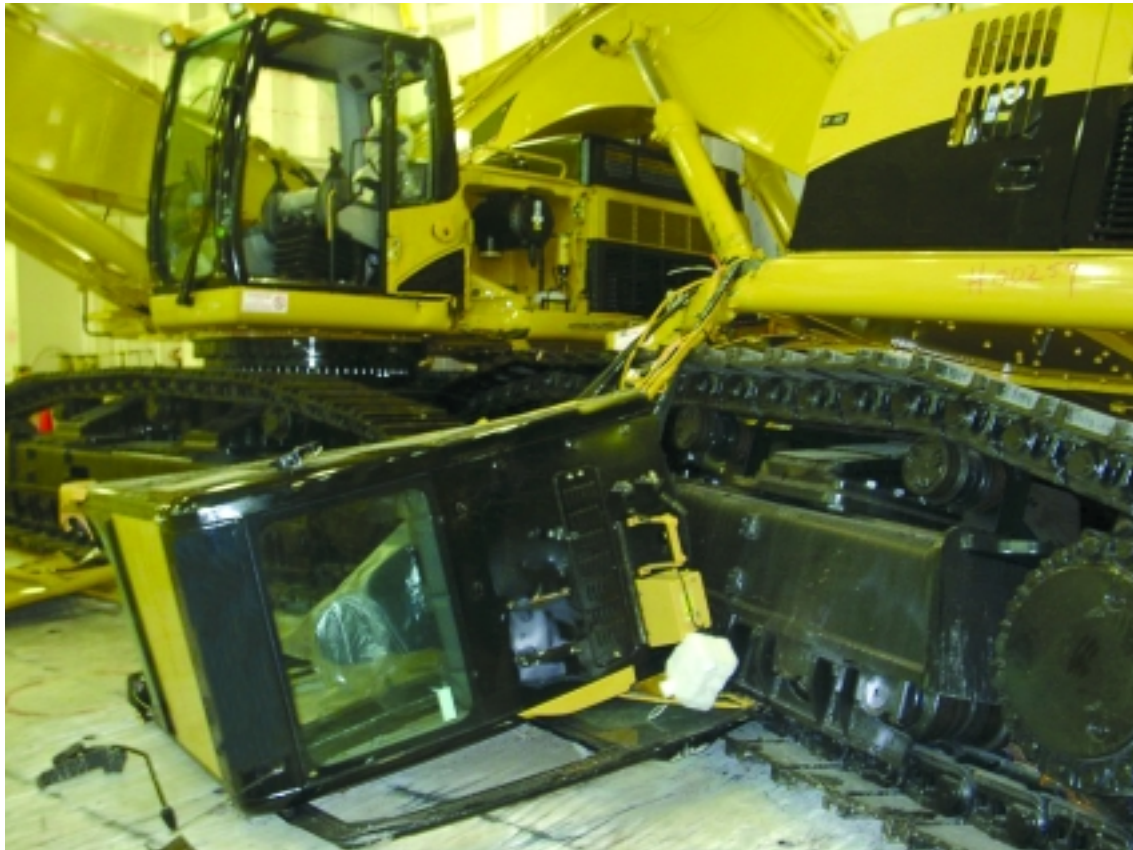
As the vessel continued to move violently, the situation on the main deck deteriorated as there were now 6 cargo units, together weighing over 200 tonnes, on the move, colliding with one another and the side of the ship. The ability of the units to move around the deck was made worse when the hydraulic tanks of some of the vehicles were ruptured, causing the vessel's deck to become very slippery.

The ship's cargo

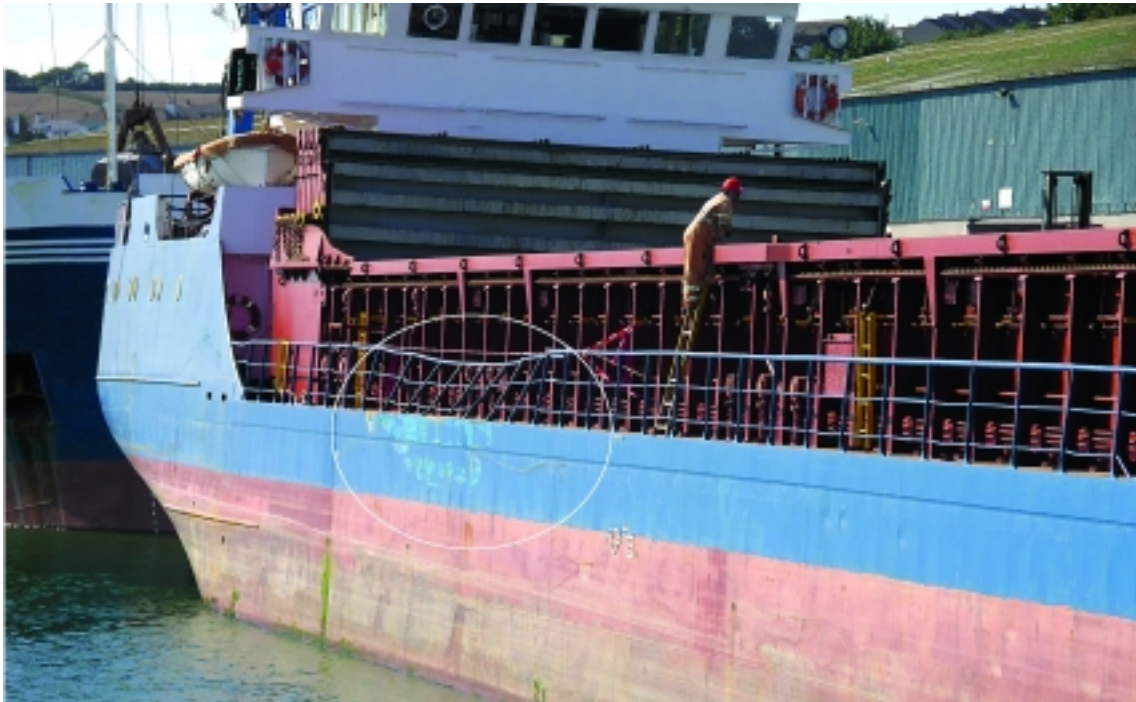
Damage to the starboard side of the ship

The OOW stopped the engines, switched on the deck lights and mustered the crew to check for damage. After identifying minor damage only, and exchanging relevant information, both ships resumed their respective voyages.

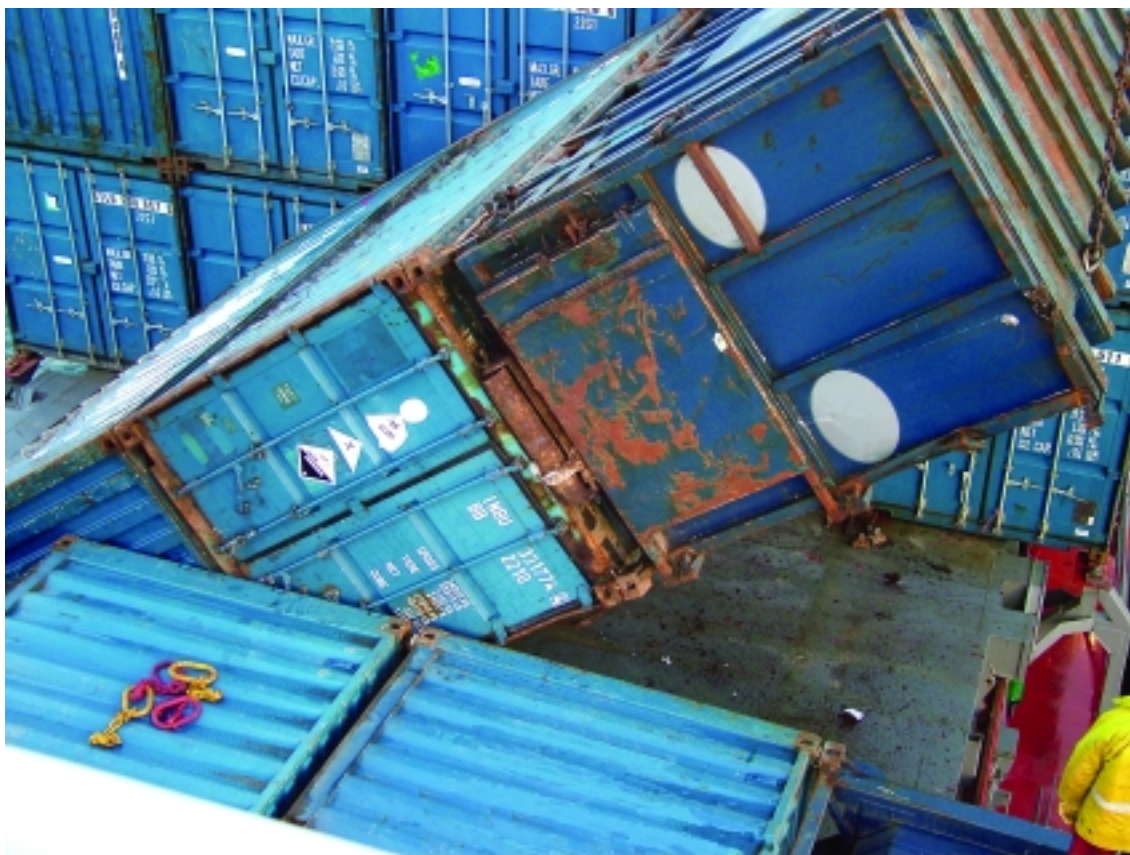
Remaining containers being lifted by crane after collapsing on deck

A general cargo/container vessel was on passage in heavy weather with a full deck load of containers. The vessel was pitching heavily in force 9 conditions with the wind and waves about 30° on her port bow. During a period of particularly heavy pitching, the vessel shed 20 containers from the deck into the sea; other containers toppled from their stowed position onto the hatches.

1. Over a period of time, the vessel had acquired a mix of left and right-handed twistlocks. When damaged units were put ashore for repair they would be replaced with exchange units; unfortunately these were not always of the same orientation as the originals. A ship's crew should check exchange units and refuse to accept anything other than same "handed" locking devices. Only by maintaining a strict operating regime will deck crew (and stevedores) be able to tell at a glance whether these items are "open" or "closed".

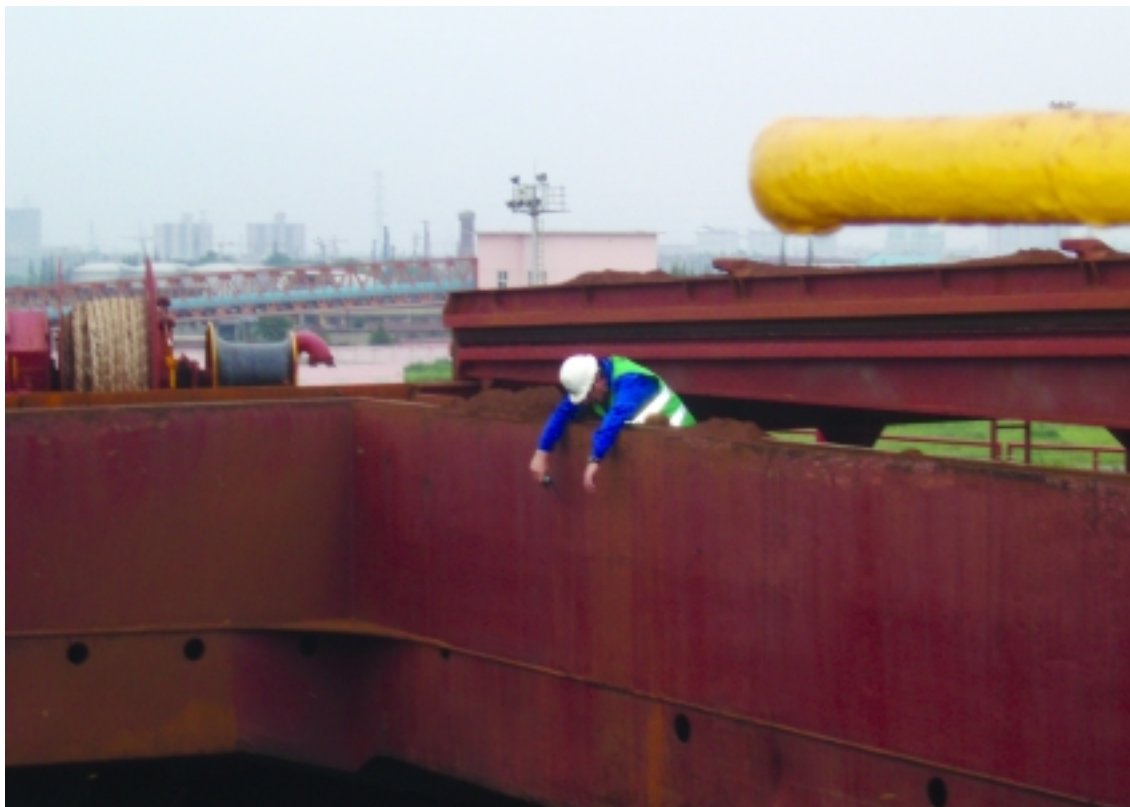
Indication of the casualty's position

received no instruction to do so. The hatch roller ran over the second officer's left foot as he climbed down, crushing his toes. He was wearing safety boots at the time.

1. When regularly operating hatch covers, it is easy to become complacent about the hazards, and for bad practice to creep in, especially if there are time pressures to get the ship to sea. Review the procedures on your vessel to ensure that measures exist to ensure personnel are clear of the danger areas before hatch cover securing pins or locks are released and power applied.
2. Ensure there are clear communications and that all involved know what is going to happen. Making assumptions that personnel are clear is dangerous; positive checks must be made before moving hatch covers.

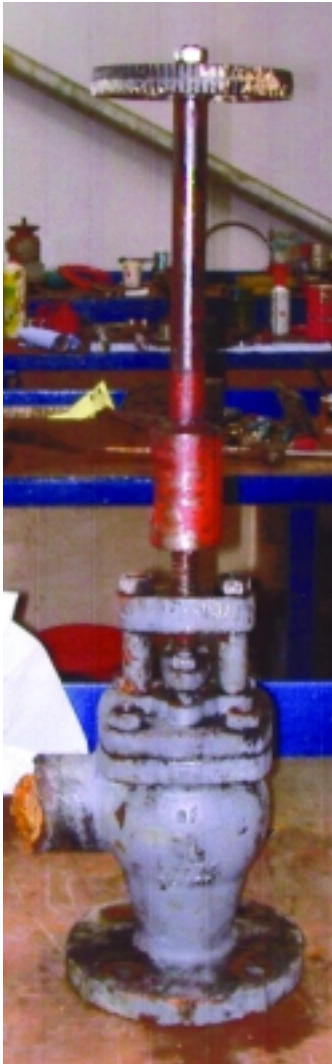
Vessel's eductor system valve

During early morning, routine, pre-sailing checks the engineer was stunned by what he discovered. He found that the starboard main engine bilge eductor system valve, which was out of sight, behind the engine, had completely sheared off from the sea water suction pipe. It was very fortunate that the pipe was completely blocked by a "plug" of corrosion products which prevented the engine room being completely open to the sea.

On investigation it was found that the pipe between the valve and the ship's side was so badly corroded that the engine vibration had finally caused it to part (figure).

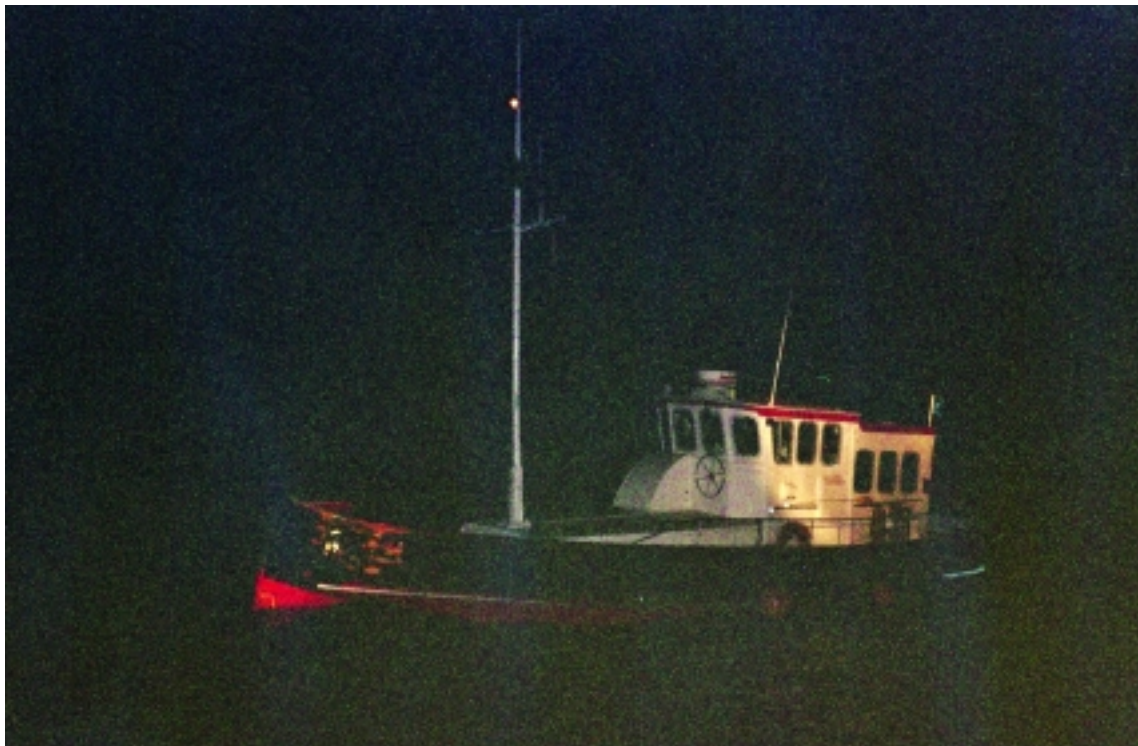
Converted fishing vessel shortly before sinking

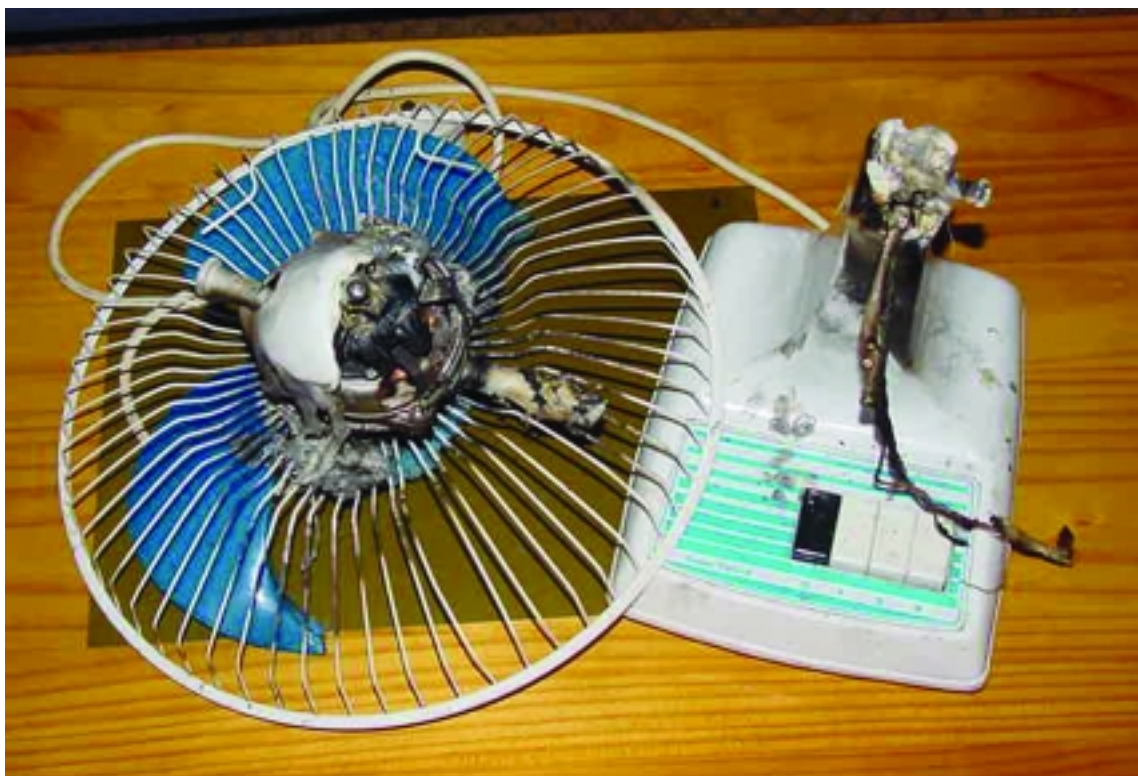
Figure 1

- The fan developed an electrical fault while on the table, and this caused the plastic casing to ignite. Once the casing had burnt through, the metal fan dropped, toppled to the deck and ignited the carpet.
- The oscillations of the unsecured fan caused it to move across the table and fall to the deck. Once on the carpet, the fan blades could not rotate because the front guard was missing, and this caused the fan motor to overload and overheat. This, in turn, led to the casing igniting and then the carpet.

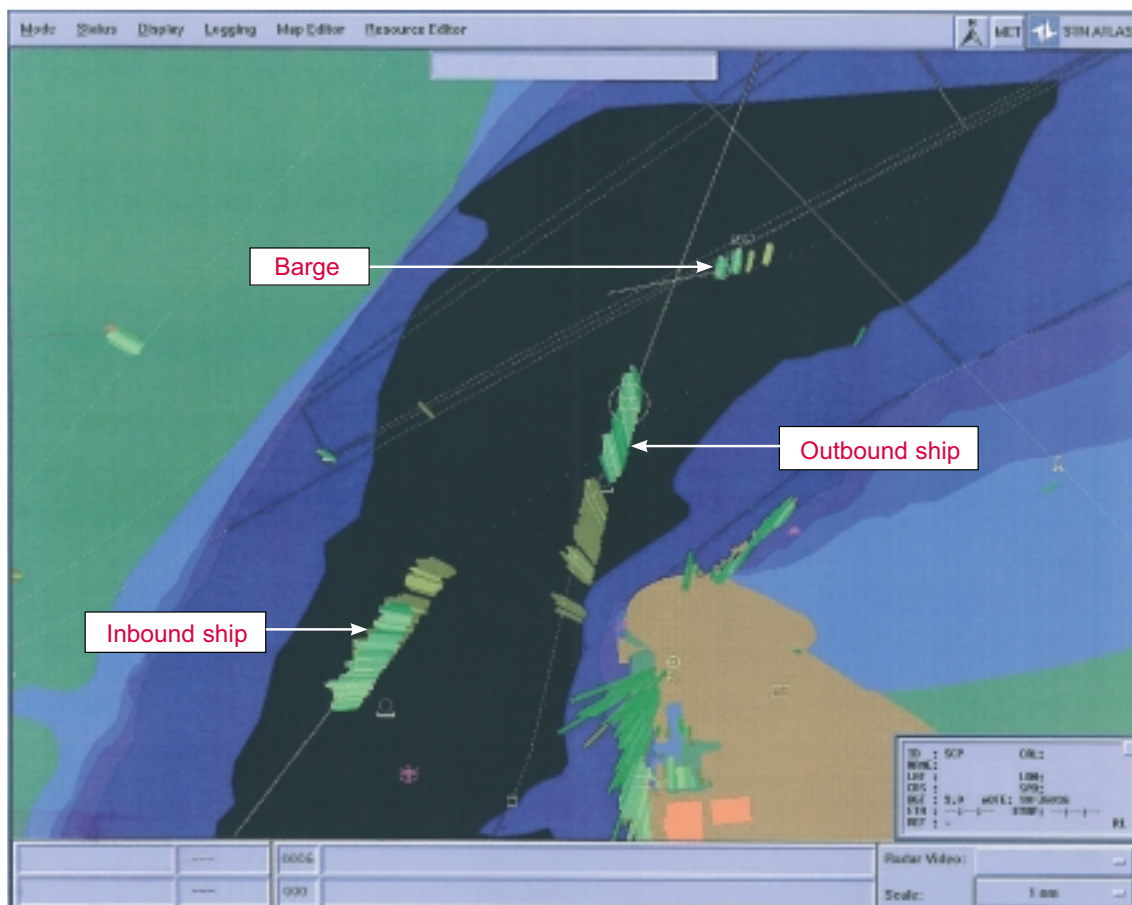
Figure 1: Shore based radar plot

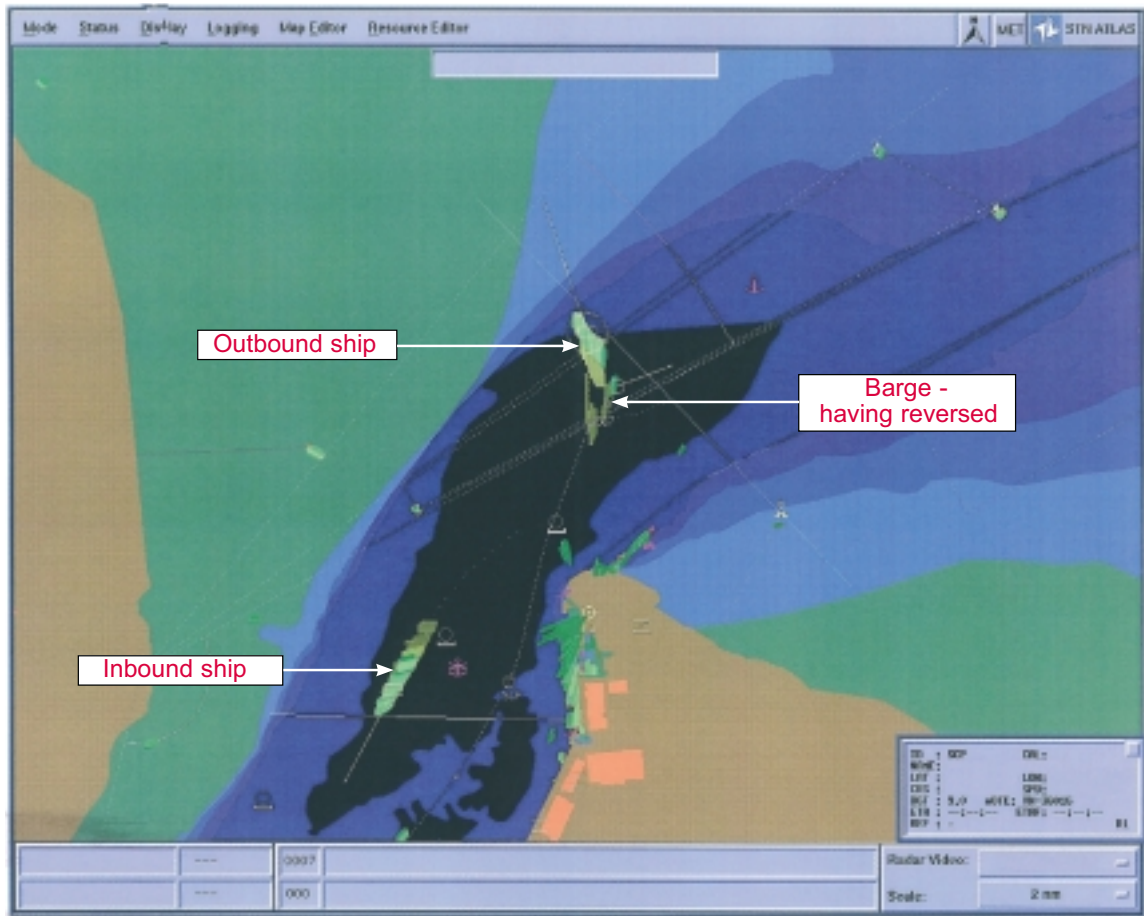
Figure 2: Shore based radar plot

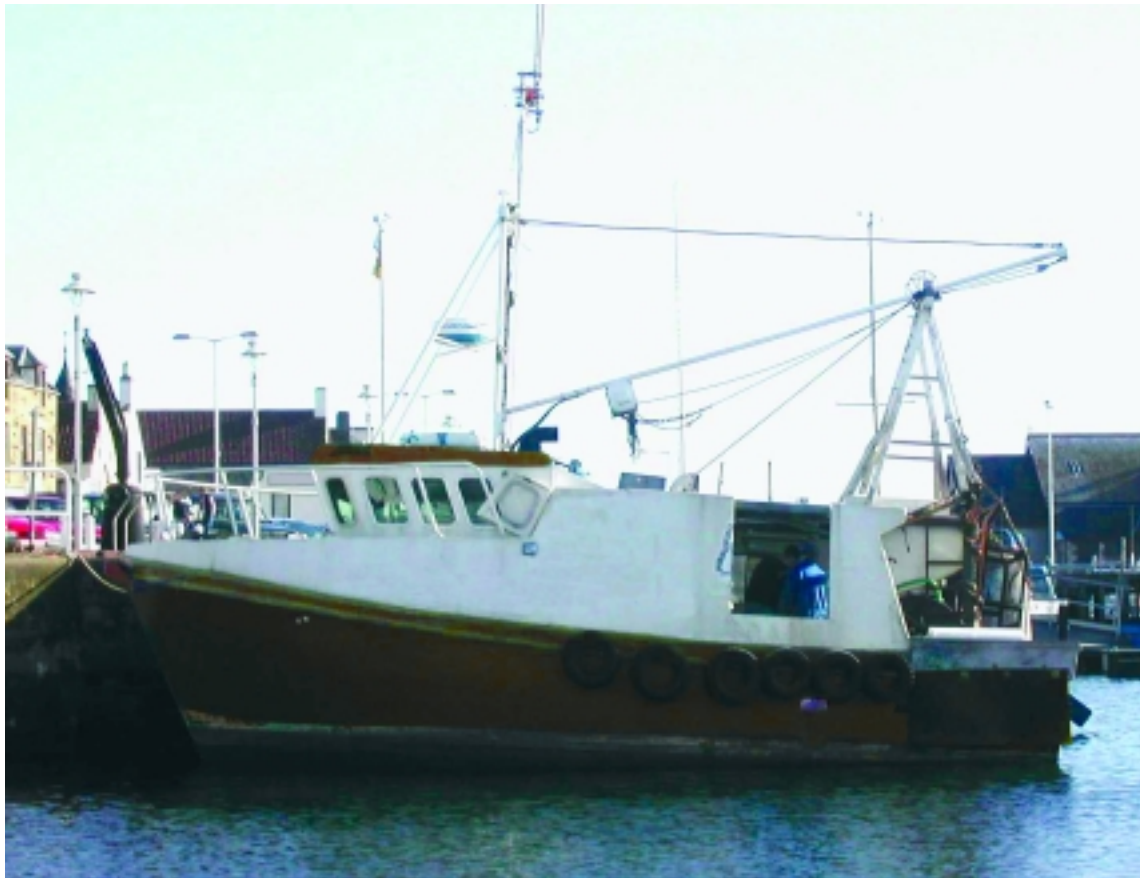
Photograph showing the vessel's point of suspension for the dog rope and cod end

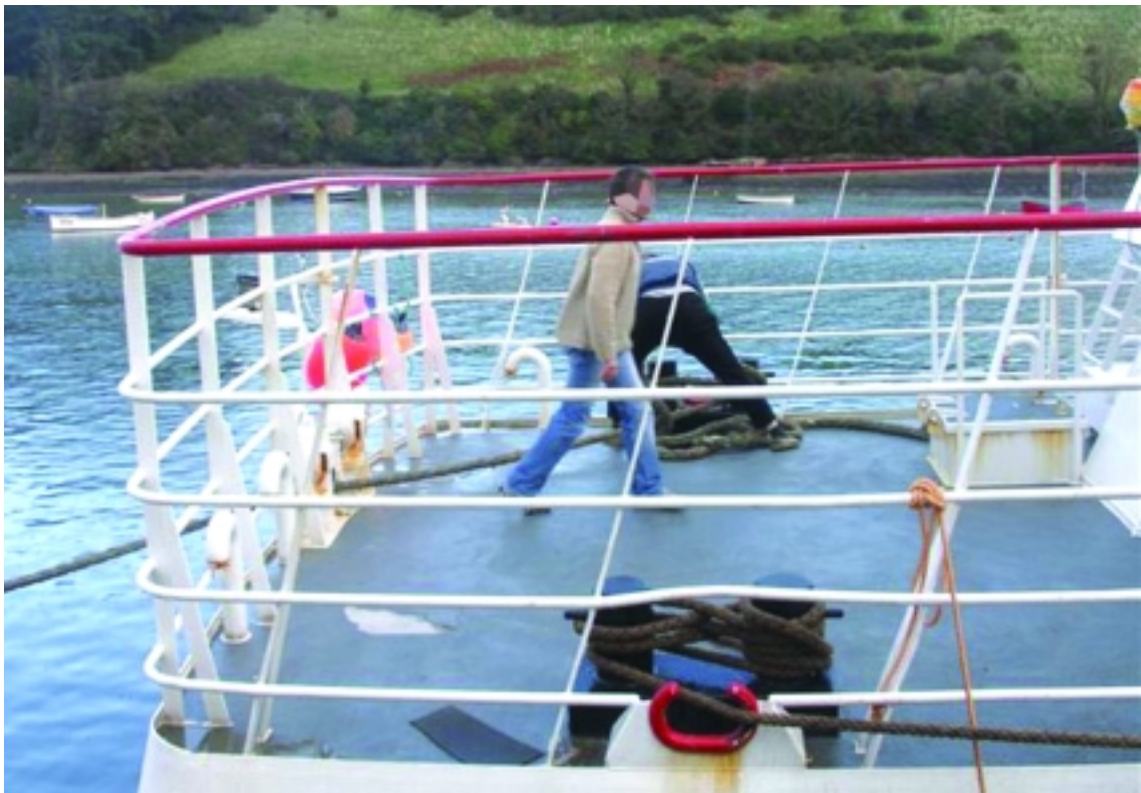
Photograph demonstrating the vessel's lifting area and height of rails

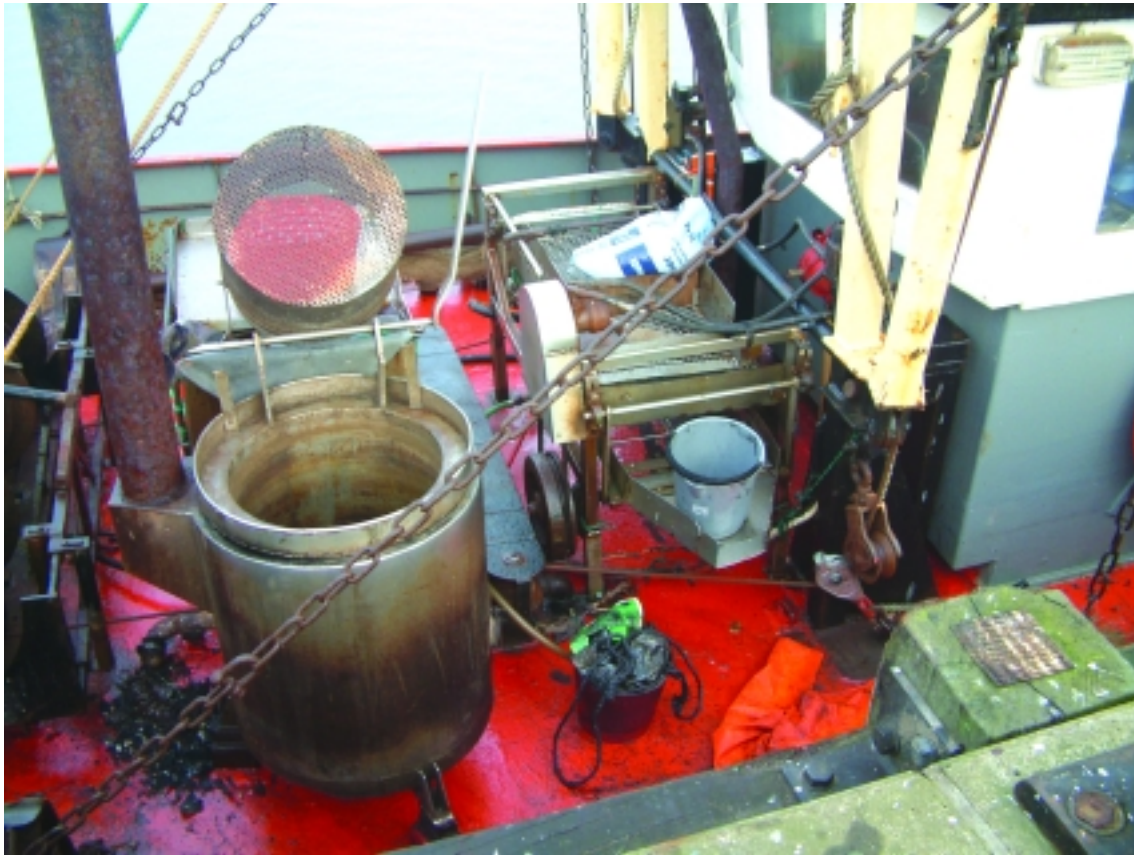
Figure 2: Shrimp boiler after the fire, with melted air supply pipe

his way forward to attack the fire with one of the crew carrying the deck wash hose. The fire was quickly extinguished, but it had melted the boiler's plastic corrugated air supply pipe (Figure 2).

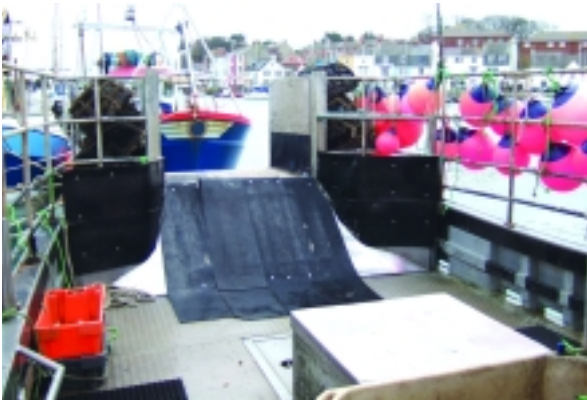
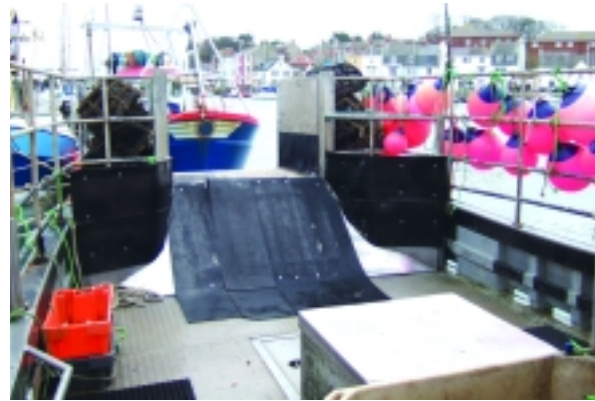
Do you notice any differences between the two photographs? – Concentrate on the ramp at the centre of the vessel's stern and imagine lines of pots being shot out through this opening. This is a common way of laying a line of pots and involves them being carefully stowed on deck, with the associated ropes, in such a manner that they are free to pass through the stern opening, without assistance from the crew, once the process has commenced.

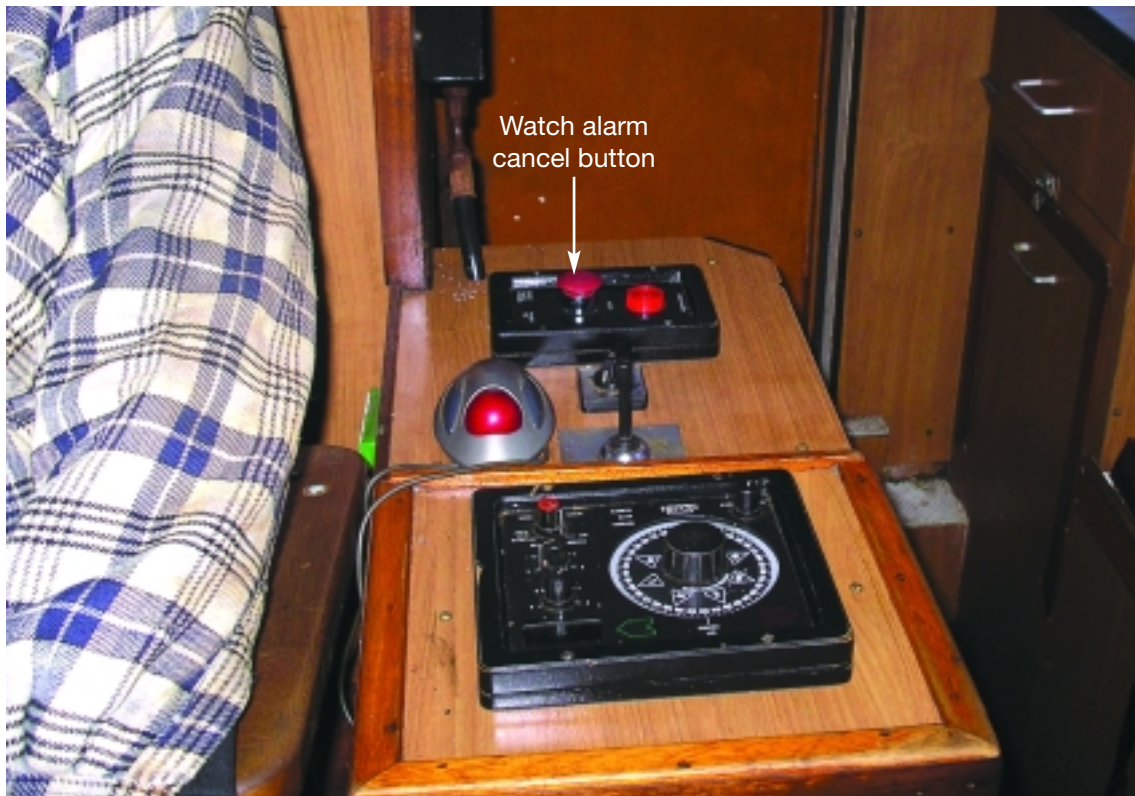
Figure 1: Vessel's watch alarm cancel button, next to the crewman on watch

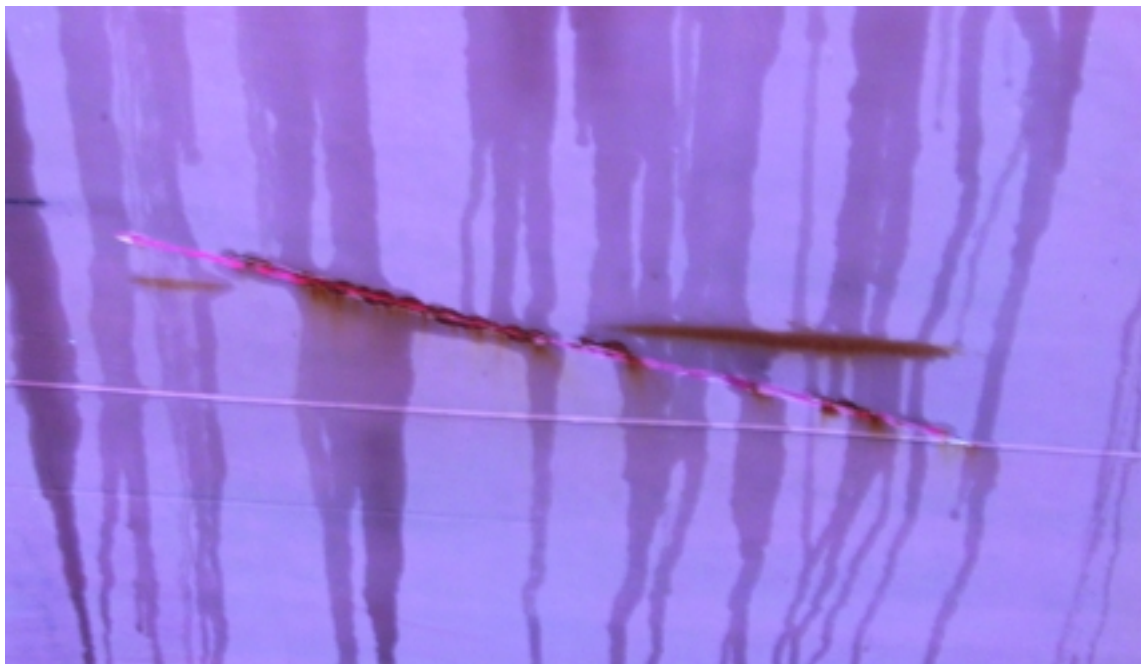
Figure 2: The damage to the tanker's side

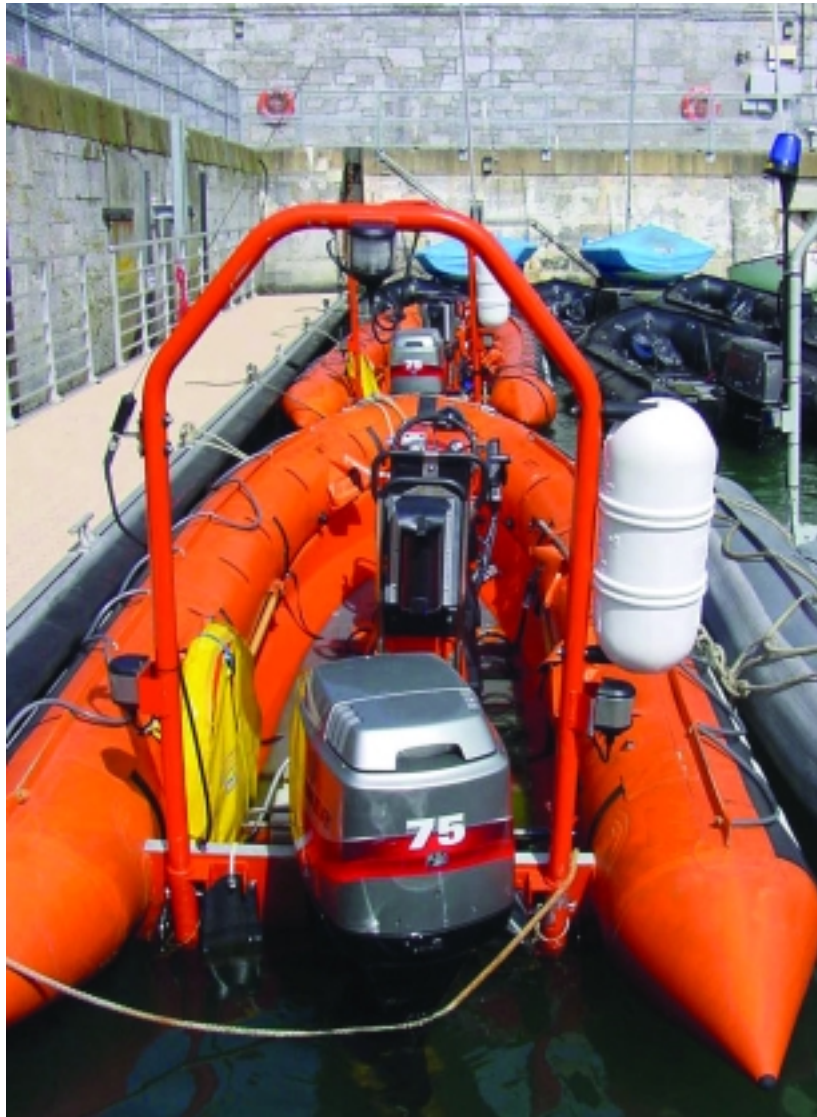
Stern view of the safety boat
