MARINE ACCIDENT  
INVESTIGATION BRANCH

# SAFETY DIGEST

**Lessons from Marine  
Accident Reports  
1/2009**

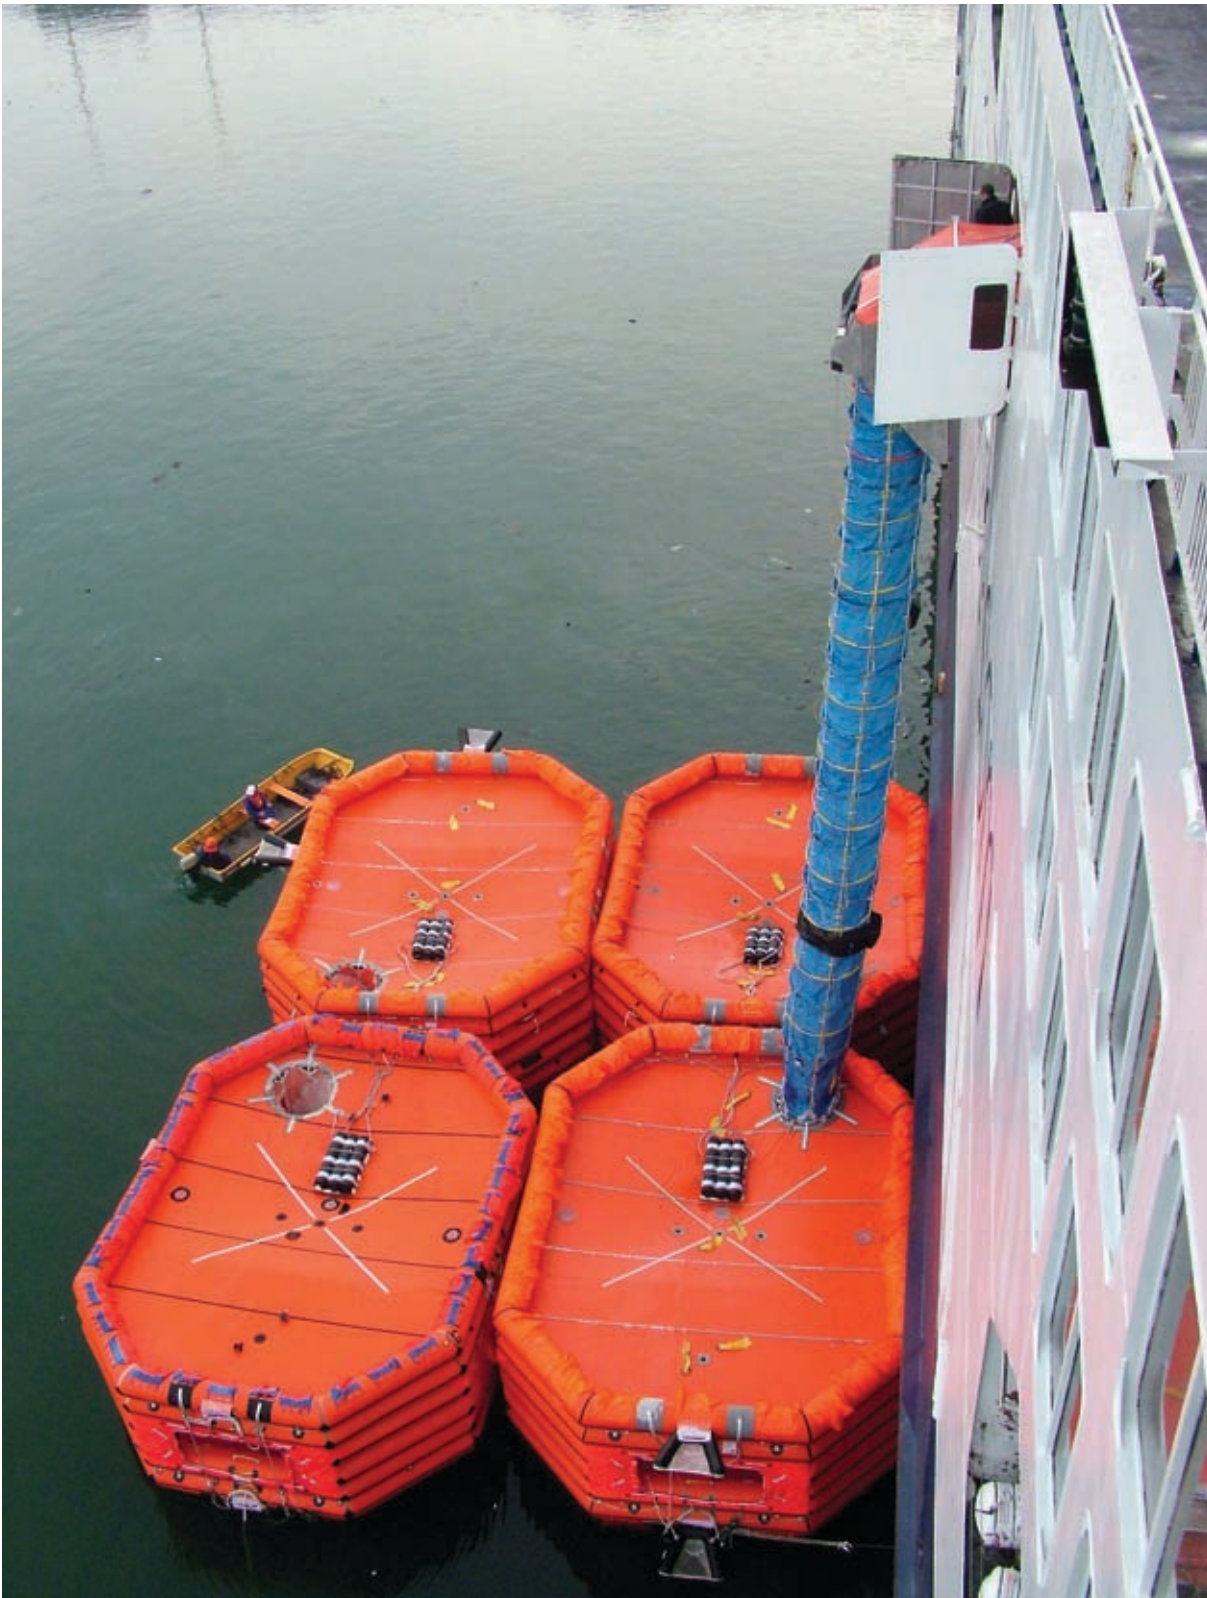
Inspection of the outer door mechanisms of both MESs found that the outer door hinges were extremely stiff to move and could not be opened as intended. The hinges were mounted on the outside of the ship and, although designed for use in a marine environment, had deteriorated significantly. In the first instance, the carriage had then caught on the door structure, causing it to ride up as it moved outboard. Manufacturing errors in the shoot bolt prevented it from engaging correctly, allowing the carriage to twist and damage the hydraulic cylinders.

In the second instance, the liferaft bowing wires had seized in their aluminium channels, on the ship's side, due to a build up of corrosion deposits within the channels. Although the crew conducted weekly and monthly inspections of the equipment, there was no requirement for them to test or maintain the door hinges, and these were only ever operated during the annual deployment or service exchange of liferafts. Inspection of the other outer doors on the vessel, and on a sister vessel, found they were all difficult to operate and had the potential to disrupt the deployment of the MES. Access to the hinges and bowing wire mechanism could only be achieved by using specialist equipment from ashore, and the time available to do this was limited by the vessel's operational schedule.

MES System showing liferafts connected to ship by vertical chute

The equipment manufacturers conducted an investigation into the failures and identified a number of system modifications designed to prevent future, similar deployment problems.

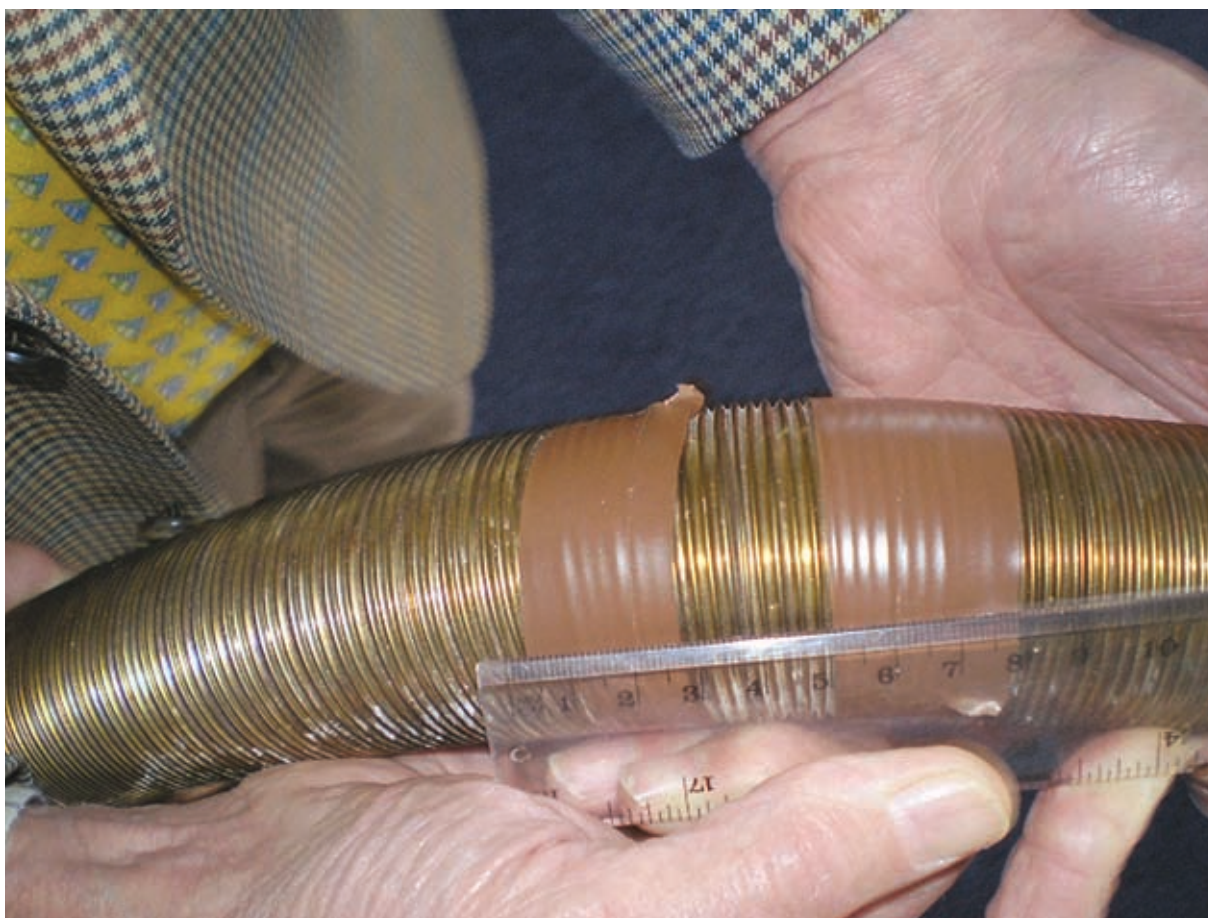
Further checks were made and a small split was found in the heater's exhaust piping in the wheelhouse (figure). It was also determined that the heater's air intake piping had been modified. Instead of drawing air from the wheelhouse, the air supply for the heater was from the engine compartment. Consequently, air contaminated by leaked engine exhaust gases was being supplied directly into the wheelhouse.

Heater exhaust pipe with crack indicated at the 4cm mark on the ruler

After the heater's exhaust piping was repaired and its air intake ducting reconnected to a vent grill, as intended, no further illnesses were reported. A carbon monoxide detector was also fitted in the wheelhouse.

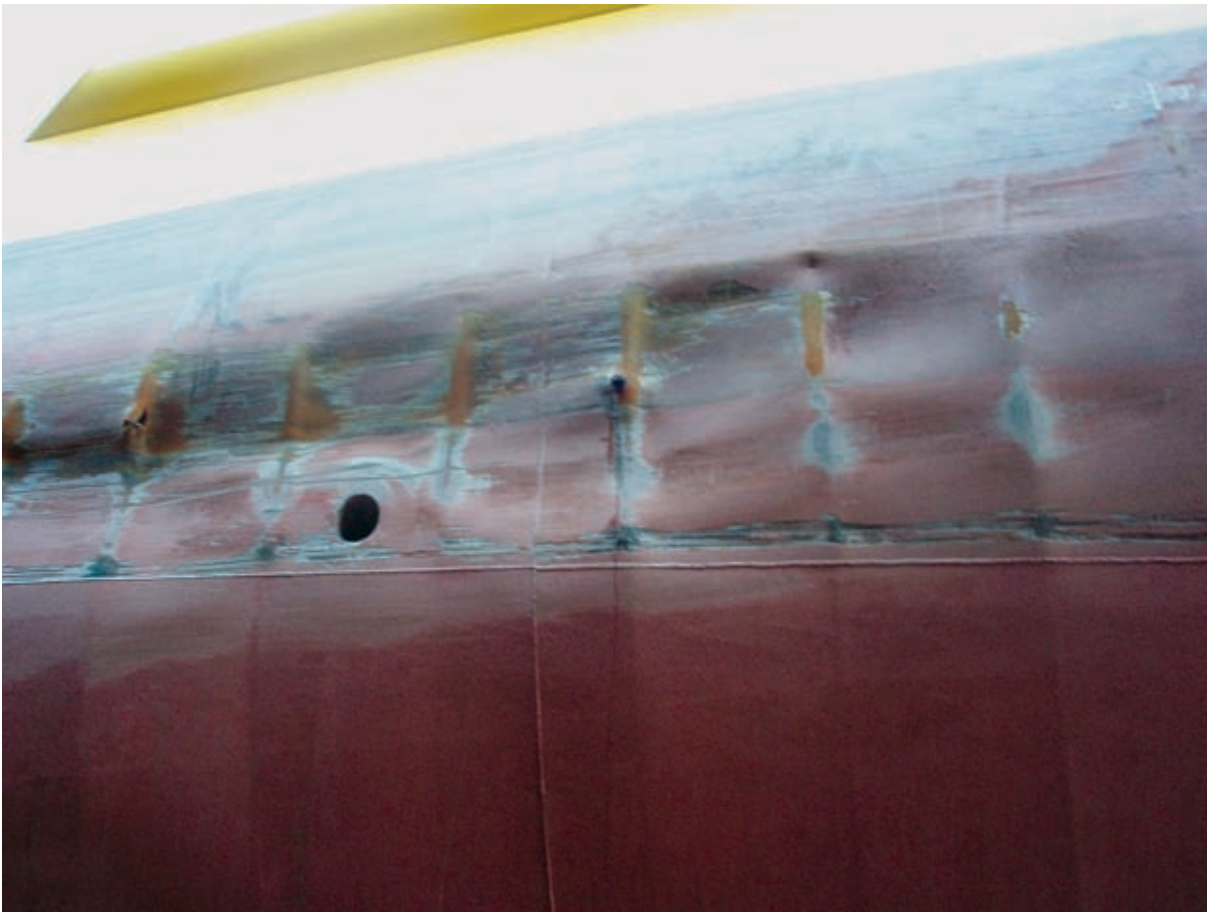
On arrival at the next port, an inspection of the hull was carried out, which revealed that the vessel was holed below the waterline. She was taken out of service for almost 2 weeks while repairs were undertaken. The contact caused significant damage to a large area of fendering, which led to the port authority revising its guidelines for the berthing and unberthing of vessels in strong winds.

Damage to hull

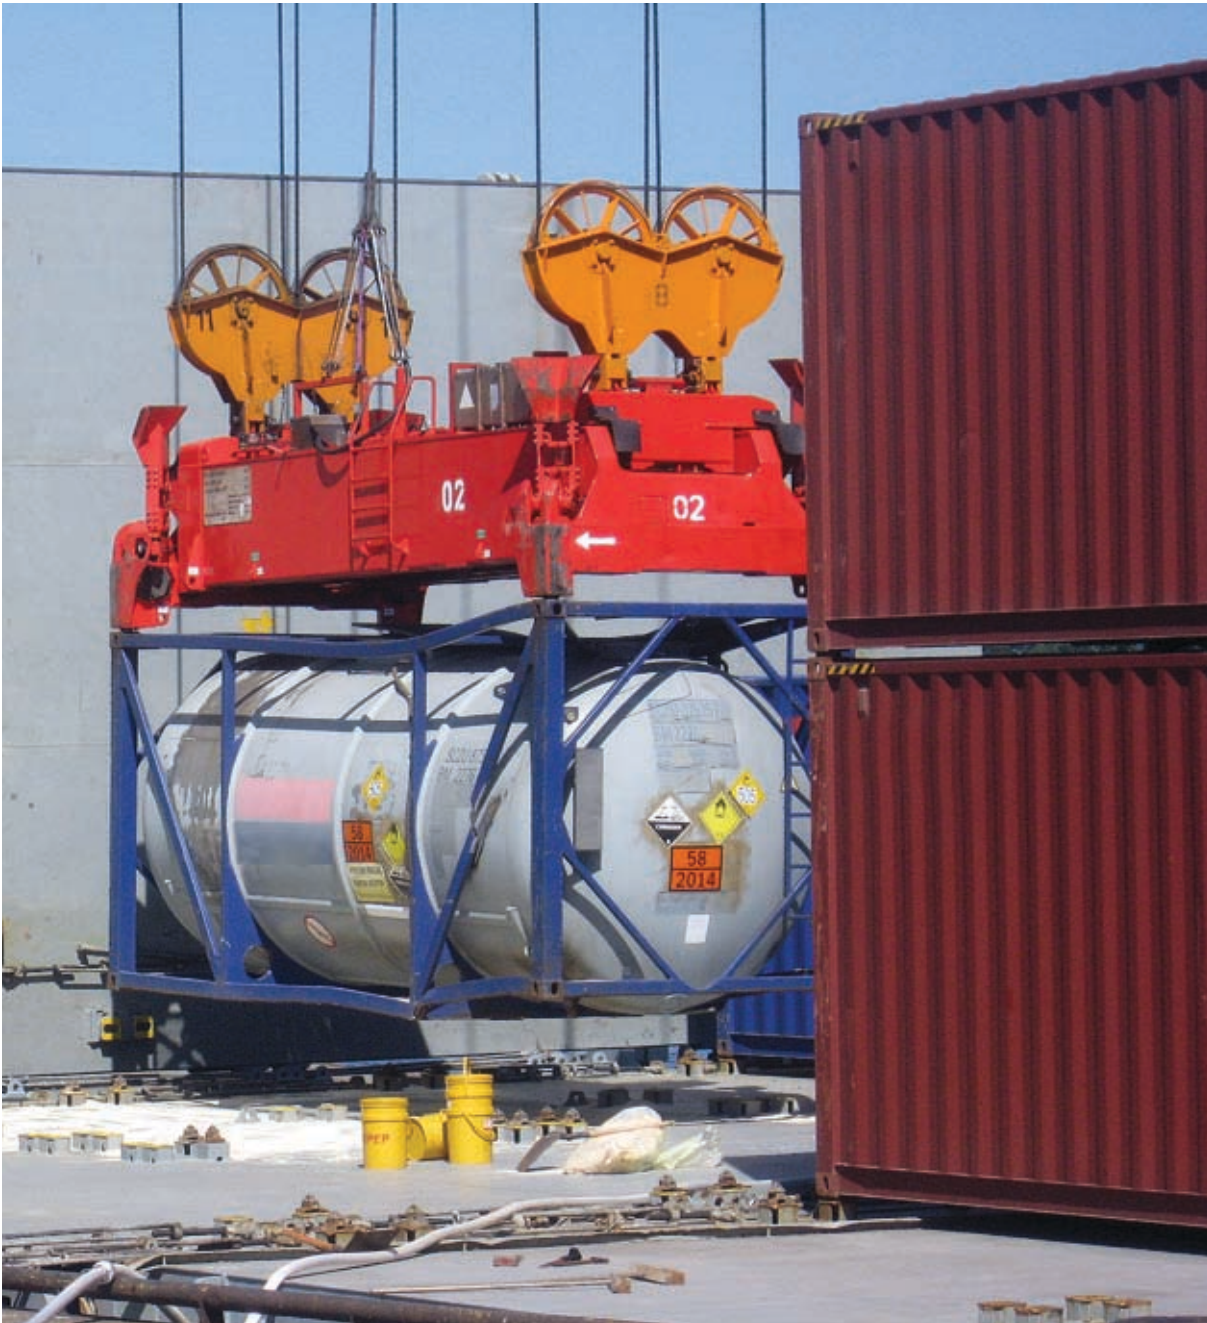
Figure 1

container was lifted between 30cm and 50cm before it dropped back to deck. The impact caused the tank frame to buckle and resulted in the release of a small quantity of the tank's contents (Figure 1). The crew immediately plugged the deck scuppers and spread sawdust over the deck to absorb the spilled liquid.

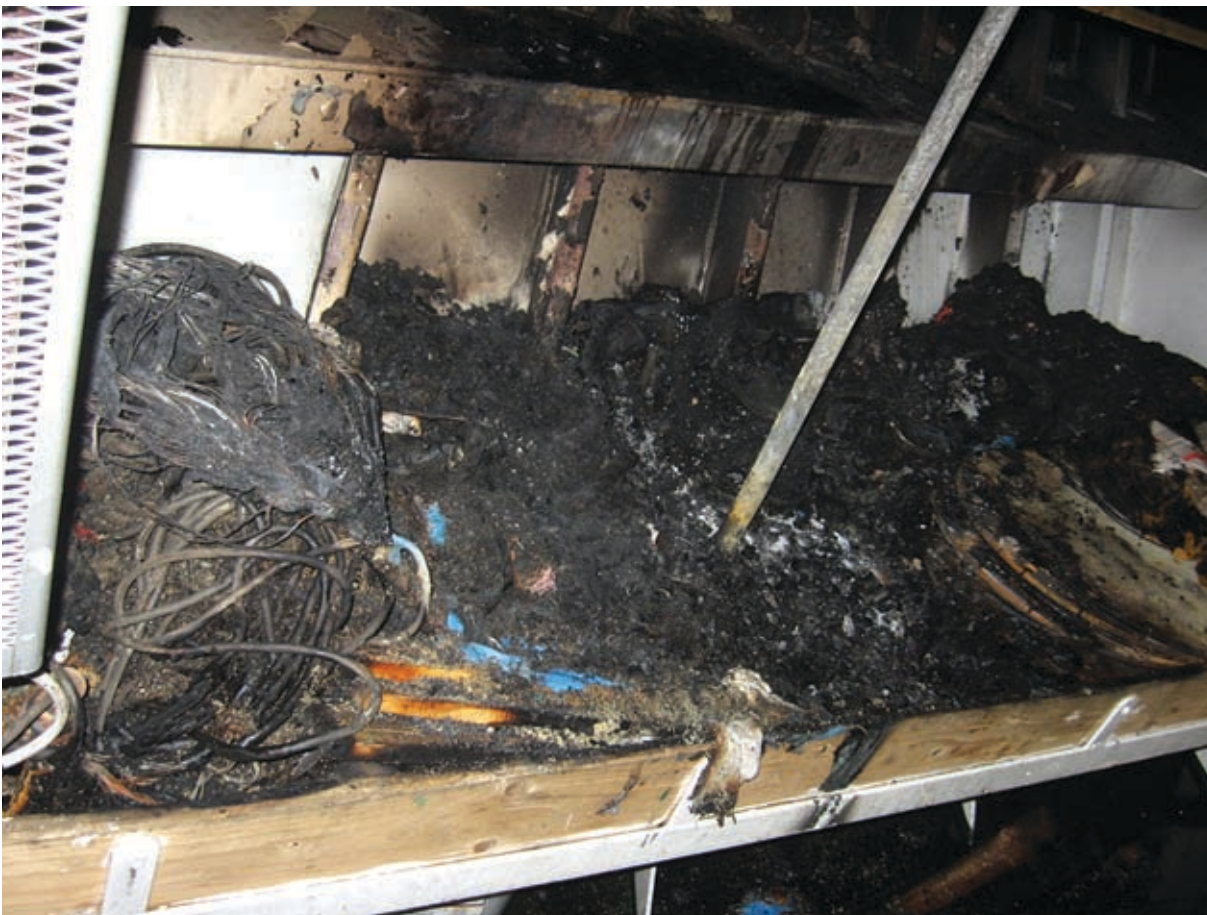
Figure 3

About 1 hour after the sawdust had been cleared, smoke was seen coming from the foc'sle store. The alarm was raised and the crew were again mustered on the poop deck. Two fire-fighting teams, wearing breathing apparatus and fire suits, fought the fire using water hoses, and it was extinguished approximately 20 minutes after being discovered. The local emergency services cleared the compartment of smoke and inspected the damage (Figure 3).

The fire was started by the self-ignition of the hydrogen peroxide-impregnated sawdust, which generated oxygen and heat as it

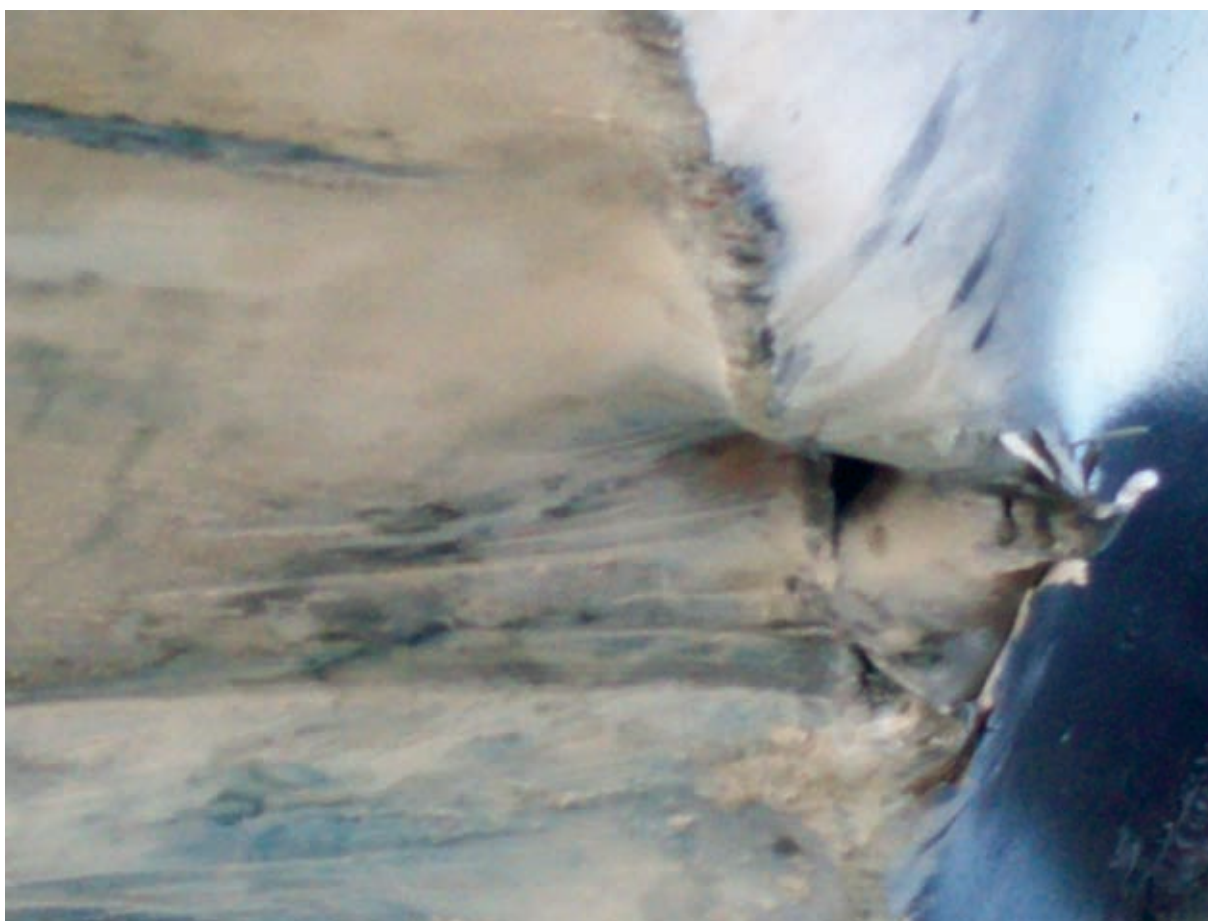
The ship then continued without further incident into the river. As the pilot boat's coxswain passed the ship's stern to take off the pilot, he reported to the master and pilot that he could see a hole in the ship's port quarter. Having inspected the damage internally and from the pilot boat, the master decided to return to port for repairs.

Figure 2: The hole

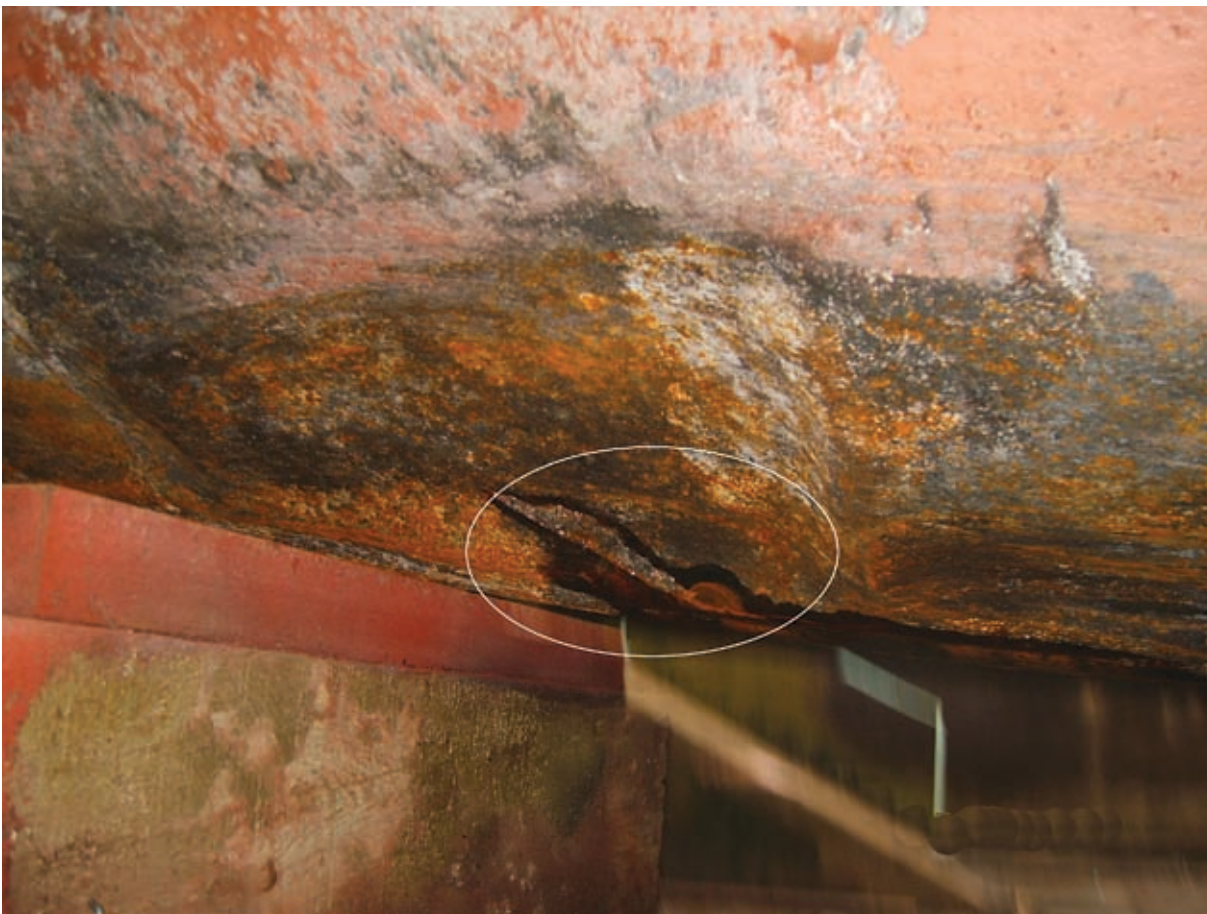
While alongside in port, a minor quantity of gas oil was discharged overboard during ballasting operations. This had resulted from a split between the ballast tank and an adjacent bunker tank, which had been caused during the grounding.

Damage to hull

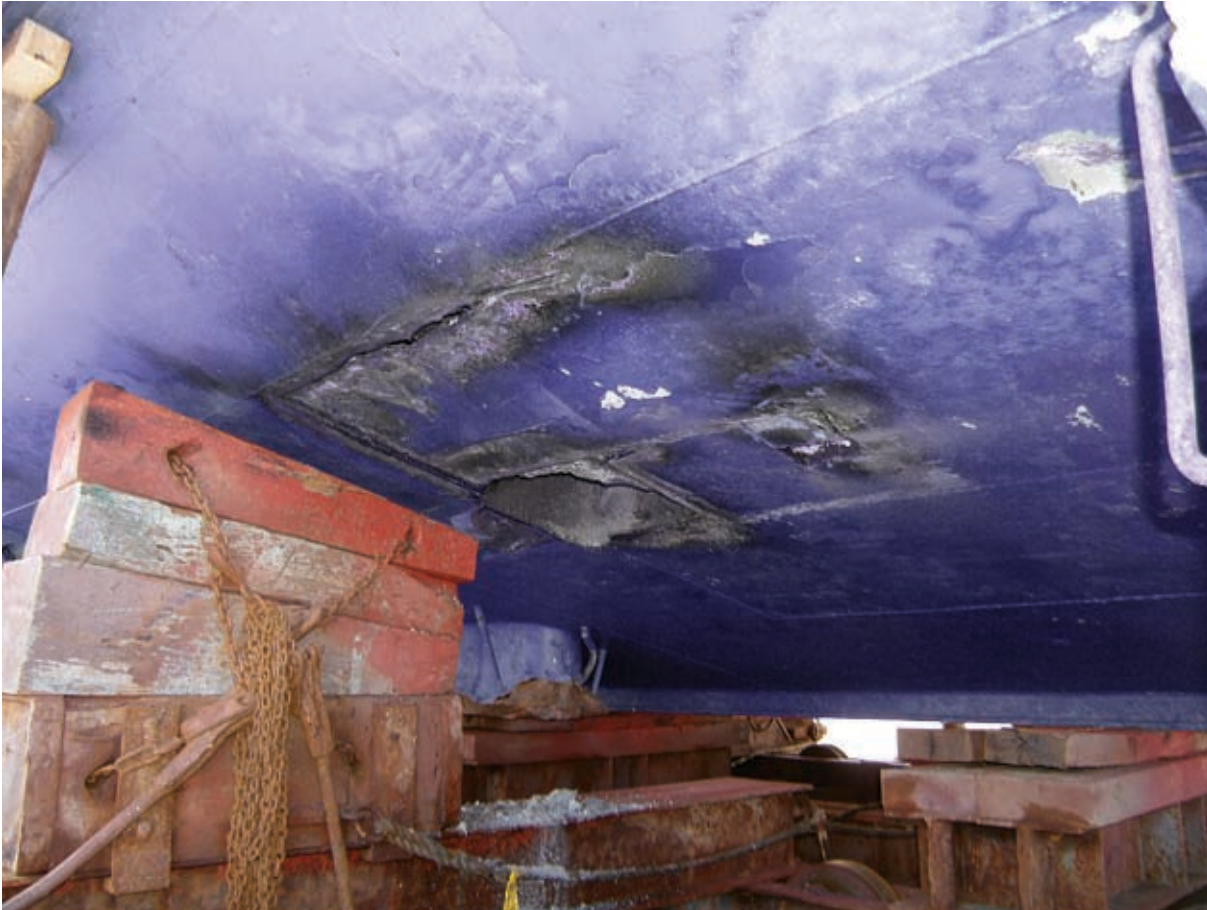
Some of the damage caused by the grounding

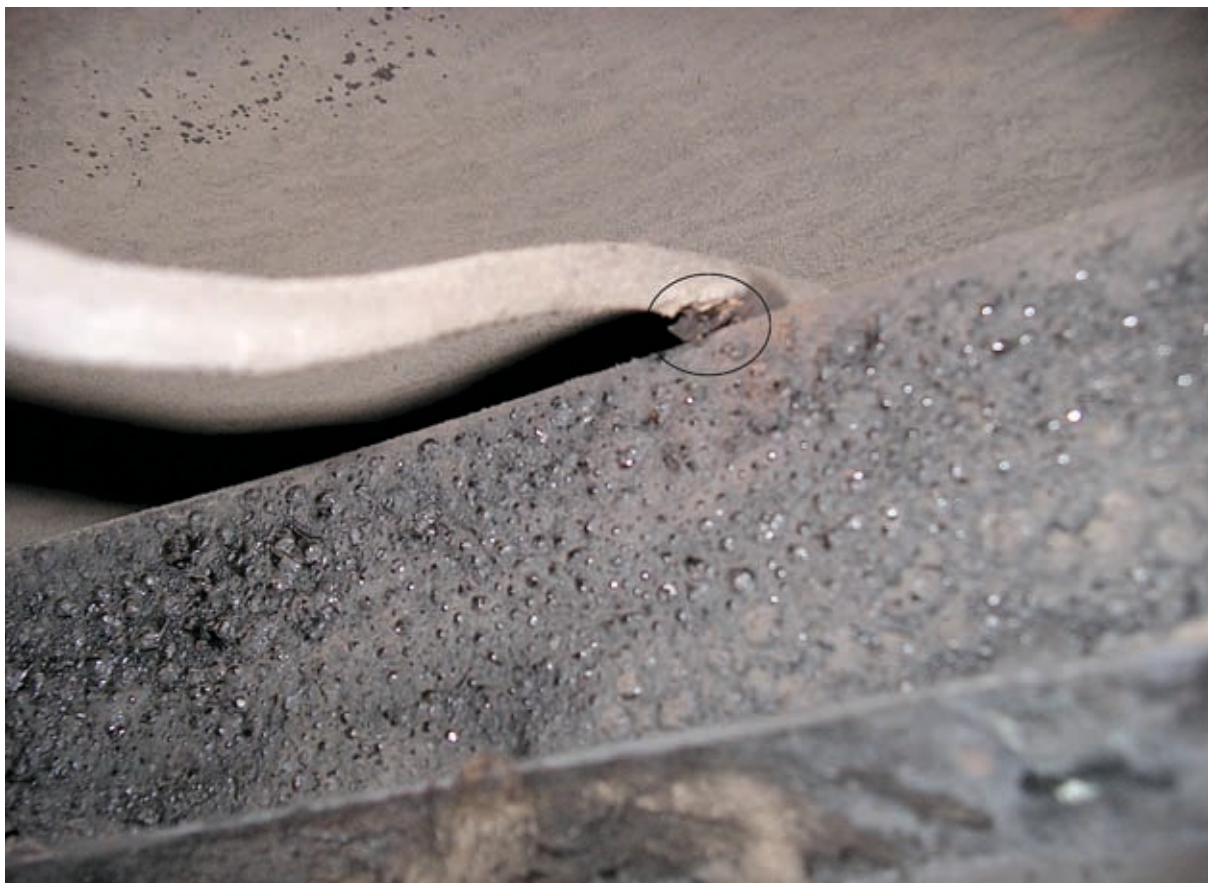
Figure 1: Cable chafing

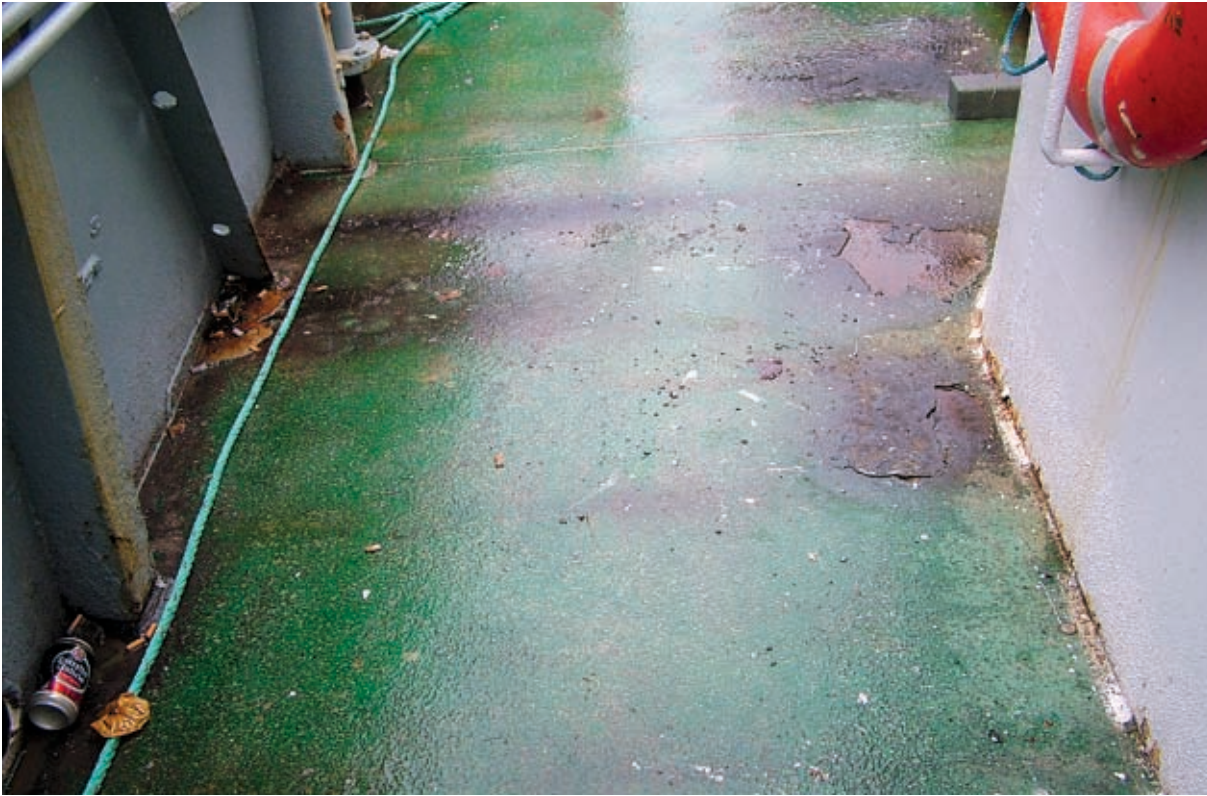
Figure 2: Blistering of the paint on the main deck

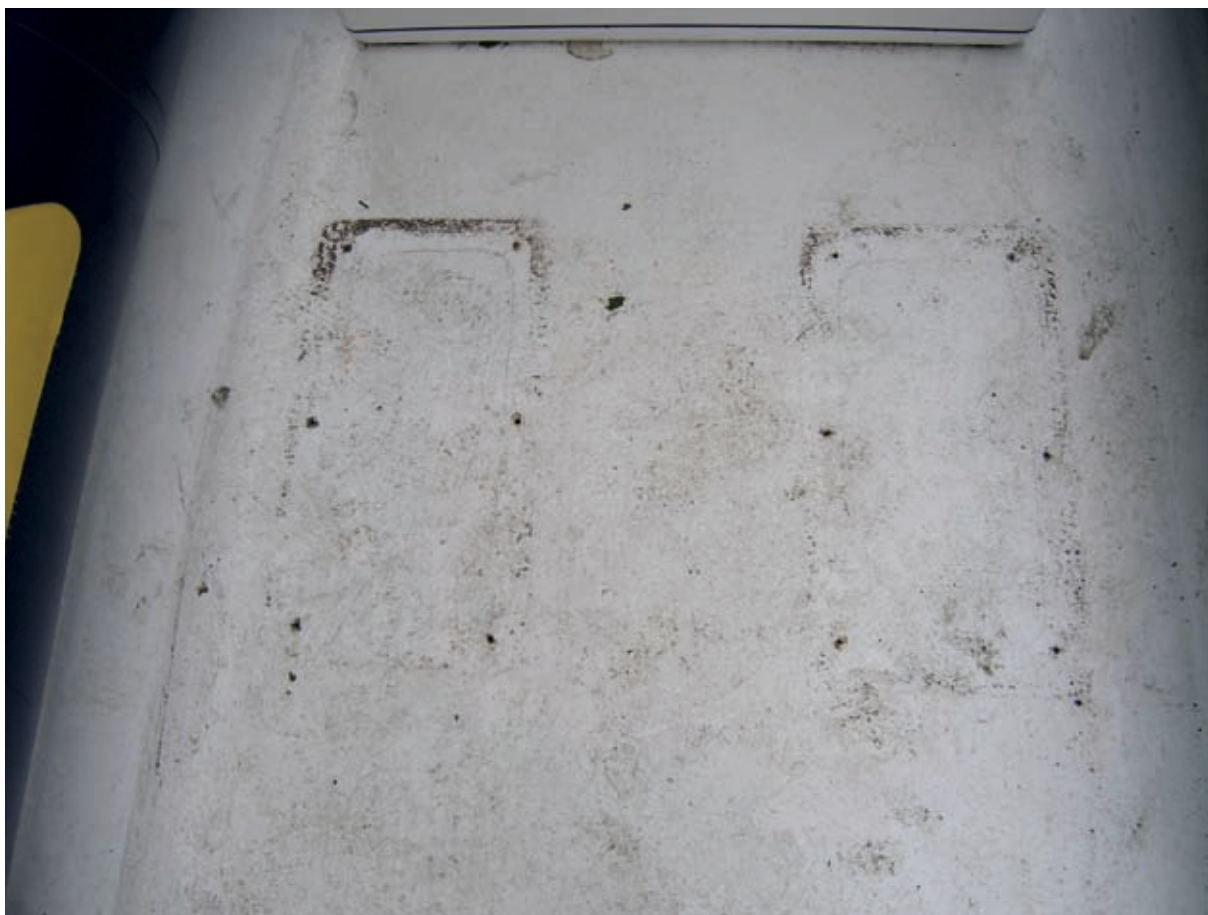
Vessel's deck showing outline of consoles – note lack of deck preparation and adhesive

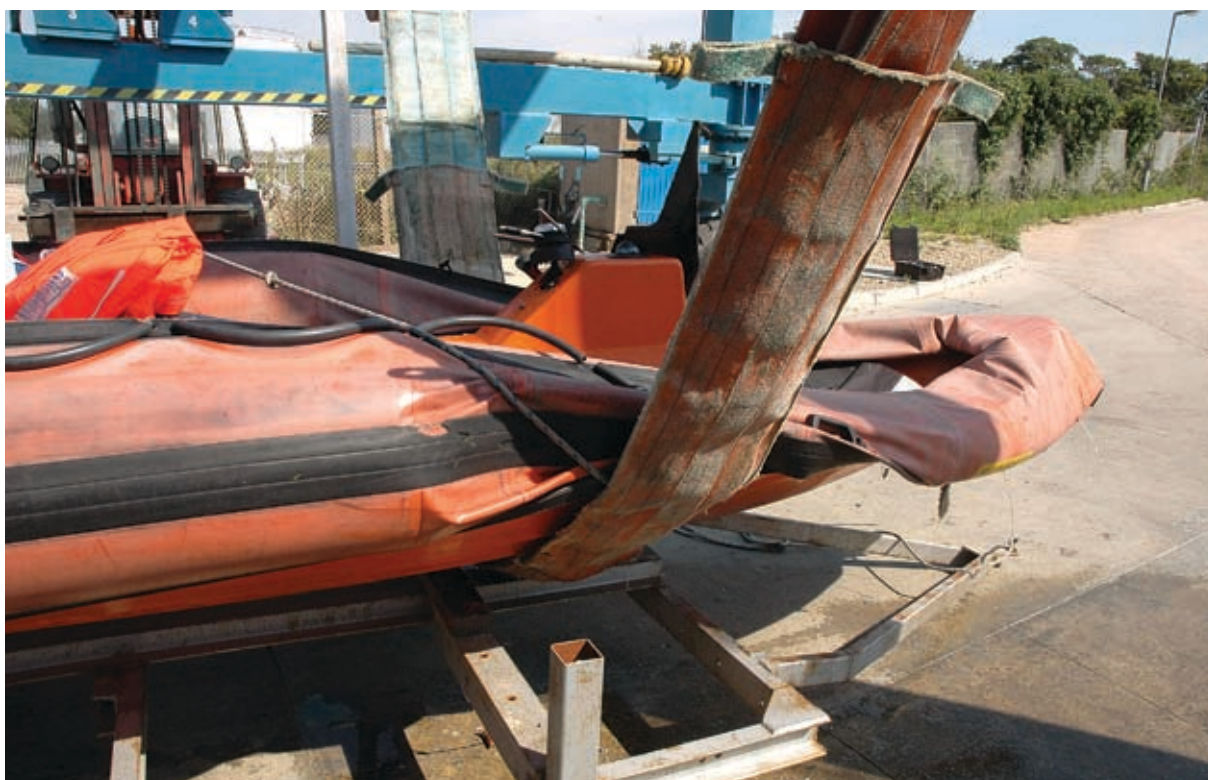
Recovered damaged RIB

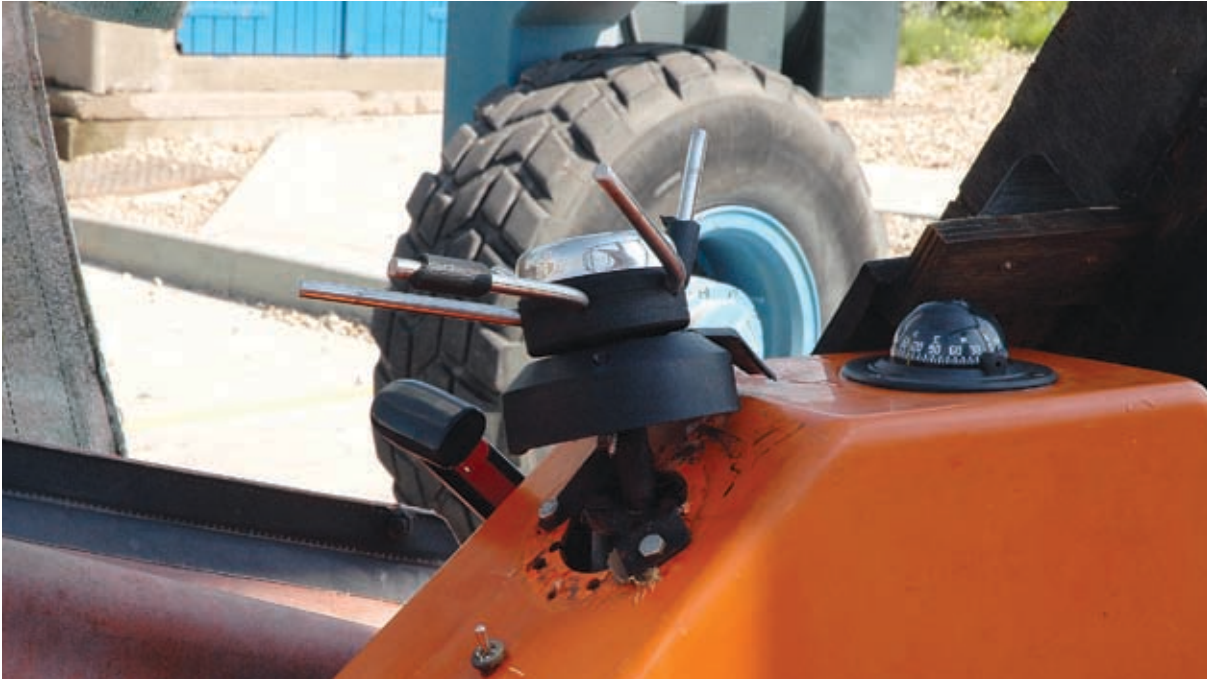
Damage to steering wheel following impact of the skipper
