MARINE ACCIDENT  
INVESTIGATION BRANCH

# SAFETY DIGEST

**Lessons from Marine  
Accident Reports  
2/2009**

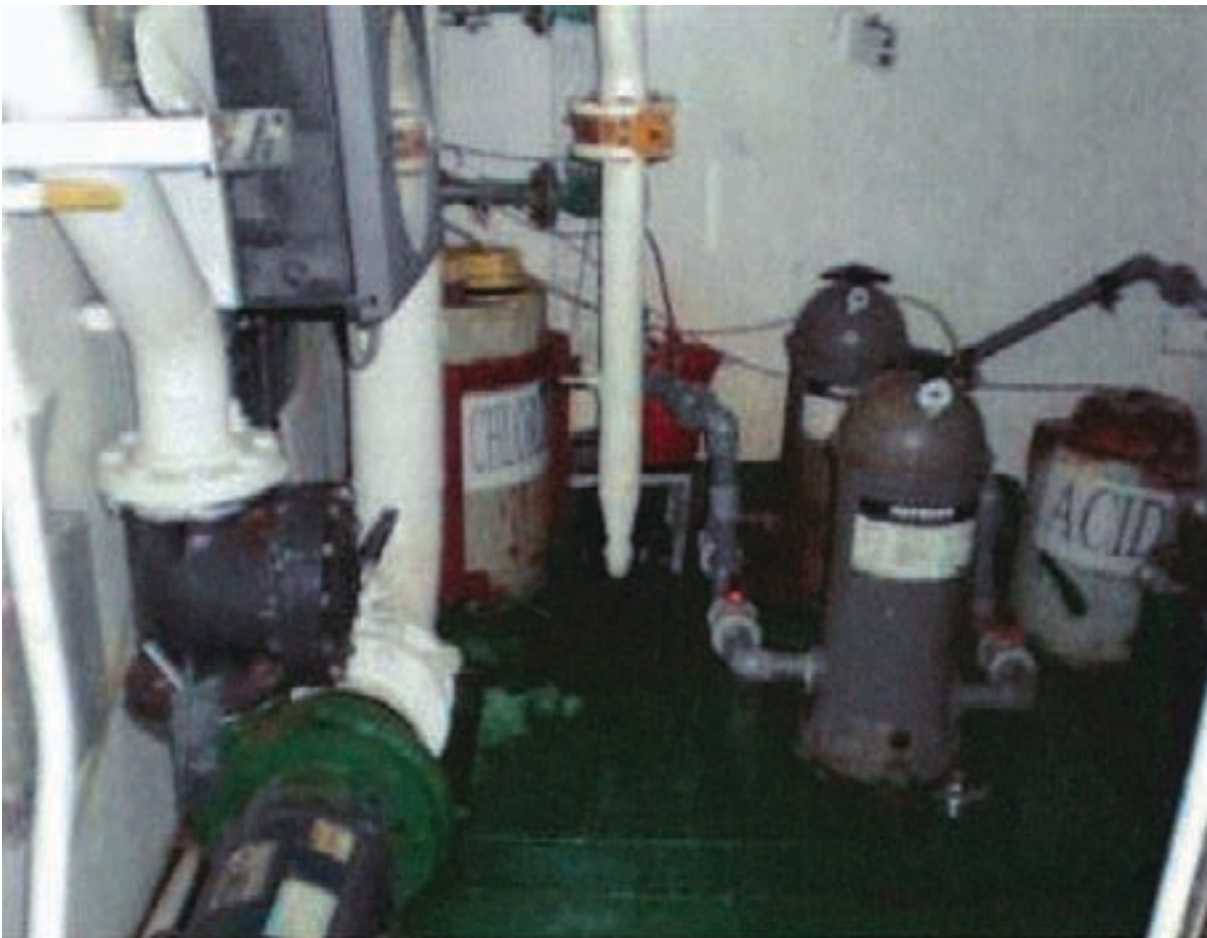
Figure 1: Pool machinery room

treatment of the swimming pool and jacuzzi waters. On the day before the incident, there had been a chlorine spill in the pool machinery room (Figure 1) and there remained a fairly strong residual smell. The technical team was unaware of the spill and mistakenly believed there had been cross-contamination between the chlorine and hydrochloric acid systems, which gave rise to the pungent smell.

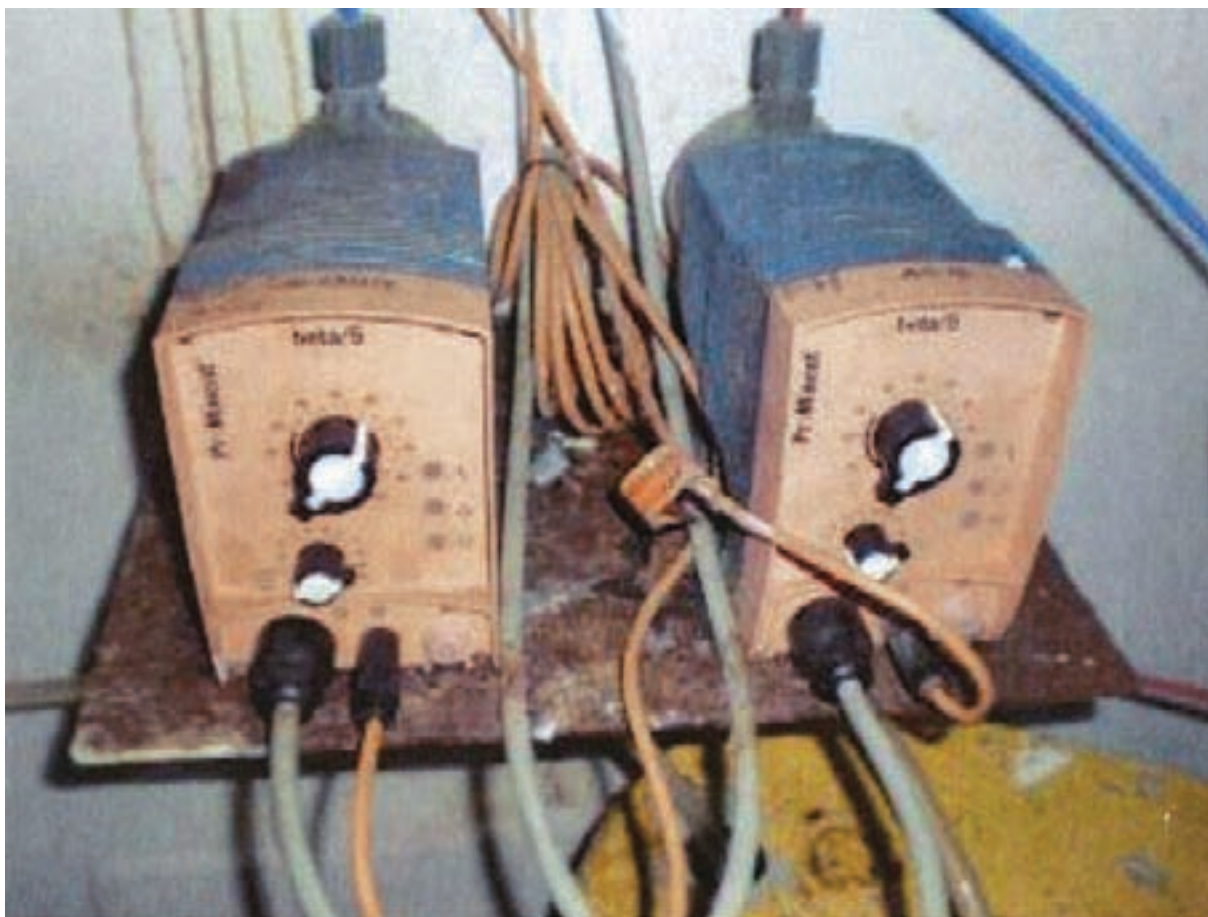
Figure 2: Pool dosing pumps

It was decided to empty the chlorine and acid drums. About 20 litres of chlorine and 50 litres of the hydrochloric acid were pumped from the drums supplying the pool dosing pumps (Figure 2), and disposed of down the pool machinery room scupper drains into the grey water holding tank. This resulted in gas being liberated into the pool machinery room, which was inhaled by a wiper who was assisting the technical team. Although he was reported as wearing personal protective equipment (PPE), it is unclear whether he was wearing the appropriate respiratory protection. Water was

6. Hydrochloric acid is highly reactive when in contact with alkaline materials and, as a result, will liberate hazardous gases. In this case the contents of the grey water tank were largely alkaline, and contributed to the release of the gases. Hazardous chemicals should be disposed of in a safe manner, and in most cases this will be at a shore-side facility.

1. Does your ship's safety system identify how to properly dispose of chemicals? It should.
2. Risk assessments should direct staff to thoroughly read and understand the hazards associated with the chemical, as specified in the relevant MSDS/Safety Data Sheet (SDS).

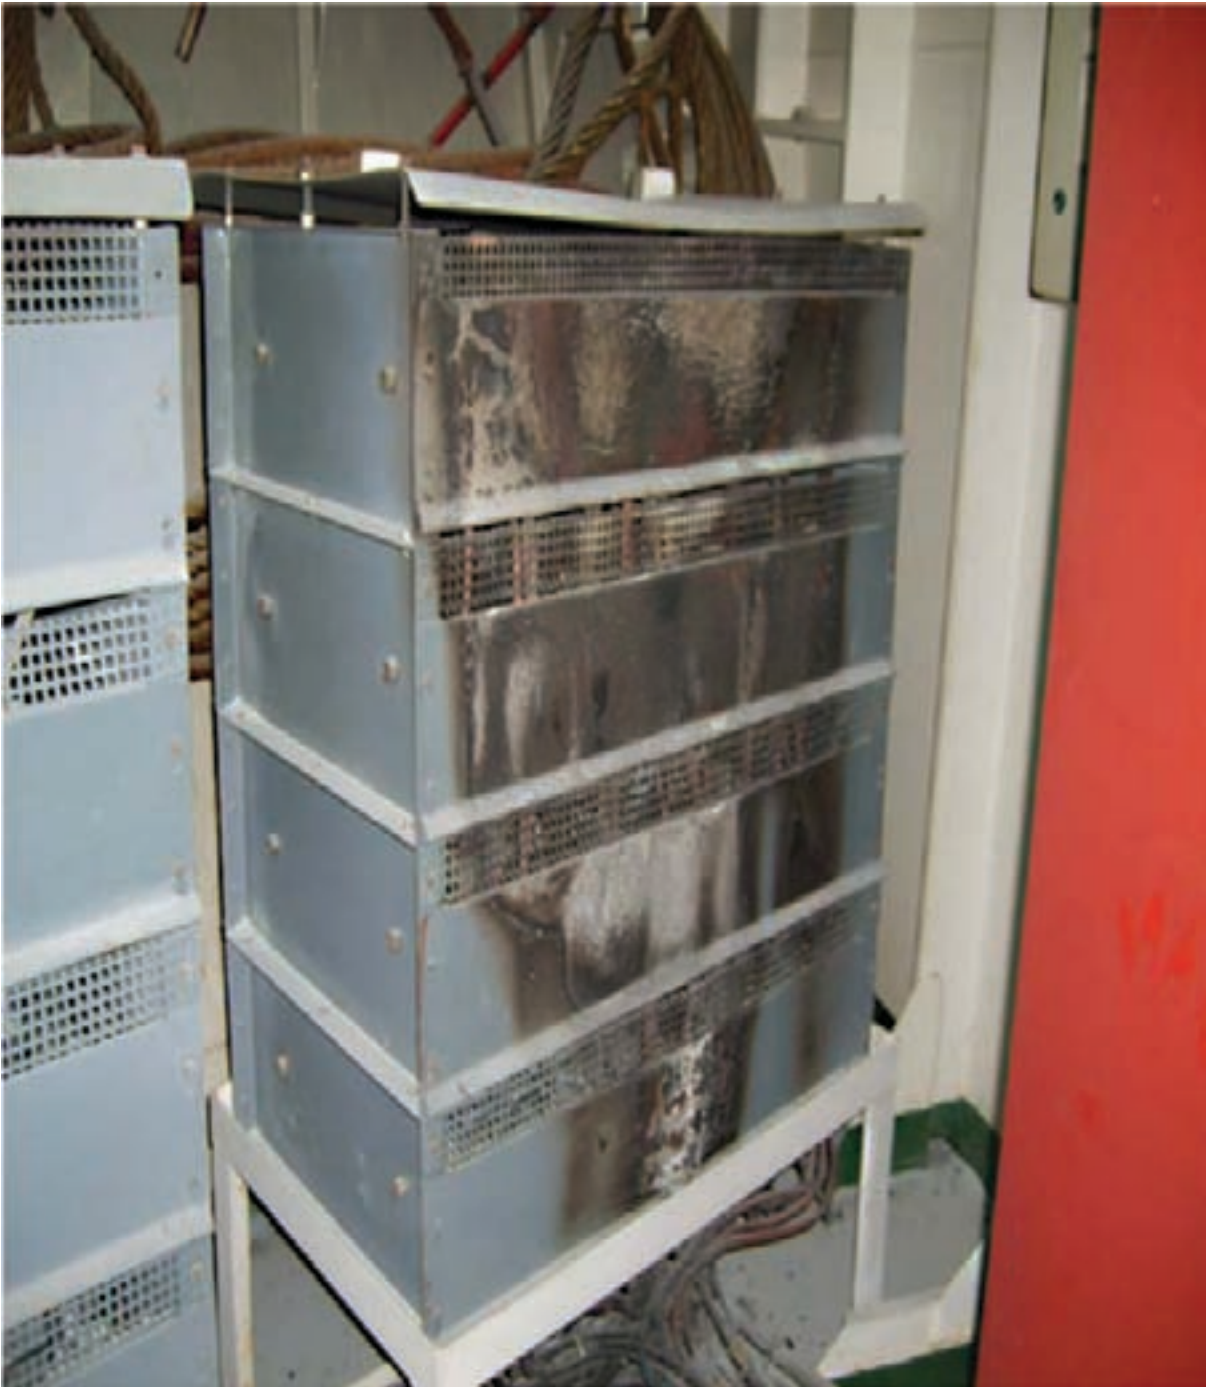
Figure 1: Bow thruster electrical resistor cabinet

The chief officer took charge of the deck and approved a two-man team to attack the fire with an extinguisher. They were able to enter the compartment and discharge their CO<sub>2</sub> extinguisher, but they were beaten back by the smoke. In the meantime, boundary cooling had been set up and additional firefighters wearing fire suits and breathing apparatus arrived at the scene. They made a controlled entry of the compartment, extinguished a small fire and doused the smouldering cables in the bow thruster electrical resistor cabinet (Figure 1).

On investigation, it was found that the resistor cable insulation had burnt, indicating that the bow thruster had drawn excess current, and this caused an increase in the cable temperature (Figure 2). All the indications pointed to a seized bow thruster as being the cause. However, once the motor brake had been released, the bow thruster shaft was free to turn, proving that the gearbox and bearing arrangements were not seized.

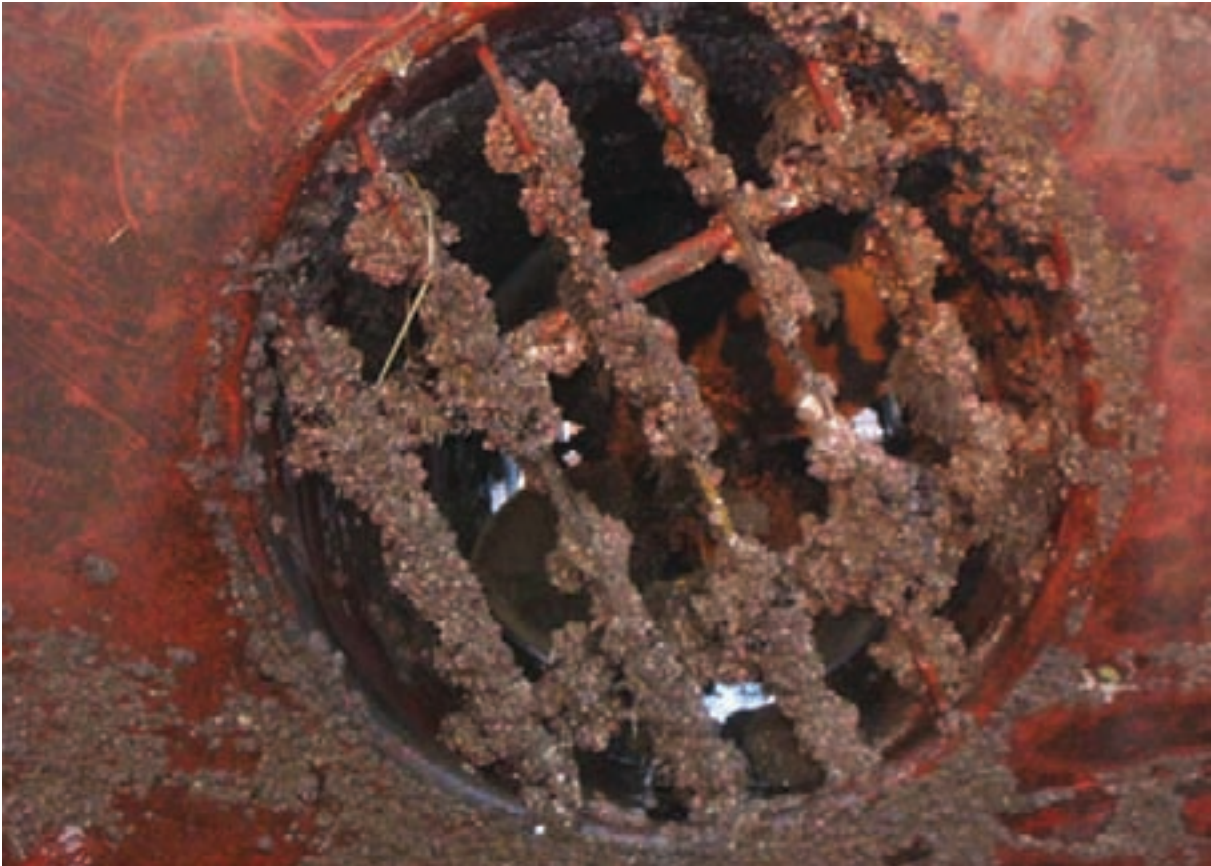
Figure 3: Mussel and barnacle fouling of an inlet grid

The vessel was dry docked a week after the accident as part of the Continuous Class Survey schedule. Subsequent investigations found that there was extreme mussel and barnacle fouling of the inlet grids (Figure 3), propeller hub, and up to one third of the

propeller blade length (extending from the hub connection) (Figure 4). The fouling led to strong turbulence and pressure build up within the bow thruster tunnel, and this in turn caused the high electrical currents leading to the overheating situation.

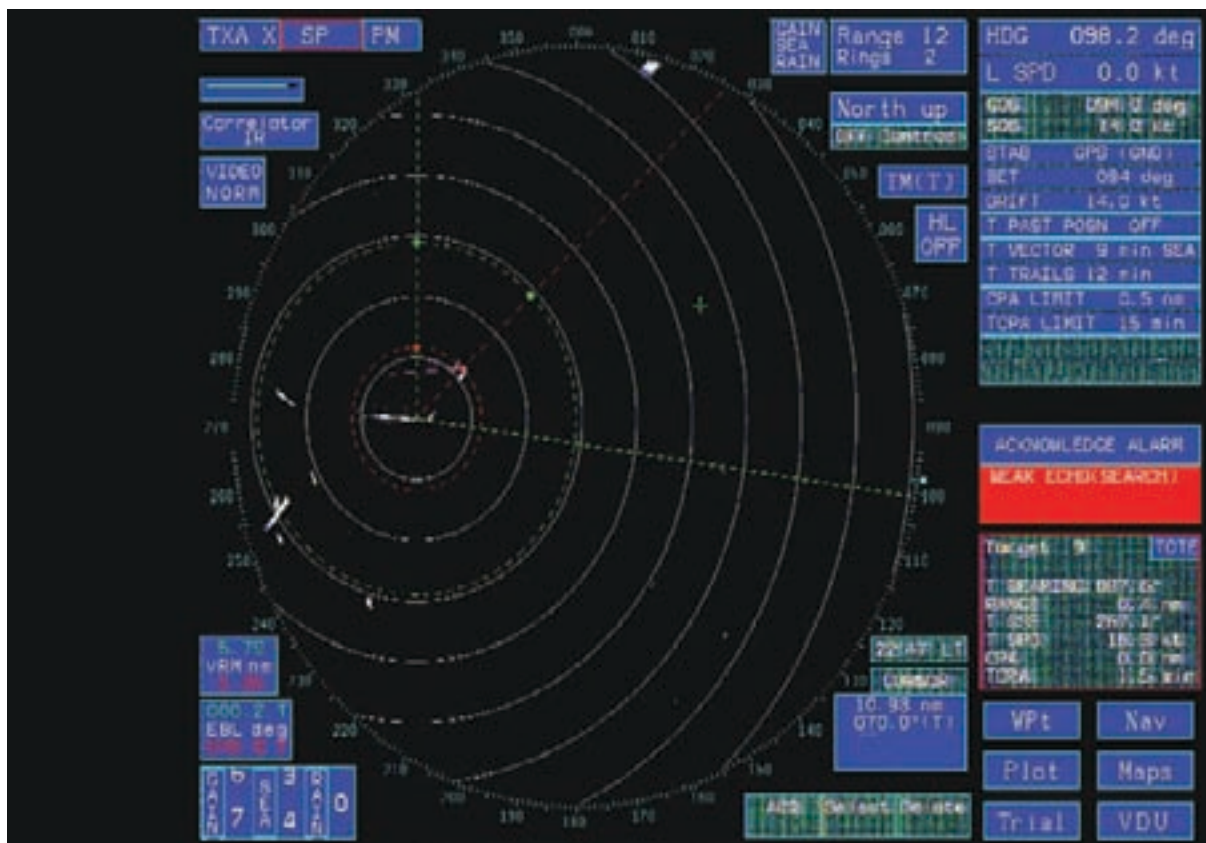
Radar image of close-quarters situation

1. The radar was set up to be sea stabilised, but the log input was reading zero knots. Therefore the target's true data was not correct. Collision avoidance was being assessed by reference to the target's and own ship's true vectors, in that if the ends of the two vectors touched, then a risk of collision existed. The fact that own ship was not displaying a true vector, due to the zero speed input, seems to have been missed, and a risk of collision was not initially identified. The relative vector and the CPA information under these conditions will indicate the correct situation. The CPA indicated was 0.0, and this was displayed as part of the ARPA target data, but was ignored. The relative vector would have pointed directly at the display origin. Had either of these been referred to, or used, a better assessment of the risk of collision by ARPA could have been made.

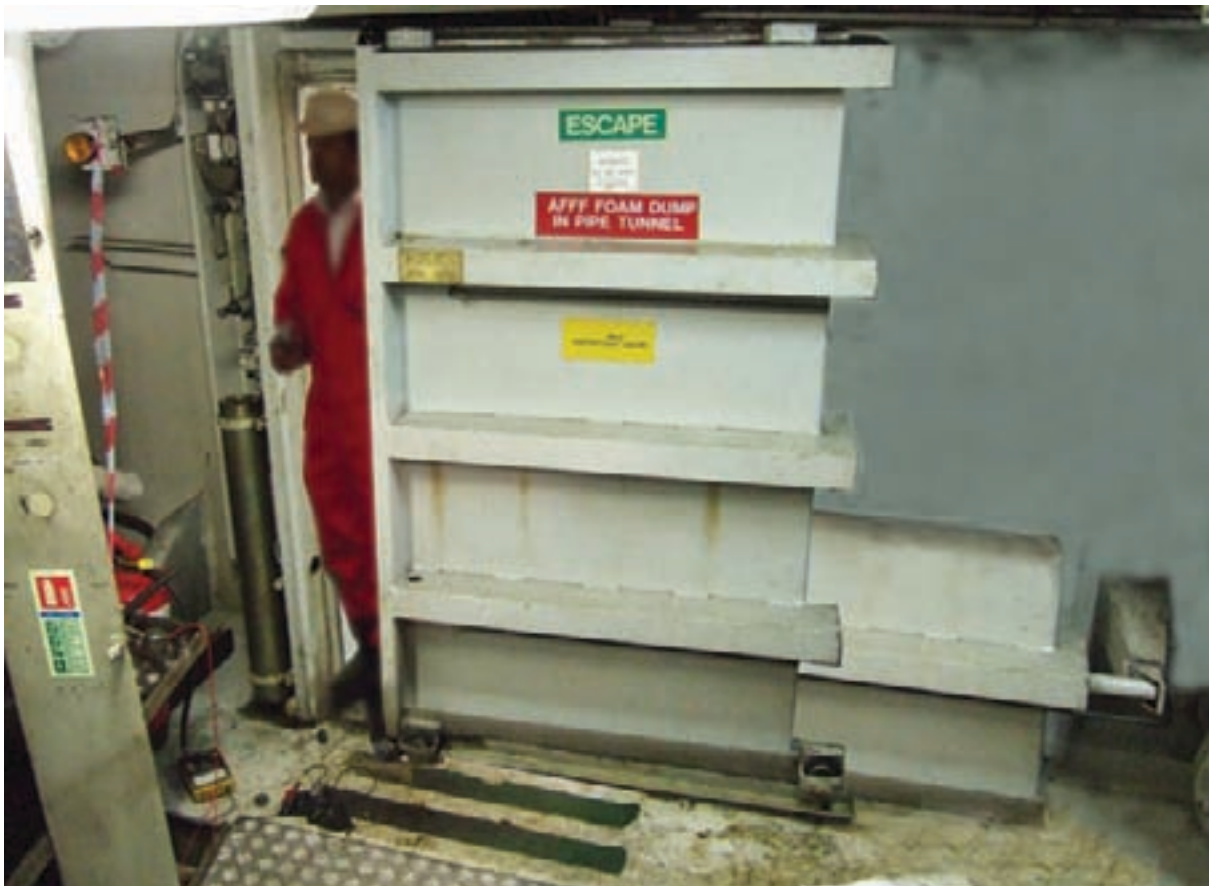
room. There, he found the ETO unconscious and pinned upright between a powered watertight door and its frame (Figure 1). The watertight door was set to operate in the 'remote closing' or 'automatic' mode and could not be opened because the movement of its operating lever was impeded by the ETO's upper torso. The third engineer raised the alarm and the ETO was eventually freed after the hydraulic pressure on the watertight door was released. The ETO's tools were found on both sides of the door.

Simulated position of casualty stuck in powered watertight door

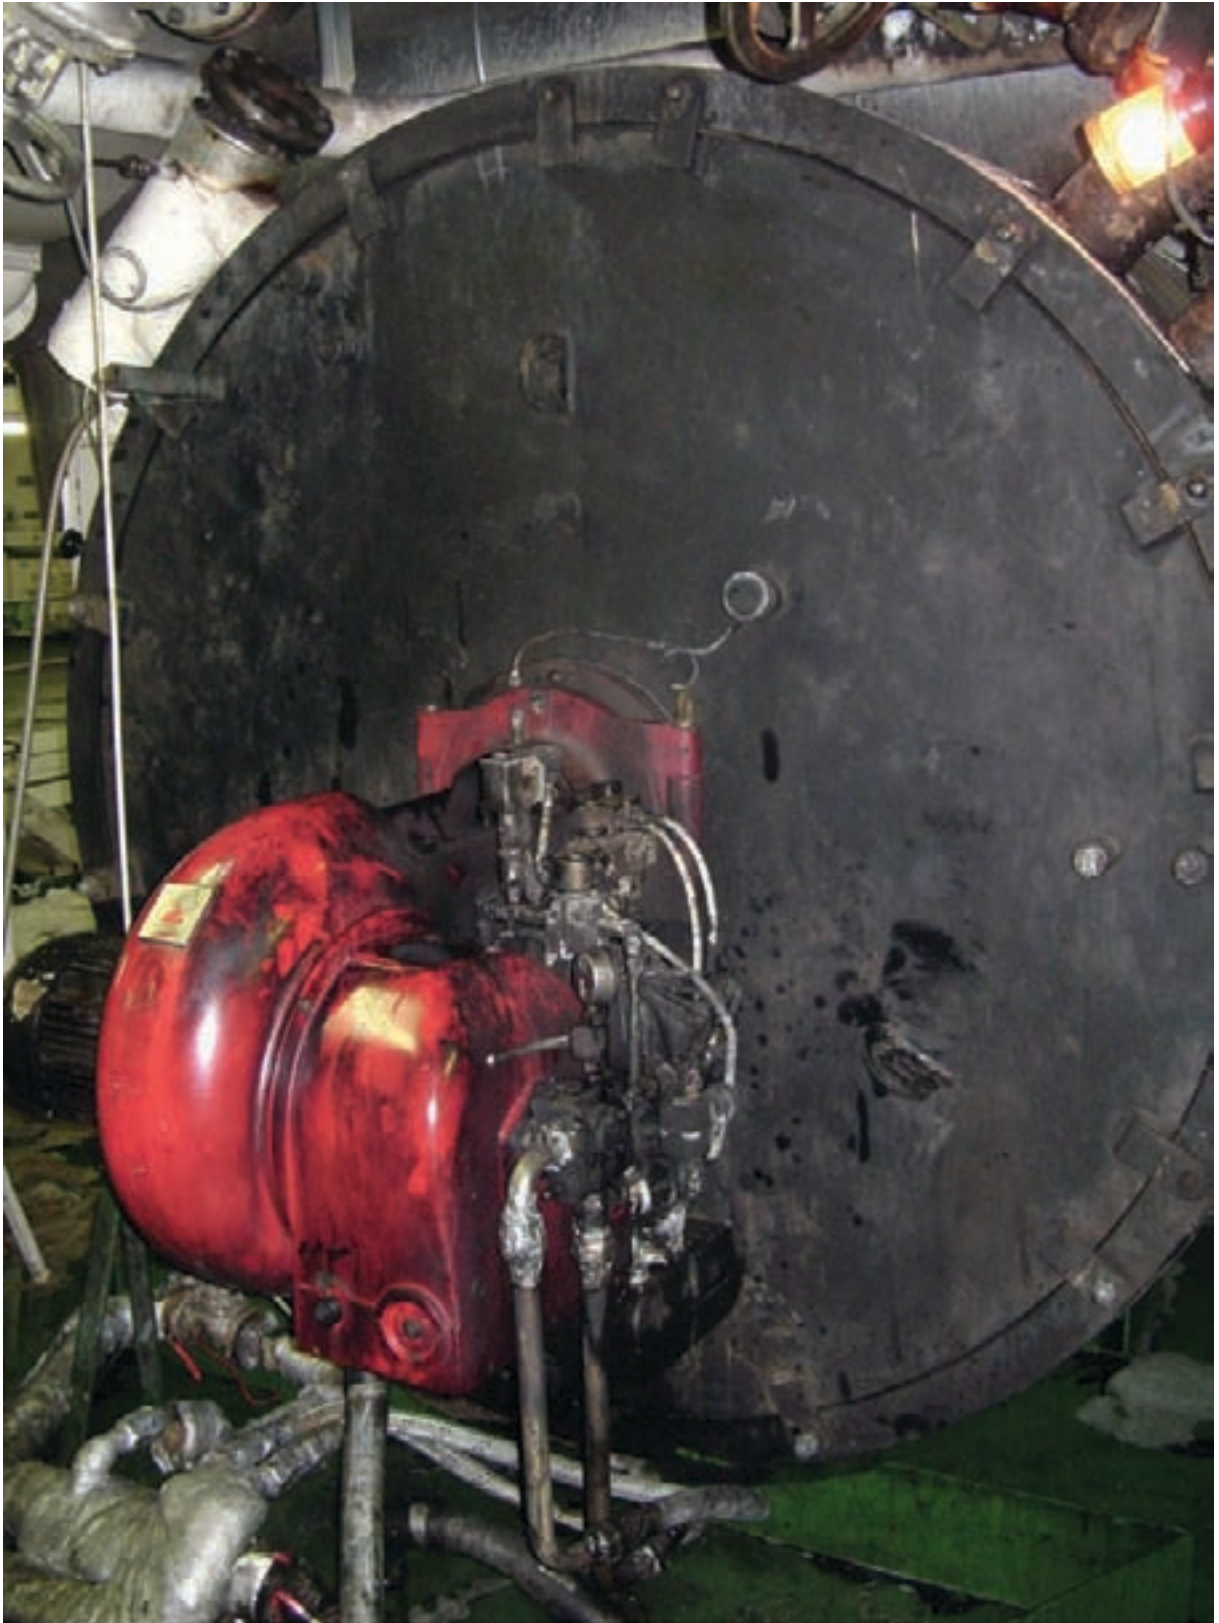
After consultation with the fire brigade, foam continued to be applied into the furnace. Eventually an inspection plate on top of the burner was able to be removed and the foam applied directly into the furnace. The fire was declared extinguished 90 minutes after it had started.

Burner after the fire

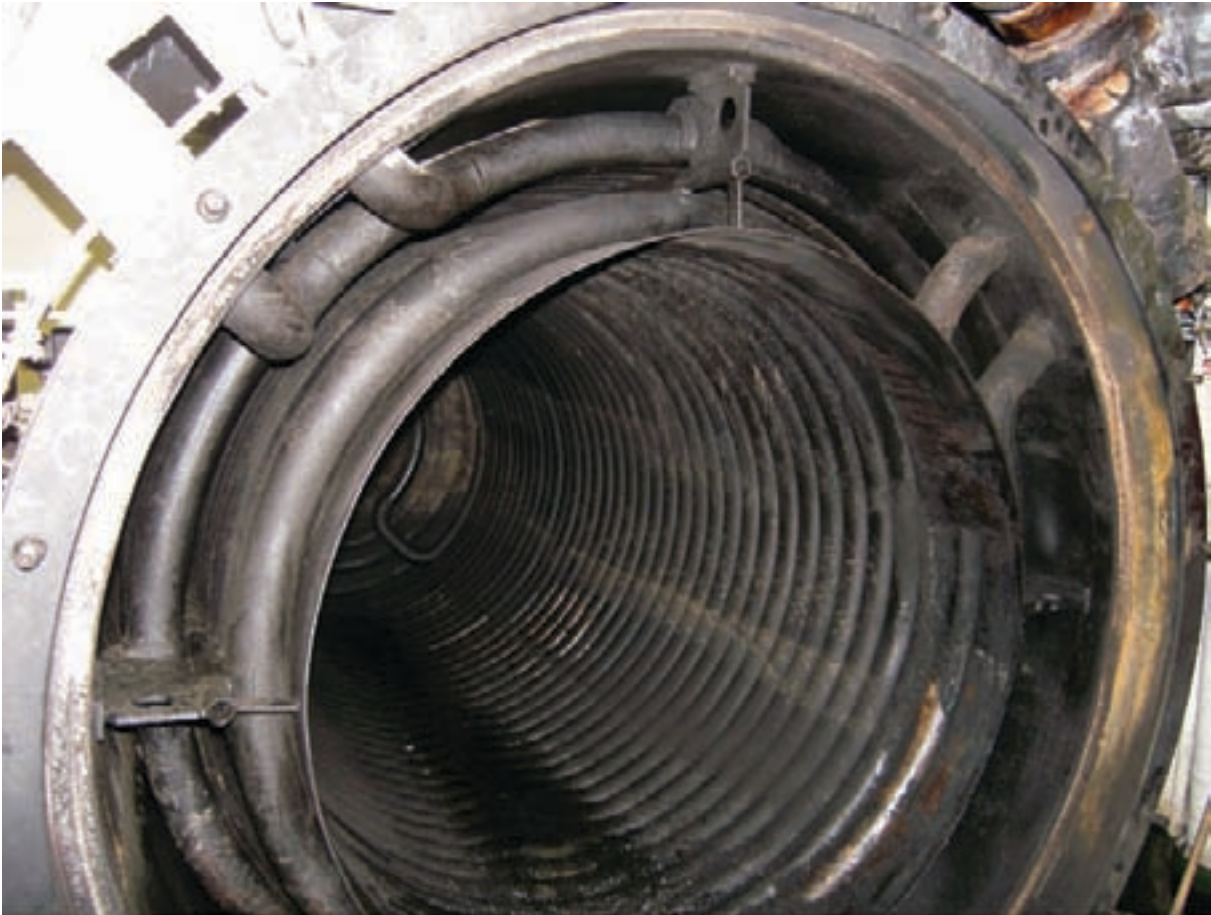
Thermal oil heater furnace

2. The thermal oil heating system was generally regarded as being very reliable and requiring low maintenance. Unfortunately, although the planned maintenance schedule required the inside of the furnace to be cleaned annually, this had been omitted from the last refit. Because the heater burnt heavy fuel oil, over time a build up of carbon in the furnace was inevitable, and this likely provided the local hot spot that started the fire.

In this case, fitting a fire damper to the burner air intake and including an injection point into the furnace for foam or CO<sub>2</sub> would not have been difficult modifications.

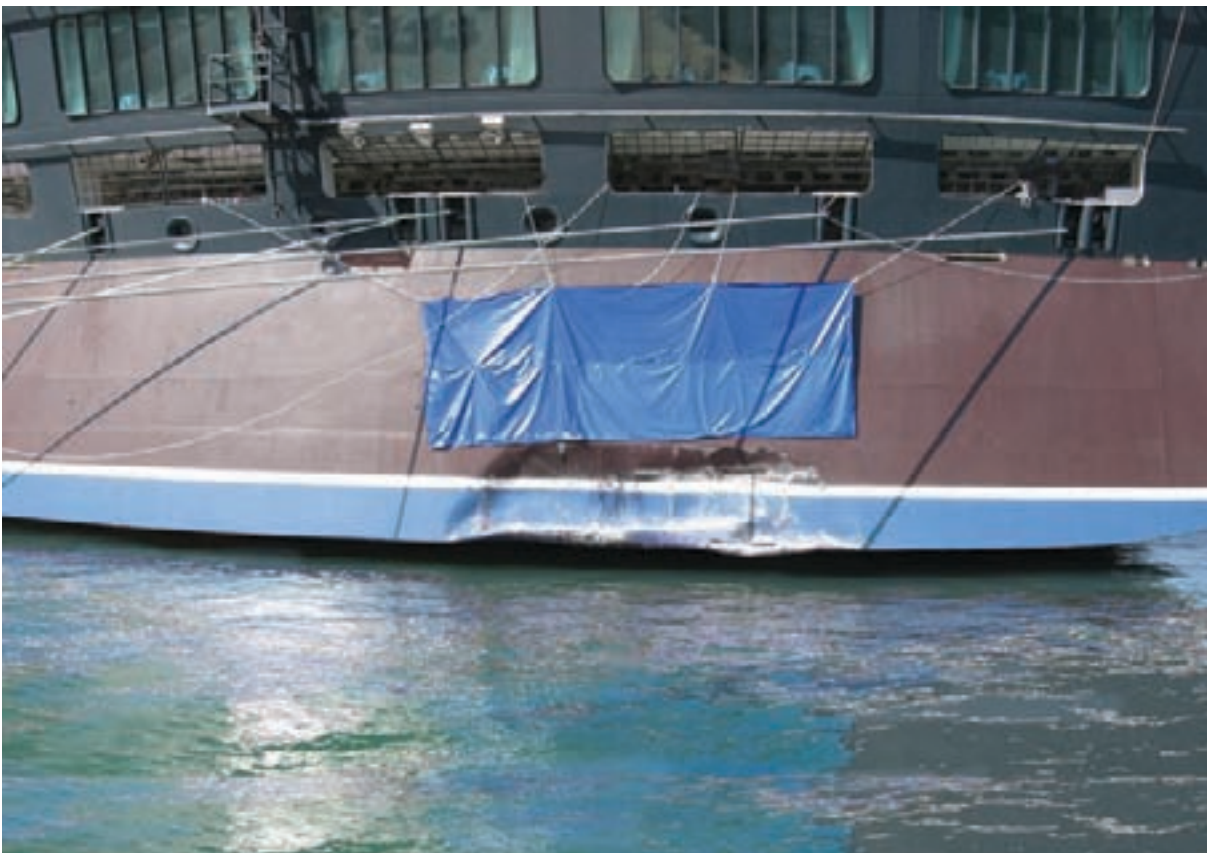
Figure 1: Damage to stern

The vessel sustained damage to her stern plating above the waterline (Figure 1) and remained alongside 12 hours longer than planned, to effect repairs; the wharf was also damaged (Figure 2).

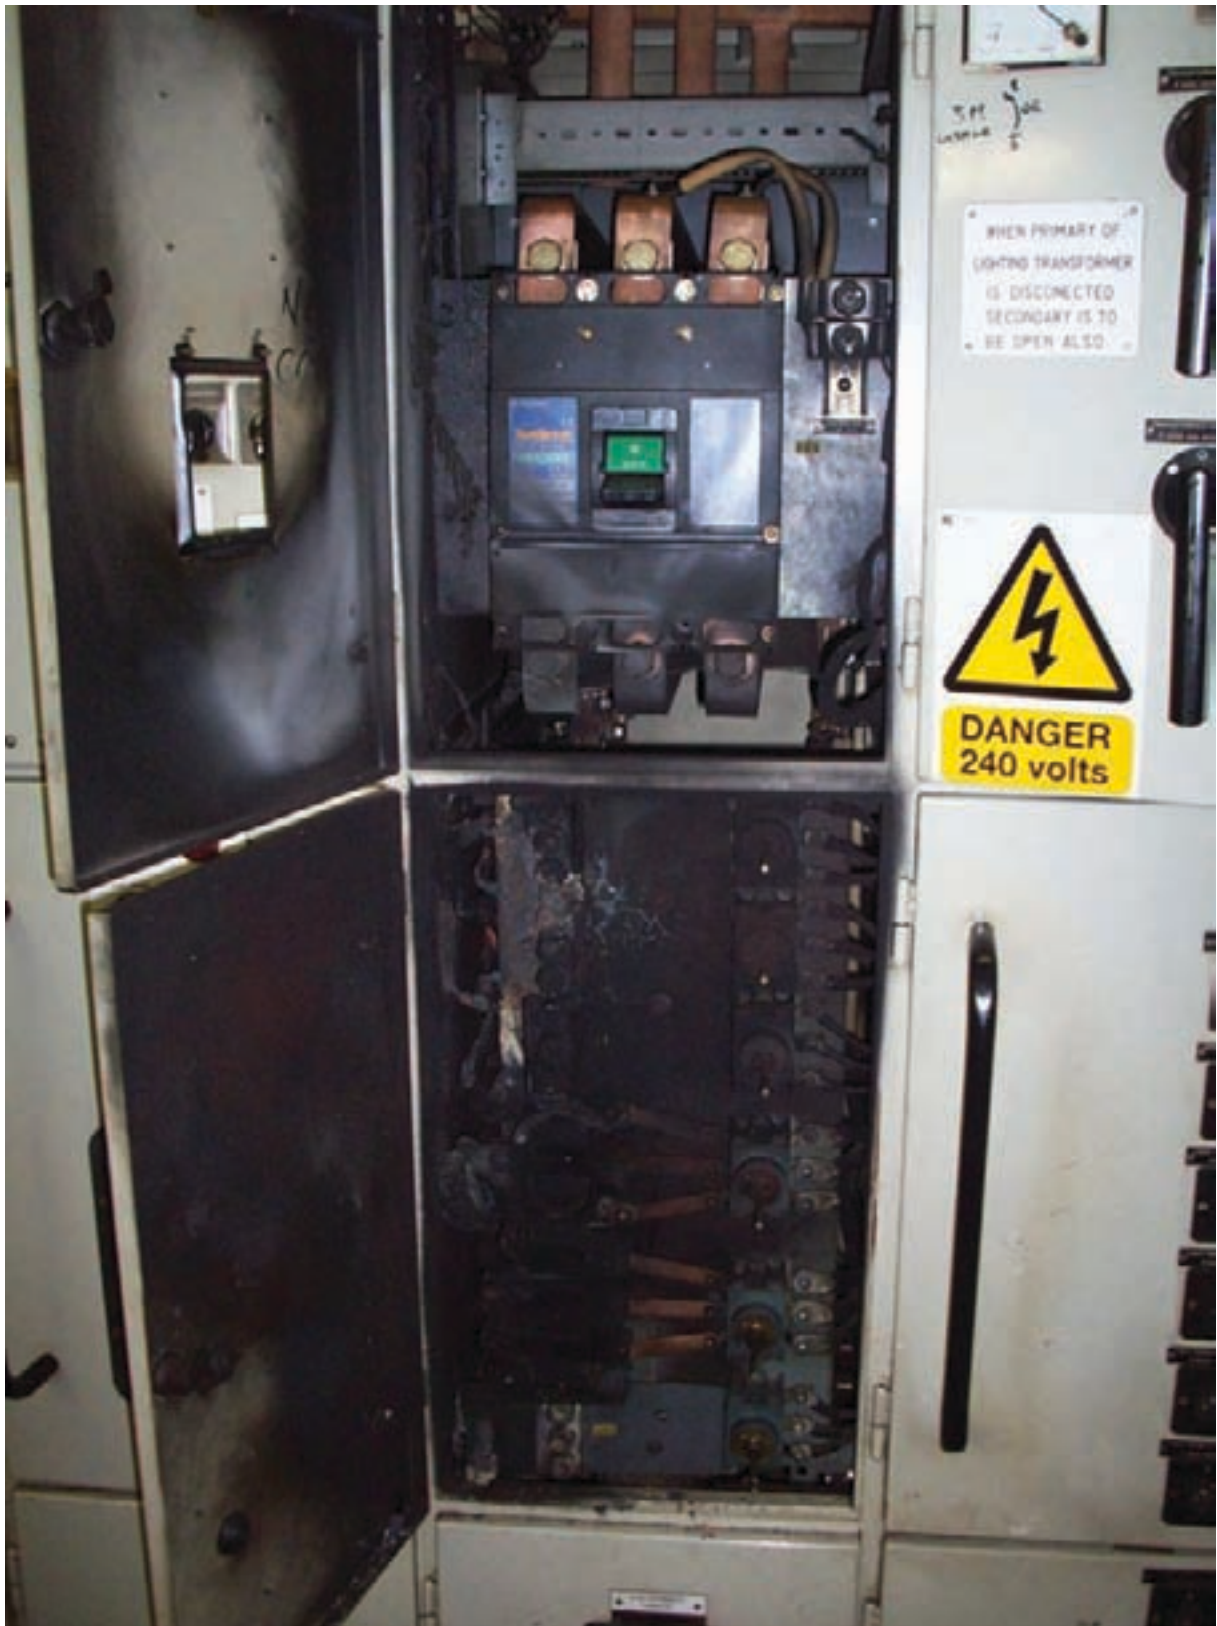
Investigations found that a loose connection enabled a cable to make intermittent contact with the steel panel casing. This caused an electrical short, resulting in sparking and leading to high temperatures which caused damage to the cable insulation and fittings (see figure). Also worrying was an annotation on the inside of the panel door indicating that a change in the circuitry had been made, but with no reason being given for it.

Damage to cable insulation and fittings

1. The security of switchboard/breaker connections should be the subject of regular checks. Loose connections increase the current drawn, which, in turn, leads to overheating and the risk of fire.
2. Loose connections and other sources of electrical overheating can easily be identified by thermal imaging techniques. Although this procedure is generally undertaken by specialists, the cost benefits of using it routinely can be great if a fire is prevented.

3. Do keep switchgear free from the build up of dust, which can be easily ignited through even a slight increase in electrical enclosure (eg breaker panel) temperature.
4. It is advisable to regularly check earth fault indications before they cause overheating problems. Where earth leakage has been identified, isolate end user equipment to determine the source of the earth, and rectify the defect as soon as possible. “Wet” areas such as the galley or pantry are frequently the source of earth leakages.
5. **REMEMBER** – internal cleaning and maintenance of a switchboard must only be carried out while it is in the “dead” condition, after a full risk assessment has been carried out, and only following the issue of a Permit to Work.

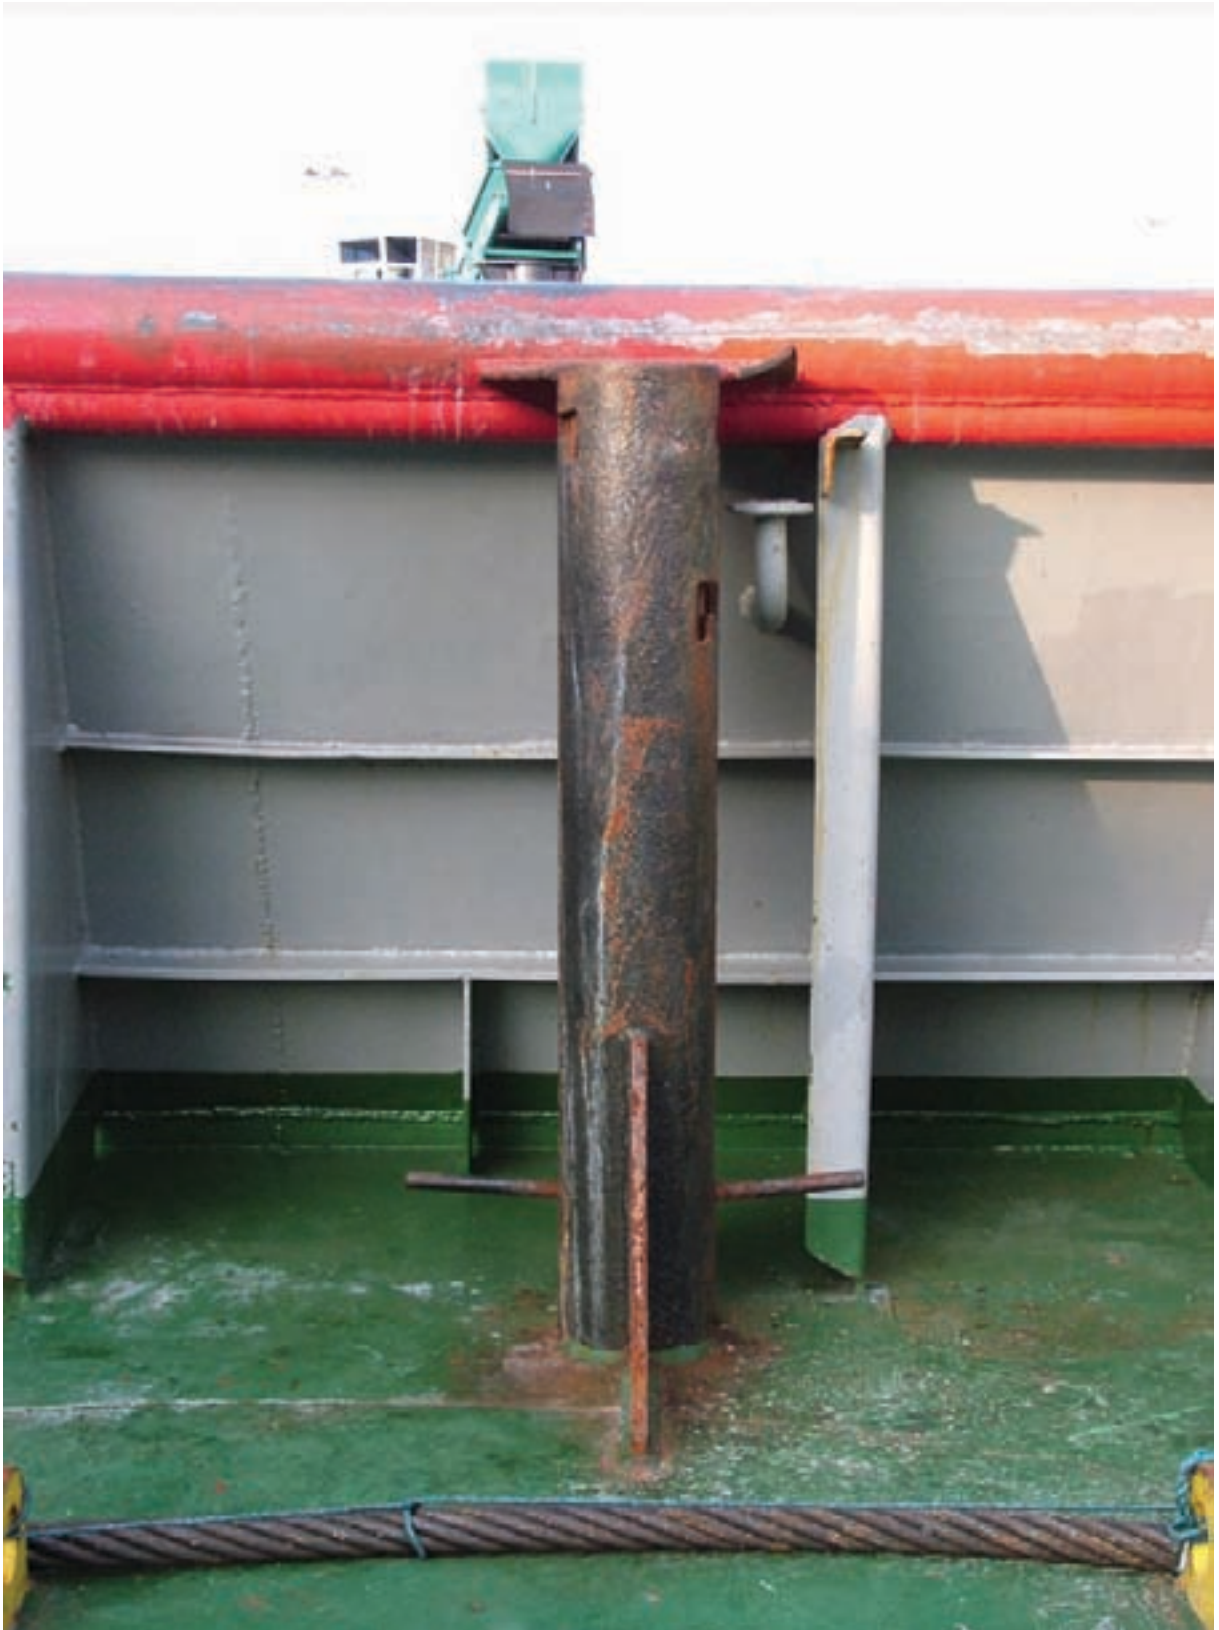
Figure 2: Damage to Norman Pin socket

towards the starboard quarter during this manoeuvre, the aft shackle on the “chafer” arrangement became caught on a bracket fitted to one of the “Norman Pin” sockets at the stern bulwark rail (Figure 2).

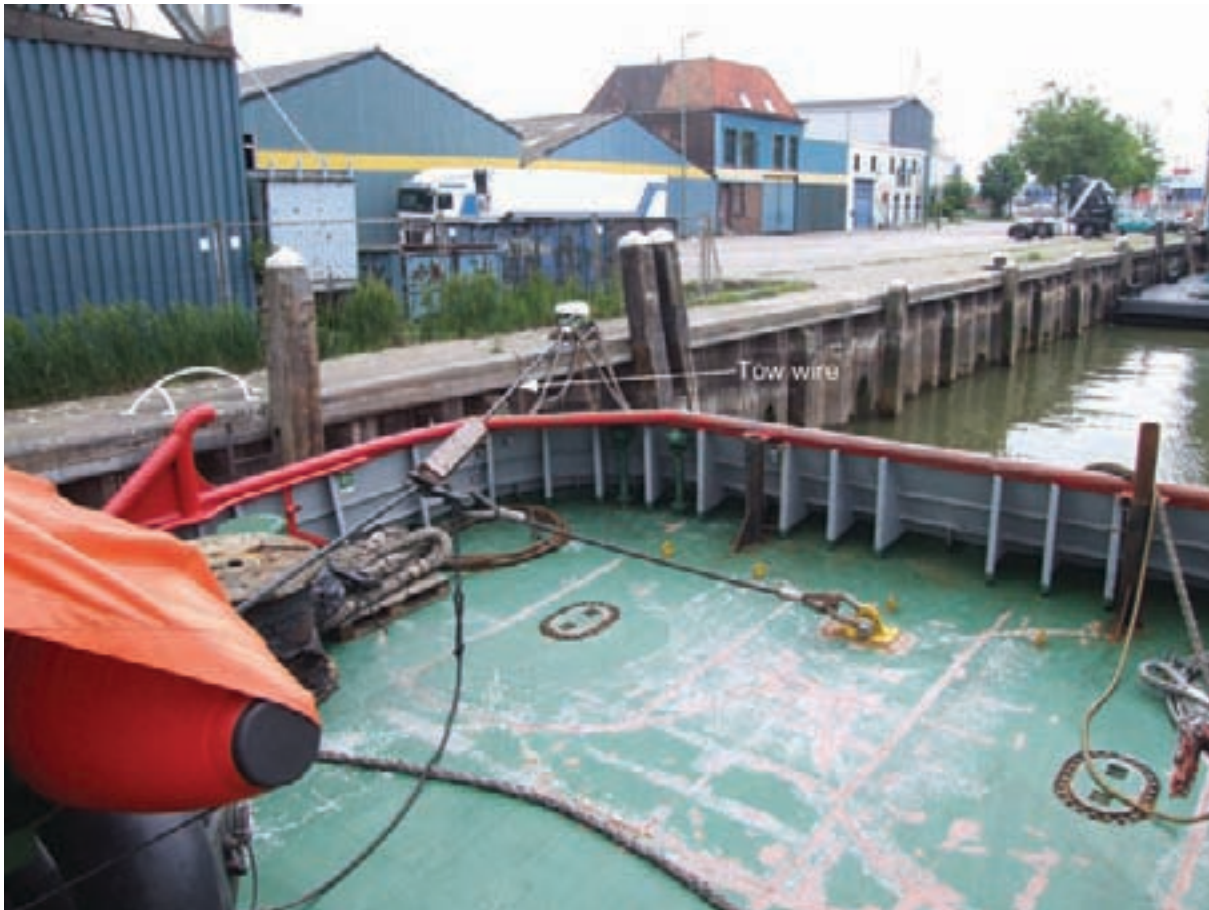
Figure 3: View of tow wire in approximate position after shackle jumped

As the wire continued to try to move to starboard (Figure 3), the bracket began to bend, freeing the shackle. This resulted in the tow wire and “chafer” jumping a metre to starboard and fatally striking the bosun’s head.

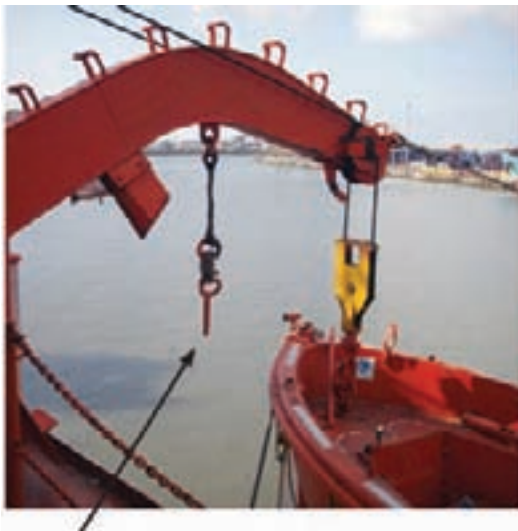
**WRONG!** Tricing pennant released before bowsing-in gear fitted.

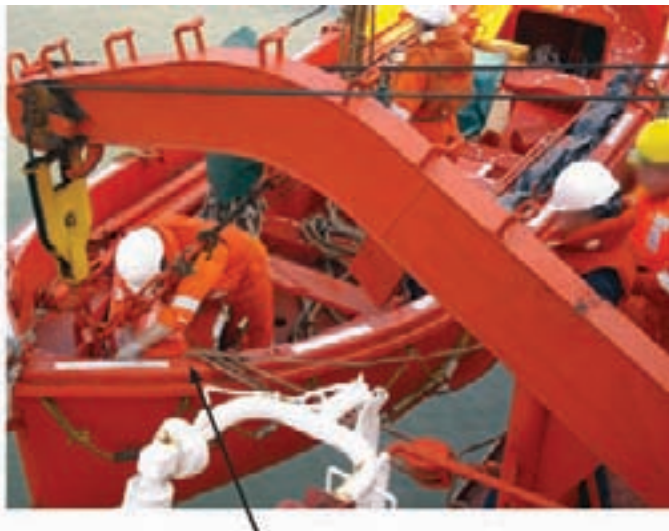
**CORRECT** Bowsing-in gear fitted before releasing tricing pennant

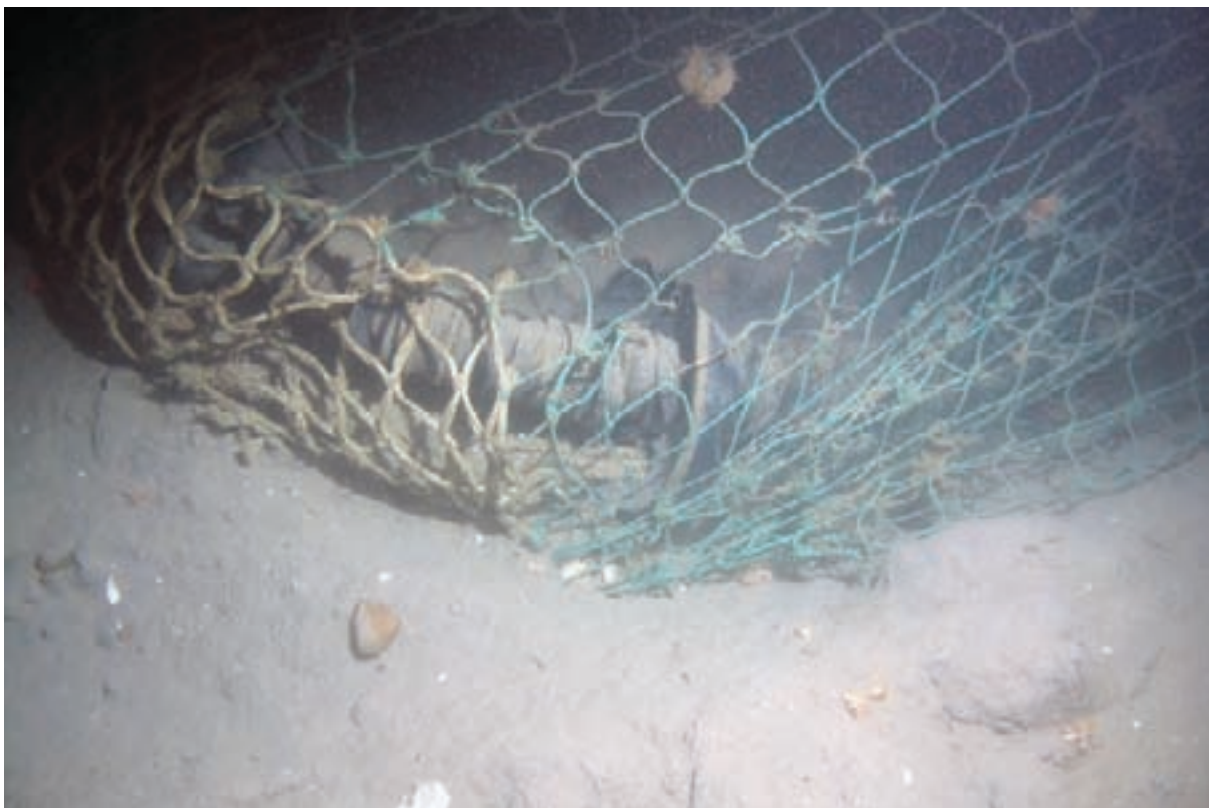
Figure 2: Trawl gear embedded into mounds of boulder clay

Given the proximity of the wreck to pipelines, the oil company undertook a video and side scan sonar survey of the seabed. These concluded that the bridle and tickler chains on the trawl gear had snagged on large mounds of boulder clay, probably created when the plough being used to back-fill the trench and cover the pipeline, had either stalled or jumped.
