## Summary of Investigations No 1/95

April 1995

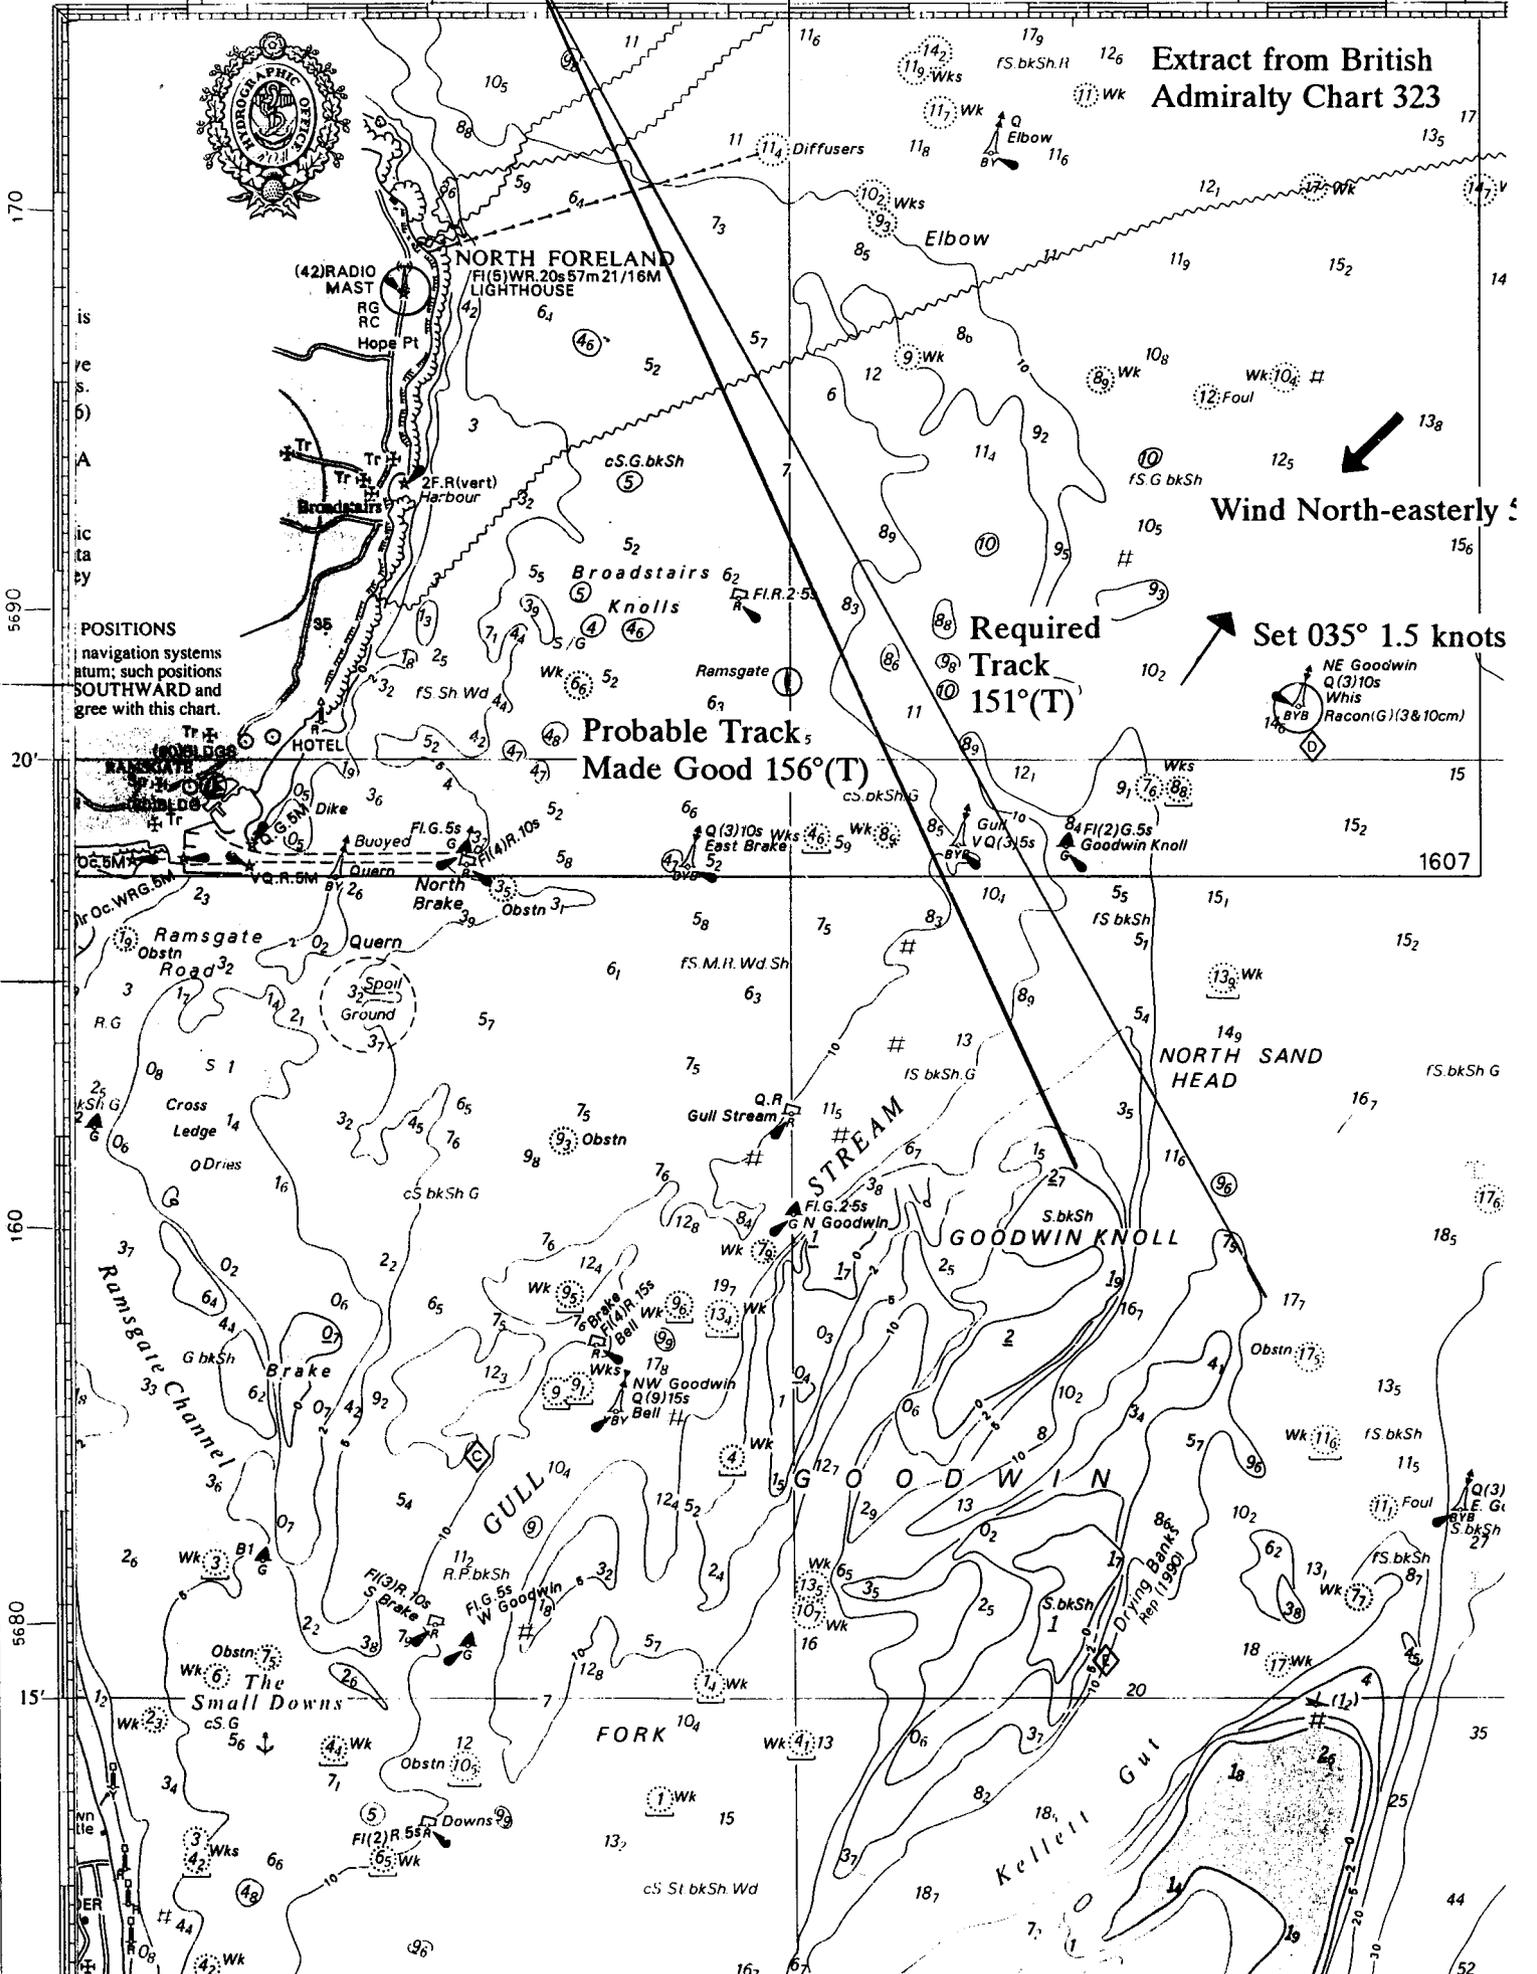
Extract from British Admiralty Chart 323

The vessel had stranded on the Goodwin Sands and was "high and dry" by the following low tide. The vessel was eventually refloated on the next rising tide. There was no damage to the ship, no injury to personnel and no pollution resulted from the accident.

Probable Track 5  
Made Good 156°(T)

Required Track  
151°(T)

Wind North-easterly

Set 035° 1.5 knots

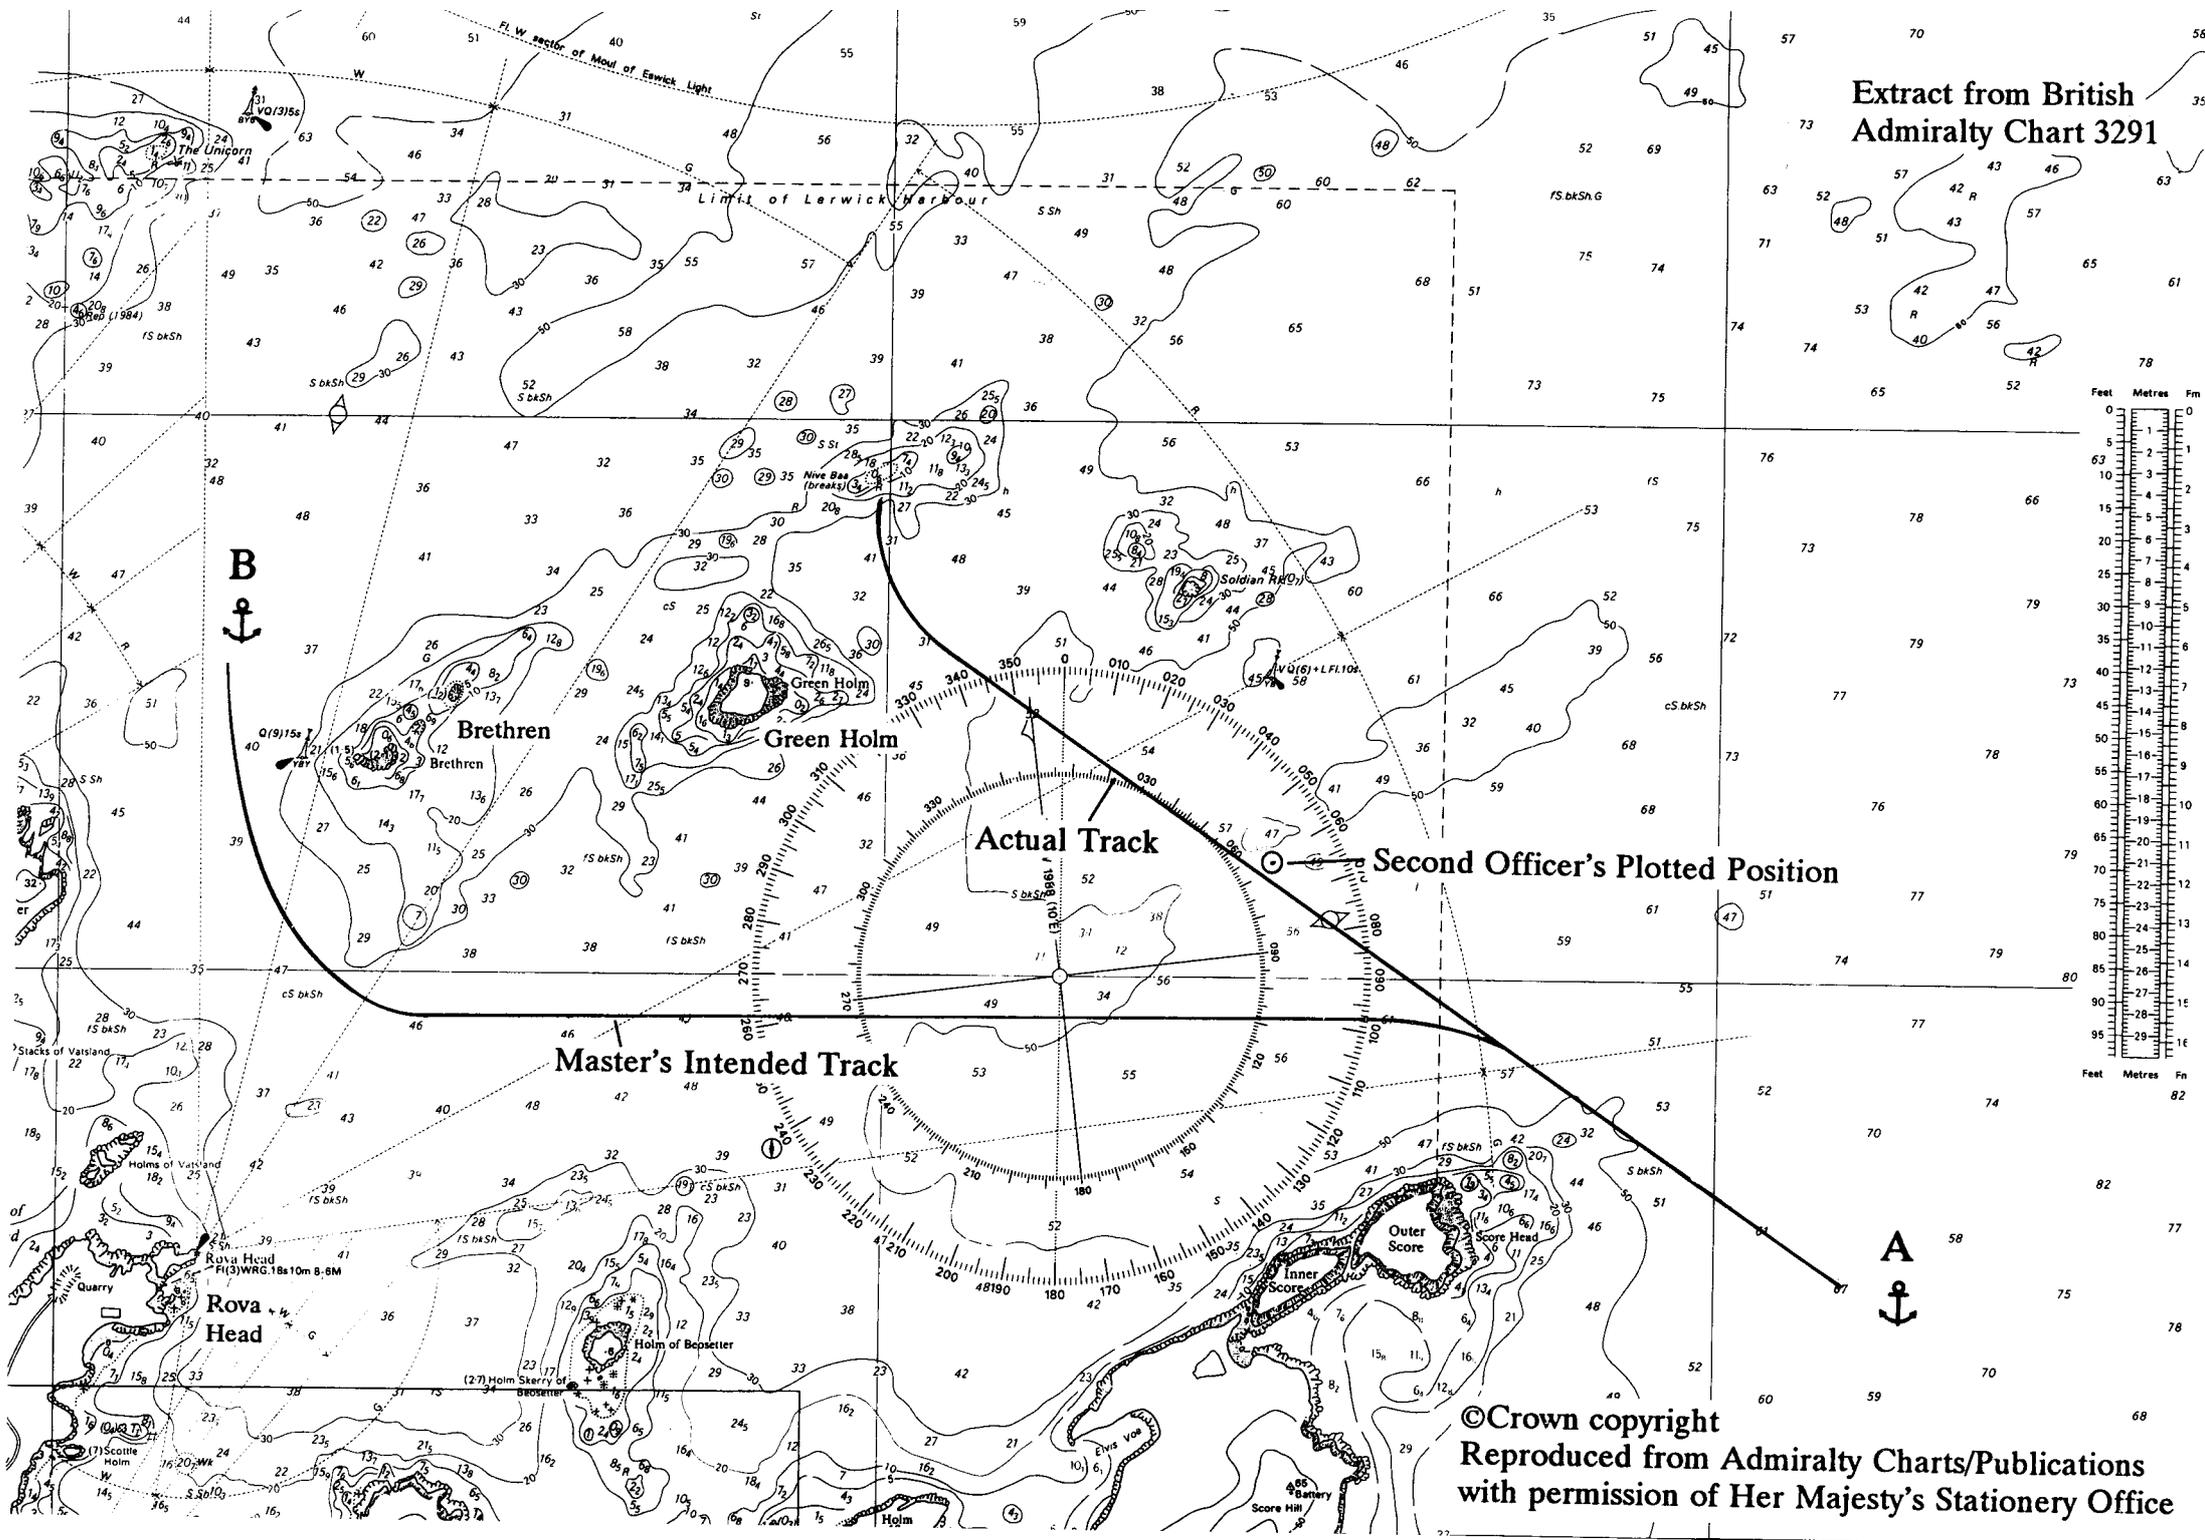
Extract from British Admiralty Chart 3291

As the vessel approached Green Holm, the Master asked the Second Officer how far they would pass from "the island". On being told "two or three cables", he ordered an alteration of course to starboard to increase the passing distance. Shortly afterwards the echo sounder showed rapidly decreasing depths and a further turn to starboard was made. The vessel then grounded heavily on Nive Baa rocks.

1. The Master had taken Green Holm to be Holm of Beosetter. The Second Officer assumed, from the position he plotted, that the Master intended to pass between Green Holm and Nive Baa. So far as he was concerned, the vessel was very close to what he took to be the intended track. For this reason, the Second Officer did not see it necessary to draw the Master's attention to his plotted position.
2. The vessel was refloated on the following tide but there was extensive bottom damage, fortunately without pollution. Although the Master had decided which route he intended to take, he had not revealed his plan to the Second Officer.

1. This accident would probably not have happened if, before starting the passage, the Master had laid off his intended track on the chart and shown it to the Second Officer.
