Marine Accident Investigation Branch (MAIB) - Safety Digest 2/1995

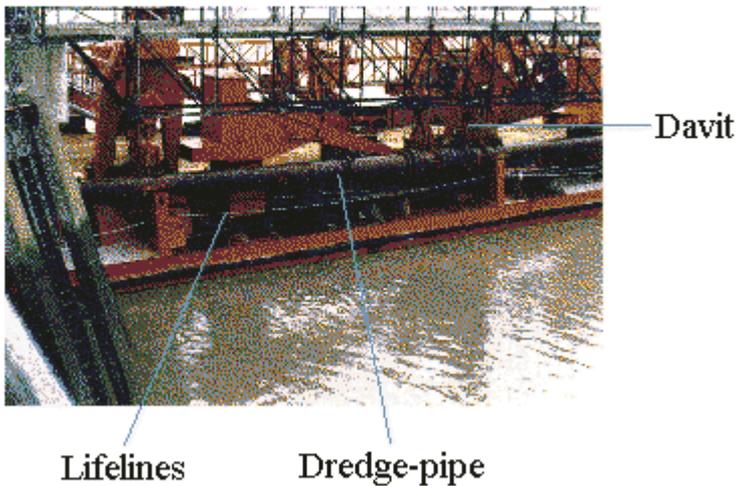
2. The equipment to be used during the repair was found on the aft side of No 3 dredge pipe davit. No scuff marks were found on either the deck or hull in the vicinity of the davit although a light covering of sand debris was present. At the time of the incident, lifelines in three sections should have been fitted between the aft and middle davits, some 1500 mm inboard. On inspection, the centre section was missing with the other two very slack. Additionally, access to the repair point required the engineer to either crawl under or climb over the fixed dredge pipe.

3. When in the loaded condition, the vessel's freeboard in way of the davits was very small with the result that in any kind of seaway, waves were likely to come inboard. Two safety harnesses were carried on board the vessel but neither were in use on the day of the incident.

1. Taking into account the evidence found, there seems no doubt that the Assistant Engineer was lost overboard whilst negotiating his way forward to his place of work. Access was difficult with limited space. Lifelines were in place although slack and the advice contained within the "Code of Safe Working Practices for Merchant Seamen" Chapter 15 regarding safety when working outboard was not heeded.
2. Subsequent to this incident, the company has issued instructions that when emergency work is required on the open deck whilst at sea, two men will work together and both will wear life-jackets and safety harnesses.

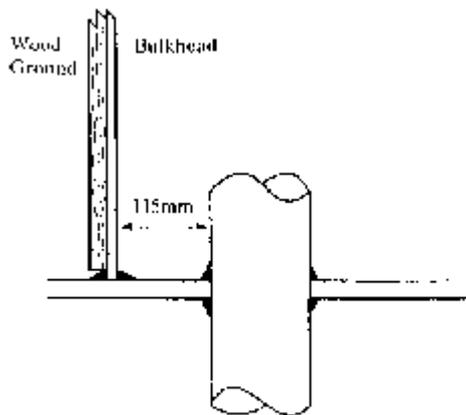
INCORRECT

1. On investigation, the fire was found to have started behind the galley bulkhead amongst the bulkhead groundings. The cause of the fire was the excessive heat generated by high exhaust temperatures being transmitted directly from the engine exhaust pipe to the steel structure via welds. A heat barrier had not been fitted between the exhaust pipe and the support structure. The steel bulkhead onto which the wooden grounds had been secured was about 115 mm from the exhaust pipe.
2. The cause of the high exhaust temperatures was probably due to a restriction round the propeller or propeller shaft. Such a restriction, possibly from fishing gear or a rope, would have caused overloading of the engine and exhaust temperature rises.

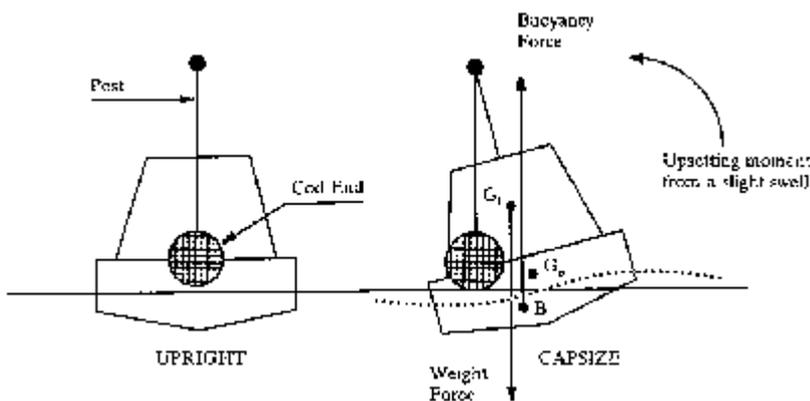
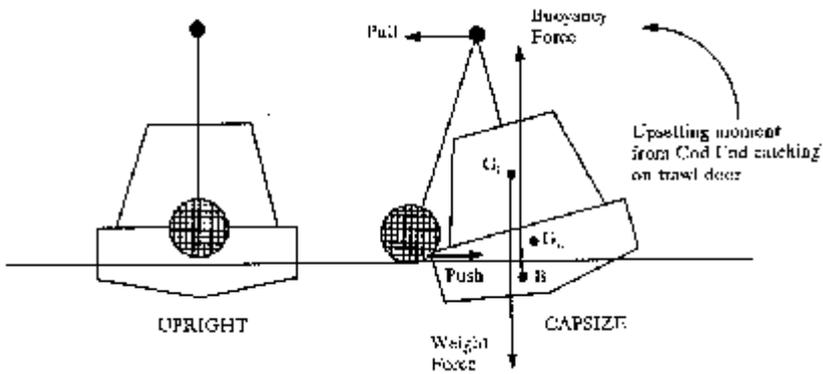
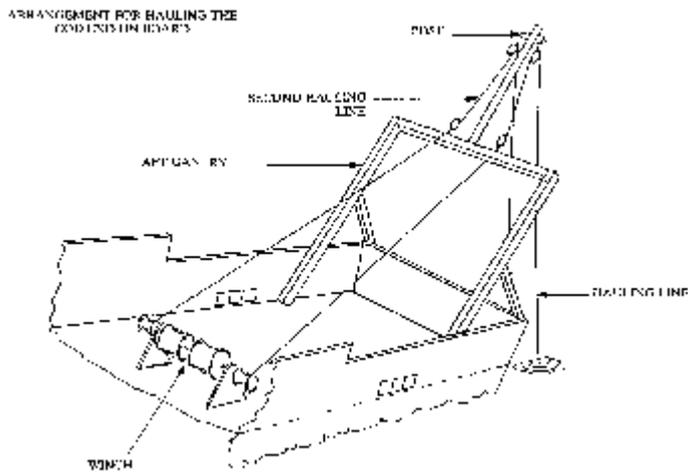
1. As this vessel was under 12 metres in length there was no statutory requirement for its stability to be established. Stability characteristics had never been determined.
2. The primary factor leading to the capsizing and loss of this vessel is almost certainly that the weight of the cod end, when lifted clear of the water, and suspended from the top of the post on the stern gantry, raised the effective centre of gravity to such an extent that the vessel's transverse stability was reduced to near zero.
3. With her stability reduced to near zero a small upsetting moment such as a roll in the slight swell would have been sufficient to cause the vessel to capsize. Alternatively the cod end could have caught on the port side trawl door and acted like a weight on the gunwale of the vessel (see Figure 2).
4. Neither crewman was wearing any form of buoyancy aid. The Skipper was a non-swimmer.

1. This accident could have been avoided if the vessel's stability characteristics had been assessed by a suitably qualified person and advice been given on any operational limitations required.
2. The Department of Transport publishes advice to fishermen regarding the stability of small fishing vessels and on the dangers of suspended loads.
3. Attention is drawn to Merchant Shipping Notice No M.989 "The Safety of Small Fishing Vessels" and the Department of Transport safety leaflet "Fishing is a Dangerous Business. Make it Your Business to Make it Safer".
4. Fishermen who understand the dangers of recovering a cod end heavy with sand will not attempt to lift it clear of the water. Instead they will tow it at speed behind the vessel for some time to wash the sand out of it and reduce its weight before attempting to lift it above the water surface.

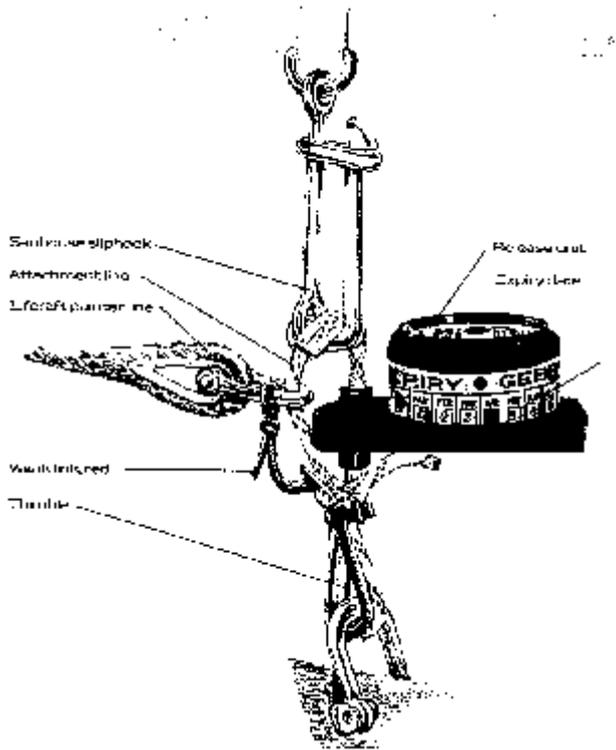
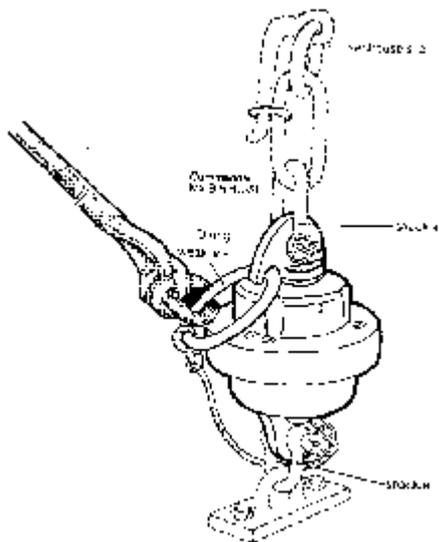
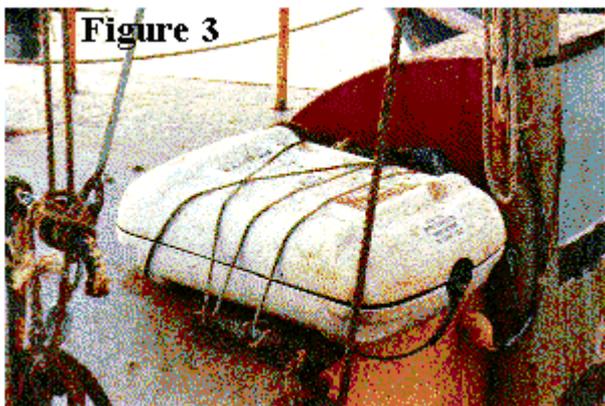
It is clear that incorrect re-installation was the most probable cause of the liferaft's failure to float free. This was an error of a type which is worryingly common. At the time of the relevant mandatory survey a vessel's life-saving equipment will be closely inspected. However, liferafts, and probably their hydrostatic release units, are likely to require overhaul or renewal before the next survey is performed. It is generally after these servicing periods that the errors of incorrect installation are likely to be made. It is thus vitally important that Masters, Skippers and Owners ensure that liferafts are correctly installed so that the equipment will operate as the manufacturer intended.

Two commonly encountered hydrostatic release units are shown in Figures 1, 2 and 3. These arrangements show a weak link to which the liferaft's painter should be attached. It must be remembered that these weak links are carefully designed components, which are intended to break under a load which is sufficient to cause the liferaft to inflate, yet not so large as to cause damage to the liferaft or prevent it floating to the surface.

Advice on the stowage of liferafts is contained in Merchant Shipping Notice No M.1400.

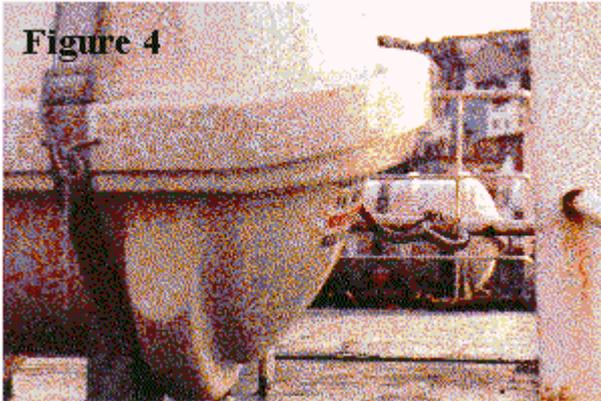
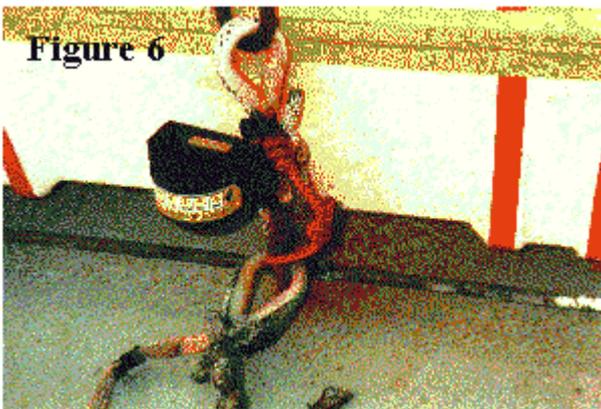
An independent sighting of 23 inflatable liferaft containers, on various types of small vessels, revealed that only two containers were correctly installed. Some of the more common errors of installation are shown in Figures 4, 5 and 6.
