# Marine Accident Investigation Branch (MAIB) - Safety Digest 02/1996

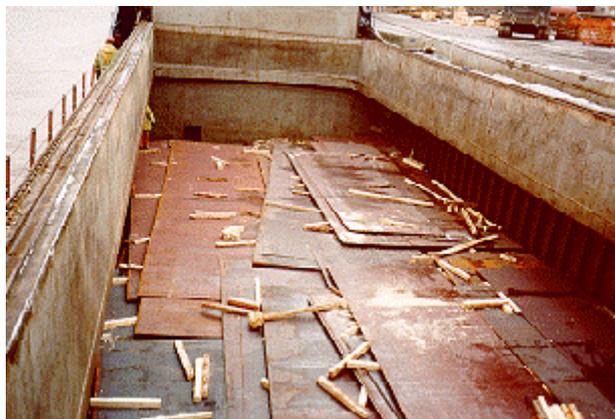
At 1958 hrs the vessel took up a list to starboard of about 10°. The vessel was brought around into the swell and the crew were mustered. The holds were inspected and it was found that the plate cargo had shifted, though there was no visible damage to the hull side or any indication of water ingress. The Coastguard were informed and the vessel was turned back towards her port of departure. The local RNLI lifeboat was launched to escort her in. Weather conditions had deteriorated to winds south-easterly 7 - 8 by the time she reached a safe anchorage.

Shift of Inadequately Secured Cargo

1. The steel plate was distributed equally between the two holds and secured with timber wedges/shores.
2. Friction would have been effectively reduced between the steel plates and the dunnage because it is likely that both would have been covered by ice to some extent, given the freezing conditions in which the cargo was loaded.
3. The original loading plan required that the steel plate cargo would be overlaid by steel pilings but this did not occur.

4. Vessels which are carrying steel cargoes can be very stiff and roll violently in a seaway and consequently any weaknesses in securing the stow will be quickly revealed. The fact that the steel pilings were not carried would exacerbate this tendency.

1. Movement of the cargo could have been avoided if it had been securely lashed in place with wire ropes set taut. This was indeed done before the vessel resumed her voyage with the overload of steel pilings.

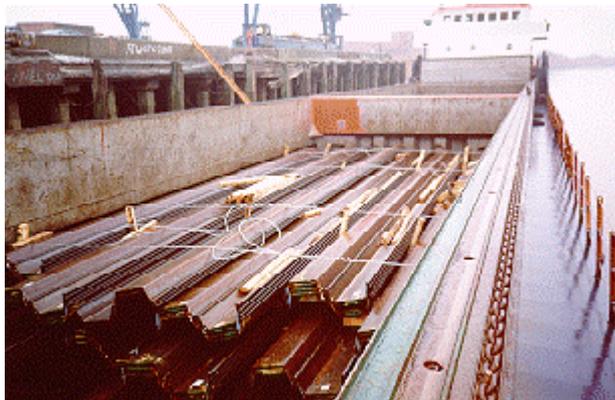
Cargo Securely Lashed in Place

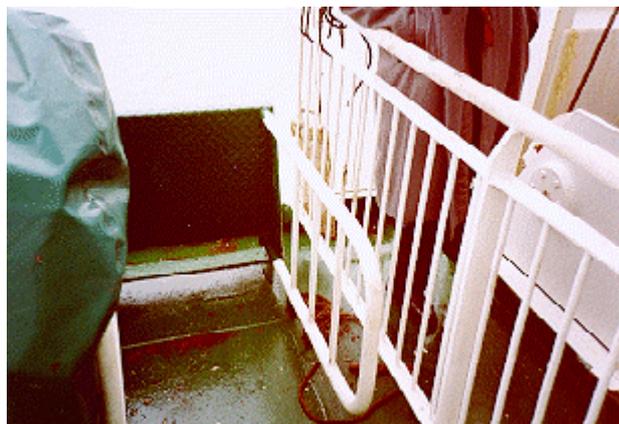
Boarding Bridge in "Closed" Position

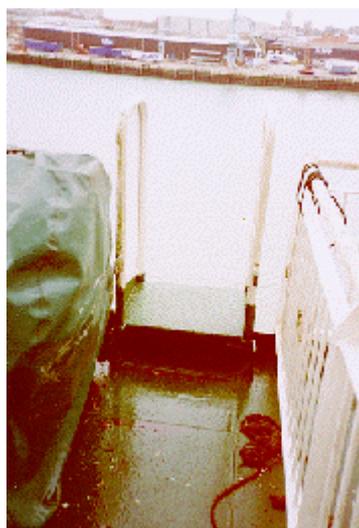
At about 0325 hrs the four young men went out on deck for some fresh air. Whilst they were there one of the group climbed over the ship's rails enclosing the lifeboat ladder, and sat on the edge of a lifeboat boarding bridge with his legs dangling over the ship's side. When his friends asked him what he was doing he turned round to face them. The change in disposition of his weight caused the hinged boarding bridge to rotate vertically through ninety degrees, which in turn caused him to fall overboard.

Boarding Bridge in "Open" Position
