MARINE ACCIDENT INVESTIGATION BRANCH

SAFETY DIGEST

Lessons from Marine Accident Reports
1/99

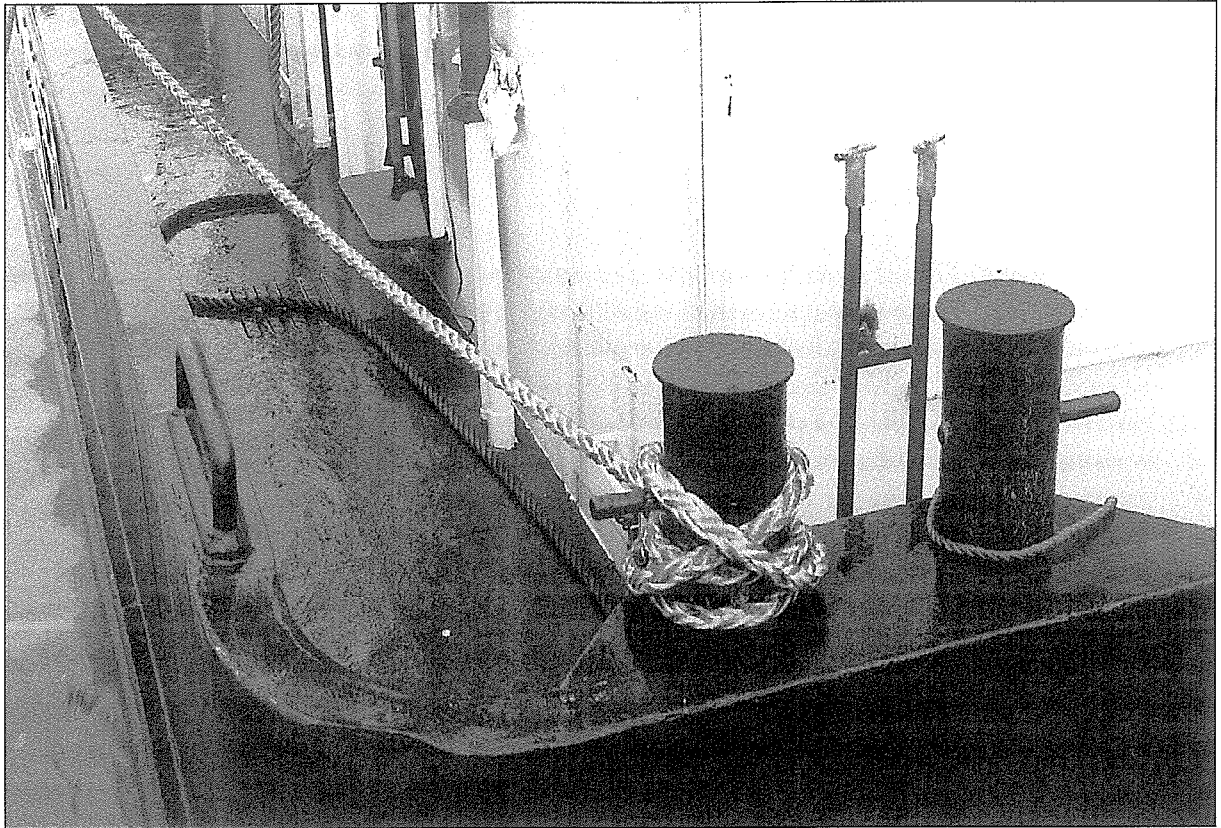
When berthed starboard side to, it was customary to lead the centre line sternrope from the centre fairlead to the after post of the starboard aft bitts to allow adequate room for the aft accommodation door to open and for the crew to use the adjacent deck space. (See photograph)

With this task complete, the chief officer turned to face the jetty. At that moment the shore linesman noticed that the centreline mooring rope was leading outboard of the starboard fairlead and realised it was liable to spring off when the rope came under tension.
