# SAFETY DIGEST

**Lessons from Marine  
Accident Reports  
2/2011**

**SAFETY DIGEST**  
**Lessons from Marine Accidents**  
**No 2/2011**

October 2011

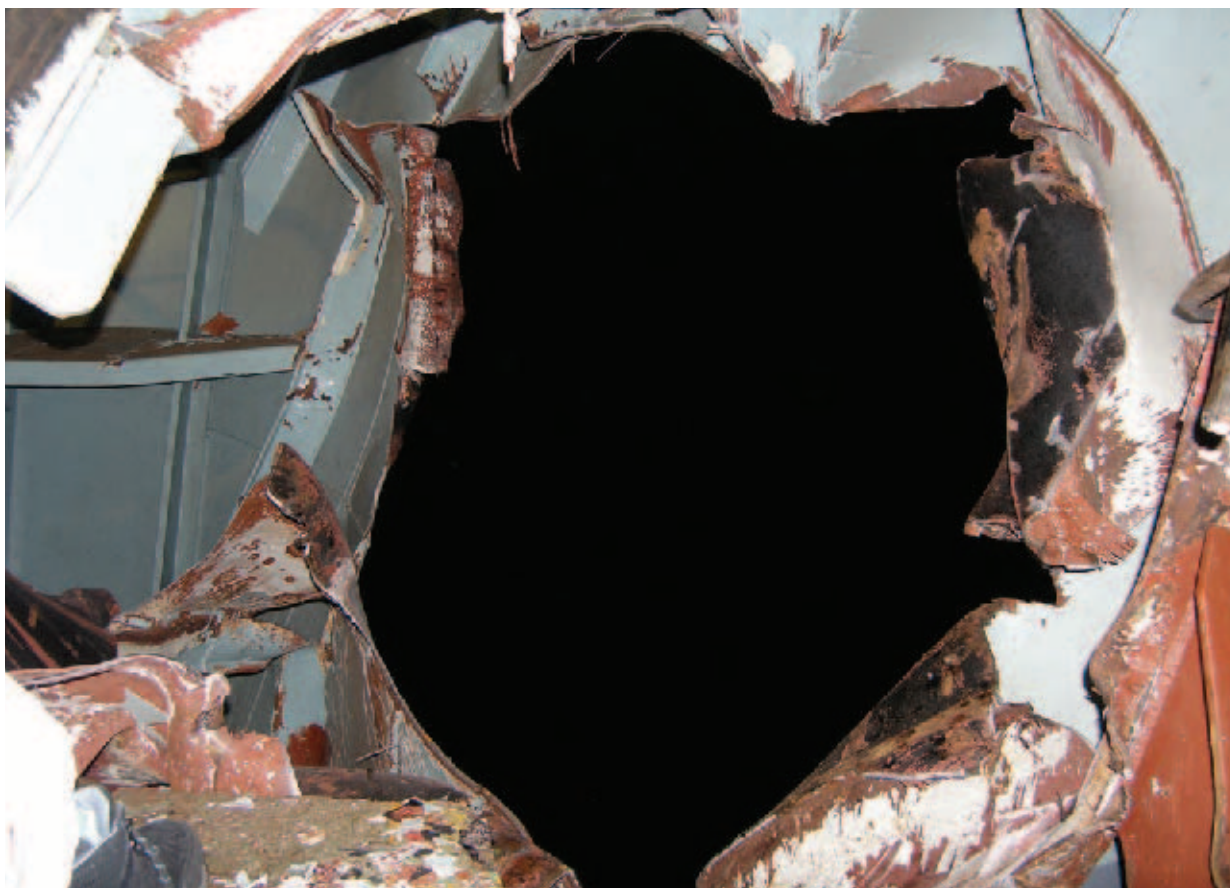
visor was penetrated by the linkspan arm (Figure 1) and the forefoot and forepeak buckled on impact with the concrete ramp (Figure 2). Control of the starboard CPP system was lost because a linkage had failed, leaving the pitch stuck on full ahead (Figure 3). An identical failure had occurred on the starboard CPP system several months earlier when the system was being tested alongside. On that occasion, the broken linkage was replaced but the cause of its failure was not investigated. The replacement linkage was taken from onboard spares but was longer than the original component and had to be adjusted after fitting. Unfortunately, the adjustment of the linkage caused it to come into contact with other components when the engine was overloaded, which ultimately led to its eventual failure during the ferry's passage.

Figure 1: Penetration in bow visor

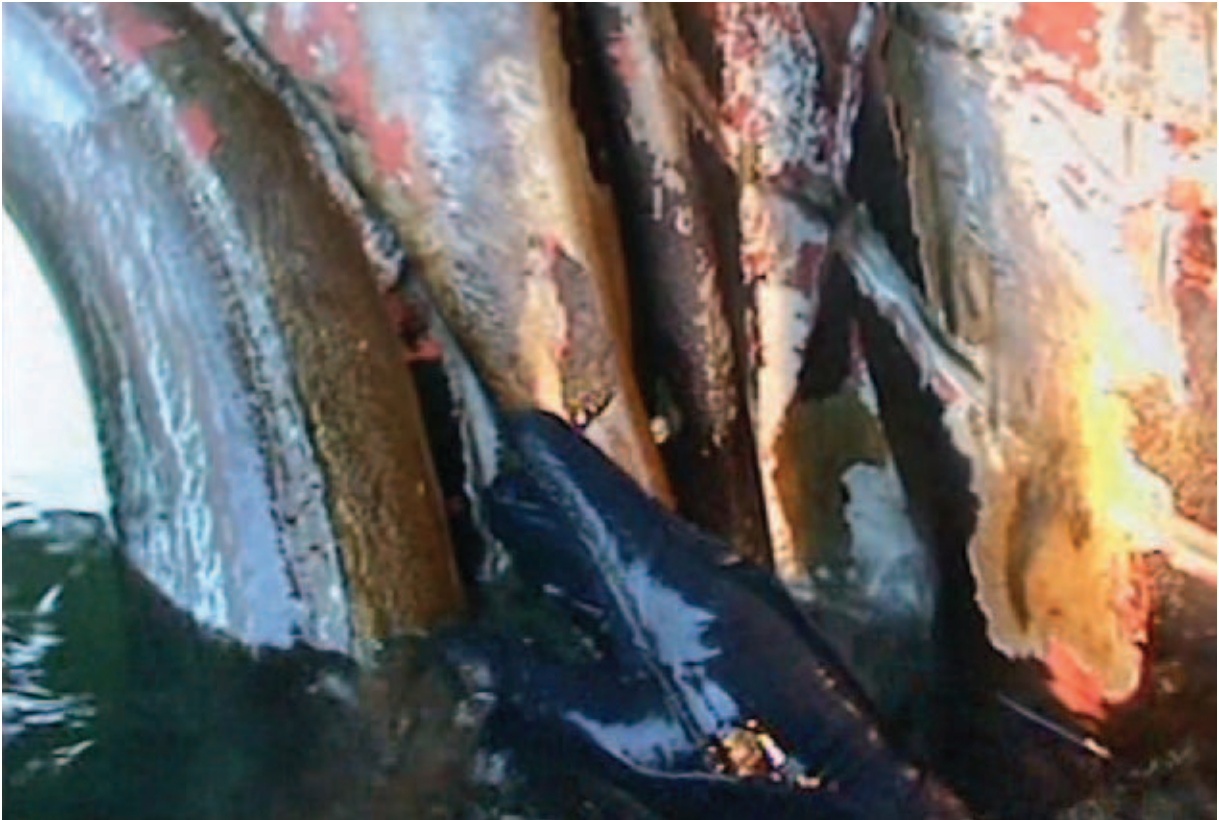
Figure 2: Buckling of the stern and forepeak

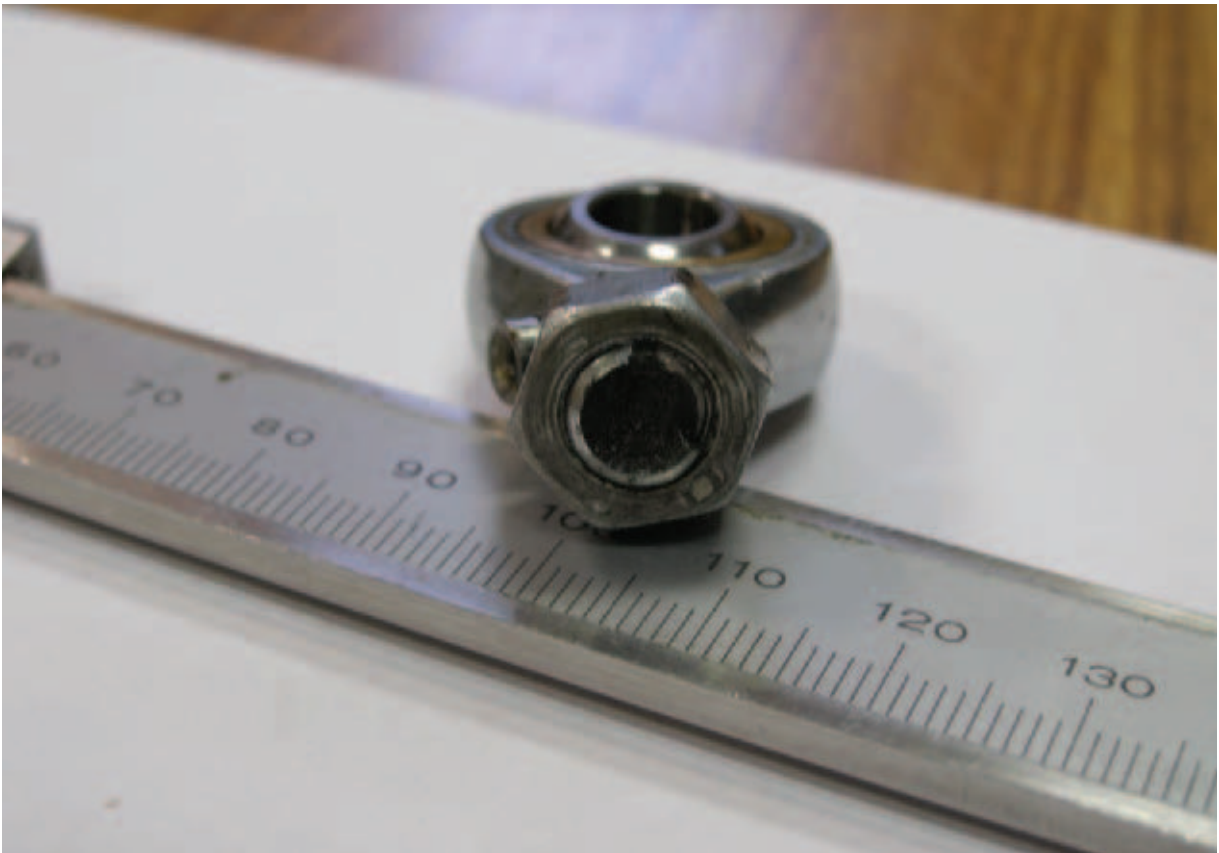
Figure 3: Failed linkage from CPP

3. When a CPP system fails, the default position for the pitch varies between full ahead and full astern. In this case, the pitch failed to full ahead. Consequently, although full astern was ordered, this only increased the power ahead on the starboard propeller.

1. Mechanical and electrical failures are not always readily apparent. Therefore, the testing of propulsion and steering controls prior to port entry and after changing control positions is crucial.

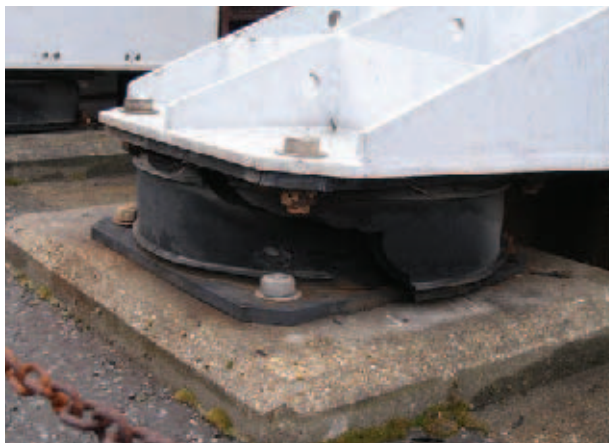
The master used considerable lateral thrust to try and align his vessel with the linkspan. However, this reduced the stern power available and the ferry struck protective fendering adjacent to the linkspan at a speed of about 4.5 knots (Figure 1). As a result, two passengers were slightly shaken and the vessel's stern ramp was damaged (Figure 2).

Figure 1: Damage caused to mounting

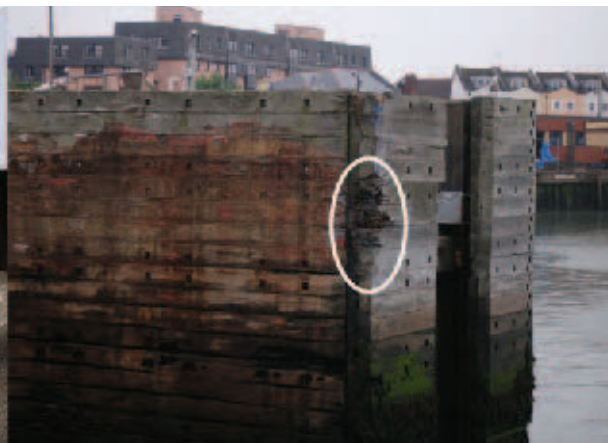
Damage caused to fendering

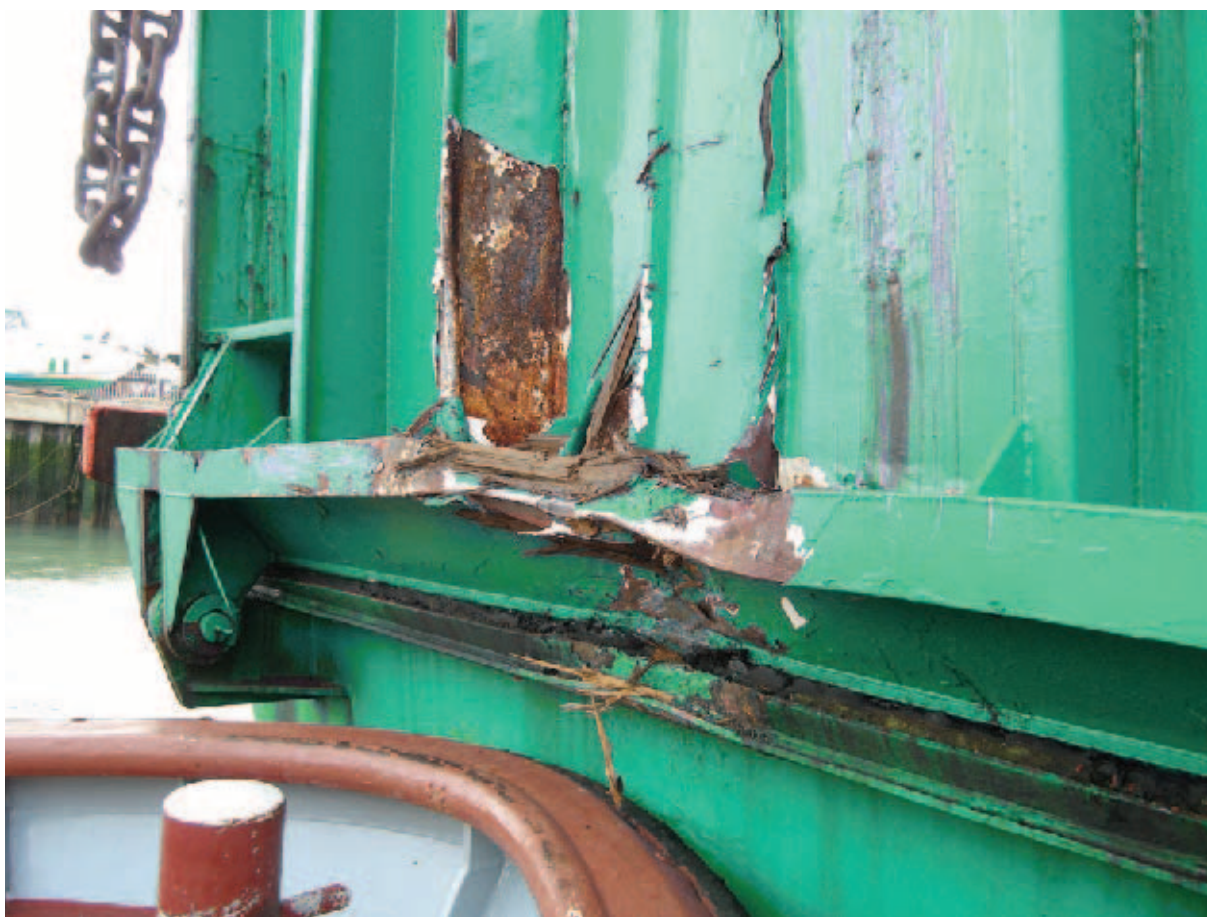
Figure 2: Damage sustained to stern ramp

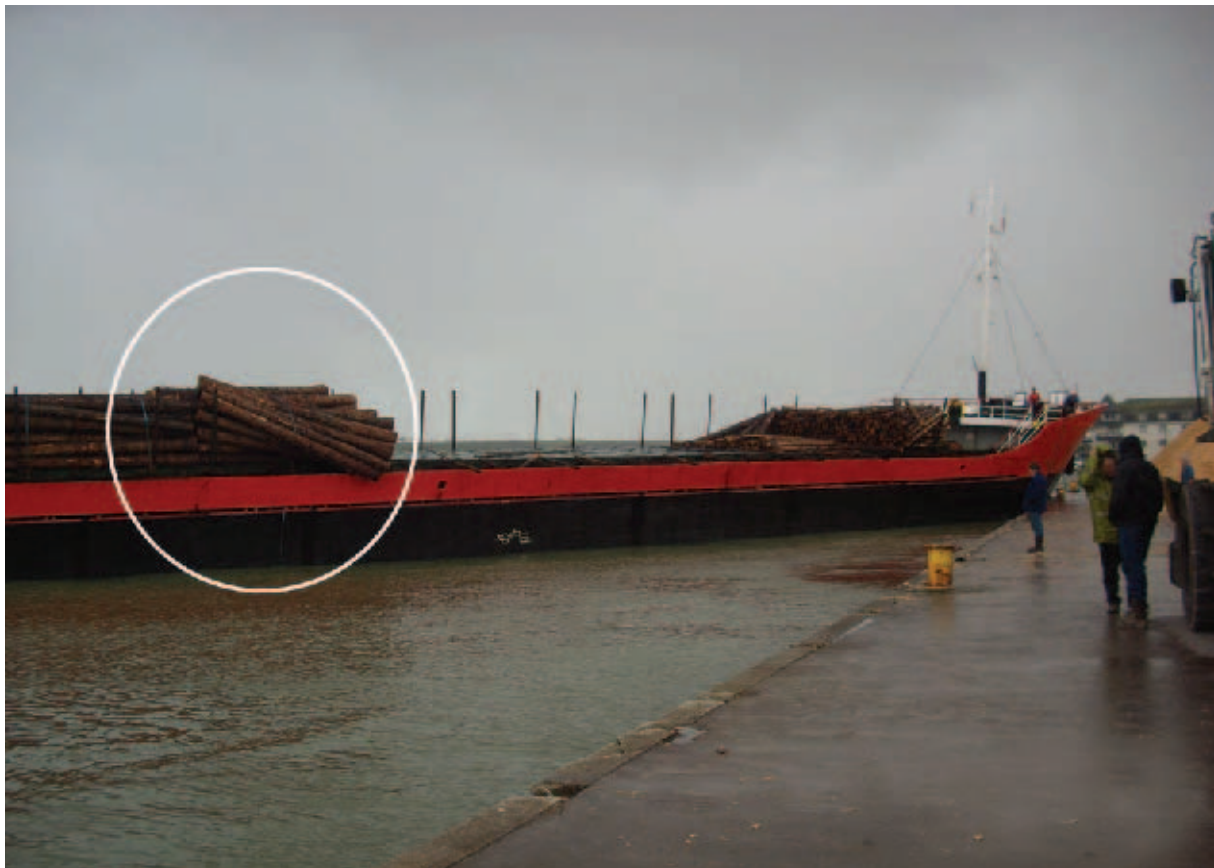
The force of the wave overloaded the lashings in the fore and middle sections of the logs on deck, and the lashings parted. This allowed the logs to move to starboard (Figure 1) and overload the uprights, which bent 90° (Figure 2). About 100 tonnes of loose logs fell overboard.

Figure 1: The timber shift

2. In cases where severe weather and sea conditions are unavoidable, masters should be conscious of the need to reduce speed and/or alter course at an early stage in order to minimise the forces imposed on the cargo, structure and lashings.

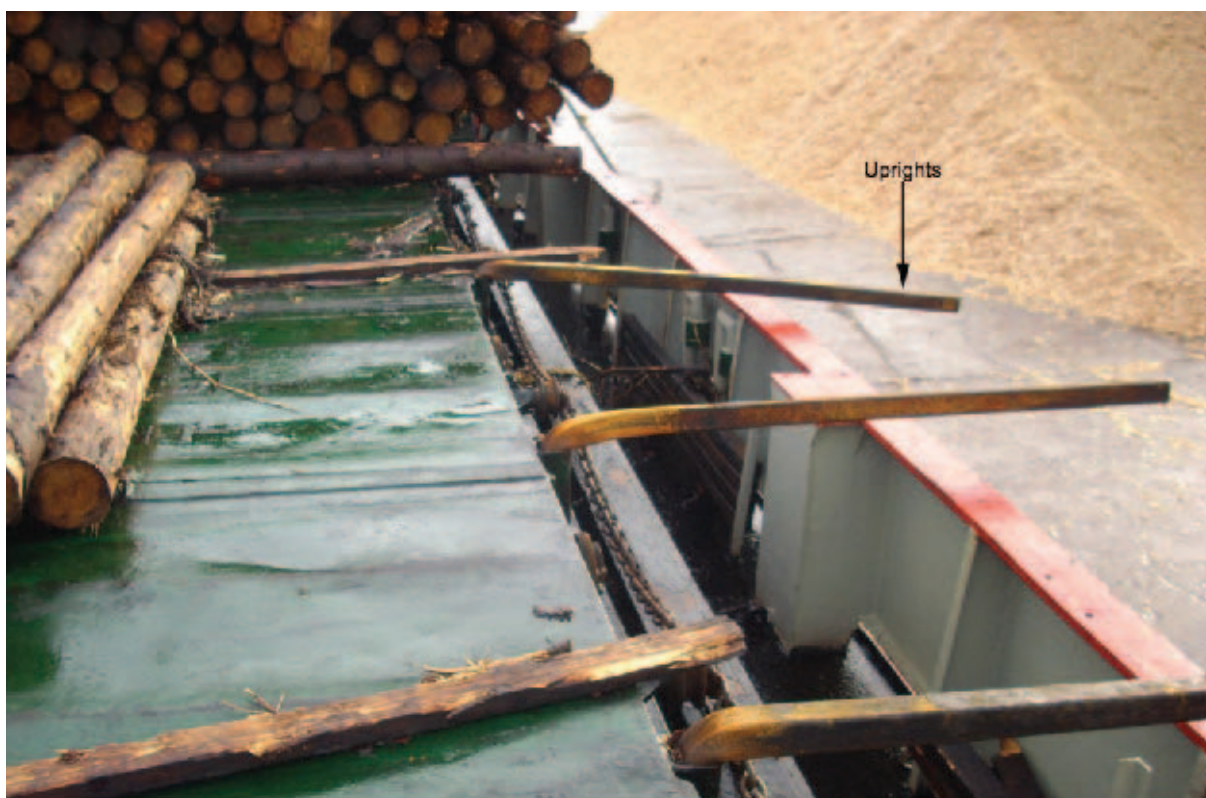
Figure 2: Uprights bent 90°

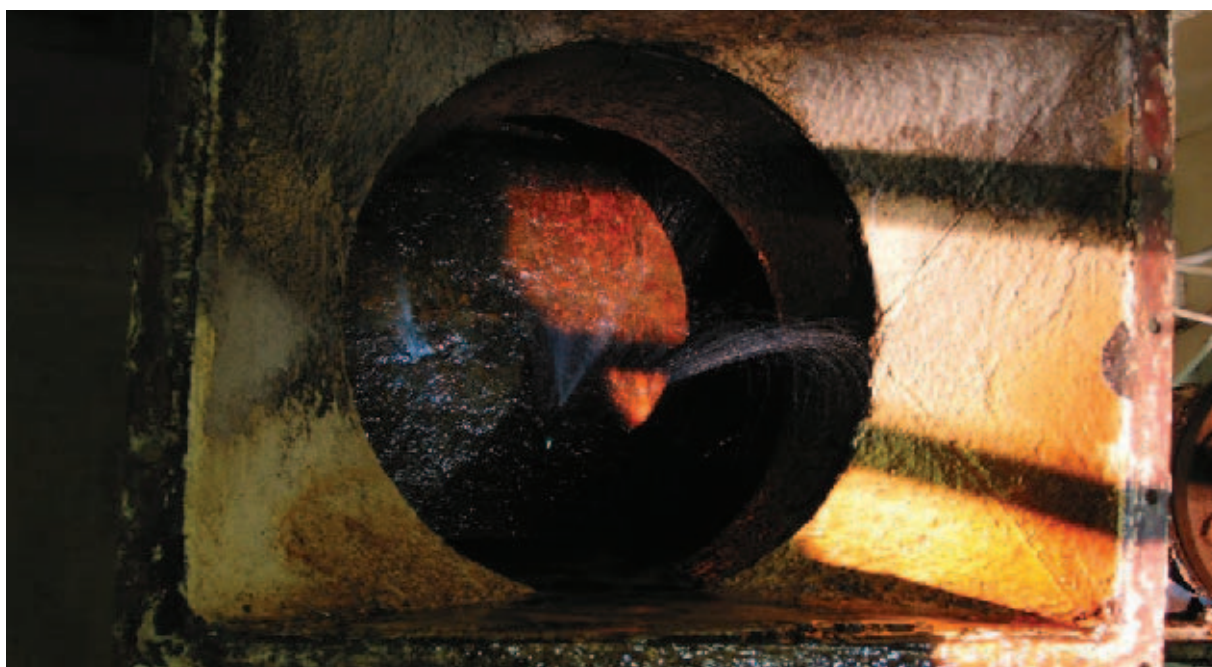
A ventilation fan was removed to enable an internal inspection of the duct. Water could be seen seeping into the ship, apparently from under a large rust flake at the ship's side. Assessing that disturbing the rust flake might cause the plate to fail, a blanking piece was manufactured and attached to the duct in place of the fan as a temporary containment measure. Previous ultrasound surveys of the area when the vessel was last in dry dock had not identified any significant diminution of the steel.

On arrival at the ship's next port of call, an underwater survey was carried out and ultrasound measurements of the shell plate were taken in way of the ventilation duct. The shell plate thickness was measured as 3mm, and further scraping of the corrosion on the ship's side around the area of leakage increased the rate of water ingress both above and below the original site.

Ventilation duct with cover removed showing the leak in the vessel's hull

1. Using the gap between the frames as a ventilation duct was an efficient use of space. The duct, however, was designed and built in such a way that it was impossible to inspect the steelwork inside. Even if the duct had been coated internally before being closed up, condensation would have regularly formed in it which, over time, would have broken down the coating and led to corrosion. The fitting of removable inspection plates at each deck would have readily enabled the duct to be inspected internally and for preventative maintenance to be carried out.

3. Classification society rules detail the areas that require thickness measurement during class renewal survey. All suspect areas are required to be measured; as the ship ages, the scope of the required measurement increases. However, it is possible for the measuring transducer to be inadvertently placed on only thicker parts of the structure. This will give a false impression of the overall state of the plate and smaller areas of extensive corrosion may not be identified. It is therefore essential to conduct a visual inspection in addition to ultrasound thickness measuring, particularly in the case of this type of ventilation duct and other areas of similar construction.

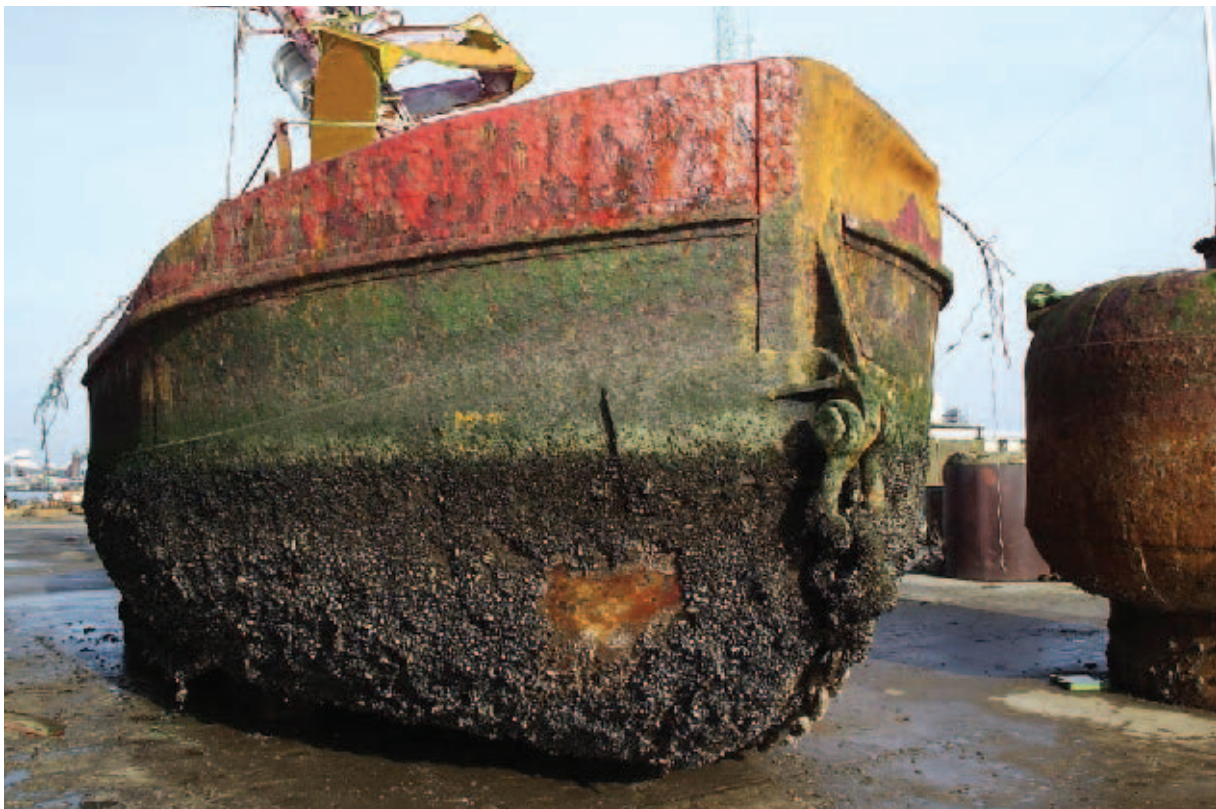
During this time, the wind and tidal stream set the ferry out of the main channel. When the master realised that the next port hand mark, a light-float, was now on the starboard bow, he used both helm and engines to try and manoeuvre the vessel towards the main channel. However, this action was taken too late and the 50 tonne lightship struck the vessel's port side. The buoy's superstructure was damaged (figure) and its mooring chain was severed by the ferry's propeller blade.

Damage sustained to the lightship's superstructure

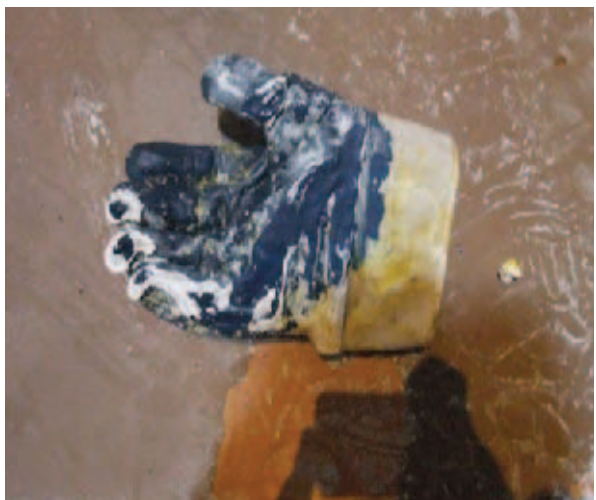
Figure 3: The crewman's heavily contaminated glove

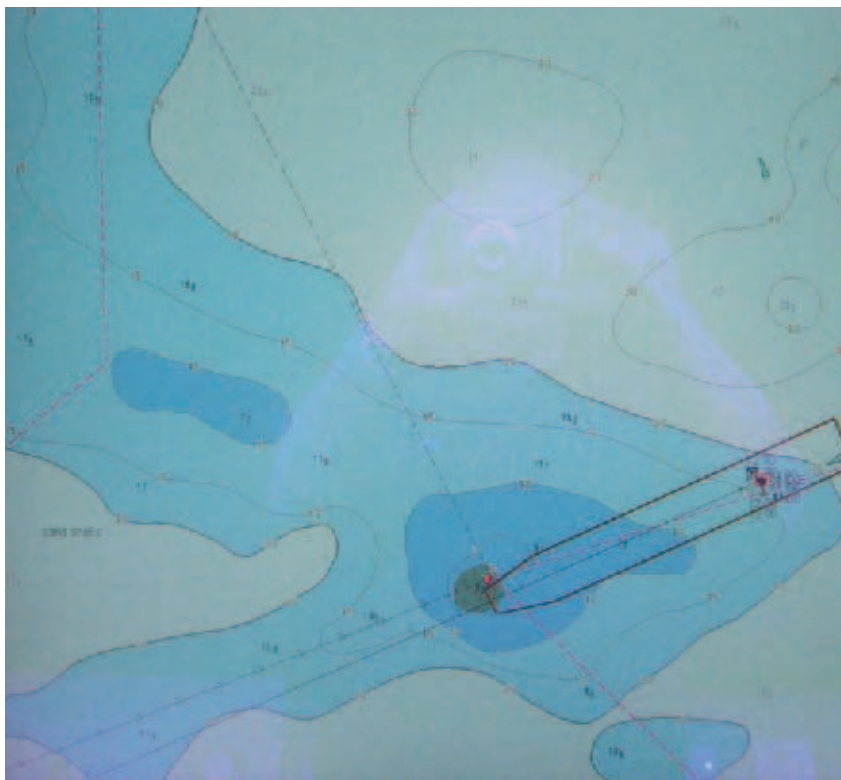
insufficient to prevent the vessel from running aground on a charted reef at 14 knots (Figure 2).

Figure 2: Vessel aground on the reef

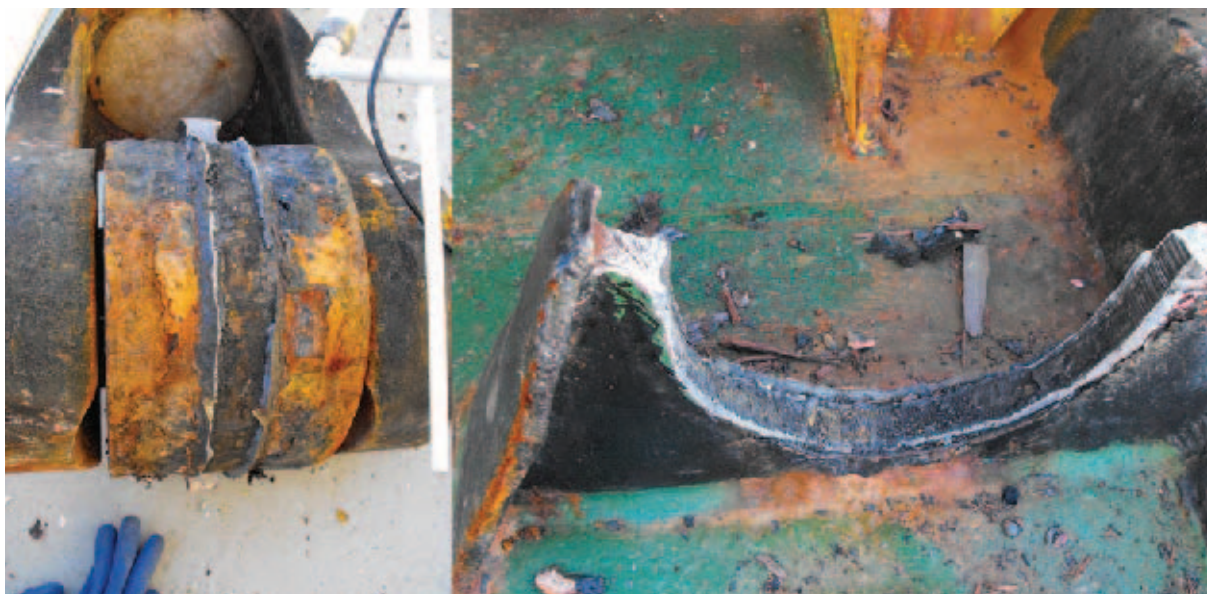
Figure 2: Damaged deck eye pad fittings

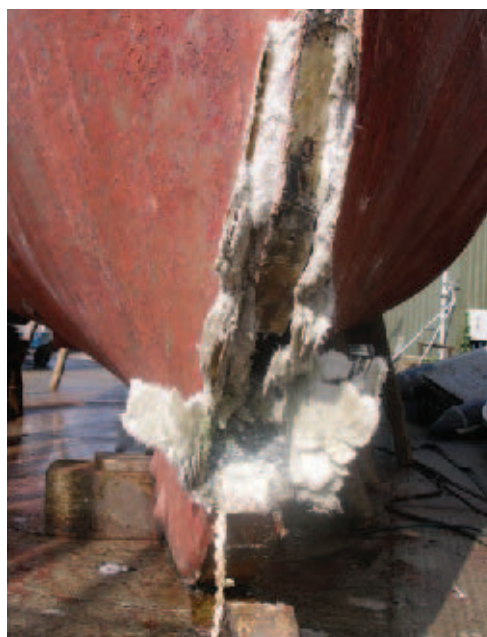
Figure 2: A close-up of the damage

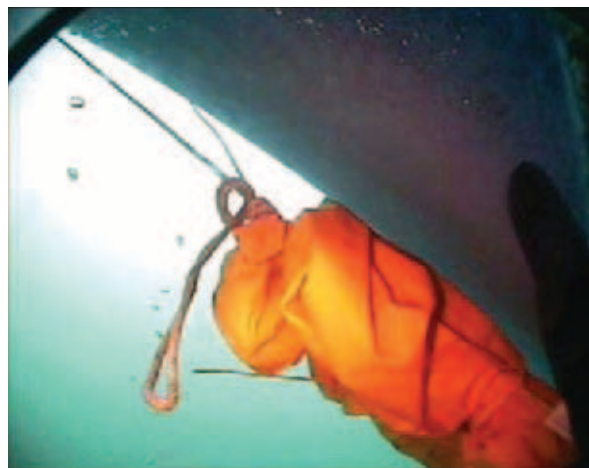
Remembering the lessons from the emergency drills carried out earlier, the skipper passed ropes through the arms of an oilskin jacket, which he intended to use as fothering. He passed it over the side of the vessel and secured it over the breach of the hull (Figures 1 and 2).

Figure 2: Oilskin jacket used as fothering

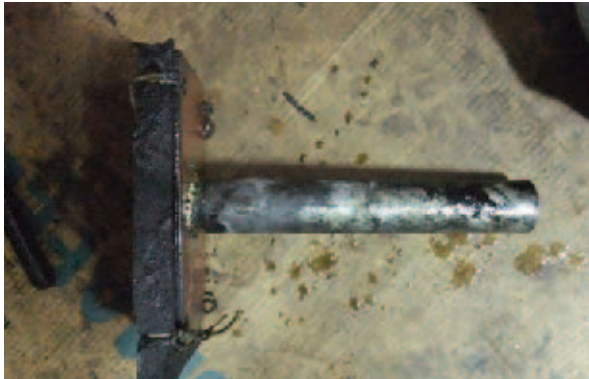
This reduced the water ingress and allowed the chief engineer to concentrate on putting a shore internally over the hole. He adapted materials at hand to manufacture a shore from a tube welded to a baseplate which was covered with neoprene rubber. He manufactured a second shore using a bottle screw from a deck wire stay which provided a method of adjustment (Figures 3 and 4).

Figure 3: Manufactured steel shoe with neoprene rubber facing

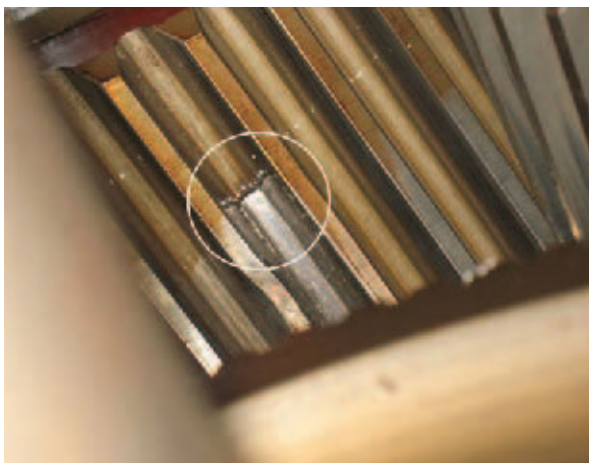
Figure 5: Gearbox pinion damage

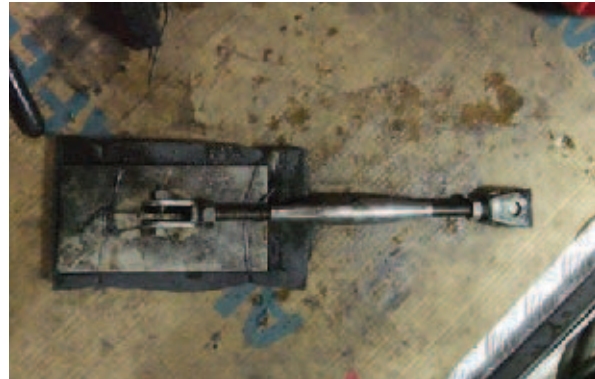
Figure 4: Manufactured adjustable shoe with neoprene rubber facing

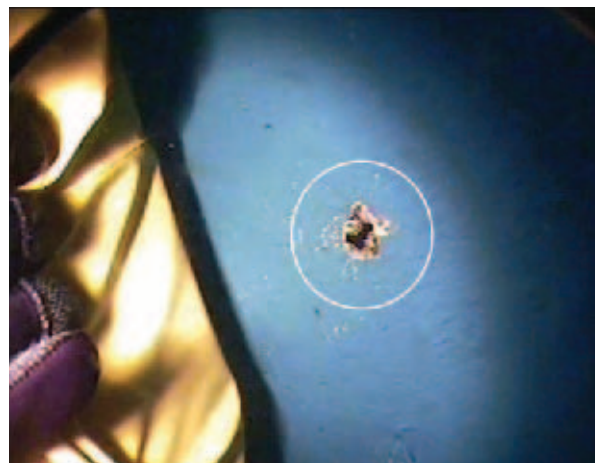
The subsequent diver's inspection of the hull identified that the leading edges of the propeller blades were polished and that there was a mass of large size monofilament longline around the propeller and the stern gland housing. When this was removed the shaft was free to turn. Checks of the gearbox found that there was damage to the gearbox pinions and clutch housing (Figure 5). The outside area around the hole in the hull was clean and there was no scraping which would indicate that something had passed down the hull. All the indications pointed to something coming into direct contact from under the vessel (Figure 6).

Figure 6: Hull penetration

Ultrasound hull plate thickness readings around the hole were also taken and this showed that the thickness had wasted to 1-1.5mm inside a 70mm diameter circle around the hole. The surrounding plate scantling then rapidly increased to 6.5-8mm.

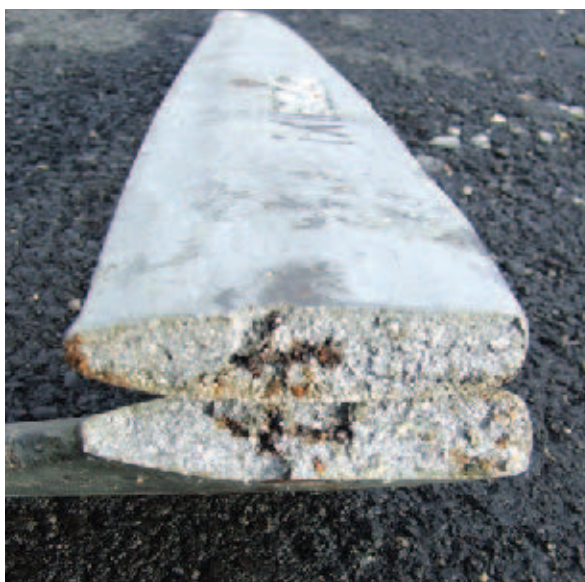
Figure 2: Flawed casting in the shank

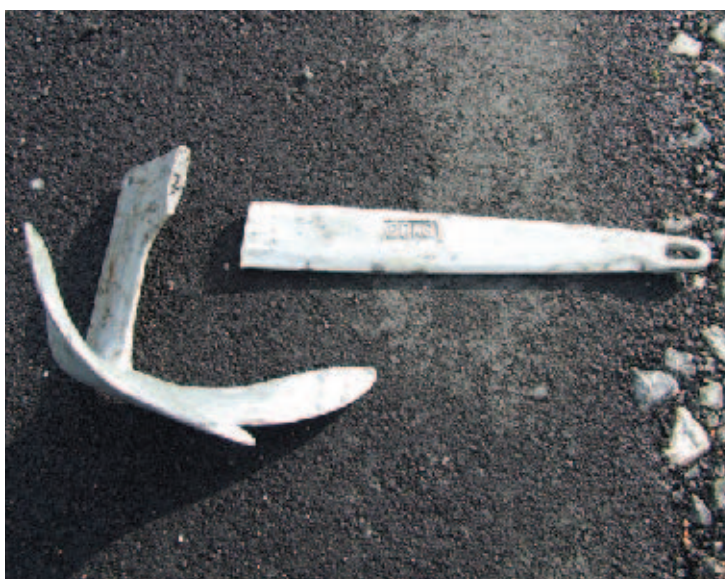
Thirty minutes later, the skipper heard the chain rumbling across the seabed and got up, to discover the vessel was almost aground. He promptly raised the rest of the crew and hauled in on the anchor chain; only the anchor shank was on the end of it. They picked up the trip buoy, and on hauling in the line found the remainder of the anchor attached.

Figure 3: Recovered head and parted shank

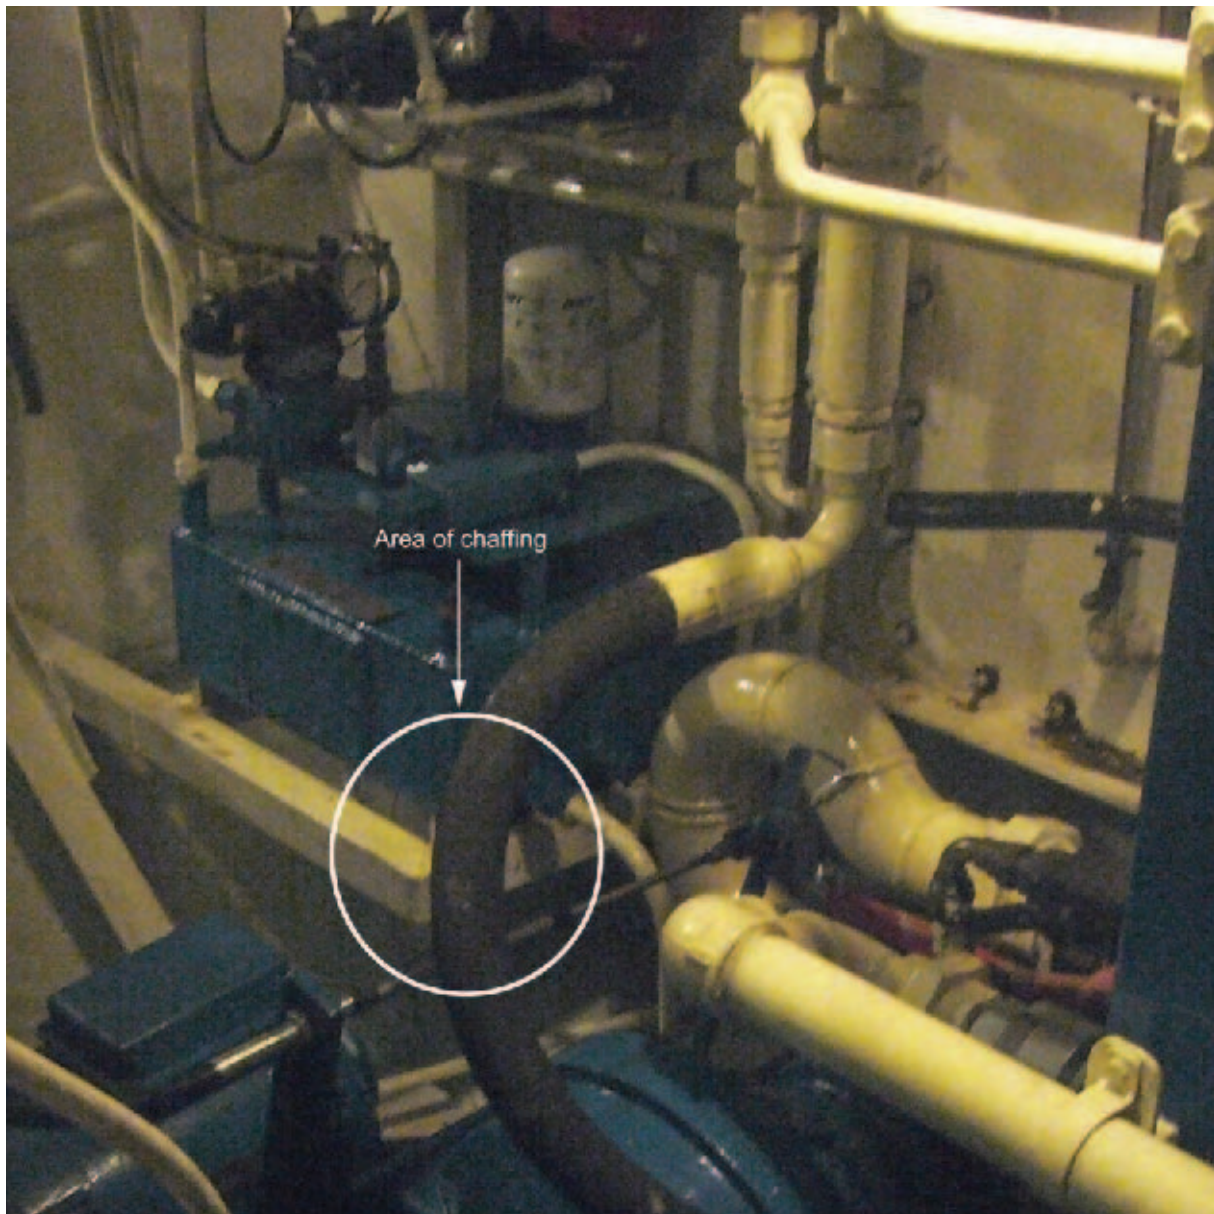
Area of failed hydraulic pipe

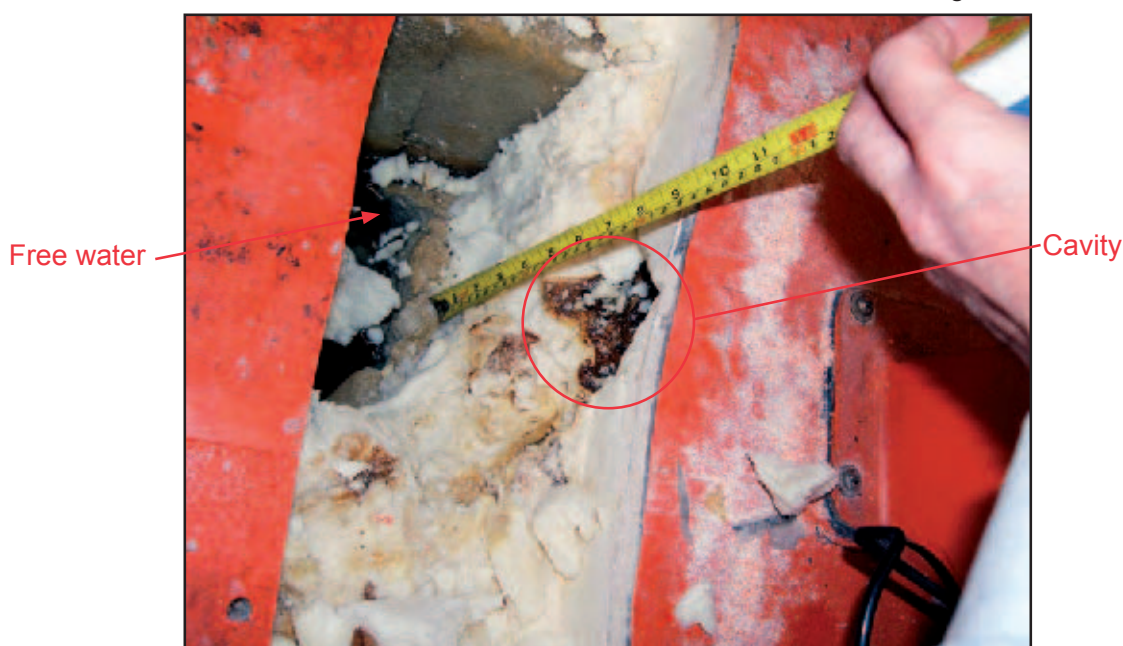
Figure 2

Below deck inspection

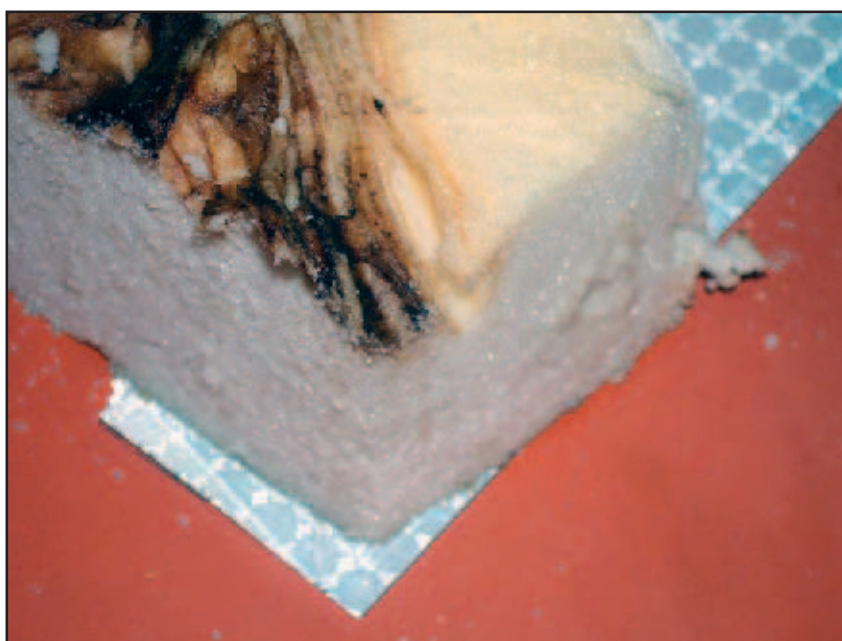
Figure 3

Foam sample from cavity

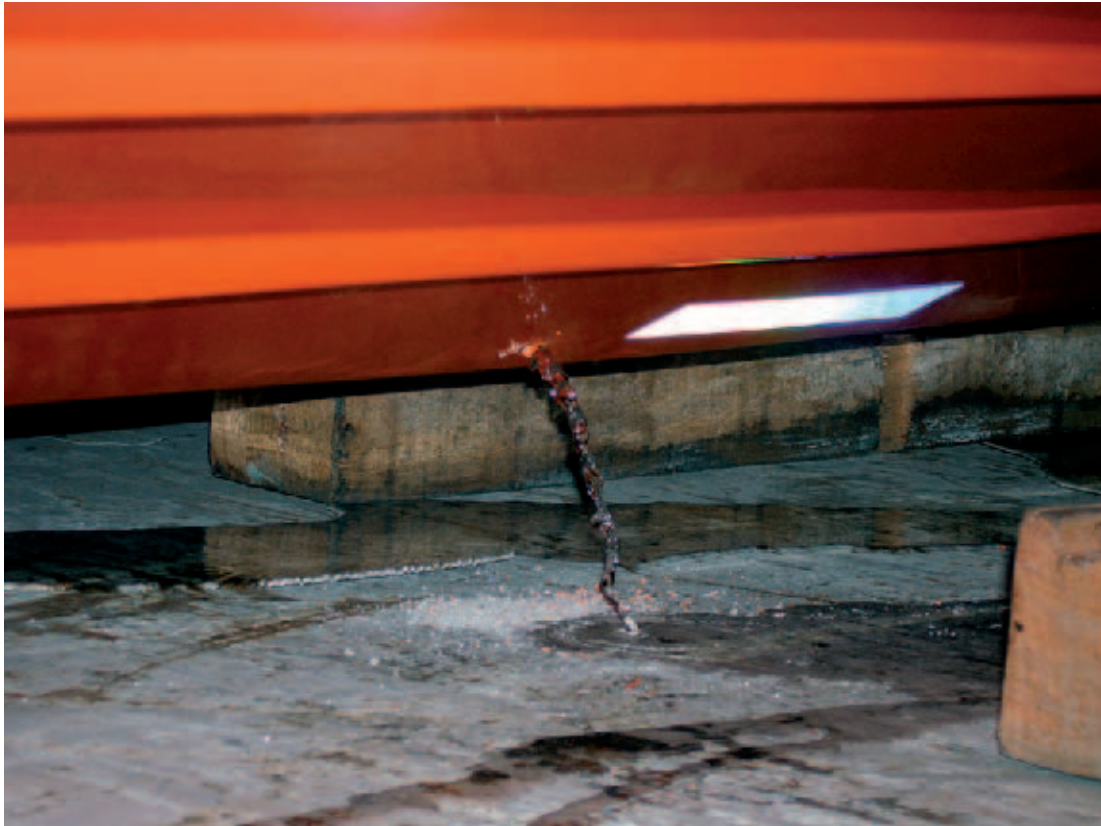
Figure 4

Although the boat was fitted with a drain plug on the transom, the internal compartments were not interconnected. The removal of the plug therefore allowed the water to drain only from the aftermost compartment. The water in the remaining compartments was trapped and had to be drained by separately drilling into each compartment through the hull (**Figure 4**).

Water draining from foam-filled compartments

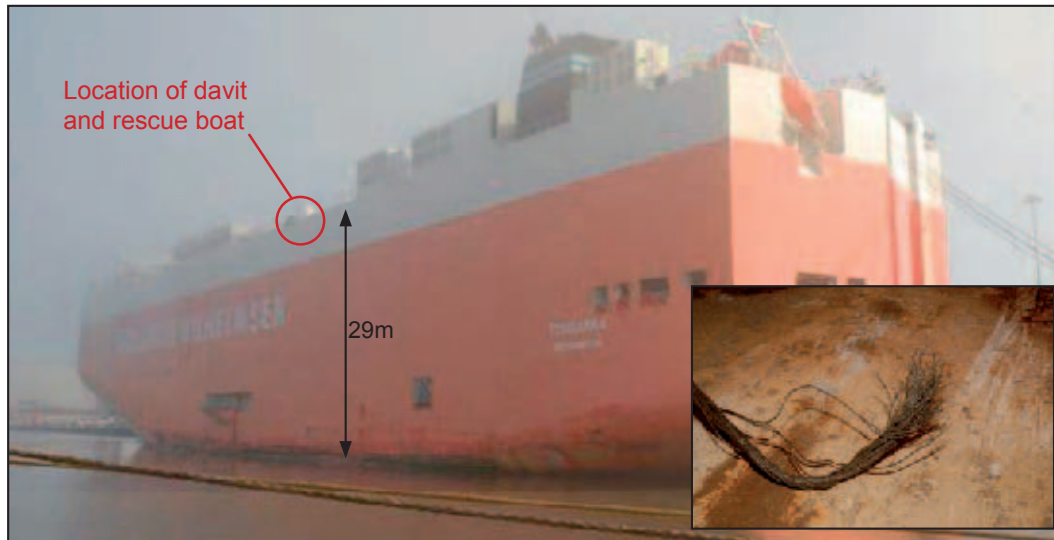
Figure 1

Vessel and parted fall wire

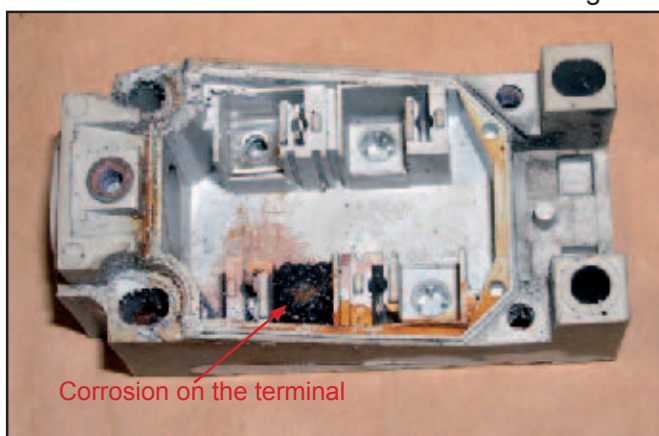
Figure 4

Water ingress into proximity switch
