**MARINE ACCIDENT  
INVESTIGATION BRANCH**

# **SAFETY DIGEST**

**Lessons from Marine  
Accident Reports  
1/2012**

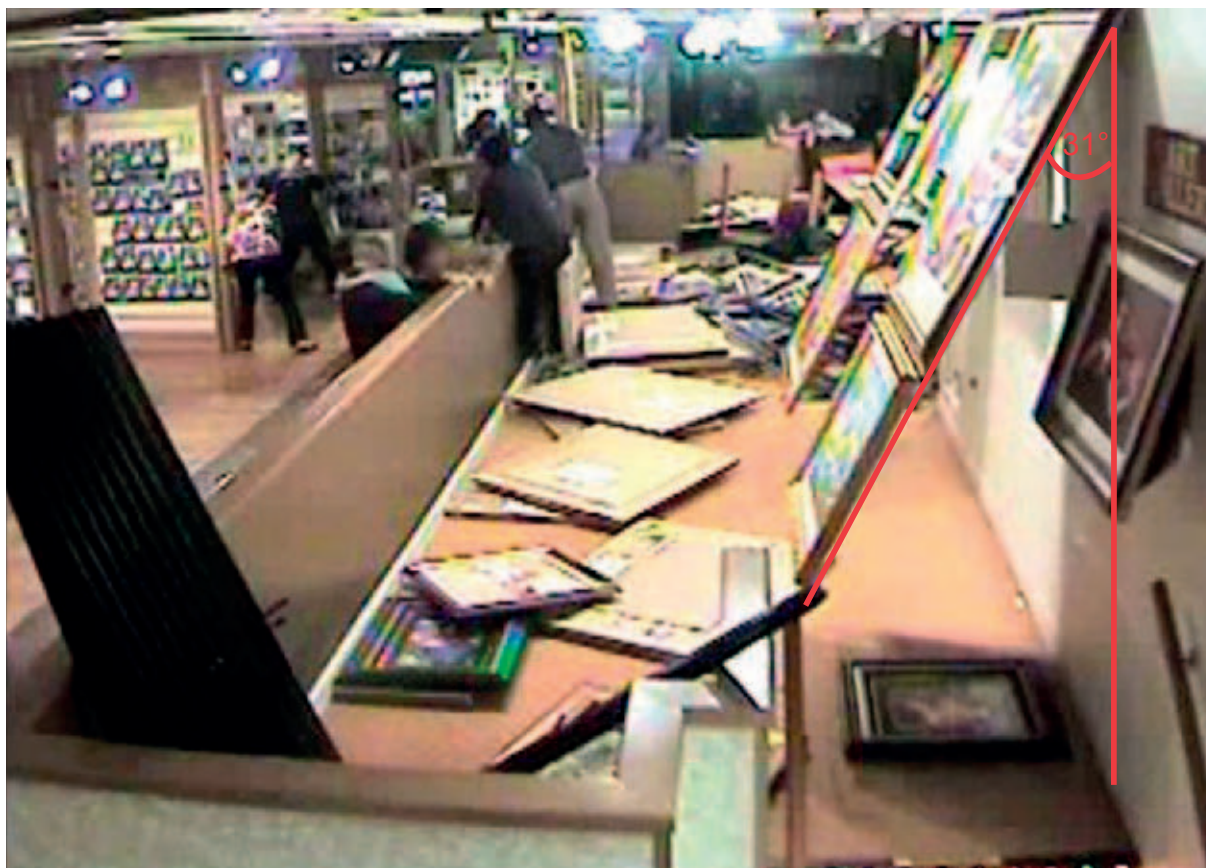
The ship rolled very heavily several times, heeling the ship to more than 30°. This roll caused passengers and crew, along with unsecured - and some previously secured - equipment to be projected across the ship several times (Figure 1). Numerous passengers and crew were injured, several seriously. The passenger public areas, including rooms designated as passenger muster stations, crew working areas and the galleys were strewn with furnishings, fittings and broken glass and crockery (Figure 2).

Figure 1: Ship heeled during heavy weather

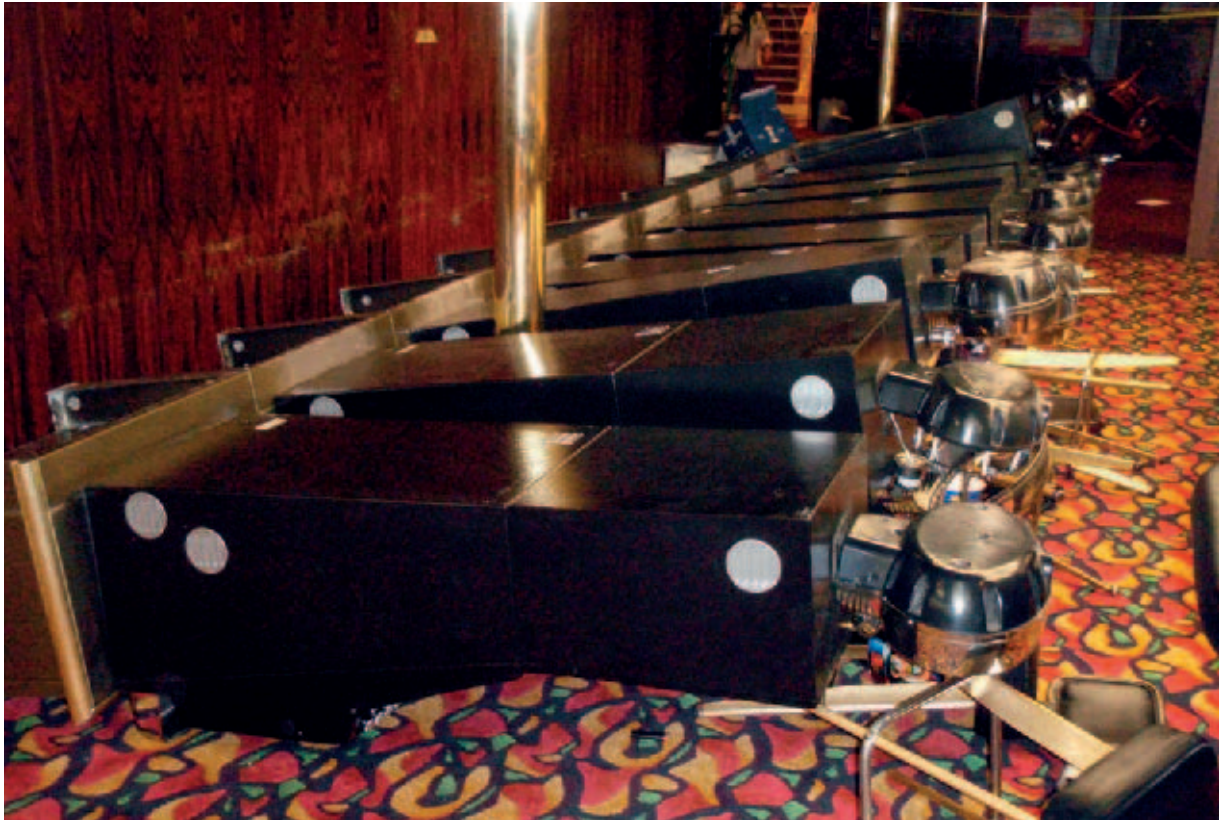
Figure 2: Crew mess room following the accident

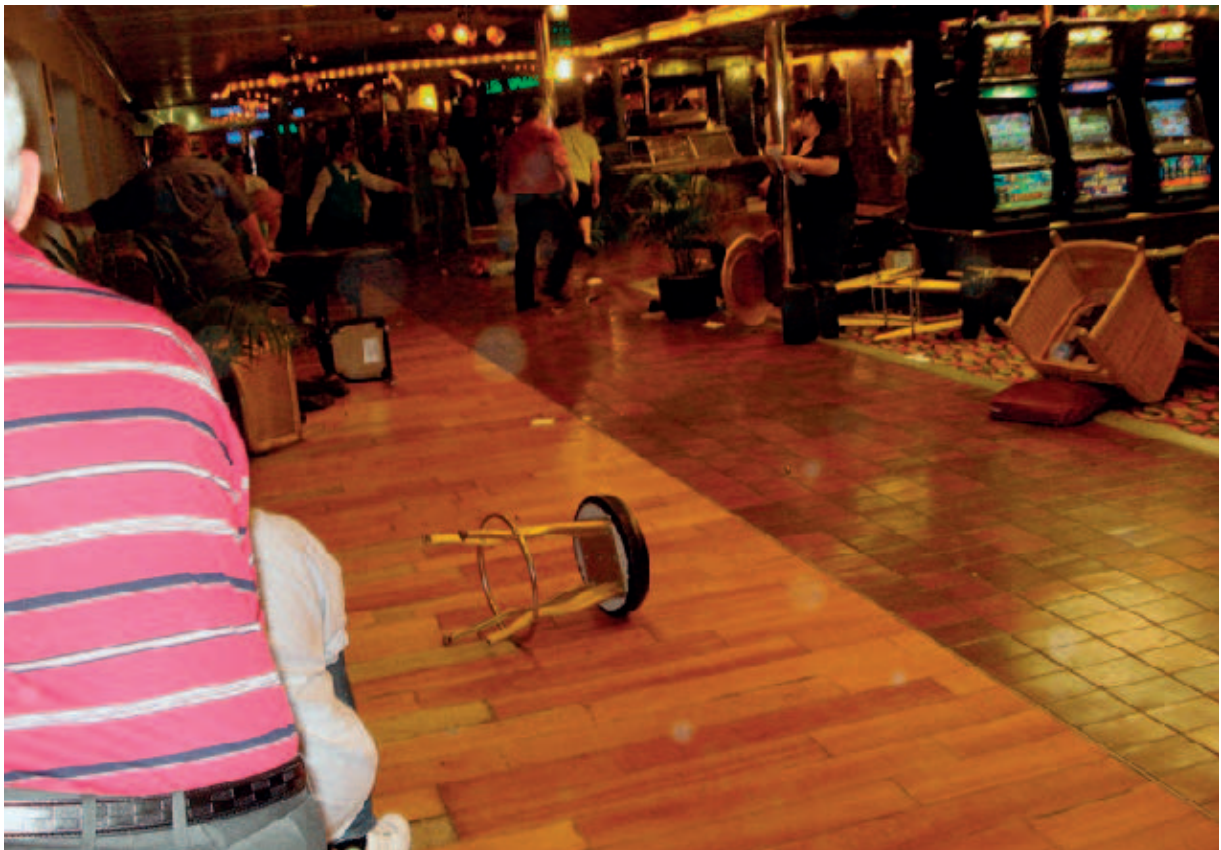
Figure 3: Passenger muster station following the accident

5. Some of the muster stations (Figure 3) were made unusable following the accident; had the situation deteriorated the master would have been unable to send the passengers to their designated areas.

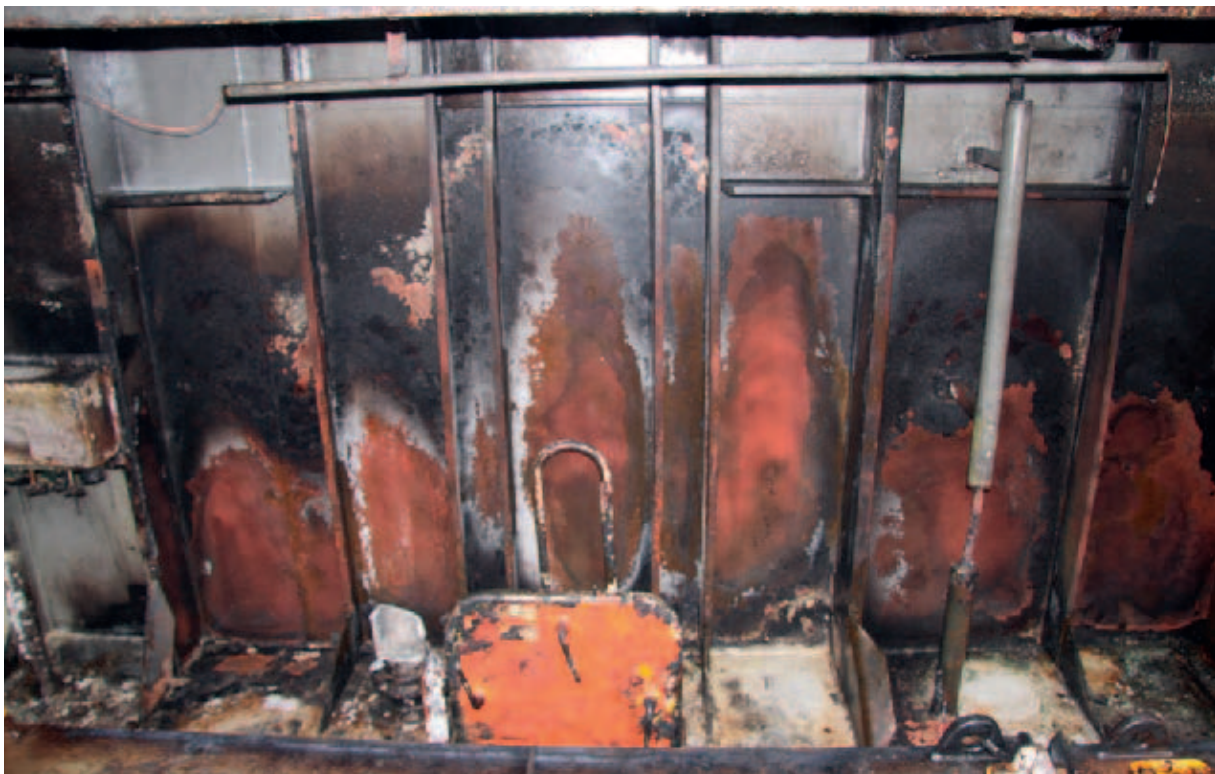
The seat of the fire was found to be a large quantity of linseed oil-soaked cotton waste. This had been used to mop up oil that had leaked from one of the containers discharged at the previous port. The waste had been left in a large pile on rubber matting on the deck which had also ignited.

Fortunately, the fire damage was limited to the paintwork on the forecastle break bulkhead, a reefer electrical supply cable, light fittings and a hold ventilation cowl (Figures 1 and 2).

Figure 1: Bulkhead damage

1. When clearing up oil spillages, especially boiled linseed oil, be considerate of the risk of spontaneous combustion; especially if the waste is piled up.
2. Good housekeeping is everyone's business and helps make for a safe ship environment. Do ensure there are arrangements in place for the safe storage and disposal of contaminated waste. Further guidance can be found in Chapter 9 of the Code of Safe Working Practices for Merchant Seamen.
3. In this case, the crew dealt with the fire in a confident and competent manner because they were well practised in fire-fighting techniques. Imaginative and properly de-briefed emergency drills will improve fire-fighting and help make reactions instinctive and success more likely.

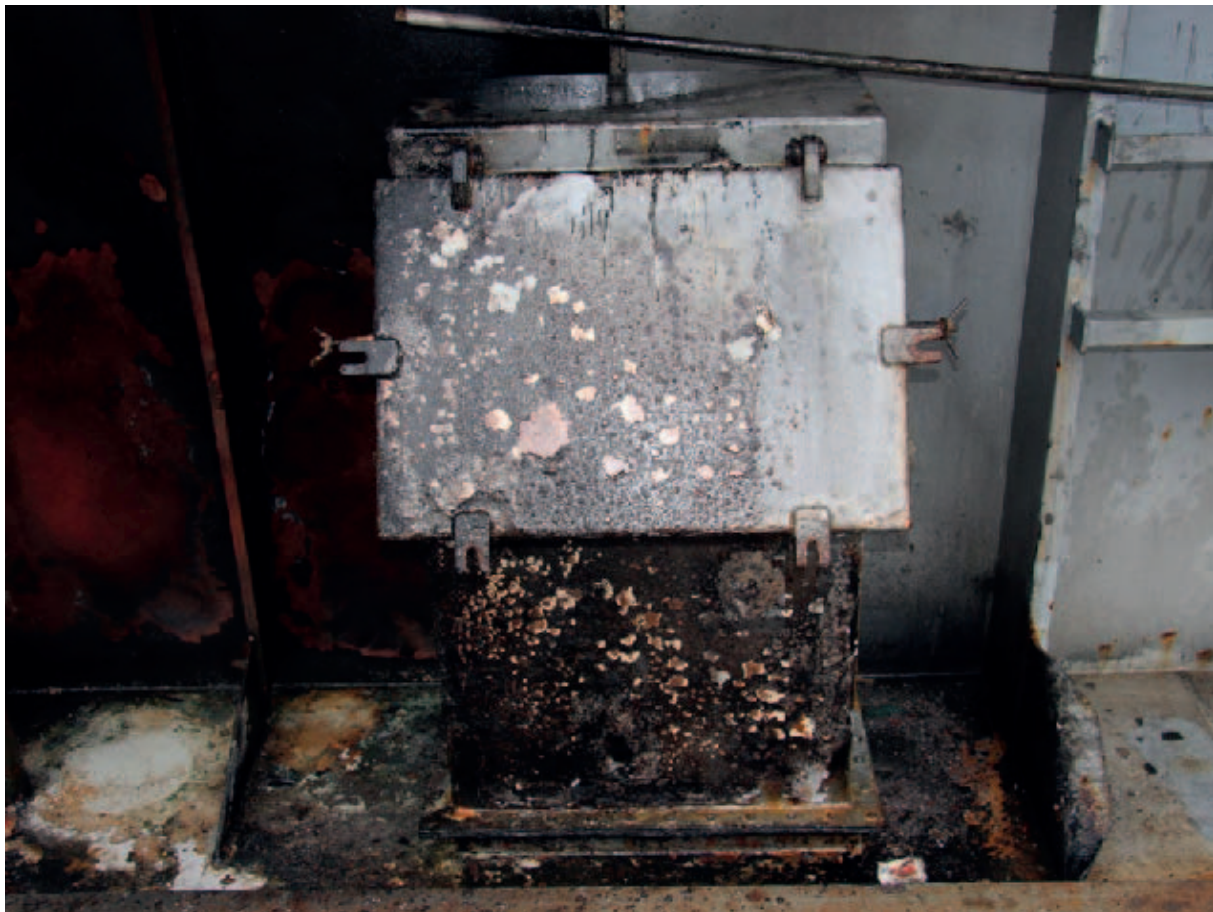
Figure 2: Hold ventilation cowl damage

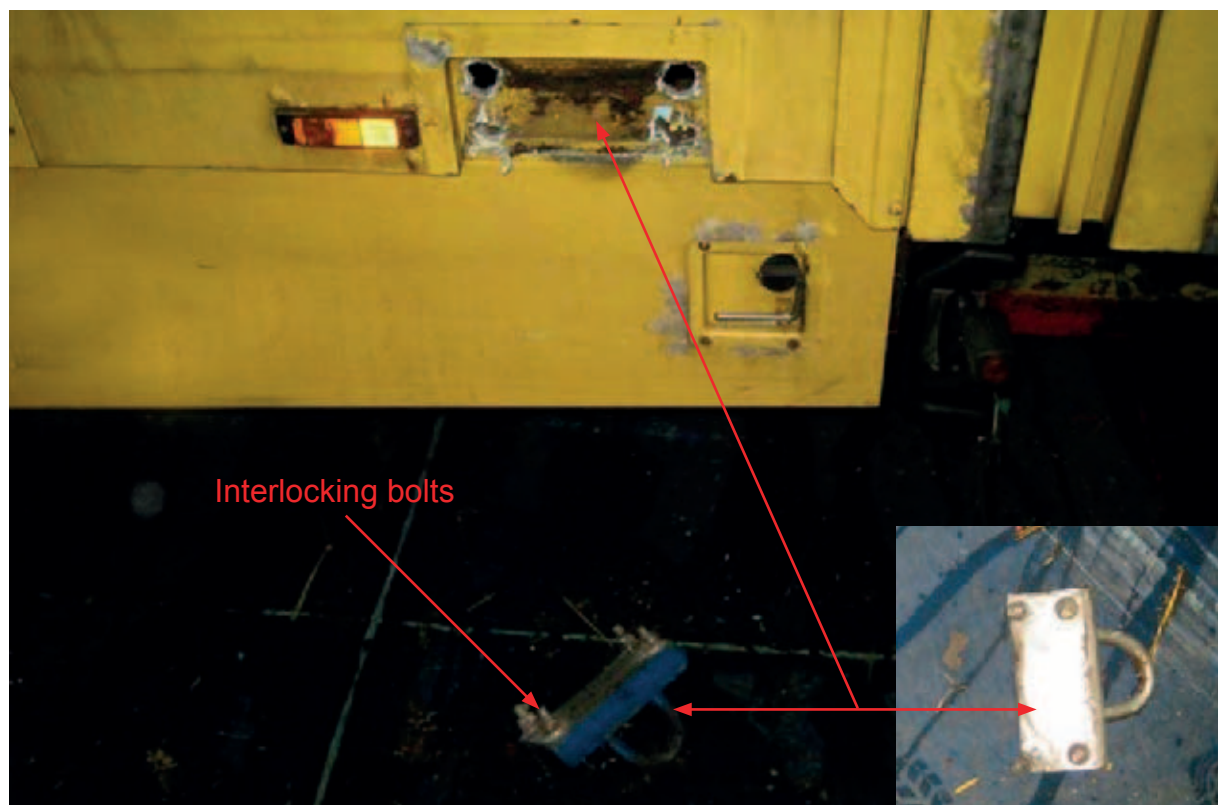
The 70 tonne vehicle and trailer had been secured by eight chain lashings, but all of the lashing points on the vehicle had failed (figure).

Closer inspection showed that the vehicle and trailer had been designed with steel lashing points secured by four steel bolts to the aluminium frame of the vehicle. The force applied to the lashings during the heavy roll had caused the four steel bolts on each lashing point to be pulled through the aluminium bodywork and become detached from the vehicle (figure).

Steel lashing point complete with securing bolts detached from aluminium vehicle frame

lashing points are detailed in international standards. However, a coat of paint can disguise many deficiencies, and it is good practice for road hauliers and ferry operators to closely check, wherever possible, that the design, construction, or condition of vehicle lashing points are not flawed.

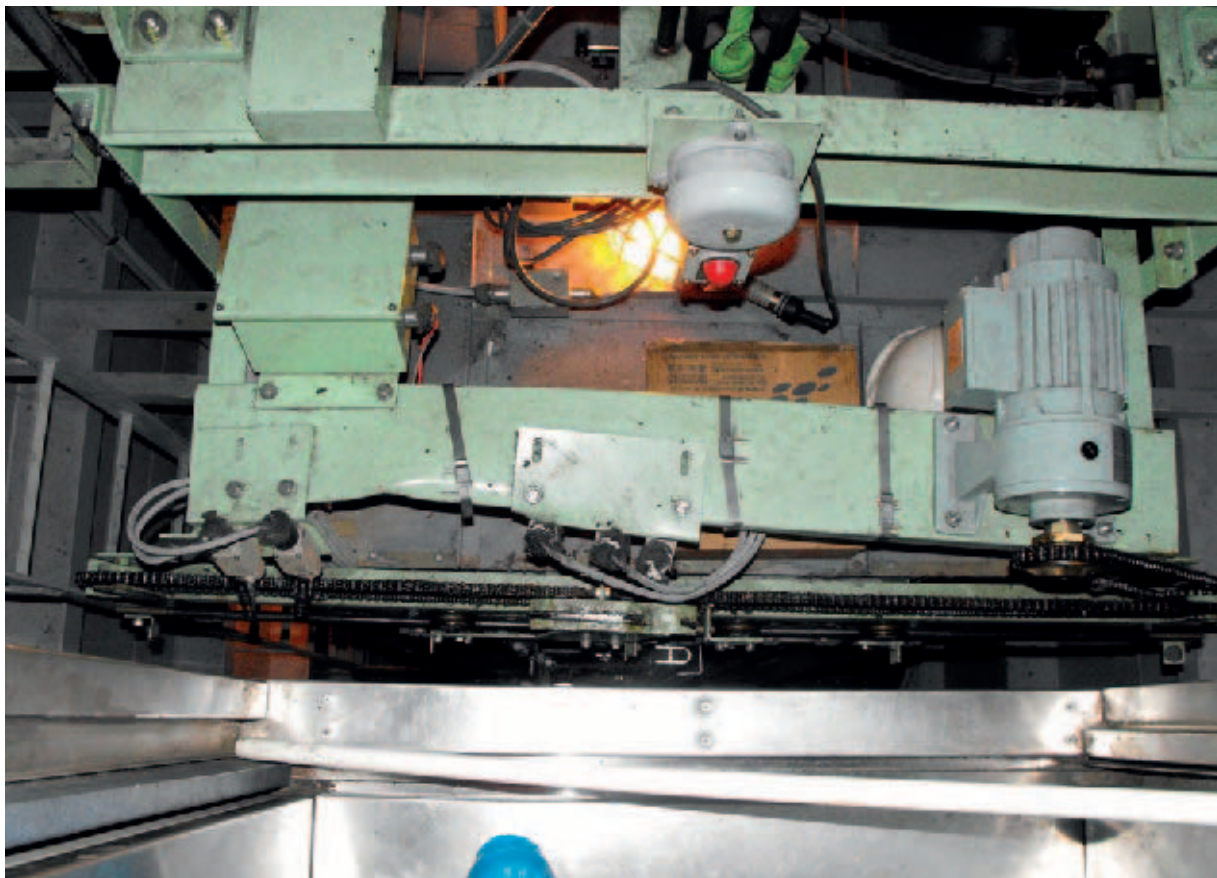
Figure 4: Location of chief engineer after the accident

1. Lack of planning, poor communications and incorrect assumptions led to the chief engineer placing himself in an extremely hazardous position while the duty engineer reset all the safety interlocks.

*Whenever doubt exists in carrying out hazardous duties, the job must be stopped until everyone understands the task in hand. Planning is required prior to lift entry; too often people are killed by lifts when work is not properly considered, particularly when it is carried out at short notice.*

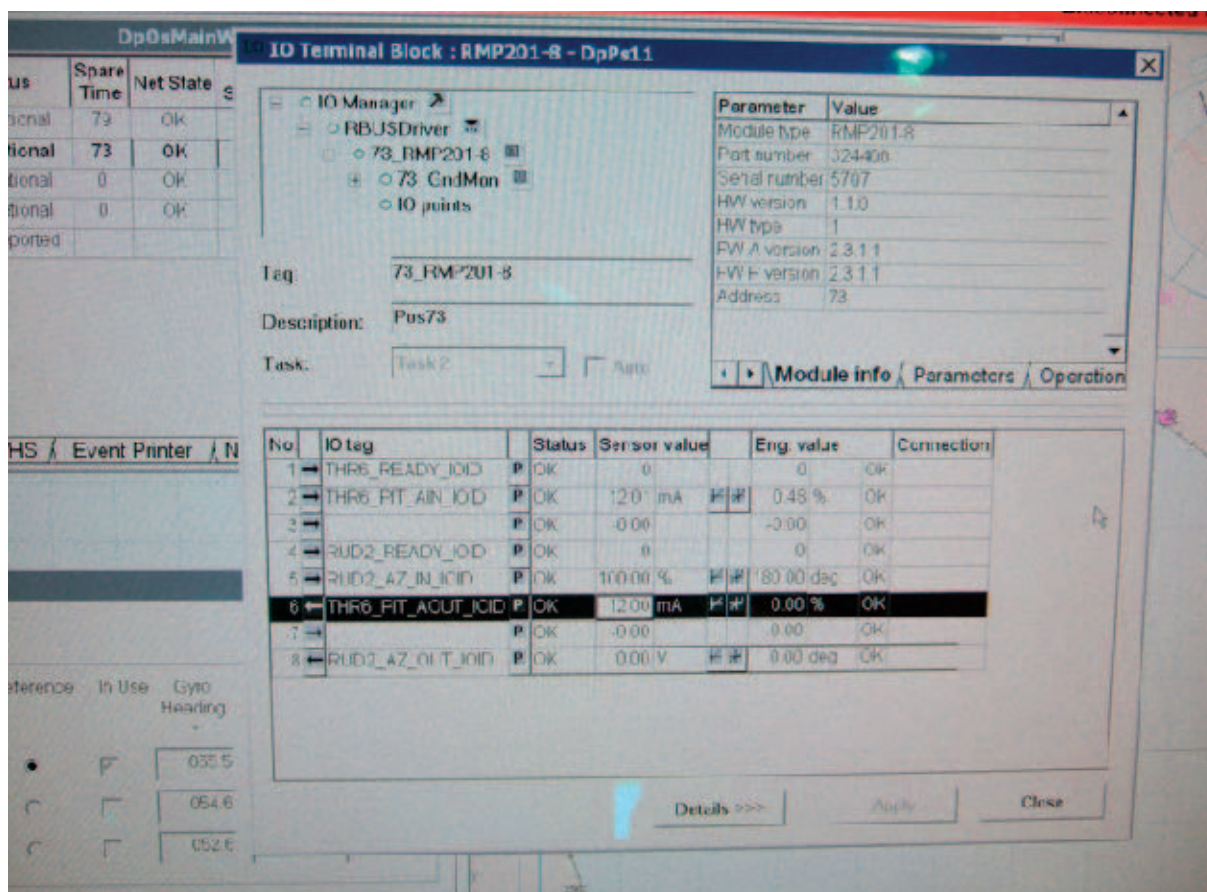
The technician noted the command signal of 12 milliamps (mA) for the CPP displayed on the DPS operator's monitor and accepted that the 4-20mA signal value range was correct (Figure 2). He did not check it against the specification as required by the HAT documentation. Had he done so, he would have noted that the correct value should have been  $\pm 10$  volts, which was the command signal range designated for the CPP controllers.

Figure 2: CPP command signal data

It was found that full CPP ahead pitch was inadvertently applied because the 4-20mA command signal resulted in a measured voltage of 13.5 volts at the CPP control module which was greater than full pitch ahead, i.e. +10 volts. This had not been identified during earlier factory test checks or during the installation stage, so it was not corrected. It was found that the most likely cause of the failure to take manual control of the CPP and thrusters was due to the mode selector switch not being correctly moved to the “manual” position after the inadvertent pitch had been applied.

3. Investigate alternative ways of proving controls, i.e. by linking out electrical/control circuits before connecting to running plant.
4. Check emergency stops regularly and do not delay in rectifying defects. In this case the stops had been checked in accordance with the maintenance schedule. The port one had been identified as being "sticky" during testing; other than lubricating it with WD40 no further action was taken.

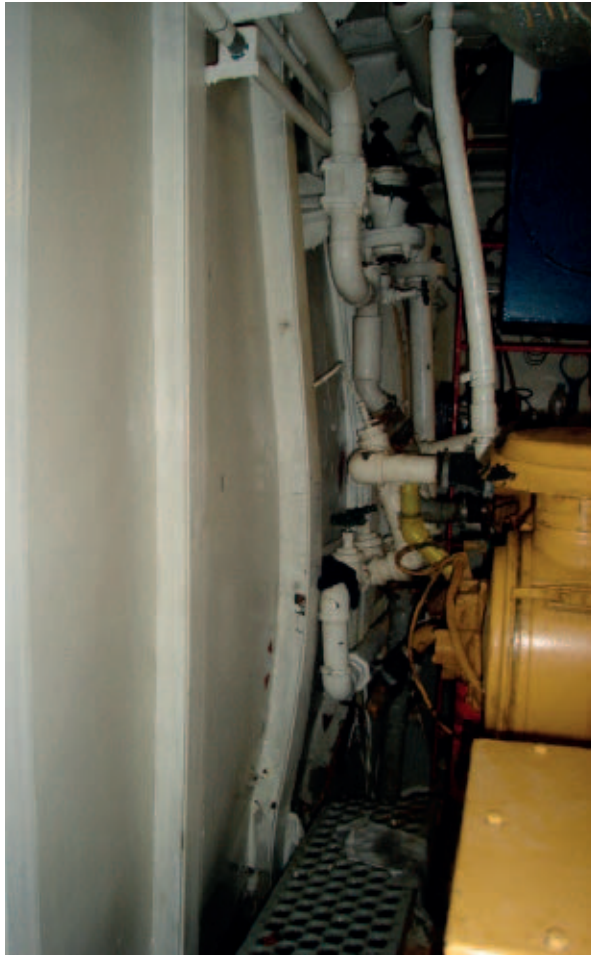
Varying degrees of shell plate, frame and upper deck equipment damage (Figures 3 and 4) was sustained on the three vessels. Fortunately there was only one case of minor bruising, to one crew member.

Figure 3: Bulkhead and frame damage

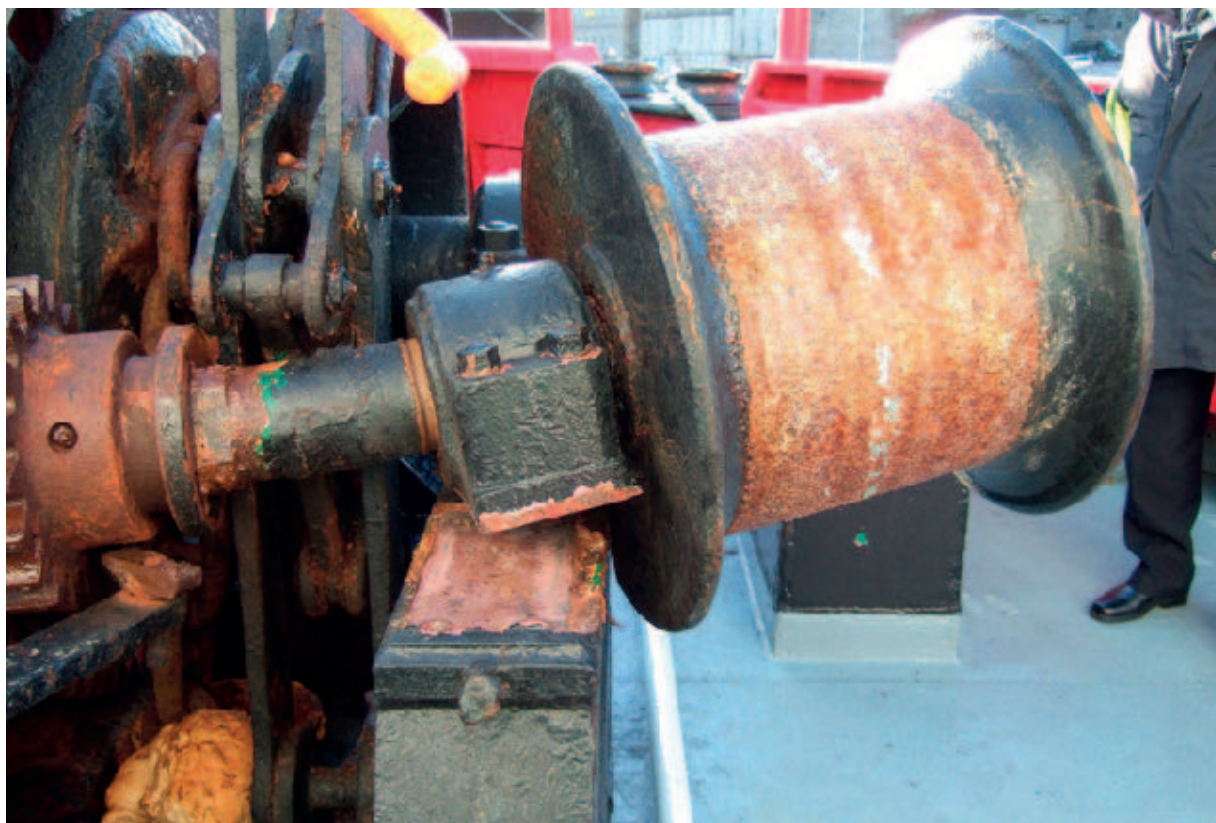
Figure 4: Fractured winch drive shaft

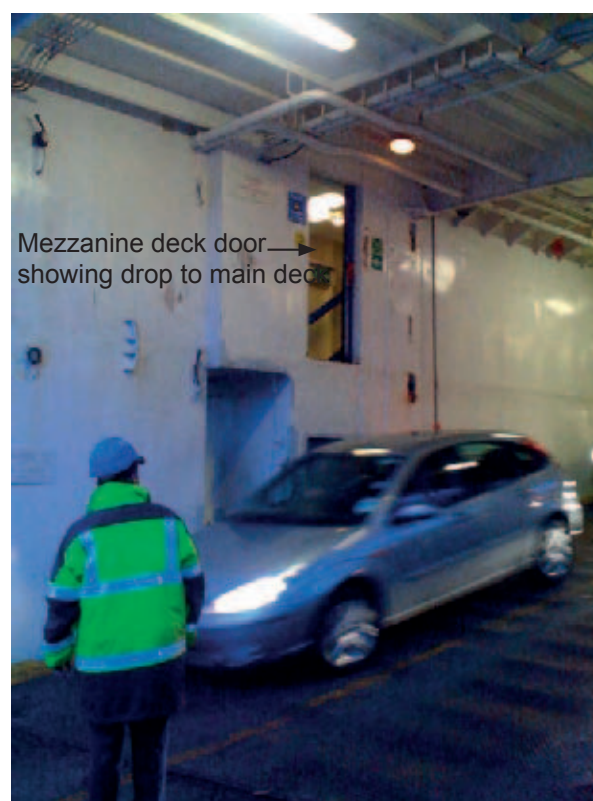
It was a pleasant journey, and as the ferry reached her destination the passengers went to retrieve their cars. Two of them proceeded to what they thought was the main vehicle deck entrance. In fact, they were both at the mezzanine deck level. One of the passengers depressed the port mezzanine deck door "open" button. The sliding door opened and the two passengers were just about to step through the door when, to their alarm, they found that there was no deck outside the door, but were instead confronted with a fall of 2.54 metres onto the main car deck below (Figure 2).

Figure 2: View of door in open position

On investigation it was found that the port mezzanine deck access door interlock bolt, which should have prevented the door from opening when the deck was in the stowed position, had not fully travelled to the safe position because of a build-up of debris in the bolt recess channel.

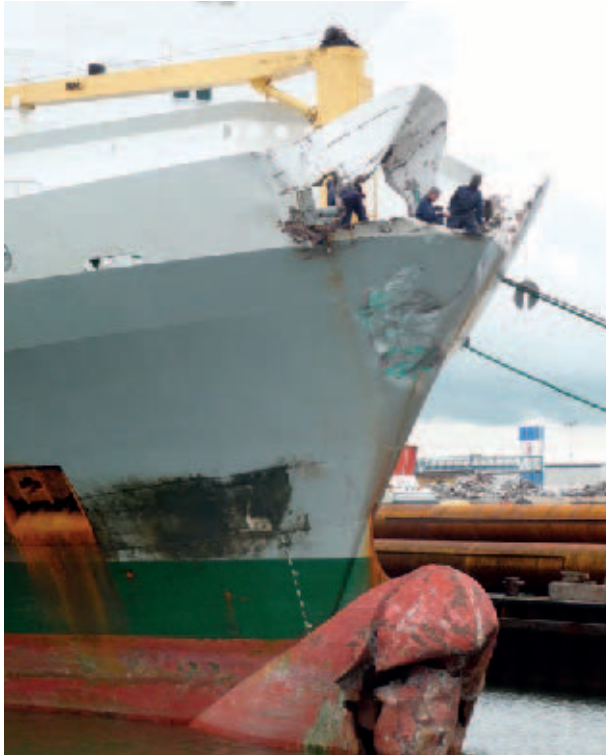
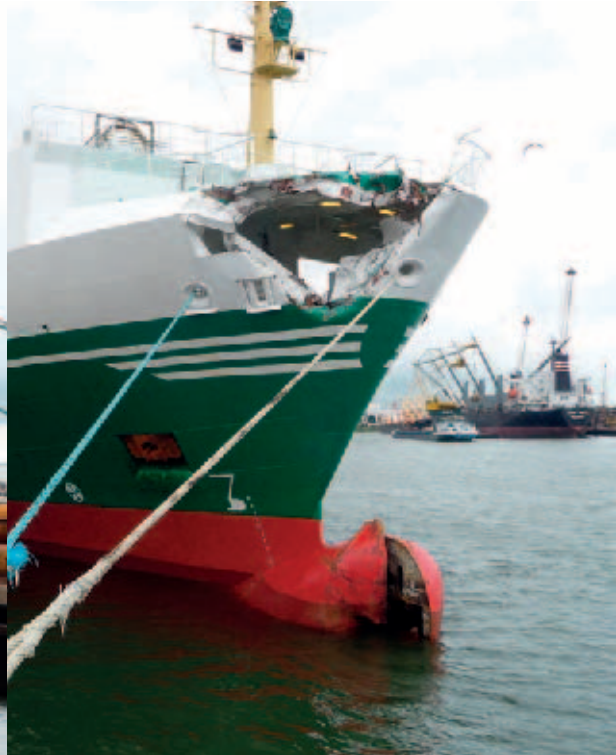
Damage was sustained to both vessels

A 10,000 tonne container vessel, with a pilot embarked, collided with another vessel which was proceeding in the opposite direction of a narrow channel. Both vessels suffered extensive damage and were out of service for a considerable period while costly repairs were undertaken.

In shallow water, with reduced under keel clearance, the vessel's pivot point would have moved aft, reducing her steering lever. Close to the edge of the bank the large forces associated with the high pressure area around her bow and the low pressure area around her stern caused the sudden sheer to port which, with a reduced steering lever, the helmsman was unable to correct before the collision occurred.

1. The cause and effects of interaction should be recognised and taken into account by all members of a vessel's bridge team. Speed is critical, since the magnitude of forces created by both bank effect and squat increases with the square of the vessel's speed through the water.
2. The fundamental requirements of planning and executing a safe navigational passage must be clearly and fully understood and implemented by all bridge officers. SOLAS

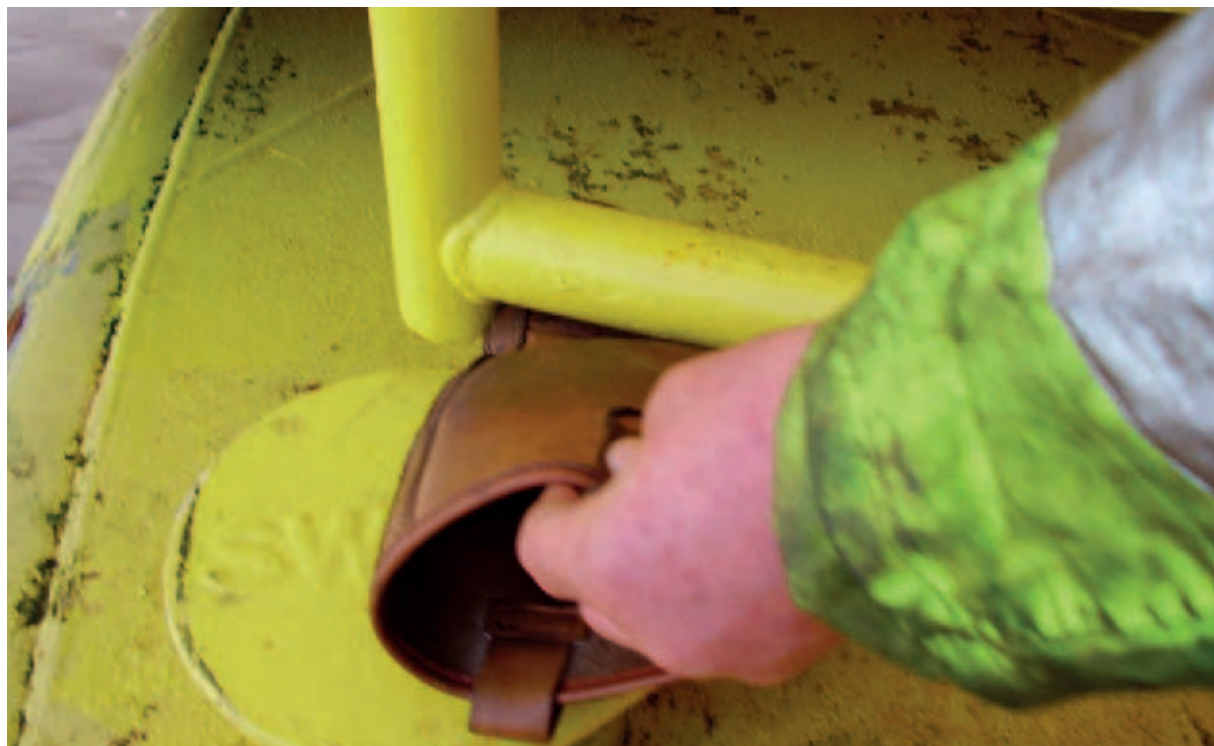
turn, the short vertical access ladder pinned the AB's ankle against the flat plate topped bollard (Figure 2).

Figure 2: Point of entrapment

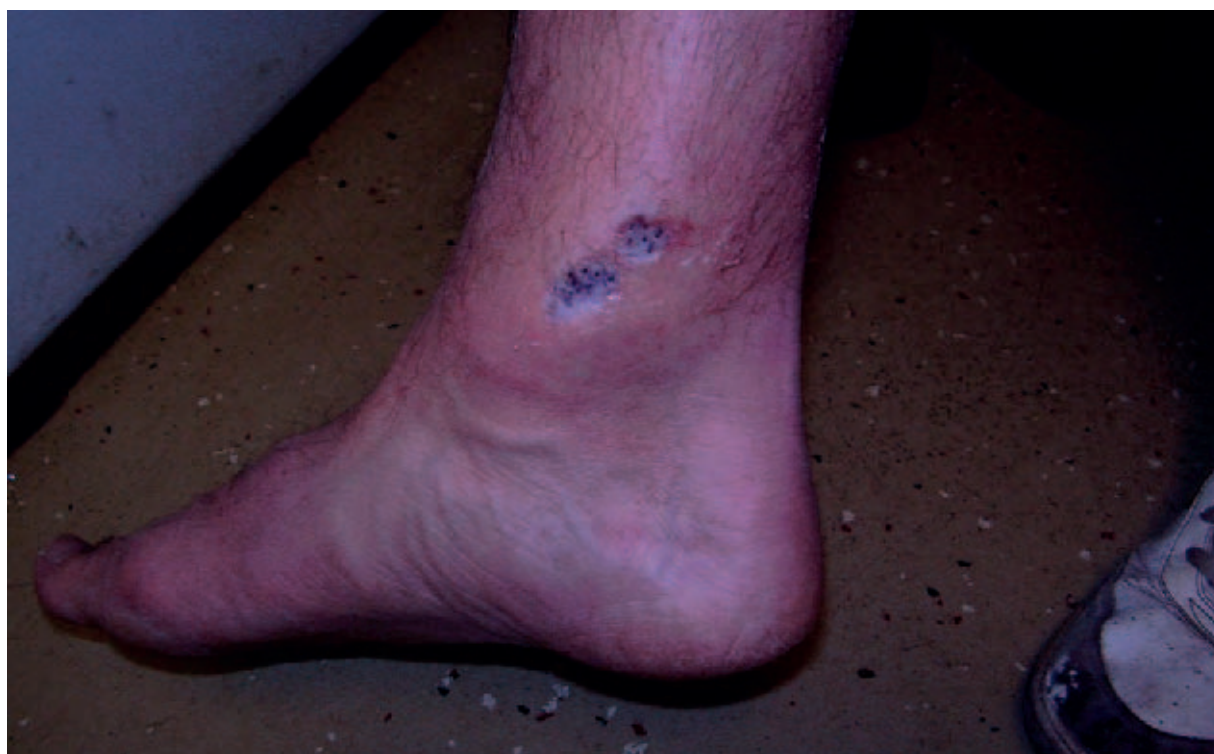
Figure 3: Ankle injury

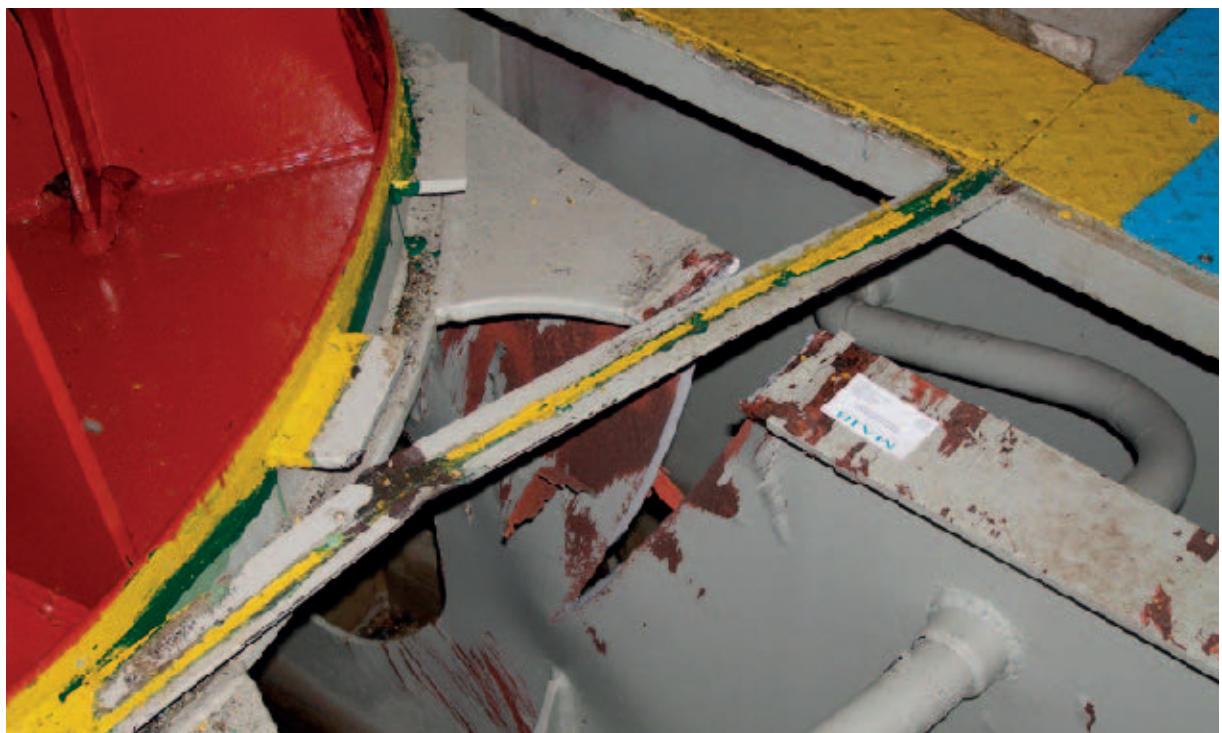
Figure 2: Damage to steering compartment

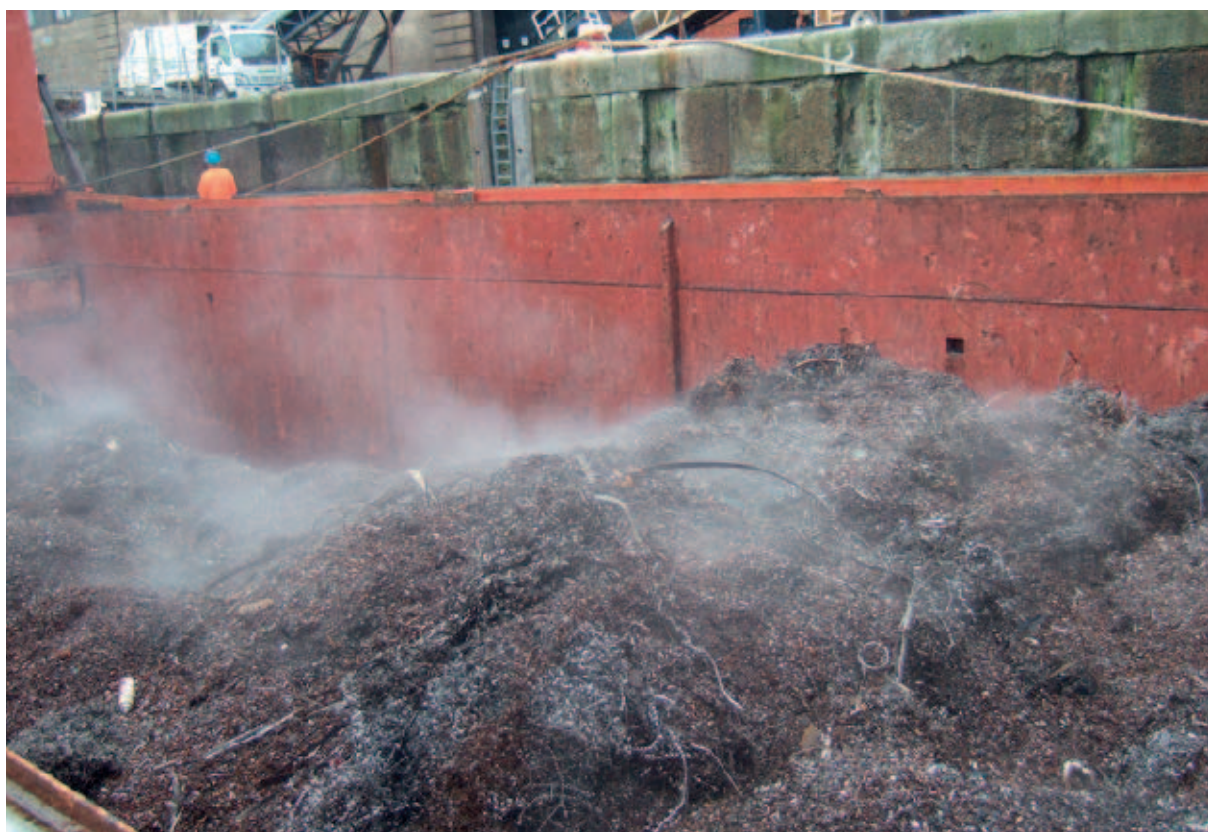
The forward store's oxygen-depleted air was caused by the heavily oxidised cargo. The cargo hold was connected to the forward store by holed ventilation ducts that ran to the closed mushroom vent on the forward deck (Figure 2). The forward store was unventilated because it had been tightly secured for the expected heavy weather. The heavy pitching motion had caused the ship to pant, equalising the atmosphere of the two adjacent spaces.

Figure 1: Cargo of ferrous metal turnings

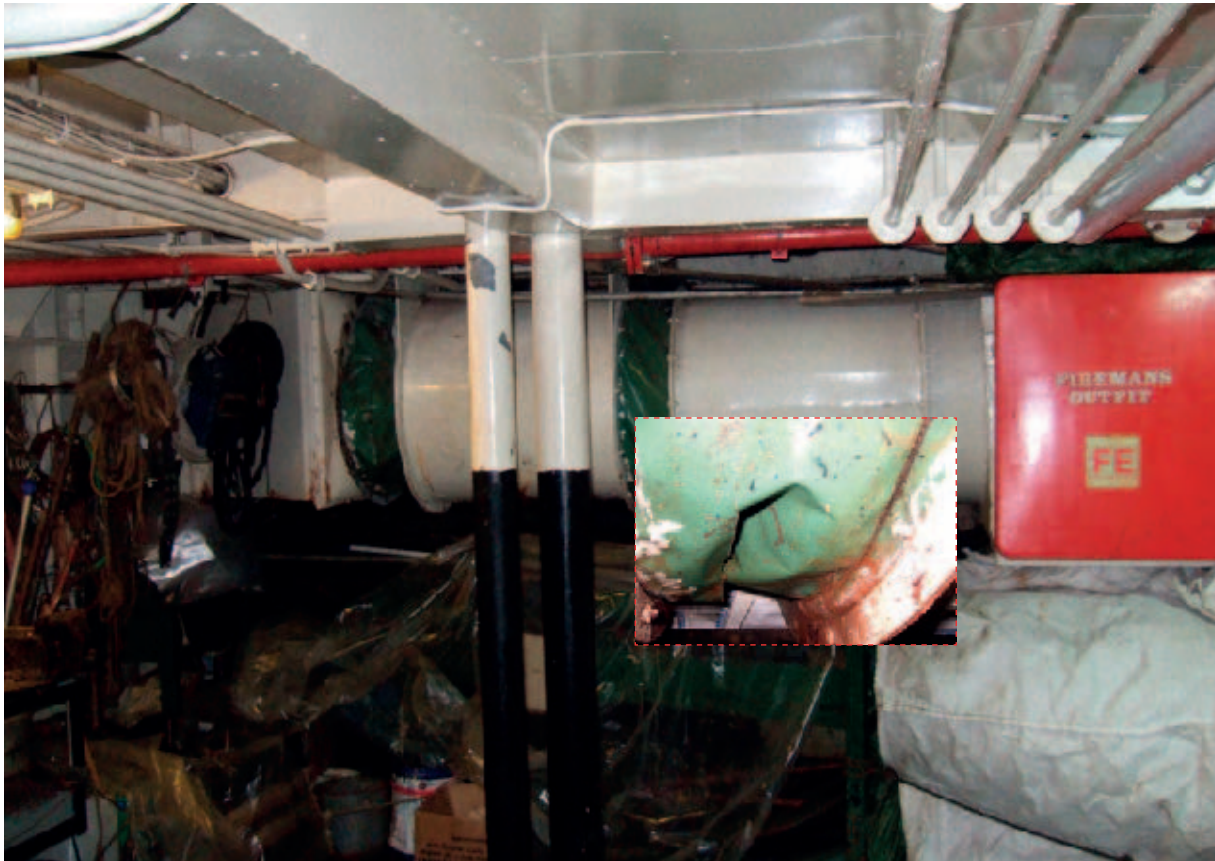
Figure 2: Forward store - vent trunking from cargo hold to deck vent

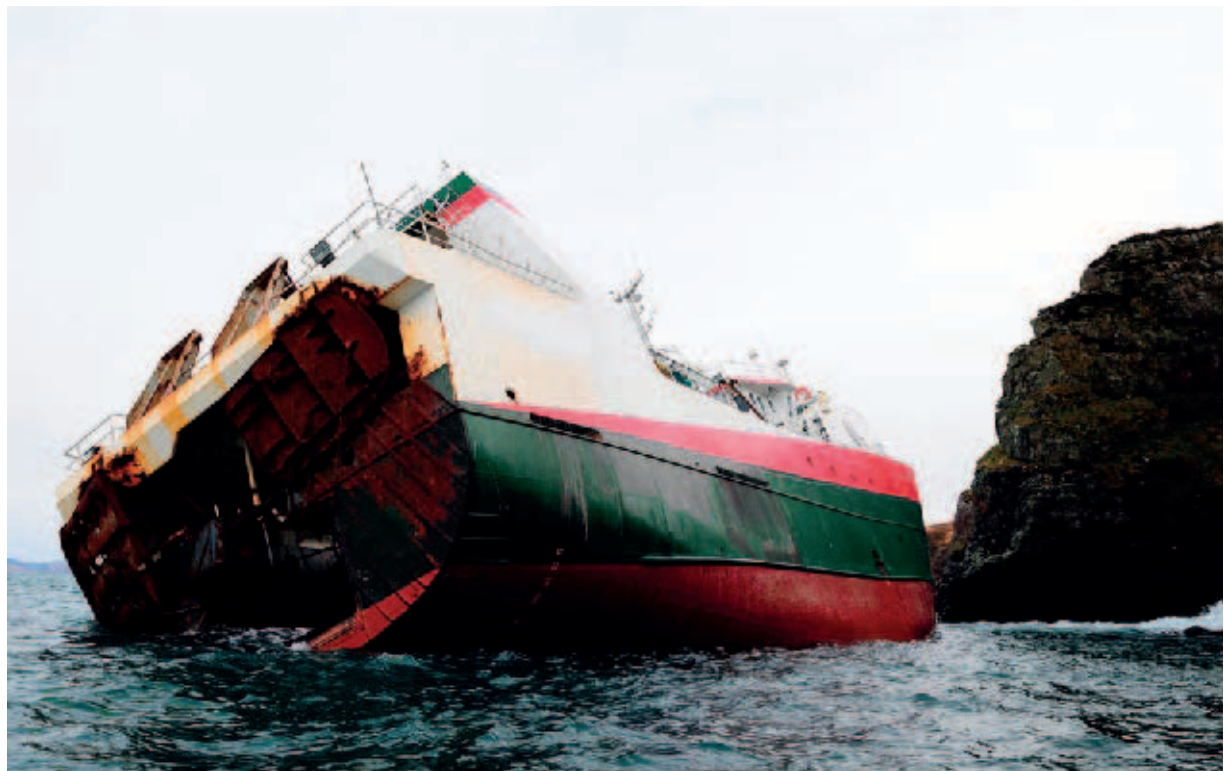
A short while later, the helicopter arrived and airlifted the uninjured crew off the vessel; a couple of the crew (not the skipper) were reported as smelling of alcohol. The vessel had grounded on a rising tide, and was found to have moved from its grounding position the following day. There was pollution as the vessel began to sustain damage and she was eventually declared a constructive total loss.

Figure 2: Vessel following grounding

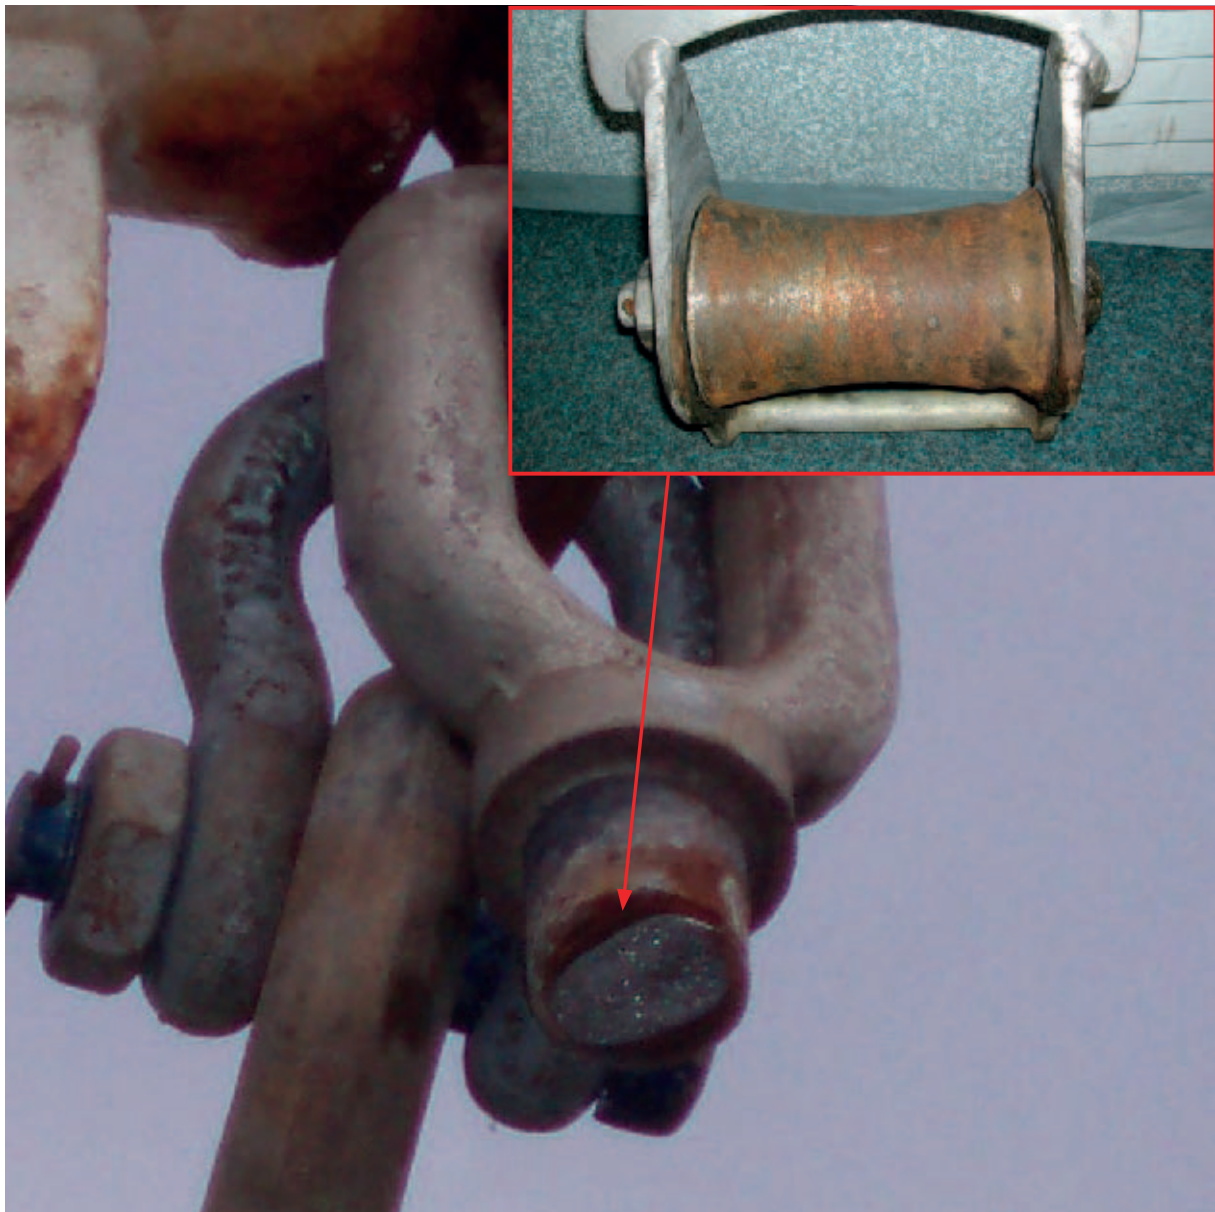
A critical sample of the failed equipment was recovered for inspection and testing along with the partner block from the other side. This revealed that uneven loading of the failed swivel eye fitting, caused by continual sideways pressure, was the primary factor why the block failed.

Corrosion visible on overhead block and swivel eye

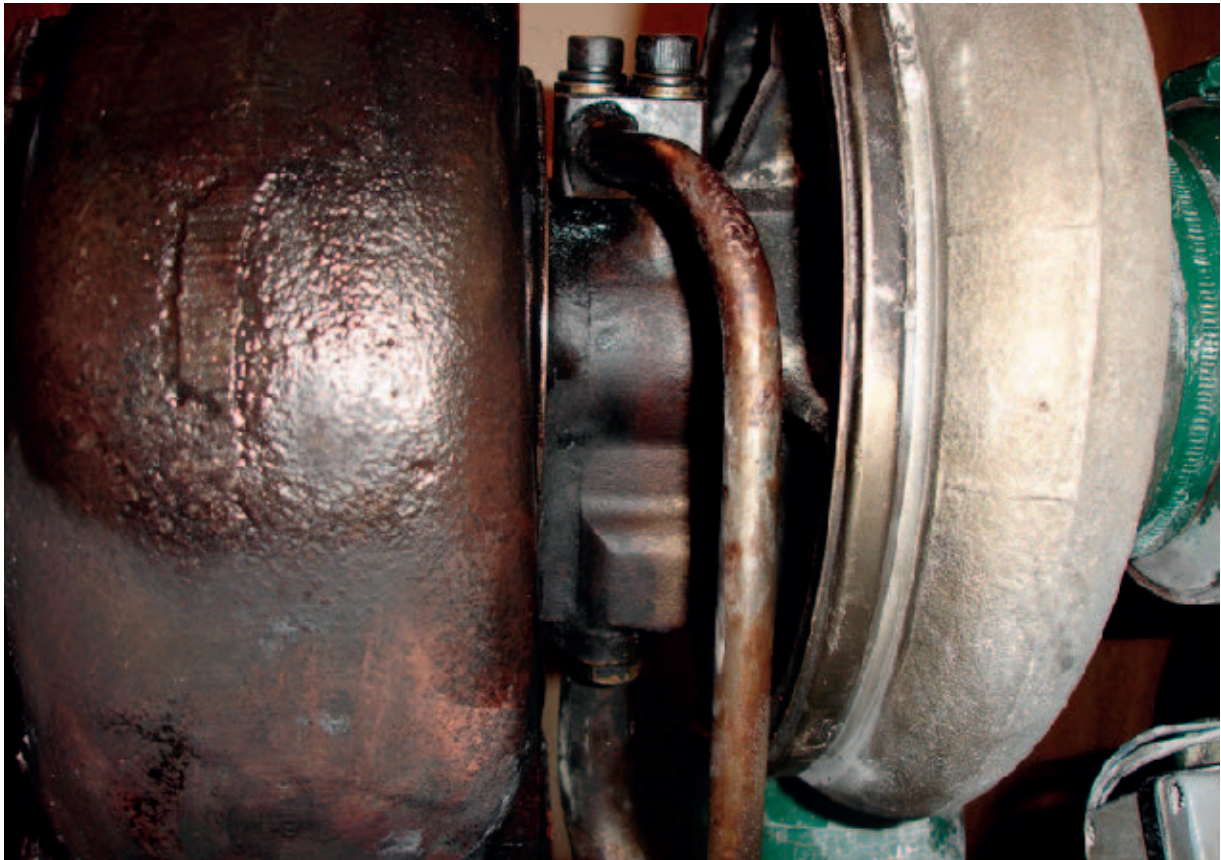
On investigation, it was found that the lubricating oil supply pipe to the turbo charger had suffered from fatigue cracking at its brazed connection to the oil distribution block (figure). This caused oil to be sprayed onto the hot turbo-charger, where it ignited. The pipe braze failure was caused by critical vibration stresses because the pipe was inadequately clamped.

Failed turbo-charger lubricating oil pipe brazed connection
