**MARINE ACCIDENT  
INVESTIGATION BRANCH**

# **SAFETY DIGEST**

**Lessons from Marine  
Accident Reports  
1/2012**

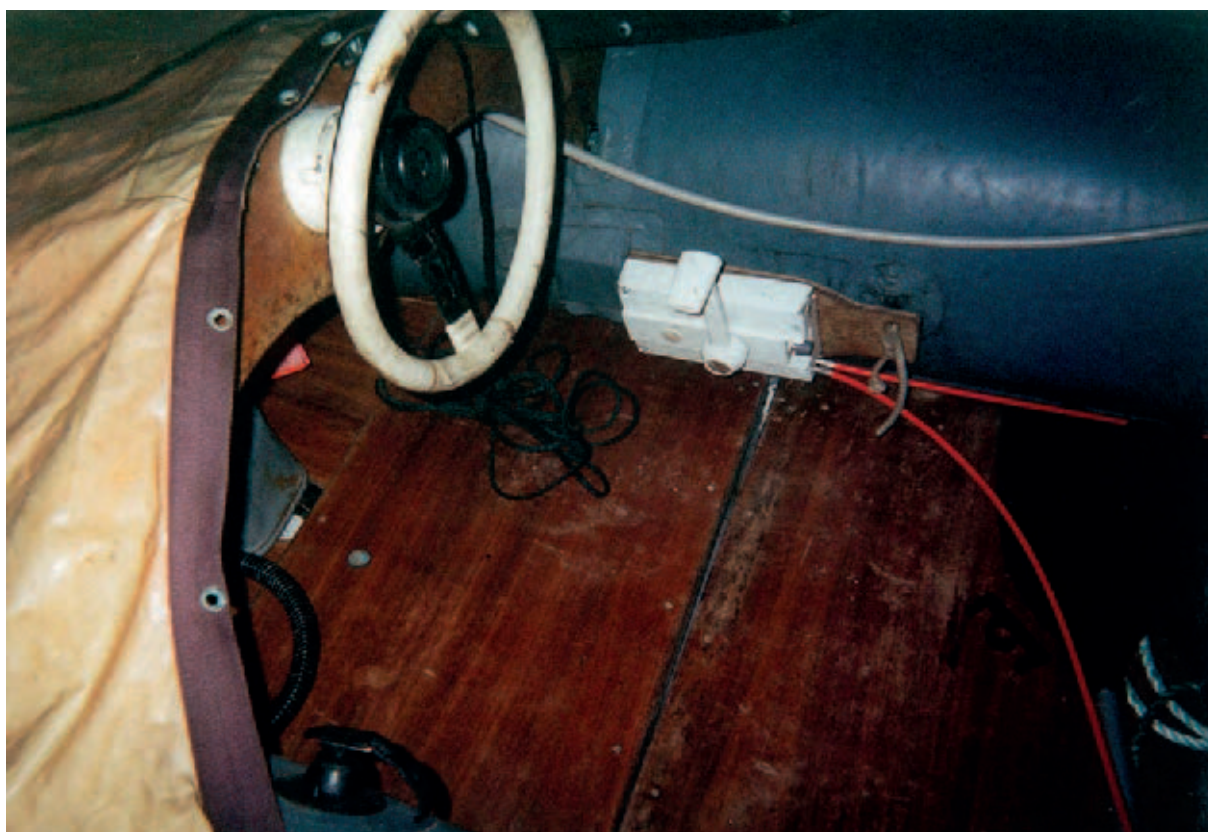
boat was not fitted with a "dead man's" switch and so the engine would not automatically stop if the helmsman was tipped from the steering position. The steering cable had been replaced using an outdated spring-loaded ball joint to connect it to the outboard engine frame. Because the cable had not been set up properly, the port and starboard ranges of movement were unequal. The throttle and gear cables had been flaked around the deck and were easily seized by foot pressure (Figure 2). In addition, the fabric of the hull was in poor condition and had been patched; the patches were peeling off.

Figure 1: Steering gear and throttle controls

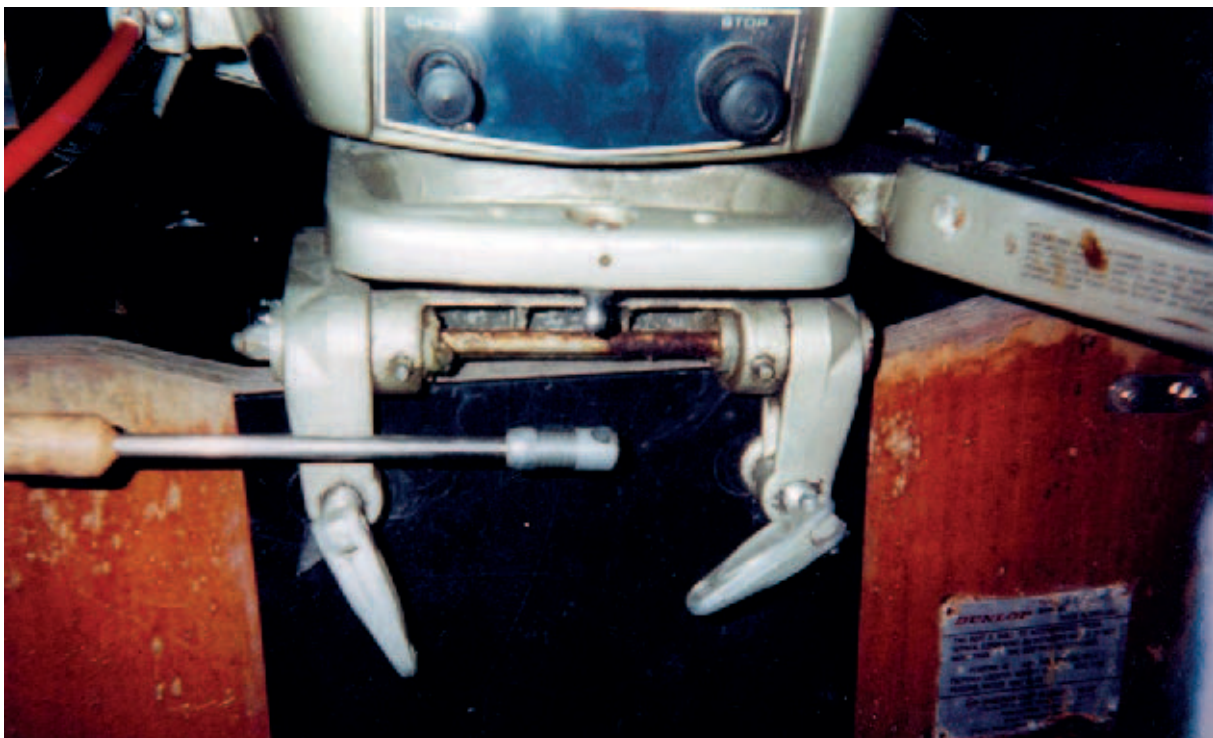
Figure 3: Disconnected steering gear connection ball joint
