MARINE ACCIDENT  
INVESTIGATION BRANCH

# SAFETY DIGEST

**Lessons from Marine  
Accident Reports  
2/2012**

**SAFETY DIGEST**  
**Lessons from Marine Accidents**  
**No 2/2012**

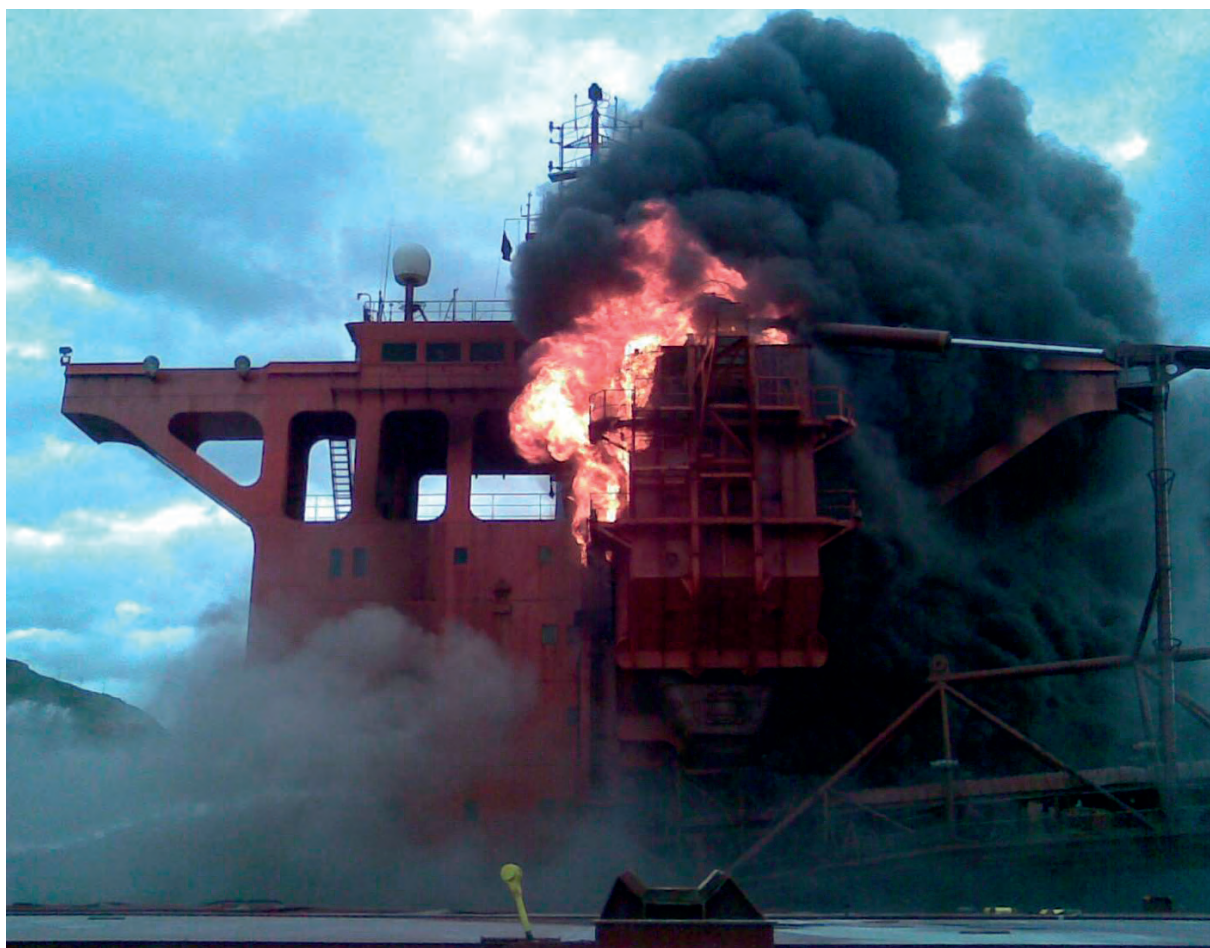
Figure 1: Fireball erupting from the vertical conveyor belt tower

The fire was most likely to have been caused by hotwork repair debris falling from the cargo hopper at the top of the tower into the side curtain of the conveyor belt. The hotwork repair had been authorised by the ship's manager, but other hotwork relating to the regular repair to the high tensile steel hull, carried out at the same time, had not. There were violations of the company's hotwork procedures, including not keeping a constant fire watch, no dedicated fire watchman being nominated and work being routinely undertaken in unauthorised areas.

1. The abrasive nature of the cargo meant that hotwork repairs were regularly required to the hopper and to the hull, which was prone to cracking. What is usually an occasional activity had become commonplace and, with it, complacency had developed. It is essential that hotwork controls are strictly adhered to and that auditing procedures assess compliance.

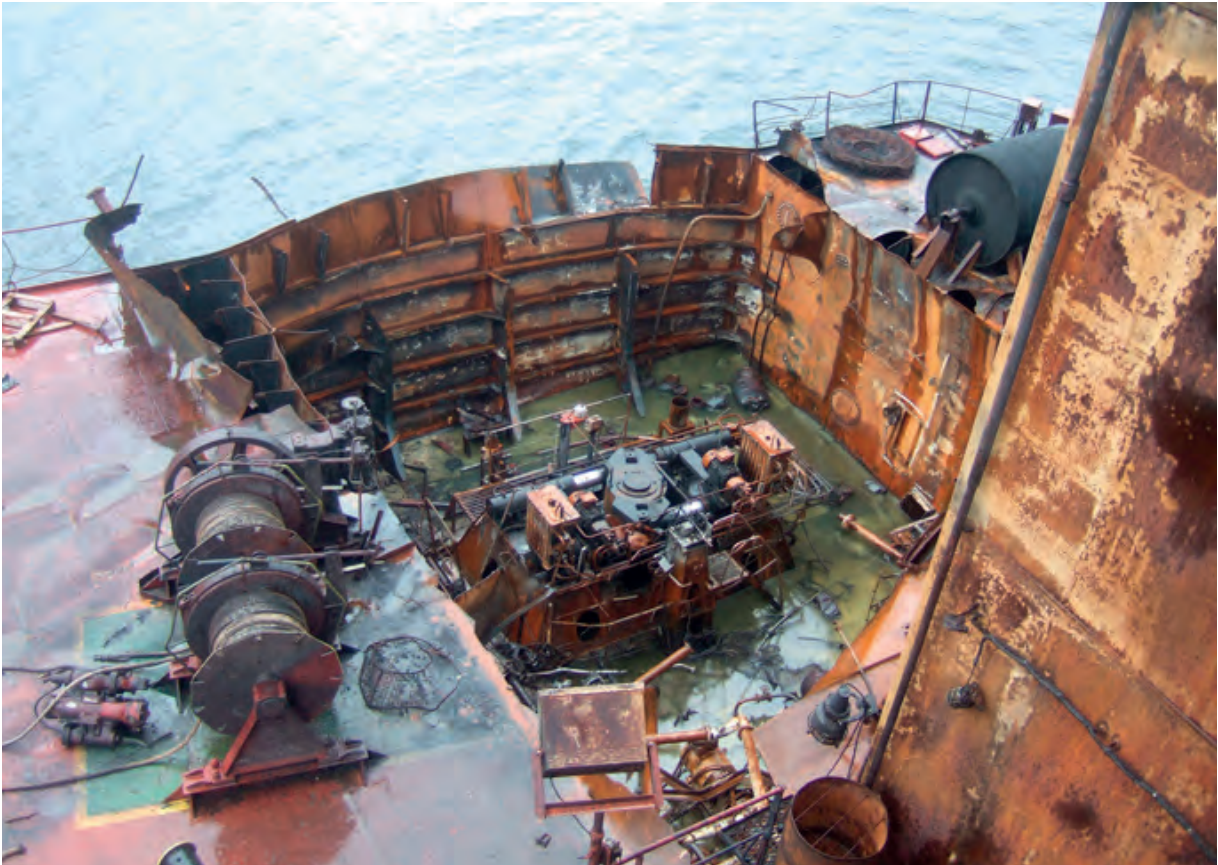
Figure 2: Exposed steering gear

It is not unusual for ship's-use chemicals to be stowed in steering gear compartments. In this case, alkalis, acids and oxidisers were in close proximity to each other and to a wide variety of oils. There was also evidence of other corrosive and flammable chemicals stowed in machinery spaces, passageways and workshops, increasing the risk of fire spread.

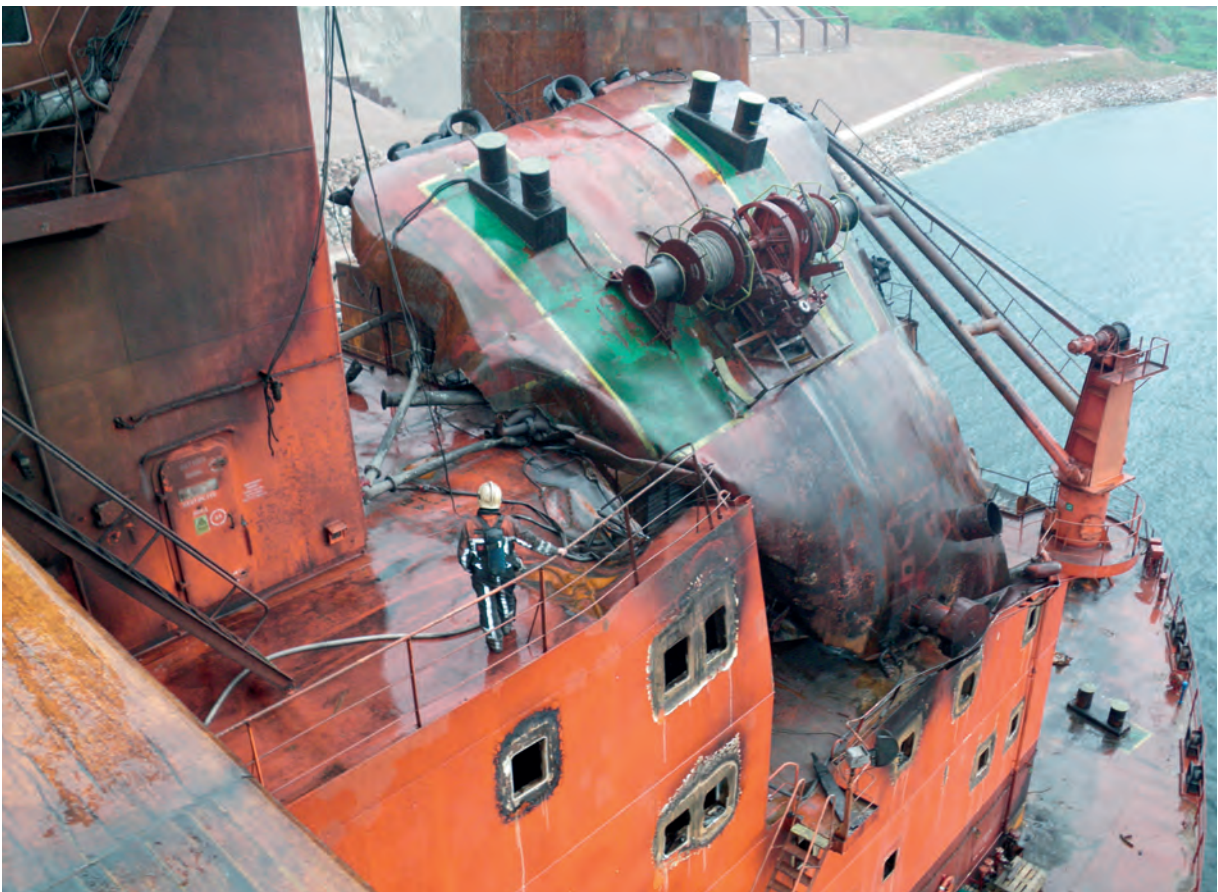
It is likely that this caused the poop deck to lift, allowing air to mix with the compartment’s hydrocarbon-rich atmosphere, created by the release of oils stowed there and from the various hydraulic systems. The resultant explosion tore off the entire poop deck, fully exposing the steering gear compartment (Figure 2), and landing it on the funnel deck (Figure 3). Fortunately, there were only minor smoke inhalation injuries.

Figure 3: Poop deck relocated on the compartment funnel deck

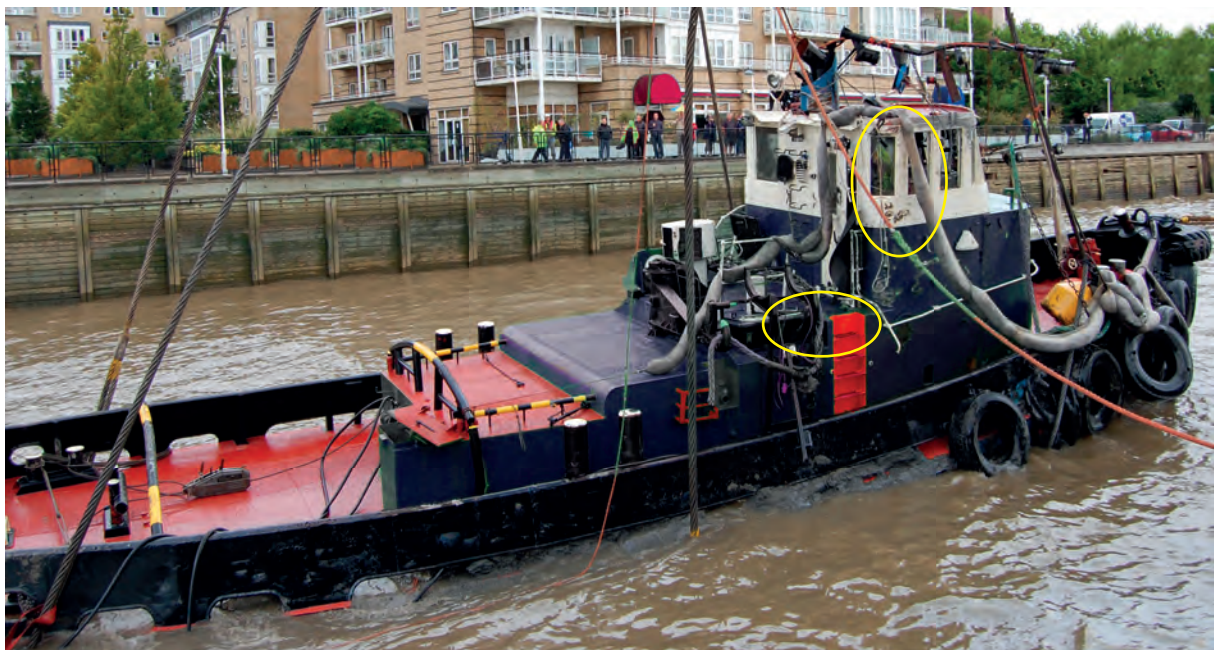
A survey of the salvaged tug (Figure 2) found that many of the watertight doors and hatches were open and it was not possible to release the towing hook.

Figure 2: Salvaged tug showing open hatches and doors

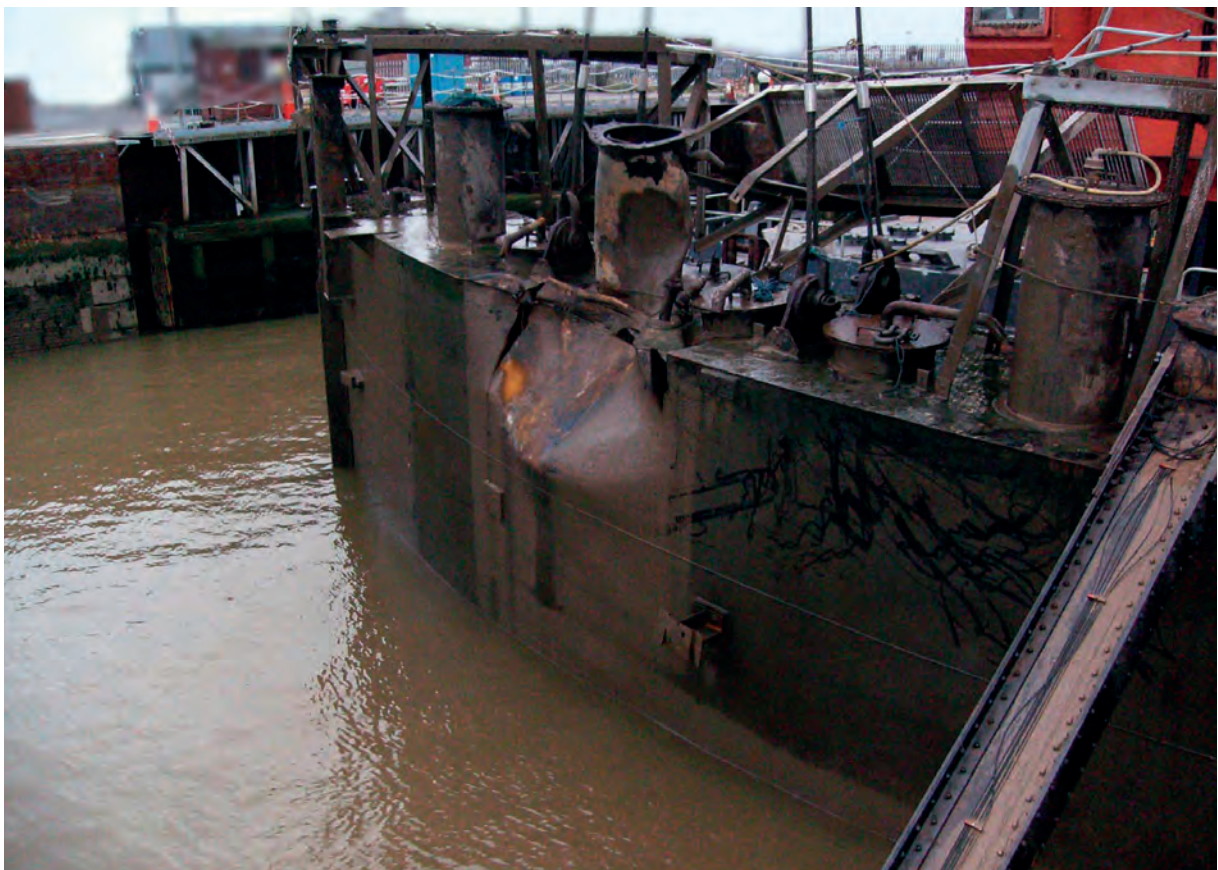
Figure 1: Salvage of sunken lock gate

Despite these measures, the vessel impacted heavily with the outer lock gates at 3.7kts, just under 1½ minutes after the CPP control power failure alarm. One of the gates sustained major damage and subsequently sank (Figure 1), with the other outer gate suffering minor damage. The inner lock gates were immediately closed and they, too, sustained minor damage when the head of water in the dock caused them to slam shut. The vessel herself sustained only minor damage to her bulbous bow (Figure 2) and was later moved as a dead ship by two tugs back into the dock. There were no injuries or pollution.

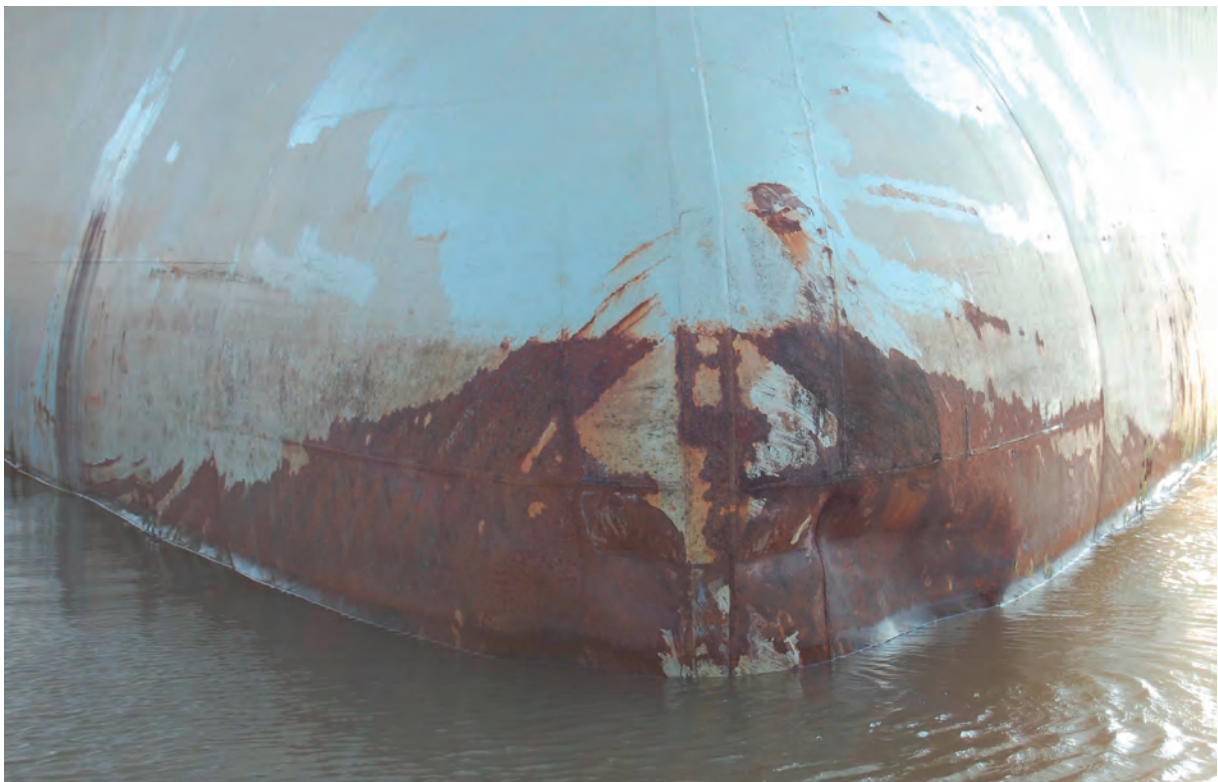
Figure 2: Damage to vessel's bulbous bow

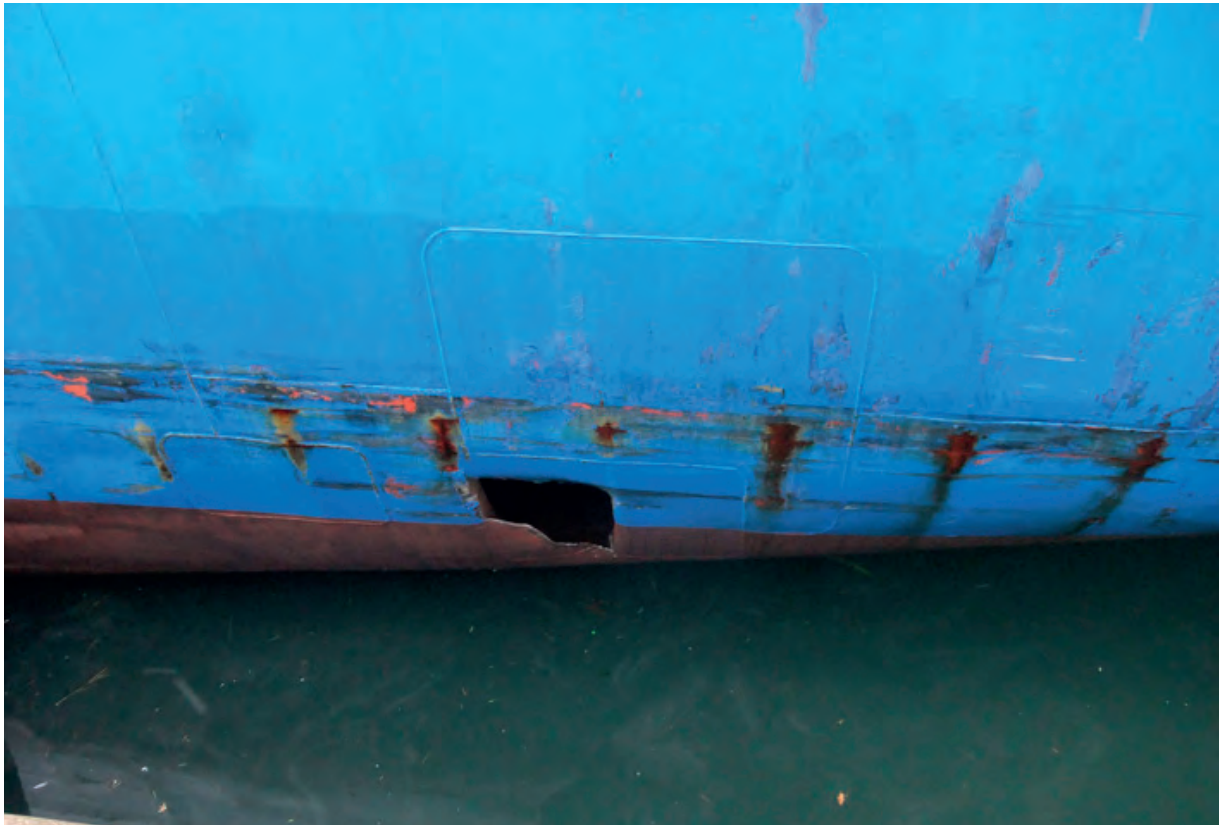
The corner of the pontoon pierced the hull. As the master put the engines astern to clear the linkspan, he dragged the pontoon away from the dockside. The ramp section of the linkspan could not be held without the support of the pontoon, and its fixings gave way, sending it to the seabed. The pilot quickly notified VTS of the situation and nearby tugs assisted the ship to get alongside an alternative berth and prevented the pontoon from drifting out and becoming a hazard to navigation.

Figure 2: Hull penetration damage to the ship

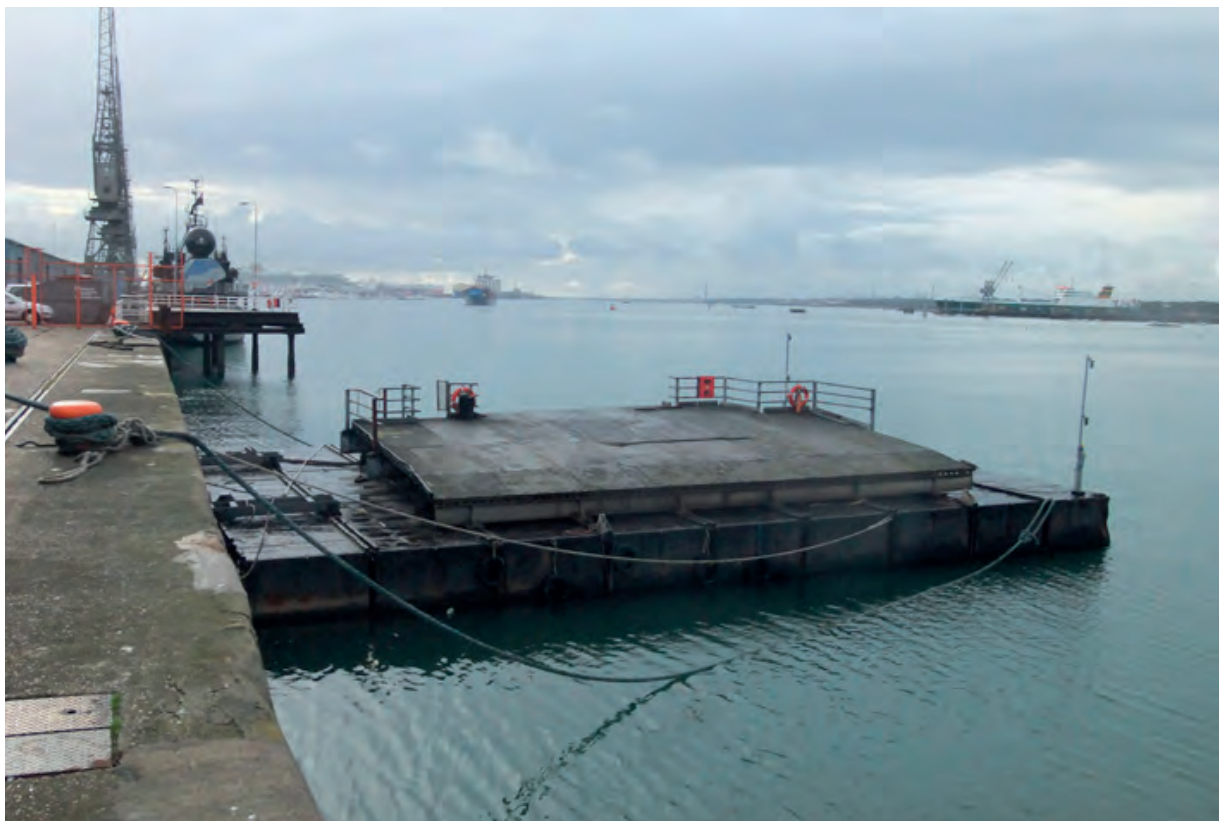
Figure 3: The linkspan with missing ramp

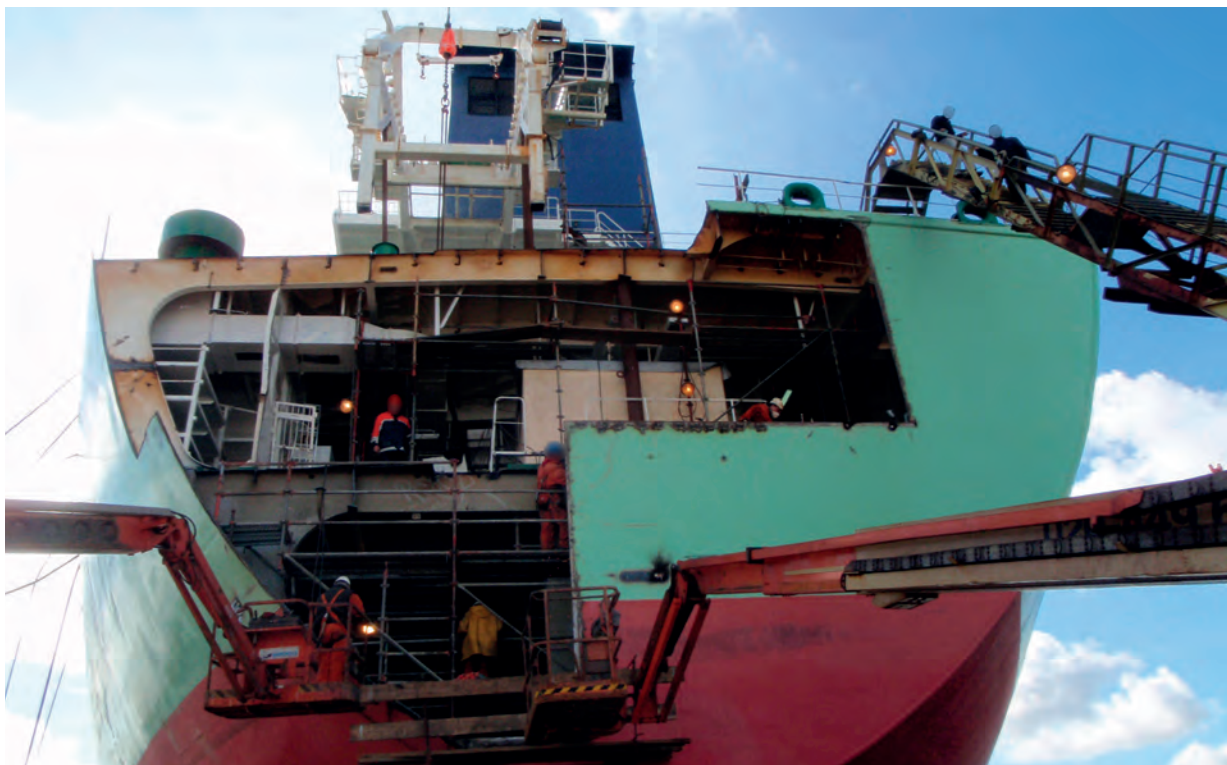
The pilot attempted to slow the ship by stopping the engines, but the ship started to turn to starboard even with the high lift rudder hard to port. The pilot gave a kick ahead on the engine and the vessel started to turn to port towards another terminal on the other side of the river. In the meantime, the pilot and master discussed a revised anchorage plan. As the rate of turn to port increased towards the jetty, the pilot ordered the engine astern, the rudder hard to starboard and the bow thrust full to starboard. The pilot then ordered the anchors to be dropped. The ship continued to sheer to port and hit another tanker that was discharging fuel at the jetty, at a speed of 5kts, causing significant damage to both vessels and the jetty (see figure).

Repairs to the stern of the vessel discharging alongside

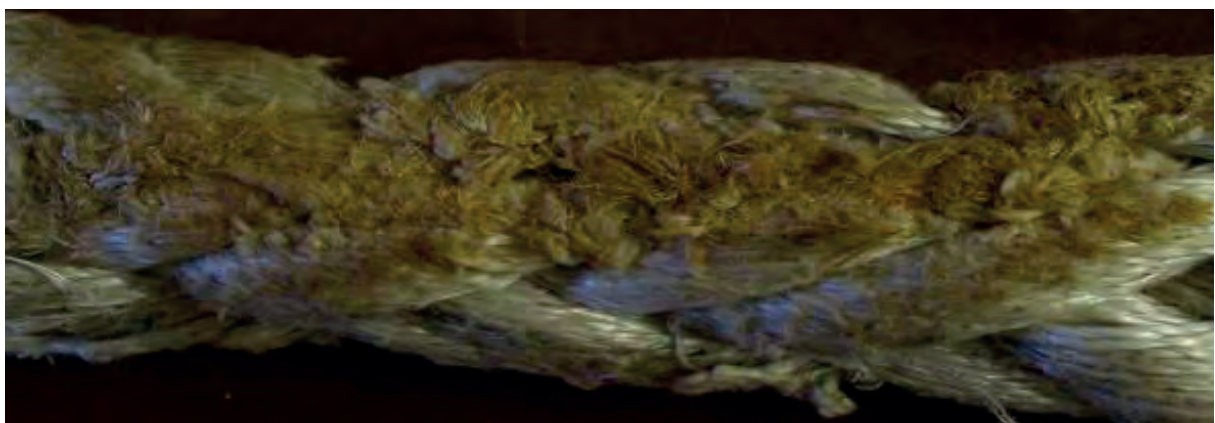
Figure 2: Section of the mooring rope failure zone showing extreme abrasion rope

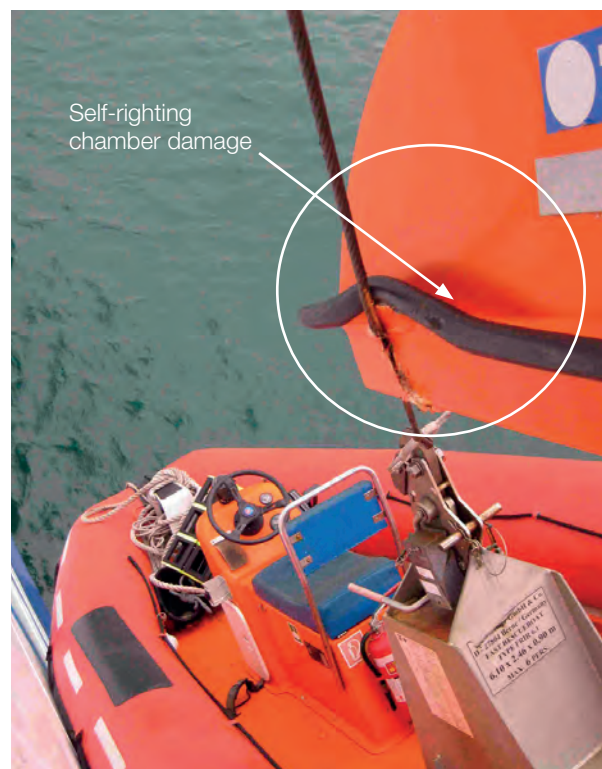
Figure 2: Winch wire snagging self-righting chamber

The FRC dropped, and assumed a 45°, bows-down position as it fell about 3 metres until it was stopped as the wire's slack was taken up (Figure 1). As the FRC fell, the winch wire became trapped around the self-righting chamber at the after end of the FRC, causing some structural damage (Figure 2).

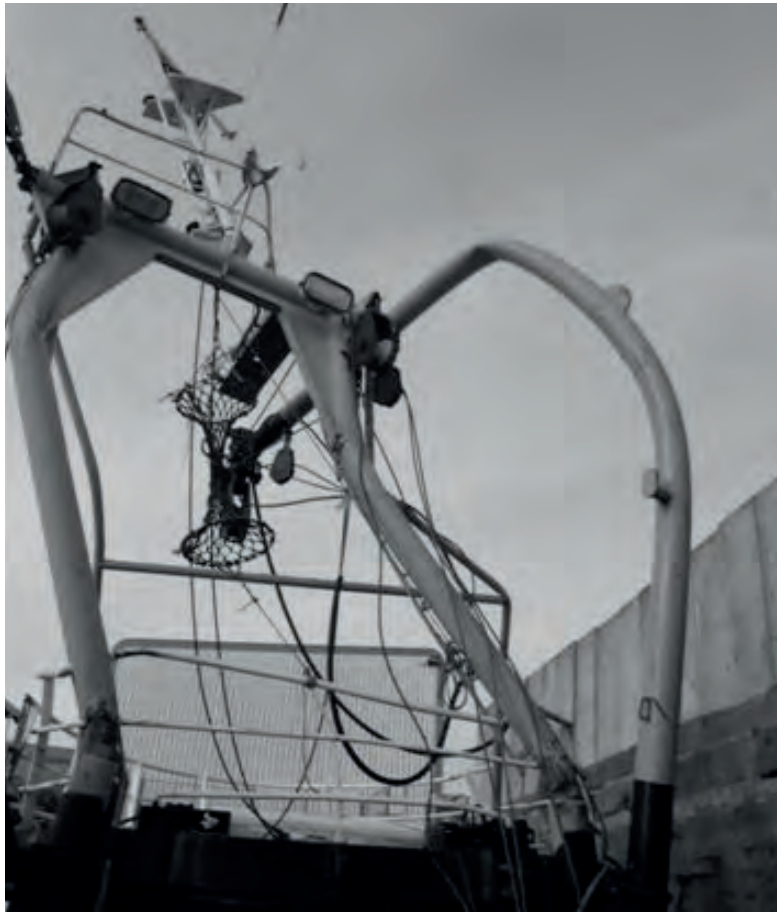
Damage sustained to the fishing vessel

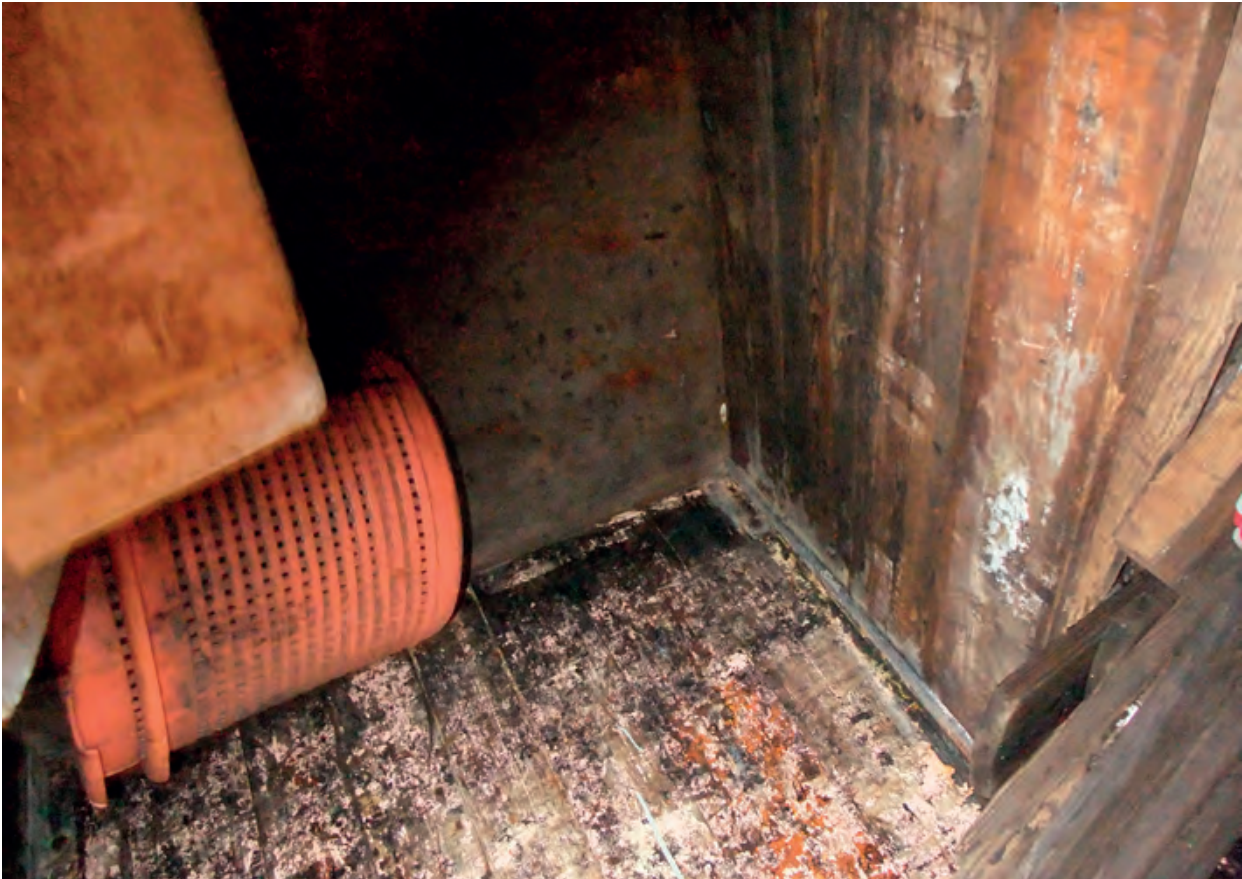
Figure 2: Collision bulkhead

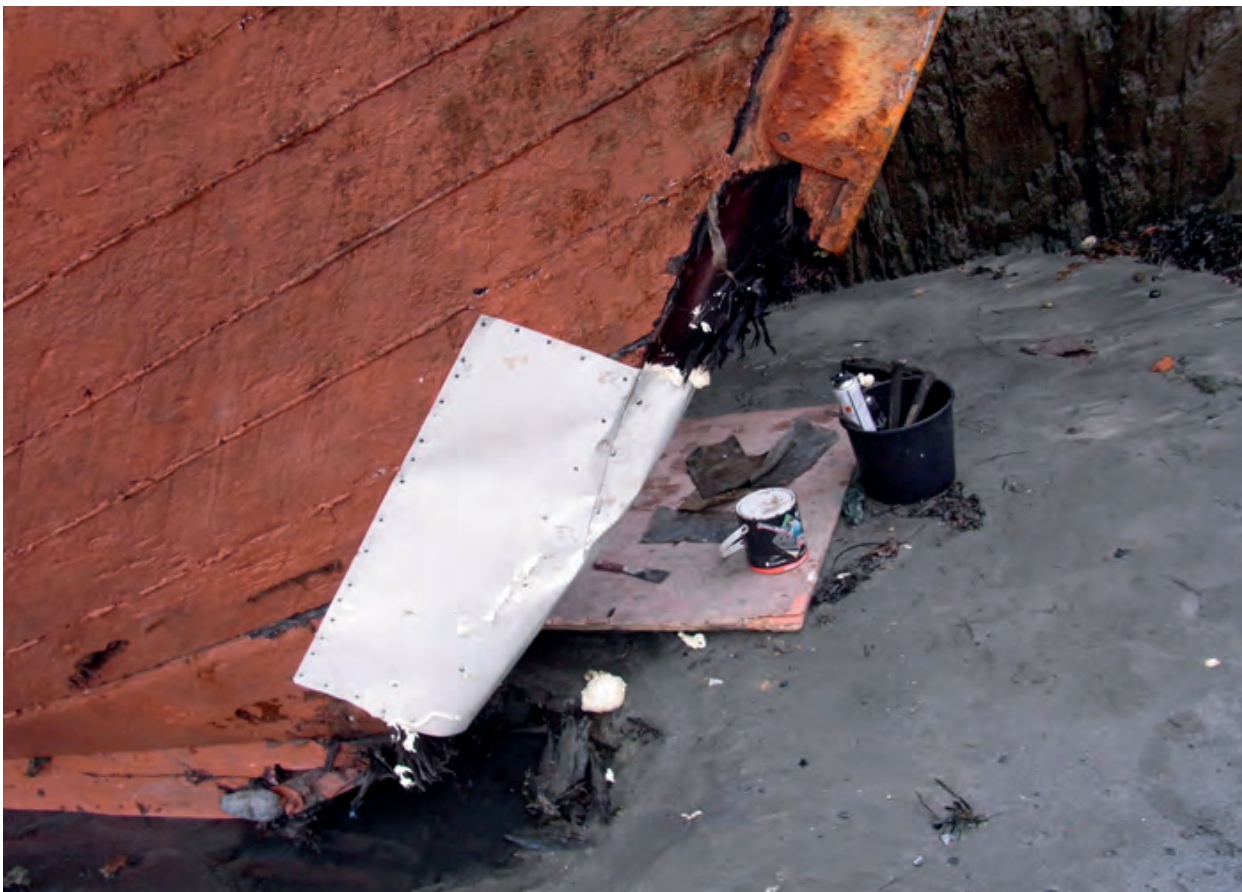
Figure 3: Stem post emergency repair

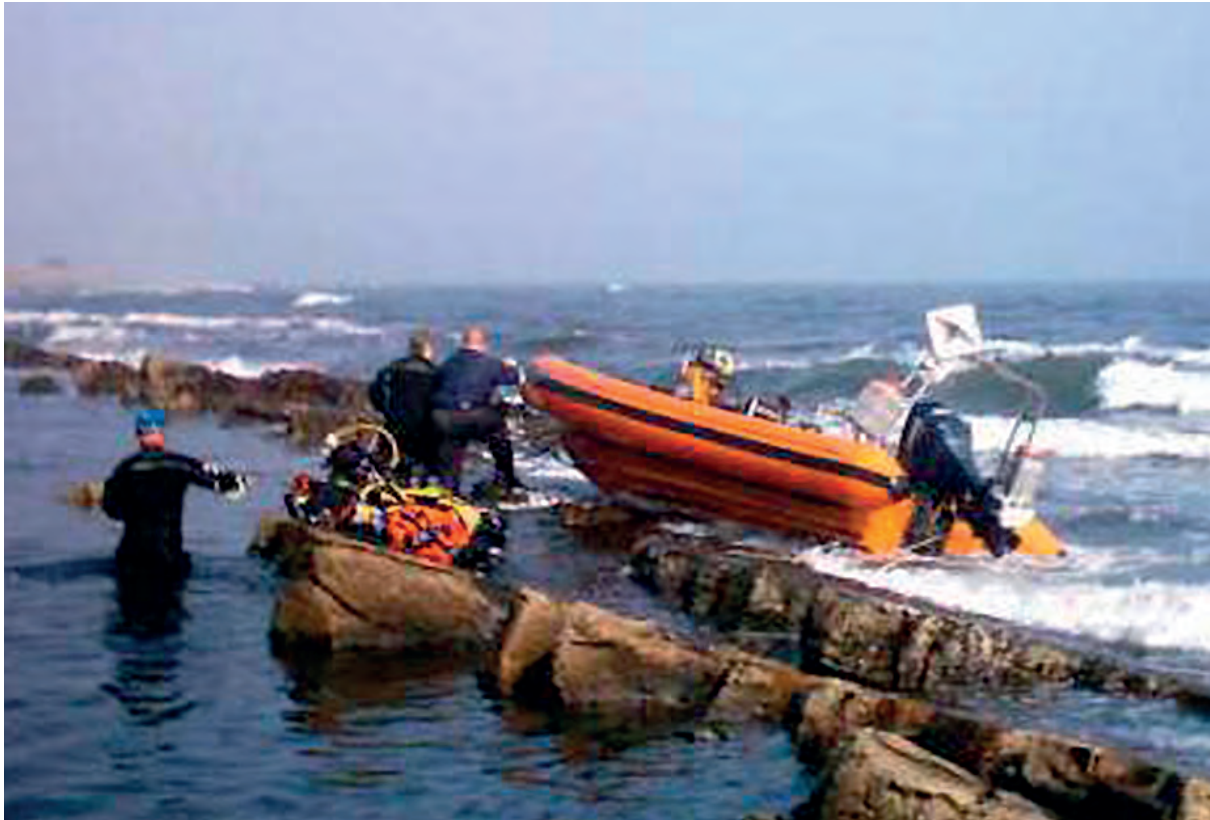
The group managed to remove their dive equipment to lighten the RHIB, which had been holed in a number of areas. The lifeboat arrived on scene some time later after the fog had lifted (figure) and took the RHIB under tow back to the port.

Recovery of the dive RHIB

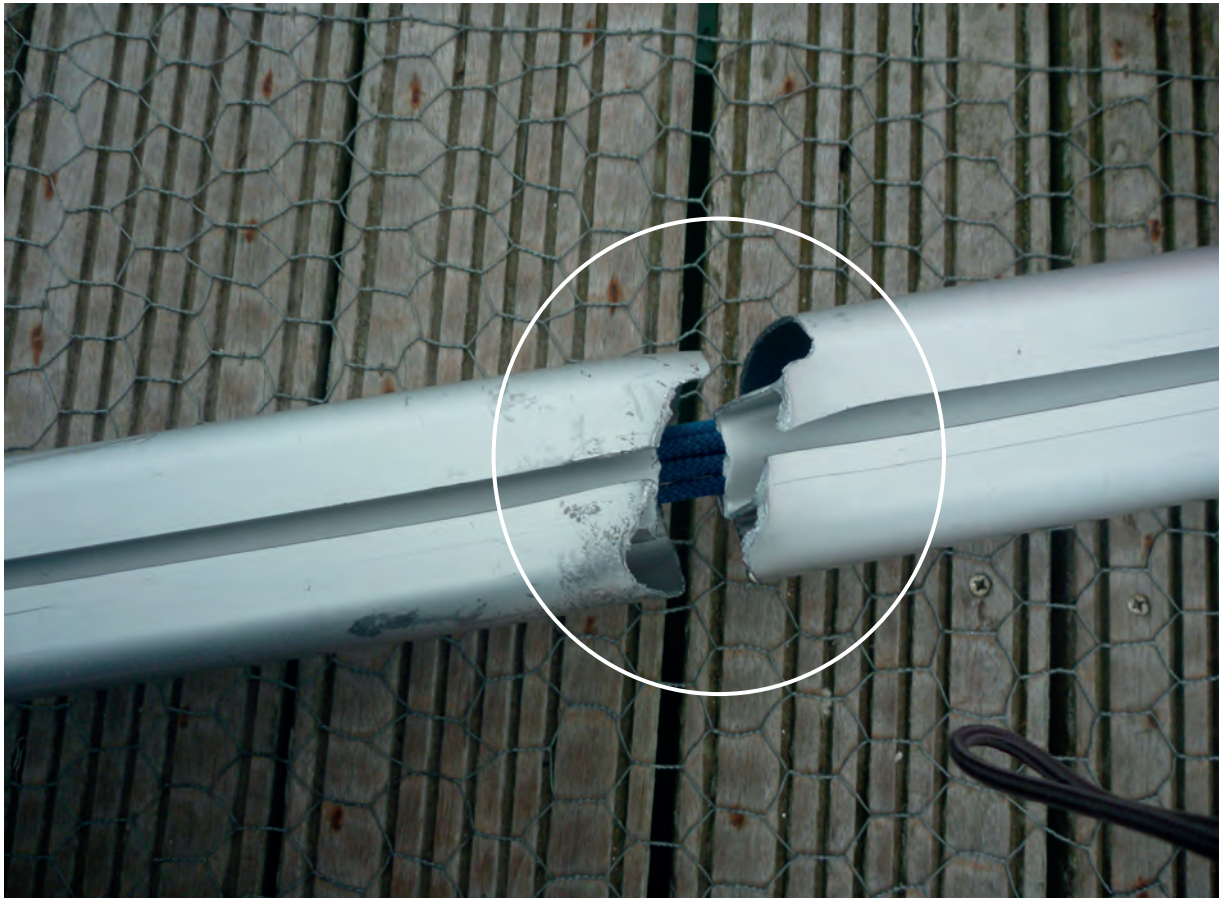
Figure 2: Failed boom

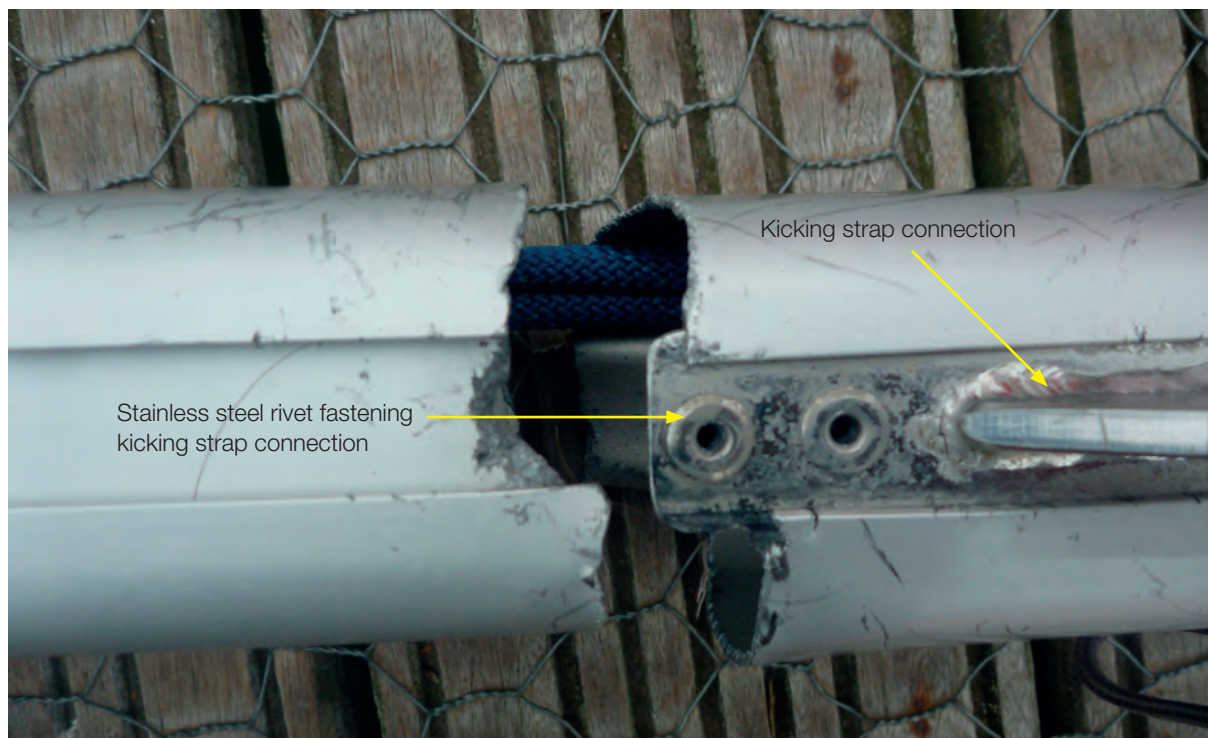
Figure 3: Stress failure point of boom
