# SAFETY DIGEST

**Lessons from Marine  
Accident Reports  
1/2013**

**SAFETY DIGEST**  
**Lessons from Marine Accidents**  
**No 1/2013**

April 2013

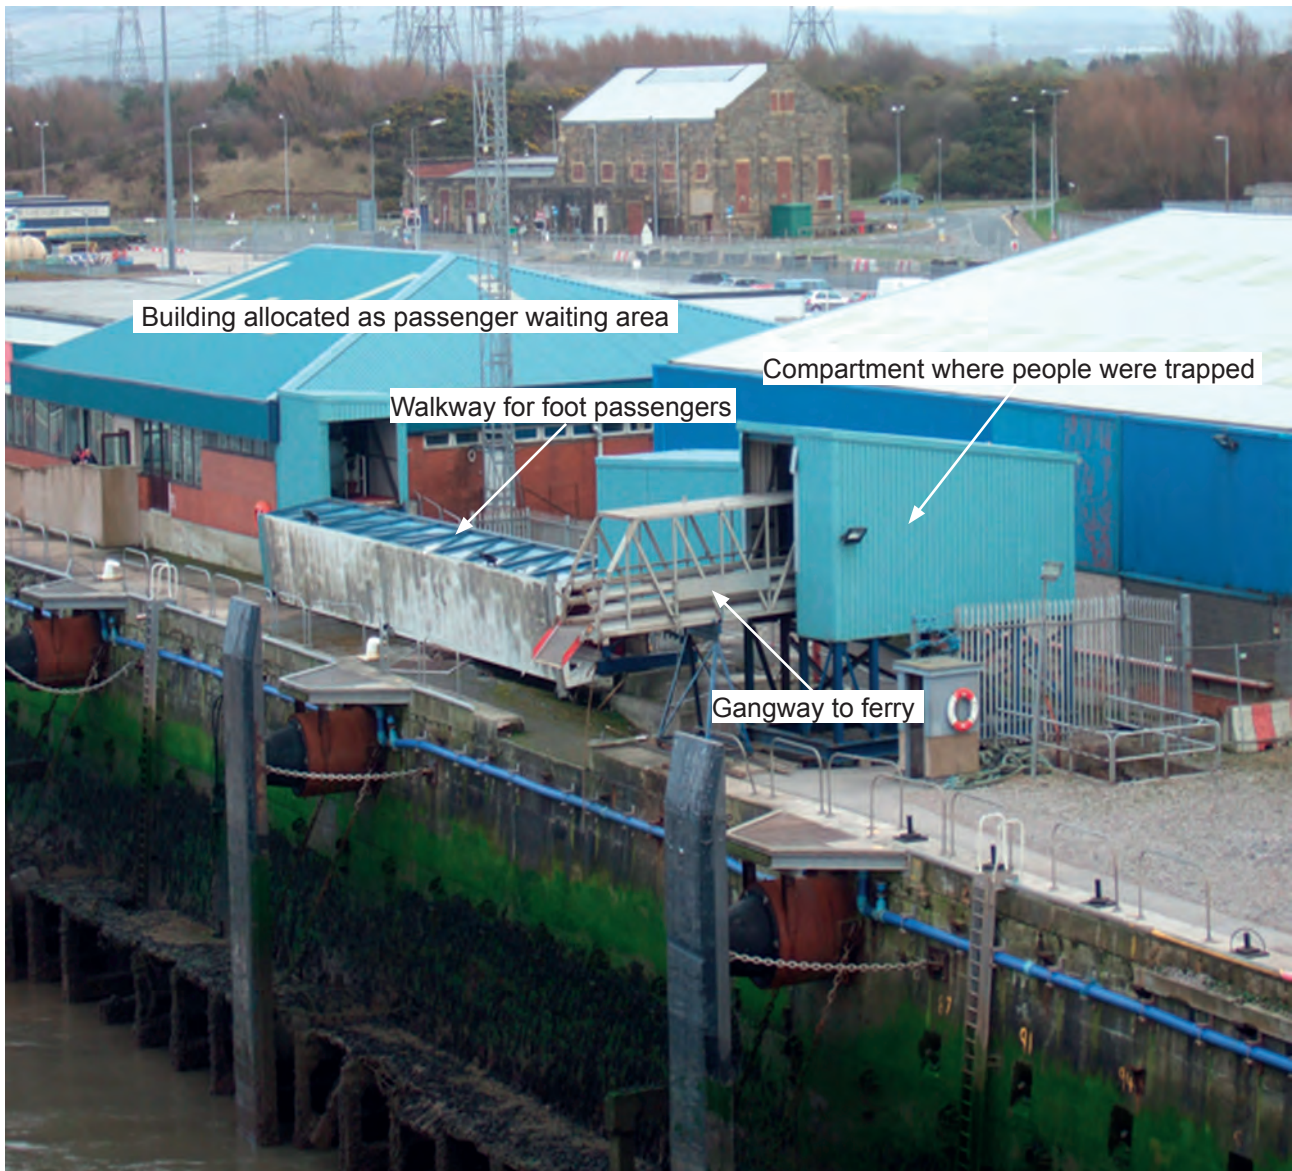
The mooring ropes, held with winches in the auto-tension mode, payed out as forward thrust was applied and the vessel surged ahead along the quay, causing serious damage to the passenger access structure. The foot-passenger walkway detached at both ends and collapsed onto the quay. The gangway fell from the vessel's side shell door and was left hanging on a single rope. Fortunately, there were no passengers in the walkway or on the gangway as these collapsed. Eight passengers were trapped in a compartment between the walkway and the gangway and were subsequently rescued by the fire service.

Figure 1: Passenger embarkation/disembarkation facility

2. Running main propulsion engines while a vessel is alongside is an extremely hazardous activity and must be controlled carefully. Clear warning notices should be displayed at any location where machinery could be inadvertently operated. Crew should be stationed to watch out for unusual tension or slack in ropes.

3. Auto tension winches on ro-ro ferries may significantly reduce the dependence on the crew to maintain the required tension in the mooring lines. However, engine movements, strong wind and interaction from a passing vessel could cause the ropes to pay out if the forces exceed the auto tension settings. Where it is essential that a vessel's position is maintained, e.g. while embarking passengers, consider securing mooring lines on bitts, or switch winches to their manual mode and apply the brake.

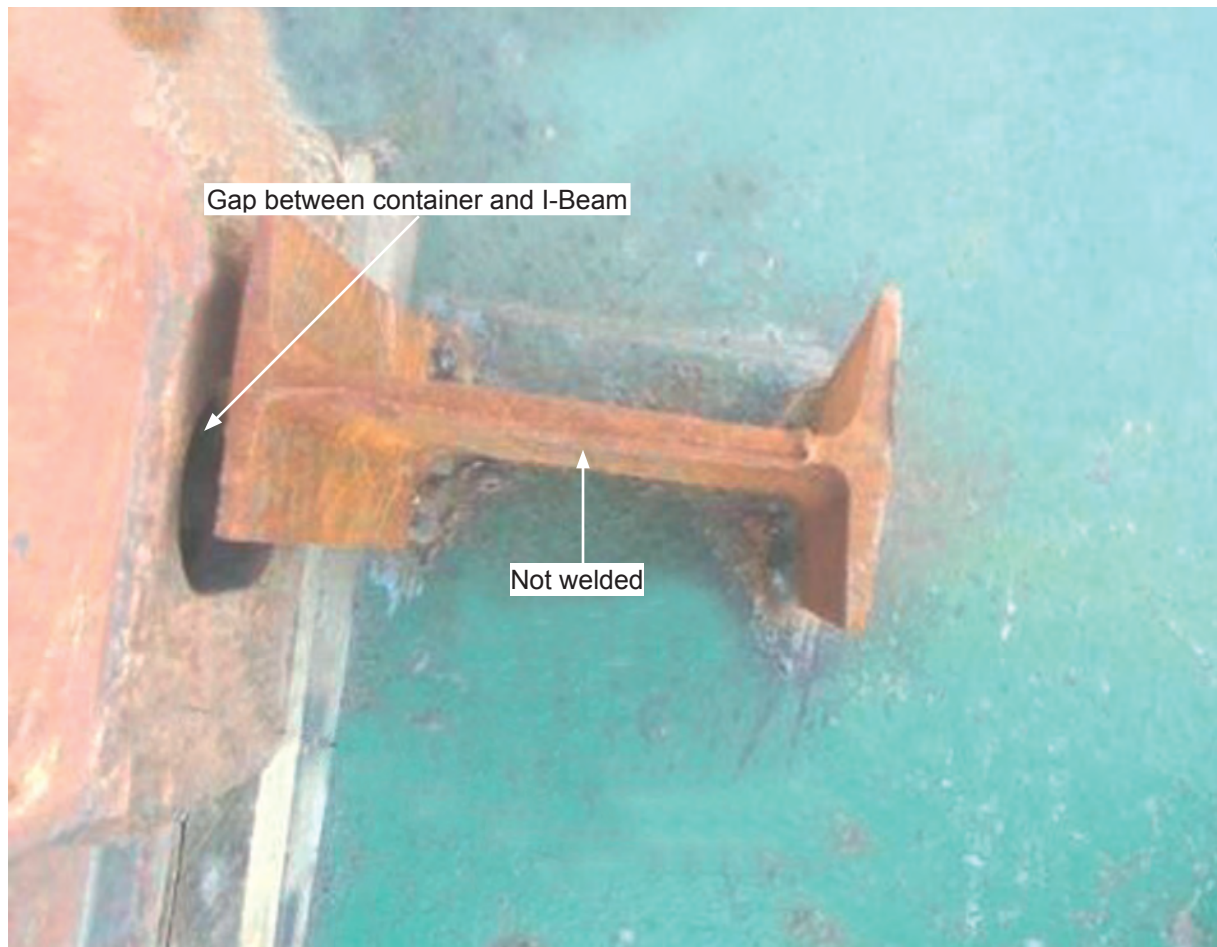
With work underway, the chief officer had the impression that the welding gang were rushing to get the ship out on schedule, and it was observed that the welding on some of the eye pads and I-beams was inadequate on hatch cover number four. It was also noted that gaps of up to 10mm could be seen between the welded beams and the edges of the containers (Figure 1). The chief officer became further concerned when containers were loaded as they arrived at the ship and, in some cases, not in accordance with the load plan. Although only two tiers high, the deck containers were potentially stacked heavy over light.

Figure 1: Poor quality welding

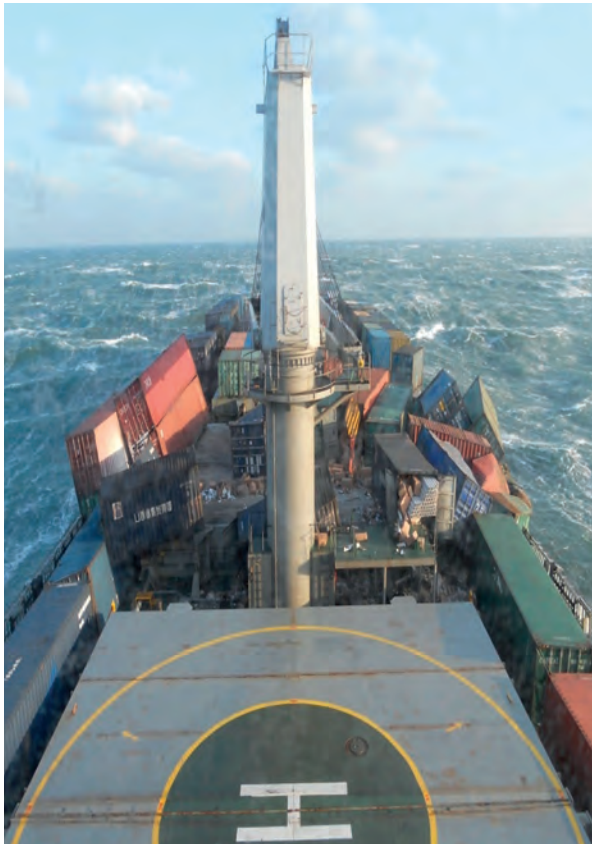
Figure 2: The aftermath on hatch cover number four

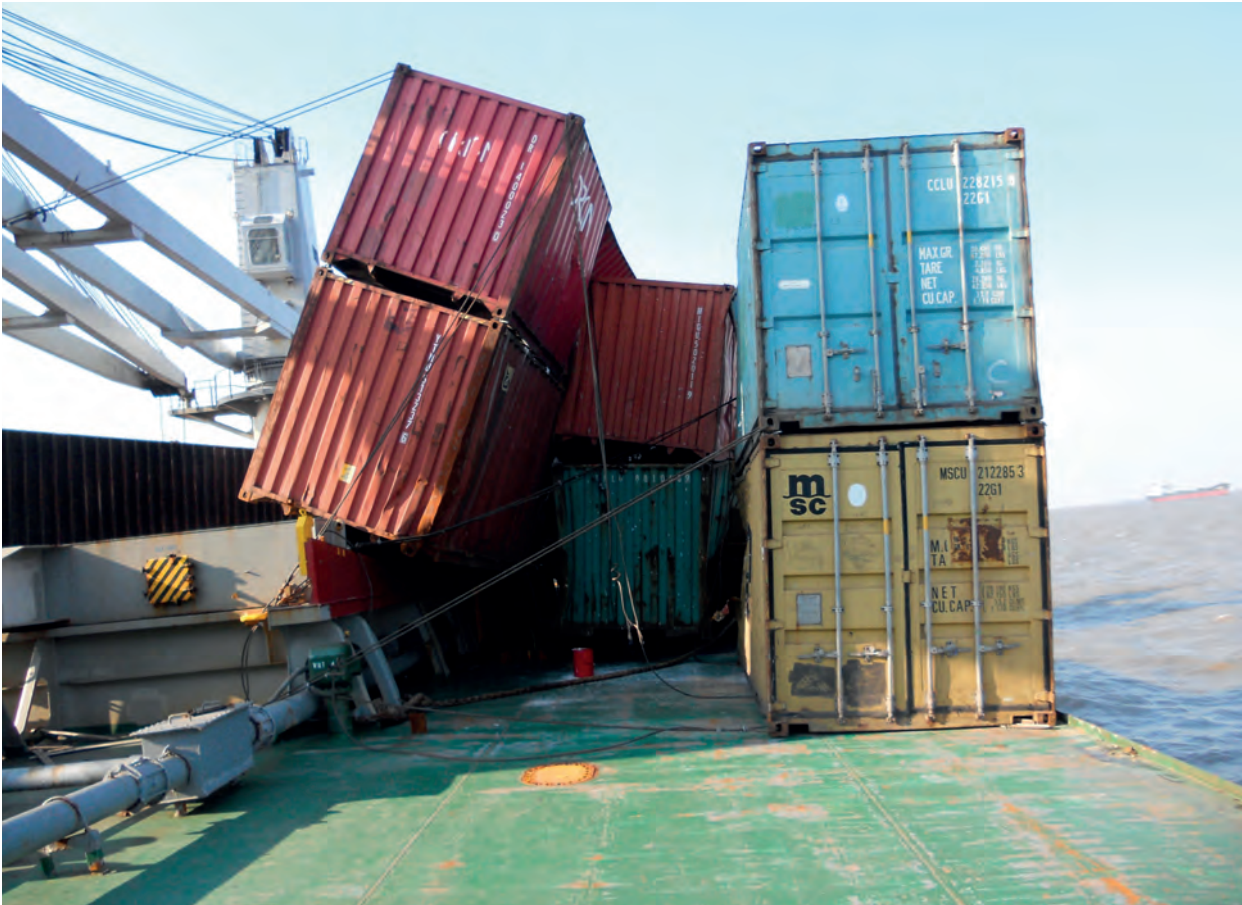
When the weather had improved, the ship returned to port for repairs and to re-secure the remaining loose containers. In total, the ship had lost 27 containers, with 28 containers loose but still on board. Damage to the ship was largely superficial with a gangway, pilot reel, guardrails and a grab rail requiring repair or replacement. However, the main structure of the ship was largely unaffected.

Figure 3: Some of the loose containers that remained on deck

The accident happened because deficiencies in the loading and securing of the deck containers were spotted but not rectified before the ship sailed. This might have been because the master was unduly influenced by the port captain's confident approach to the task. It might also have been because the charter agreement and the mate's receipt seemed to absolve the master of all responsibility if things went wrong. What ever the reason, the master chose to accept those sub-standard arrangements.

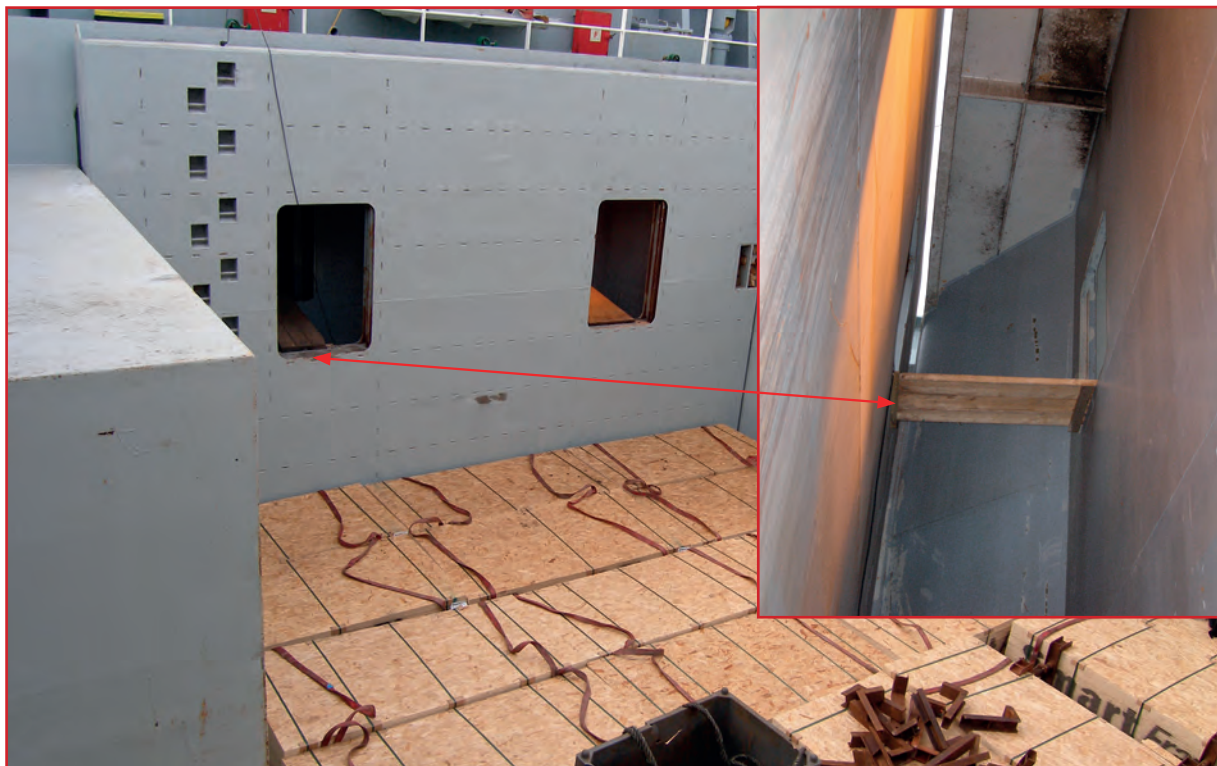
A short time later, the AB tried to leave the hold via the wooden footbridge, but he either slipped or lost his balance and fell. The rest of the crew working in the hold heard a thump and realised that the AB was missing. The crew went towards the forward bulkhead and peered down into the dark void below the wooden footbridge. With the aid of a torch, they were able to see the AB lying 5m below; he was unconscious and was bleeding from a head wound.

Wooden footbridge in its location

1. Any ship spaces that are regularly entered must have a safe means of access - ad hoc measures are likely to be unfit for purpose. This wooden footbridge had no guardrails or toe boards, the openings were not full height and lighting was inadequate. Therefore, it did not meet the requirements of a safe means of access required under UK legislation and was unsafe to use.
2. Have you ever been expected to do something you thought was unsafe, but still did it anyway? Don't take undue risks when often simple solutions or corrective action can rectify the problem. Safety is everyone's responsibility.

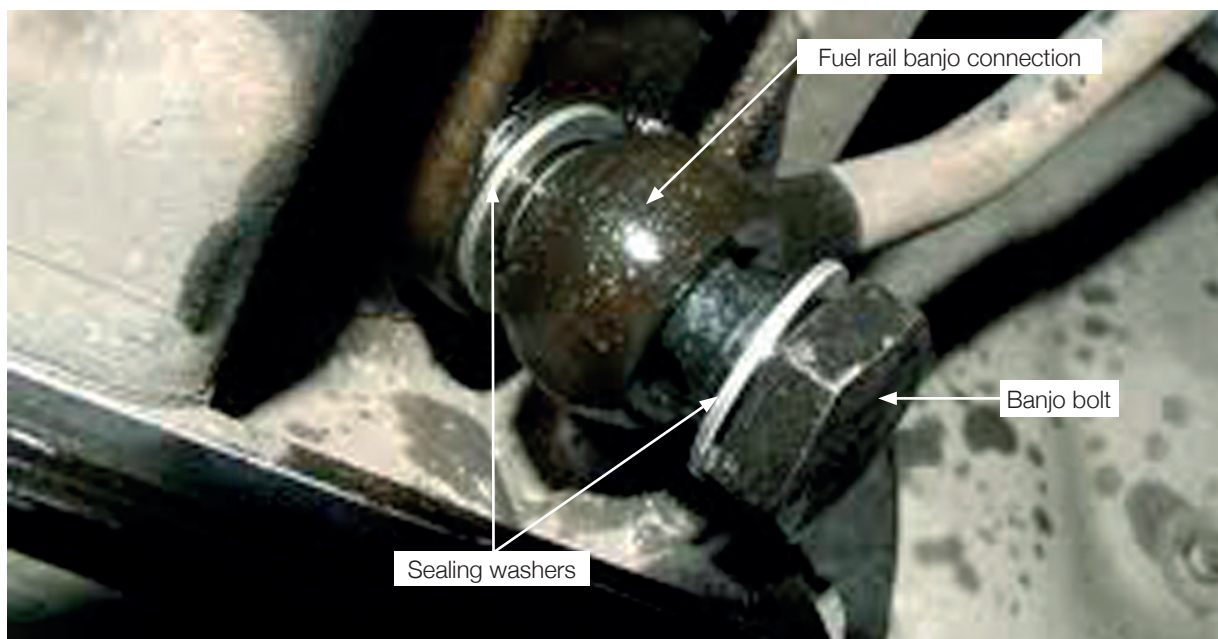
Figure 1: Loose fuel rail "banjo" bolt

Investigations quickly identified the cause of the fire to be a loose fuel rail “banjo” bolt fitted to the port main engine (Figure 1) - these bolt connections had been prone to previous leakage. This allowed high pressure, atomised fuel to spray onto the hot port engine and turbo-charger, which then ignited (Figure 2). This caused extensive wiring damage, including that supplying the fire detection and suppression systems, and also damage to many of the plastic fittings and deckhead lining (Figures 3 and 4).

1. "Banjo" bolts should be fitted with a sealing washer on either side of the connection. Where any system, especially one carrying flammable liquids, has shown signs of leakage, it should be regularly checked. Where the leakage is persistent, consideration should be given to changing the type of fitting. It is often helpful to consult with the equipment manufacturer for advice in this event.

2. Equipment overhaul/maintenance routines can sometimes introduce self-induced defects. It is all too easy to forget to fully tighten fastenings during reassembly. During test runs do check the integrity of pipe connections and make a habit of regularly doing so while a vessel is in service. These can loosen over time, especially when fitted to reciprocating machinery.

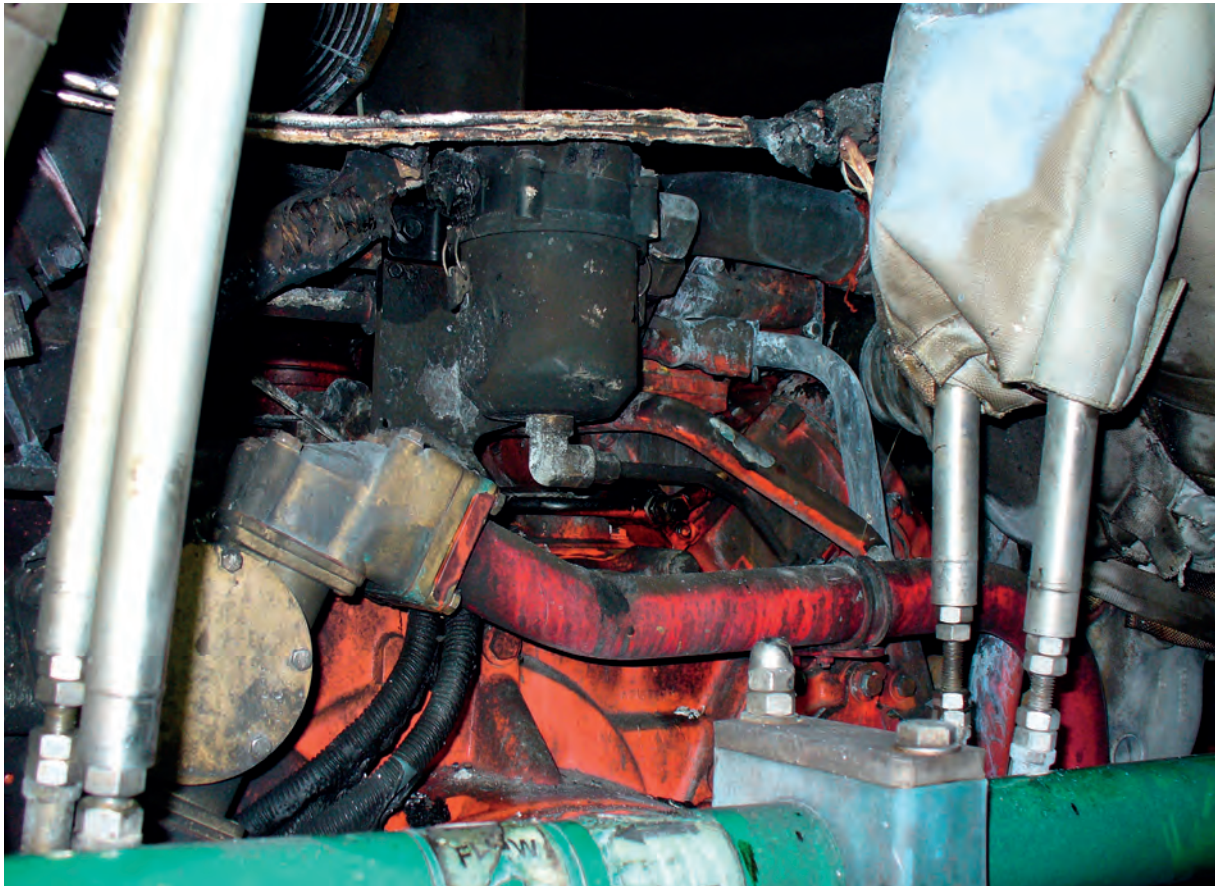
Figure 2: Port main engine

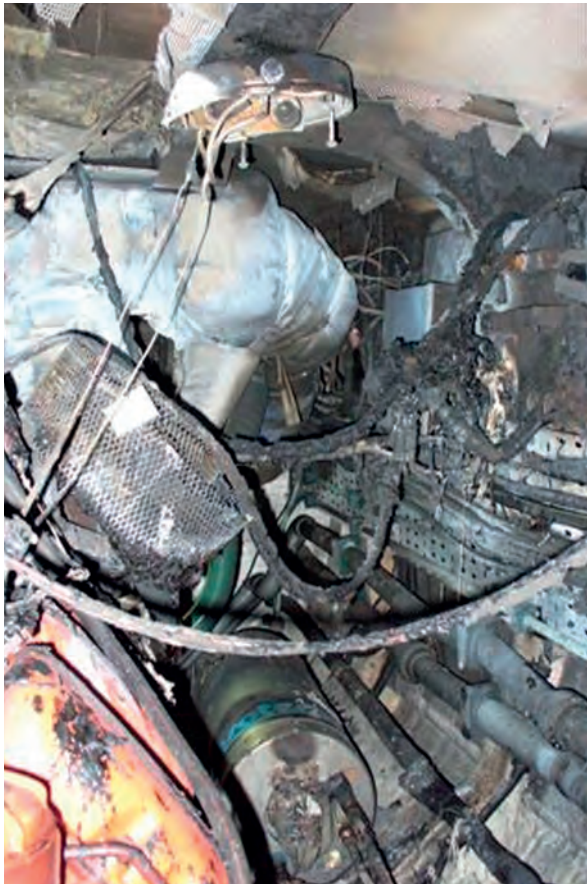
It was also found that only one of the pyrogen fire suppression cylinders had activated because the electrical cables which triggered the system had suffered an open circuit during the early stages of the fire. In addition, all of the fire detectors were of the smoke detection type - there were no flame or heat detectors fitted.

Figure 3: Electrical cable damage

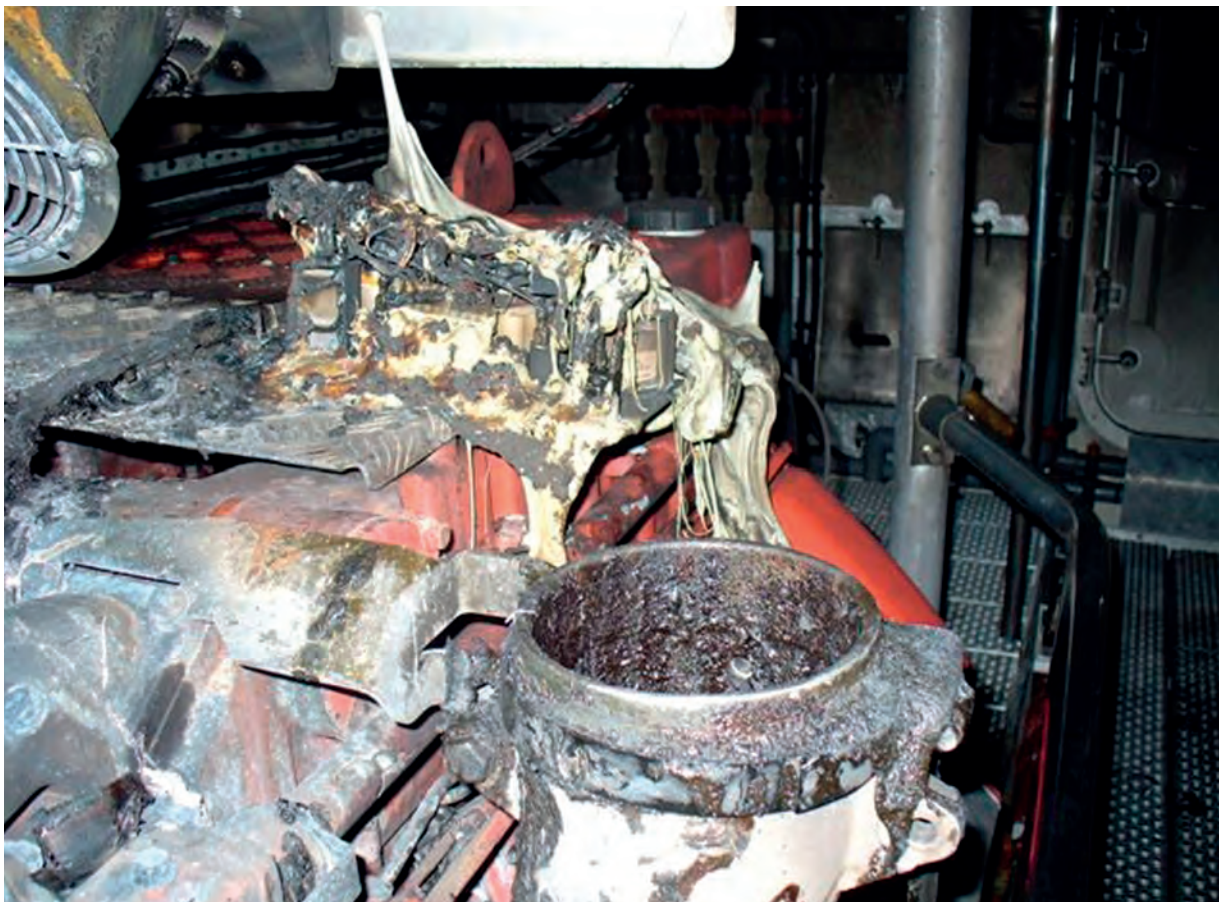
Figure 4: Damage to plastic fitting

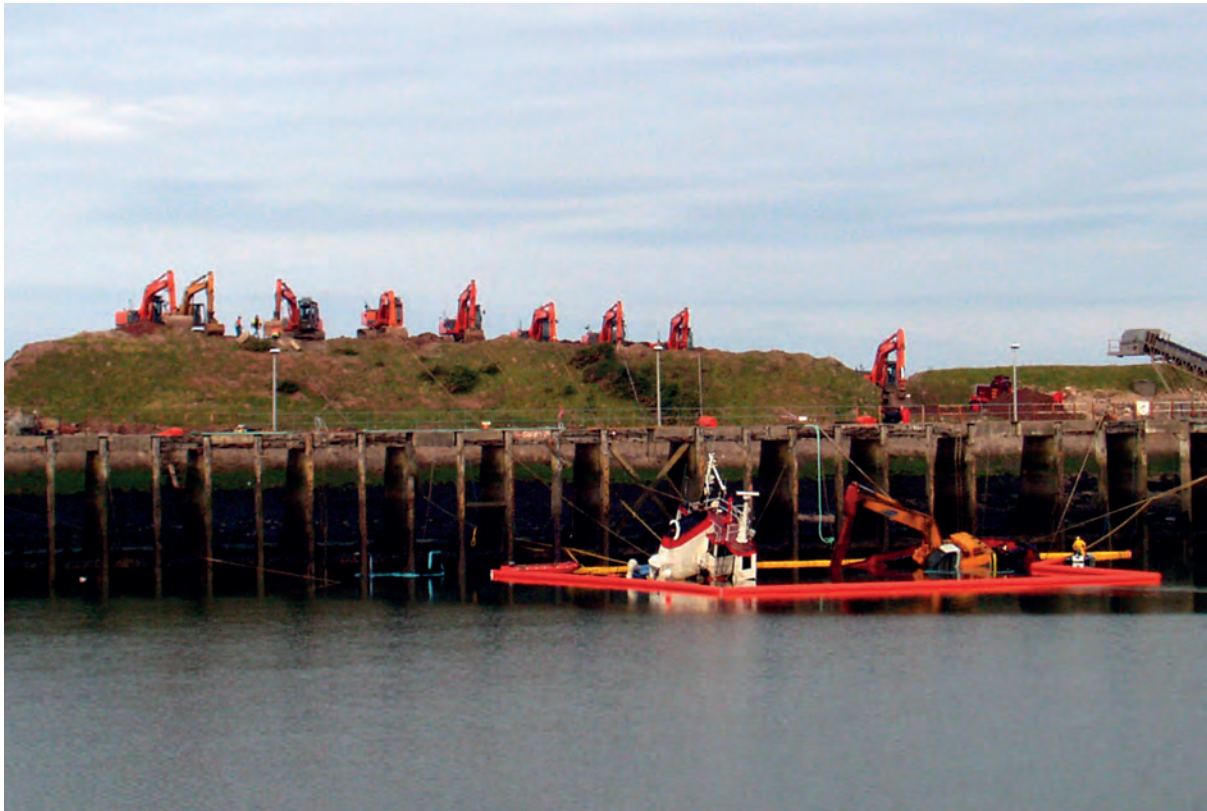
The dredger was eventually salvaged and, after much investigation, water was found to be leaking through the hull plating near to the stern gland in the engine room. The regulations did not require that the vessel had a bilge alarm as the engine room was continuously manned when operating.

Excavators used to stabilise the dredger

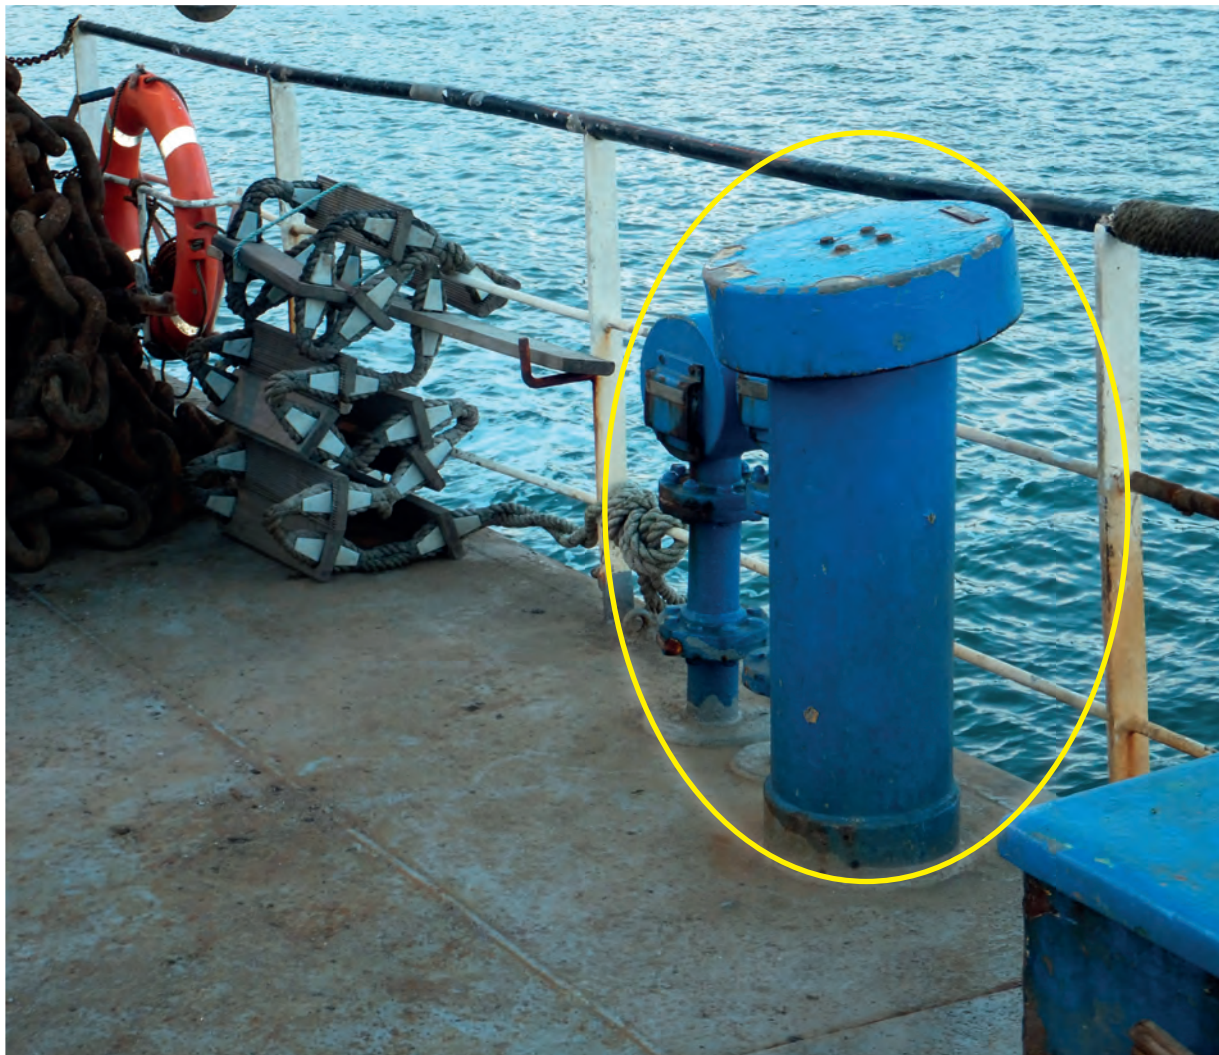
After sailing, the first buoy was replaced without difficulty. On completion, the chief engineer, who was seen as the most experienced of the crew working on the deck, went to the engine room, leaving the remaining crew to recover the vessel's anchor and tidy the deck in readiness for the next buoy operation. This involved moving a 6t navigation buoy from aft of the crane on the vessel's starboard side to an area between a pile of mooring chain and a 'mushroom' air vent on the vessel's port side (Figure 1).

Figure 1: The mushroom vent and mooring chain

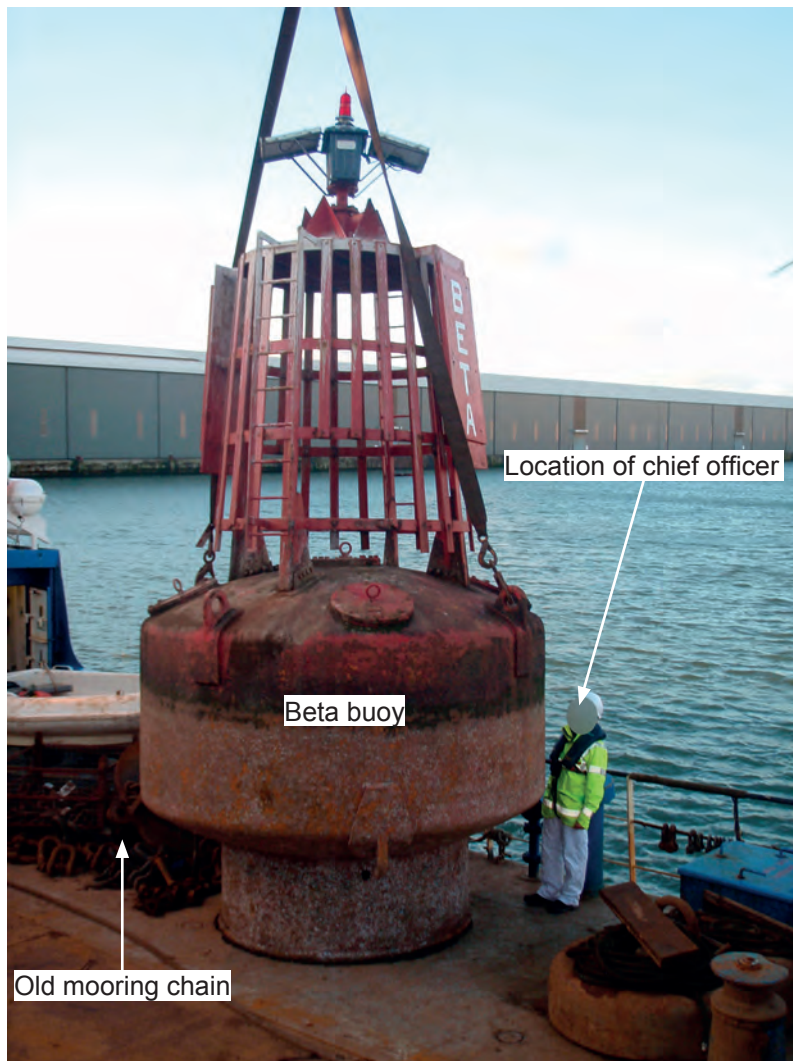
Figure 2: A demonstration of where the chief officer was trapped

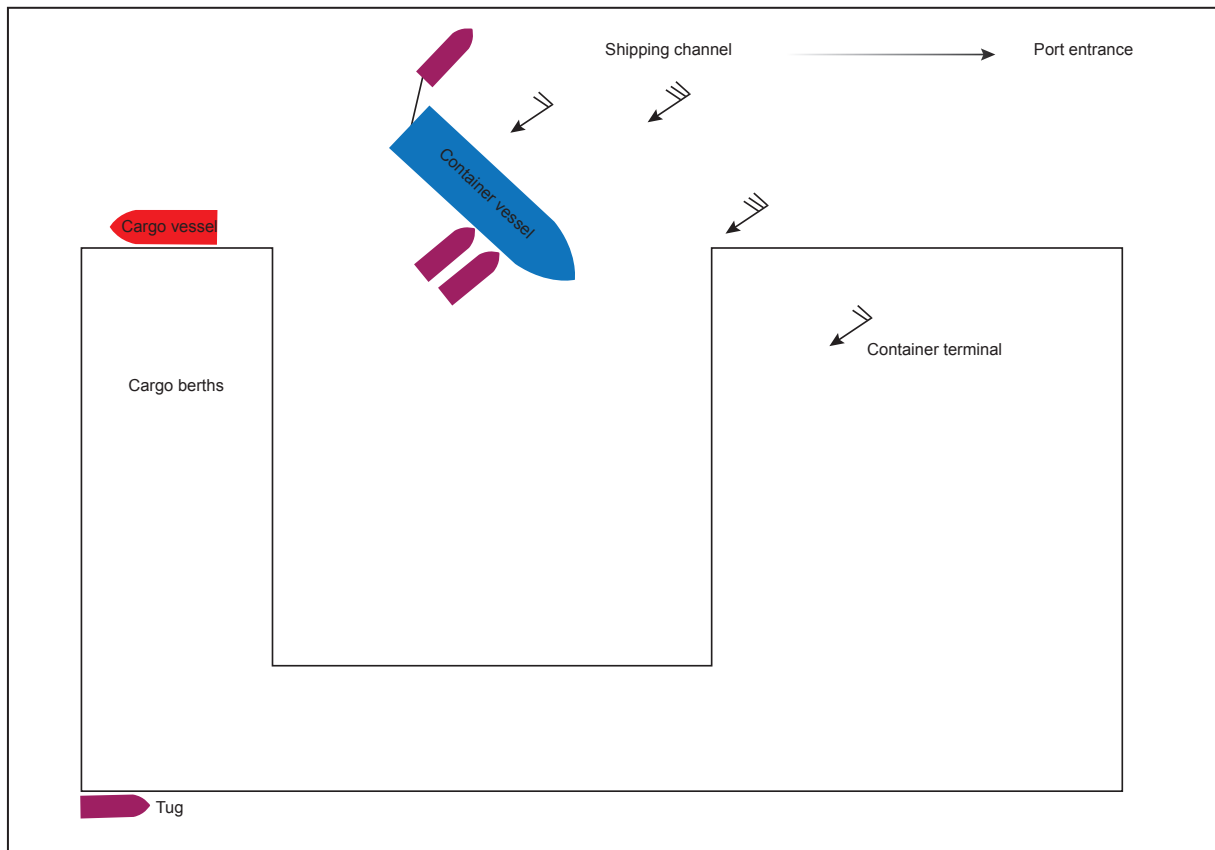
Figure 2 - The bridge team then decided to power the vessel ahead, and attempted a turn to port to avoid the cargo vessel downwind.

Figure 2: Failed manoeuvre to port

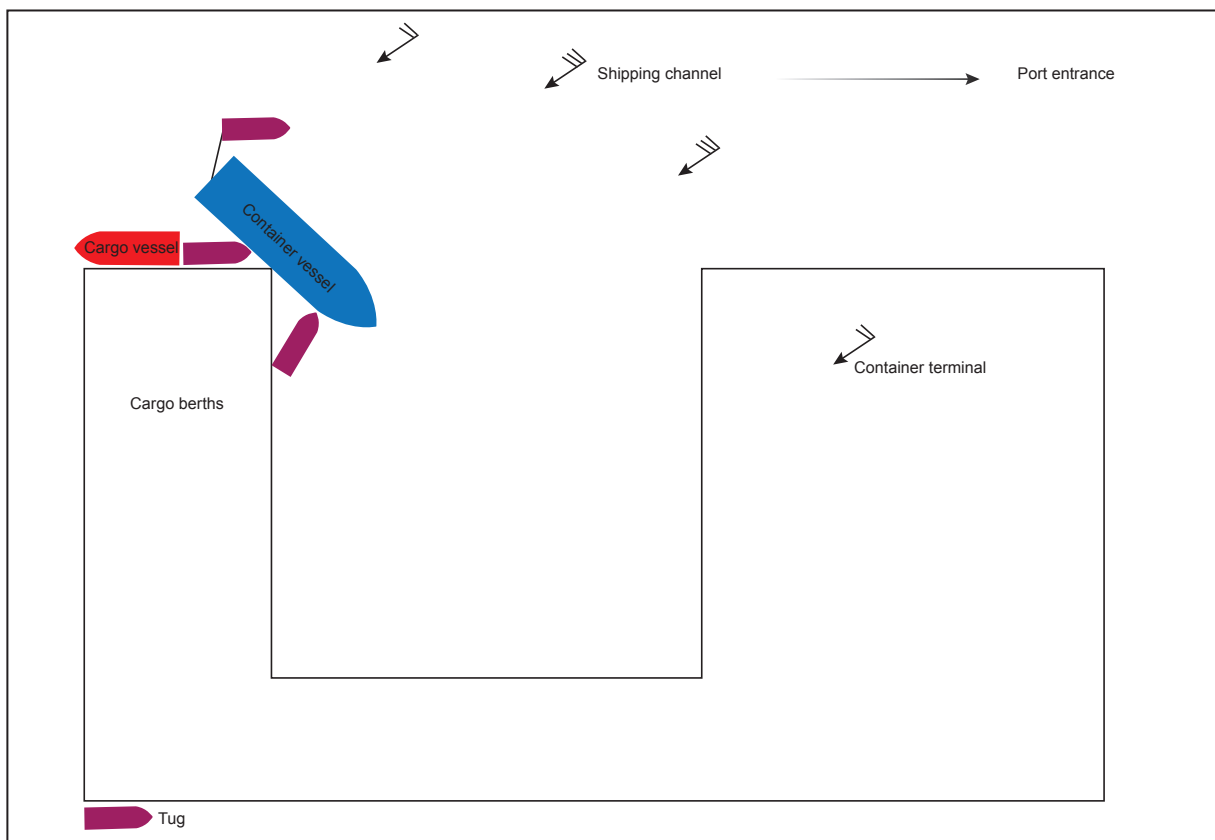
container vessel's stern set rapidly to starboard towards the other vessel (Figure 3).

Figure 3: Set towards a cargo ship

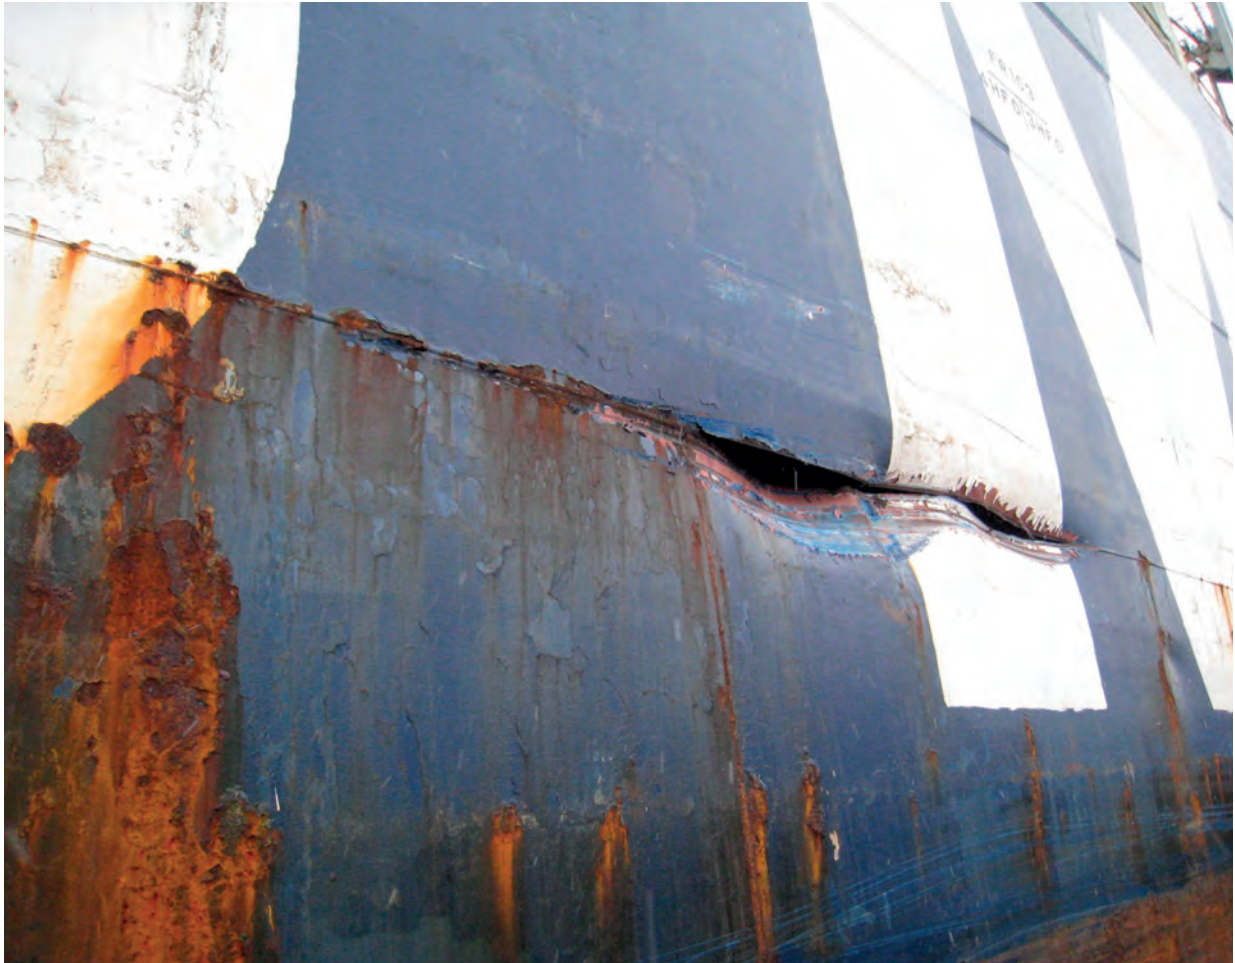
Figure 4: Hull damage to container vessel

The container vessel made heavy contact with the aft quarter of the cargo vessel and her hull was split open above the waterline (Figure 4). One of the tugs then became trapped between the vessel and the berth knuckle, causing major damage to the tug and putting her in

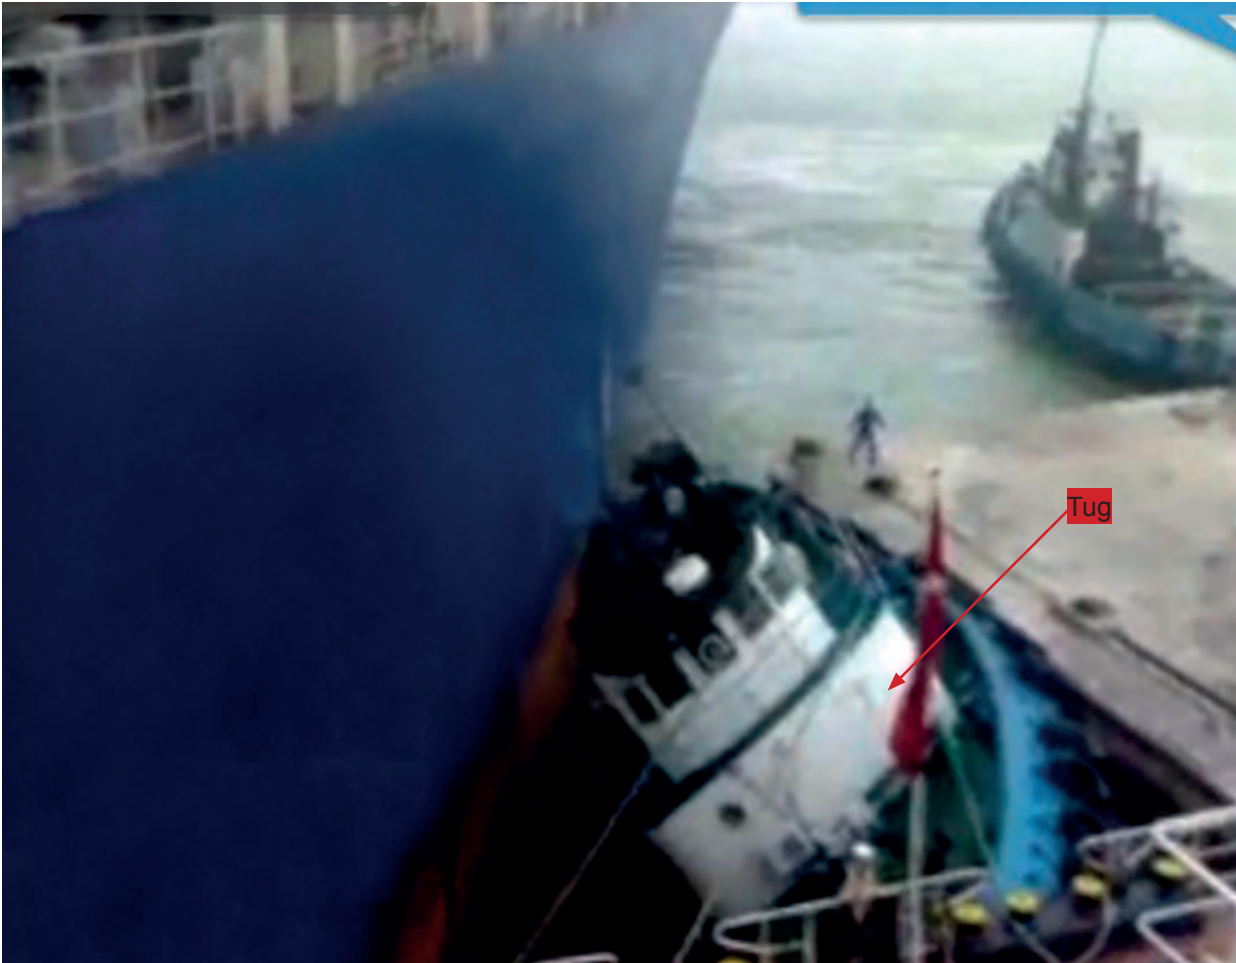
Figure 5: Tug trapped between vessel and quayside

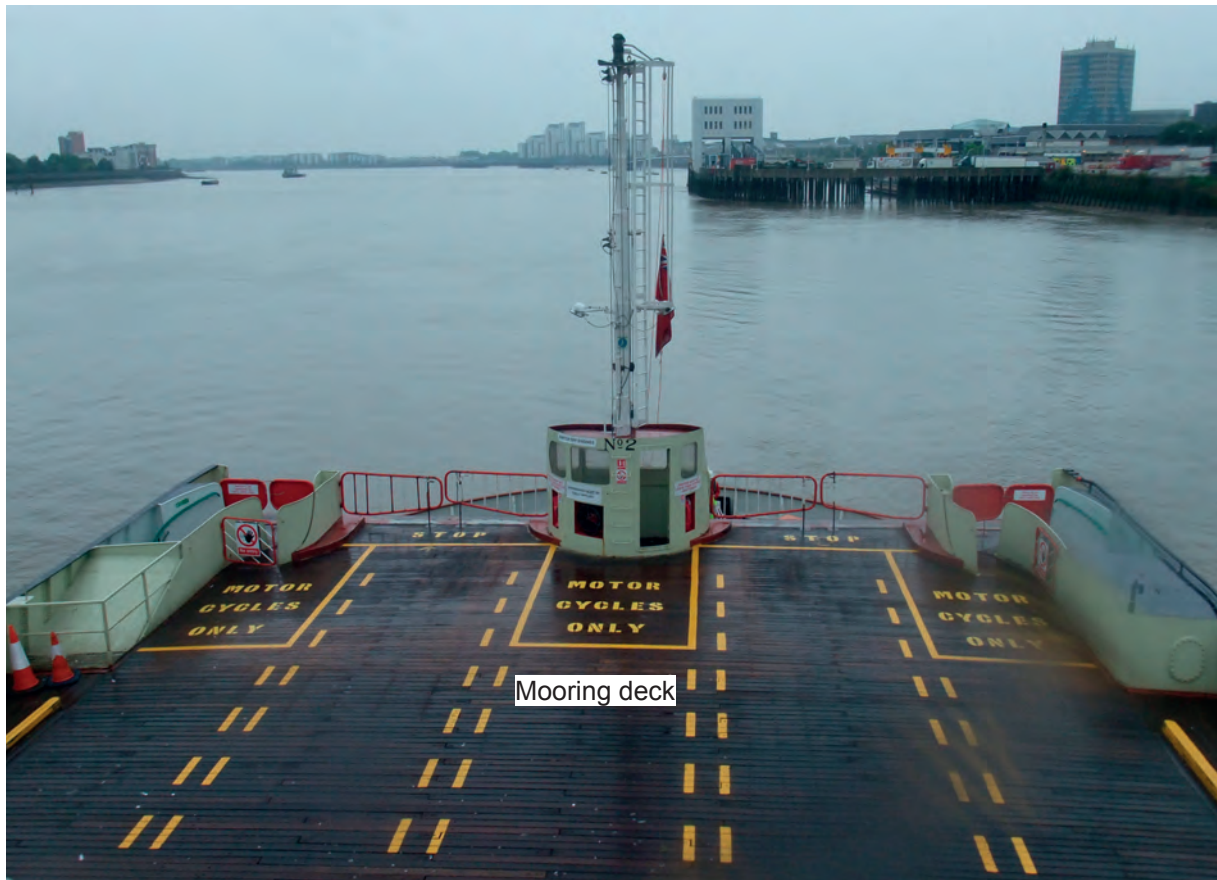
Figure 2: Master's obstructed view from steering position

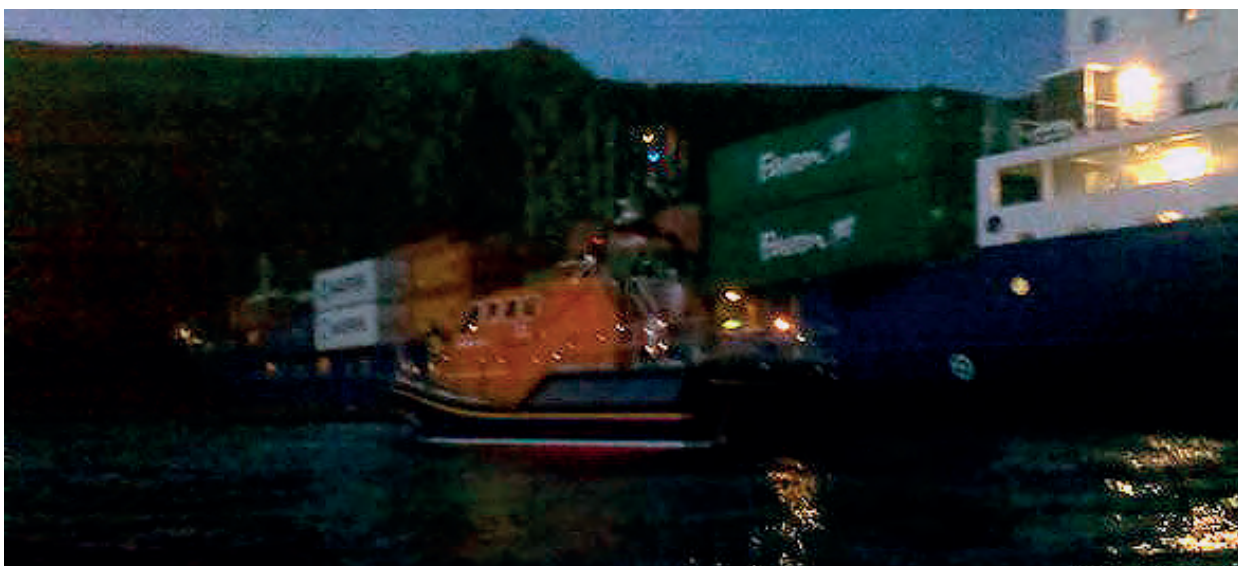
The coastguard had mobilised lifeboats and a helicopter, which stood-by the vessel while she was aground (Figure 2) as it was assumed the vessel had sustained damage. However, when the master eventually responded to the coastguard he informed them that the vessel was undamaged and that the crew were all safe.

Figure 2: Vessel aground

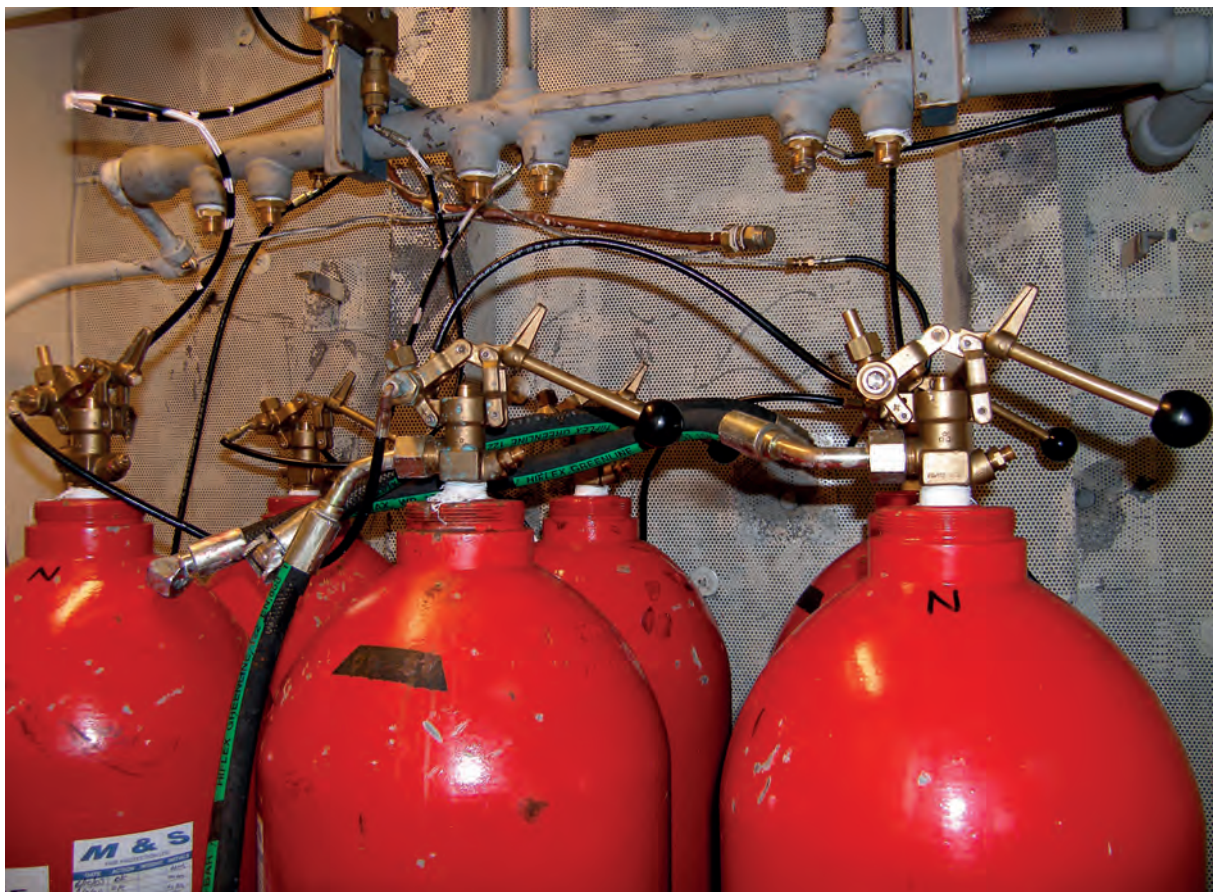
Figure 2: The disconnected hoses

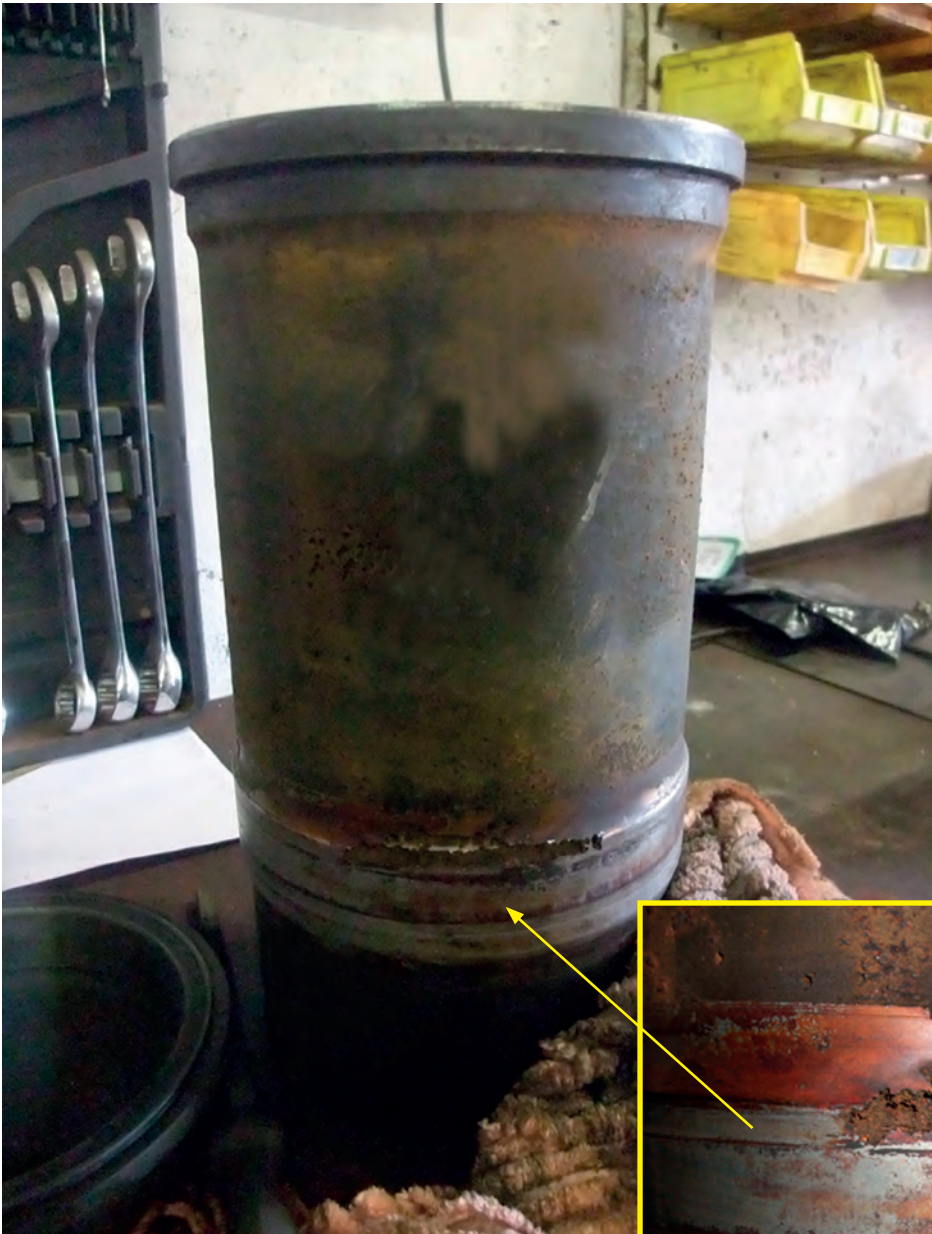
Electrolytic corrosion on vessel's cylinder liner
