# SAFETY DIGEST

**Lessons from Marine  
Accident Reports  
1/2013**

**SAFETY DIGEST**  
**Lessons from Marine Accidents**  
**No 1/2013**

April 2013

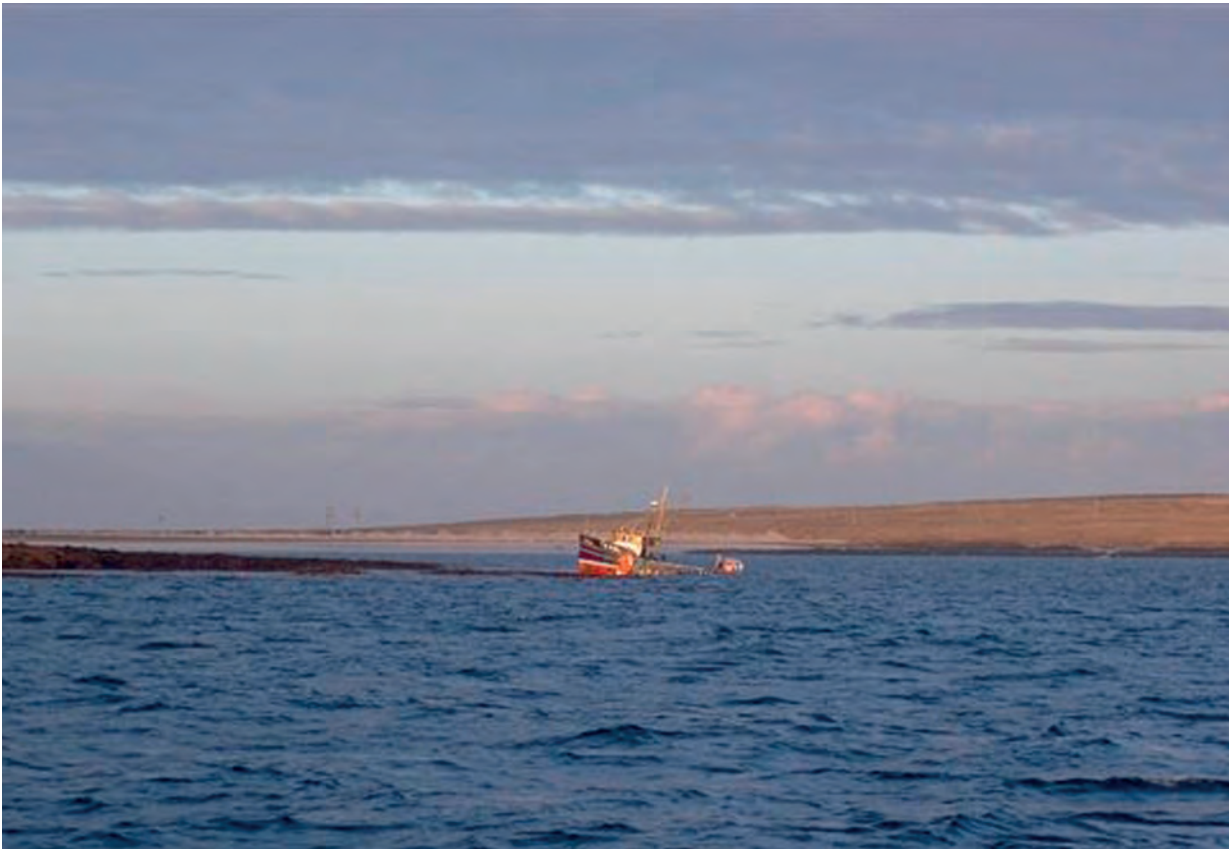
Unfortunately, they were unable to get the vessel off the rocks immediately and were forced to abandon ship as the boat lay over dramatically in the ebbing tide. Neap tides and strong onshore winds in the following days resulted in the boat being completely destroyed before she could be salvaged.

Figure 2: Fishing vessel aground on the rocks

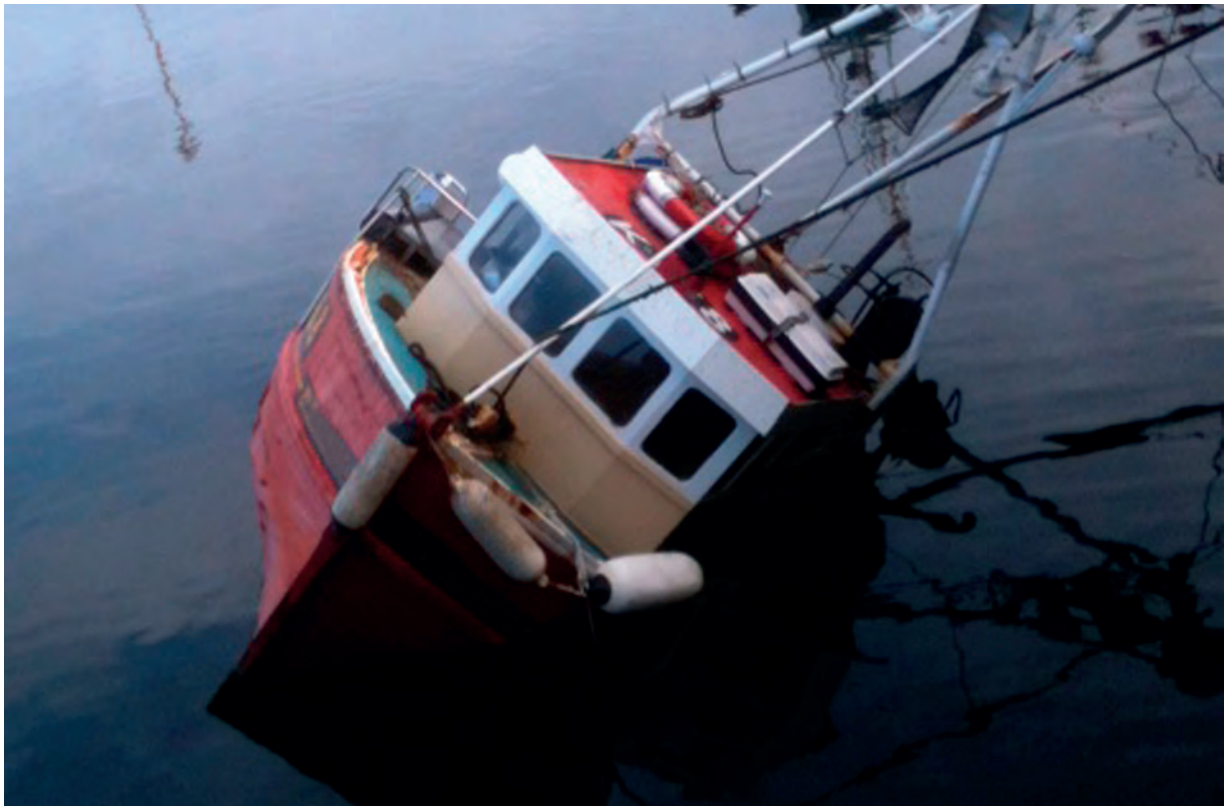
The cause of the sinking was failure of the electric bilge pump, leading to the bilge slowly flooding. This eventually caused the discharge overboard to become submerged, which allowed back flooding into the vessel.

The vessel as it started to sink
