# SAFETY DIGEST

**Lessons from Marine  
Accident Reports  
2/2013**

**SAFETY DIGEST**  
**Lessons from Marine Accidents**  
**No 2/2013**

October 2013

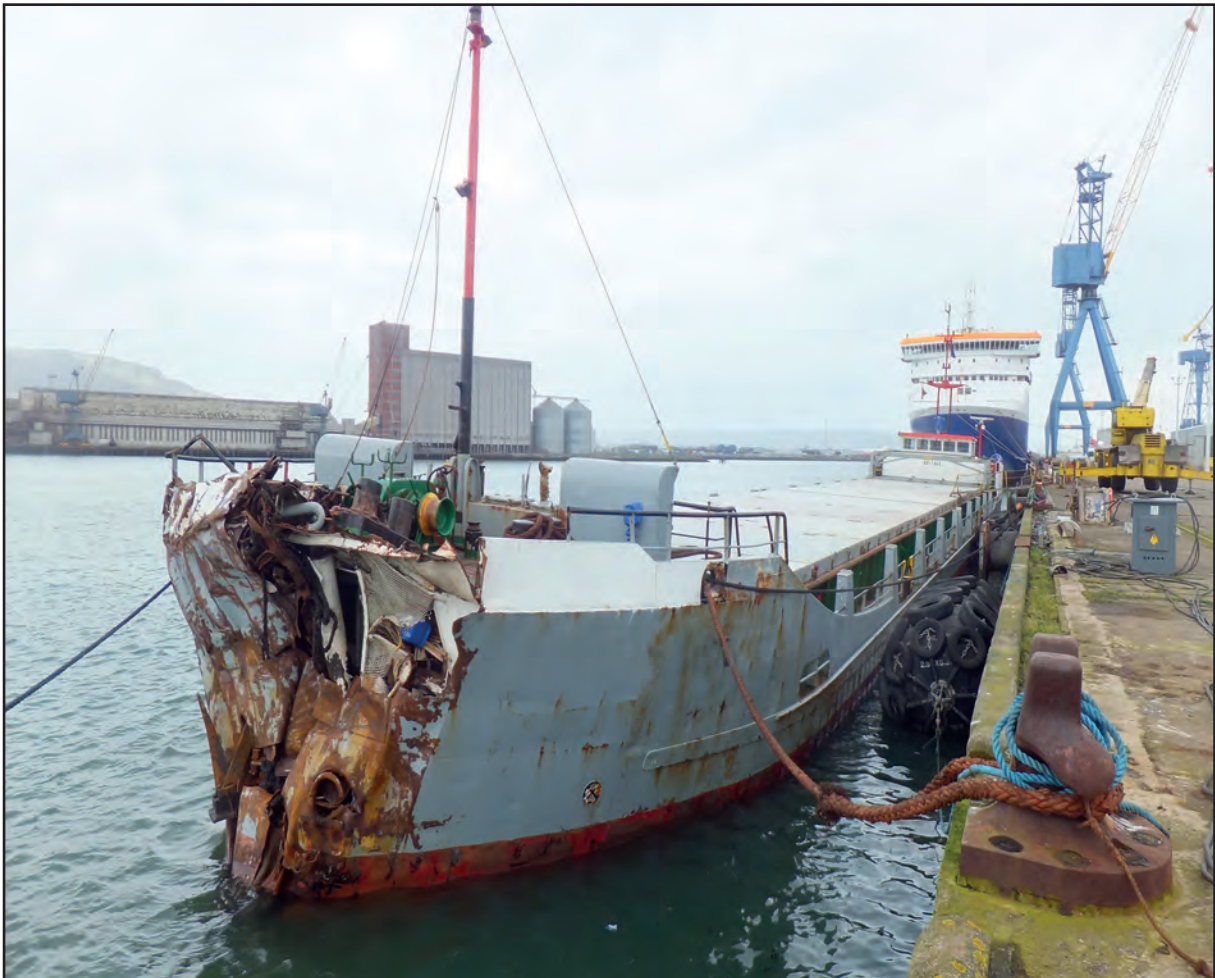
A small outbound general cargo vessel and a large inbound ferry collided near the fairway buoy that marked the seaward limit of a port. Fortunately, there were no resulting injuries or pollution and both vessels managed to proceed into port under their own power. However, the cargo vessel's bow was extensively damaged (Figure 1) and the collision caused a large gash in the ferry's port side (Figure 2).

Figure 1: Damage sustained to the general cargo vessel

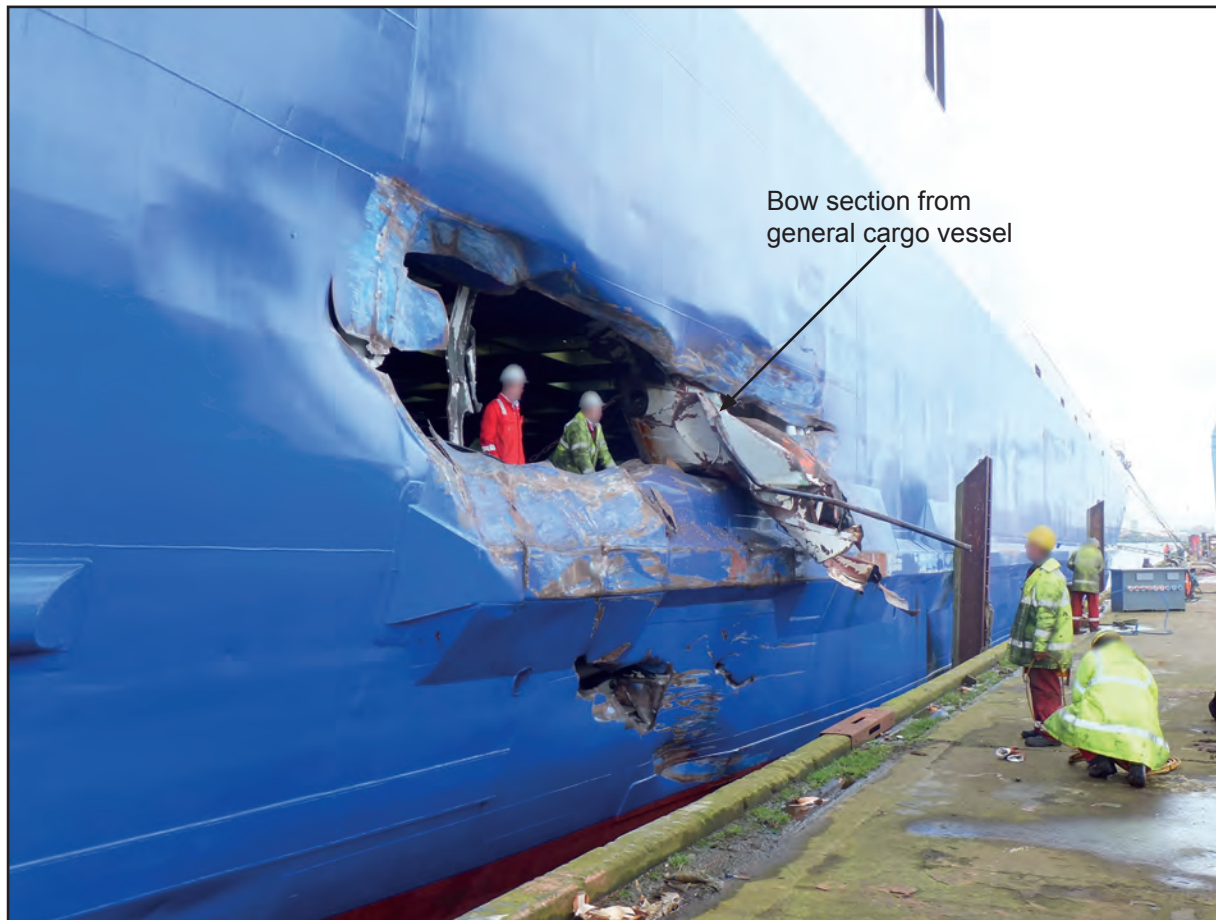
Figure 2: Damage sustained to the ferry

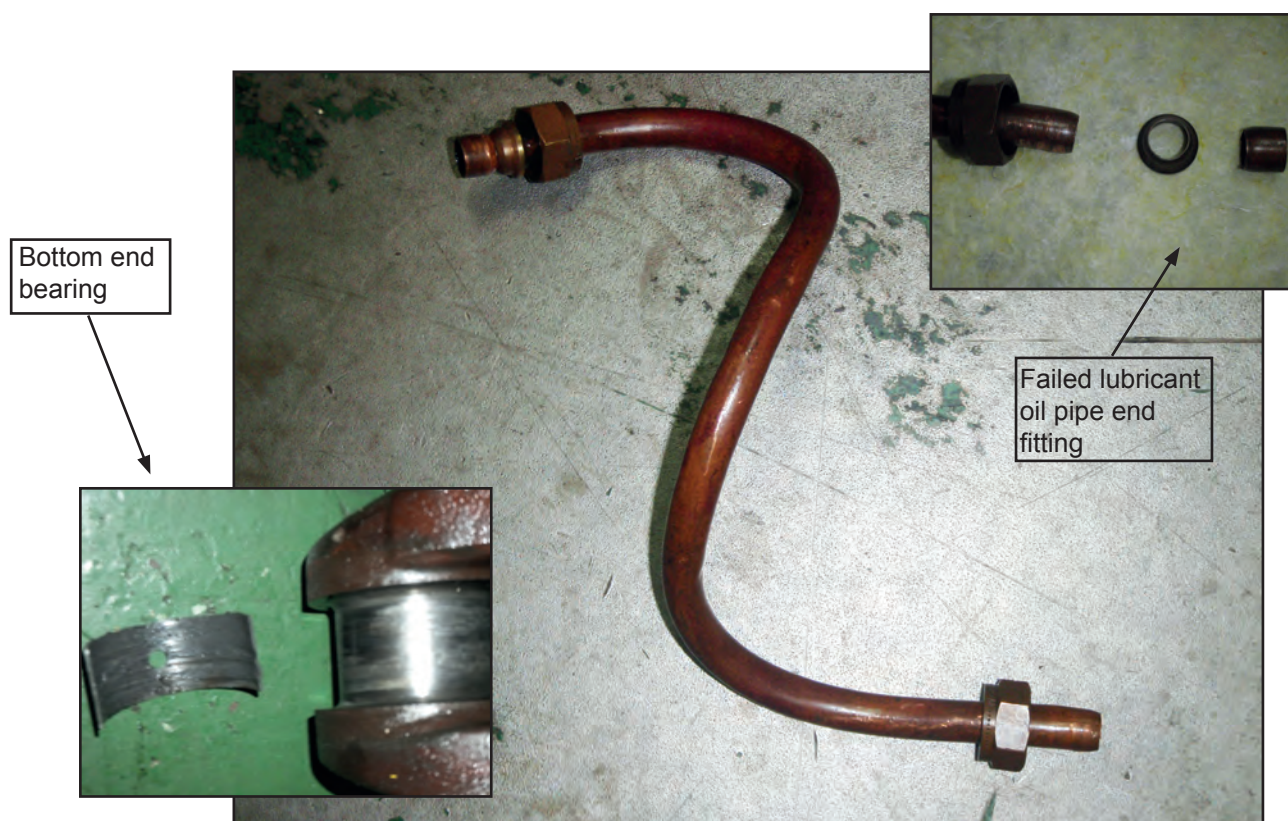
Damage to lubrication oil pipe and bottom end bearing

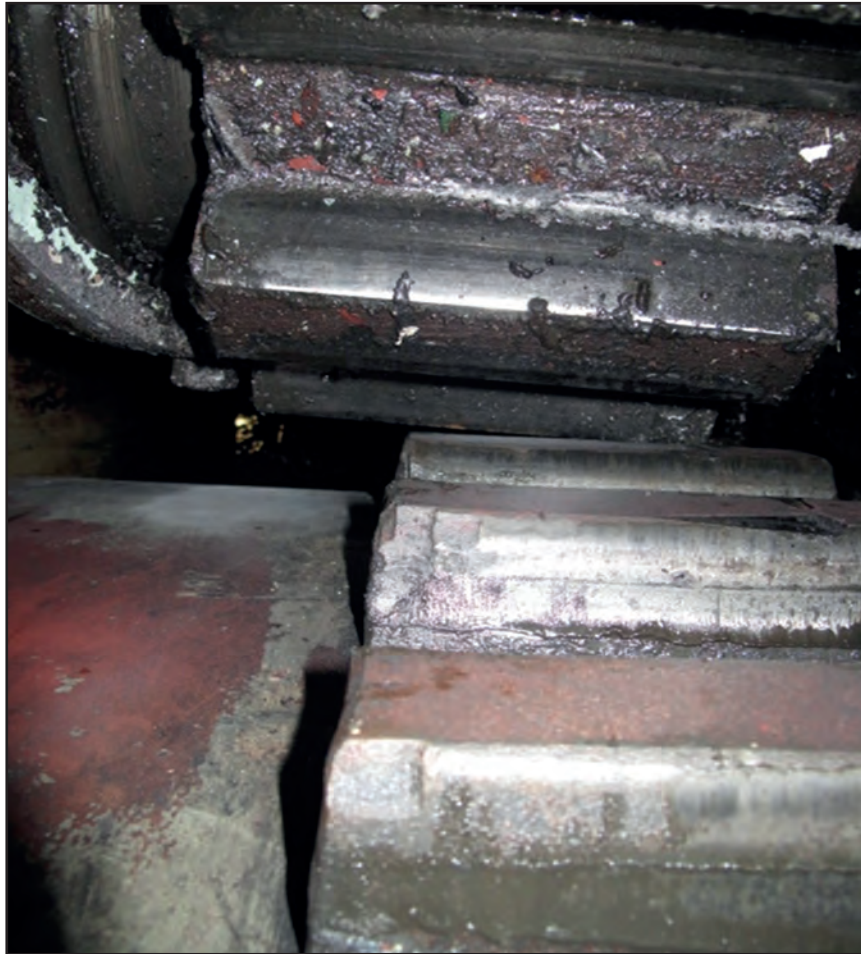
The engineer then went to the machinery control room to start the engine. Although the indicator for the turning gear, which was sited on the control panel, showed that the turning gear was in, this was poorly illuminated and was not seen by the engineer. When the main engine start button was pressed to turn the engine on compressed air, a loud bang was heard; the turning gear interlock, the last remaining safety barrier, had failed to work. The resulting damage to the shaft and gearing (Figure 1) and to the turning gear casing (Figure 2) disabled the ship for a month and cost a six-figure sum to repair.

Figure 1: Damage to gearing

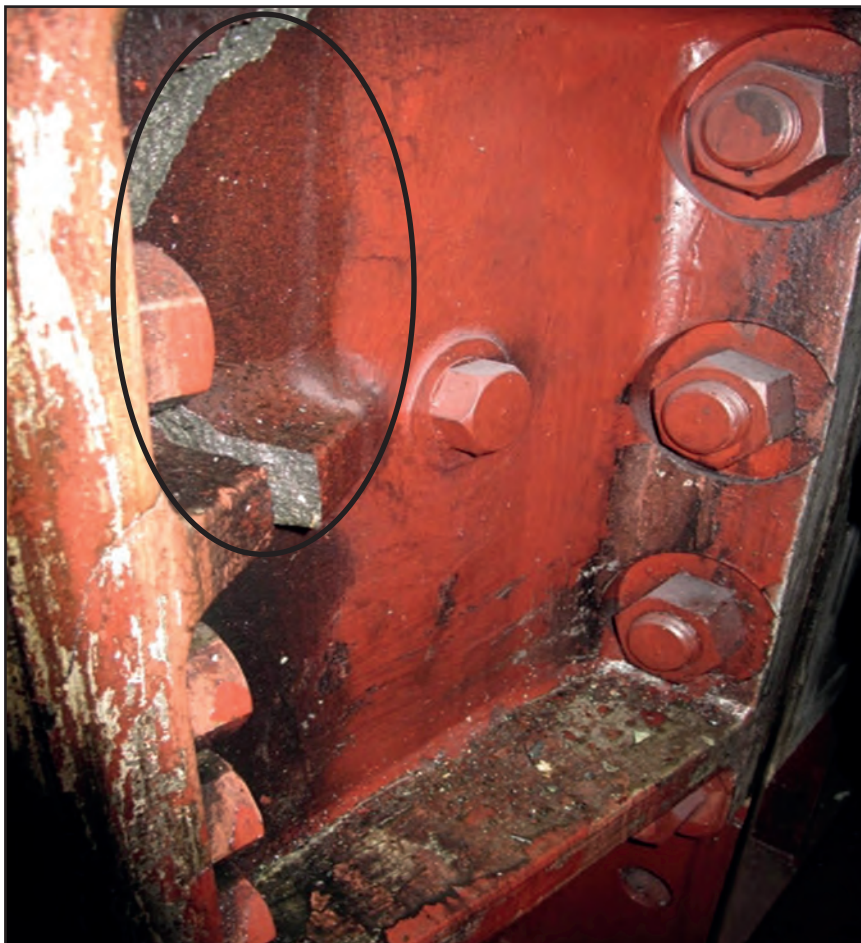
Figure 2: Gearcase middle section crack

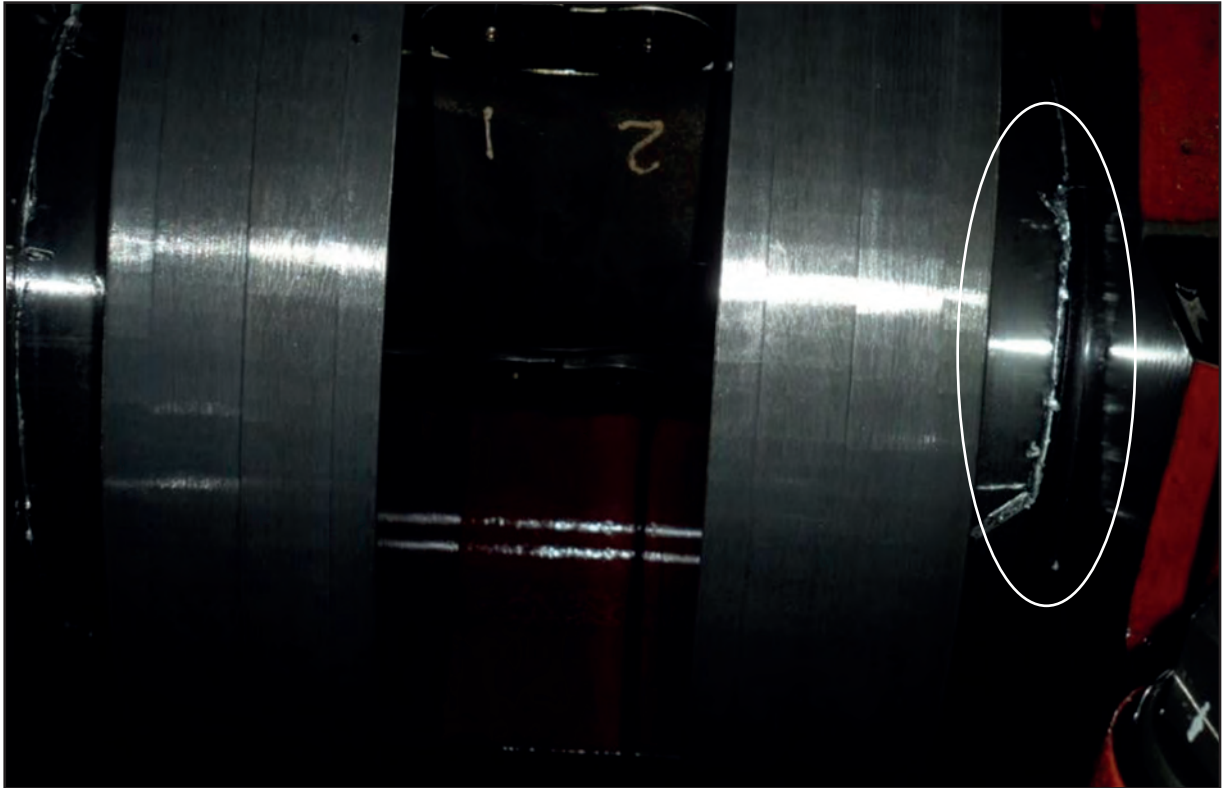
After the engine was allowed to cool, the crankcase doors were removed; several crankshaft bearings were severely damaged (Figure 1) which prevented the engine from further operation. The vessel was towed to the nearest available port for further assessment.

Subsequent investigation by the engine manufacturer determined that the damage included: the failure of all crankshaft main and crankpin bearings; the displacement of all the crankshaft main bearing shells; scoring of the crankpin and main bearing journals; overheating of crankpin and main bearing journals; overheating of the bedplate at the main bearing housings; overheating of the piston connecting rods; the seizure of several pistons (Figure 2); failure of the camshaft and turbo charger bearings, and metallic debris throughout the lubricating oil system. The damage sustained necessitated an engine rebuild and the replacement of the bedplate and crankshaft.

The repairs were carried out by contractors under the supervision of the engine manufacturer's service agents and the vessel's classification society, and the vessel returned to service. Up until the engine failure the engine appeared to operate without any problems and the vessel undertook several voyages. However, after the engine failure, the duplex filter was found without a filter cartridge in the on-line filter chamber, and the engine lubricating oil system was contaminated. The contamination caused main bearing seizure, the rotation of bearing shells and the blockage of oil ways, and subsequent oil starvation and overheating to other bearings and to the pistons.

Figure 1: Damage to crankshaft bearings

1. Maintenance periods can be busy times; however it is imperative that ships' staff maintain sufficient oversight of work undertaken by contractors to ensure that critical steps are not overlooked.
2. One of the advantages of completing daily logs is the ability to assess trends in the operating machinery. A consistently low reading on the filter differential oil pressure gauge, and a comparison with previous operating hours between filter changes, should have rung alarm bells that something was wrong.
3. An oil mist detector gives advance warning of an impending major failure. When a detector alarm occurs, the thought of stopping and inspecting the engine as soon as possible should be uppermost in an engineer's mind. The consequences of ignoring it are clear, and expensive.

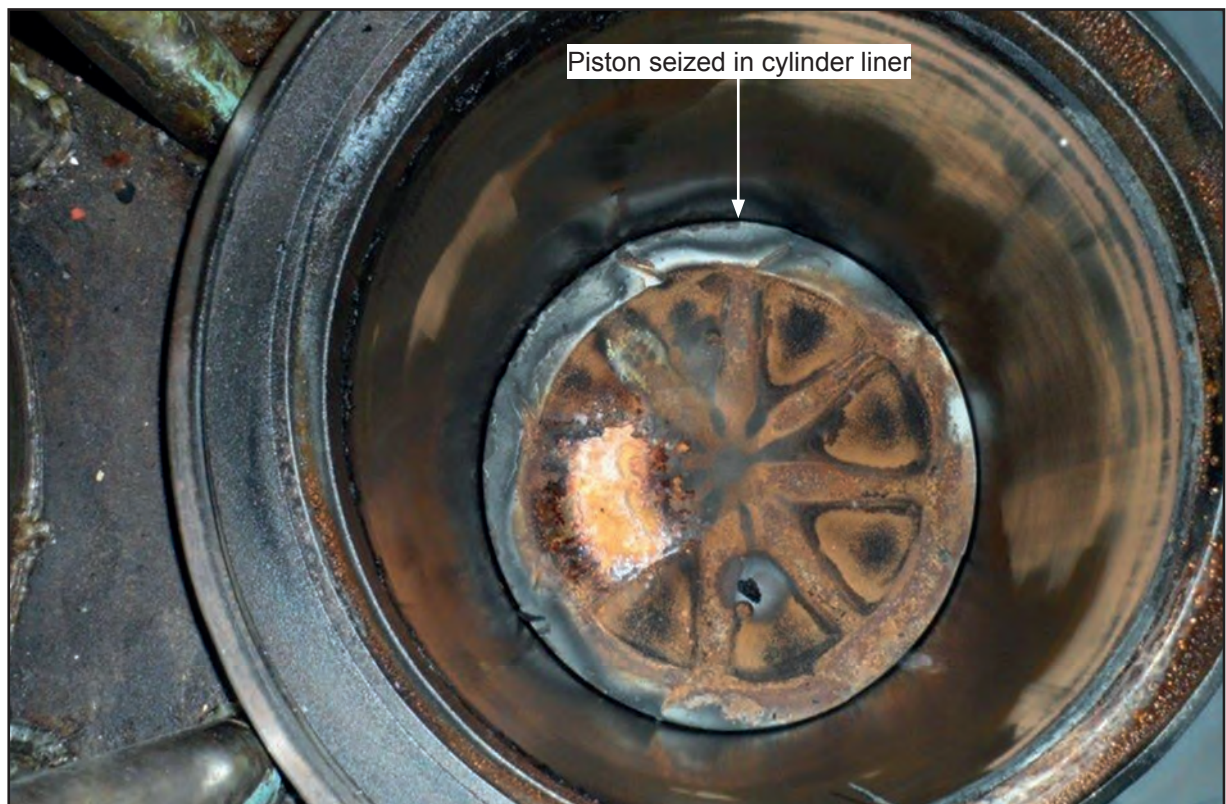
Figure 2: Seized piston

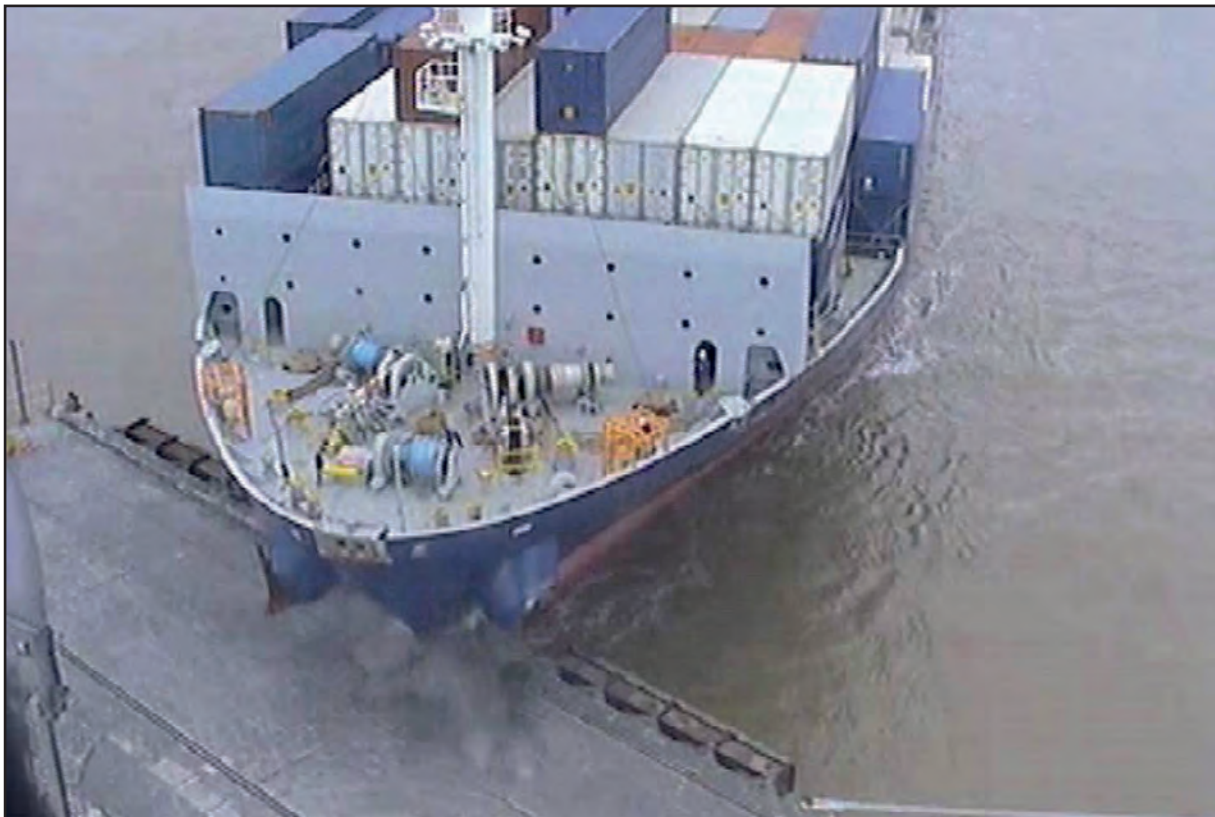
Although the vessel's engine developed full astern power, this was insufficient to arrest her headway in the space available and she made heavy contact with the quay on the opposite bank of the river (see figure). Fortunately, no one was hurt and there was no pollution. However, the vessel's bow suffered significant damage.

Contact with the quay

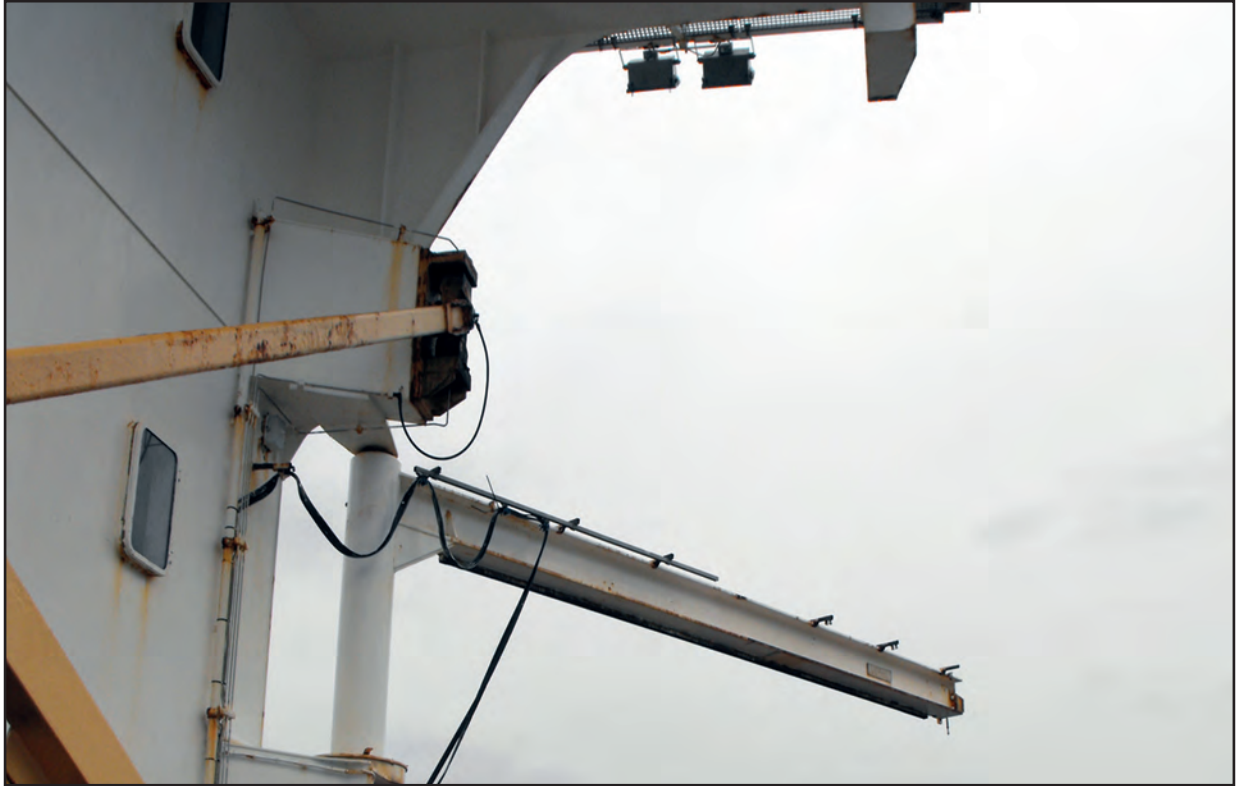
Investigation after the accident found that, despite the ship's manager's very pro-active approach to maintenance and a strong safety culture, the provisions crane trolley had been left out of the planned maintenance regime. The trolley was difficult to get to and impossible to inspect or maintain without putting up scaffolding or using a man-carrying basket. As a consequence, the trolley wheels had seized up and flat spots had been worn where the wheels had been dragged along the 'T' beam.

Figure 1: Stores crane

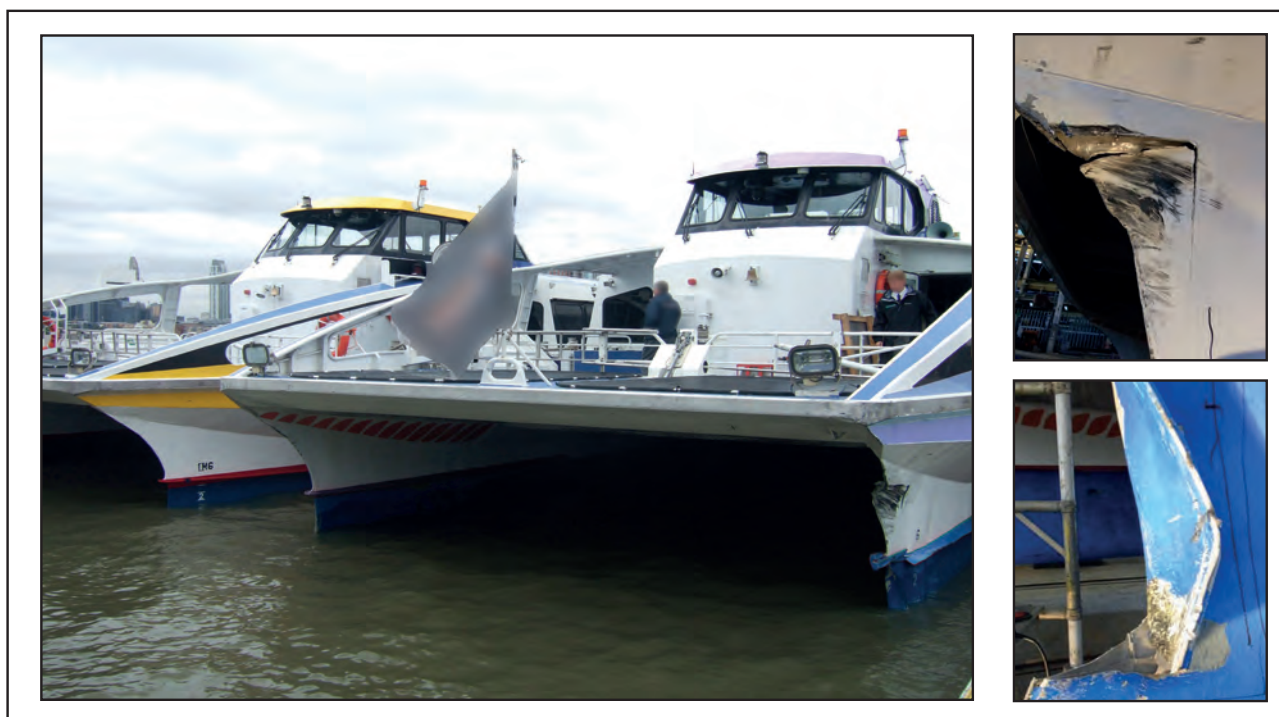
At twilight on a clear autumn evening a high speed passenger catamaran, operating a scheduled service on a major English river, made heavy contact with a pier while berthing. As a result, 14 passengers and 2 crew members were injured and the vessel sustained damage to one of her hulls (Figure 1).

Figure 1: Hull damage caused by contact

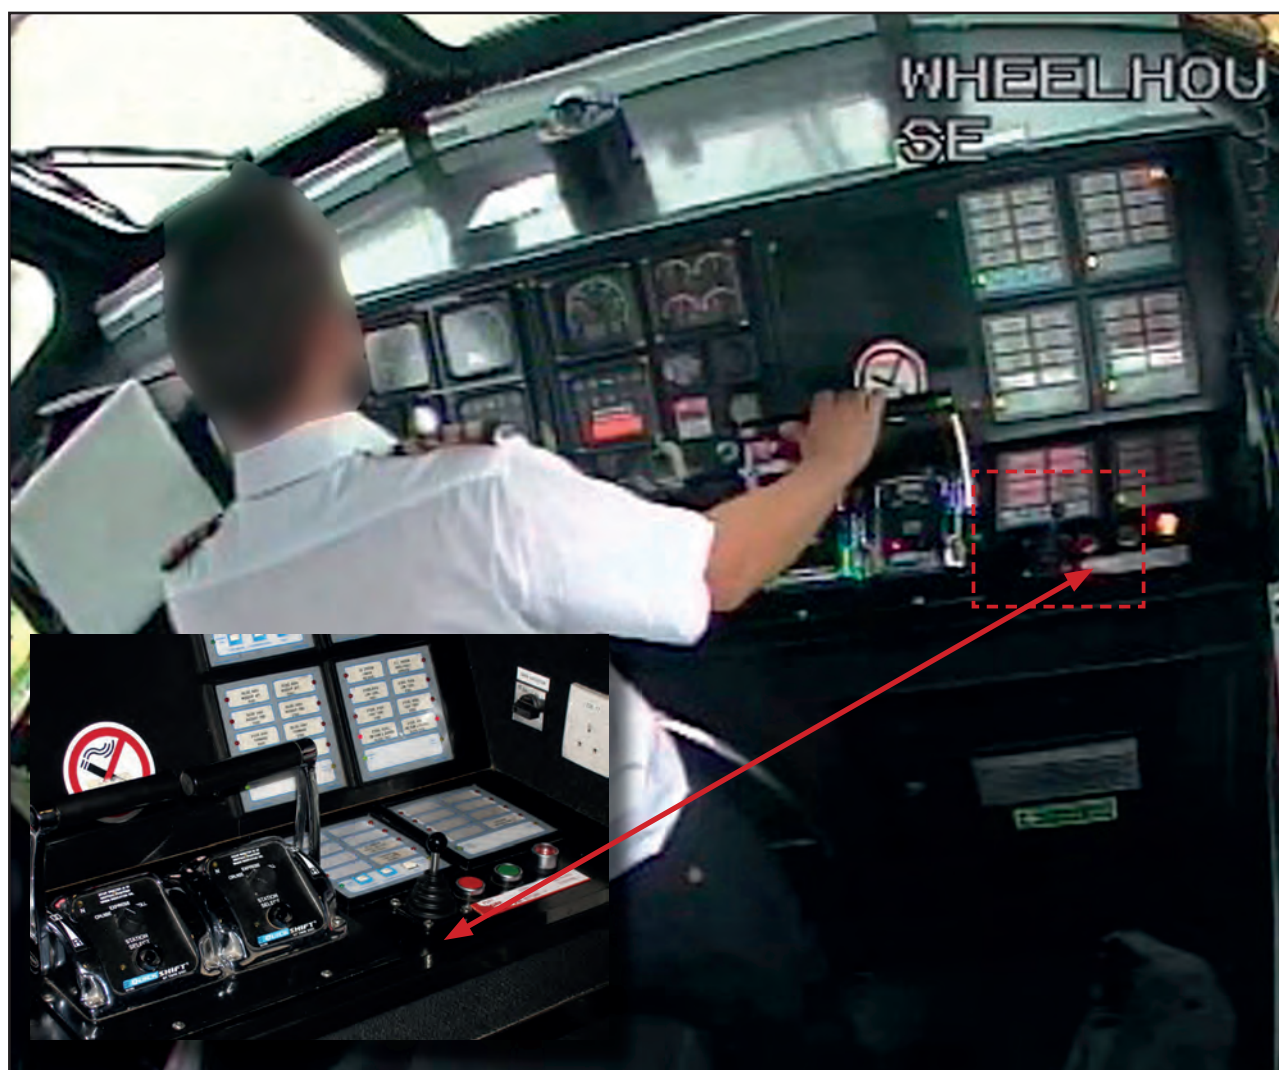
Earlier in the day the master had reported there was a defect with the vessel's steering control joystick, which was sometimes sticking hard over to port or starboard when released, instead of springing back to its normal central position (Figure 2).

Figure 2: Showing wheel steering and steering control joystick system

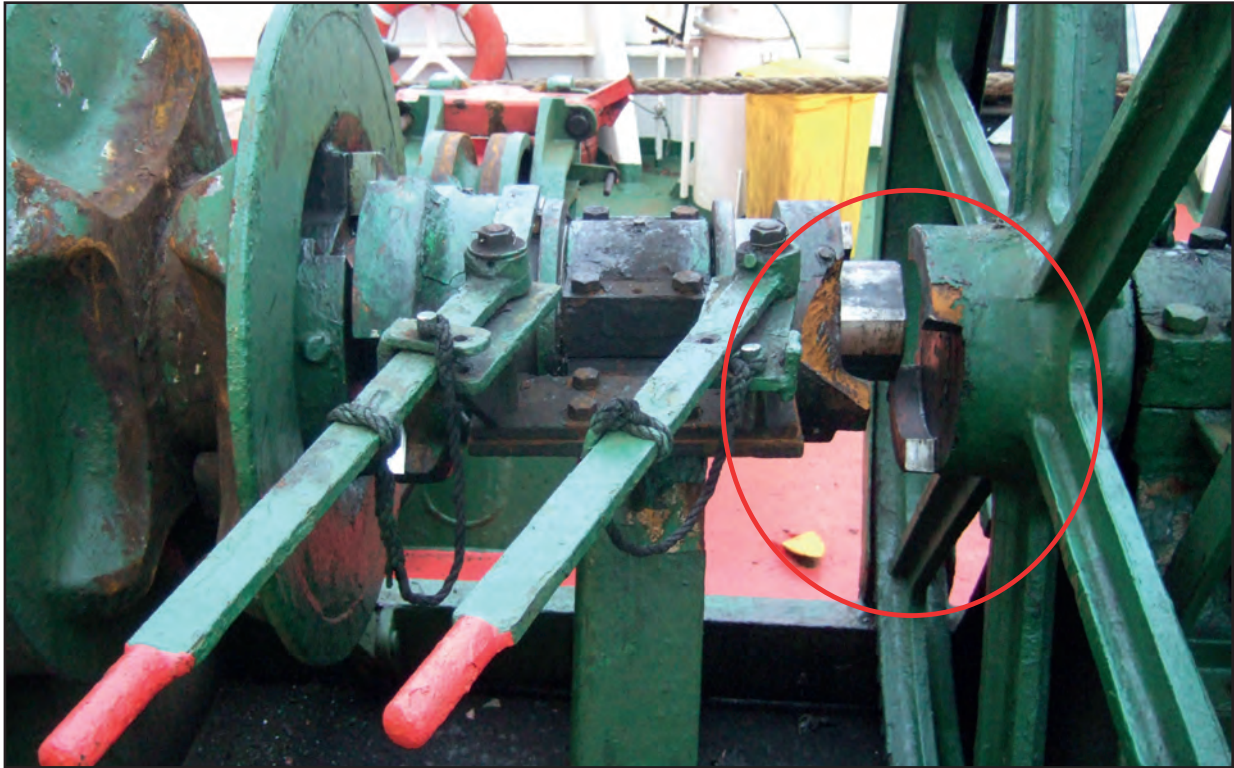
Dog clutch damage and bent shaft

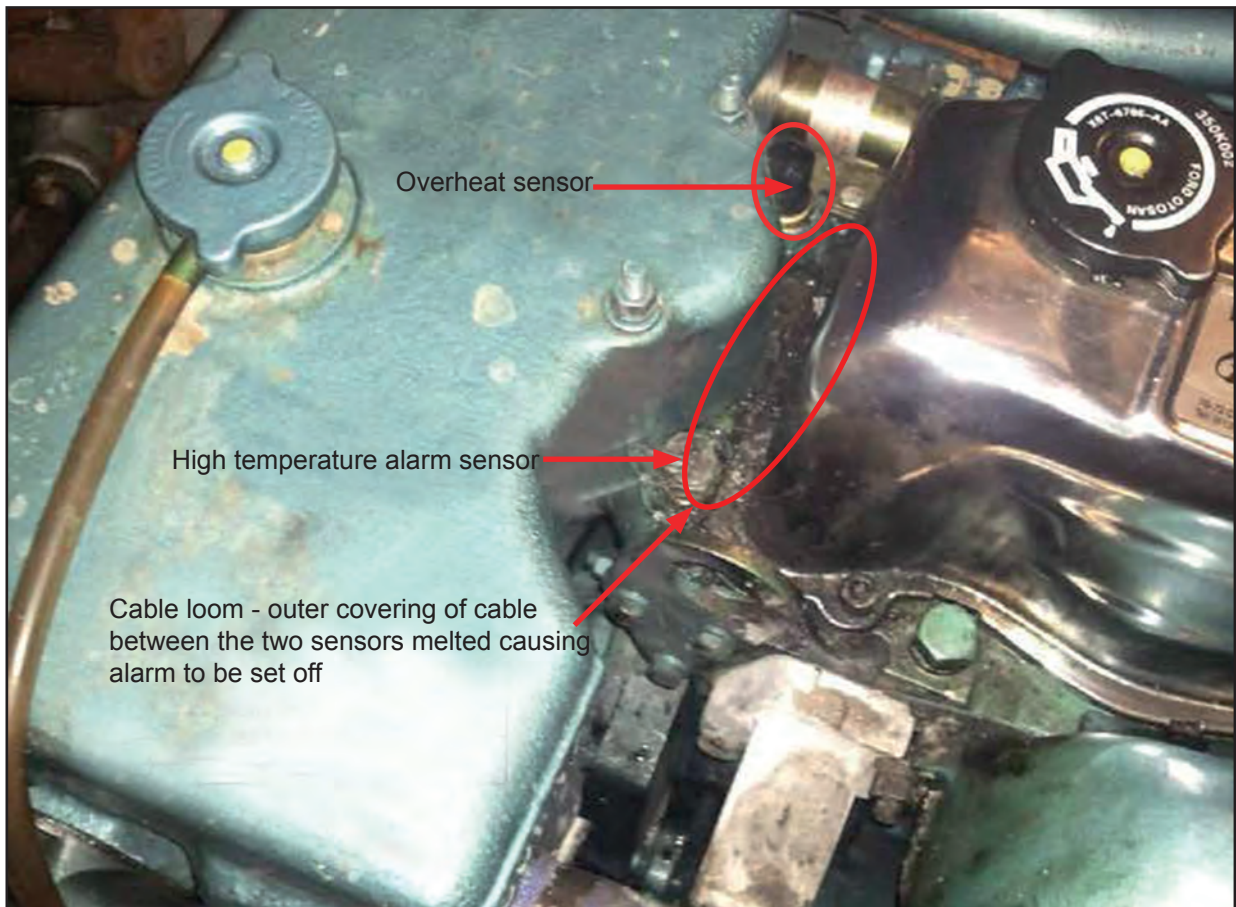
Investigations found that when the mate did his pre-sailing checks, he wiped the engine sump dipstick on a rag, which he casually left on a tank top above the engine exhaust manifold. Vibration caused the oil-soaked rag to fall onto the hot manifold and catch fire. The small fire then ignited the engine high temperature alarm cabling loom, causing it to short circuit and set off the alarm in the wheelhouse (Figure 2). The functional fire and smoke alarm sensors were some distance from the fire, and the smoke and heat had not migrated that far by the time the master noticed the smoke on the camera monitor.

Figure 2: Location of fire and damage to the high temperature alarm cabling loom

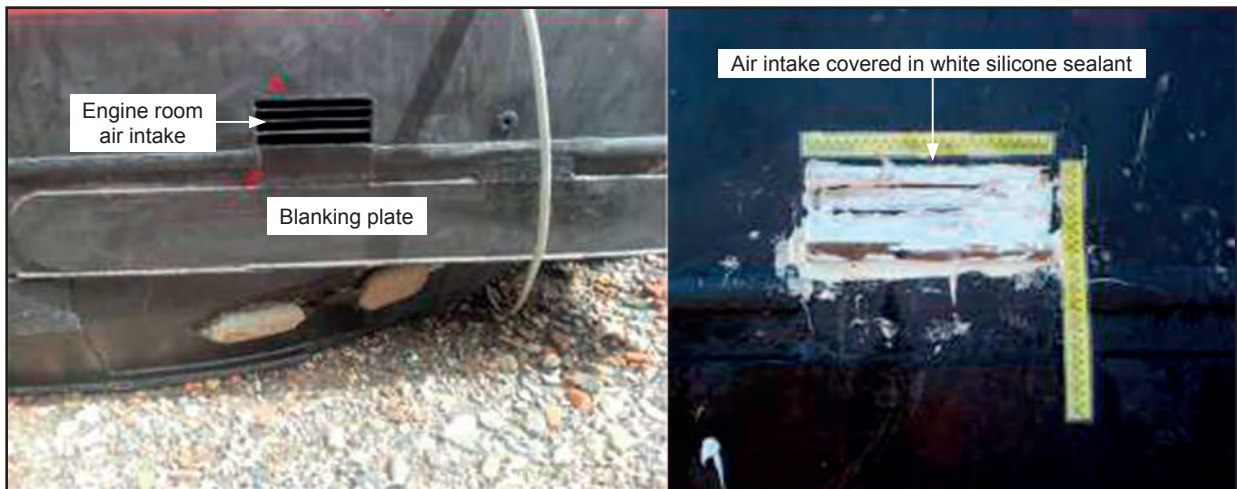
In the choppy waters of the river, it was possible for waves to lap over the lower edge of the vent. With three adults standing aft, the rate of flooding increased until the inevitable sinking happened.

Figure 2: Engine room air intake

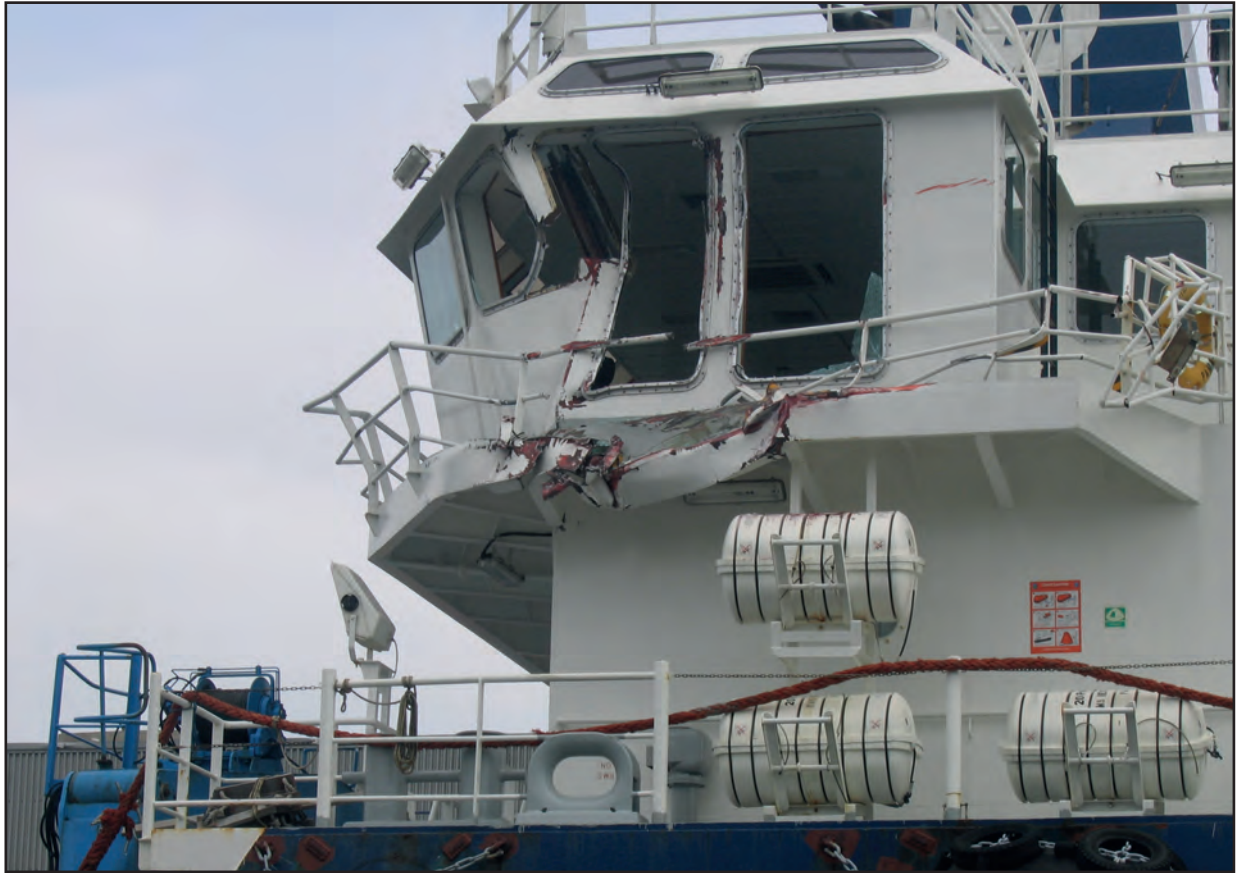
Figure 1: External damage to the bridge wing

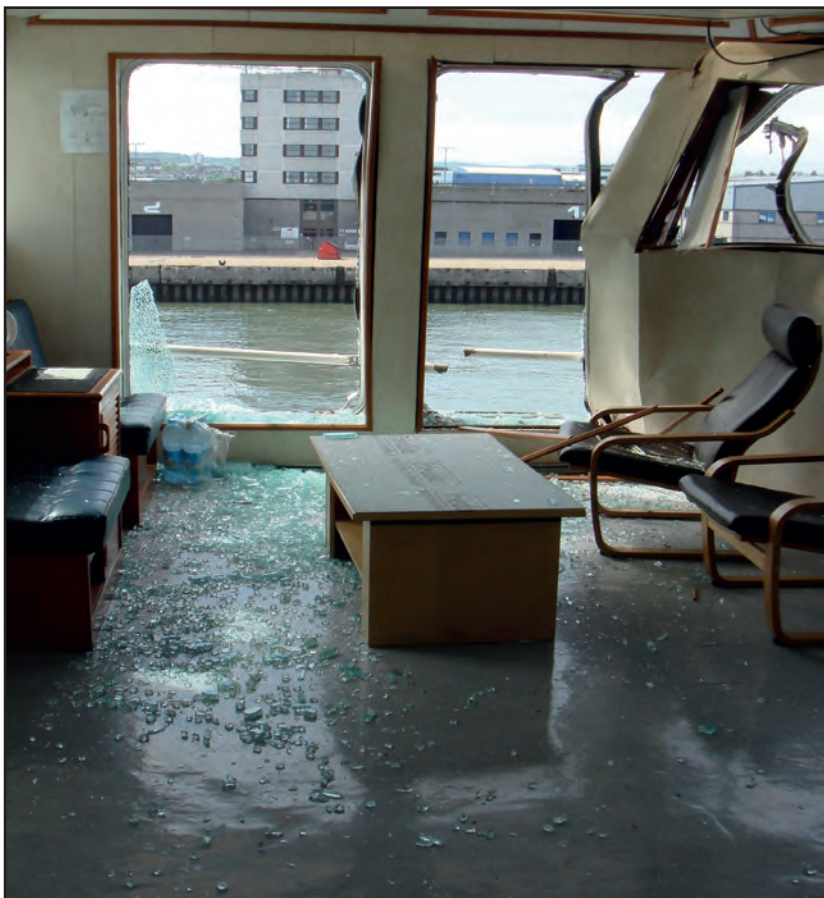
Figure 2: Damage viewed from inside the bridge wing

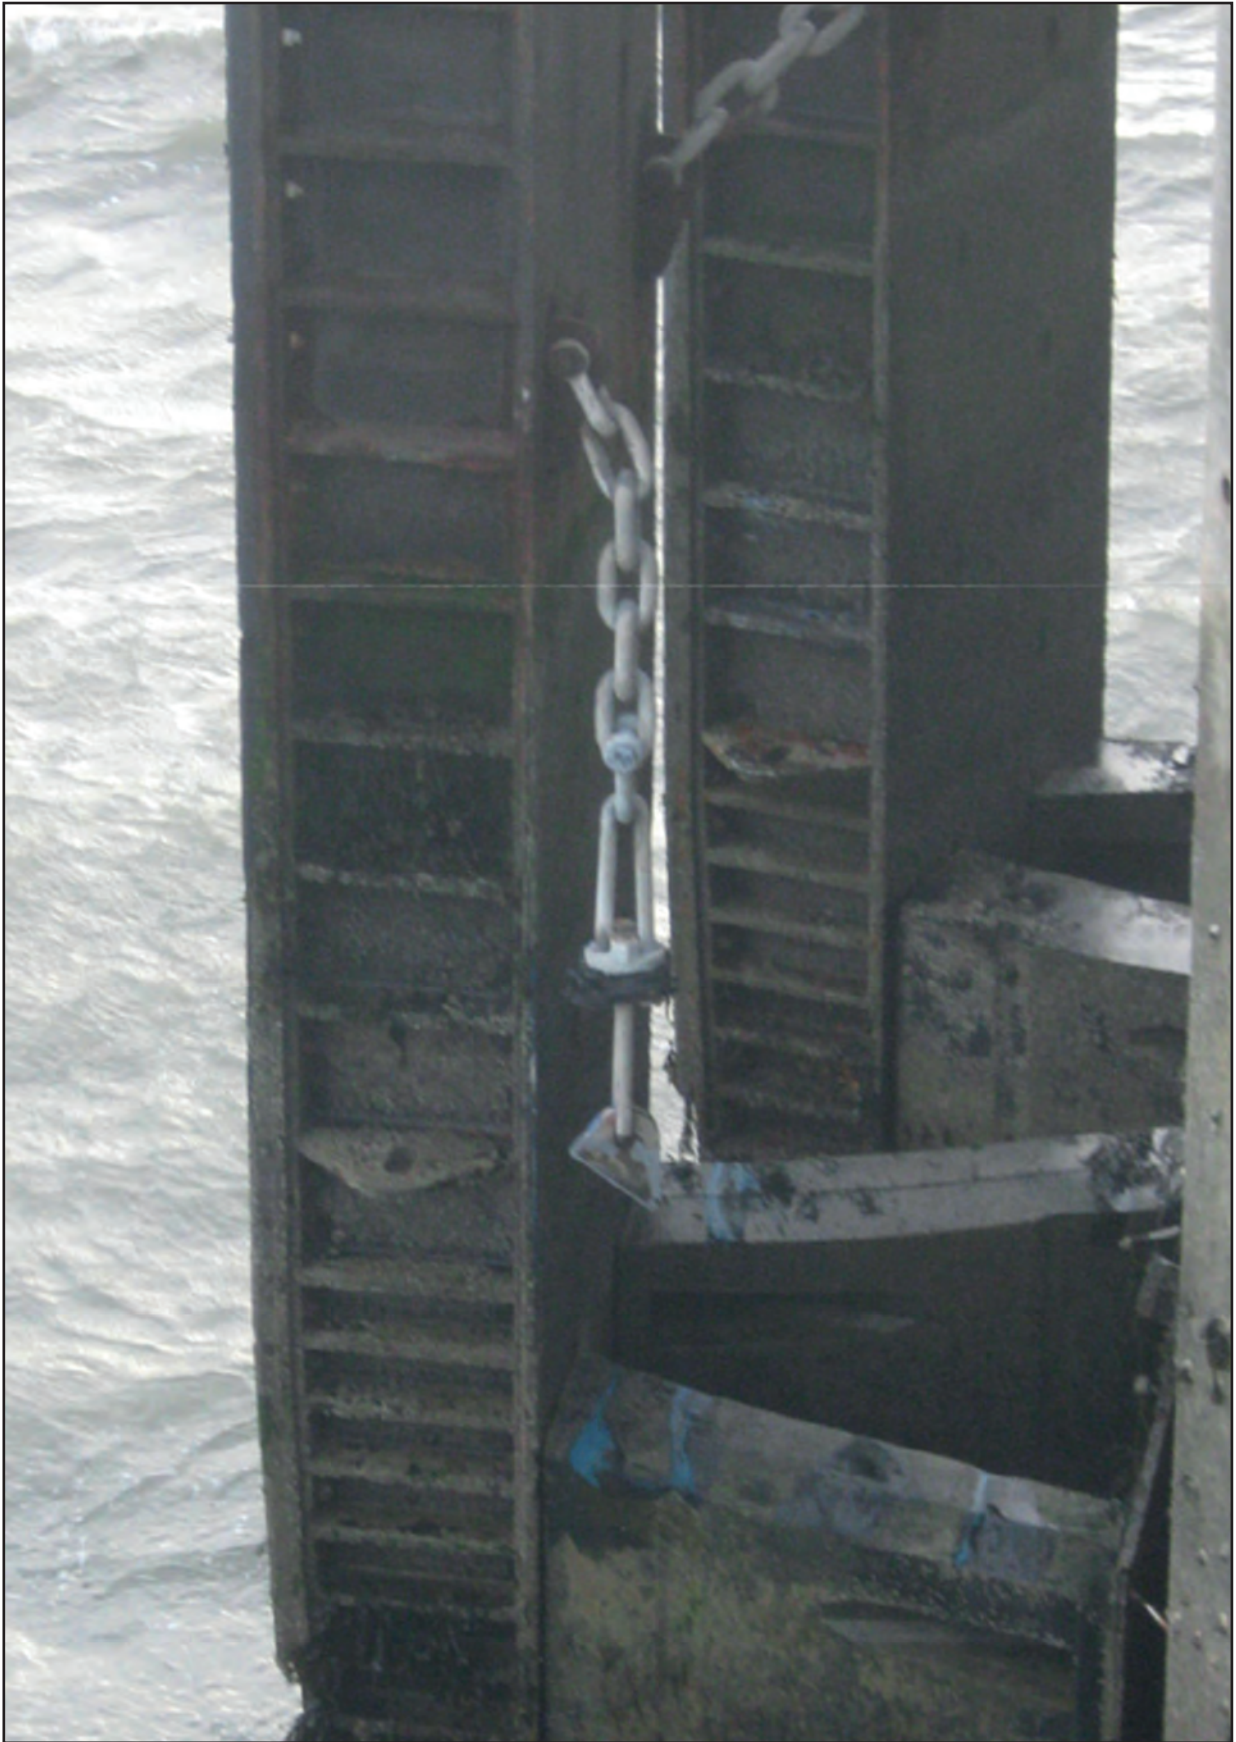
The master eventually managed to manoeuvre the HSC clear. However, in doing so, the vessel's starboard prow became wedged behind a fixed fender attached to a dolphin to the north. This was not seen by the master or the bridge team. The vessel continued to move ahead and the fender was detached from the dolphin (Figure 2). The vessel's starboard prow was also badly damaged. The HSC was assisted to her intended berth by the port's duty tug before proceeding to a repair yard. The catamaran was out of service for 5 days.

Figure 2: Damaged fender

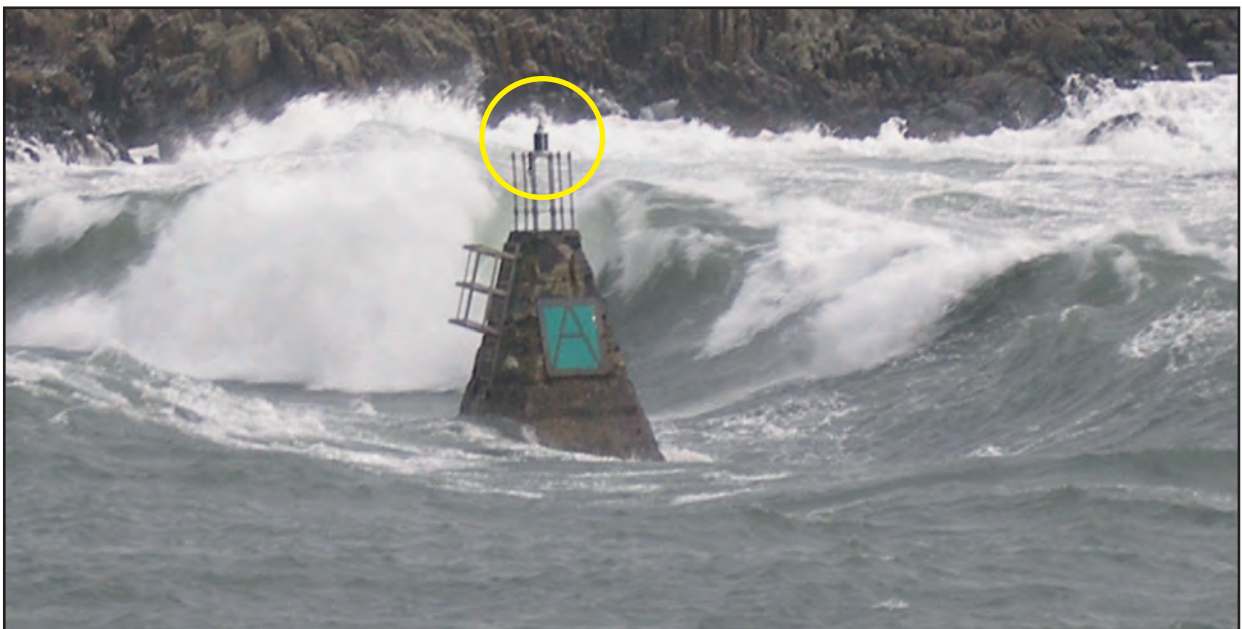
Unbeknown to the skipper, the green navigation light was inoperative at the time of the accident. However, the harbour's sectorised leading light was functioning normally.

Unlit beacon

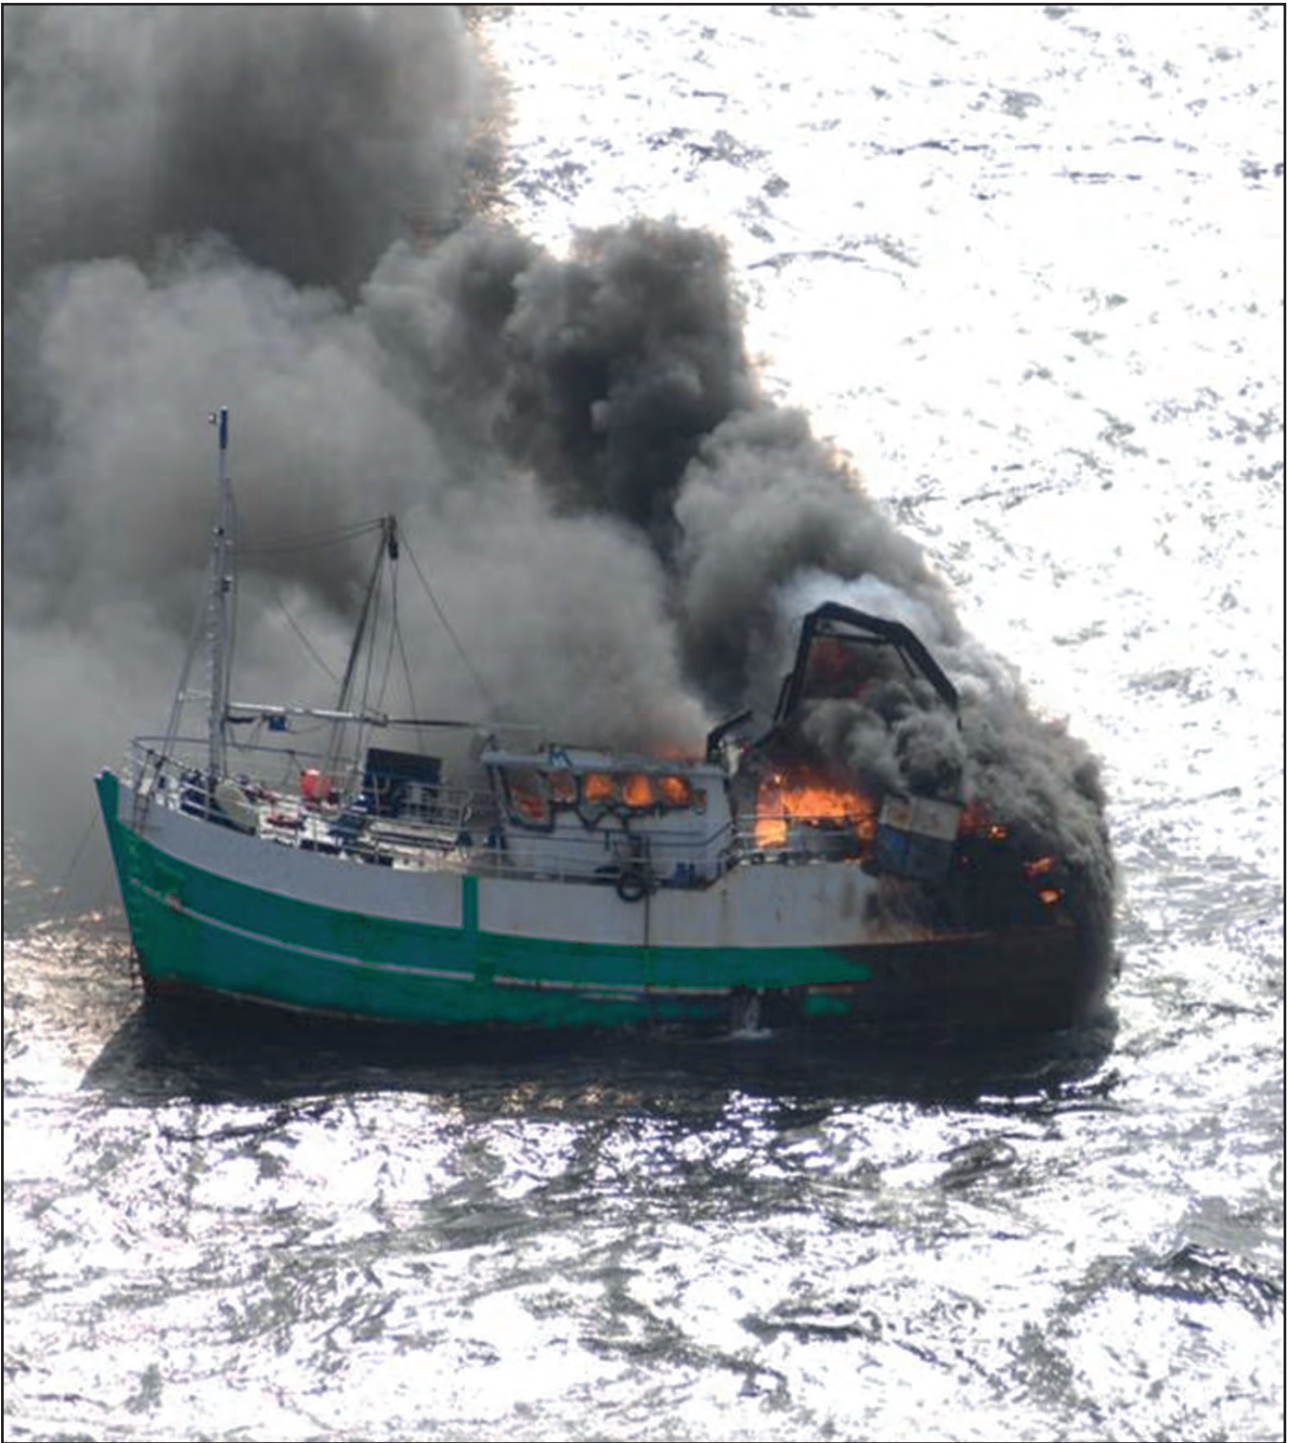
The cause of the fire is unknown, but it is likely to have started in the engine room. A fire detection system was fitted but it was not routinely tested and clearly it did not work on this occasion. The fire appears to have spread rapidly for a number of reasons, including: a number of doors and hatches were either not properly sealed or were left open; the engine was not stopped by use of the 'emergency stop' in the wheelhouse or the fuel supply trips at the foot of the wheelhouse access; the crew were unable to get to the activation point for the fixed CO<sub>2</sub> extinguishing system for the engine room, which was sited on the shelter deck; and the crew were not drilled to deal with a fire on board.

The stern trawler on fire
