# SAFETY DIGEST

**Lessons from Marine  
Accident Reports  
2/2013**

**SAFETY DIGEST**  
**Lessons from Marine Accidents**  
**No 2/2013**

October 2013

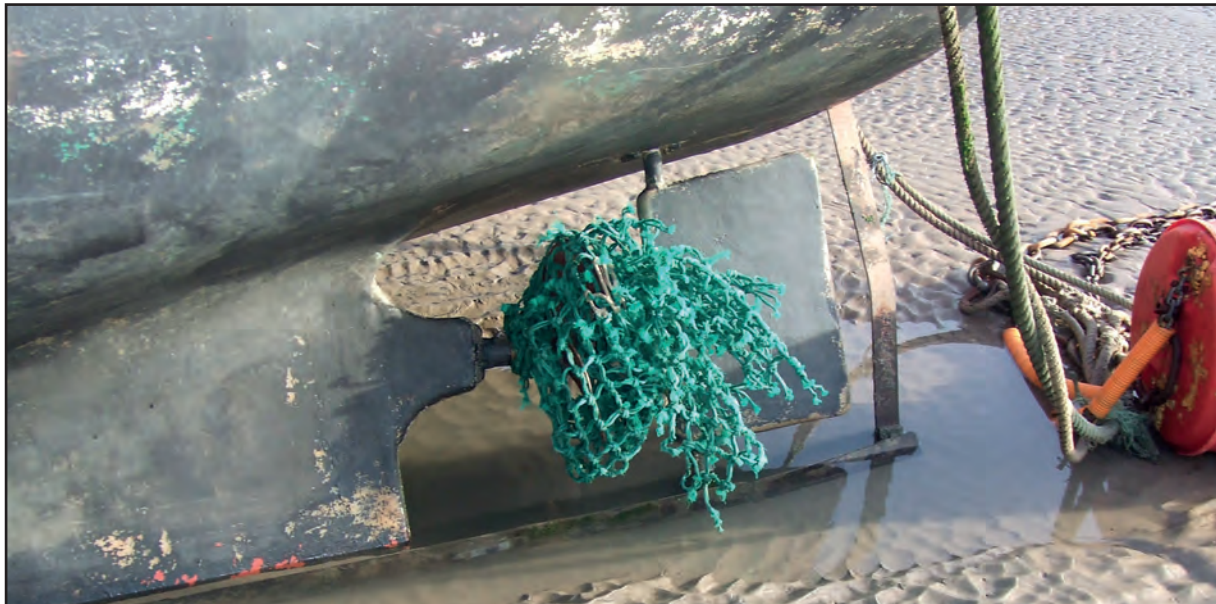
Once back in the safety of the harbour, the skipper was able to beach his boat and make an inspection at low tide. Drying out revealed that the propeller was indeed fouled by a section of double, 8mm thick netting that had either been discarded carelessly or, more probably, torn from a trawl belly and carried by the tide towards the shore.

Net fouling propeller

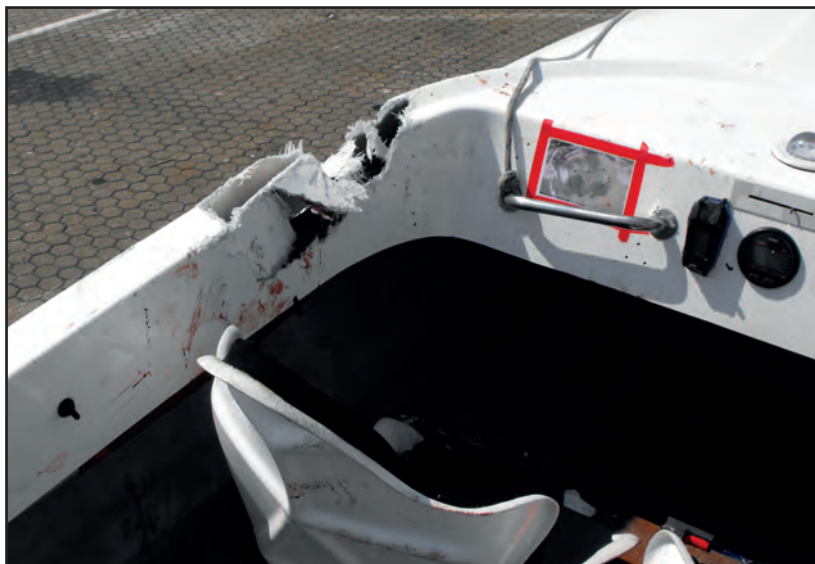
Impact damage to port side cockpit coaming

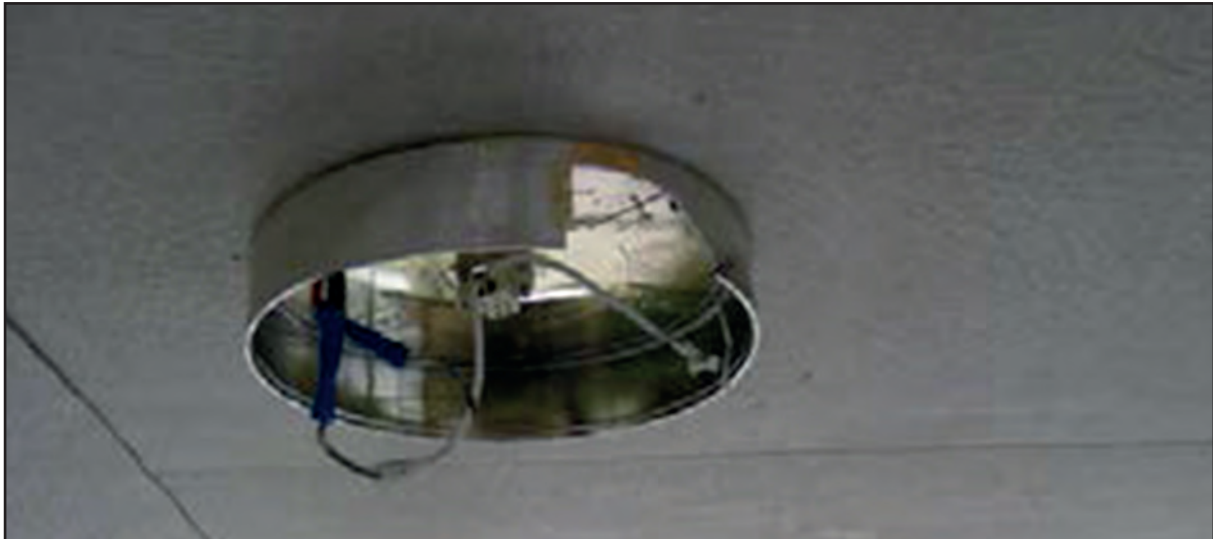
The man left the winch handle slack and was facing aft when the canopy suddenly and rapidly slid open. As it did so, a light fitting on the underside of the canopy struck him on the back of his head. He was then lifted off his feet as his head and shoulders became trapped between the canopy roof and the aft bulkhead of the cockpit.

Figure 3: The light fitting

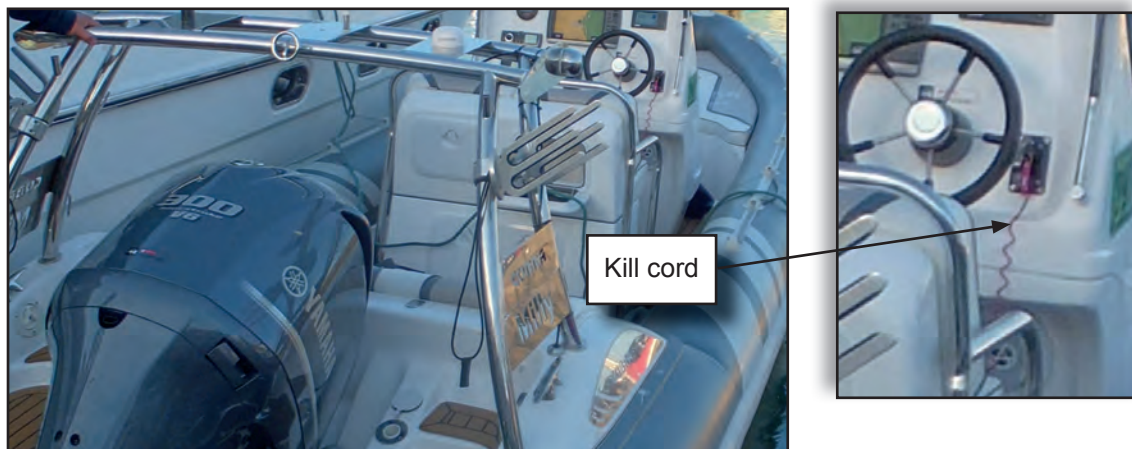
The RHIB was fitted with a kill cord (**Figure 1**), but this was not attached to the driver at the time of the accident. Consequently, when the driver was ejected from the boat, the kill cord did not operate to stop the engine and the RHIB continued to circle out of control, and at speed. As the RHIB circled, it ran over the family in the water a number of times, leading to the deaths and injuries. A few minutes later a local boatman was able to board the RHIB and bring it under control before further people were hurt.

Figure 1: Boat with kill cord in place
