SAFETY DIGEST

**Lessons from Marine
Accident Reports
2/2014**

SAFETY DIGEST
Lessons from Marine Accidents
No 2/2014

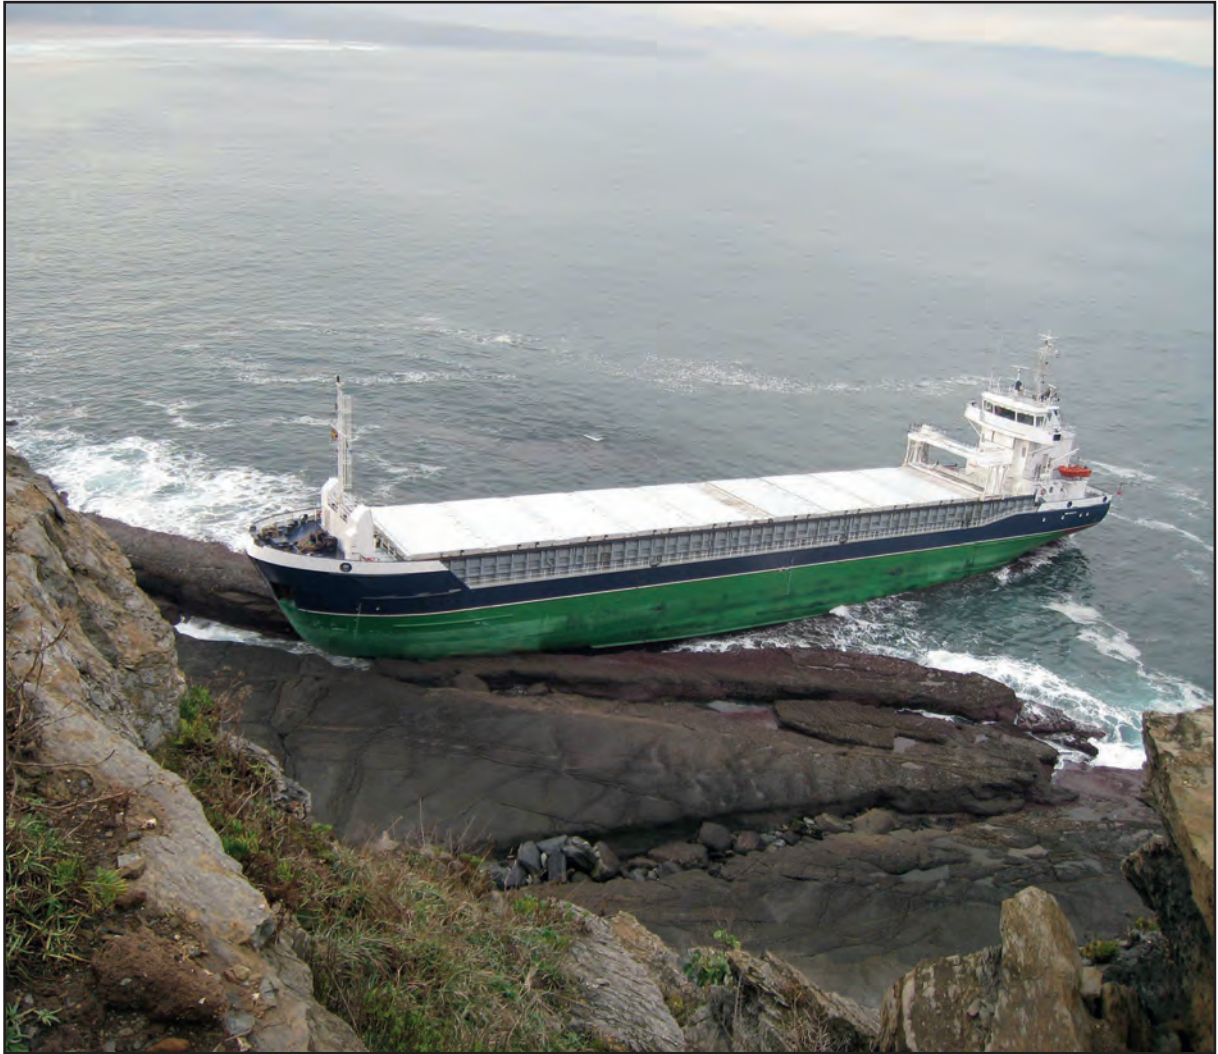
Fortunately it was quickly established that the hull was not holed and, although sitting on rocks, because of the fine weather the vessel was not pounding. The vessel was refloated 9 hours later when it was discovered that substantial plate and frame buckling had occurred, requiring almost 50 tonnes of steelwork to be replaced.

Vessel aground

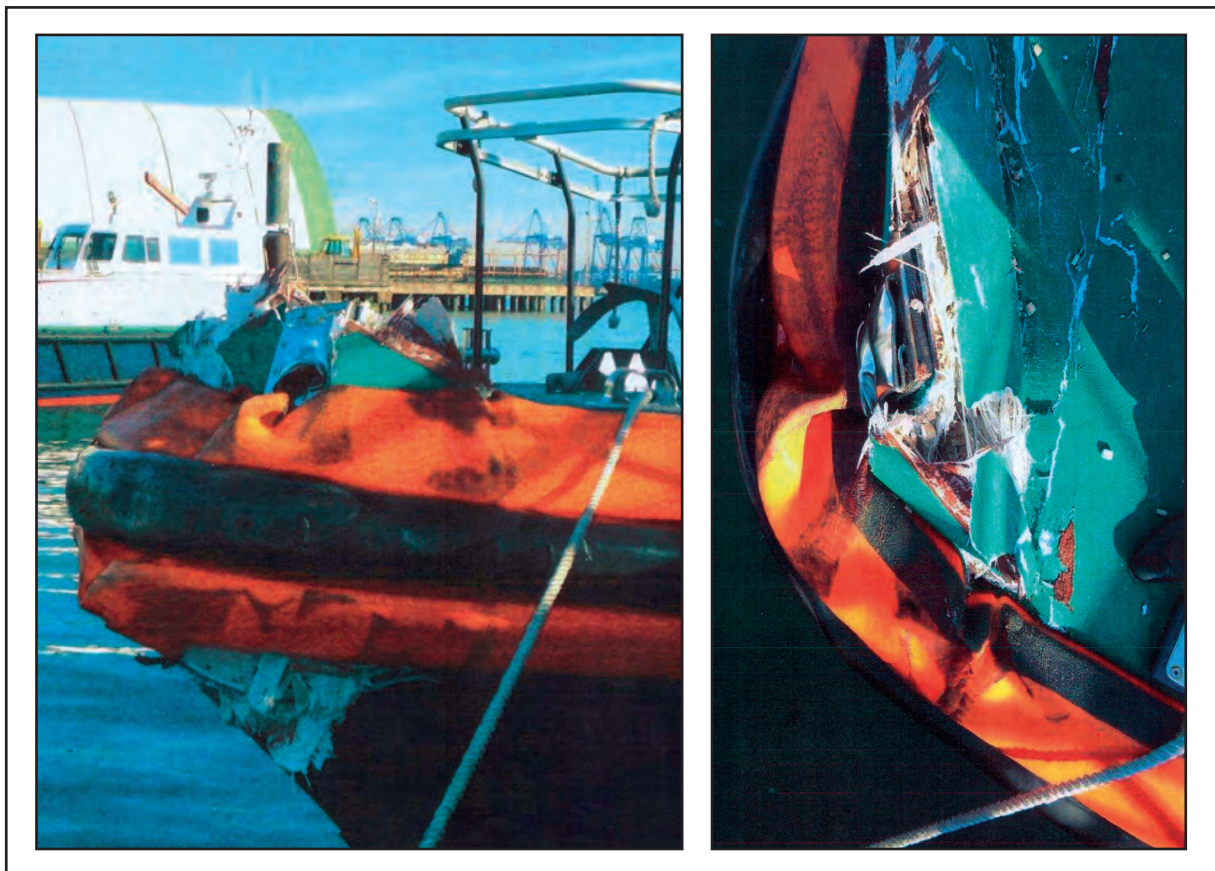
It was a calm night on the east coast of England and the visibility was good when a pilot boat collided at speed with a container vessel. The pilot boat suffered significant damage to its bow area (Figure 1) but was able to return to harbour under its own power. One of the crew on board was injured and required evacuation by lifeboat.

Figure 1: Damage sustained to the pilot boat

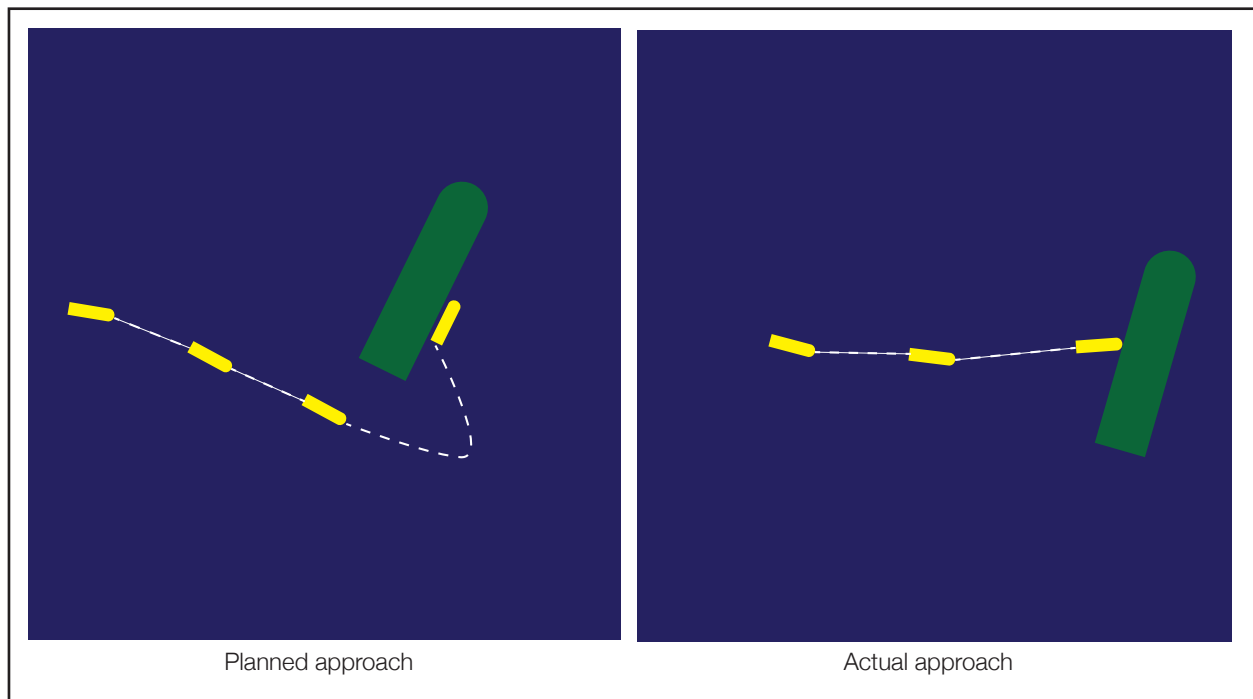
ship's port side, then pass around its stern before collecting the pilot from the ship's boarding ladder on its starboard side (Figure 2). However, as the pilot boat approached the container ship, instead of turning to starboard to pass under the container ship's stern, it made a slow turn to port and collided with the container ship's side. At the point of collision, the pilot boat was still at full speed.

Figure 2: Pilot boat approach to departing container ship

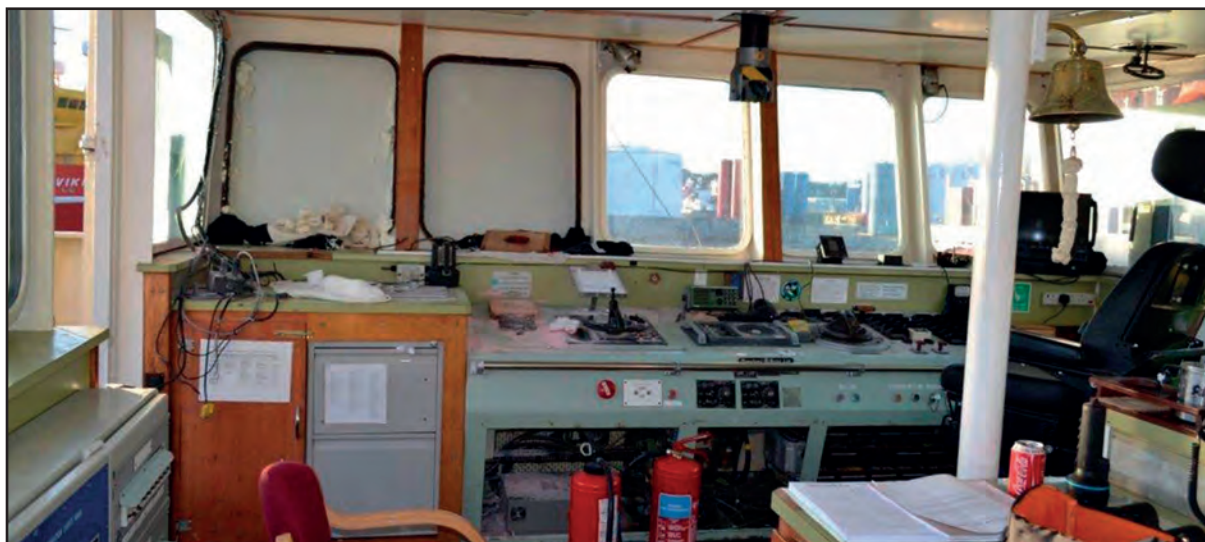
Some 30 minutes into the watch, the vessel encountered three distinctly larger waves than normal. The second wave caused the second officer to feel that the vessel had ‘fallen into a hole’, and the third struck the vessel hard on its port shoulder, causing two of the bridge windows to fail.

Now open to the elements, the bridge quickly flooded, resulting in water damage to several of its electrical systems, including the engine and steering controls.

The master quickly returned to the bridge, assessed the situation and gave instructions for blanks to be fitted to the open window frames. The bridge was then bailed out, and steering and engine control was regained locally. The vessel was then navigated back to port using its magnetic compass.

Bridge after window blanks fitted

2. This vessel had been provided with storm shutters to be used in conditions such as those experienced. Don't allow yourself to be lulled into a false sense of security because everything has been okay up to that point. It's better to employ a barrier unnecessarily than to regret not having used it after an accident has happened. However, make sure that you are able to maintain an effective lookout once barriers have been fitted.
3. In this case, the company investigation identified weaknesses in the window glass securing arrangements, including corroded screws, and silicone sealant having been used instead of a rubber gasket. Take the time to carefully inspect your bridge window securing arrangements to ensure that they are appropriate and in good condition.

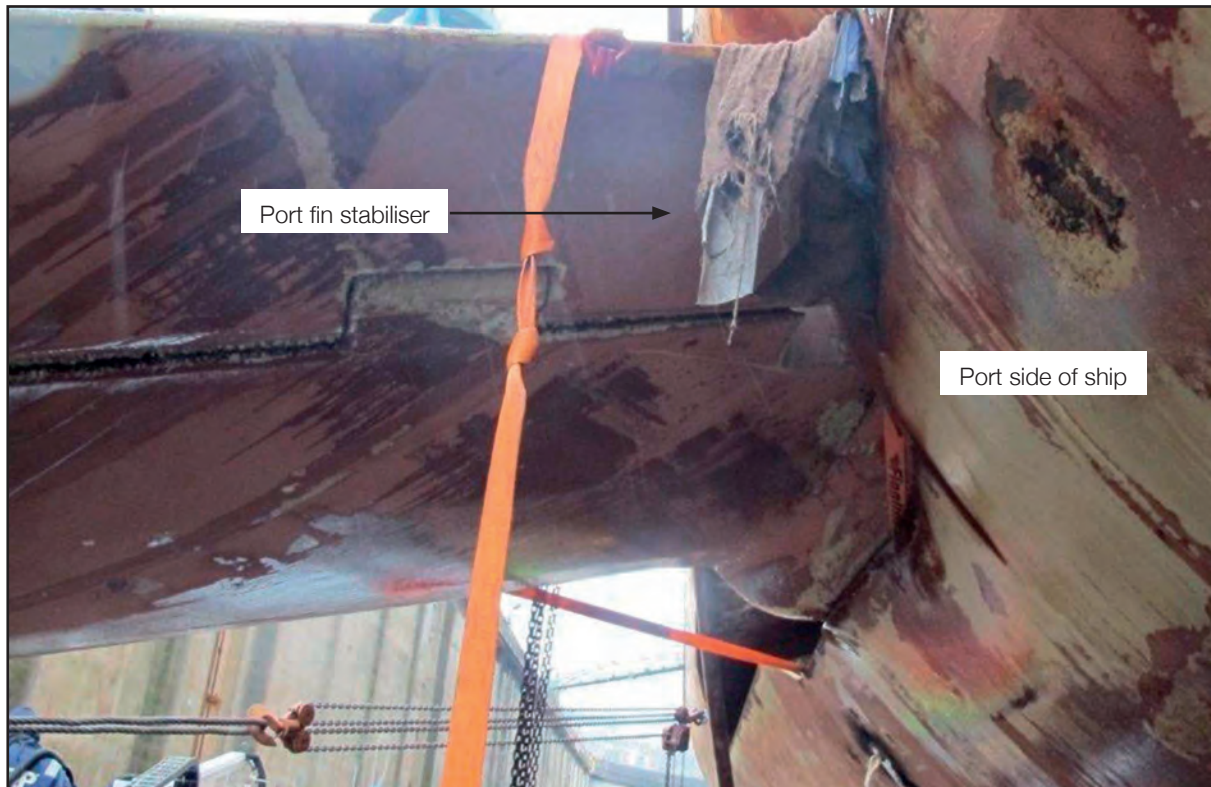
The engineering department investigated and found the port stabiliser head severely damaged. The pump room was also flooding where the fin stabiliser had punctured the hull. Watertight doors were closed and the ship's three separate bilge pumps were started to discharge the flood water overboard. The ship's loading computer was then used to check that the vessel was safe with the pump room flooded.

Port fin stabiliser view from below, while ship was in dry dock

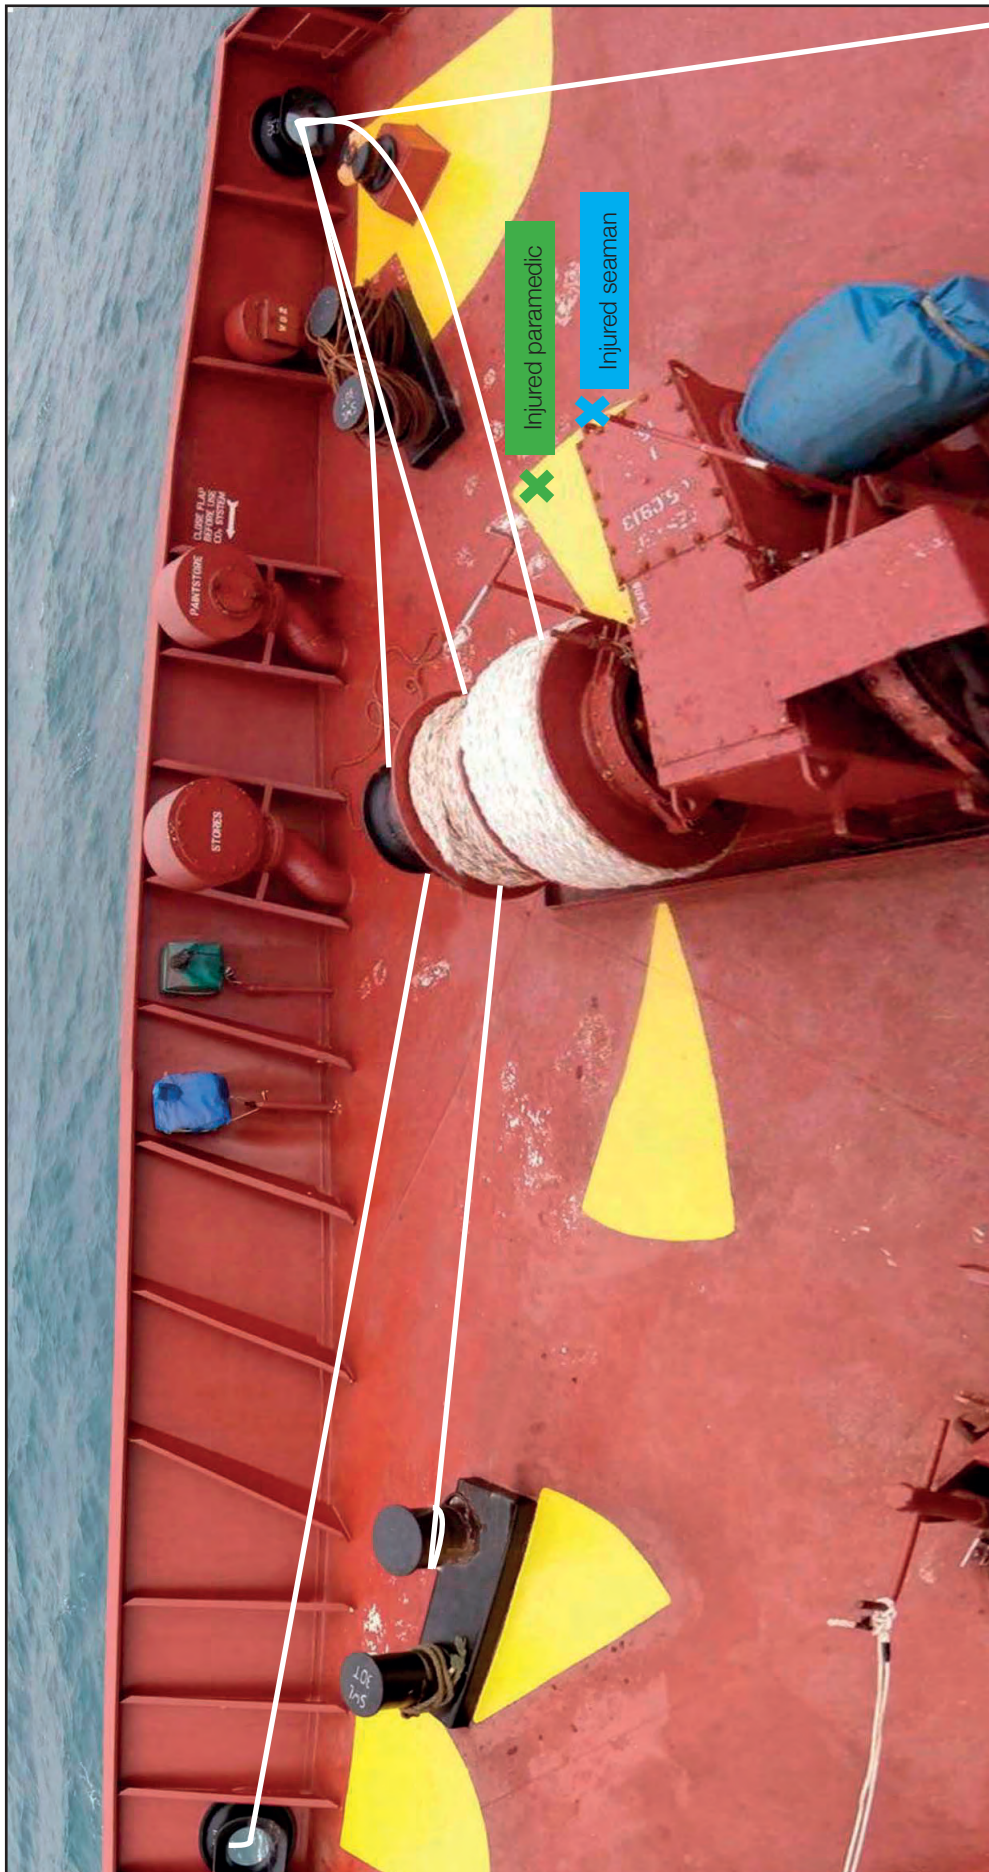
2. During poor weather in port, mooring lines are subjected to huge loading. The ropes that parted in this case broke as the rope passed through the fairlead, an area where the rope is subjected to immense pressures and chaffing. While in port, mooring ropes must be regularly inspected and the use of chaffing gear is recommended.

Focsle mooring arrangement

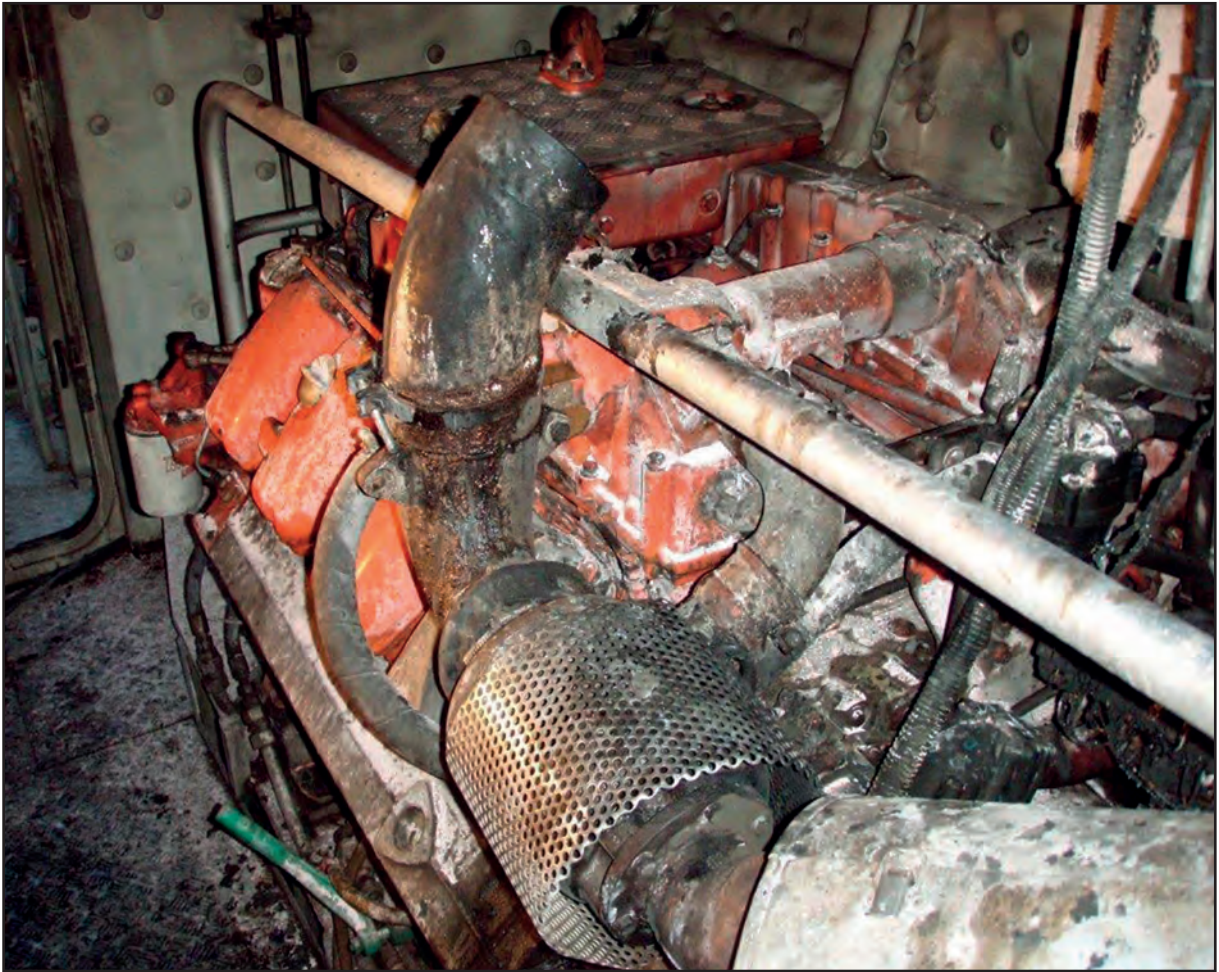
Subsequent investigation revealed that the fire was initiated by an oil leak from the inboard turbo-charger lubricating oil pipe on the starboard engine, spraying an oil mist onto the hot turbo-charger casing. The resultant fire caused extensive damage to both engines, their controls and engine room fittings (Figures 1 and 2).

Figure 1: Starboard inboard turbo-charger

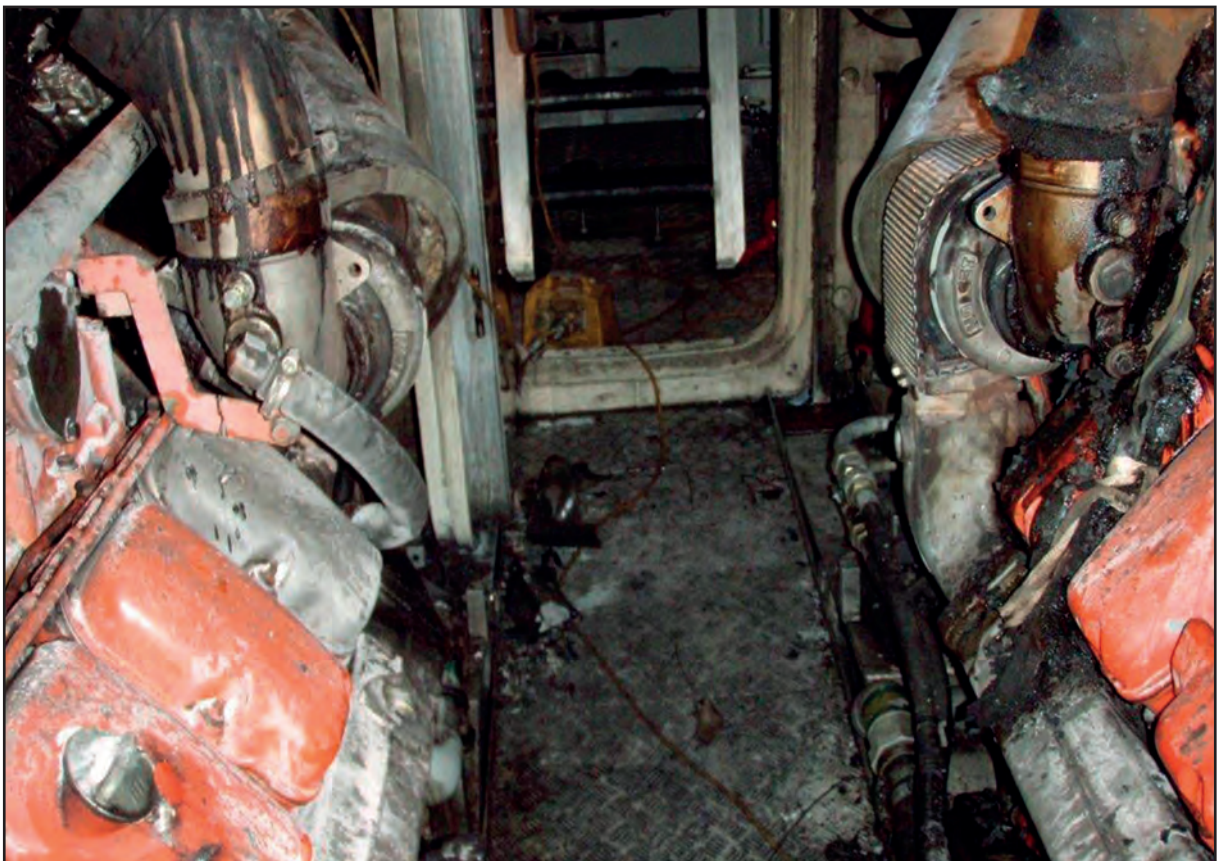
Figure 2: Engine room damage

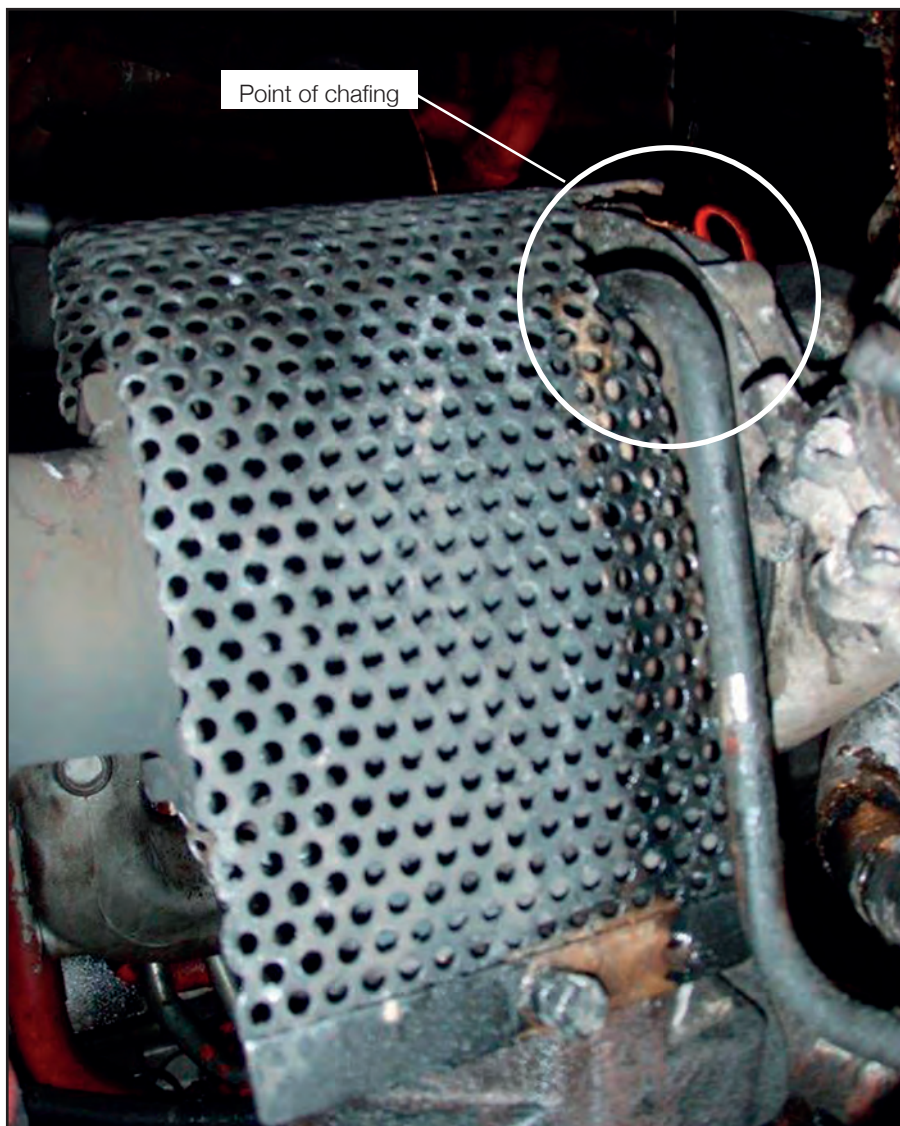
It was found that the leak was the result of an oil pipe chafing on a heat shield, which led to a pin-hole in the pipe. The heat shield was a post-installation modification - originally the turbo-chargers had been fully clad with heat-resistant insulation. However, a spate of turbo-charger bearing failures had been linked to overheating. Removal of the cladding solved the bearing overheating issues. The modified heat shields were designed to protect personnel from contact with the hot surfaces which had been exposed by removal of the cladding. The new shields took the form of a shaped guard manufactured from stainless steel, and were only fitted to the inboard turbo-chargers, which were located adjacent to a centreline walkway (Figures 3 and 4).

Figure 3: Point of chafing

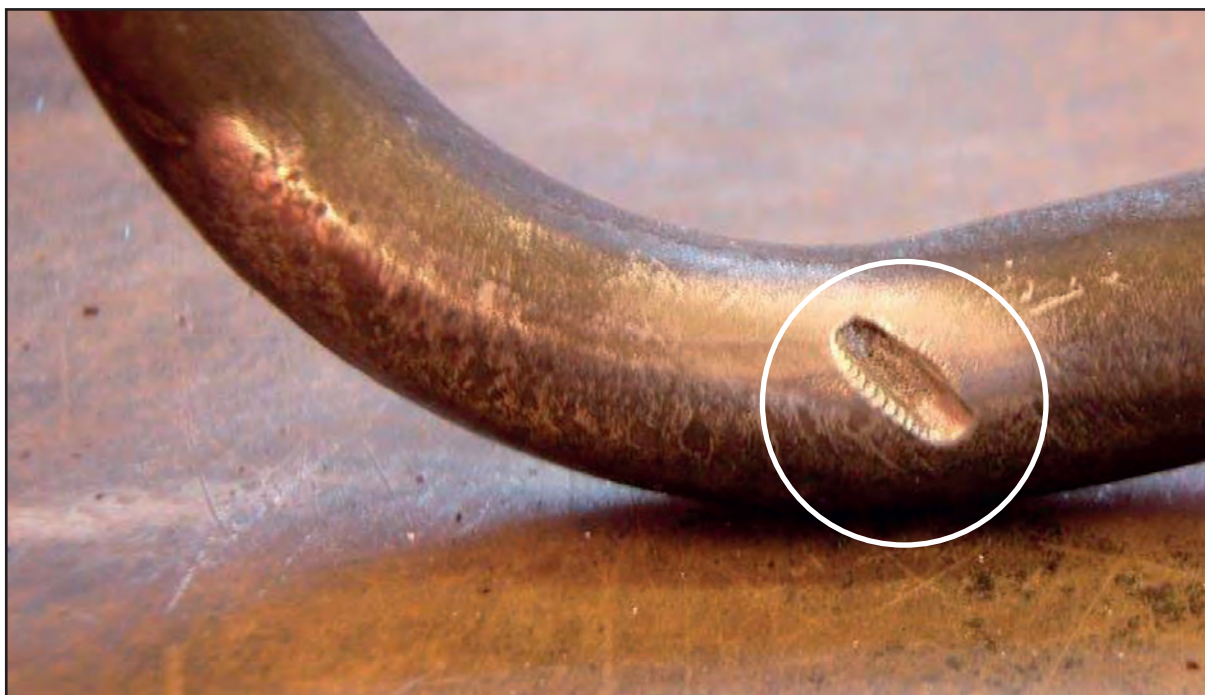
Figure 4: Lubricating oil pipe point of failure

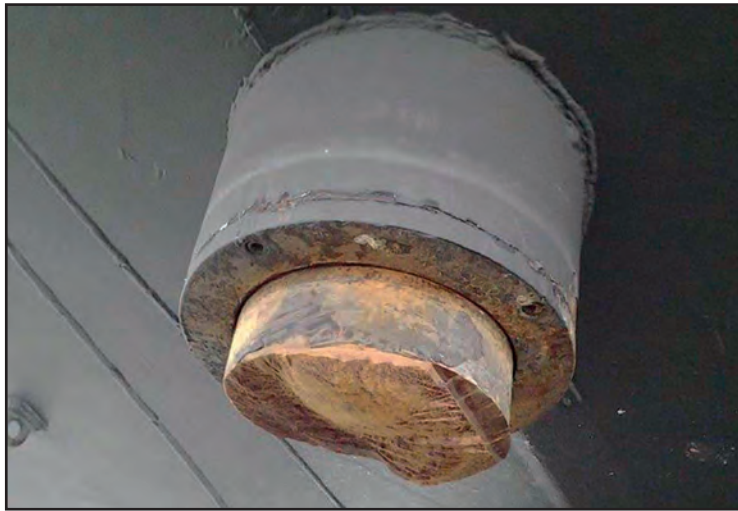
To try and move the vessel clear of the bank, the master manoeuvred its engines between 'full ahead' and 'full astern'. The vessel eventually re-floated after about 1 hour on the rising tide. However, it would not respond to the helm so the master ordered the anchor to be let go. Soon afterwards, the master reported to the coastguard that the cargo ship had anchored due to steering difficulties; he did not mention the grounding. Subsequent inspection identified that the vessel had lost its rudder (Figure 3). The vessel had to be towed to port for repair.

Figure 3: Broken rudderstock

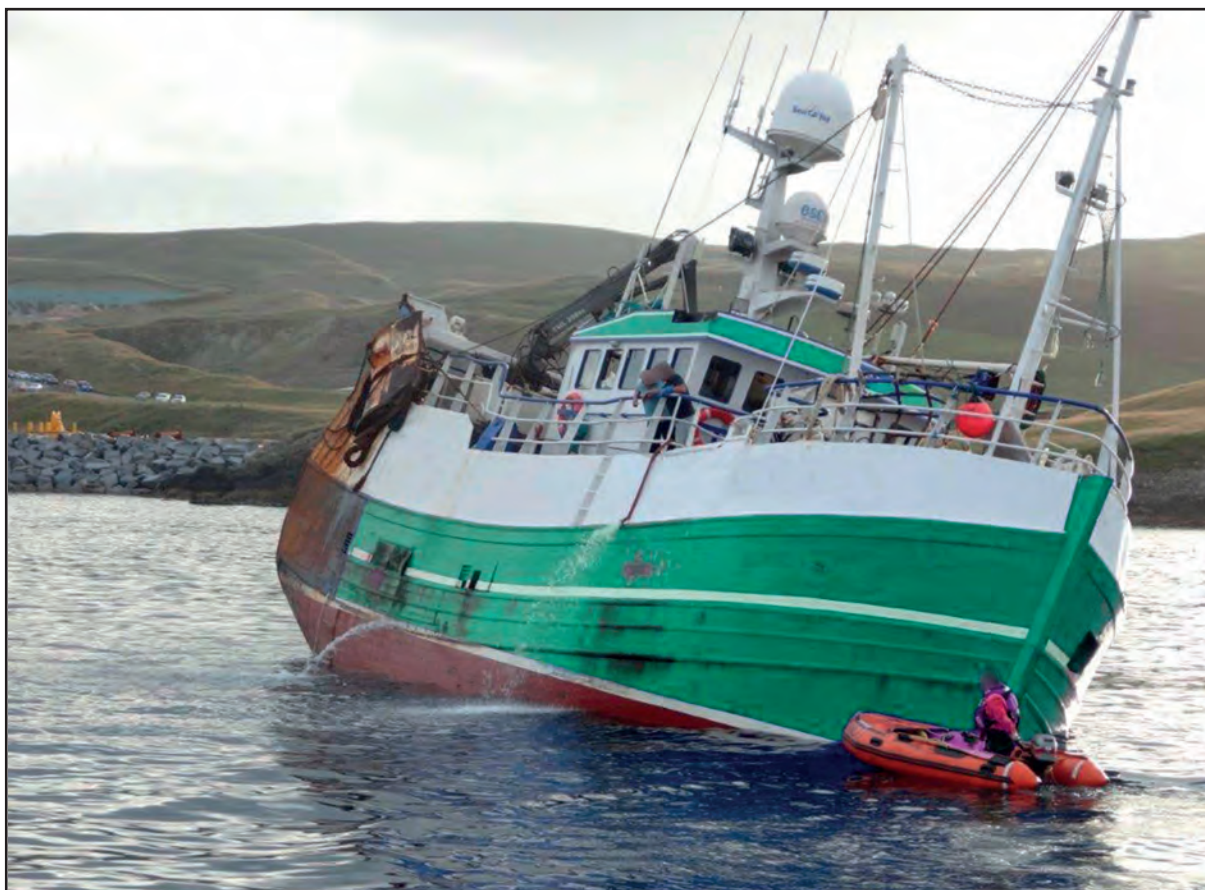
Figure 2: Vessel aground

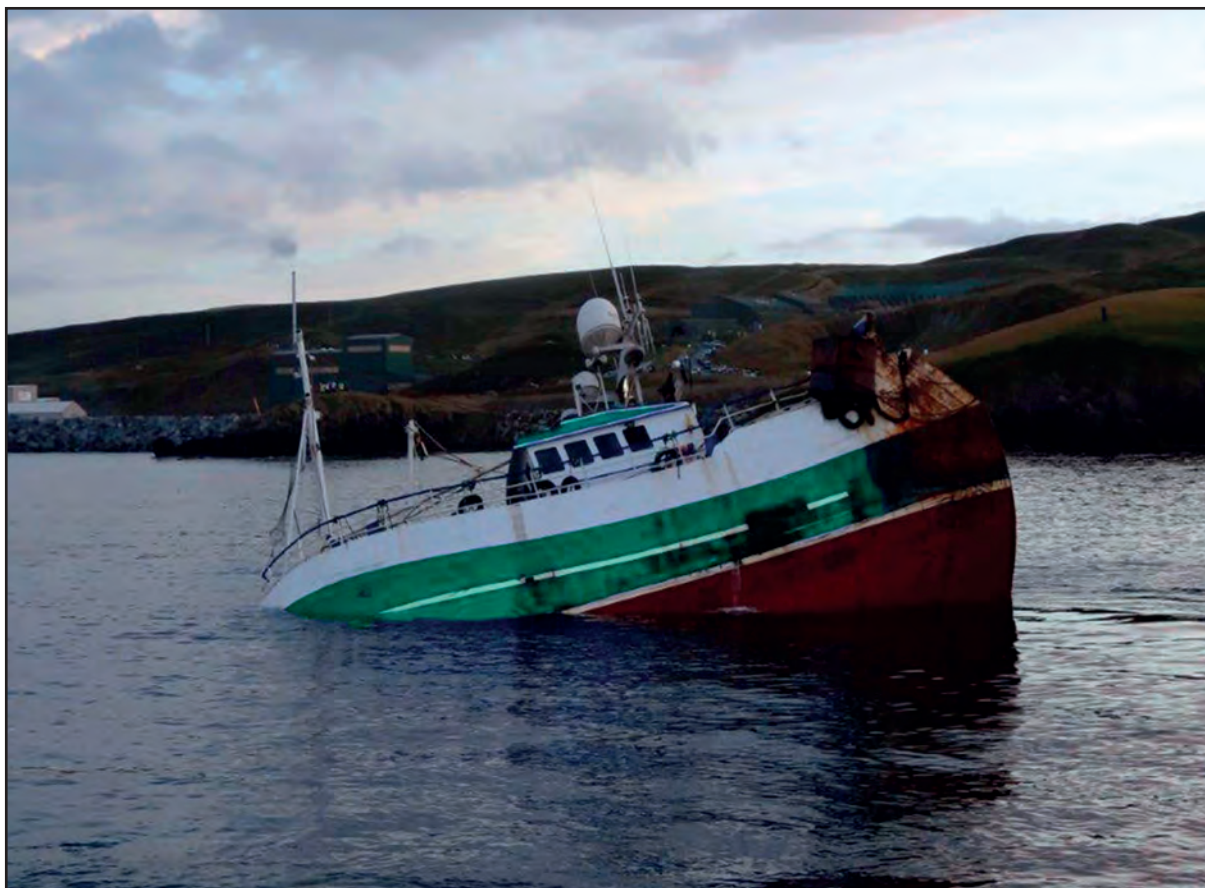
The tug and ALB arrived a short time later. Additional salvage pumps were supplied, but despite a total pumping capacity of about 200 tonnes/hour the water ingress could not be stemmed. At 2040, the vessel floated free of the rocks on the rising tide. It was decided that the ALB would tow the vessel away from the main channel, assisted by the port's tug. With the fishing vessel crew now on board the ALB, the vessel was taken under tow. However, it adopted an angle of loll and the towline was cut. The tug gently pushed the vessel towards the shore but it foundered in 15 metres of water (Figure 3) a short time later.

Figure 3: Vessel foundering in 15 metres of water

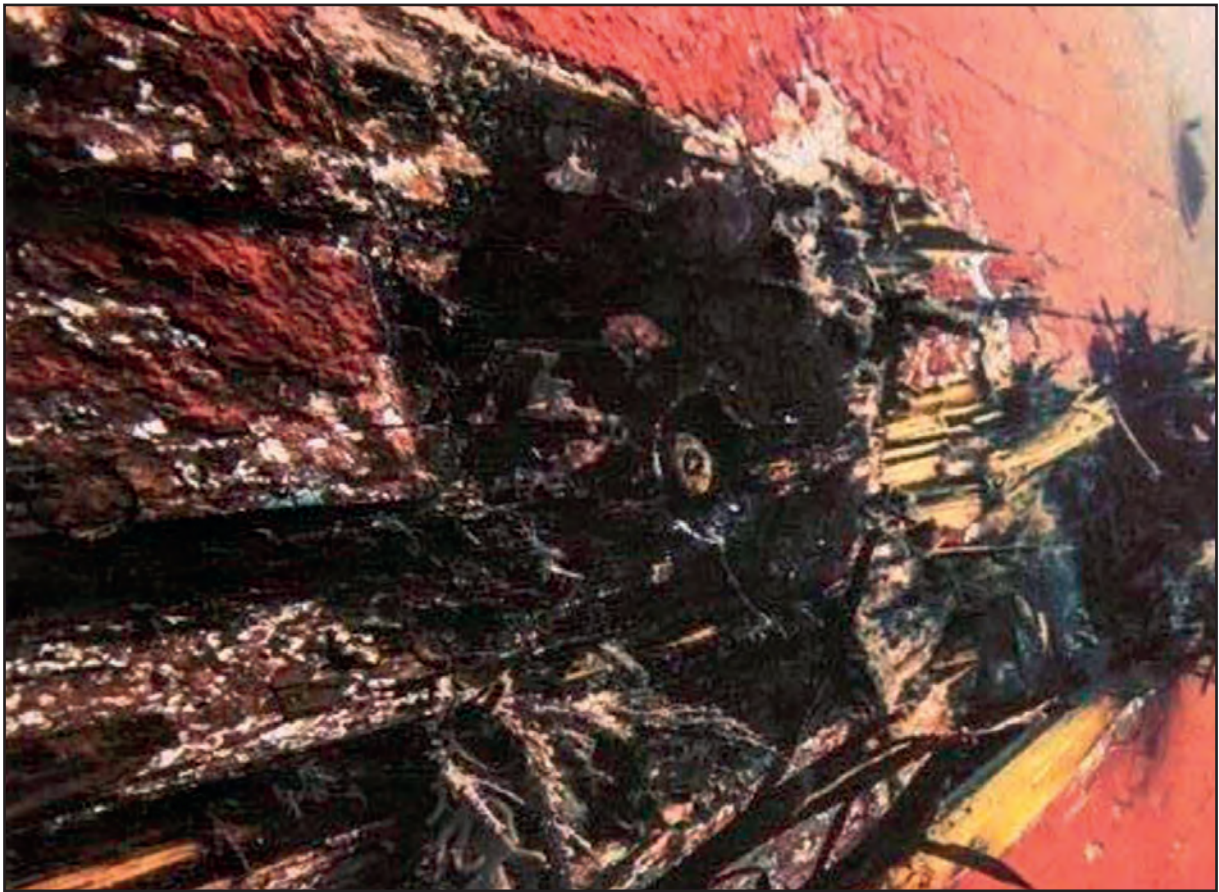
Fortunately there were no injuries, and pollution was negligible. The vessel was salvaged and there was extensive damage in the vicinity of the fish hold (Figure 4). The vessel was later declared a constructive total loss.

Figure 4: Underwater damage in way of the fish hold

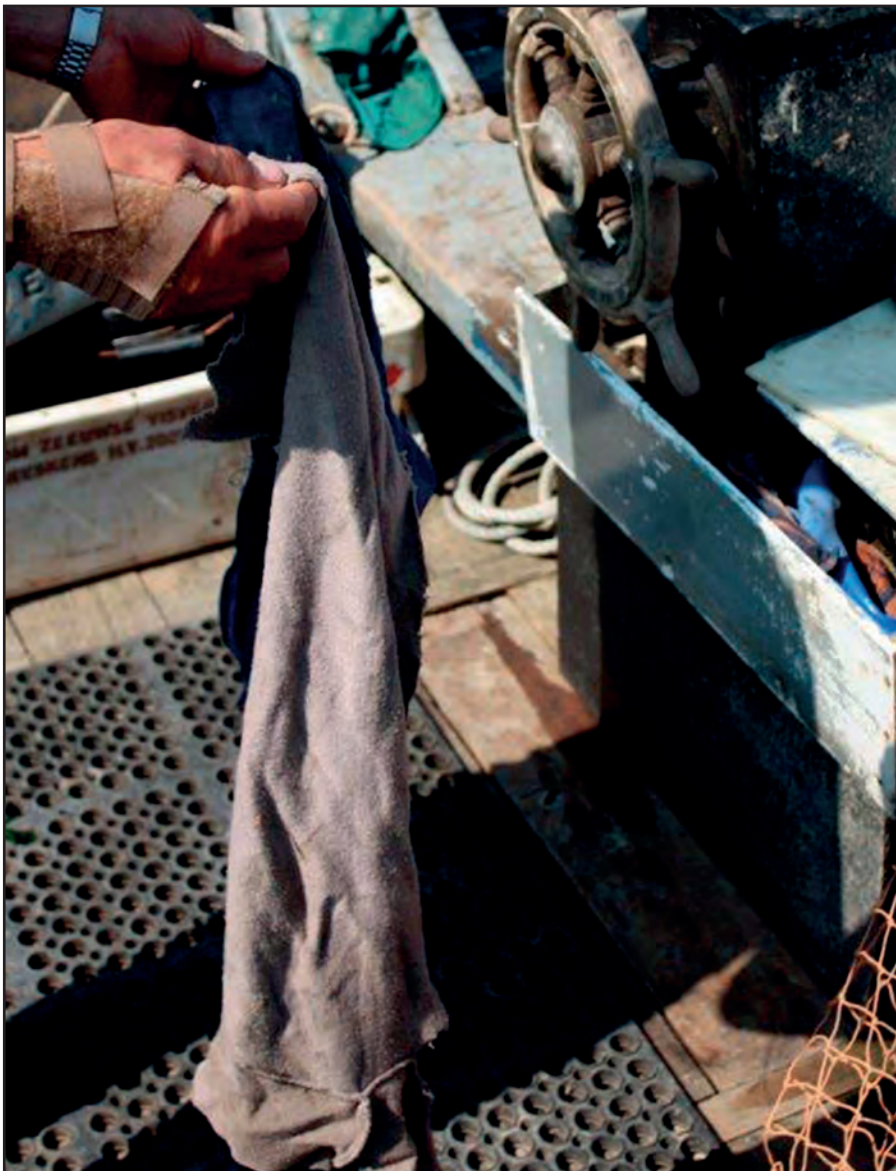
Figure 2: Ragged smock sleeve

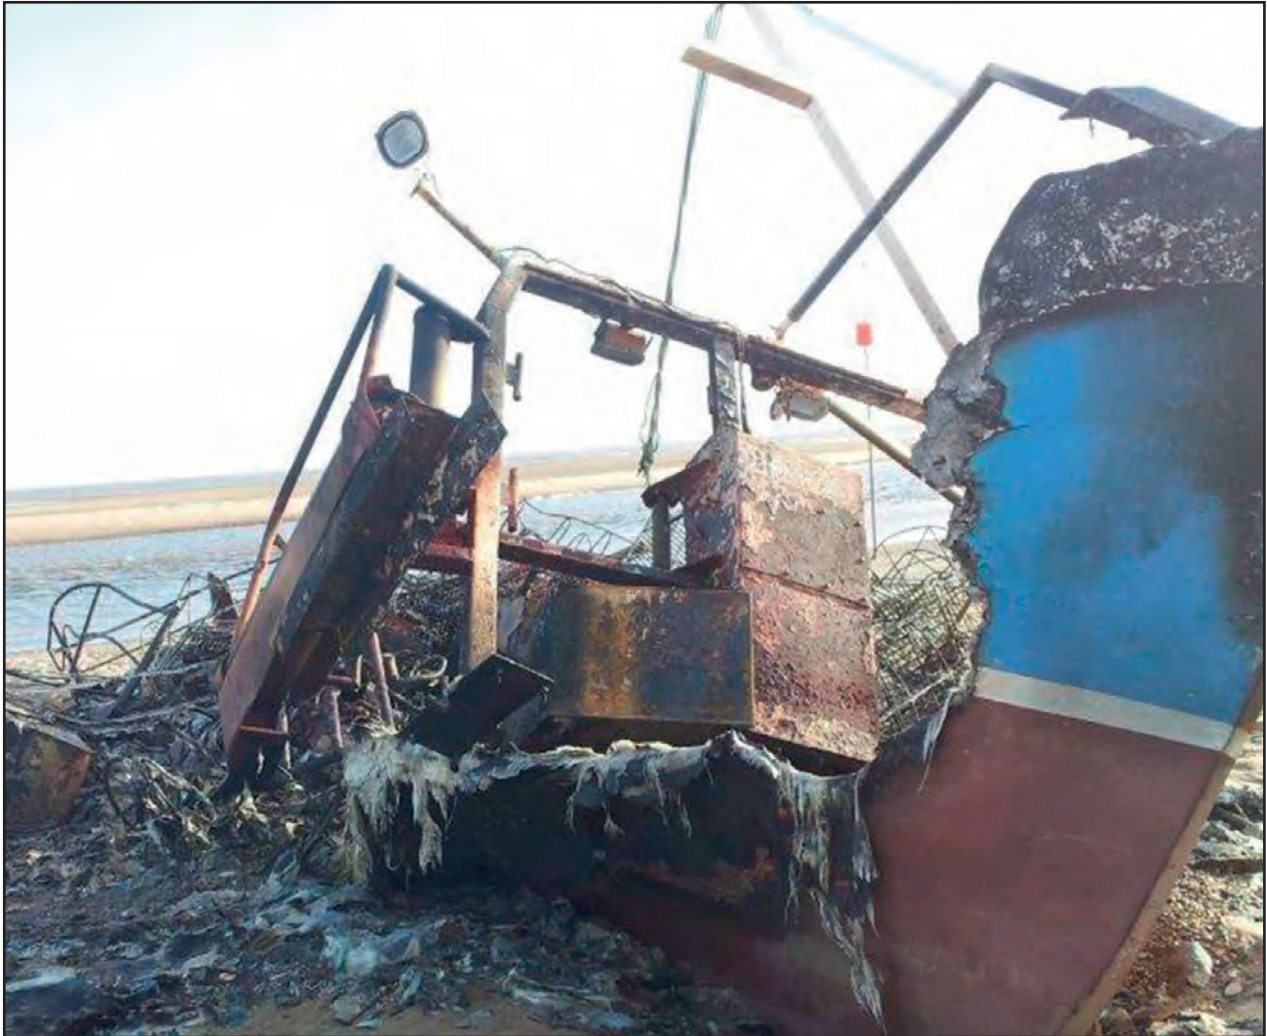
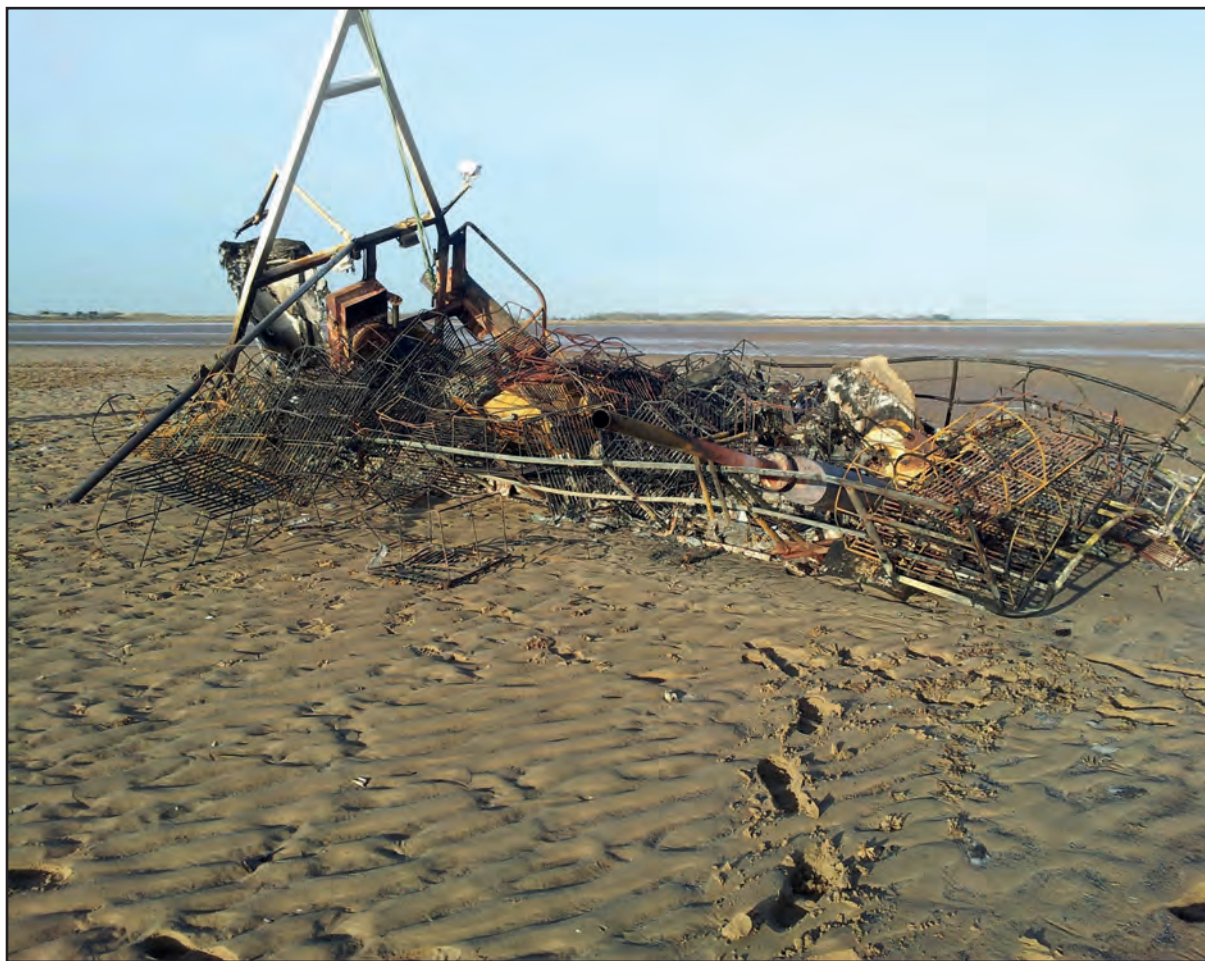
Figure 1: Burnt out wreck of the fishing vessel (looking aft)

Later found among the charred ruins of the vessel was a slack fuel inlet pipe at the engine cylinder immediately next to the dry exhaust pipe.

Figure 2: Burnt out wreck of the fishing vessel (view from port side)

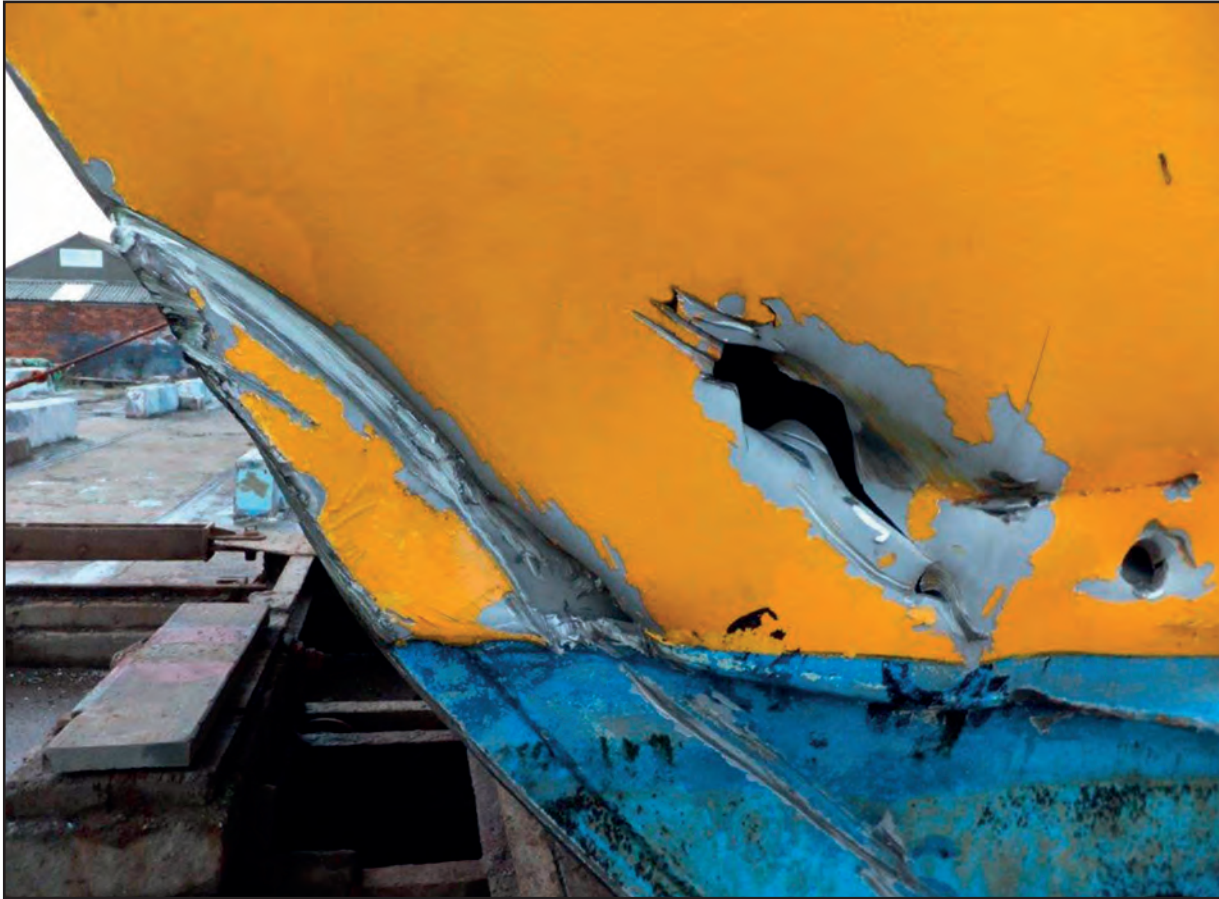
Fortunately there were no injuries, but the vessel suffered extensive penetrations to the port hull shell plating (Figure 2). The port skeg was removed, the port propeller shaft was bent and the port propeller blades were badly damaged (Figure 3). The target also suffered extensive damage.

Figure 2: Penetration to the port hull shell plating

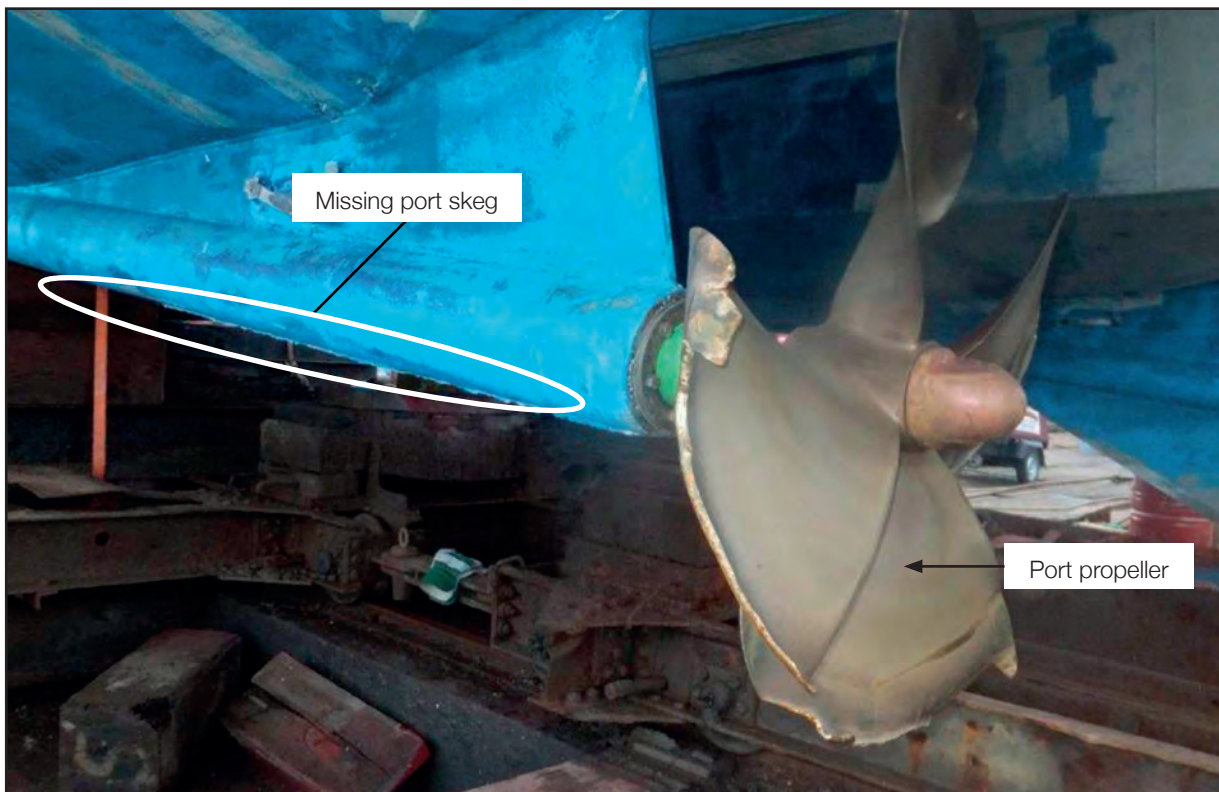
Figure 3: Missing port skag and port propeller blade damage
