SAFETY DIGEST

**Lessons from Marine
Accident Reports
2/2014**

SAFETY DIGEST
Lessons from Marine Accidents
No 2/2014

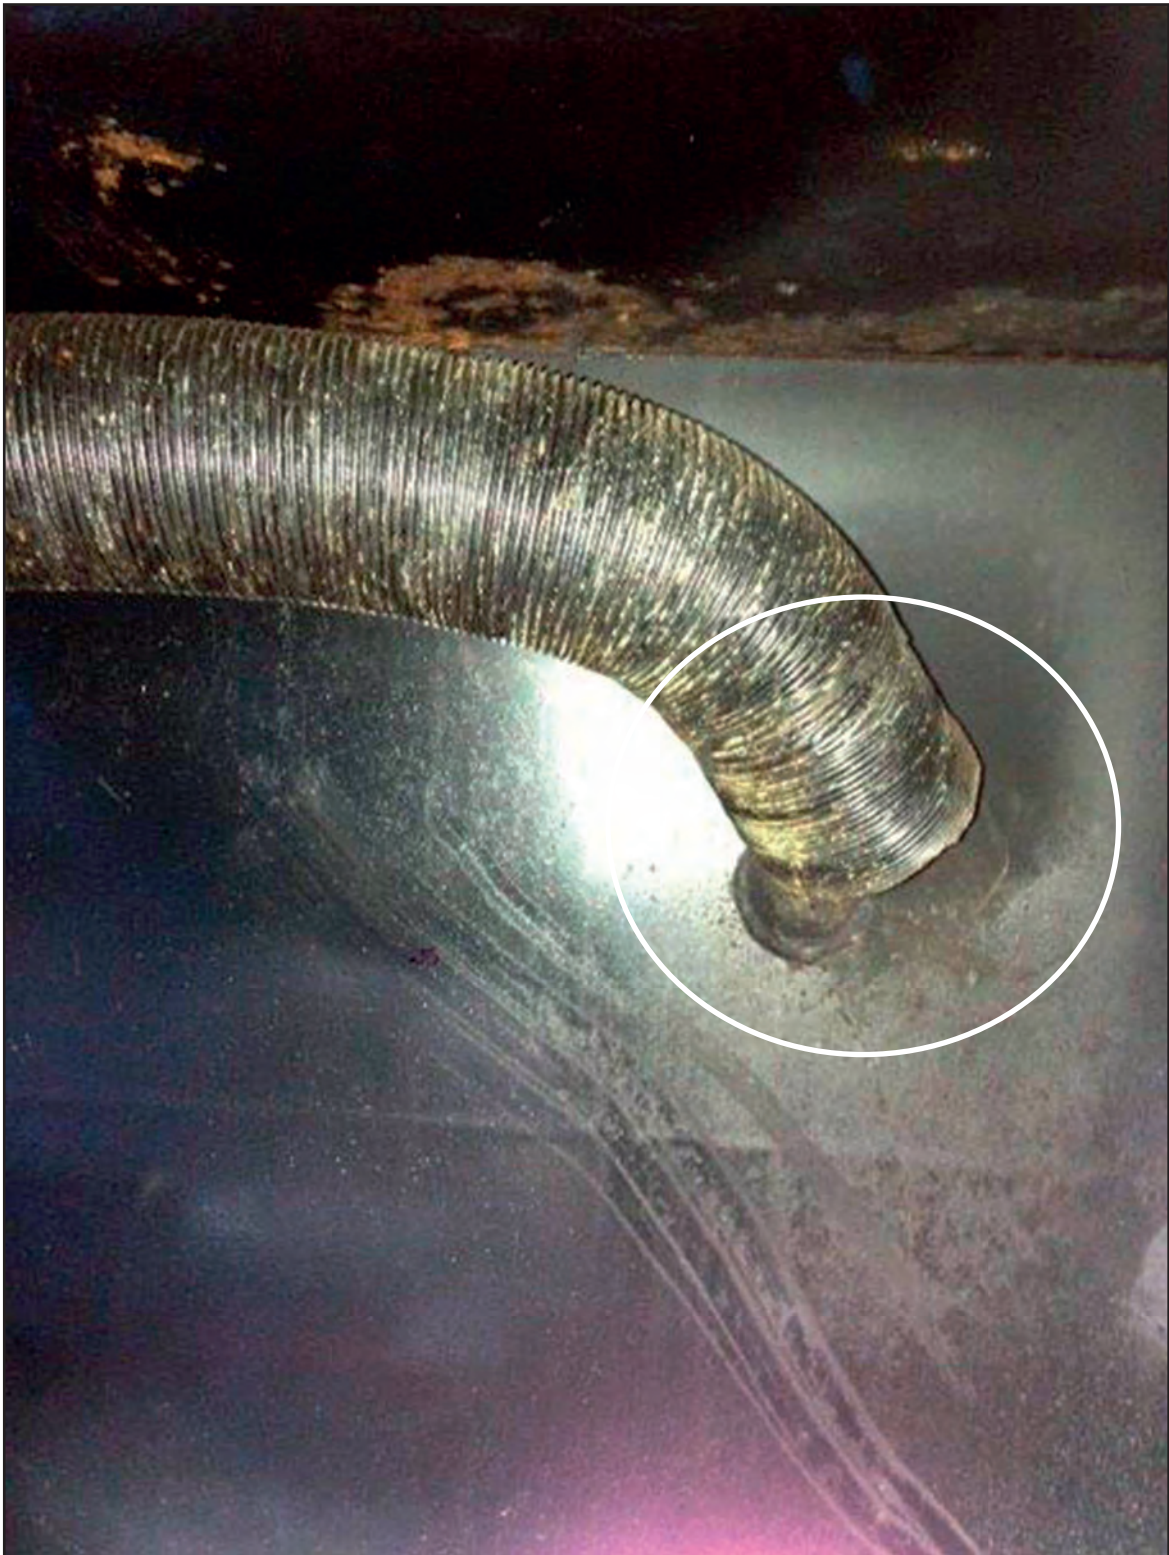
Figure 1: Soot staining around heater's exhaust

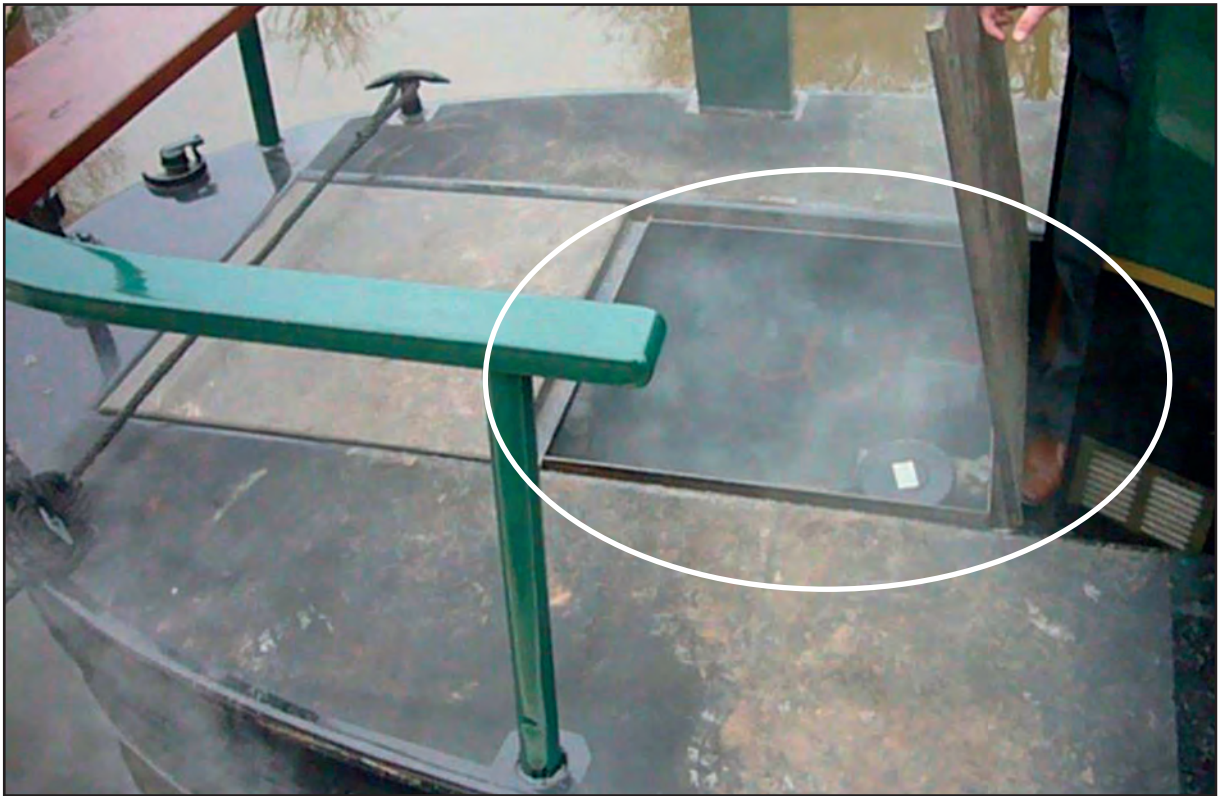
Figure 2: Smoke-logged engine compartment

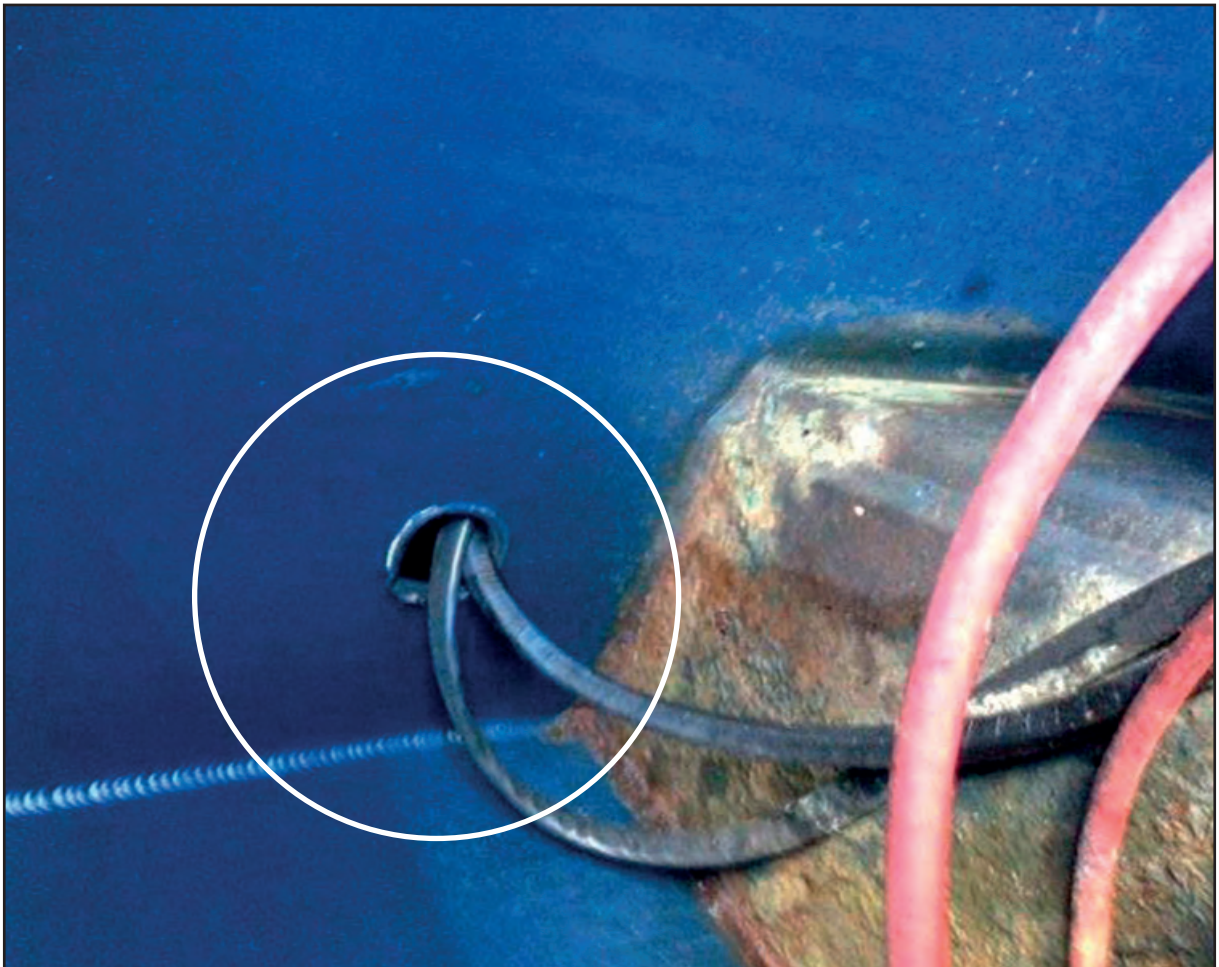
The mechanic waited until the engine compartment had been thoroughly ventilated before investigating the defect. The heater’s exhaust system comprised inner and outer corrugated, stainless steel pipes. The exhaust gases passed through the inner pipe and were discharged overboard through a gas-tight connection to the hull. The outer lagged pipe was designed to protect against the risk of burns. Later examination identified there was soot staining around the outer lagged pipe (Figure 1). When the system was dismantled, the inner pipe was found to have fractured, allowing exhaust gases to enter the engine room. It is likely that the gases then migrated from the engine compartment (Figure 2) into the domestic areas through gaps around the services that passed through the engine room forward bulkhead (Figure 3).

Figure 3: Gaps around services passing through bulkhead
