SAFETY DIGEST

**Lessons from Marine
Accident Reports
1/2015**

SAFETY DIGEST
Lessons from Marine Accidents
No 1/2015

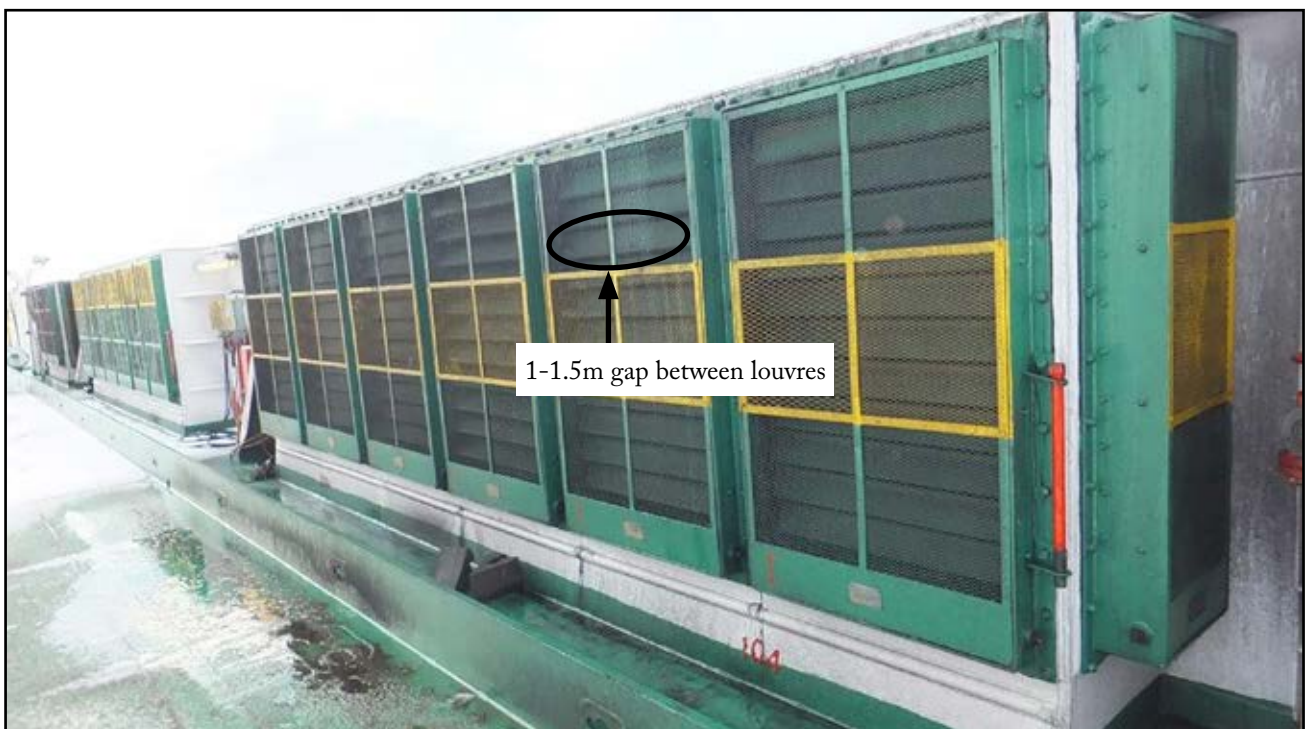
Figure 1: Ventilation jalousie and louvres arrangement

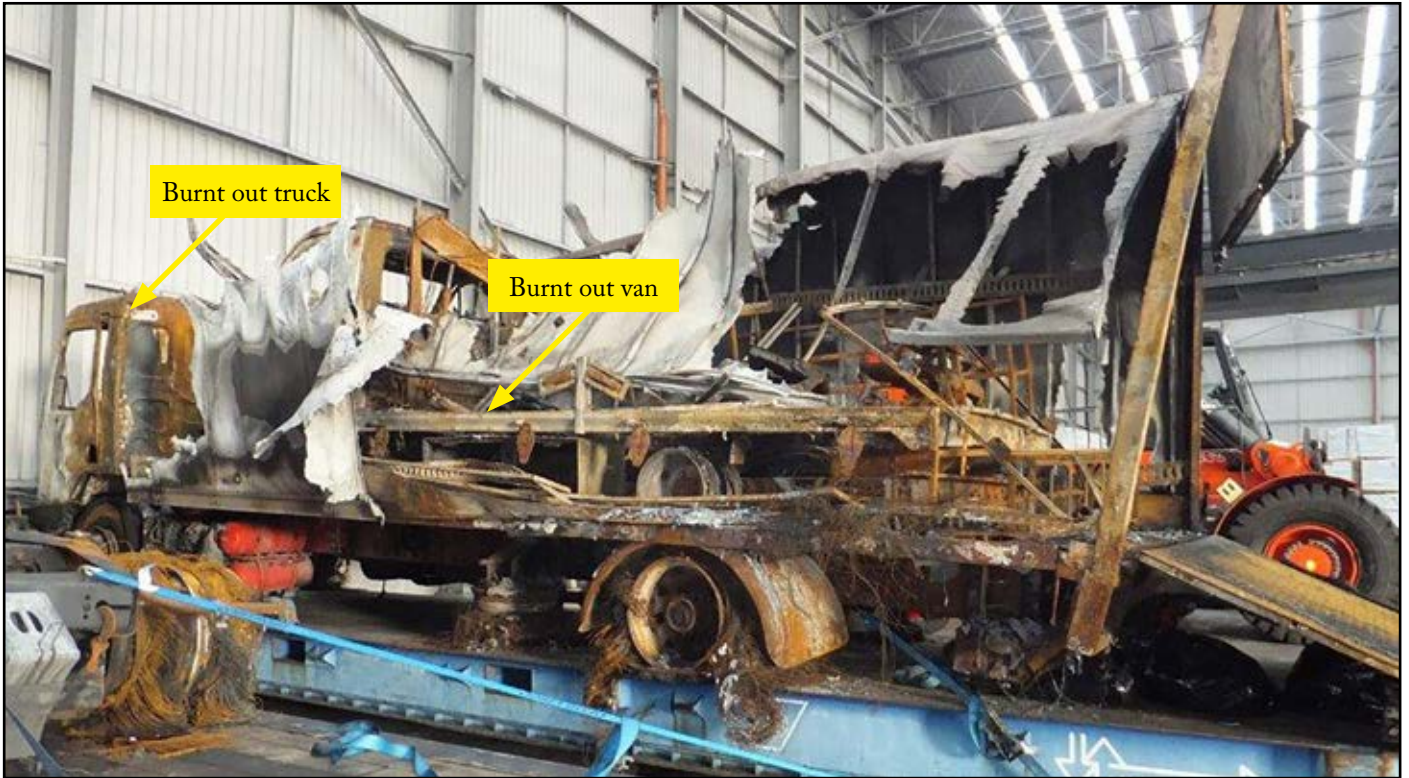
The vessel suffered distorted deck plates and longitudinals, and damage to minor electrical circuits. A truck carrying a van was completely destroyed and a cab unit and six trailers suffered severe damage (Figures 2 and 3). Other vehicles suffered from radiated heat damage.

Figure 2: Burnt out truck and van it was carrying

Systems will inevitably deteriorate, including electrical insulation and components. In this case, it was found that the engine pre-heating control solenoid had seized, preventing the air charge from being heated to ease starting. It was also found that the engine starter motor solenoid had suffered catastrophic internal electrical arcing caused by the moving contact becoming detached from its supporting post. This caused the main battery supply cable to overheat, which was live even though the ignition key was in the 'off' position, and the insulation to burn and ignite other components. The fire travelled into the cab and then to the cargo compartment, igniting the tyres, and then to the adjacent vehicles.

2. Despite the obvious concern of the crew about the carriage of these vehicles, no risk assessments were undertaken. An electrical defect was identified as the most likely ignition source. A control measure of isolating the battery would have significantly reduced the risk, and the fire would not have occurred.

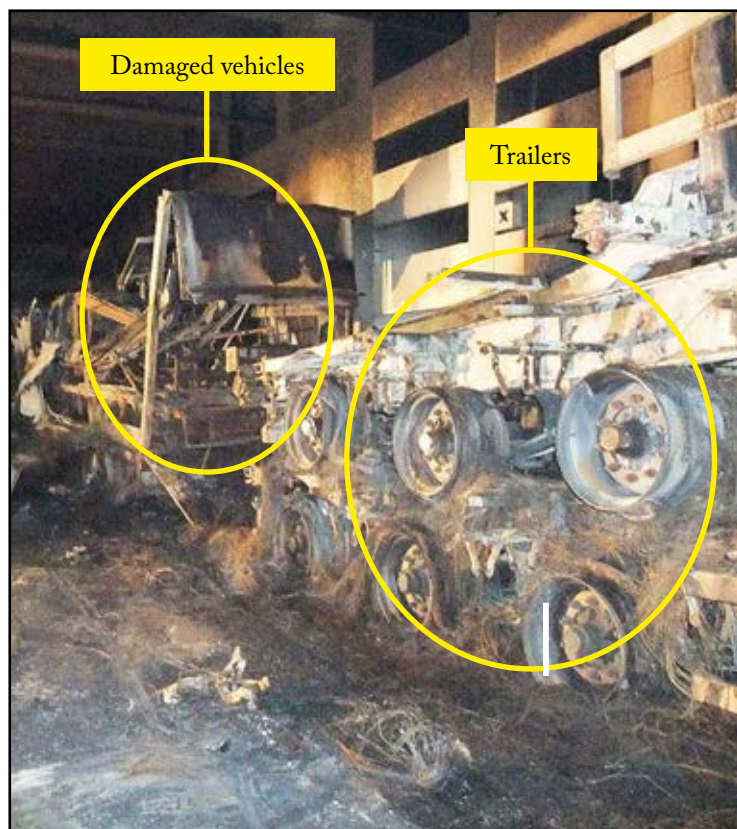
Figure 3: Damaged vehicles

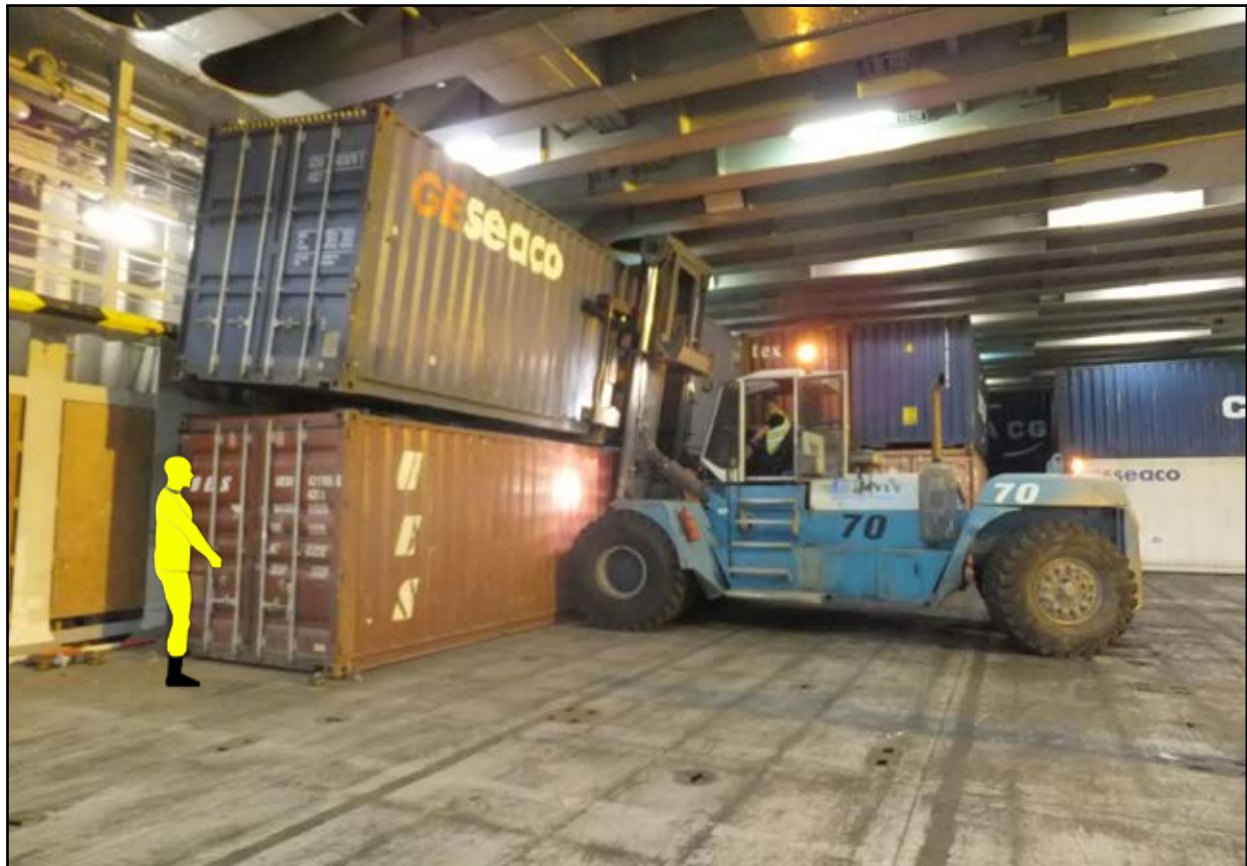
Figure 1: Initial lift of the upper container - crewman standing clear

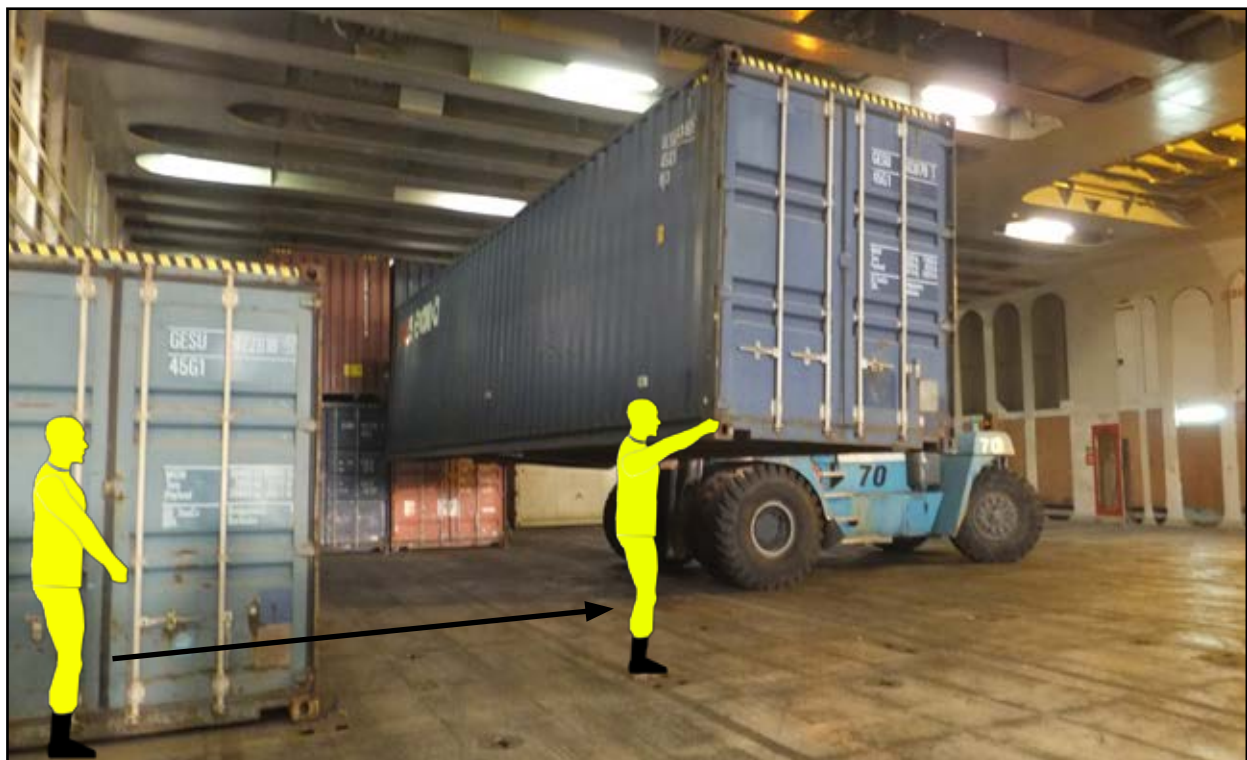
Figure 2: The crewman moves forward to remove an underslung twistlock

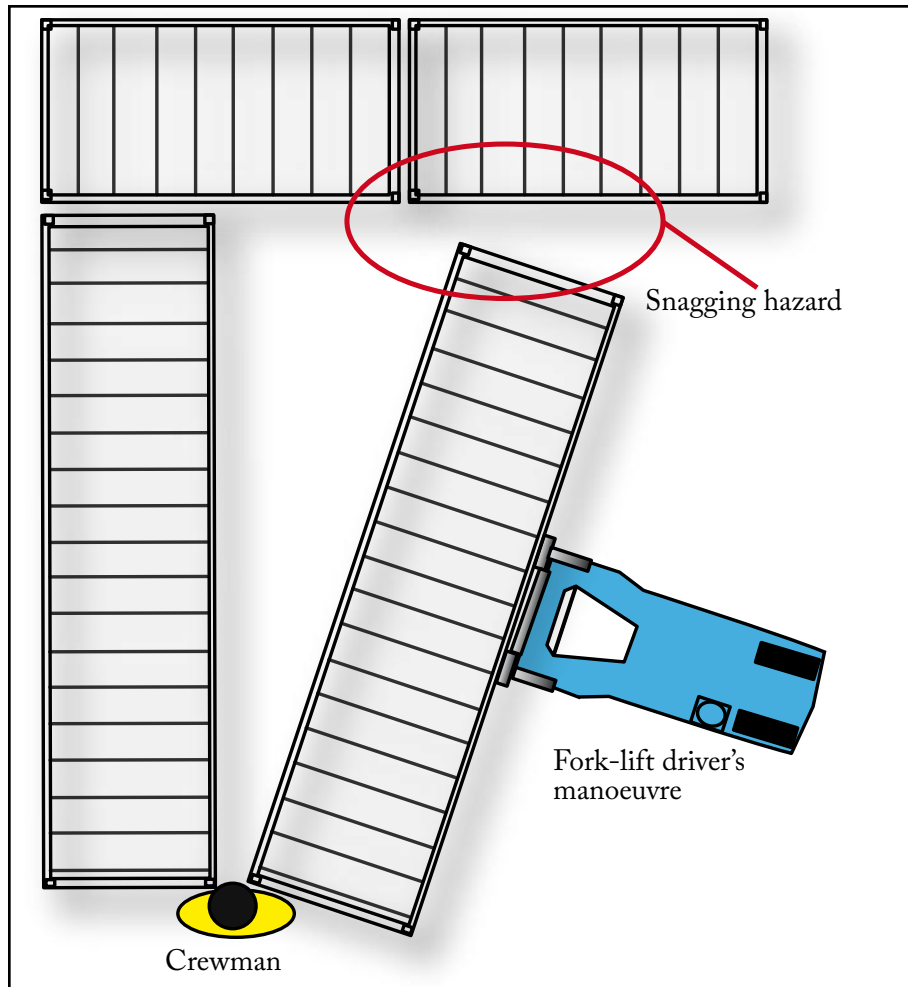
Expecting the vehicle to continue its movement away from him, the crewman then turned round, facing away from the vehicle, and started removing redundant twistlocks from the deck. However, the fork-lift truck driver, who could not see the crewman, started to steer his vehicle to avoid the potential snagging hazard from other stacked containers. This manoeuvre caused the end of the suspended container nearest the crewman to change direction and collide with a static container, fatally crushing him in between (Figure 3).

Figure 3: Fatal manoeuvre

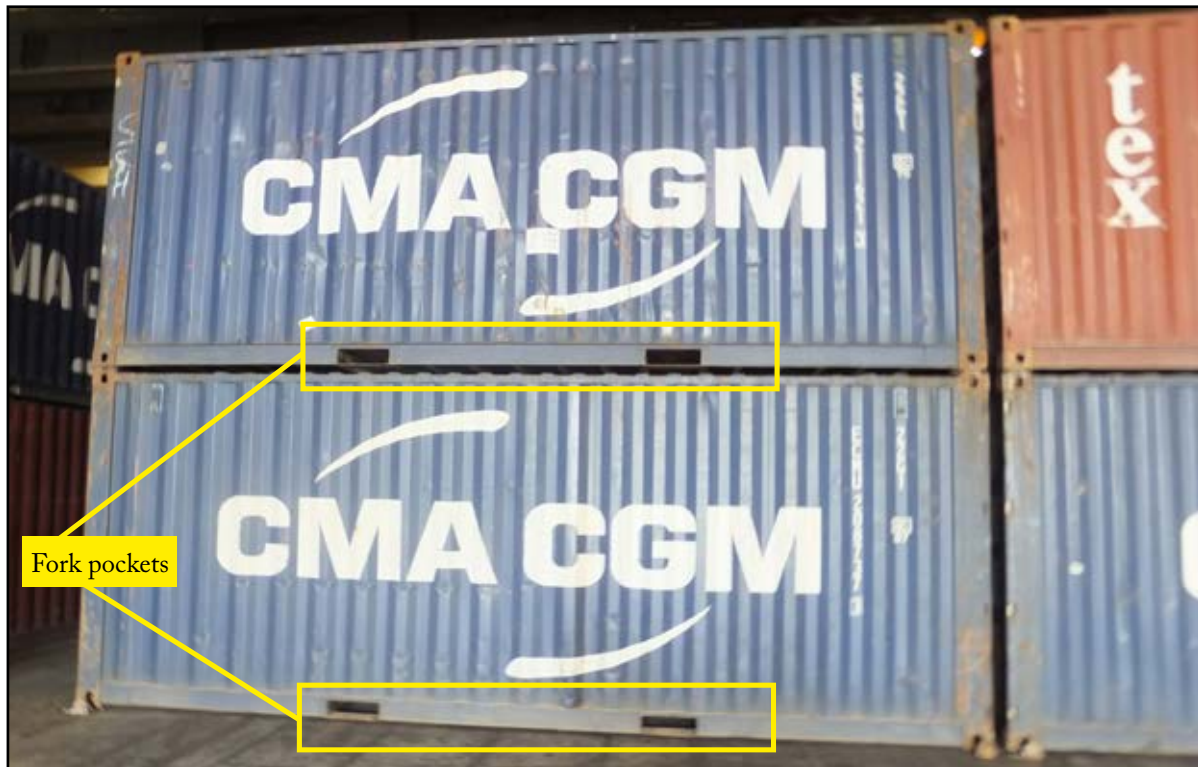
Figure 4: Fork pockets fitted to 20 foot containers which are not present on 40 foot units

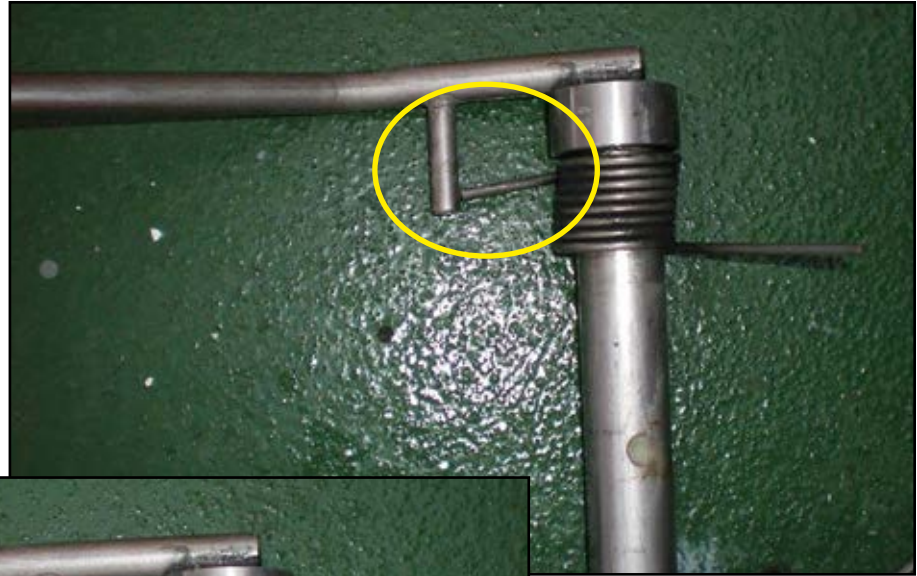
A ship's investigation found that the bowsing tackle brake tension spring tail was broken, allowing the bowsing tackle to pay out in an uncontrolled manner. The spring was replaced and the bowsing tackle was then successfully tested (Figures 1 and 2).

Figure 1: Broken spring tail

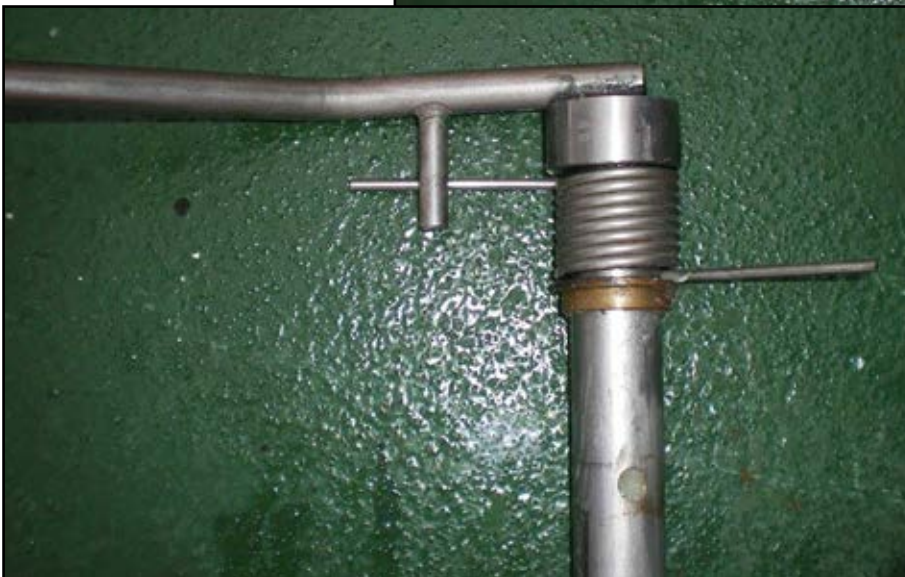
Figure 2: New spring

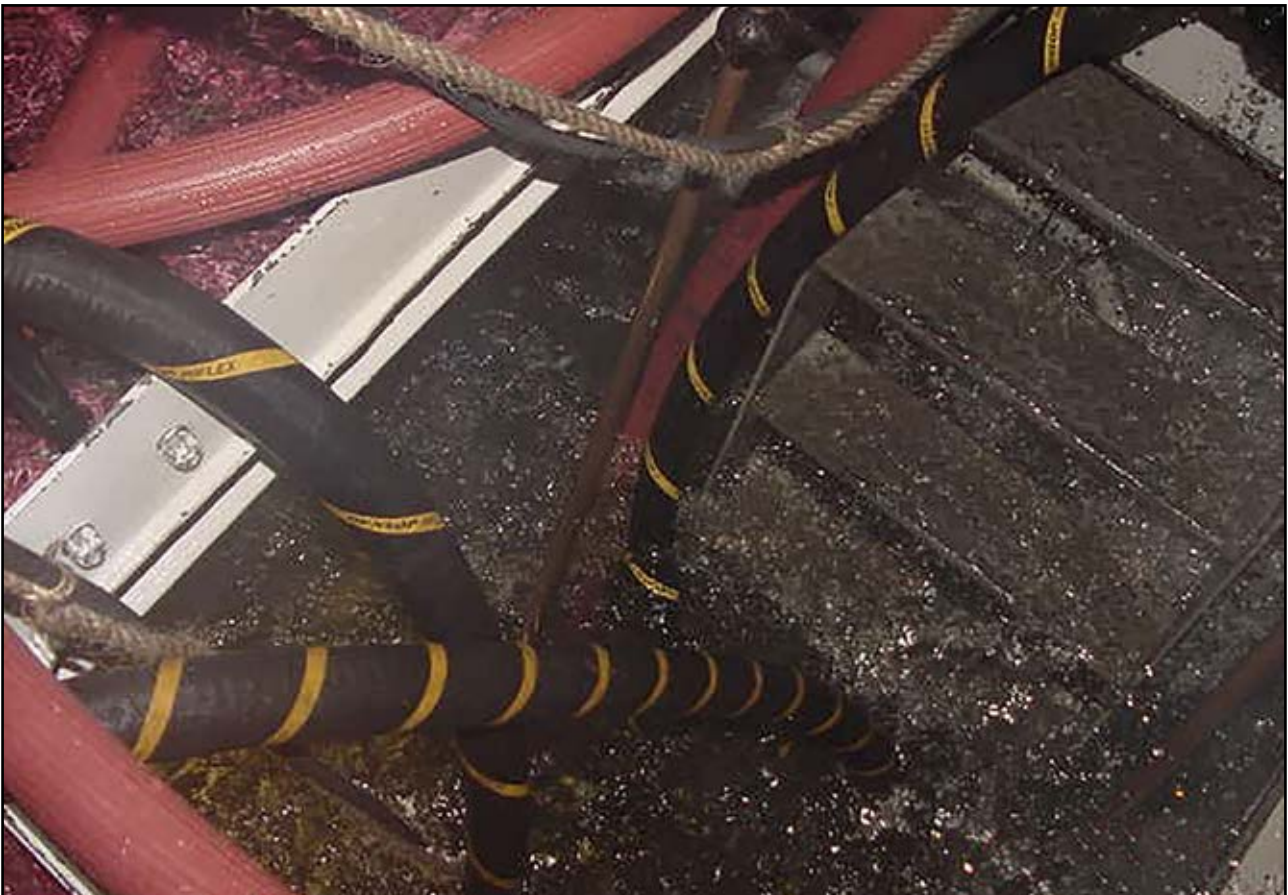
The water spread rapidly into all compartments on two decks (Figures 1 and 2), including the high voltage converter space (Figure 3). Quick action by the ship's crew to isolate the power supplies to the high voltage equipment prevented serious damage to the propulsion system. Nonetheless, the ship drifted not under command for several hours until temporary repairs were completed.

Figure 1: Flooding on the deck

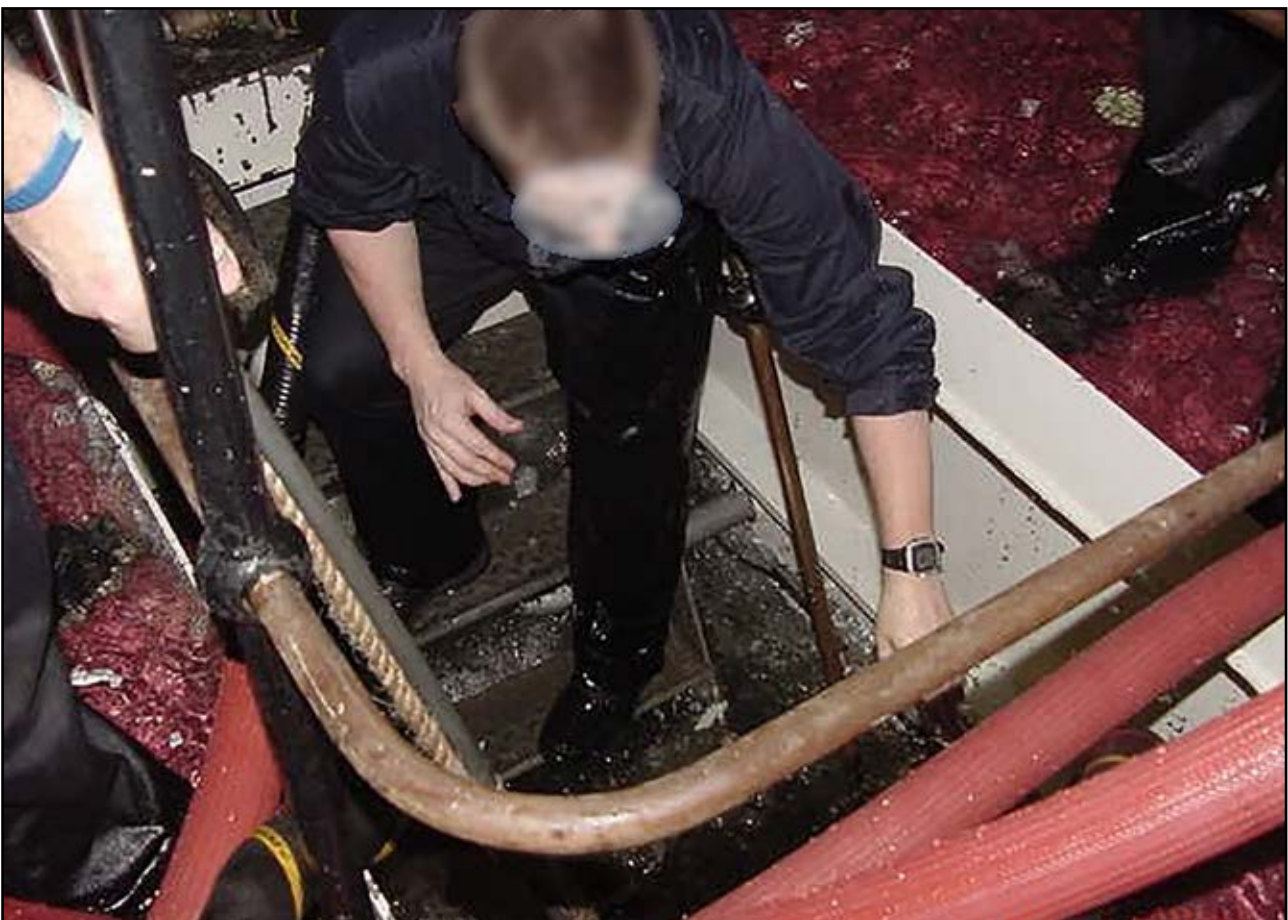
Figure 2: Top of stairway

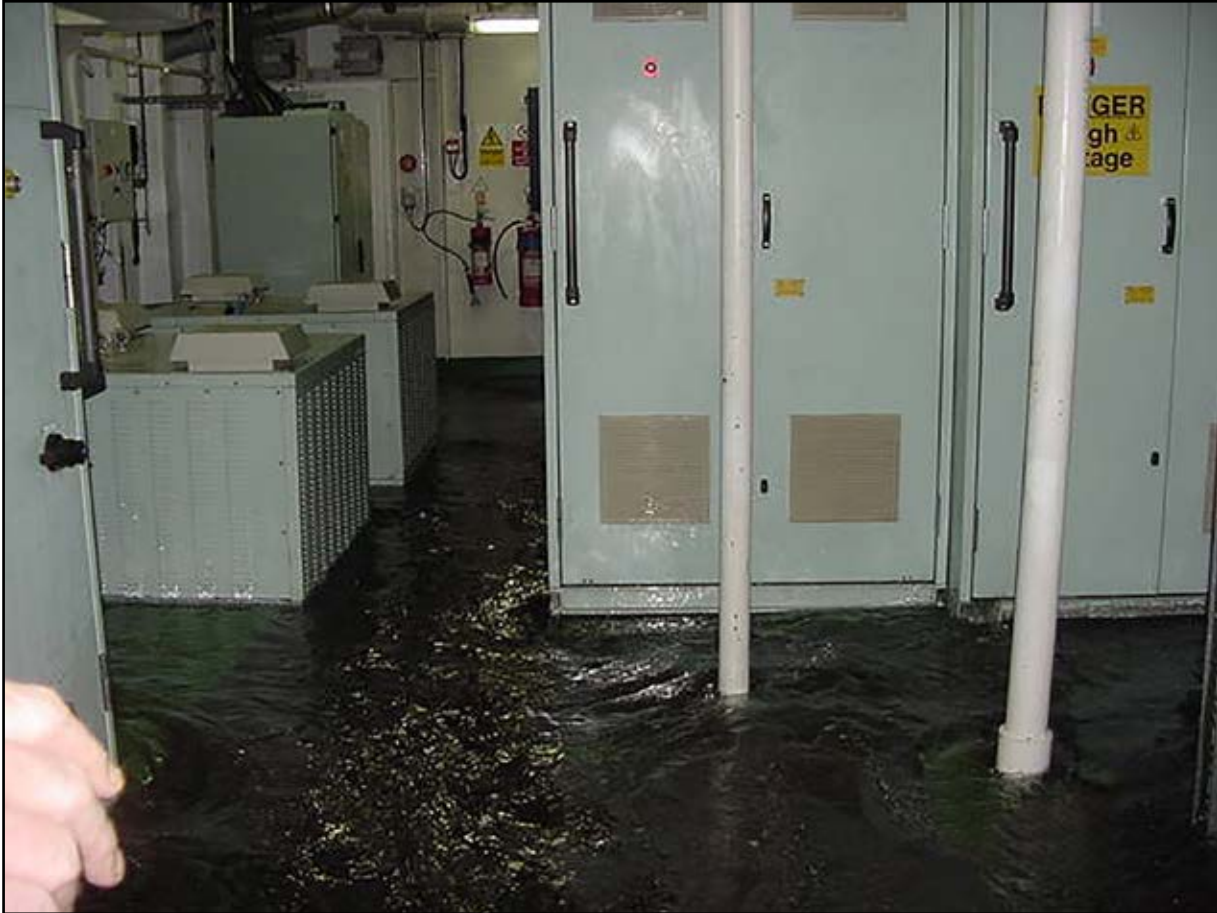
Figure 3: High voltage converter space

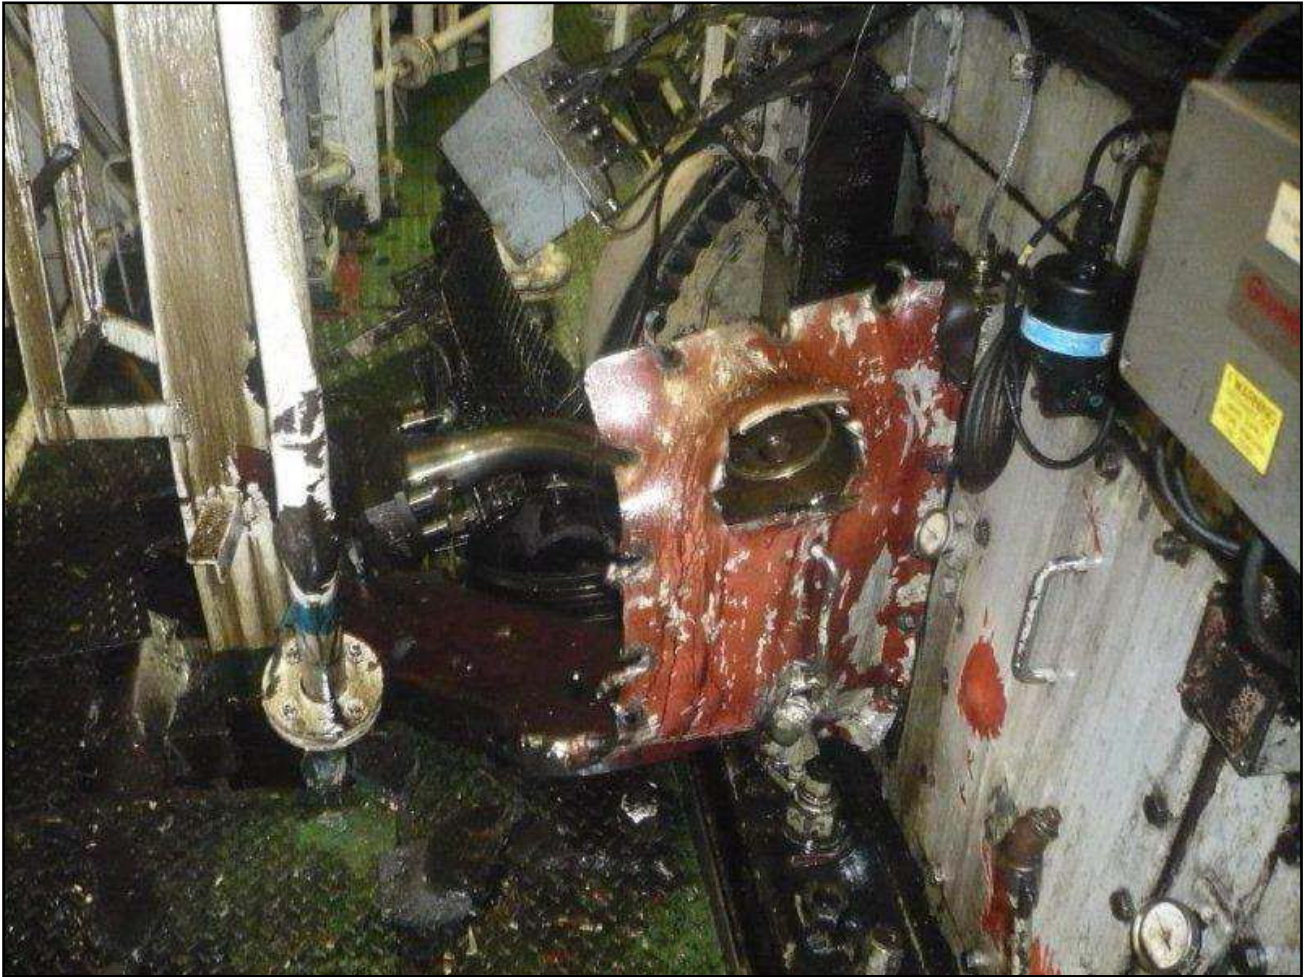
- Routine testing of the over-speed trip mechanism had not been carried out in accordance with the planned maintenance system because the engine tachometer was faulty and did not provide an accurate measurement of the engine's speed.
- The over-speed trip assembly bracket had broken away from its mountings, which prevented the trip from operating as designed.
- The engine's governor contained insufficient oil to enable it to operate correctly. The governor oil had leaked over a period of time from a loose pipe fitting.

Condition of engine immediately after over-speed

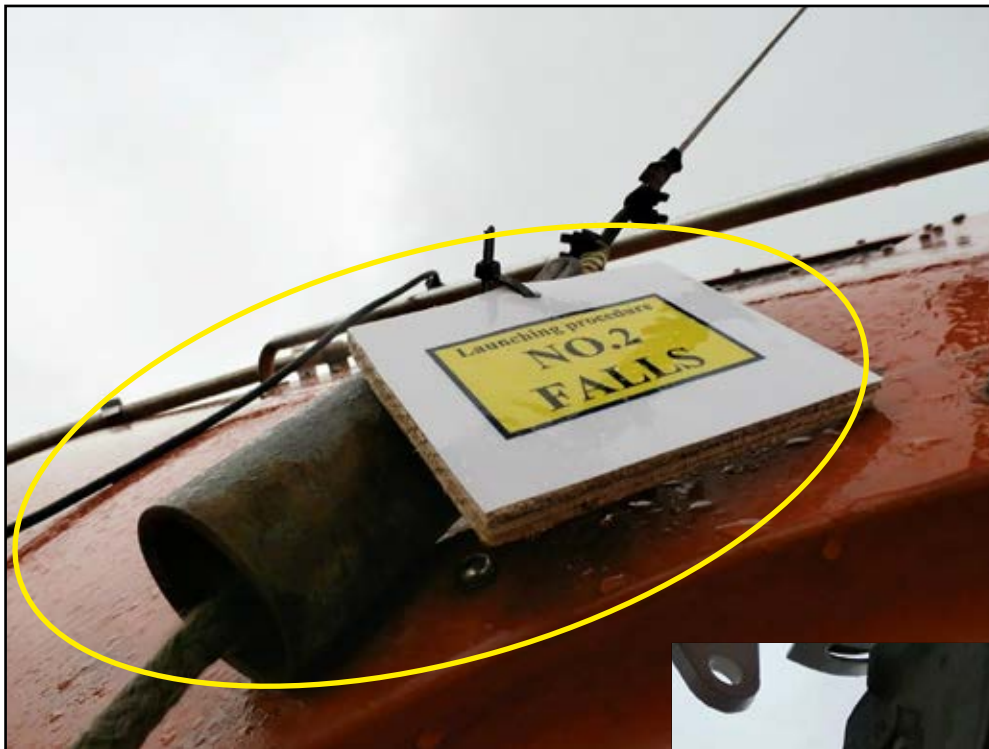
Figure 2:
Brake release and falls
lowering control wire
cylindrical handle

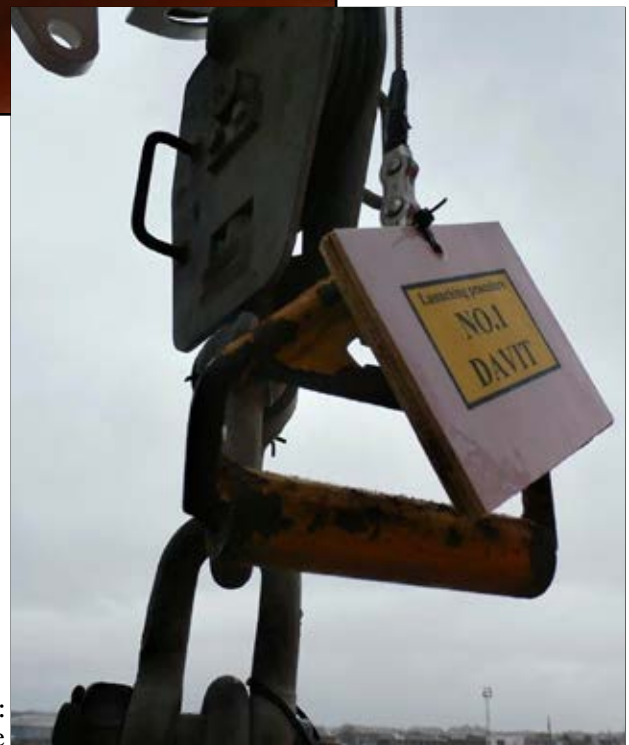
Figure 3:
Slewing control wire triangular handle

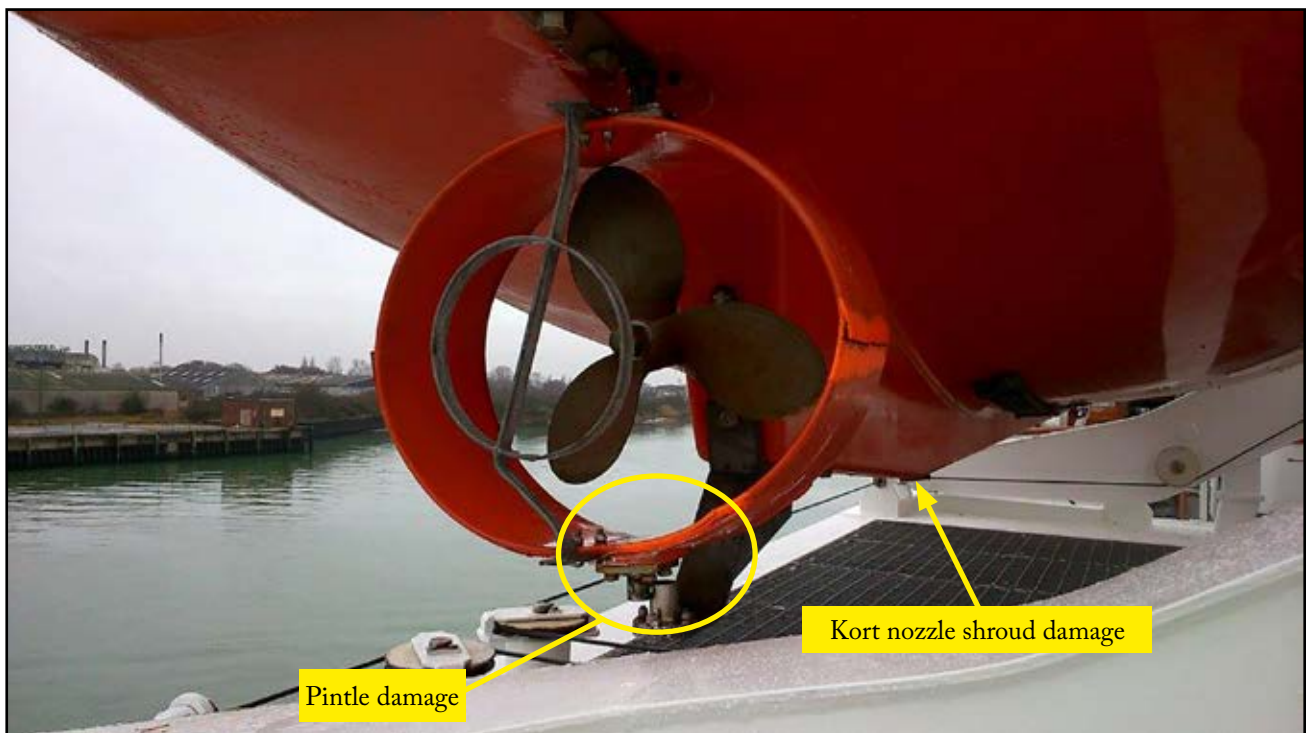
Figure 4: Kort nozzle damage

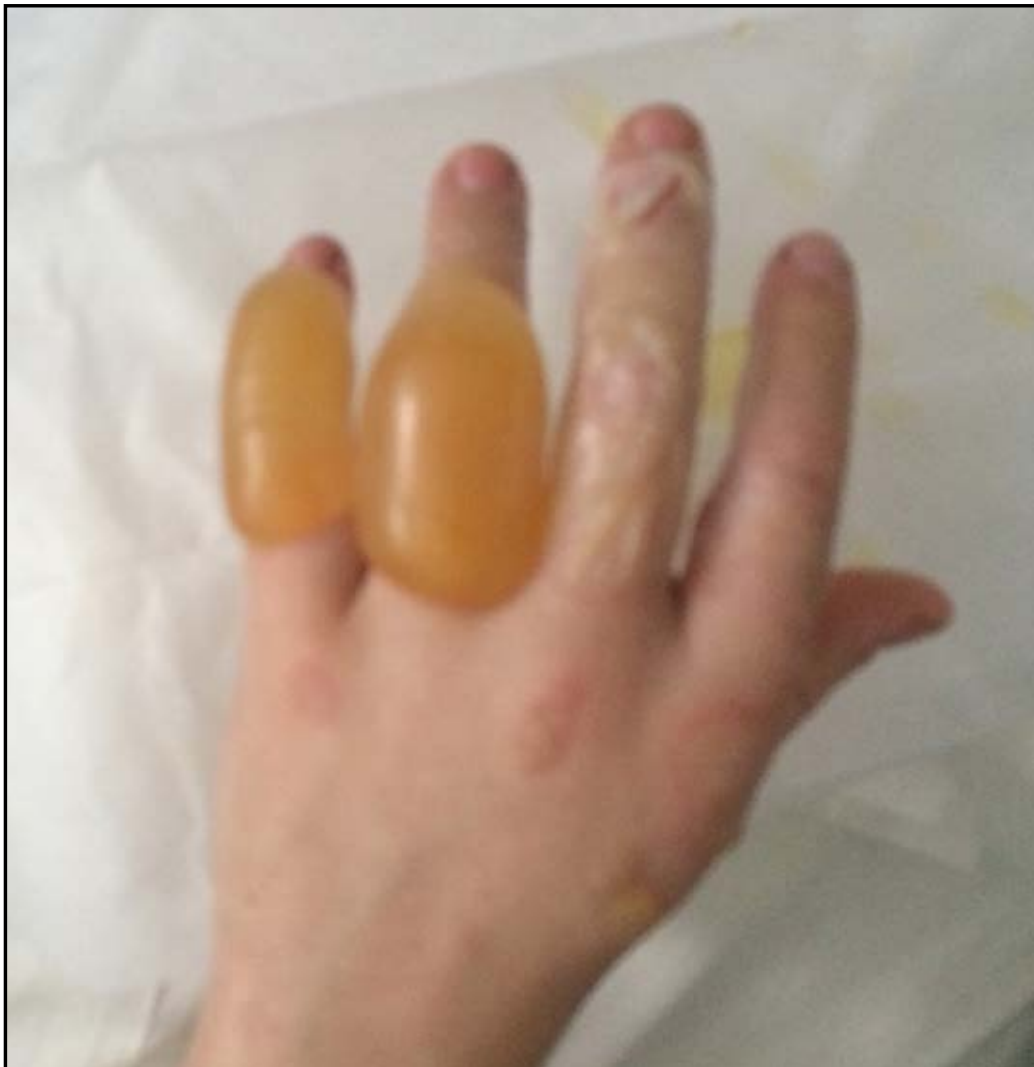
Second degree burns sustained to the fourth engineer's hand

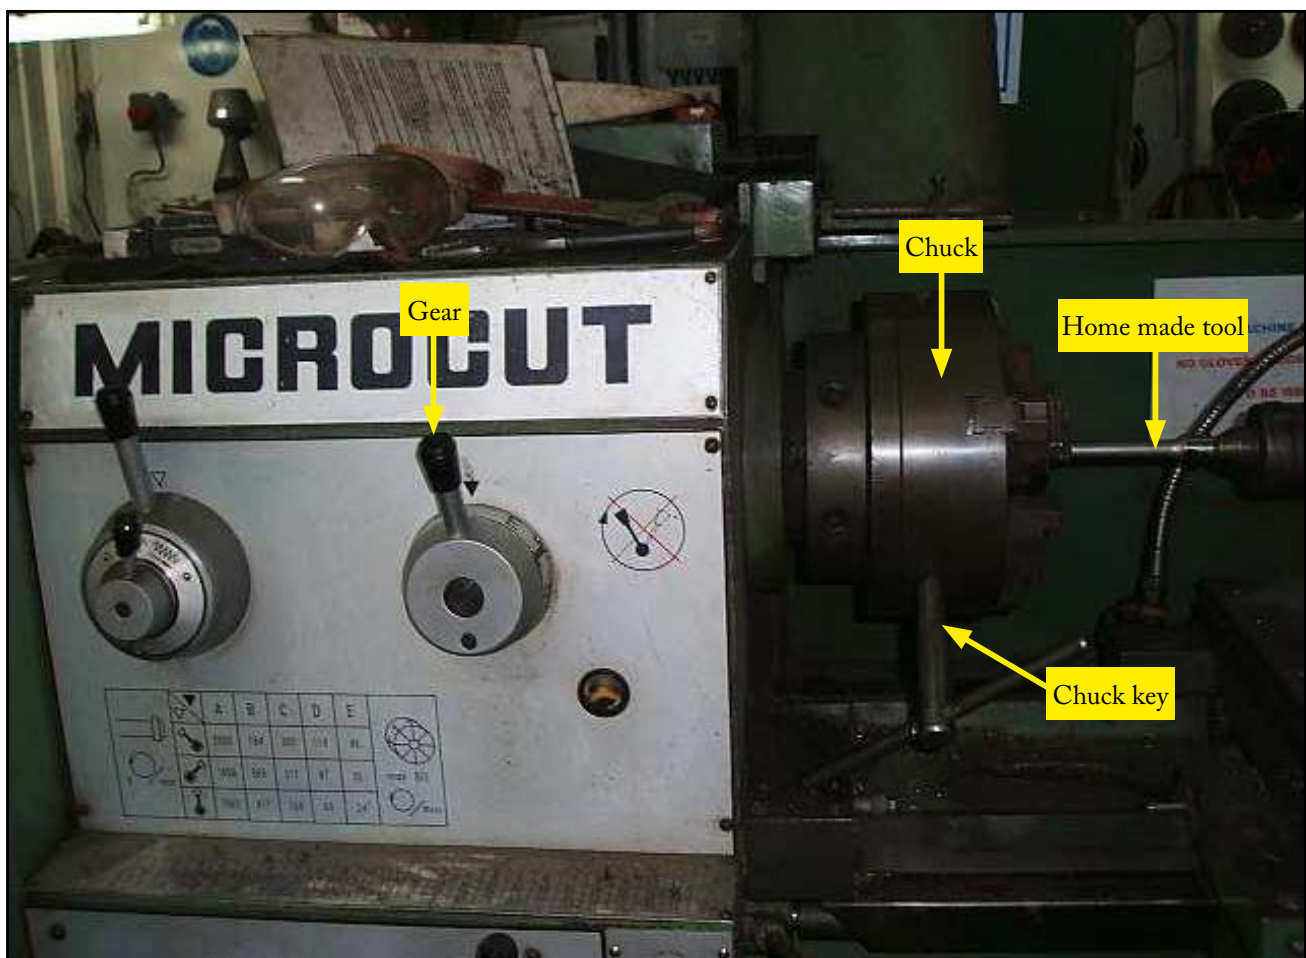
3. Using the lathe's chuck key for any use other than its intended purpose for tightening the chuck is a particularly unsafe practice. Numerous accidents have occurred when lathes have inadvertently been started with the key still in the chuck. While this did not happen in this case, it remains a significant safety concern.

Lathe with chuck key in appropriate position where the finger was trapped

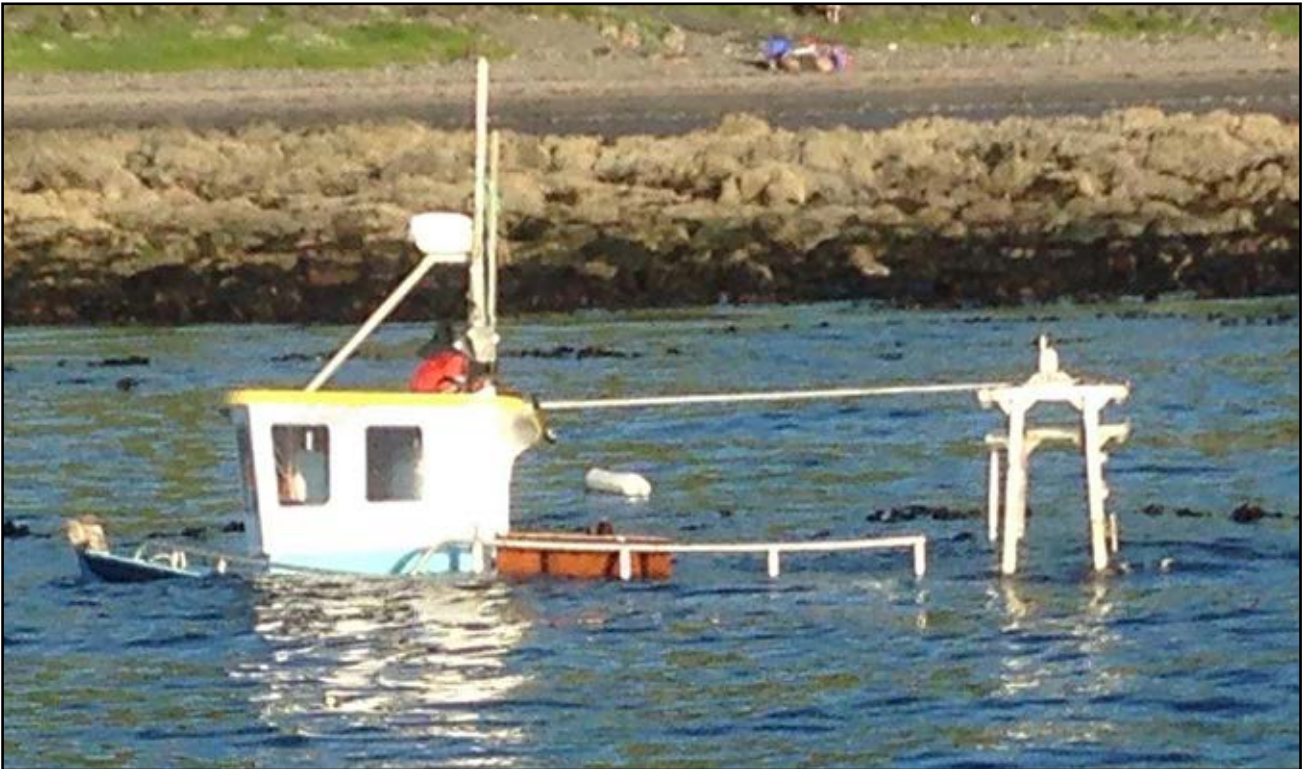
Figure 1: Vessel 1 abandoned on the rocks

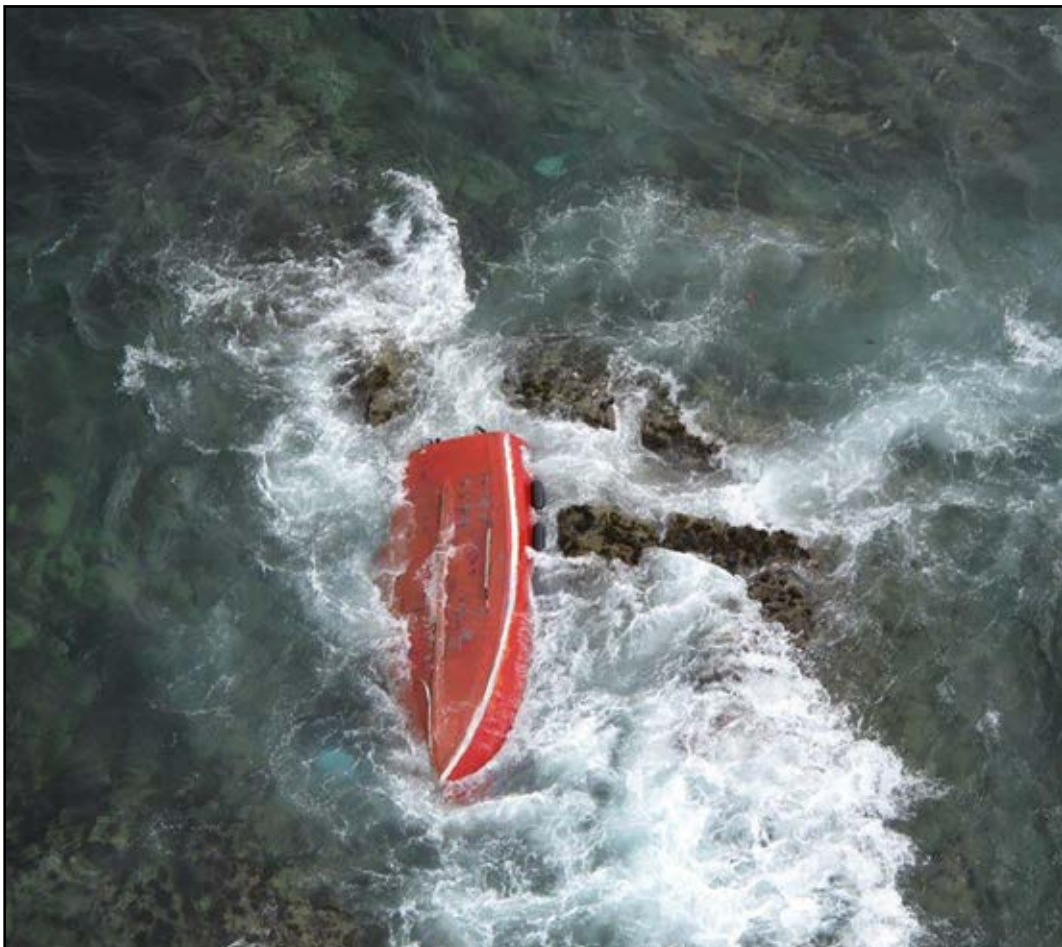
Figure 2: Vessel 2 abandoned on the rocks

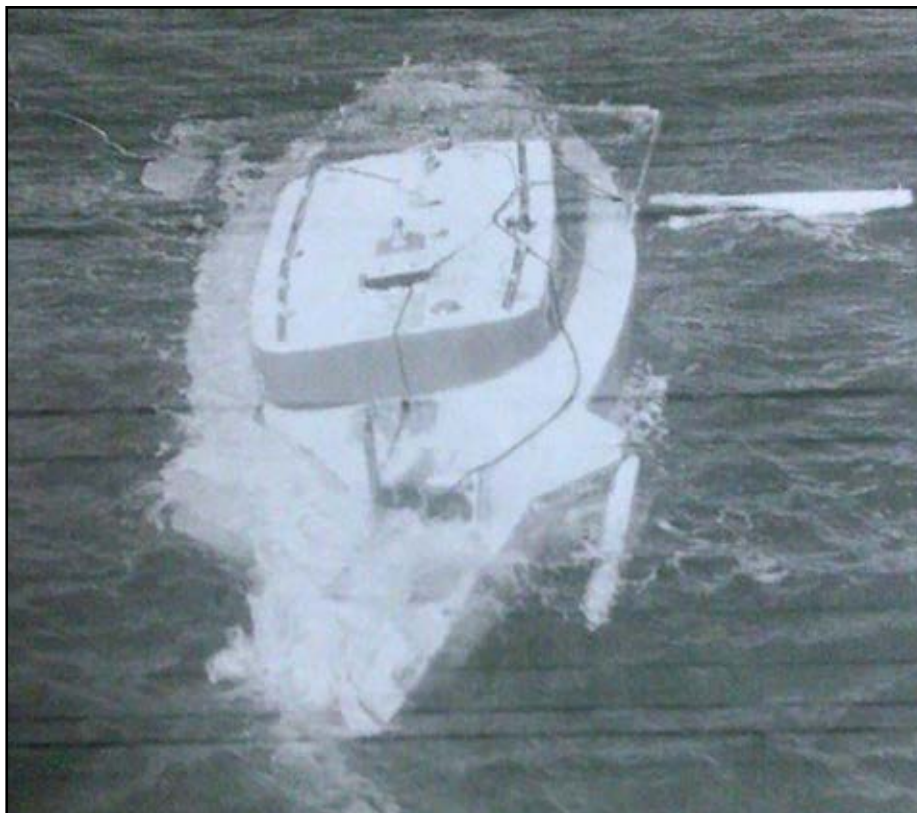
Due to the condition of the trimaran when it was recovered, it was not possible to determine when or how the vessel and its crew perished. However, in view of the prevailing current in the area and the positions in which the boat and its skipper were found, whatever happened probably occurred while the trimaran was near its intended track, which crossed a relatively busy shipping area. As a VHF call was not heard, it is also likely that whatever happened, happened quickly.

Figure 1: Upturned hull

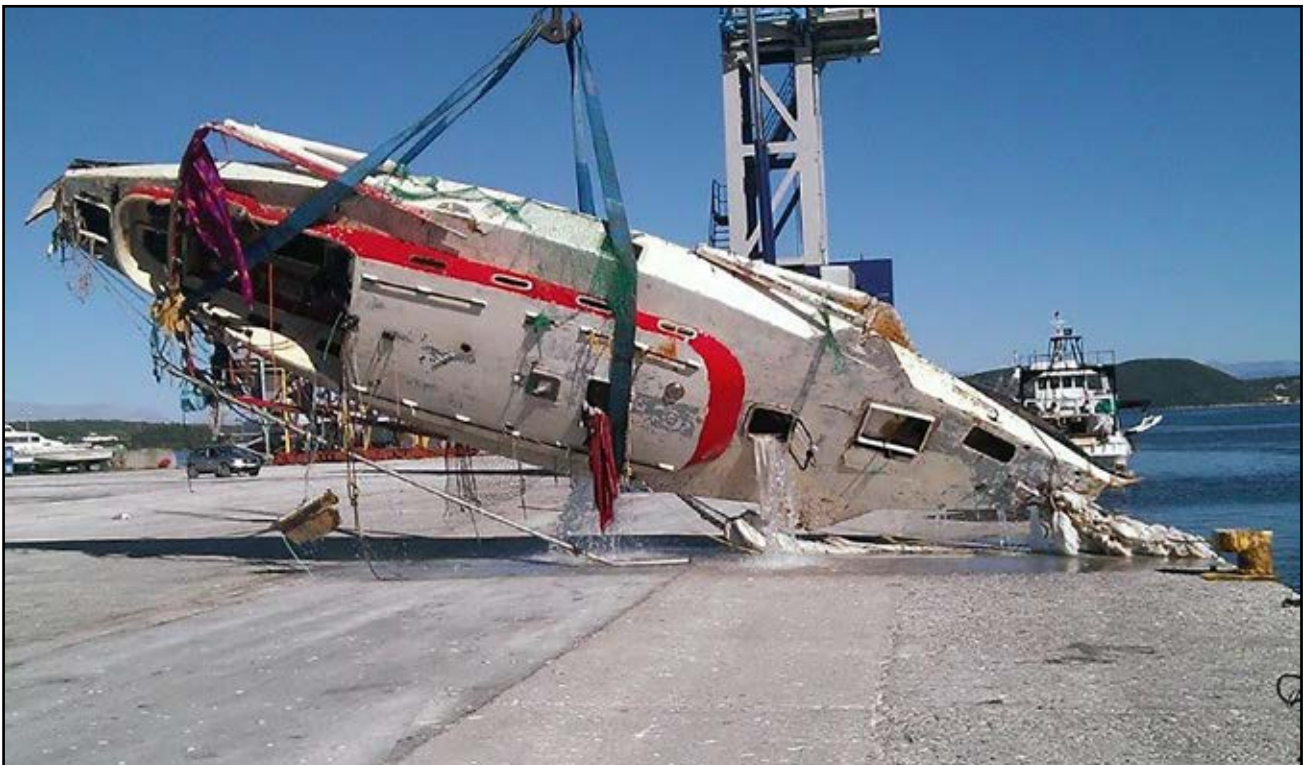
Figure 2: Hull lifted out of the water
