SAFETY DIGEST

**Lessons from Marine
Accident Reports
1/2015**

SAFETY DIGEST
Lessons from Marine Accidents
No 1/2015

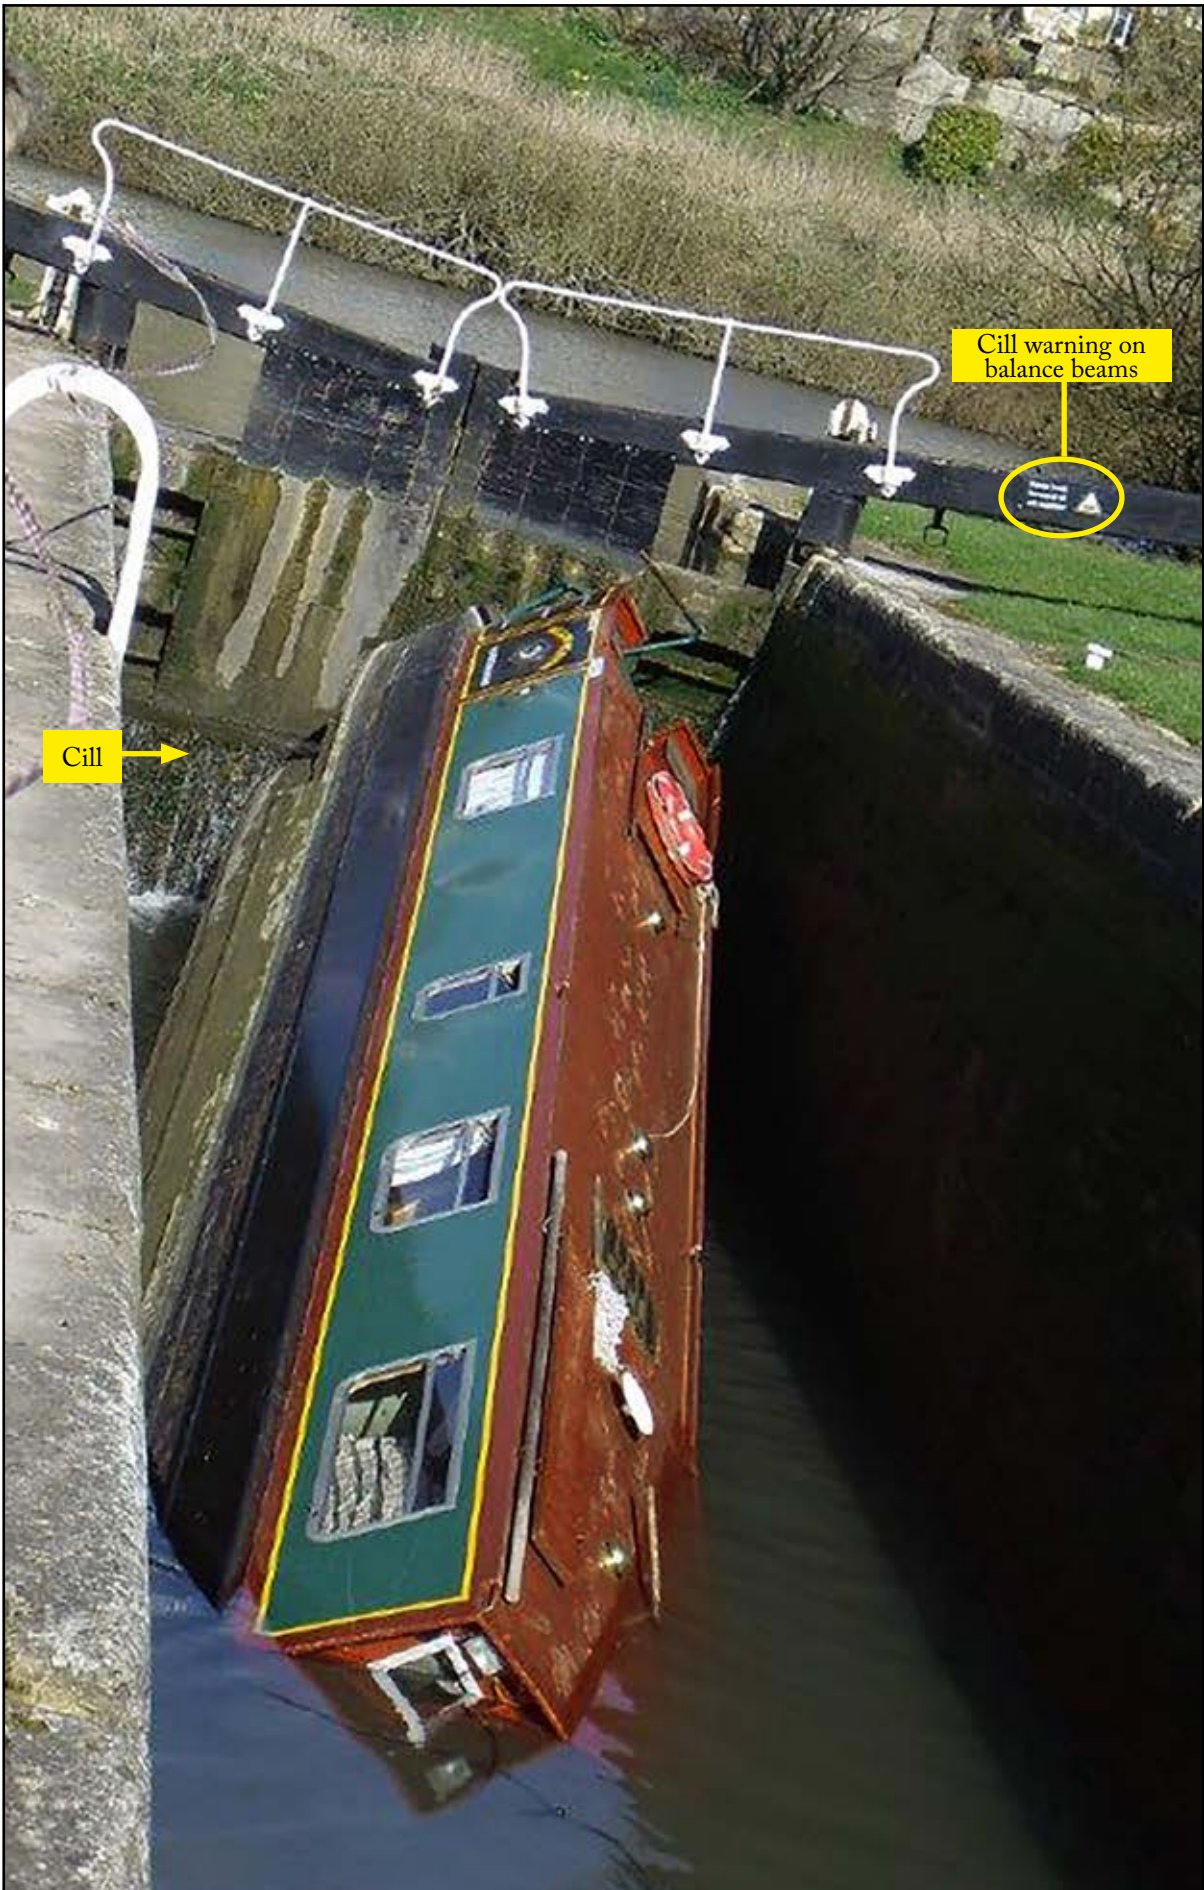
Figure 2: Narrow boat 'hung up' on lock cill

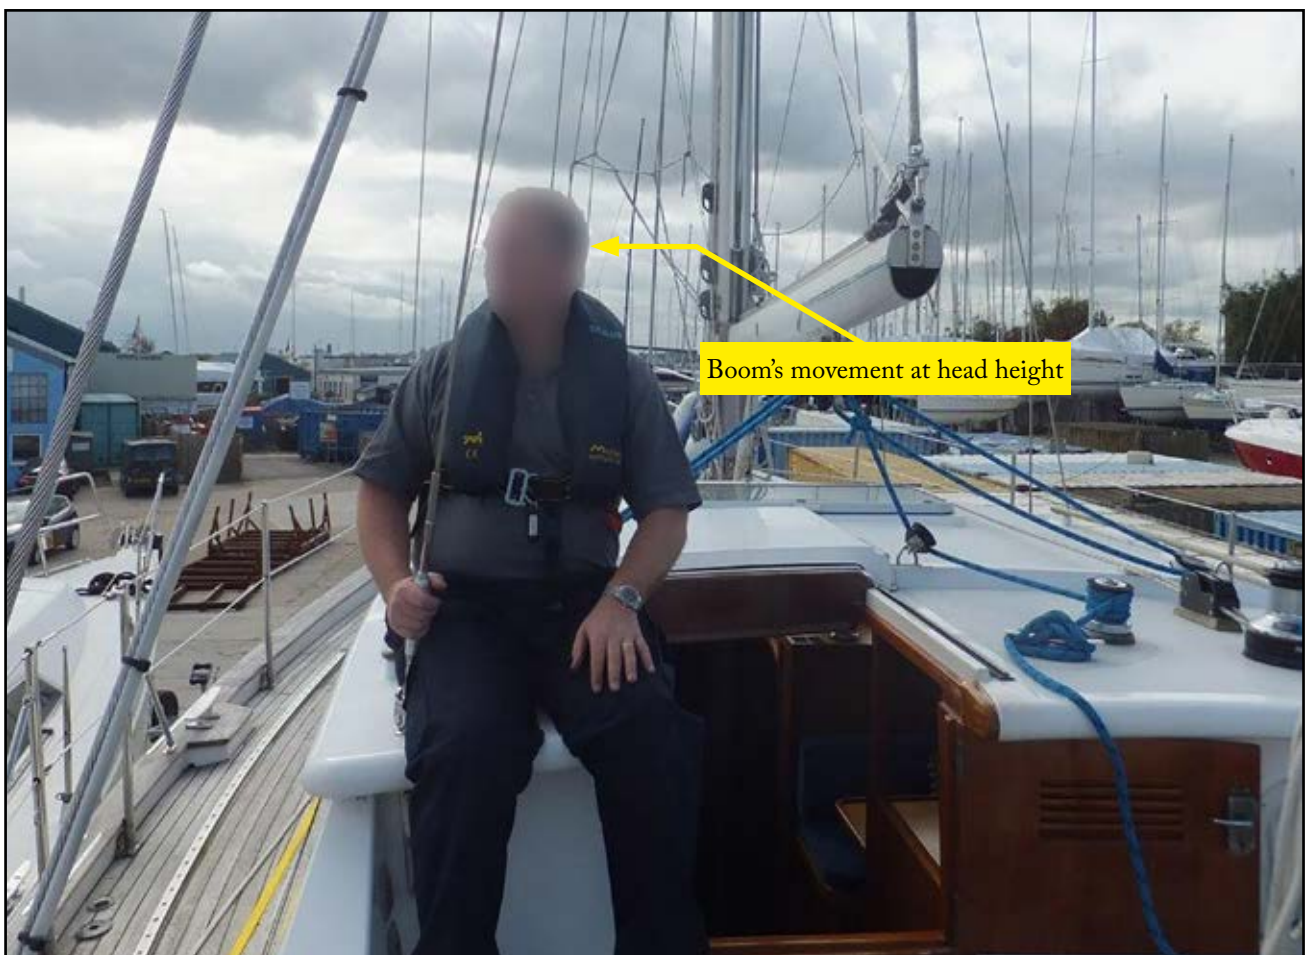
Reconstruction of the crewman's sitting position on the coach roof showing the boom at the same height as his head

1. When sailing downwind in windy conditions, an unplanned gybe probably presents the greatest risk to safety. Serious consideration should be given to rigging a line to prevent an accidental gybe. With or without such a preventer line, it is absolutely vital that those on board the boat keep clear of the boom.
2. Despite being safety conscious and having briefed his friends about safety on board, the skipper was distracted by his investigation of the unusual steering noise.
3. Although a couple of the crew had sailed before, it was really only the skipper who was qualified and experienced to operate the boat in the prevailing conditions. All the more reason to be focused and for everyone on board to think and act safely, as well as looking out for one another.

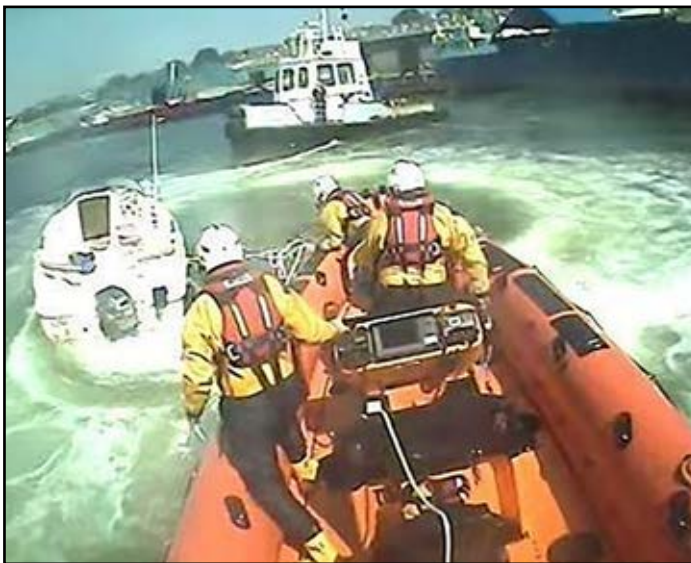
Runaway speedboat being captured by RNLi crew
