**Lessons from Marine
Accident Reports
2/2015**

SAFETY DIGEST
Lessons from Marine Accidents
No 2/2015

October 2015

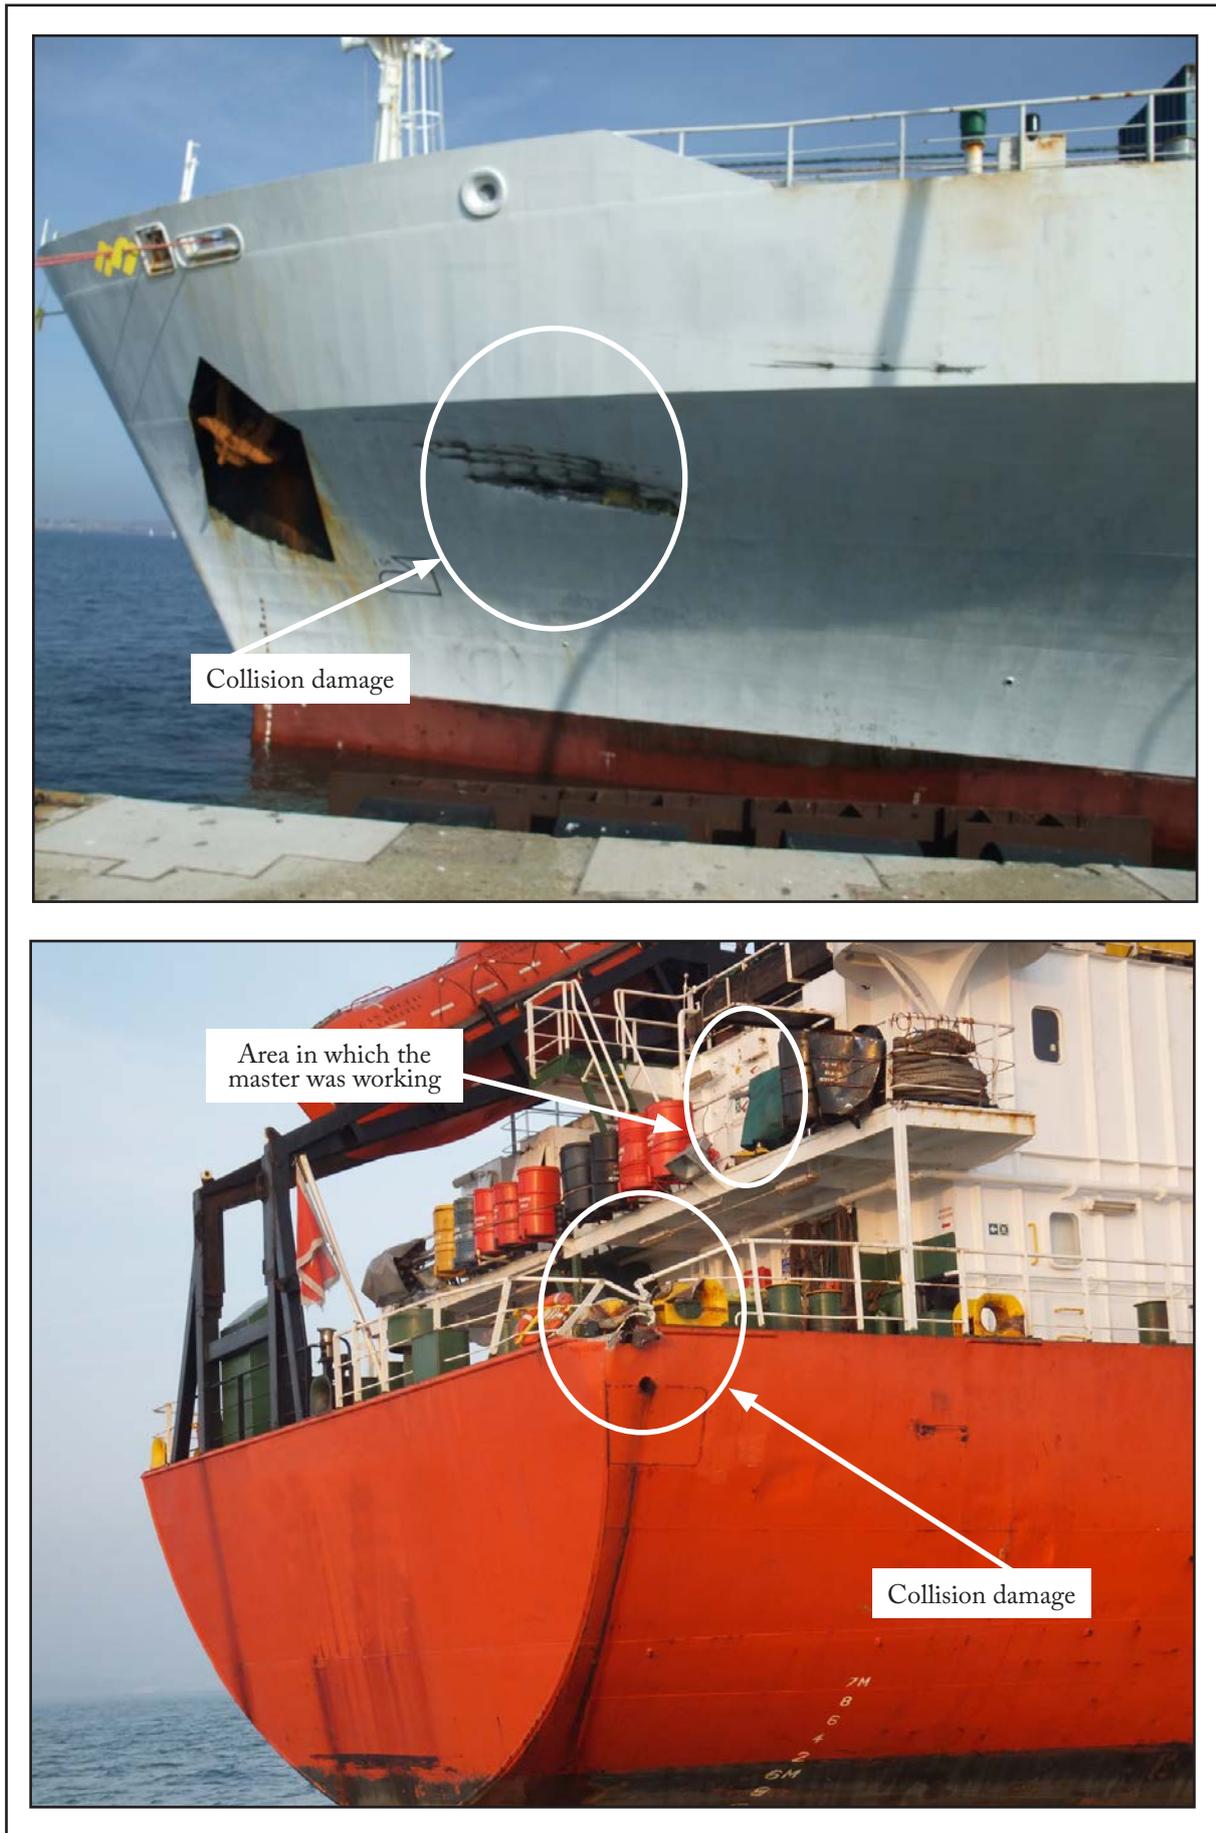
The general cargo vessel's port bow collided with the LPG tanker's starboard quarter and the hulls of both vessels were breached above their respective waterlines. Both vessels were directed by the coastal state to a nearby port of refuge for inspection and repairs.

Figure 1: Damage to both vessels

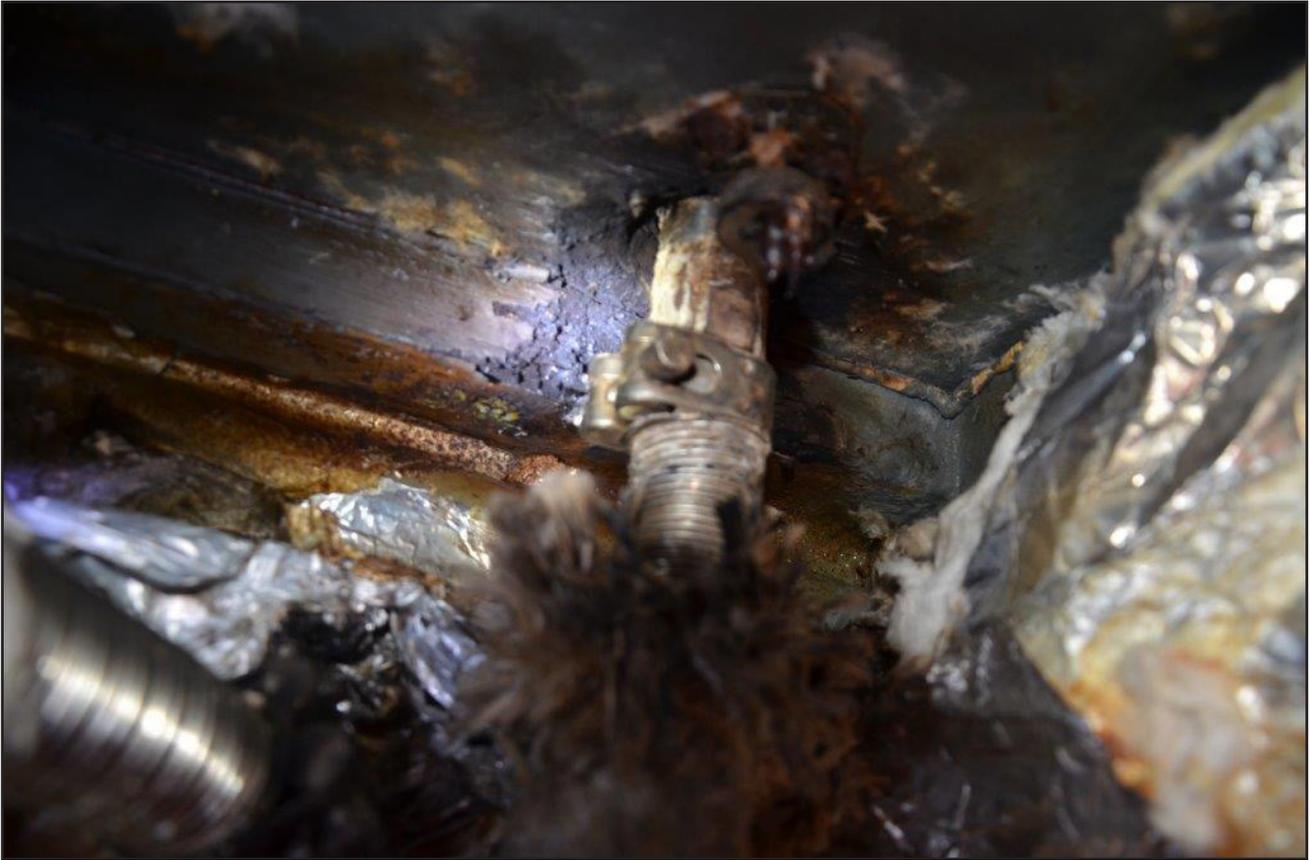
- A section of the air heater exhaust pipe passed through the plywood deck; this section was not insulated.
- There was little or no clearance between the bare exhaust pipe and the plywood; this led to charring of the under-deck area (Figure 2).
- Cans of diesel, cotton rags, paper and other flammable material were stored in the same compartment as the heater.
- The heater compartment was not fitted with fire detection or fire suppressant systems.

Figure 2: Uninsulated exhaust pipe causing the wooden deck to char

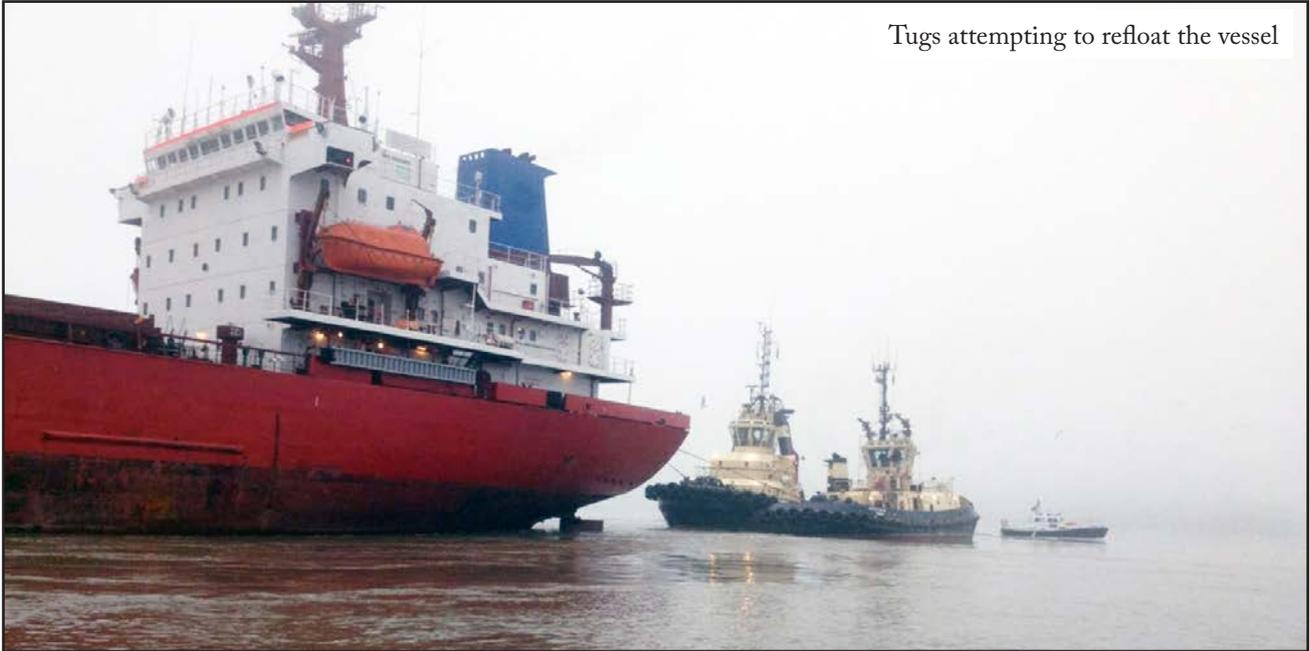
As a result of the contact the vessel was holed above the waterline, but no damage was caused to the hull by the grounding, which occurred in an area of soft mud. The vessel was refloated

Tugs attempting to refloat the vessel

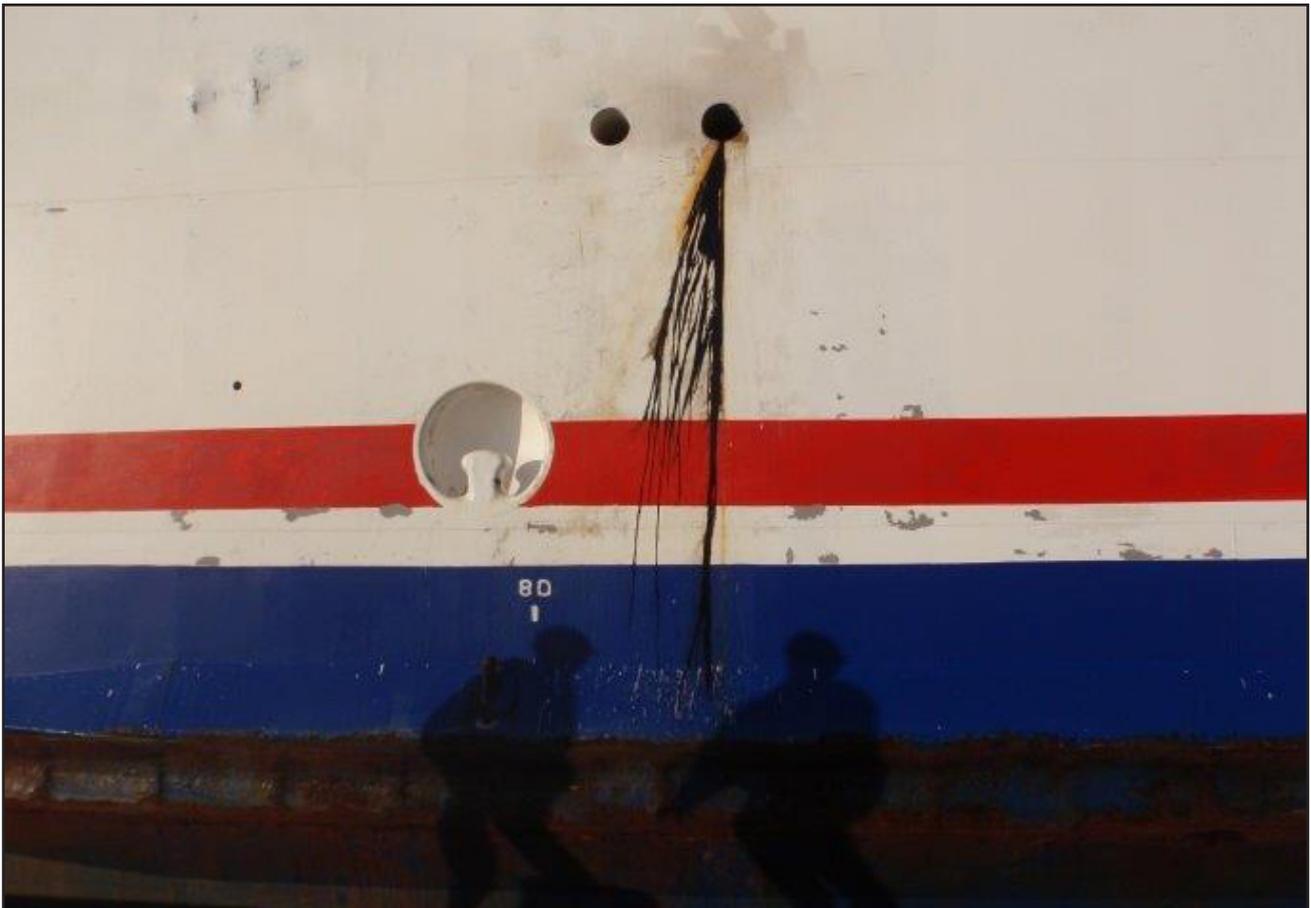
tank as intended. This caused 600 litres of oily water already in the tank to discharge overboard through the tank's air vent (Figure 3).

Figure 3: Oily water discharge on ship's side

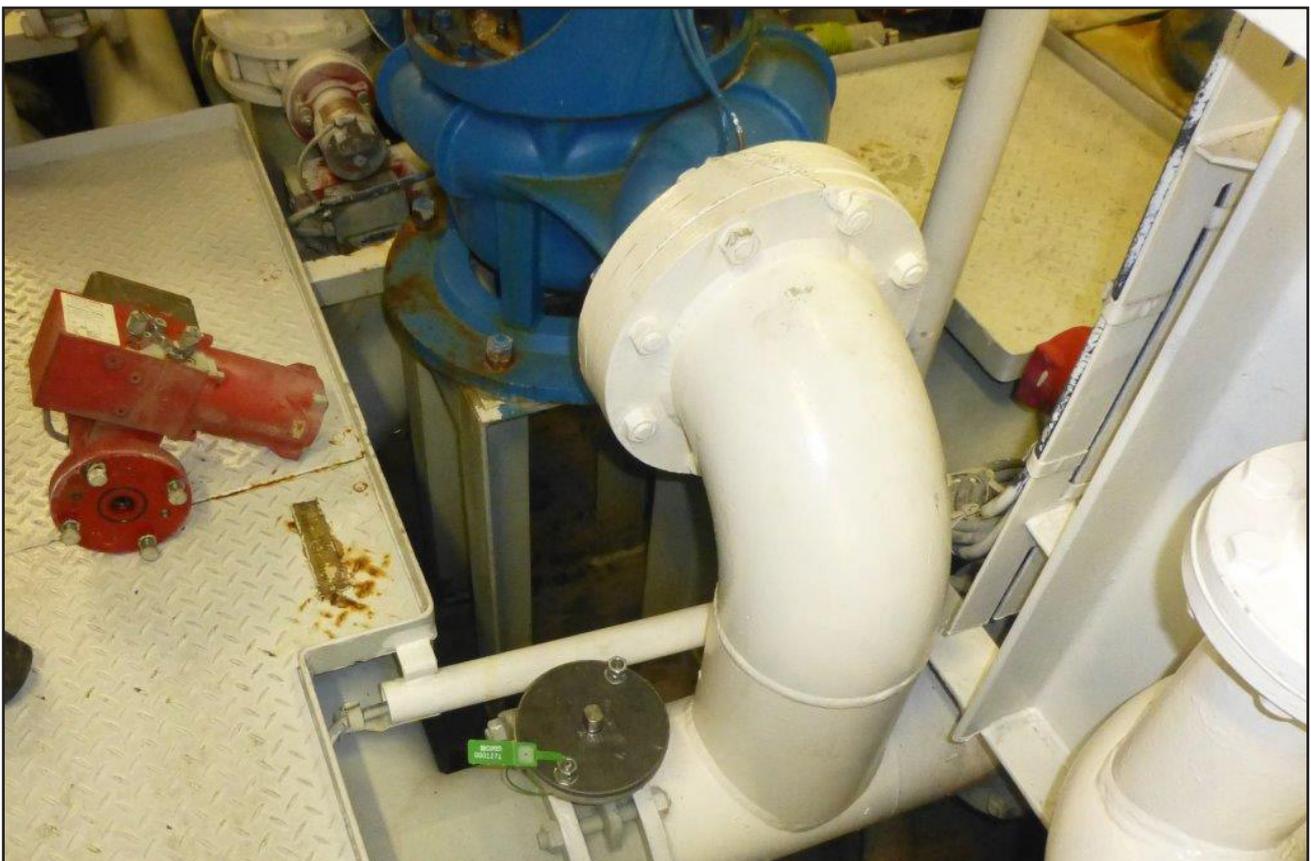
Figure 4: Modified cross-over valve - actuator removed, locking device fitted

3. Where key ship systems can be cross-connected, a padlock or equivalent is a simple measure that goes a long way in preventing inadvertent operation and unintended consequences (Figure 4).

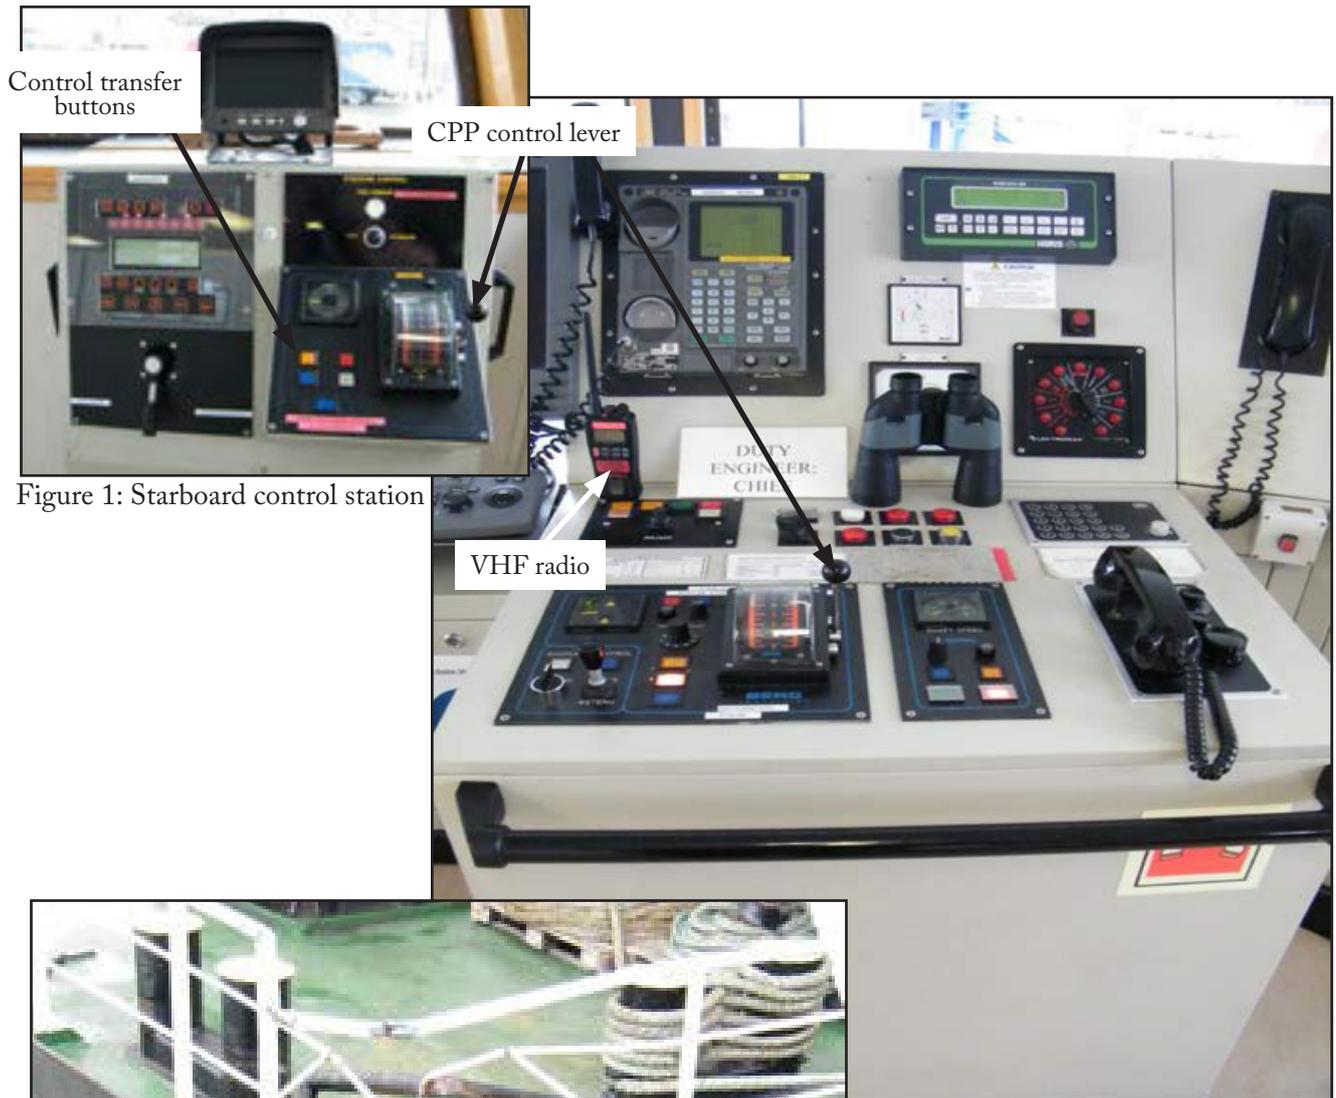
The master pressed the 'accept control' button at the starboard station in preparation to continue the manoeuvre. The button on the remote station was backlit. It had been previously dimmed to prevent the light from affecting the bridge team's night vision, but had not been later reset for daylight operations. The illuminated button was designed to act both as a means of taking control and as an indication that control had been achieved or as an alarm to indicate a failure of the control transfer. The button showed a solid colour once control had been established or a flashing light to indicate a fault. Owing to the light having been dimmed, the master did not become aware of a system fault until it became obvious that the propulsion was not responding to his inputs. At this point, the master noted that the CPP pitch was set at 50% astern and was not responding to the starboard station control lever (Figure 1).

Figure 1: Starboard control station

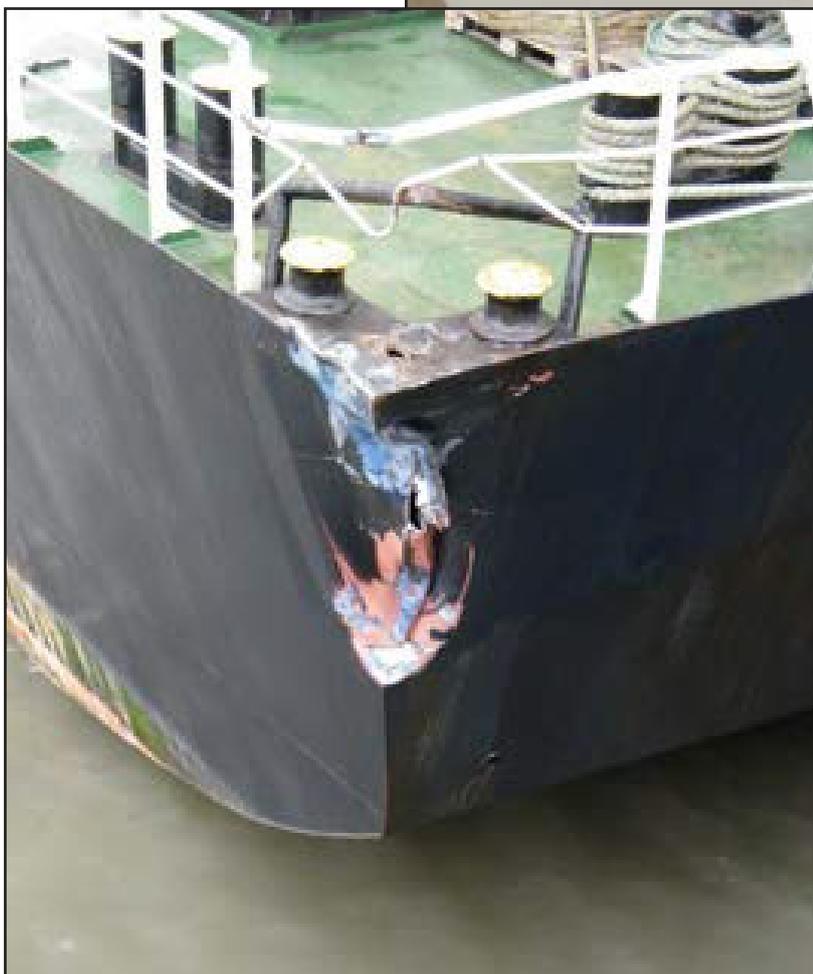
The damage (Figure 3) to the shell plating on both vessels was significant and resulted in the two vessels being out of service for several days for repairs to be undertaken. Fortunately there was no injury to personnel or any pollution as a result of the collision.

Figure 3: Damage to shell plating

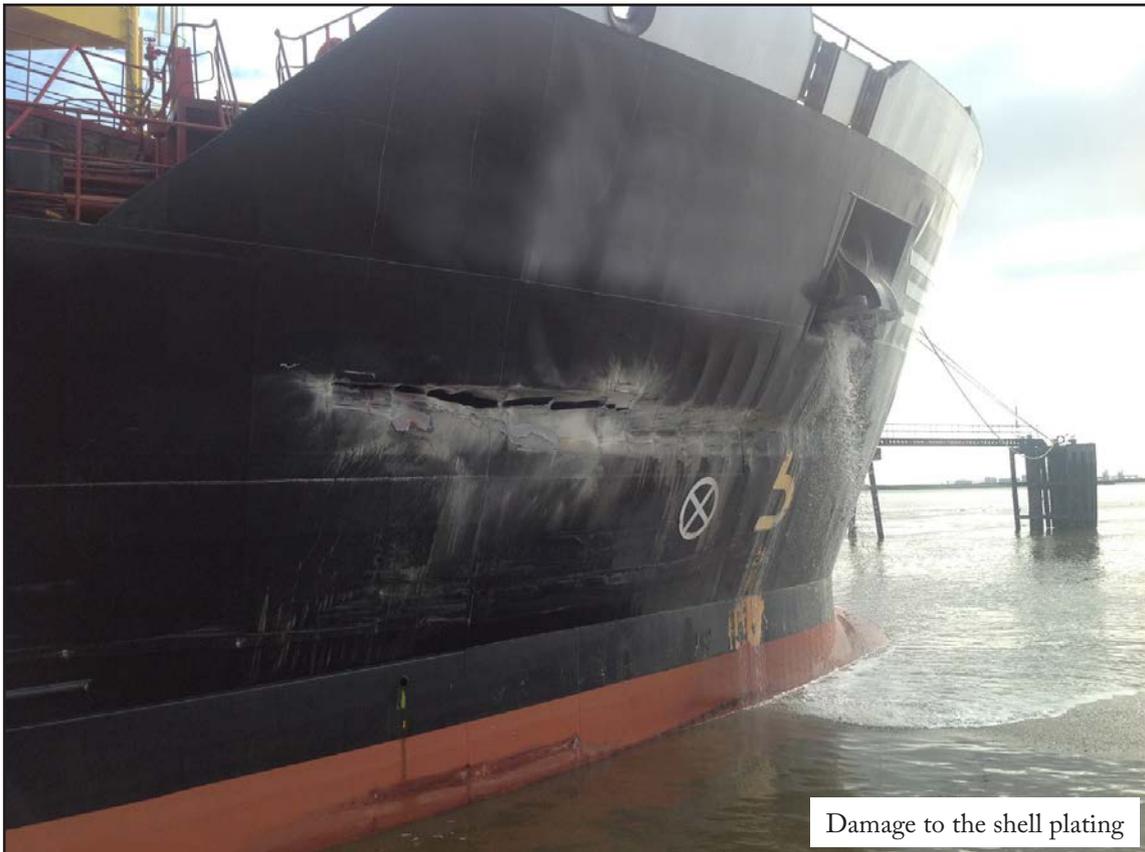
Damage to the shell plating

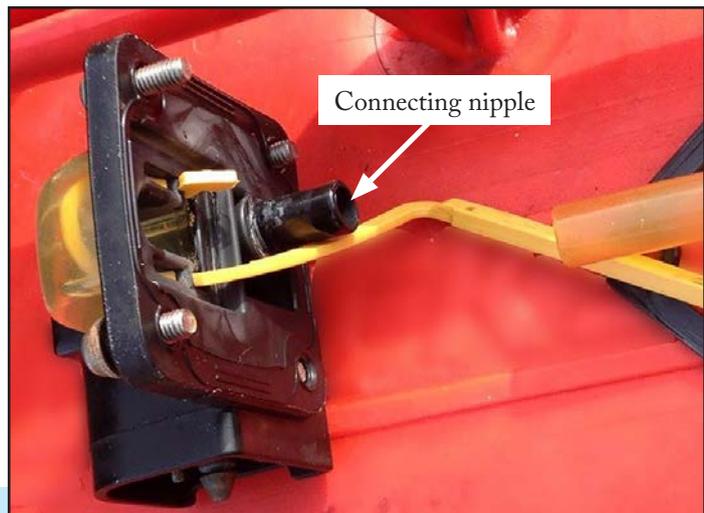
Information from the engine and fuel tank supplier indicated that an annual inspection of the fuel tanks should form part of the boat's maintenance schedule. The pick-up tubes were secured to the tank top assembly by use of an adhesive. The vessel had a diverse operating schedule and, over a period of time, had purchased petrol from a number of different countries. There was a risk that fuel with a high ethanol content could cause the adhesive to deteriorate.

Fuel tank pick-up tube assembly

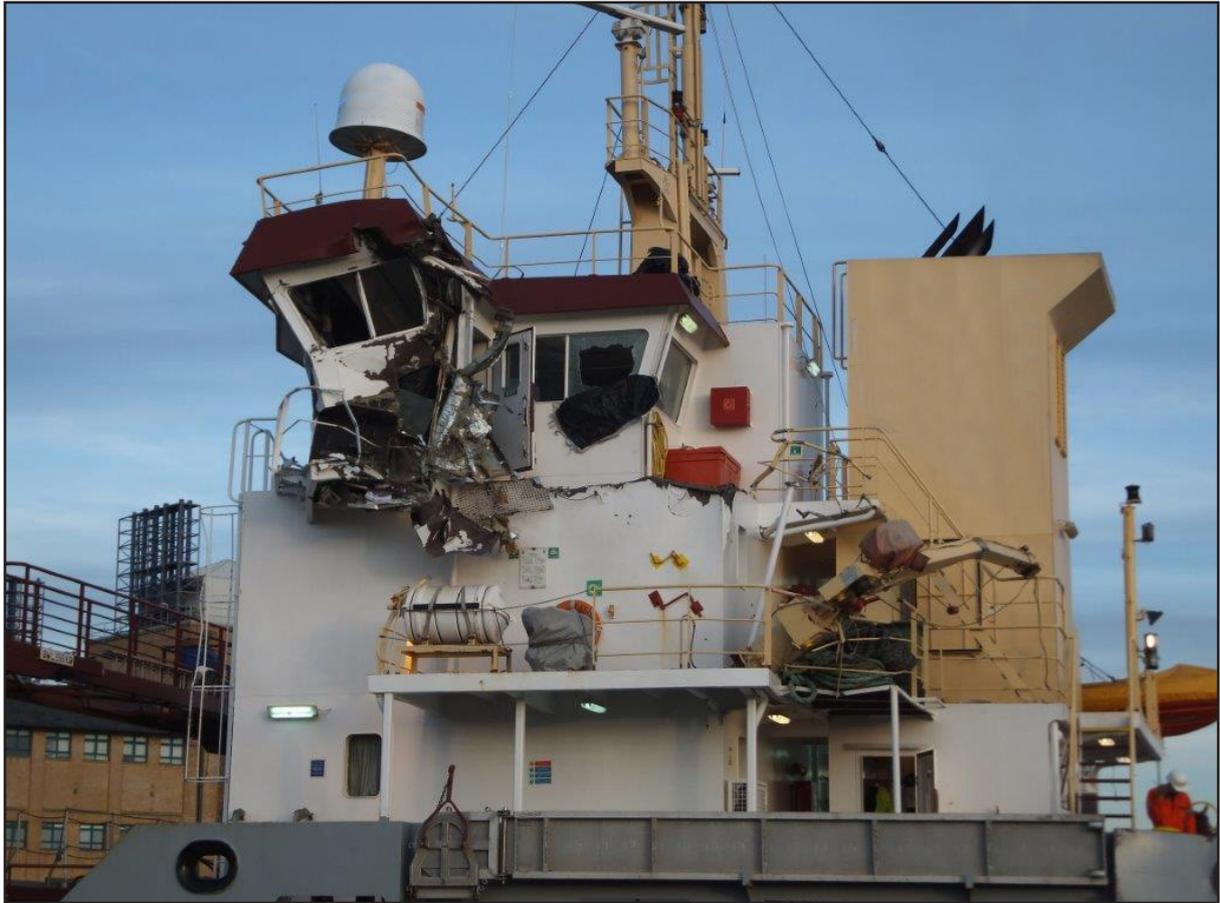
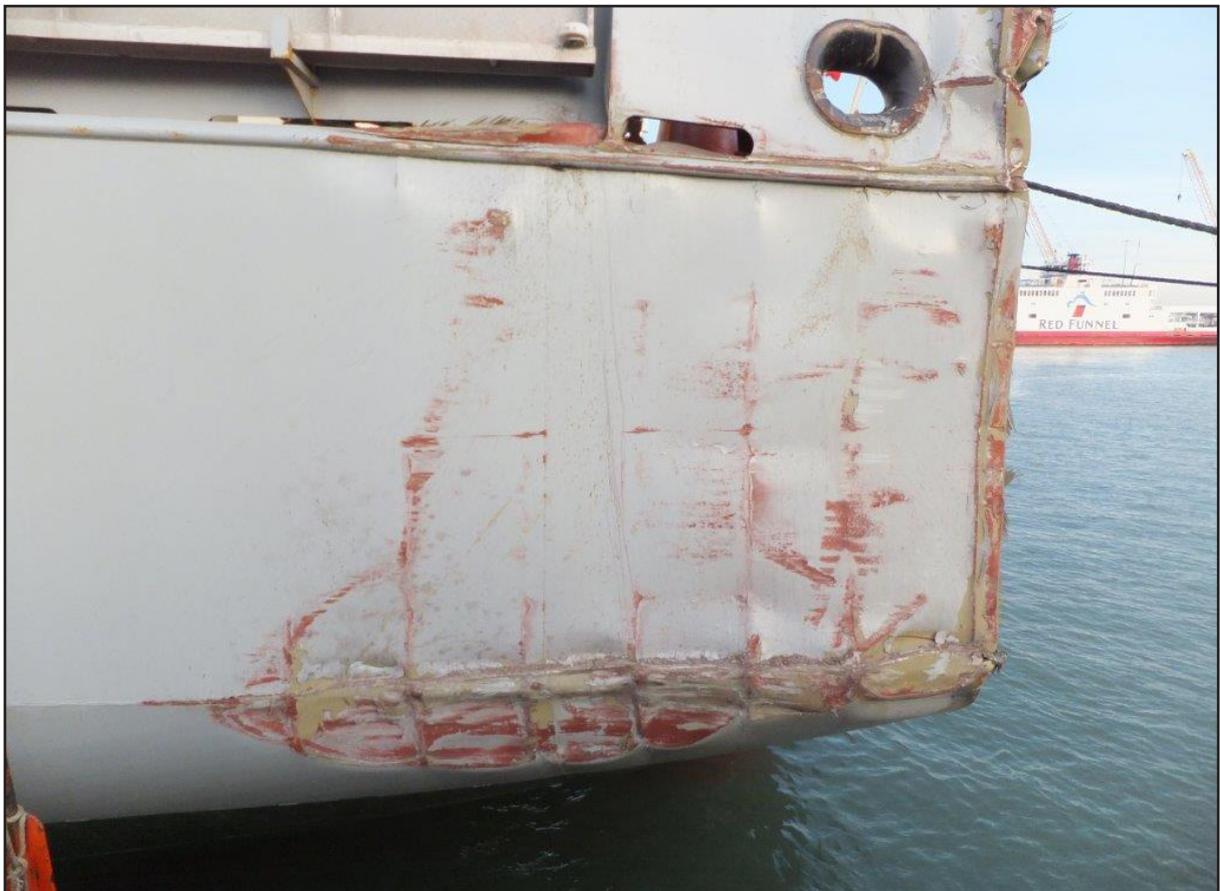
Damage sustained to the general cargo vessel

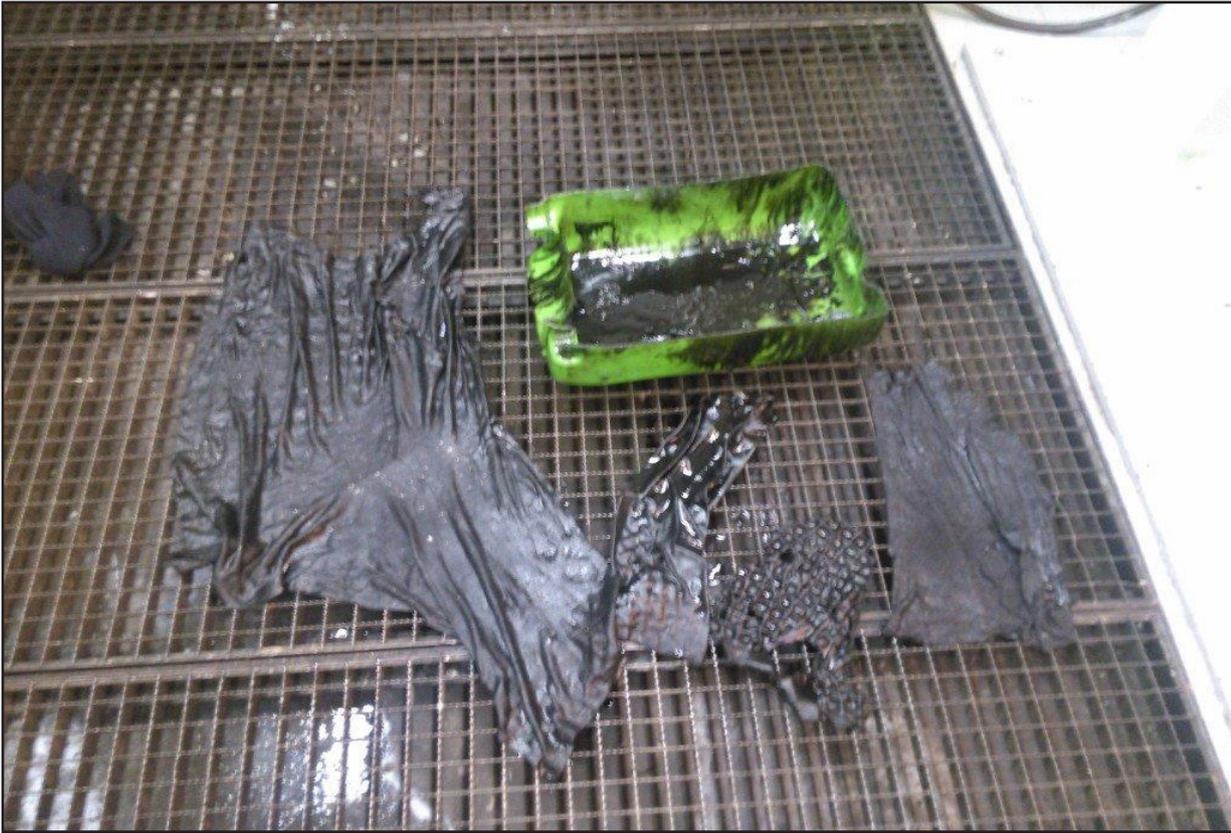
Figure 1: Rags found in the drain tank

1. Tanks and engine crankcases should not be left open after work has finished. Before being closed, they should also be thoroughly inspected to ensure that no detritus or tools are left behind. Ideally this should be done by someone not involved with the work being carried out.
2. Prompt and appropriate responses to machinery alarms are necessary if damage to equipment is to be prevented. This requires the on-watch engineers and the bridge team to have a good understanding
- of the propulsion system and to be well drilled in the event of an alarm or breakdown.
3. Anchoring and returning alongside following mechanical problems inevitably causes delays. However, it is better to be late than to not reach the intended destination through 'pressing on' until a problem is sorted. Tug assistance and engineering expertise are easier and less expensive to access in port than they are elsewhere.

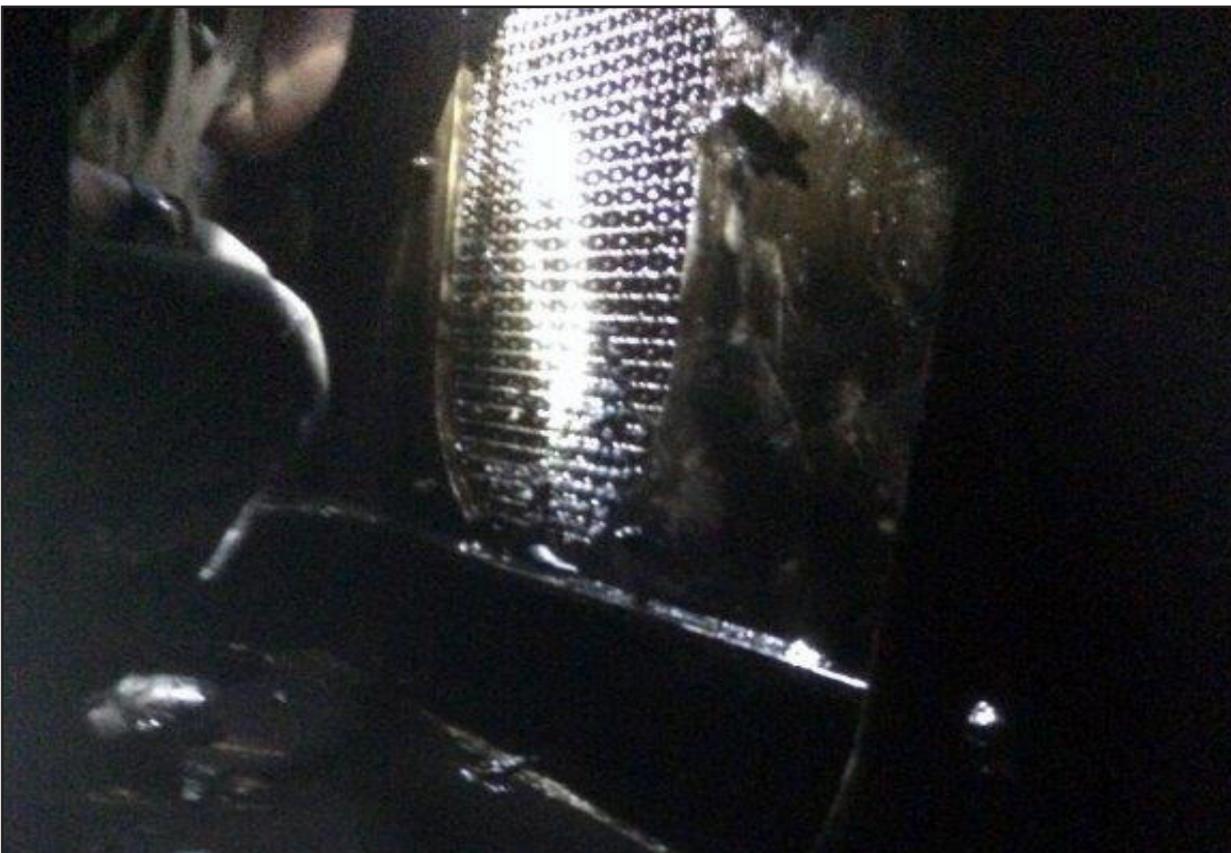
Figure 2: Sump grid

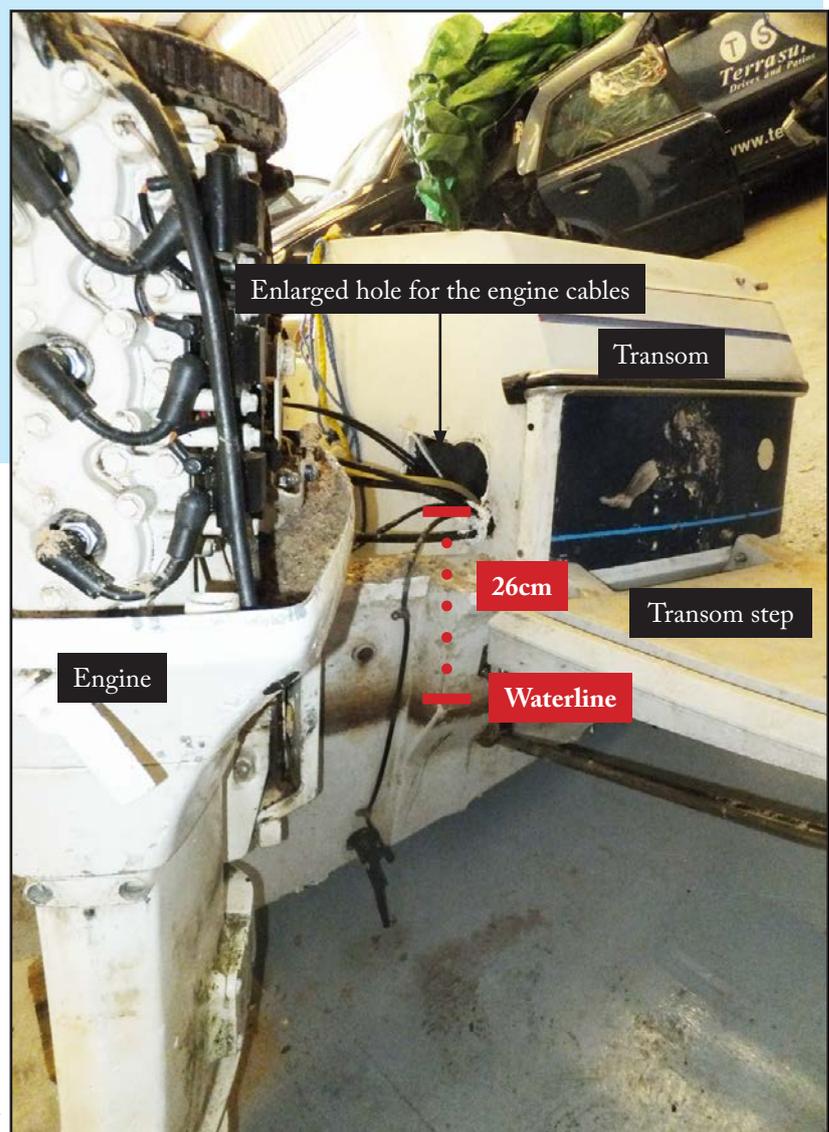
Figure 2: Stern view showing enlarged hole cut in transom for engine cables

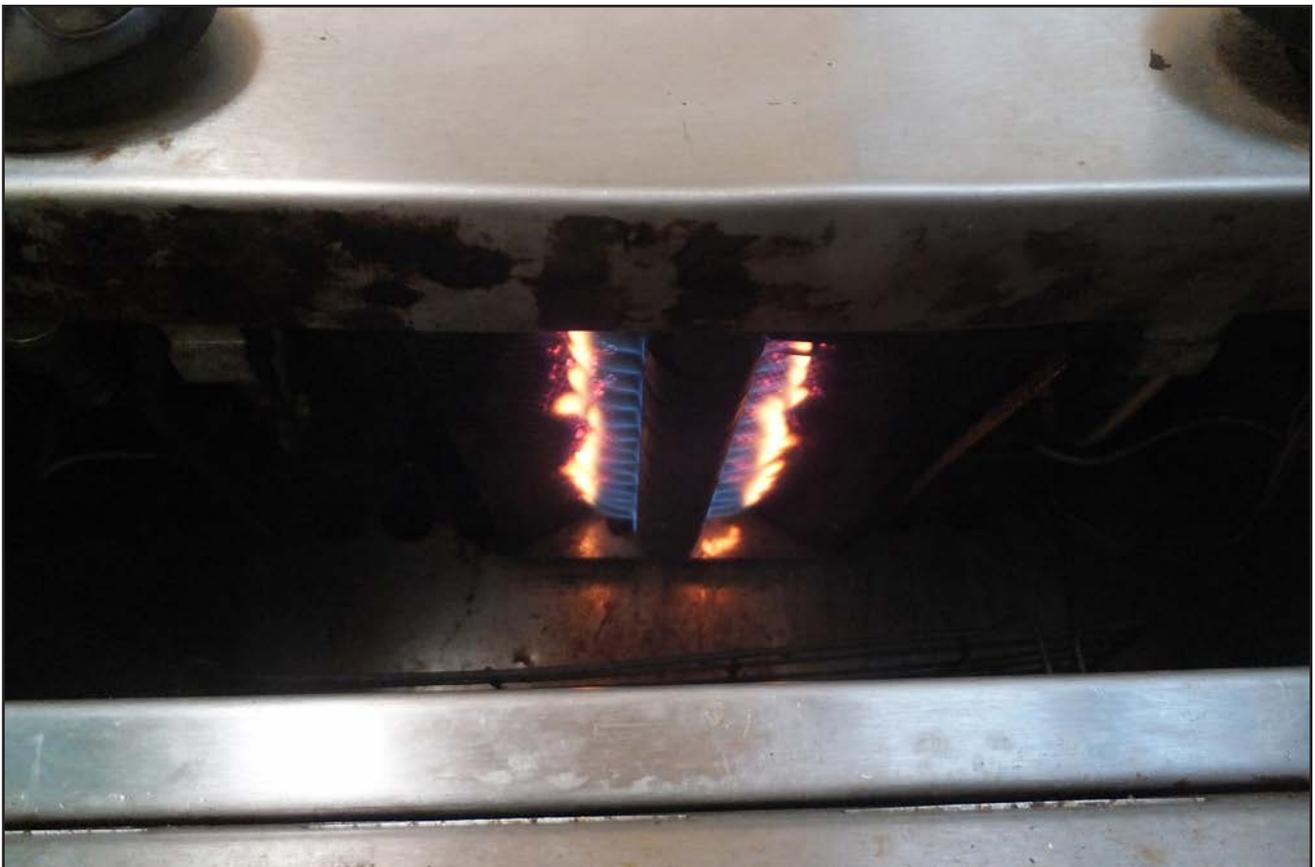
The deceased had left the grill lit overnight to heat the wheelhouse and the accommodation. The grill was corroded (see figure) and emitted high levels of CO. Another crewman, who had recently left the dredger, had shown the symptoms of CO poisoning a few days earlier. A CO detector was not fitted.

Corroded grill

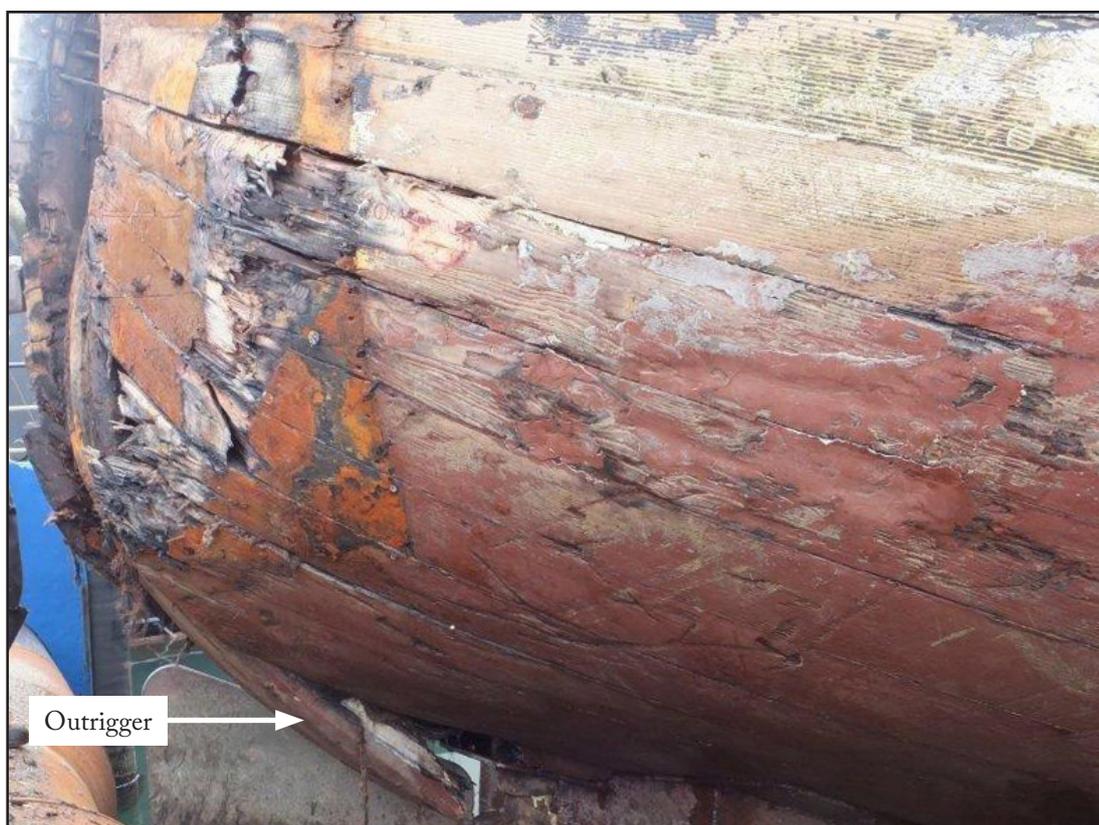
Figure 1:
Stern damage

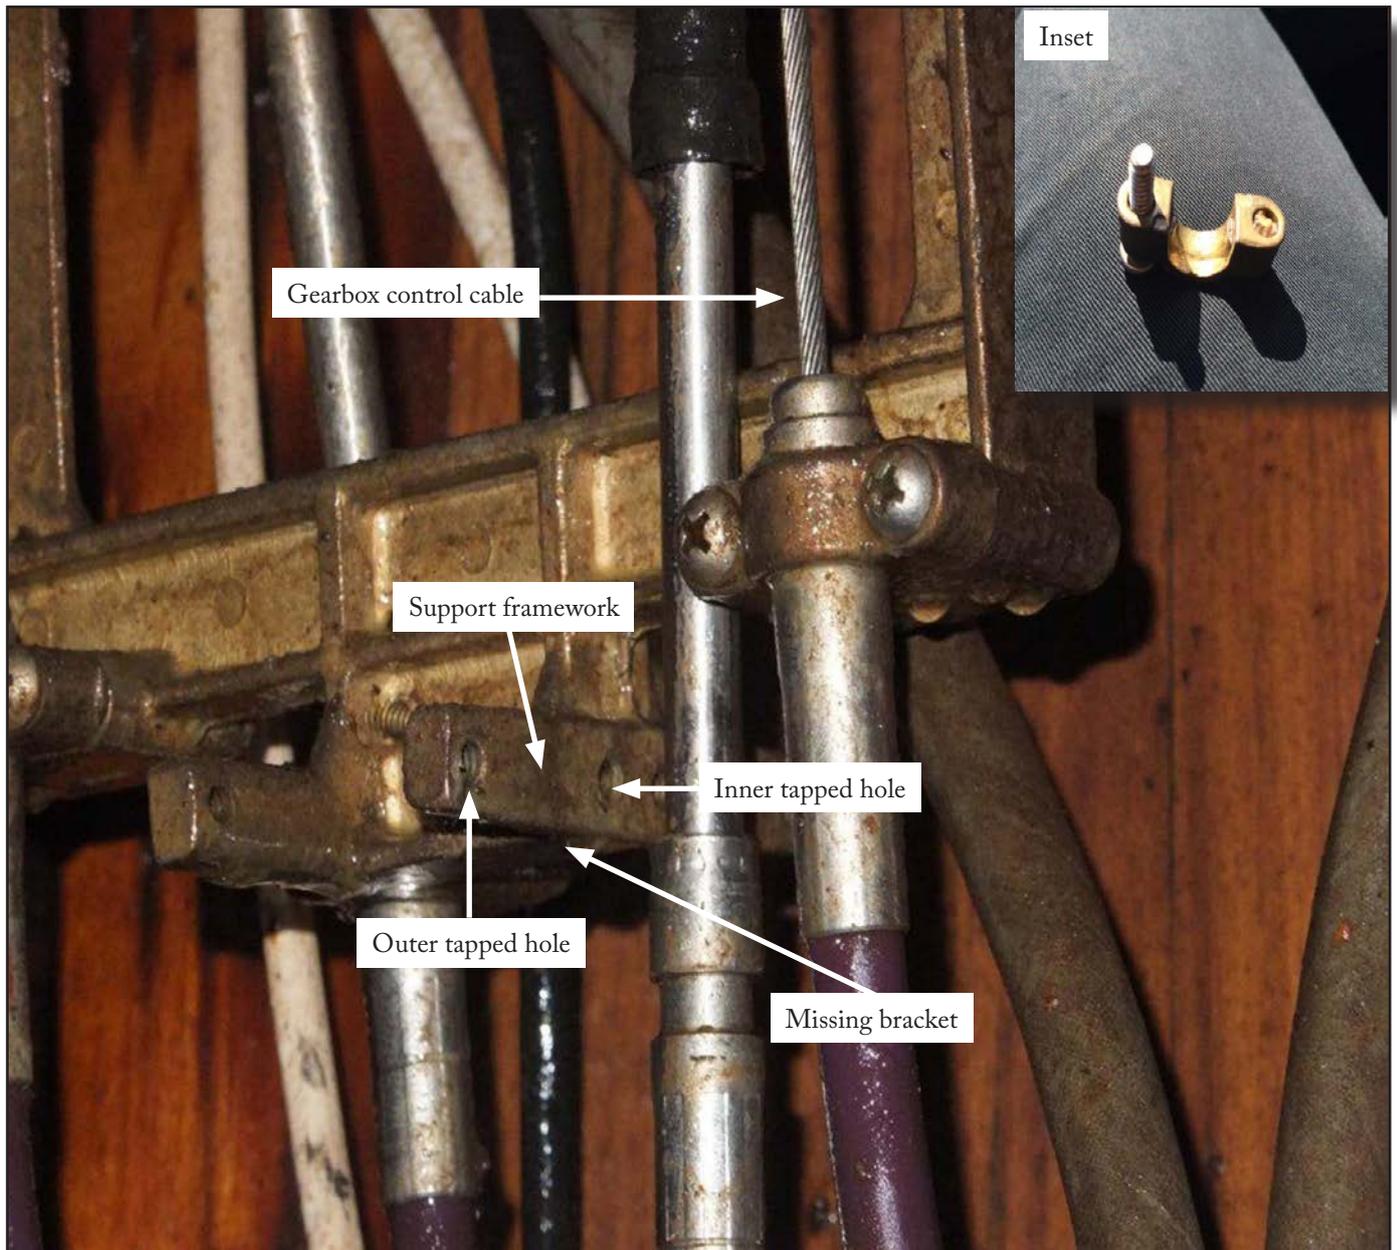
The trawler was eventually re-floated (Figure 2) and an investigation discovered that the loss of control was due to a clamp, used to secure the Morse cable between the control lever in the wheelhouse and the engine and gearbox, detaching from supporting framework (Figure 3). The clamp had been secured with one rather than two screws as intended (Figure 3 inset) and the lone screw had worked loose and had fallen out.

Figure 3: Support framework and detached securing bracket (inset shows clamp secured with one screw)

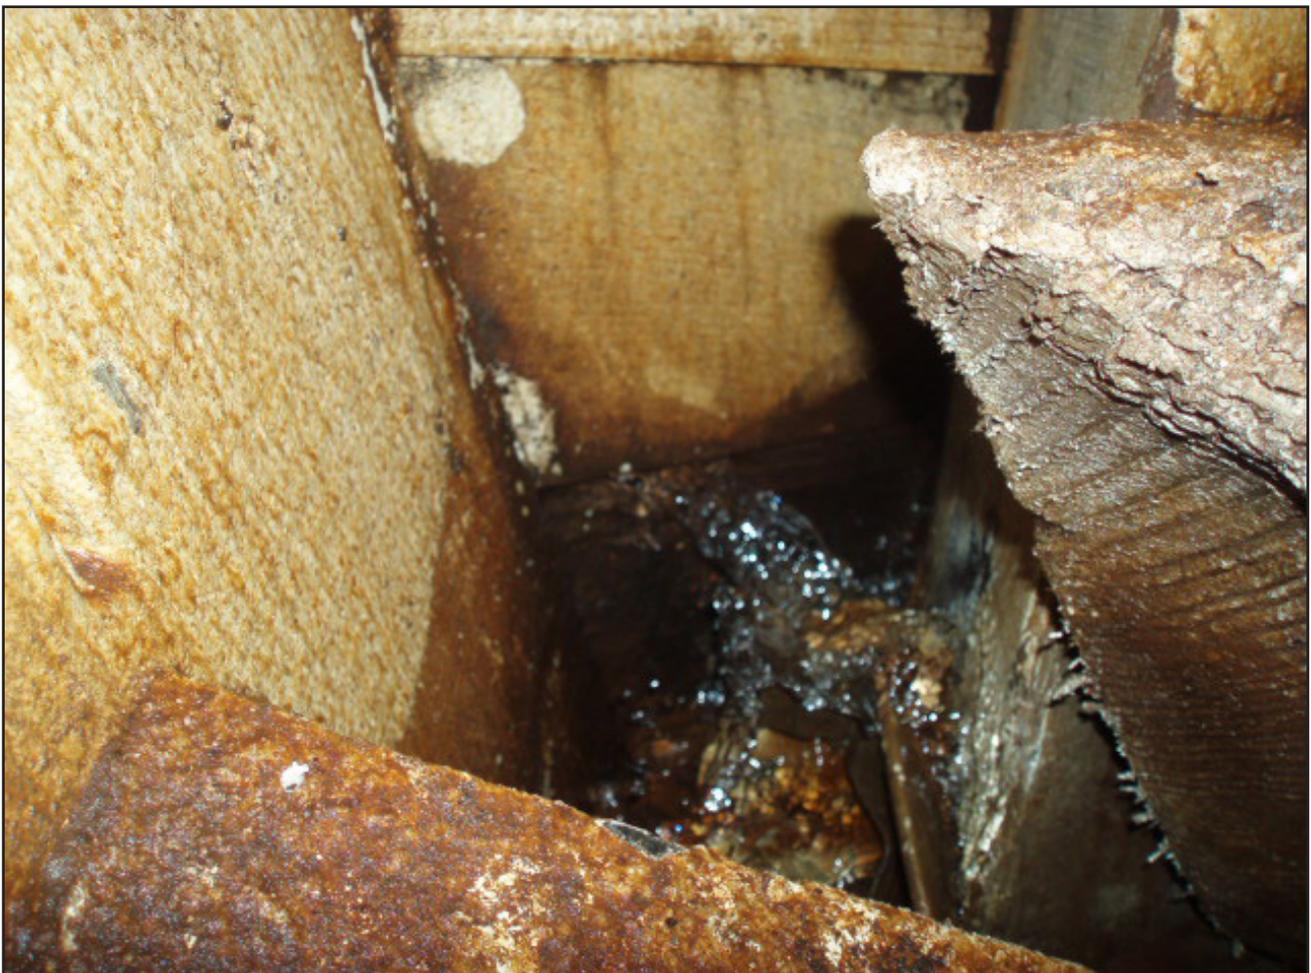
When the trawler had been on the slipway, the sun had dried out the caulking around its stem. The caulking eventually fell out, leaving gaps of approximately 6mm between the planking, which allowed seawater to penetrate into the forepeak and beyond (see figure).

Water ingress between the planks
