MARINE ACCIDENT
INVESTIGATION BRANCH

SAFETY DIGEST

**Lessons from Marine
Accident Reports
1/2019**

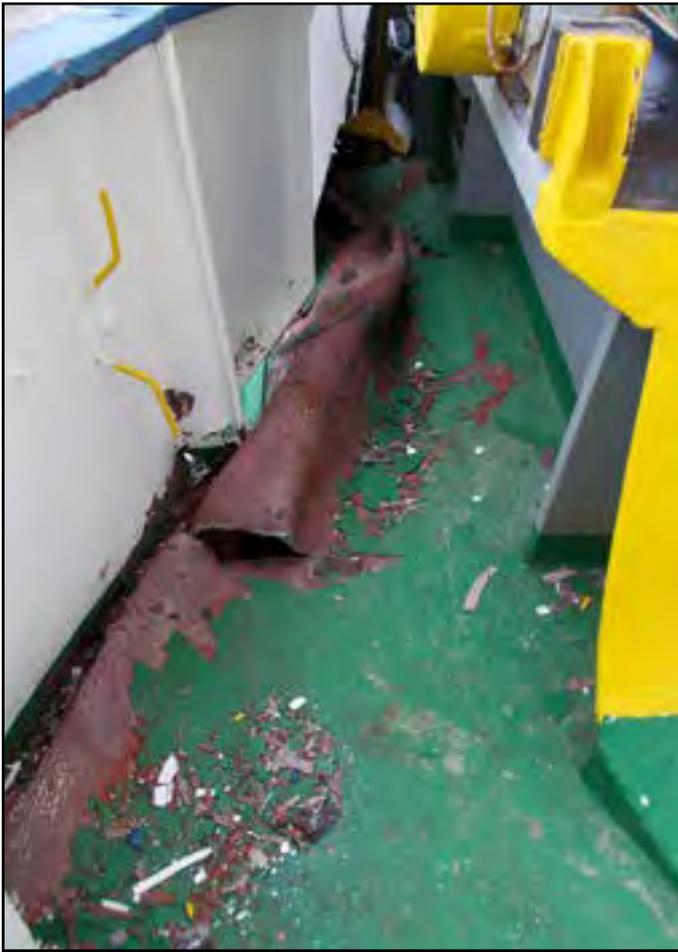
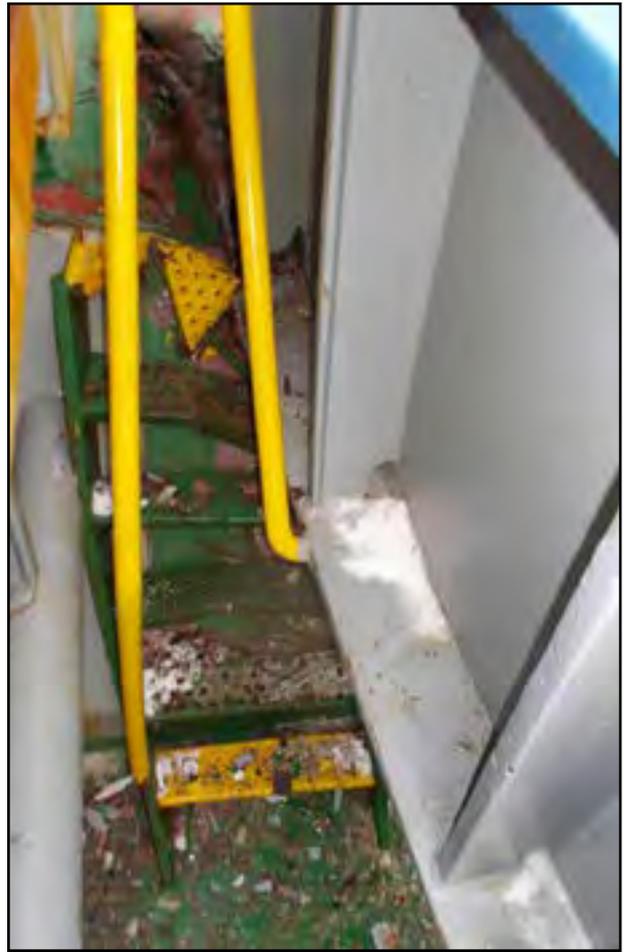
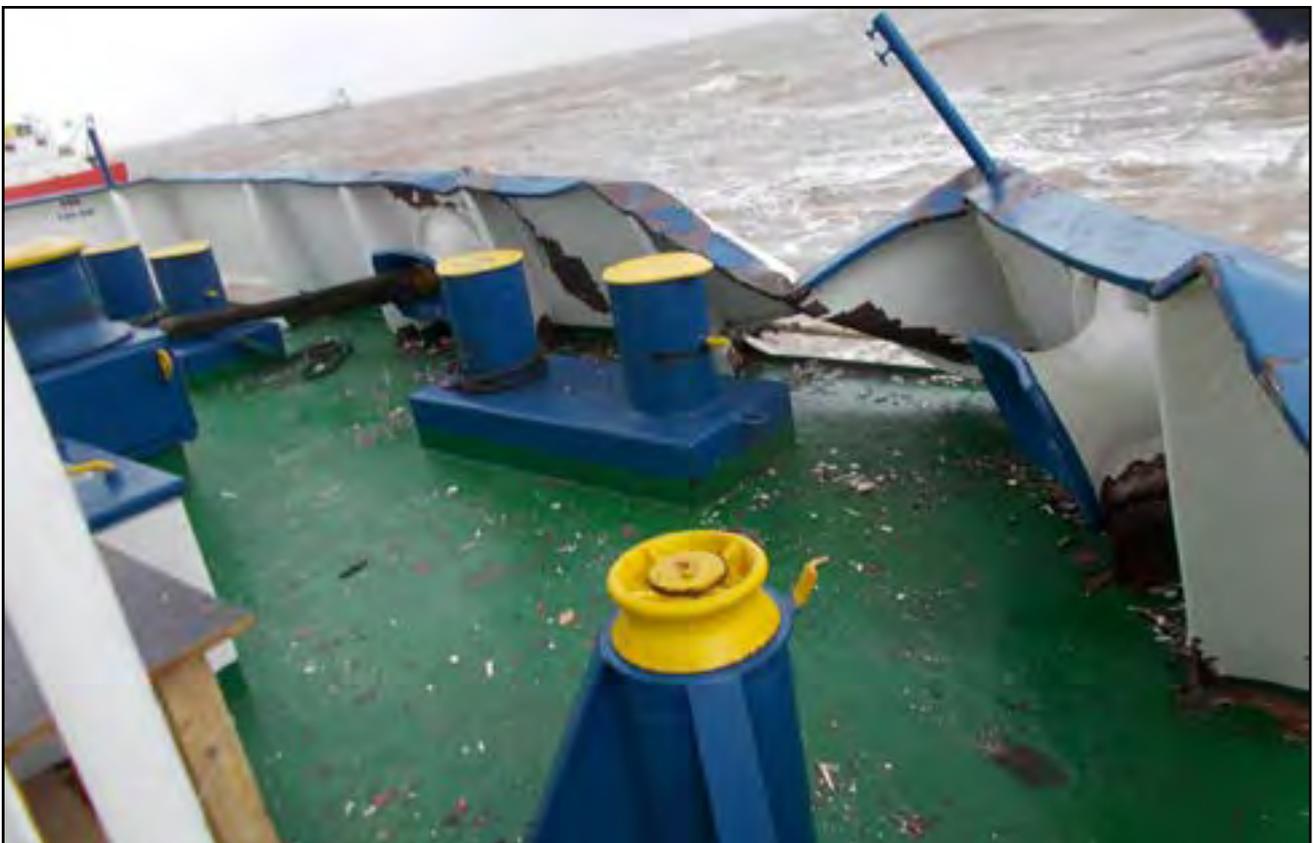
By the time the cargo vessel's engineer had dressed and started the main engine it was too late to avoid a collision. The cargo vessel struck the other vessel at anchor, which then also started to drag. Both vessels then collided with a third vessel, which was also at anchor. Nobody was injured but all the vessels sustained damage (see figure).

Figure: Damage to the small cargo vessel

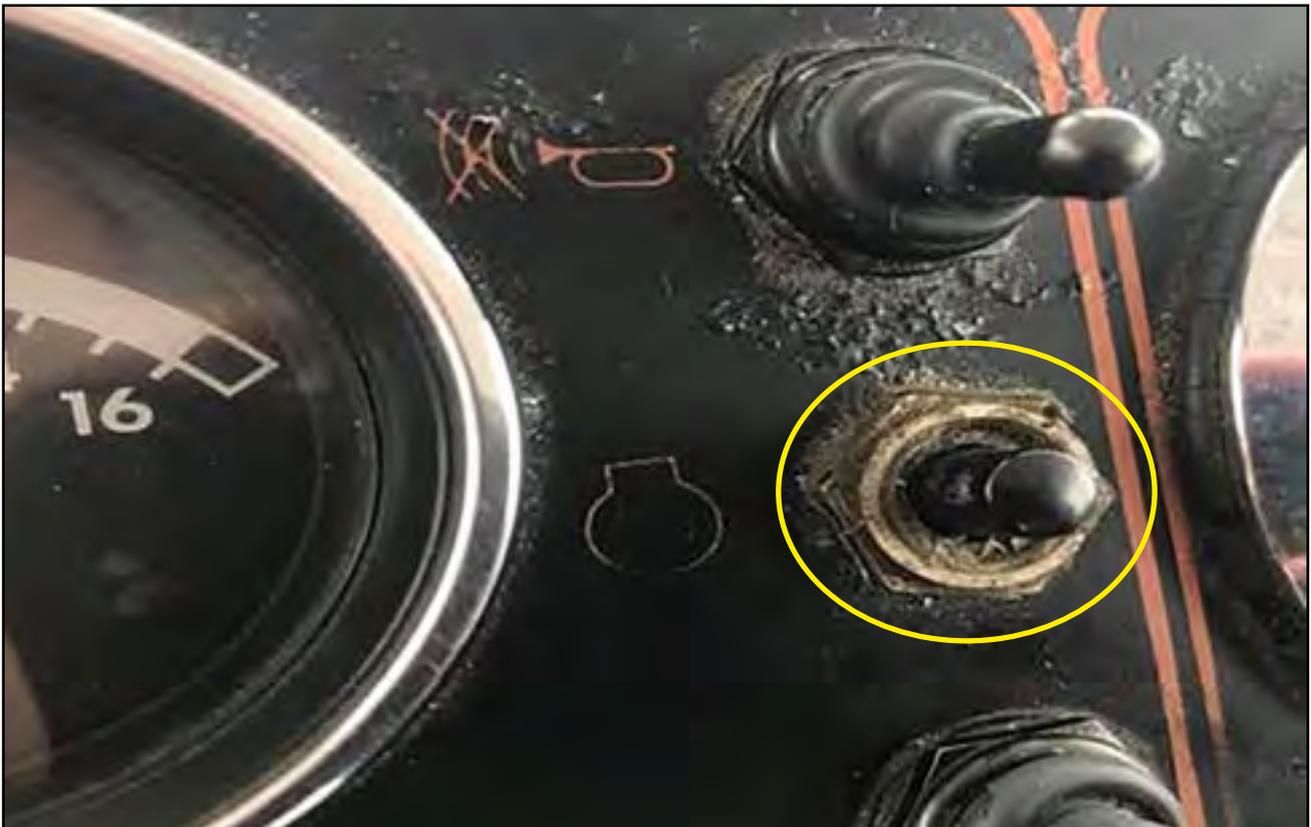
Post-fire examination of the port main engine and its electrical starting system identified an intermittent fault on the wheelhouse engine starter button (Figure 1). This allowed the engine starter motor solenoid to remain energised, and to overload and ignite the electrical cabling (Figure 2).

Figure 1: Main engine starter button

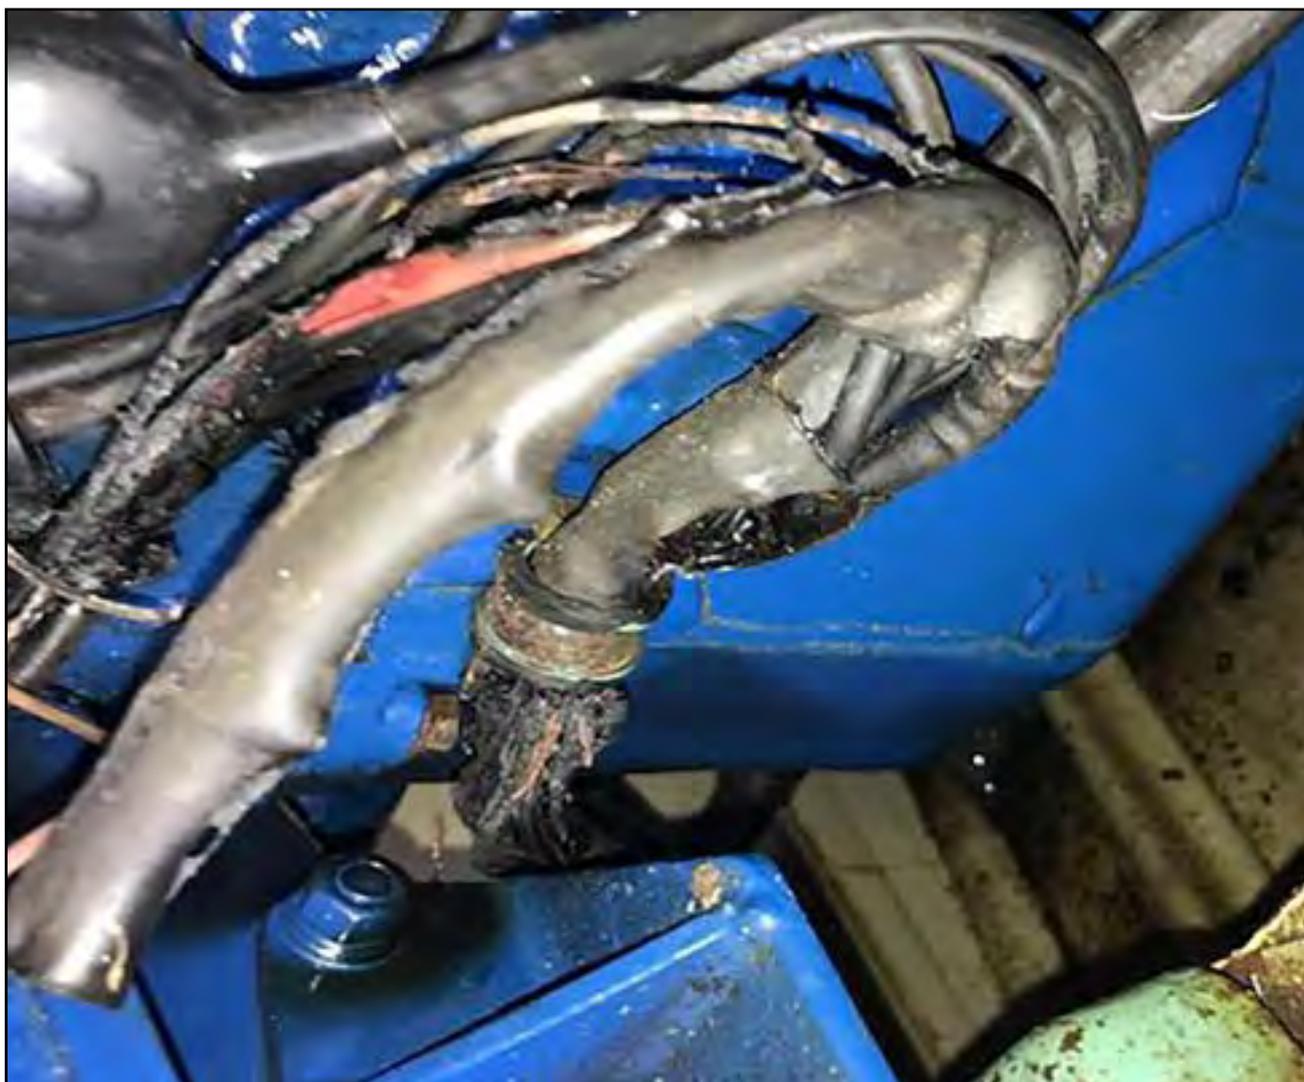
Figure 2: Heat damage to electrical cabling

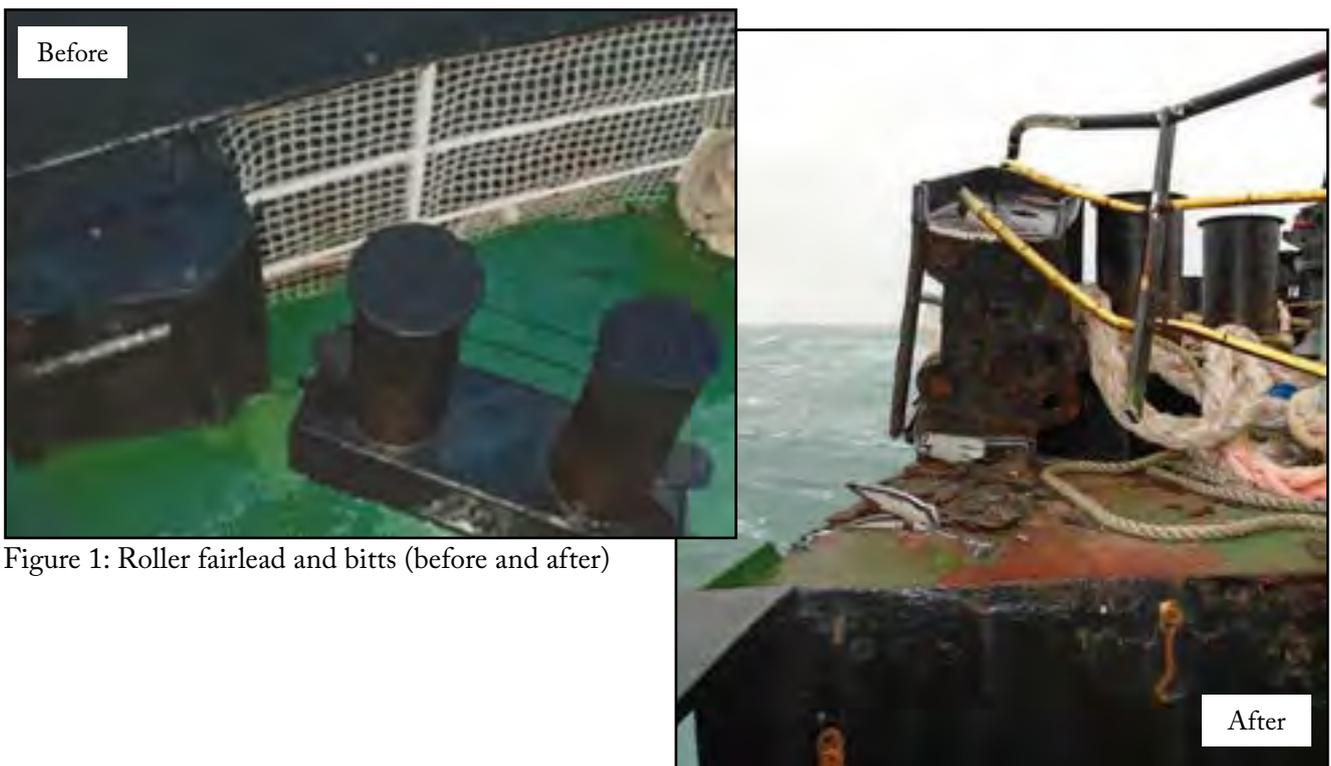
A passenger ferry was attempting to moor on a berth with a strong groundswell in strong winds when, without warning, one of its mooring line bollards was ripped from the deck. The ferry had to be taken out of service for several days to facilitate repairs to its deck plating and a roller fairlead (Figure 1). Fortunately, nobody was injured.

eye spliced at each end. The minimum breaking load (MBL) for the 48mm, 64mm and 80mm ropes was 43t, 75t and 116t respectively. The safe working load (SWL) of the damaged bollard and roller fairlead was 20t and 12t respectively.

It was evident that the forces acting on the mooring line - because of the combined effects of the wind and groundswell - did not reach its MBL but significantly exceeded the SWL of the vessel's deck fittings. This happened because the SWL of the deck fittings had not been properly considered when the size of the mooring line was increased.

Figure 1: Roller fairlead and bitts (before and after)

3. Vessel operators and crew should ensure that mooring line strength does not exceed that of the load limitation of installed mooring equipment such as deck bitts/ bollards, rollers, fairleads and winches. It is recommended that ships' staff make themselves aware of load limitations of equipment and mooring ropes used before using a rope that deviates from that included in the design of the vessel.

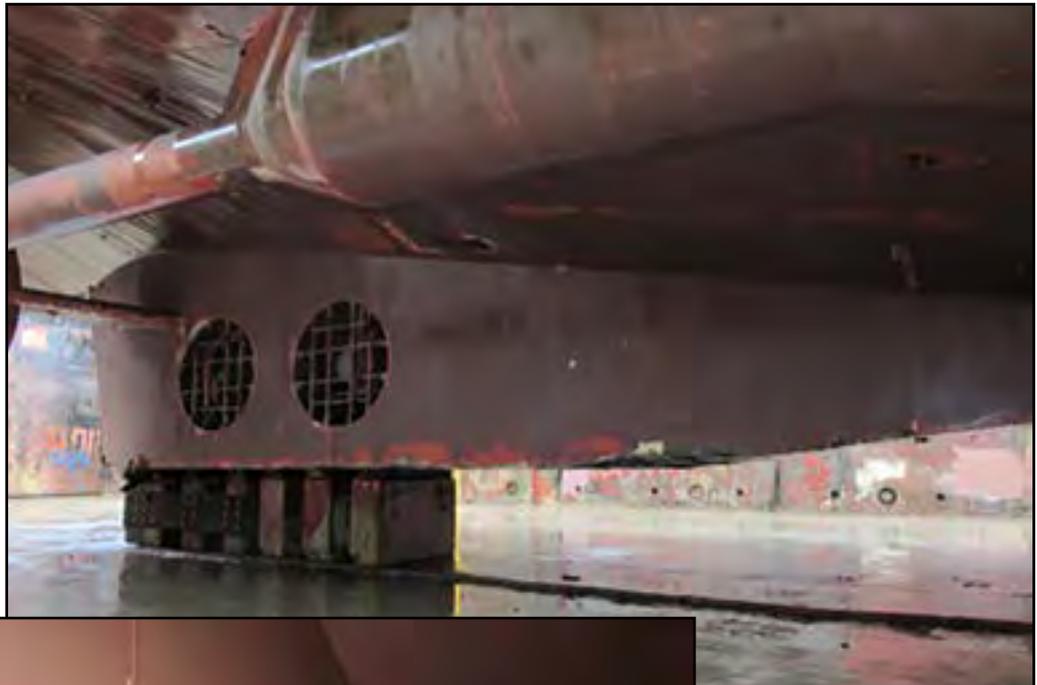
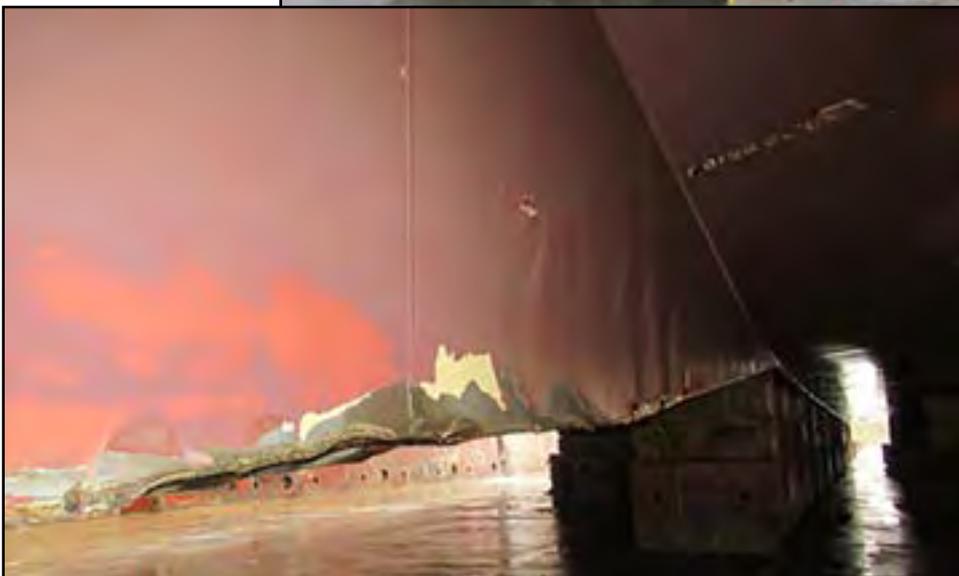
Later, the divers conducting the planned underwater hull inspection saw that the vessel's skeg was damaged. The master was uncertain how this had occurred, and reported to the VTS the vibration felt during the inbound passage. Review of the vessel's position during entry, along with the height of tide, identified that the vessel had been on its intended track. However, it also identified that, because the inbound passage was 1 hour later than intended, and the height of tide was 0.4m less than predicted, insufficient water had been available. The vibration felt during the starboard turn resulted from the vessel taking the ground towards its stern. The damage to the skeg (see figure) required the AHTS to be dry docked for repairs.

Figure: Damage to keel

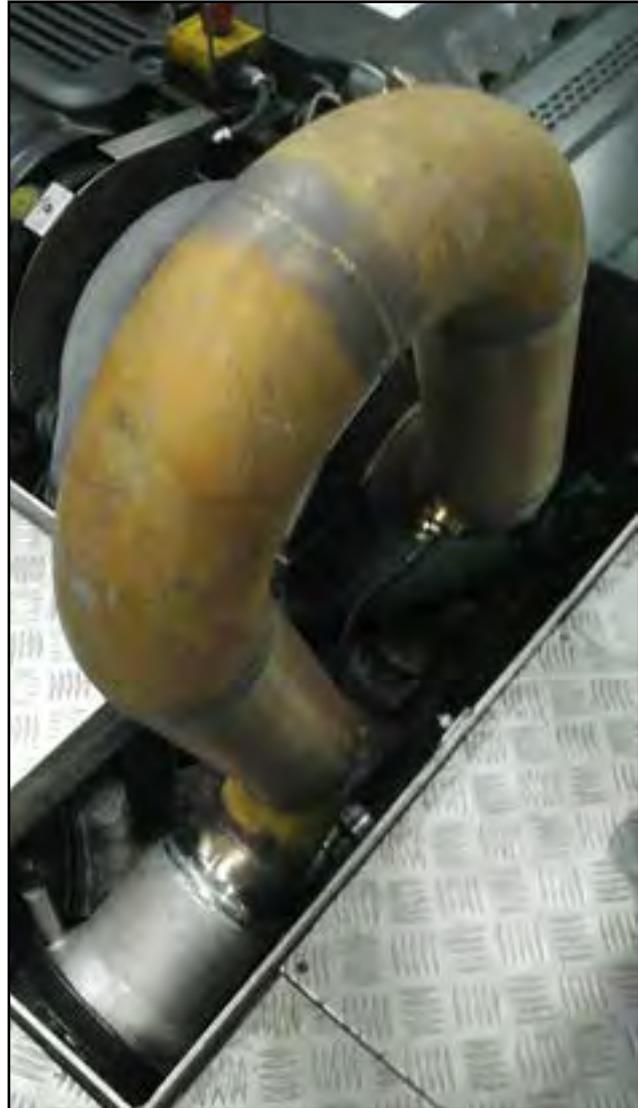
The engines had a history of exhaust pipe cracking and the starboard engine exhaust pipe had been replaced 20 days before the accident, but its lagging had not been refitted. The vessel had a wet exhaust system and the exhaust pipe was raised above the sea level as a precaution against water flowing into a stopped engine.

Figure: Starboard engine exposed exhaust pipe

1. Exposed surfaces with temperatures above 220°C are prohibited by SOLAS regulations as they are fire hazards.
2. If it is necessary to remove exhaust lagging for access, always ensure it is refitted as soon as the work has been completed.

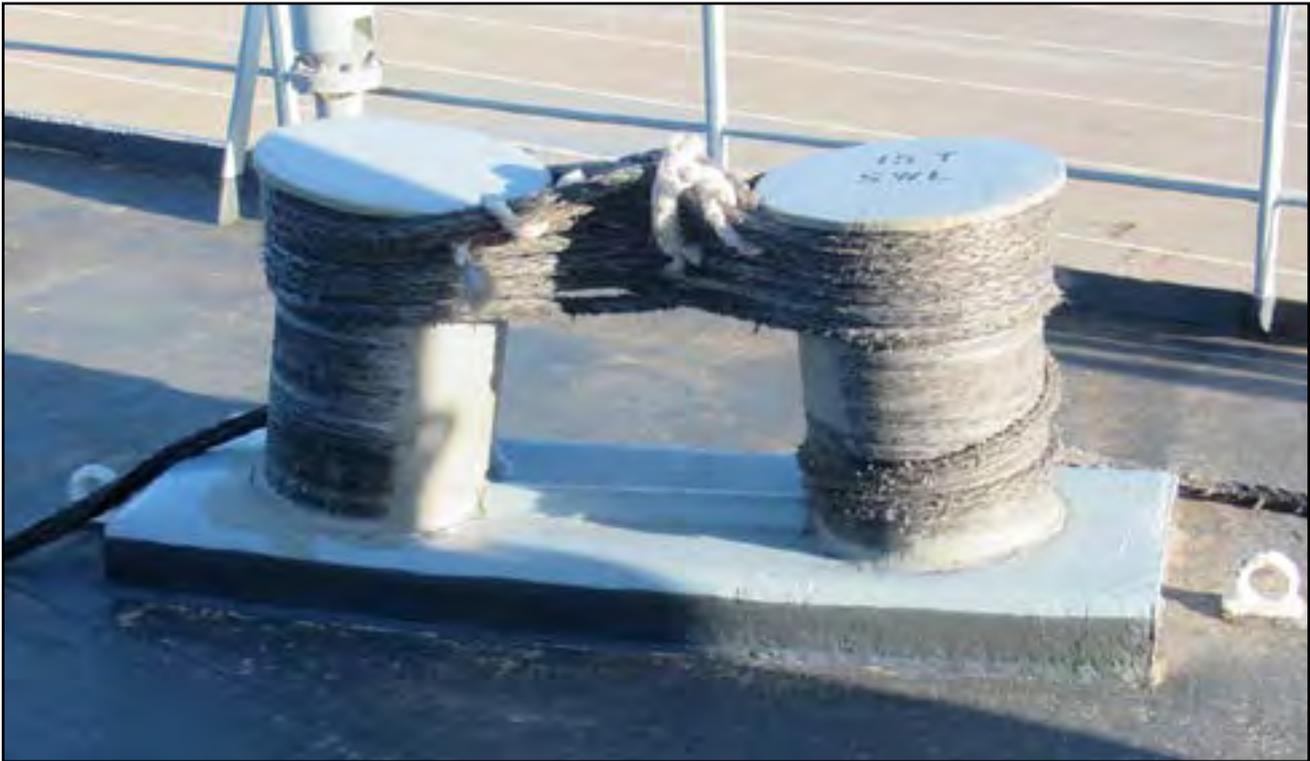
Figure 2: Damage to mooring bitts following surging alongside berth

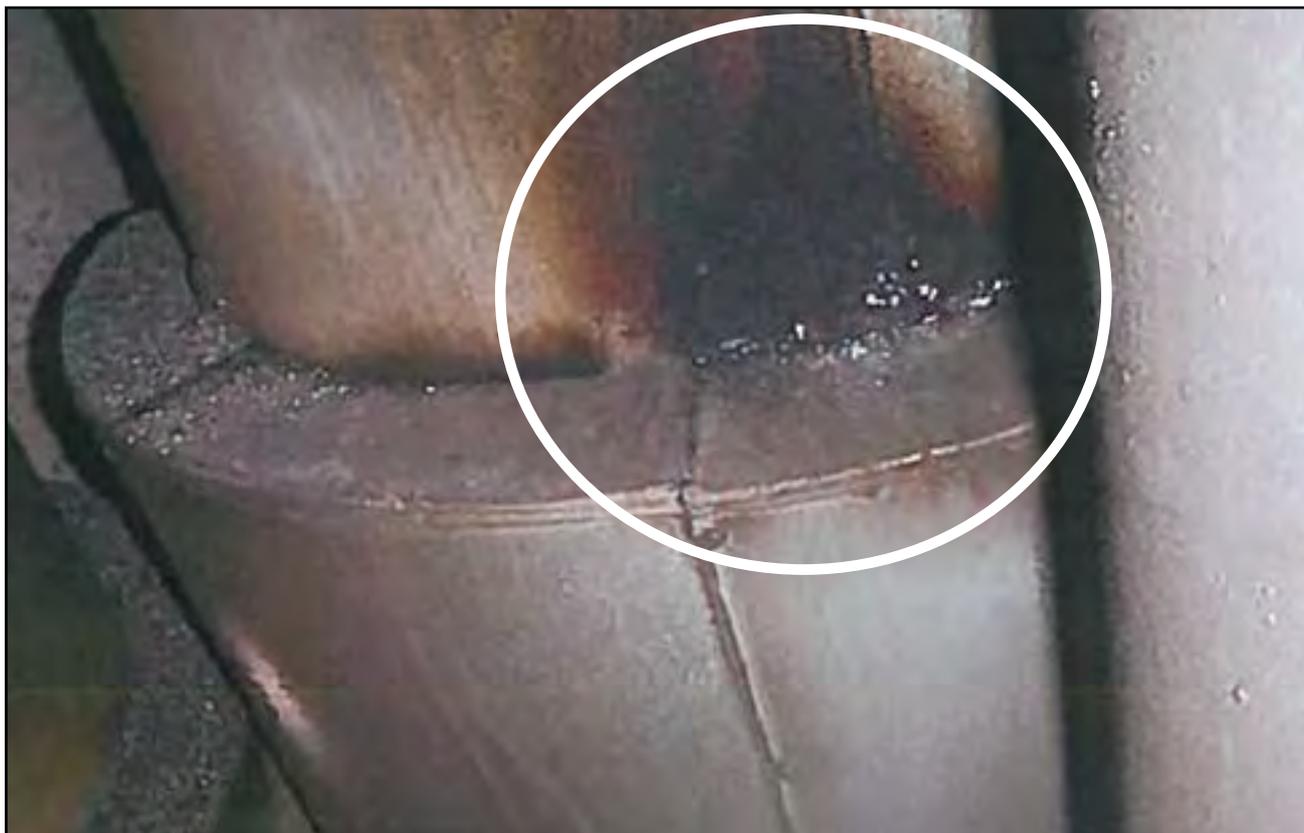
The ship immediately went to emergency stations and diverted to anchor to allow the propulsion system to be shut down. When the ship's teams, wearing fire suits and breathing apparatus, entered the funnel, they found that the source of the smoke was an exhaust gas leak from a loose flange. The sparks had been caused by the hot exhaust gas charring the funnel insulation material (Figure 2).

Figure 2: Damaged area of exhaust lagging

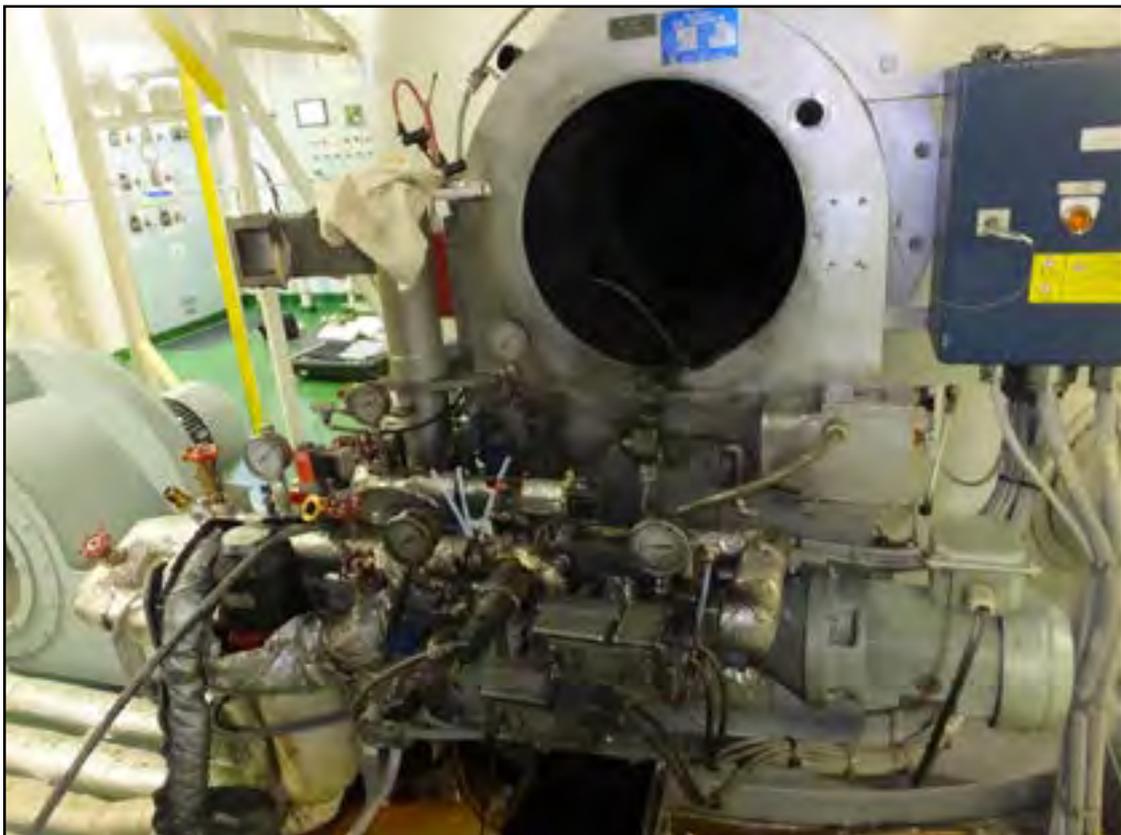
The force of the explosion blew the burner unit off the front of the boiler (Figure 1) and released a fire ball. The motorman was standing directly in front of the burner unit and took the brunt of the explosion. The second engineer was caught in the fire ball, but was able to raise the alarm and attempted to revive the motorman. As the vessel was alongside, shoreside medical teams were quickly on the scene, but they were unable to save the motorman.

Figure 1: The damaged boiler

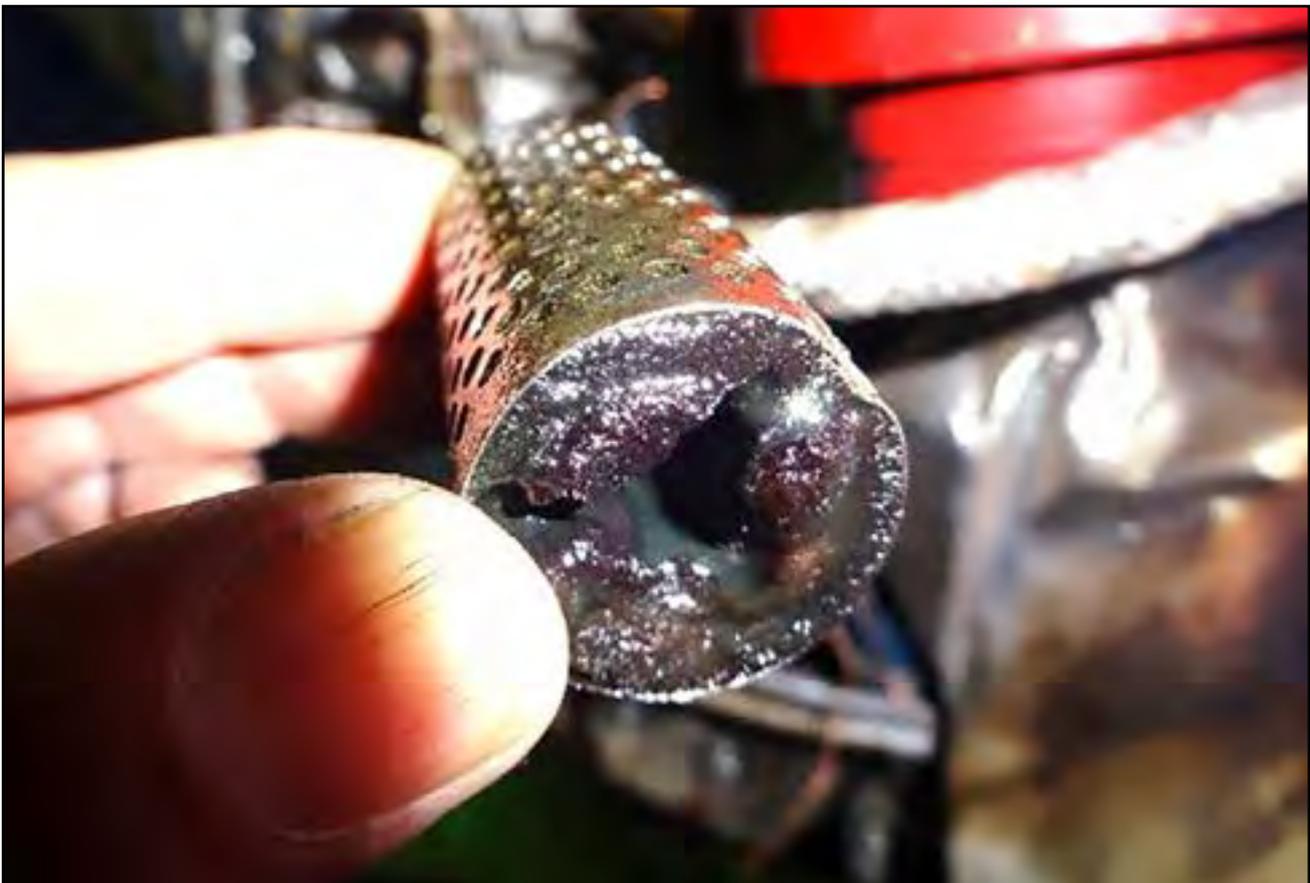
3. Analysis of the low sulphur fuel in use identified it as a summer grade MGO with a Cold Filter Plugging Point (CFPP) temperature of 14°C, indicating that the fuel could become waxy and block filters at 14°C and below. The external ambient air temperature was 4°C, and 9°C in the vicinity of the boiler. Although the fuel had met the international standard test criteria at the time of bunkering, its CFPP was not assessed. Ensuring fuel is suitable for all expected operating conditions in which the vessel may operate is critical to its safe use.

Figure 2: Waxy deposits in fuel line filter

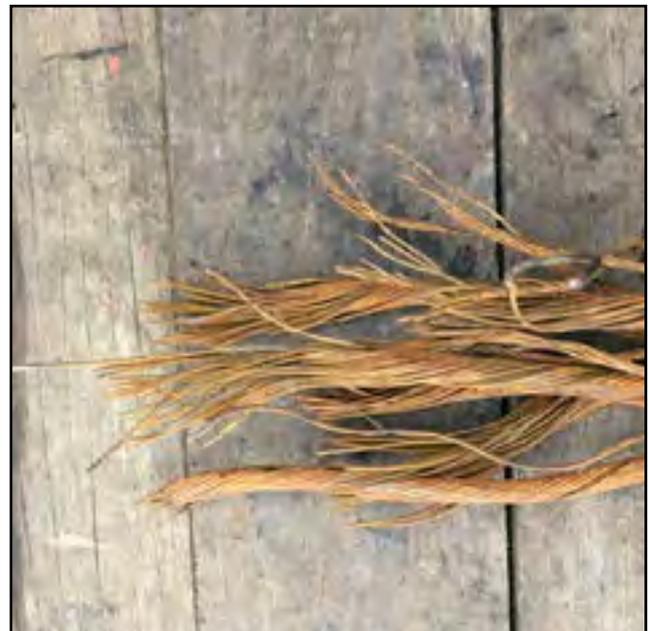
Figure 1: The broken towing wire

1. The towing wire failed as the tug's anchor was being heaved. The tow line failed in the vicinity of the hard socket on the eye of the towing wire. Subsequent destructive testing of the towing wire showed that it parted at a significantly lower load than expected. The towing wire had a certified minimum breaking load of 102.95t; during testing it began to fail at 64t and parted at 87.74t.
2. An inspection of the towing wire identified that the wire was rusty, and flat spots and areas of wear were identified. However, the towing wire was 7 years old and had been inspected regularly by the ship's master as required by the company safety management system. No defects or damage had been recorded.

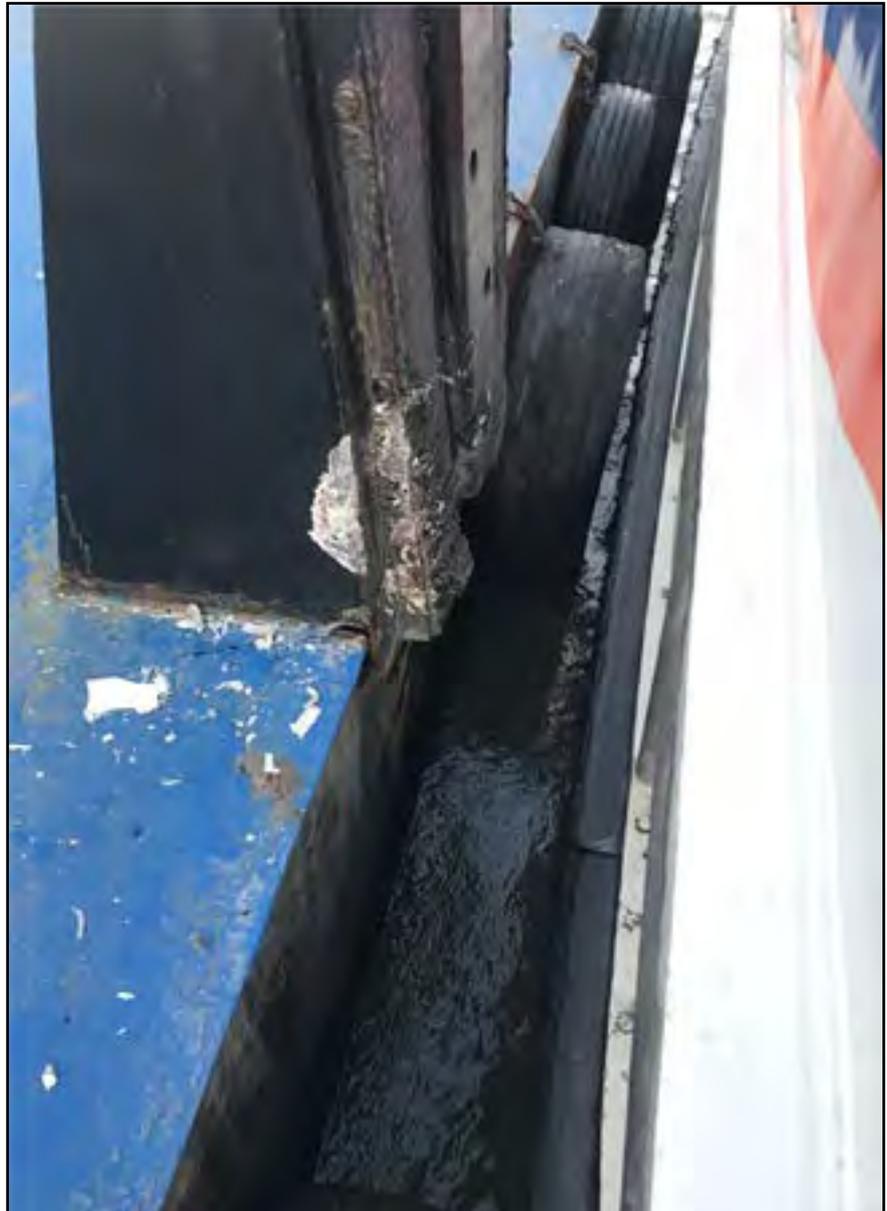
The ferry struck the pontoon (Figure 1). Most of the passengers and crew were seated at the time of the impact, but those who were standing were thrown forward, with two passengers and two crew suffering minor injuries. Damage to the ferry's port bow above the waterline (Figure 2) required it to be taken out of service for repair.

Figure 1: Damage to pontoon

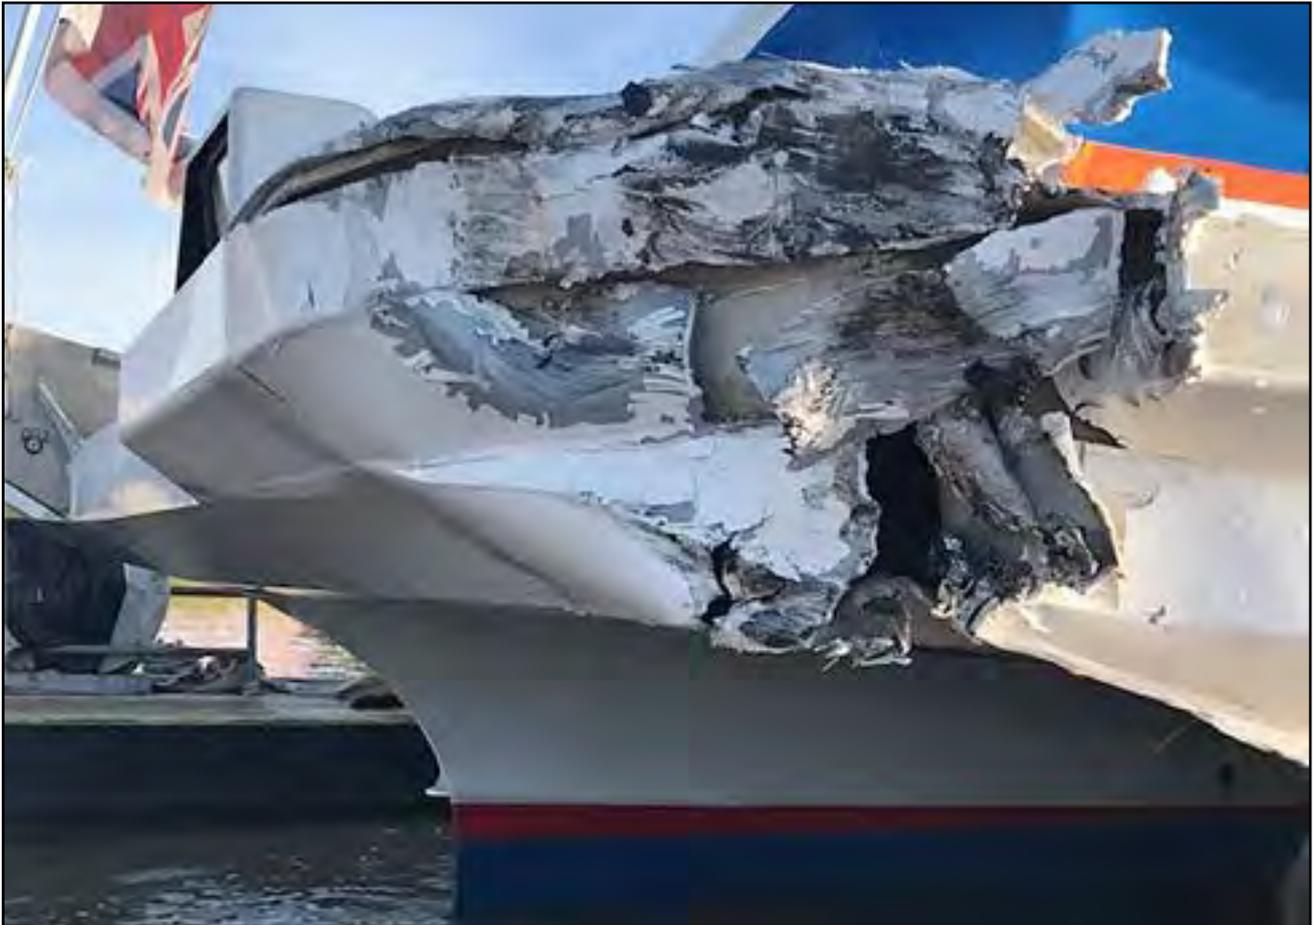
Figure 2: Damage to bow of ferry

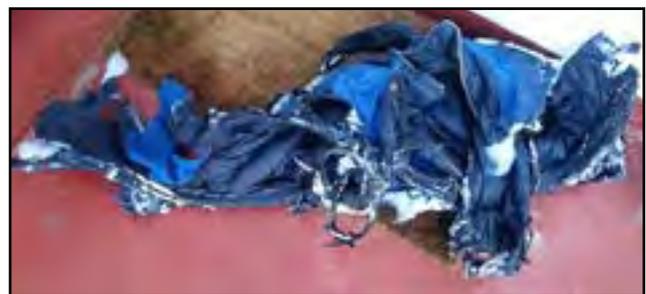
(Figure 2) onto his skin and he suffered severe burns to his head and body. He staggered out of the store and a crew member assisted him to the mess room. He was subsequently evacuated to hospital by a rescue helicopter. The chief engineer had suffered first degree burns to his face and second degree burns to his body, both hands and lower extremities. His recovery took several months.

Figure 2: The chief engineer's burnt waterproof coat

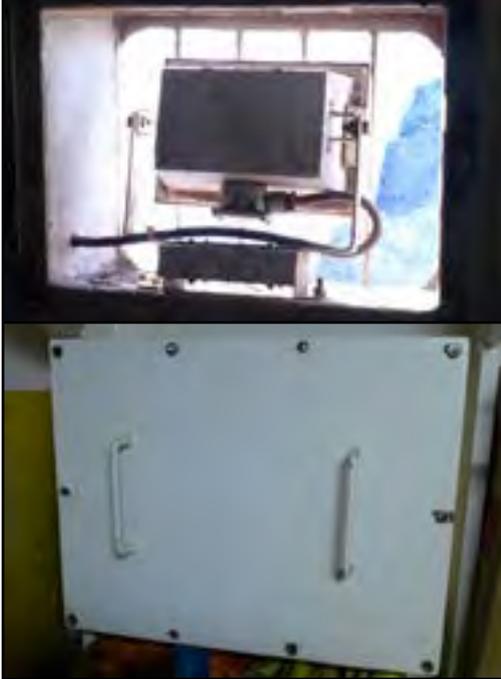
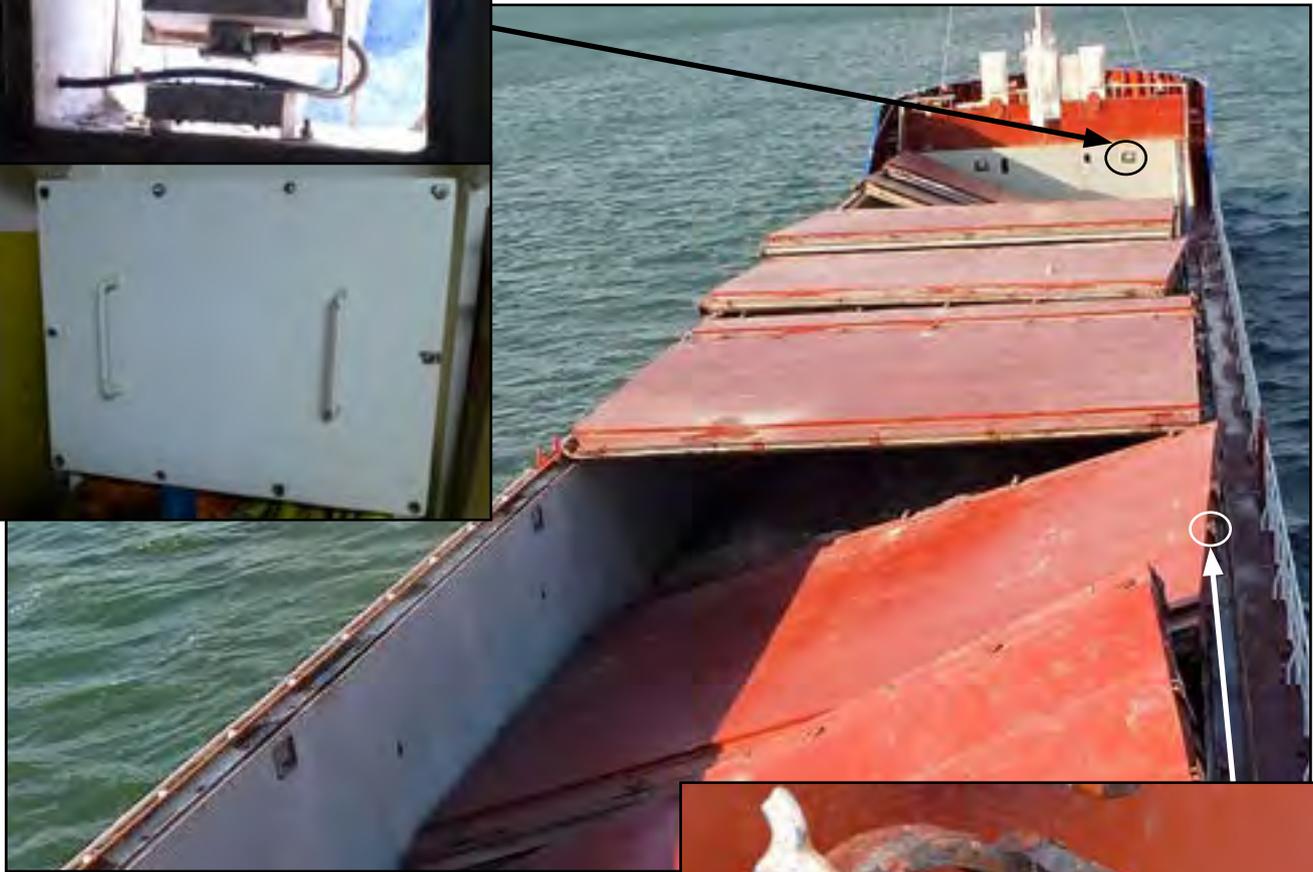
Figure 3: Damage caused by the explosion and the location of the cargo lamp access plate

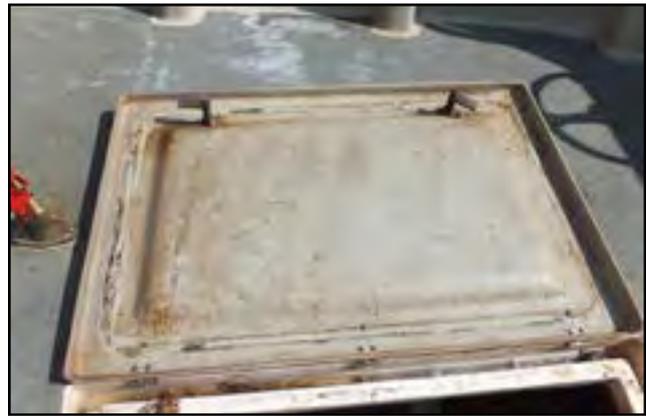
When the boat was recovered and beached a few days later, the deck hatch seals were found to be either missing or damaged (Figures 2 and 3). It is almost certain that while the deck had been awash, water had seeped down into compartments below and, although automatic bilge pumps were fitted in these, they failed to operate.

Figure 2: Missing hatch seal

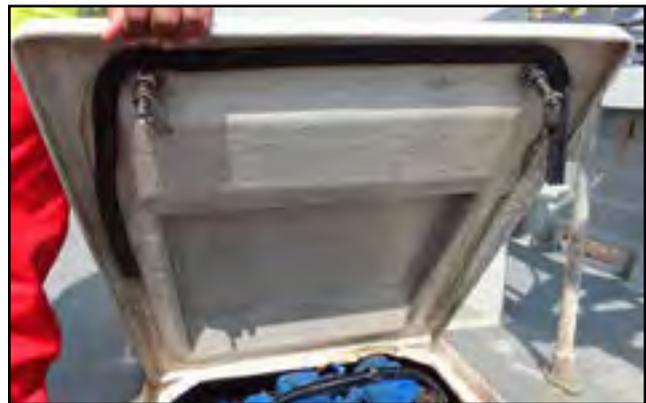
Figure 3: Damaged hatch seal

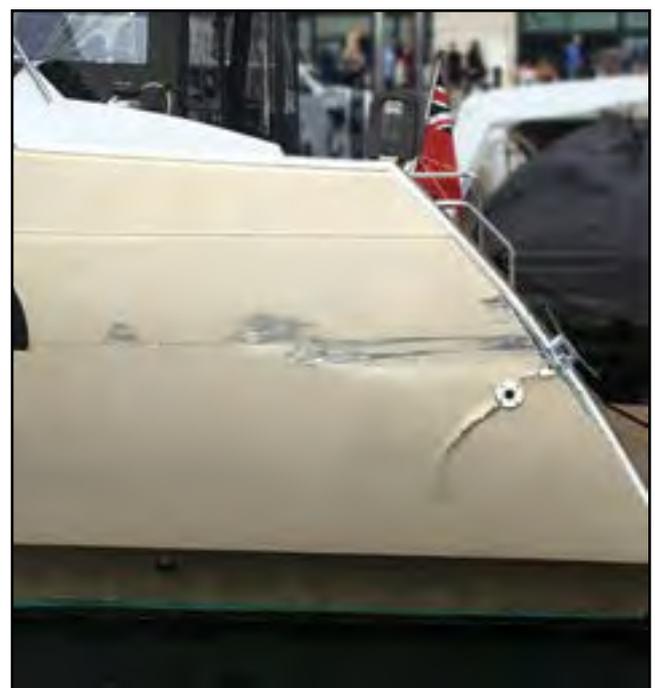
The skipper made a "Pan Pan" emergency radio call and checked that all the guests were safe. Soon afterwards, a harbour patrol boat and the inshore lifeboat were on hand to help the catamaran safely alongside. There were no injuries but the catamaran was damaged by the collision (Figure 2).

Figure 2: Collision damage to the catamaran's port quarter

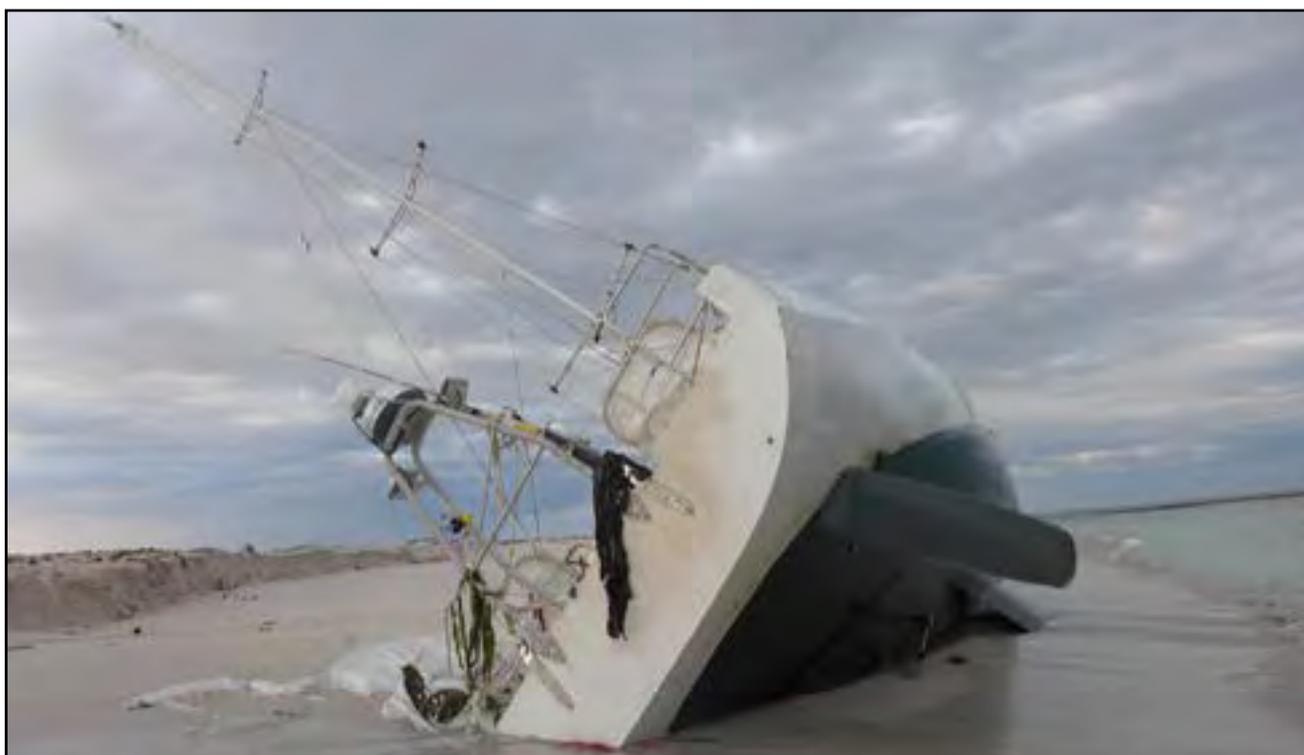
The skipper had been monitoring the situation and realised that the yacht needed to be turned away from danger. However, soon after this turn was made, the yacht grounded and could not be freed. There was a delay of nearly an hour in alerting the coastguard; however, once they had been alerted, all the yacht's crew were rescued into lifeboats. The yacht could not be salvaged and was cut up on the beach where it had grounded (Figure 2).

Figure 2: The stranded yacht on the beach

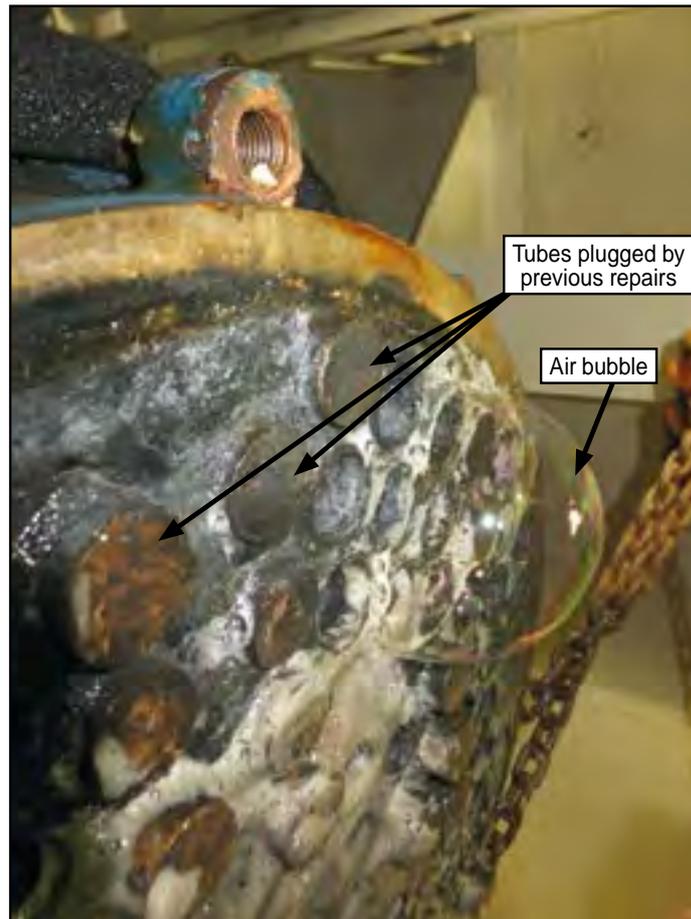
Figure 3: Starboard evaporator tube leak
