This *Safety Digest* draws the attention of the marine community to some of the lessons arising from investigations into recent accidents.

MARINE ACCIDENT INVESTIGATION BRANCH

Chief Inspector's Foreword	4
1 Check Your Lifejacket	6
2 Incorrect Use of Trawl Blocks Leads to Fatal Accident	8
3 Skipper Killed by Lifting Gear Failure While Alongside	10
4 The Tragic Outcome of Overloading	11
5 Cook's Crash Diet	12
6 Rude Awakening!	13
7 Steering Fault and Poor Lookout Cause Pair Trawlers to Collide	14
8 Quay Ladders Always Require Care	16
9 Heavy Weather Fishing – Fatal Accident!	18
10 Lookout! – Unfortunately Not	20
11 Lookout! – Unfortunately Not	21
12 Perished in the Darkness	22
13 NUC or Not?	23
14 Near Miss Leads to Grounding	24
15 Loss of Fisherman Within Harbour Breakwater	25
16 Can You See/Hear Your Bilge Alarm?	26
17 Bilge Alarm Success Stories	28
18 Back Rope Bights Back	30
19 The Price of Coronation Street	32

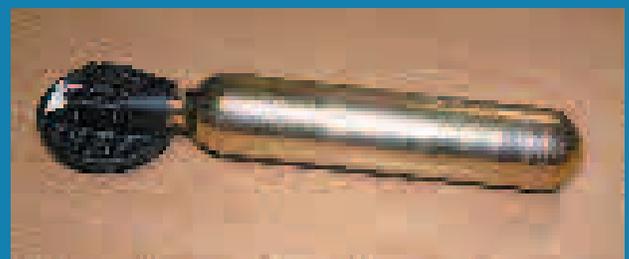
Before abandoning the sinking vessel, the five crew wearing lifejackets tried to inflate them manually by pulling the release toggles, rather than waiting for automatic inflation on taking to the water. Only one of the five lifejackets inflated.

The tests revealed that the lifejackets which had failed to inflate, had probably done so because the gas cylinders had become detached from the Hammar release units.

1 Fishermen and mariners who routinely wear inflatable lifejackets should ensure that the gas cylinders are firmly tightened into the release units. Owners of lifejackets fitted with Hammar release units are particularly urged to make this check, and should also carry out the safety checks listed in the booklet issued with every lifejacket:

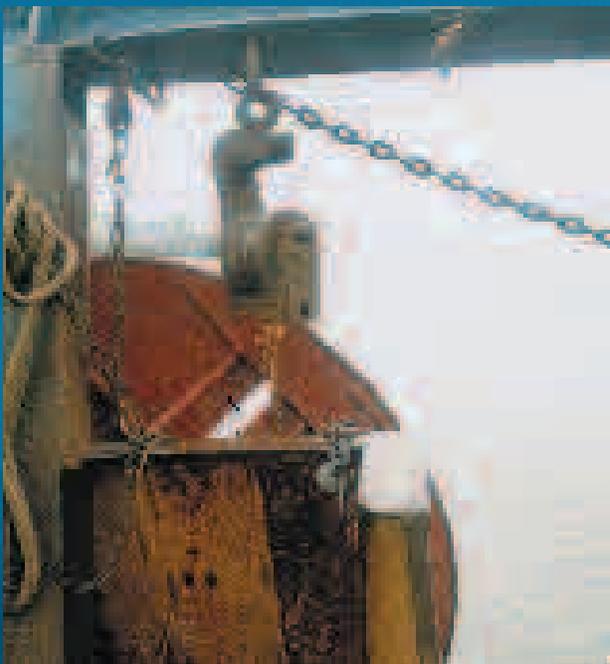
The snatch blocks being used on the aft gantry to lead the trawl wires over the stern, were being used in the open condition. Because of the general condition of the blocks, and the lack of any locking pins, they were unable to be used in the correct manner anyway.

1 Snatch blocks must always be operated in the correct manner, with the cheek plate closed. Although at times it may be convenient and time saving to operate them in the open position, this accident proves the consequences of doing so can sometimes be fatal.

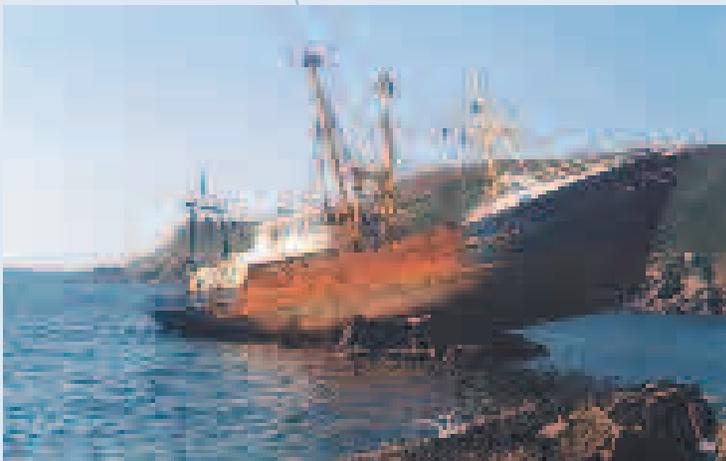
The crewman's last recollection was noting the GPS showing 12 miles of the passage remaining. He was woken when the vessel grounded at a speed of 12 knots. The skipper, who was also woken, rushed to the wheelhouse, where the watch alarm was still sounding.

The vessel was refloated on the following tide, having sustained heavy damage to her hull plating.

head down' for a few hours before his watch, but chose not to do so. The dramatic photographs illustrate only too well the consequences of this ill-fated decision.

2 Although not a mandatory requirement, fitting a watch alarm can be a very effective safety measure. However, if you are a fishing vessel owner or skipper, you are recommended to ensure that if one is fitted on board your vessel, it is loud enough to alert the watchkeeper, and is connected to a secondary back-up system that will alert the remaining crew should the watchkeeper, for whatever reason, fail to cancel the initial alarm.
