# Fishing 2005 Safety Digest

MARINE ACCIDENT INVESTIGATION BRANCH

This *Safety Digest* draws the attention of the marine community to some of the lessons arising from investigations into recent accidents.

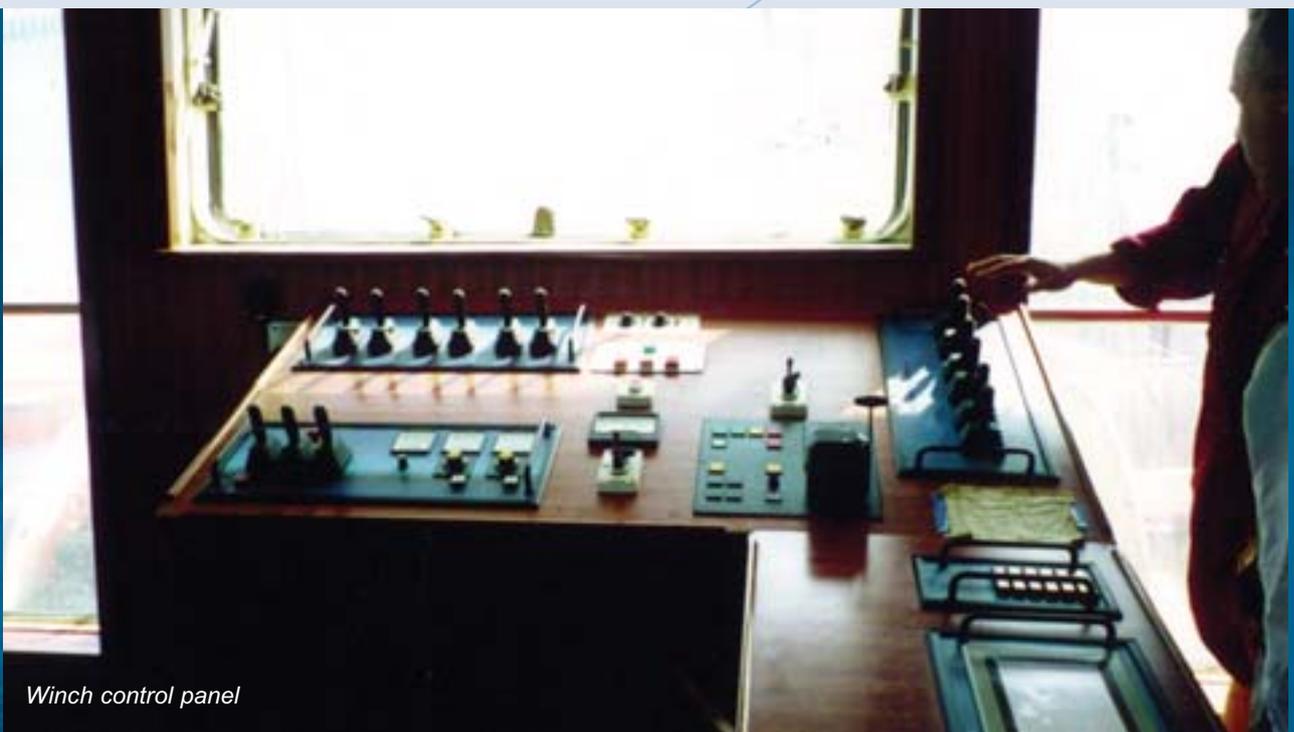
*Winch control panel*

After the winches stopped, all six hydraulic pumps that powered them were restarted, but before the load could be taken off the port winch, the system failed again. The computer-controlled winch system on the vessel was very complex. It has not been possible to identify clearly the reason why the winches stopped. However, had the

The brakes were set up so that they came on automatically when the winches stopped. The winch

control system could have been configured so that the brakes stayed off. Had the safety brake been enabled, and worked as intended, it might have saved the vessel.

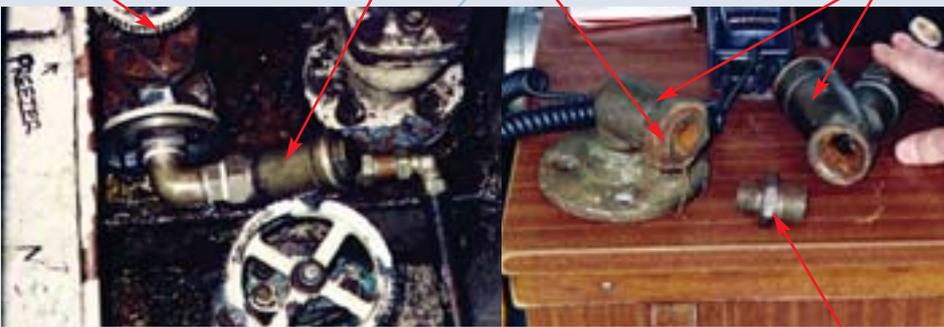
Larger part of failed pipe fitting (including nut)

Sections of pipe either side of the failed pipe fitting

Example pipe fitting – showing design of failed item

The fracture occurred at a screwed joint between steel and brass piping; the problem was probably caused by galvanic action (Figure 2).

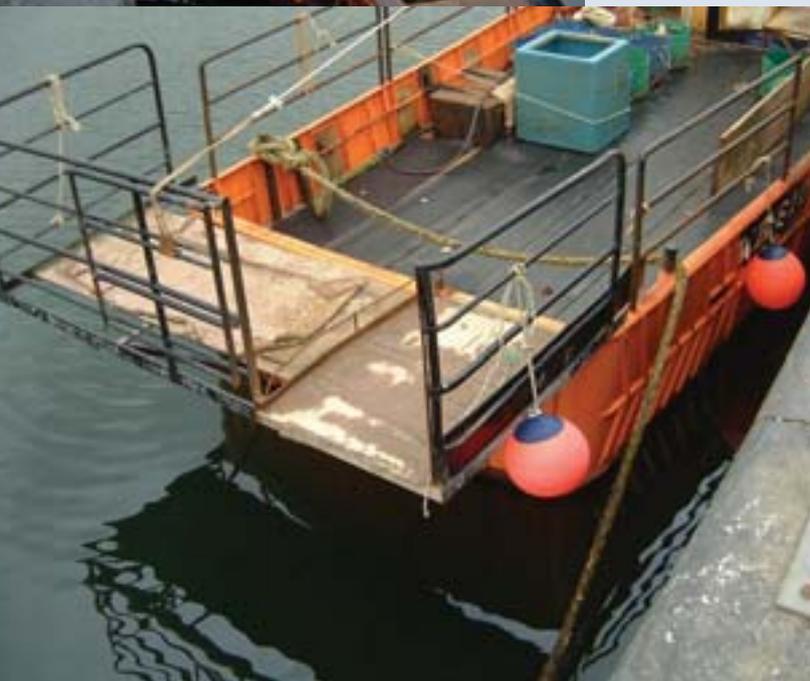
After the last of a fleet of creels had been shot over the side, a deckhand shot a 56Kg drag anchor from the bulwark just forward of the shooting post. The deckhand's right ankle was instantly trapped in a bight of either the back line, or the line securing the anchor to the back line. He was dragged hard up against the top of the steel bulwark. The skipper immediately put the engine astern, and a second

*Working deck area showing configuration of pound board and back line*

**1** Shooting creels is a dangerous business, and the deck layout of many fishing vessels has been altered in recent years to allow fishermen to keep their feet clear of the working ropes. Indeed, in this case, the deckhands were separated from the back-line by pound boards for all of the shooting procedure, other than when the anchor had to be thrown overboard. When precautions are taken, although risk is normally reduced, it is seldom eliminated.

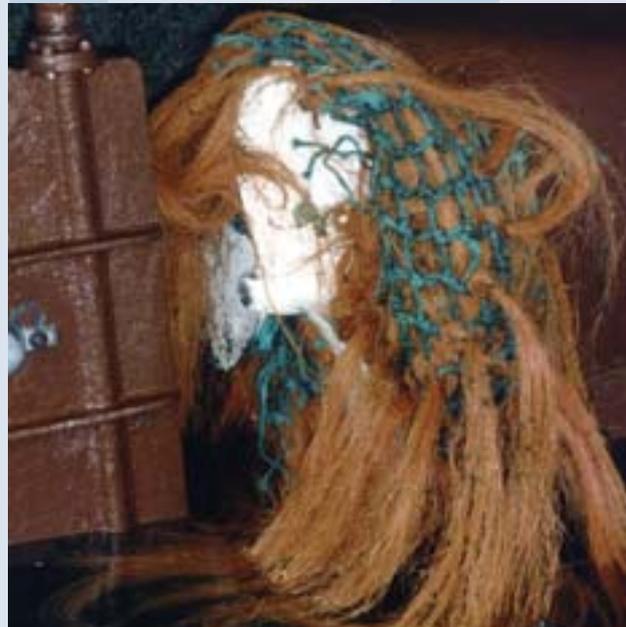
While trawling, a vessel's main engine suddenly stopped when her propeller was fouled by discarded fishing gear from a beam trawler. The vessel had to be towed back into port; fortunately there was no damage to the main engine or gearbox.

*Photograph of propeller fouled by discarded fishing gear*

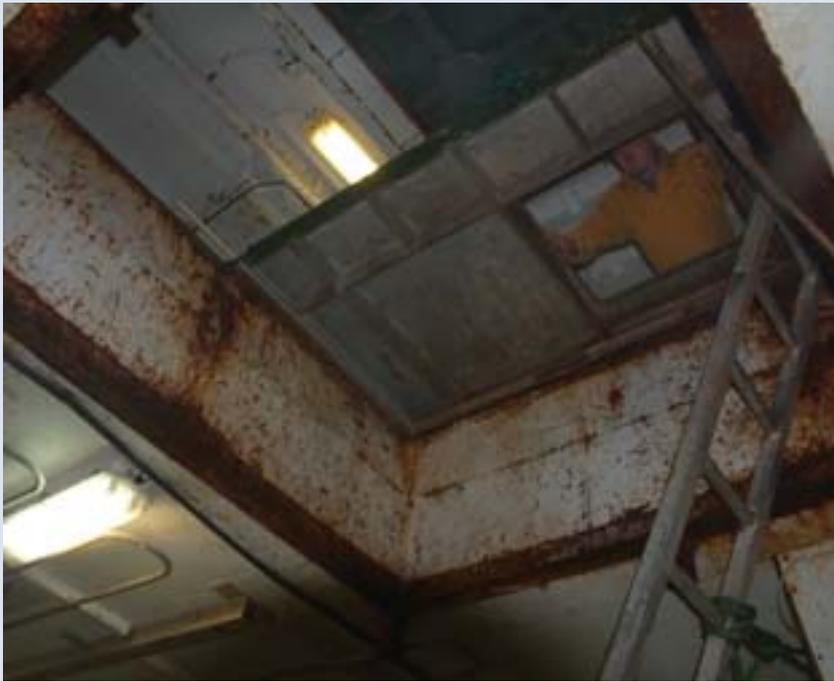
*Views into and out of the fish hold indicating the distance the casualty fell*

A 34m vessel was trawling when one of her crew fell down into the fish room through the open hatch from the deck above.

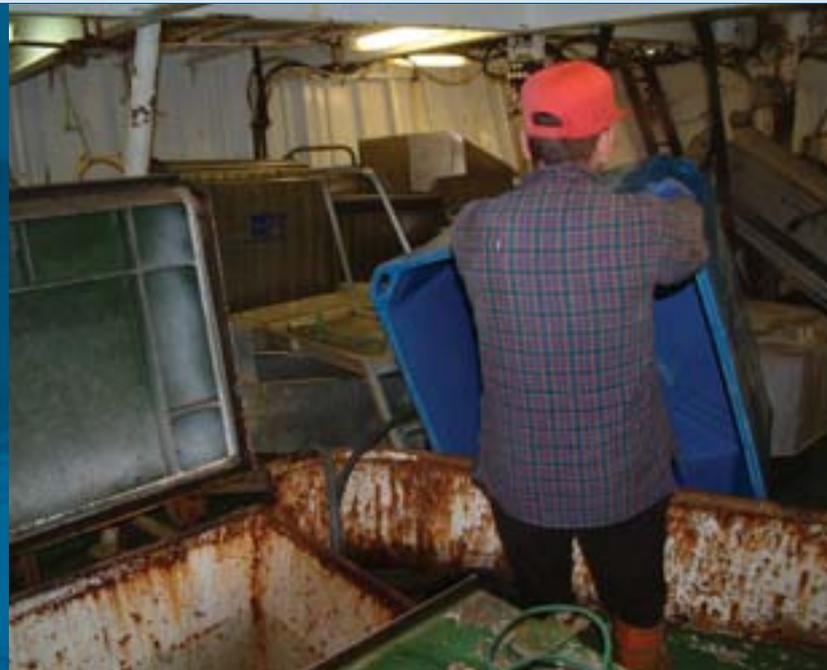
*Bin being lifted into fish hold*
