Fishing 2009 Safety Digest

MAIB

This *Safety Digest* draws the attention of the marine community to some of the lessons arising from investigations into recent accidents.

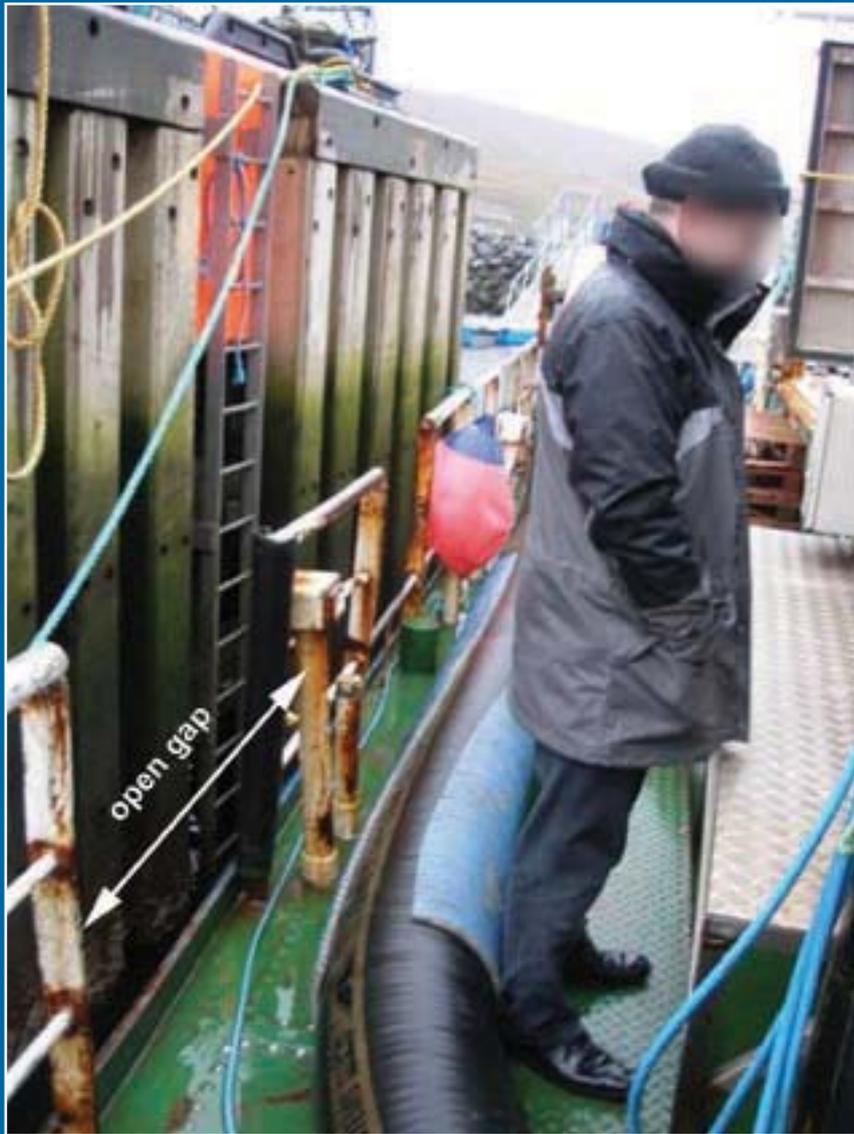
Subsequent examination of the vessel highlighted two large gaps in its side guardrails (placed there for

ease of access to the salmon cages) which had no means of closure when not in use. Also, large fish pumping hoses created a serious trip hazard in way of these gaps. Directly inboard of one such gap a damaged salmon, which had been kept aside by the deceased, was discovered away from where the crew had seen him place it earlier. It is highly probable that the crewman left the wheelhouse and fell overboard through the gap in the adjacent guardrail while recovering the fish from where he had left it.

2 The vessel had been operating with unguarded openings for several years. These openings were accepted by the crew and unrecognised by the company managers. Crewmen should not accept unnecessary hazards which, if ignored, can very soon become the norm – until an accident occurs. If you suspect something is dangerous, bring it to the attention of crewmates and the vessel operators. It is possible that others have simply not noticed the potential danger, and if alerted would be more than happy to carry out improvements or change the way of working.

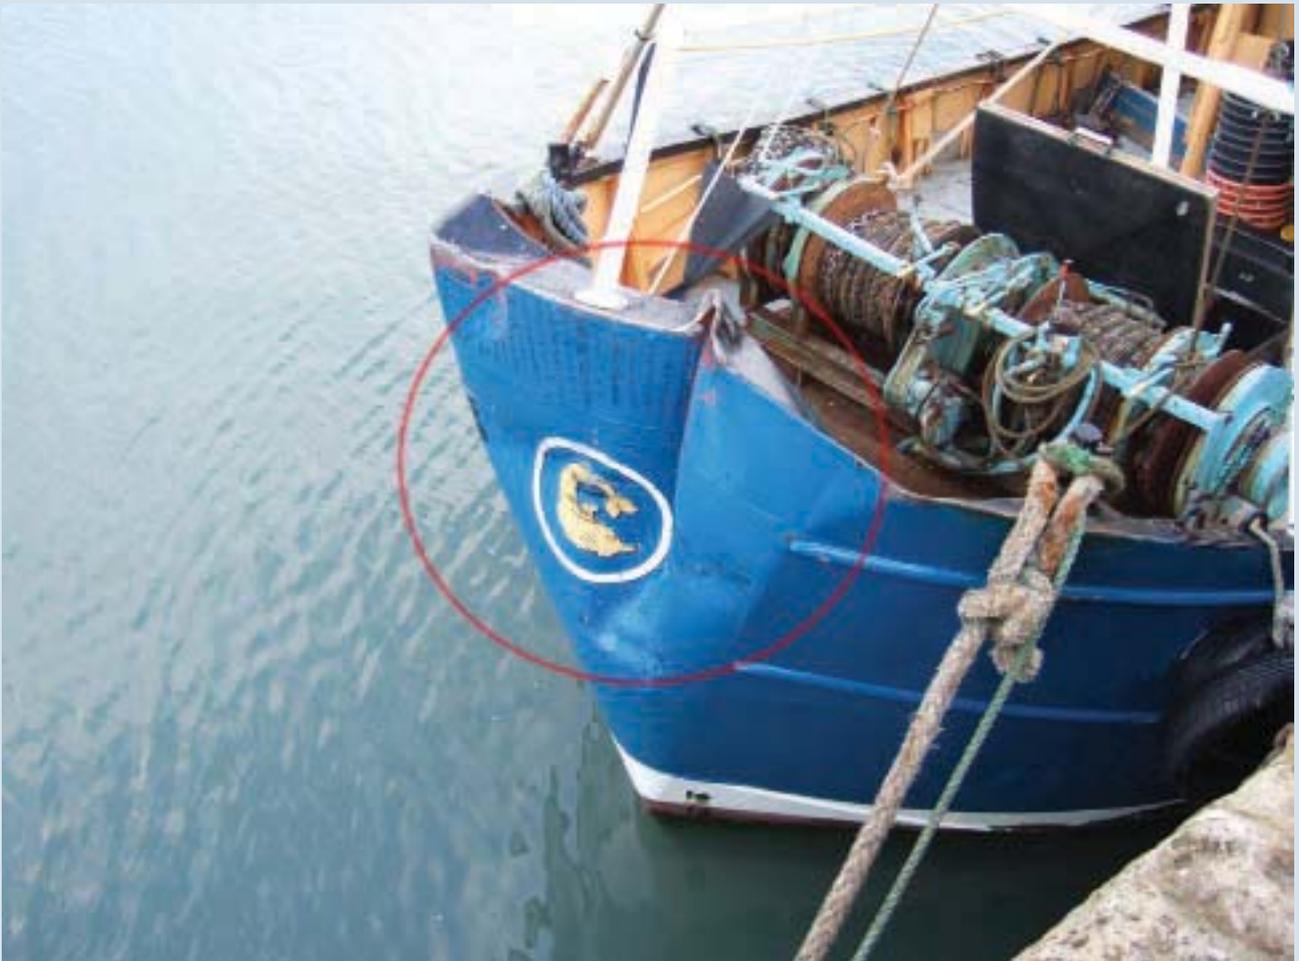
As a result of the collision, the fishing boat suffered extensive damage to its bow area and the repairs took more than 2 weeks; this represented a significant loss of income for the skipper and crew at a time when the catches had been particularly good. The commercial vessel was also damaged by the collision, and was off charter for a day, with a consequential loss of revenue.

Damage to the vessel's bow

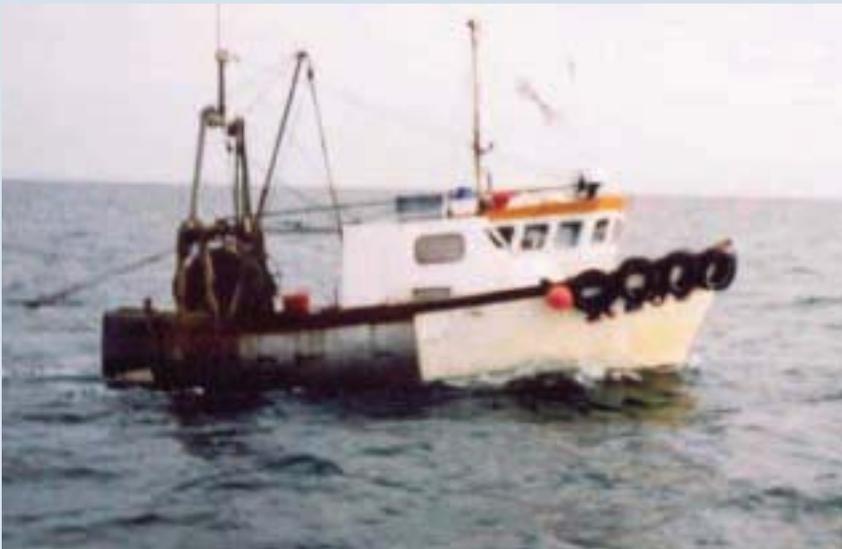
Figure 1: Vessel before alterations

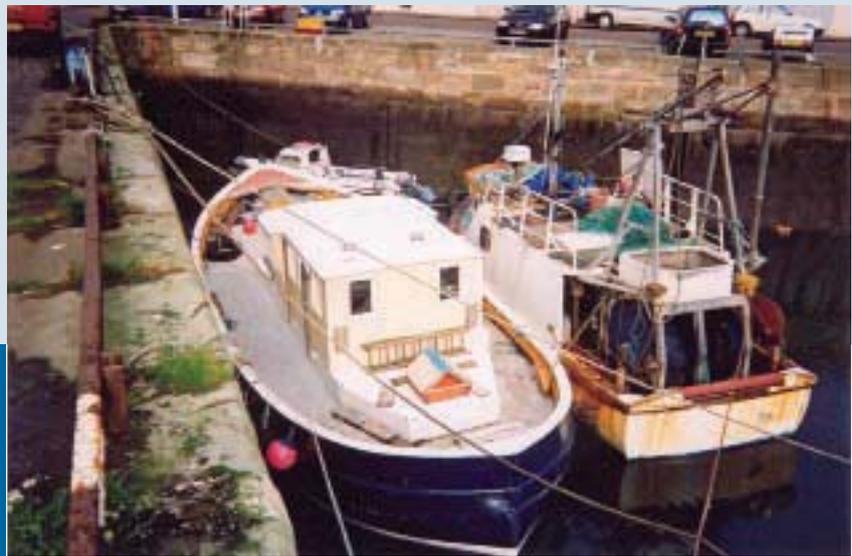
Figure 2: Vessel after alterations (right)

1 The vessel had been significantly modified by the current skipper. The structural modifications included a considerable amount of additional top weight, which probably had the effect of reducing the vessel's intact stability and her ability to return to the upright condition. Before making alterations, or adding additional weight, seek guidance from a qualified naval architect and, if necessary, have the vessel inclined to confirm the condition of the stability.

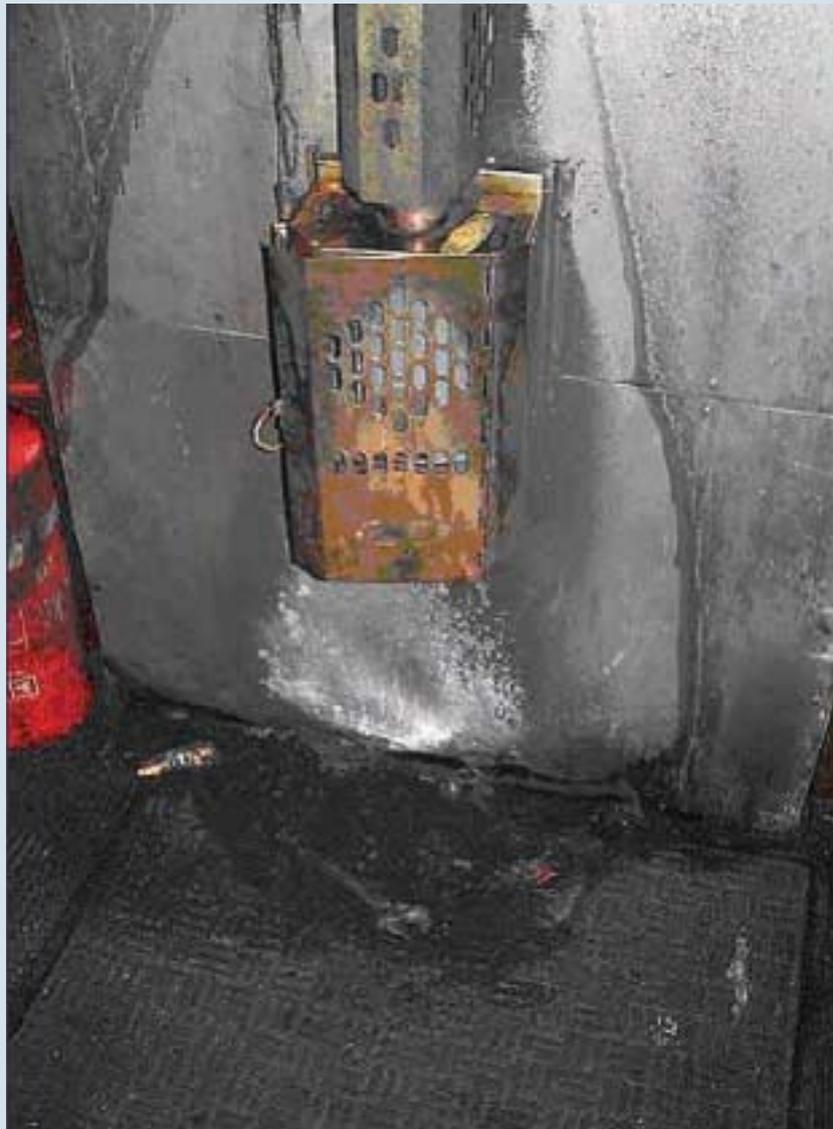
The exact cause of the fire was not determined, but it was thought most likely that the thermostatically controlled valve had failed, possibly because of the high levels of vibration on the boat when the catch was hauled. Too much fuel had been able to flow and spill from the glass part of the sight glass and down the outside of the pipe, until it was ignited by the flame in the furnace. The fire had then spread as the fuel leaked down the bulkhead and onto the carpet.

Damage around the diesel-fired heater

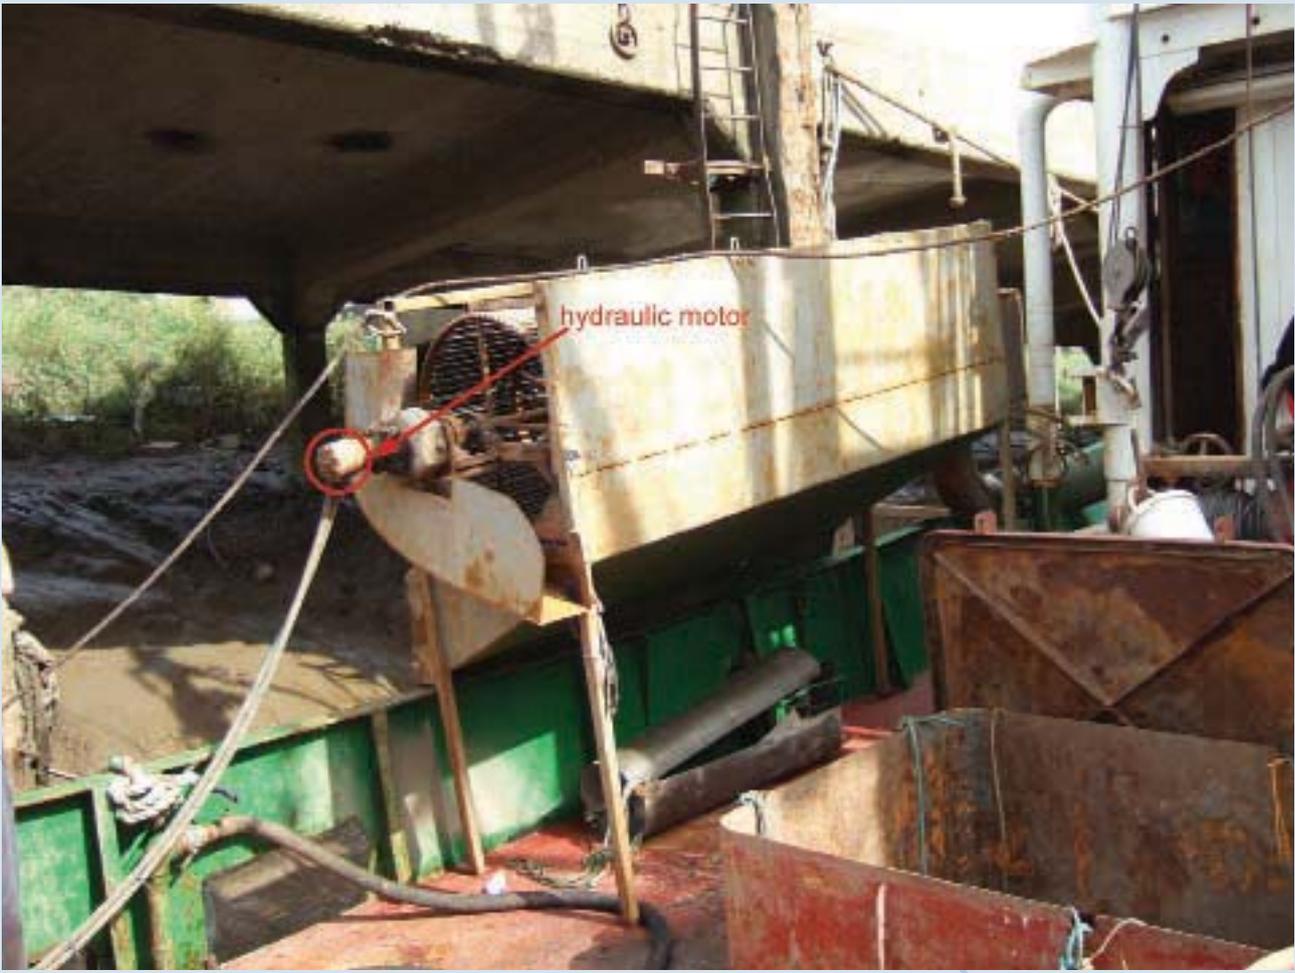
Figure 2

sorted from the water and mud by a riddle, a hydraulically powered rotating perforated drum, before being transferred via a chute into bags stowed in the hold or on deck (**Figure 2**).

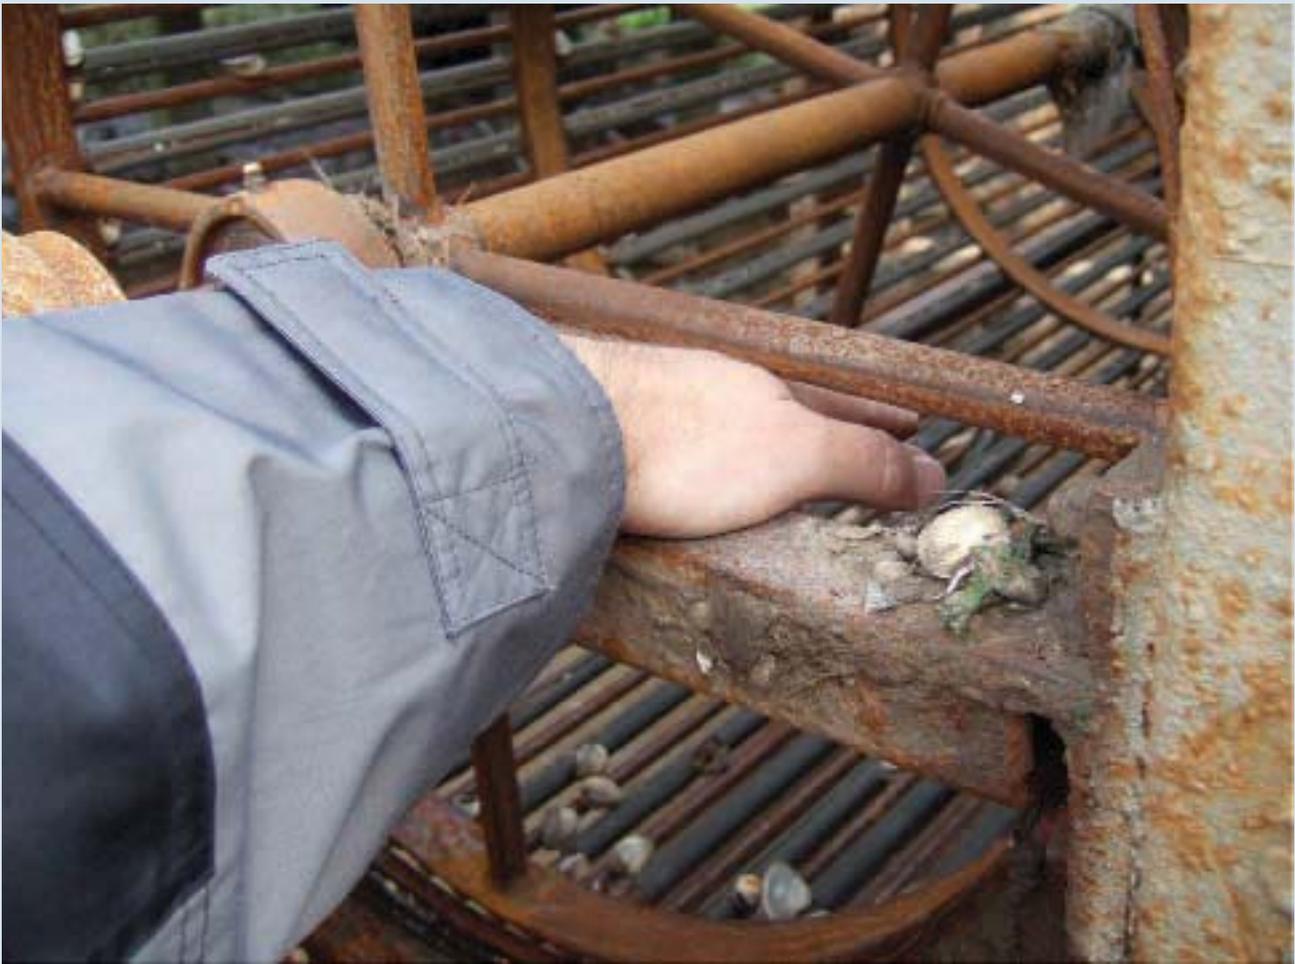
Figure 3

clear of the rotating inner drum. There was not (**Figure 3**). The riddle's rotating drum caught his thumb, fractured his wrist and pulled his arm into the riddle when his left elbow fractured and the skin was removed from his inner arm.

2 The construction and location of the riddle created a significant “shear trap” risk to the crew working adjacent to this unguarded machinery. The usual crew accommodated the risk of personal injury when working close to the riddle in their normal operations, but they had not identified that the shear trap posed a significant danger to an inexperienced crewman on board. While the dangers associated with fishing may be blatantly obvious to experienced hands, they might not be recognised by new crewmen. A risk assessment would have identified the hazard from the riddle earlier, and the machine could have been guarded properly, thus protecting all the crew from the shear trap risk.

1 Dangerous machinery like this must have protective guards in place to stop operators unintentionally getting caught in the moving parts. This is particularly important at sea, where the movement of the vessel may unbalance the crewman and cause him to fall into the machinery.

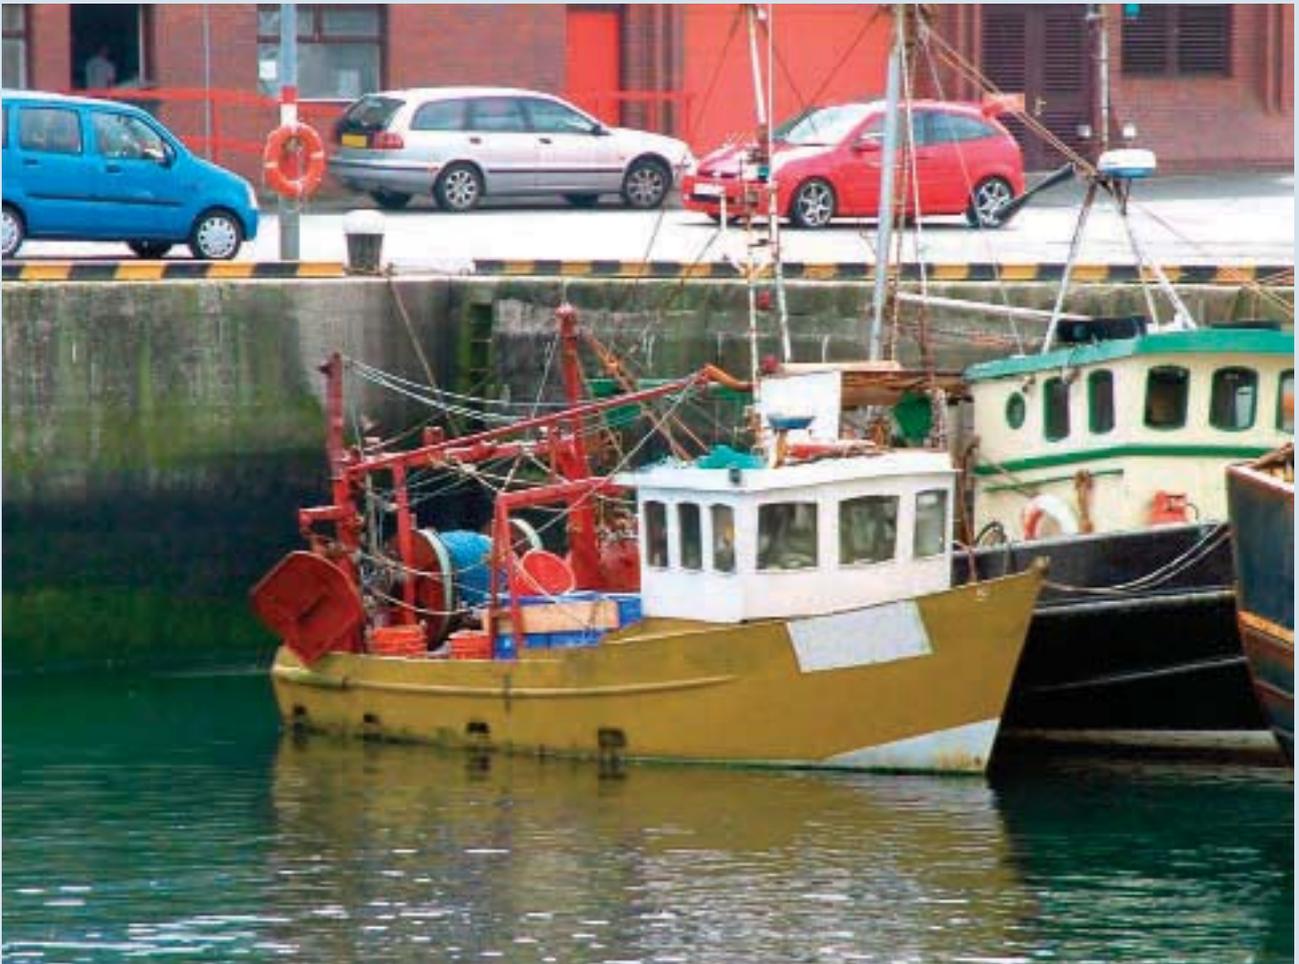
the exhaust trunking created ideal conditions for corrosion to take place, which would have led to water entering the below deck space.

Analysis of previous accidents to similar vessels shows that water can flow through relatively small holes at a surprisingly high rate, and that a relatively small amount of water entering the hull area can adversely affect the stability to such an extent that very rapid downflooding can occur. For example: 0.5 tonne of water per hour will flow through a hole of just 18mm in diameter assuming a constant head of 25mm.

1 This tragic case illustrates the vital importance of having – and maintaining – an adequate freeboard and keeping your vessel watertight.

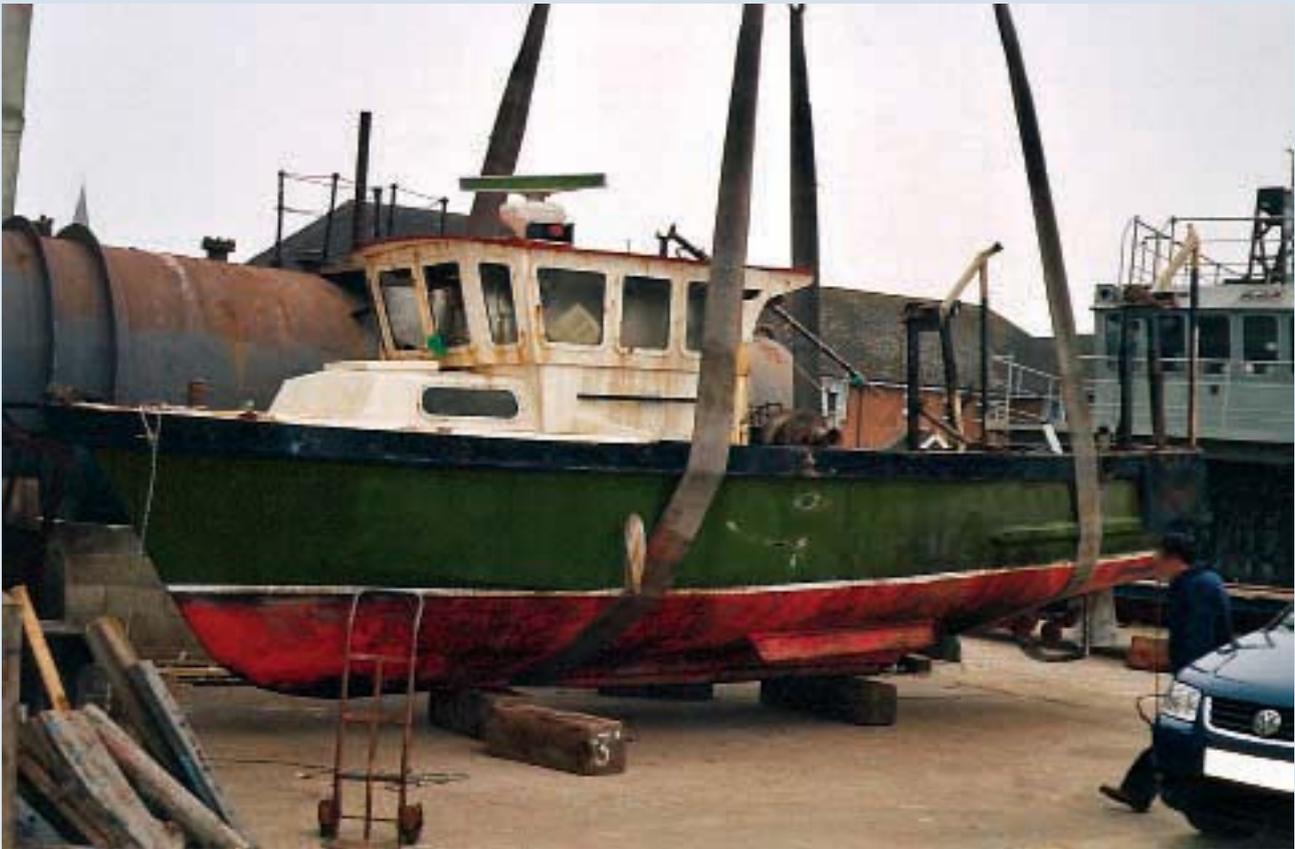
The vessel was raised so that the cause of sinking could be established. It was found that her starboard quarter was damaged such that water could enter the hull under conditions of limited freeboard or poor weather. At the time of her loss, she had additional weight on deck in the form of water tanks which held live catch. This weight reduced the freeboard sufficiently to allow flooding through the damaged area of the hull. To complicate matters further, the skipper had removed the electrical bilge pump to use it to provide a flow of sea water to the holding tanks, and there was no bilge alarm.

It is not certain when the hull damage occurred. Because protective rubber matting largely covered the area of damage, it was obscured to the casual observer and might have been present for some time, becoming critical only when the freeboard was reduced by extra weight.

Vessel after recovery

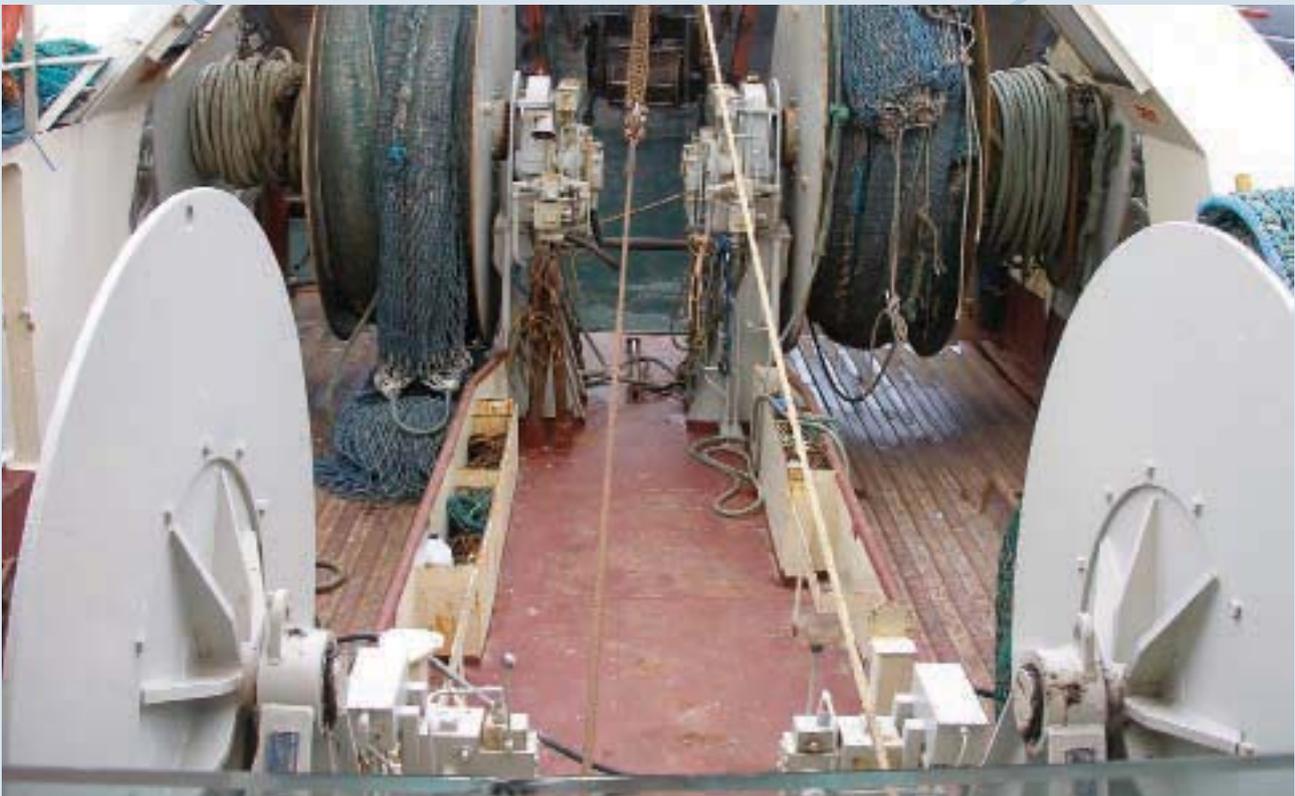
Operator's view towards net drums (casualty obscured behind drum)

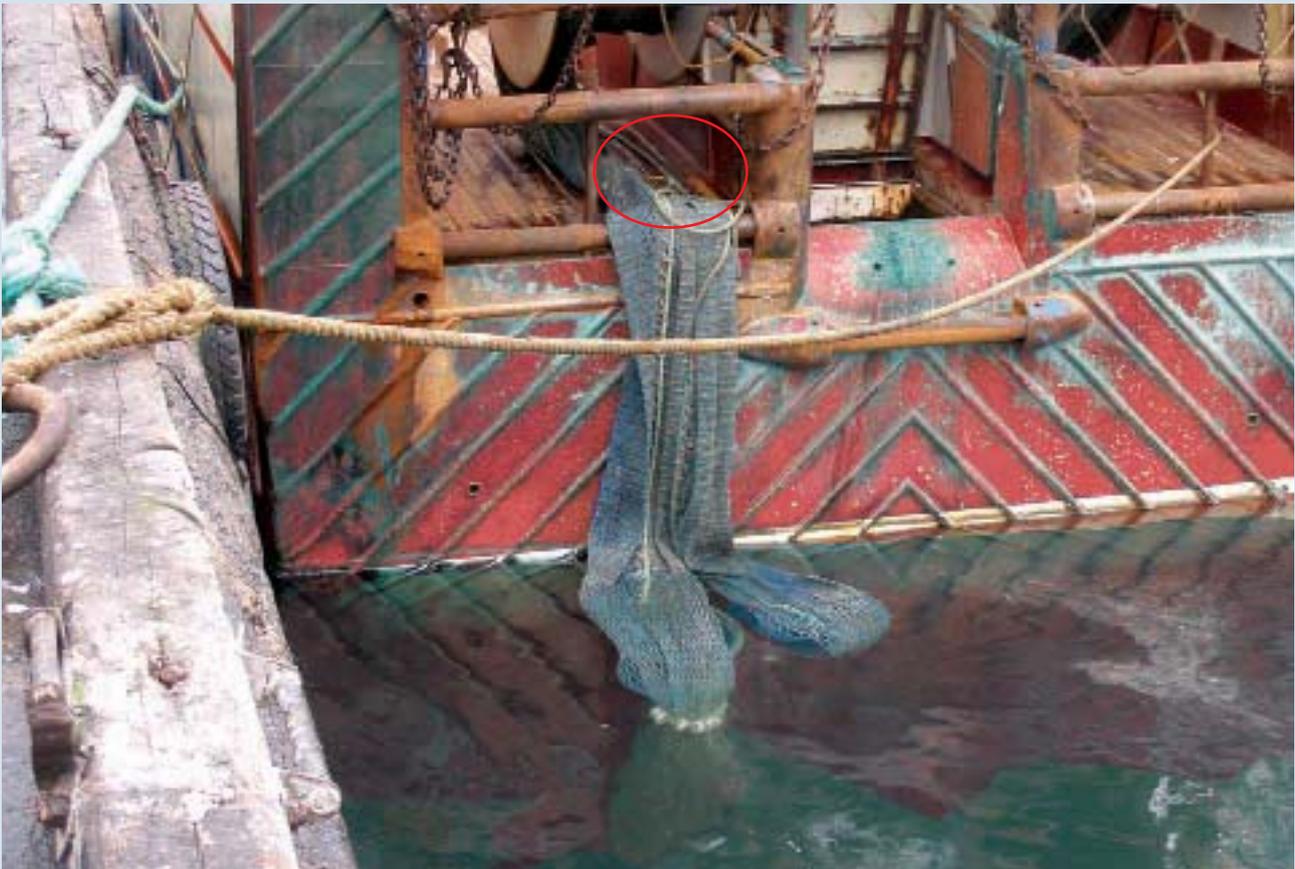
Position of the casualty before going overboard

4 Carrying out tasks on board a fishing vessel will sometimes necessitate leaning overboard. The simple precaution of wearing some sort of flotation aid will help mitigate the obvious risks and will increase your chances of survival if you fall overboard. The casualty involved in this case had been a fit and healthy man, yet after just a few minutes of being immersed in the cold water, the debilitating effect of cold shock rendered him unconscious.

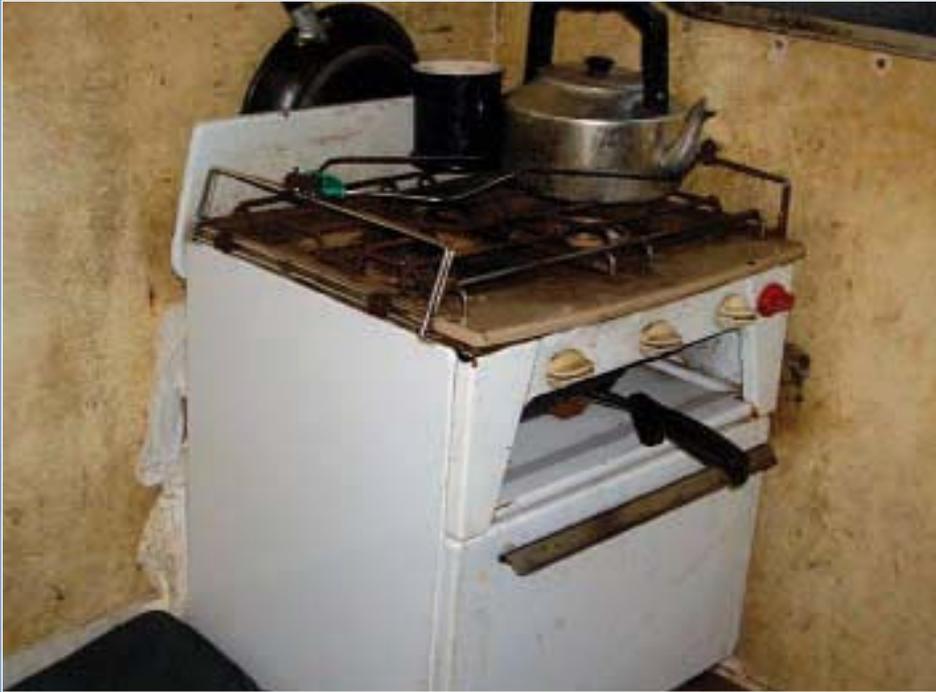
The skipper later inspected the fiddle to establish why the kettle had been able to fall from the stove. He found that the fiddle had not been properly adjusted to suit the kettle which had been recently supplied to replace an older and different sized model.

Cooker with old fiddle and kettle

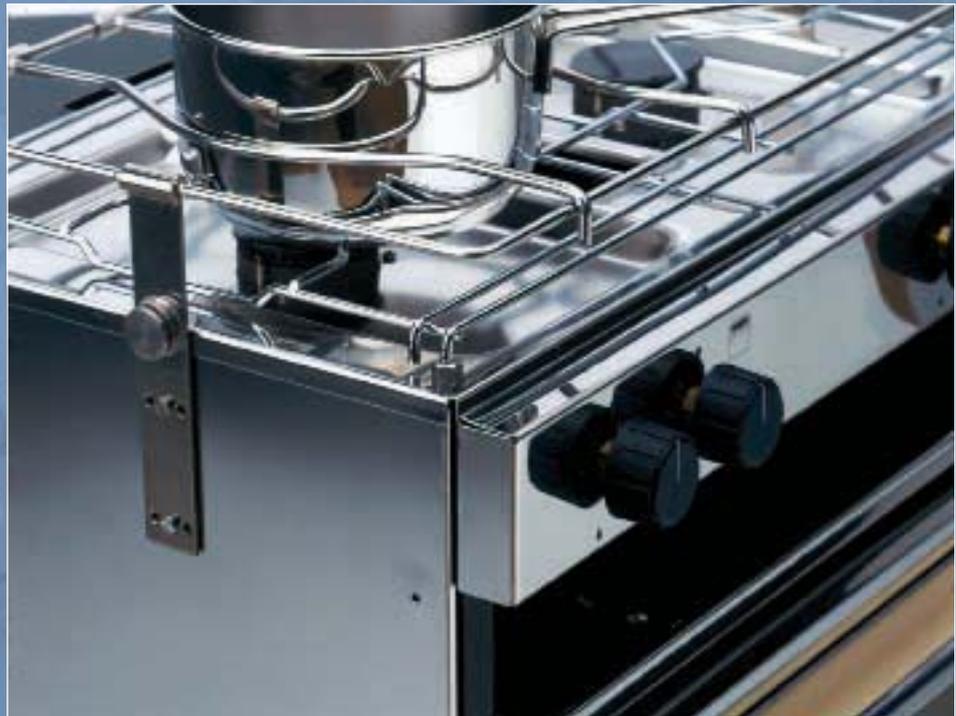
New fiddle

The skipper ensured that the fiddle was properly adjusted to fit the kettle before the stove was used again.
