Rail Accident Investigation Branch

# Rail Accident Report

**Train collision with material washed out from a cutting slope at Corby, Northamptonshire  
13 June 2019**

Report 04/2020  
May 2020

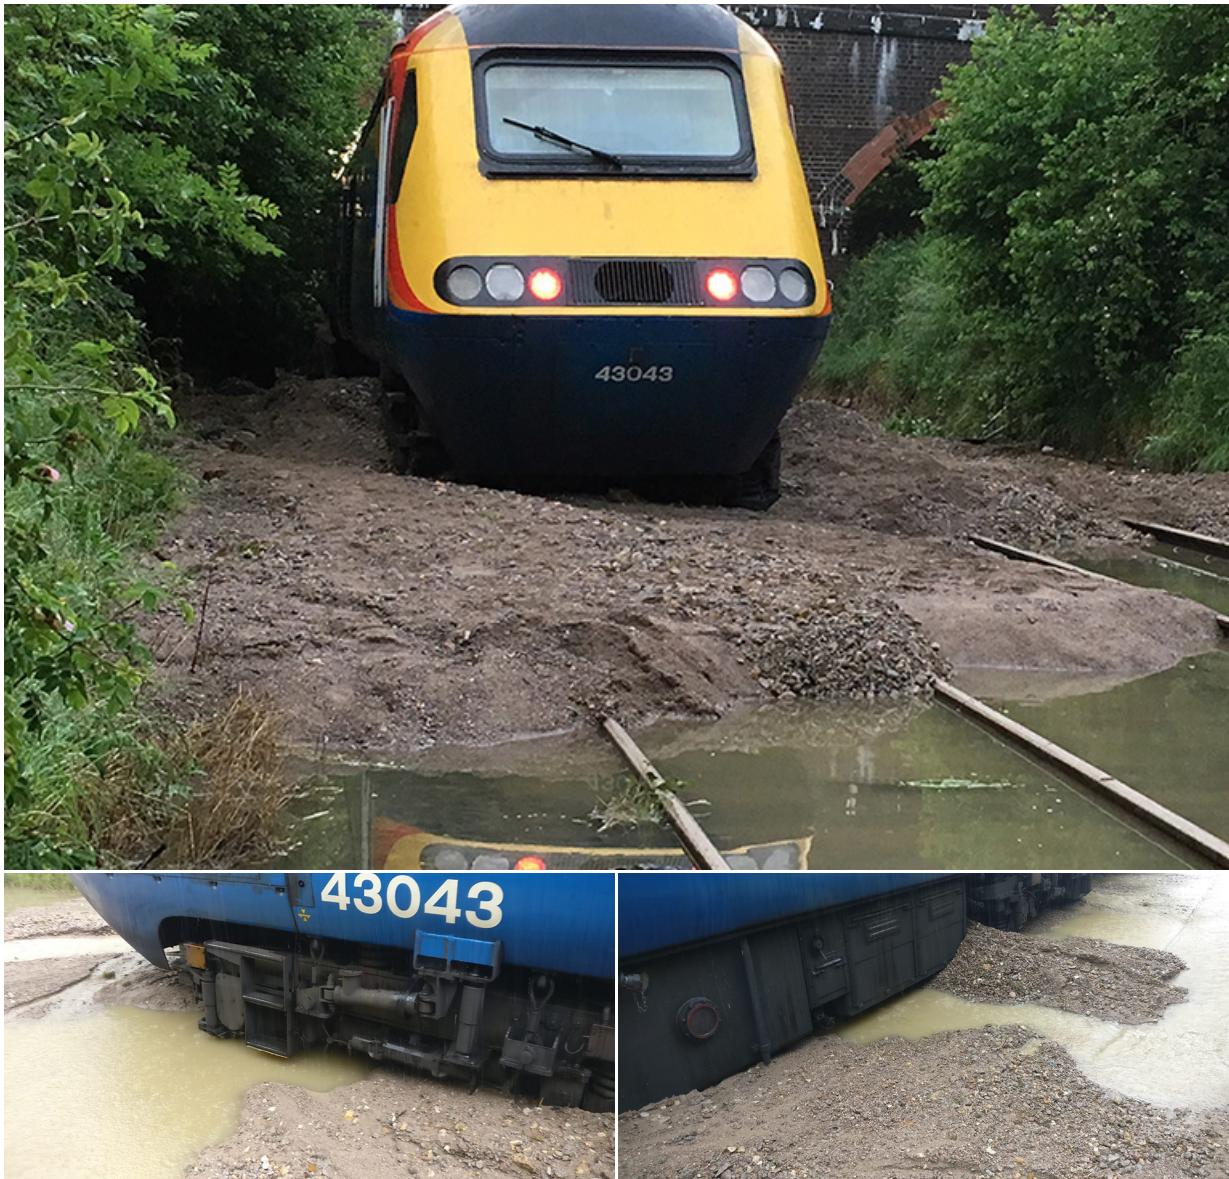
Figure 3: The rear of the train after further sandy gravel washed-out around it (main image courtesy of Network Rail, other images courtesy of the driver of train 1C52).

- 53 Train 1D43 did not stop before colliding with sandy gravel and soil that flood water had washed onto the track from the adjacent cutting slope.
- 54 The driver of train 1D43 reported seeing debris and flood water ahead as he rounded the left-hand curve approaching the washed out debris. The forward facing CCTV footage from train 1D43 showed a pile of debris on the down line at the foot of the cutting slope, close to where it had failed (figure 7).
- 55 Once the train had stopped, flood water continued to flow onto the railway, at the aqueduct and where the cutting slope had failed. It washed a large volume of sandy gravel and soil from the cutting slope onto the track, which flowed underneath and around the rear of train 1D43 (figure 3).

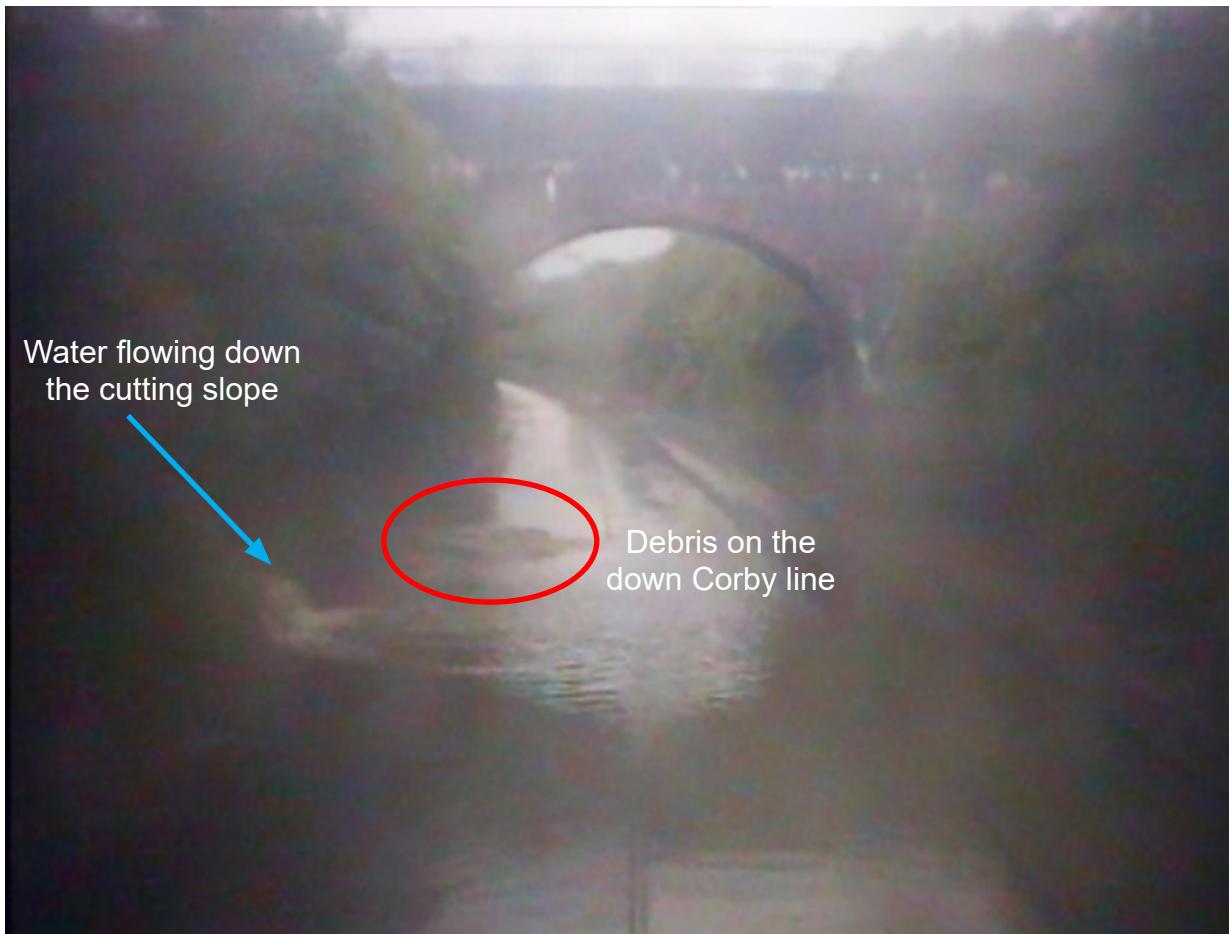
- 27 As the train entered the cutting at Pen Green Lane on a left-hand curve, the driver noticed the track ahead was flooded. As the train continued around the curve, the driver also noticed debris on the track ahead (figure 7). At 15:50:20 hrs, while travelling at 40 mph (64 km/h), the driver made an emergency brake application. At about the same time, train 1D43 struck sandy gravel and soil that had been washed out from the cutting slope onto the track. Train 1D43 stopped at 15:50:40 hrs, after travelling for a further 193 metres.

Figure 7: Image from the forward facing CCTV on train 1D43 showing the flooding and debris on the down line.

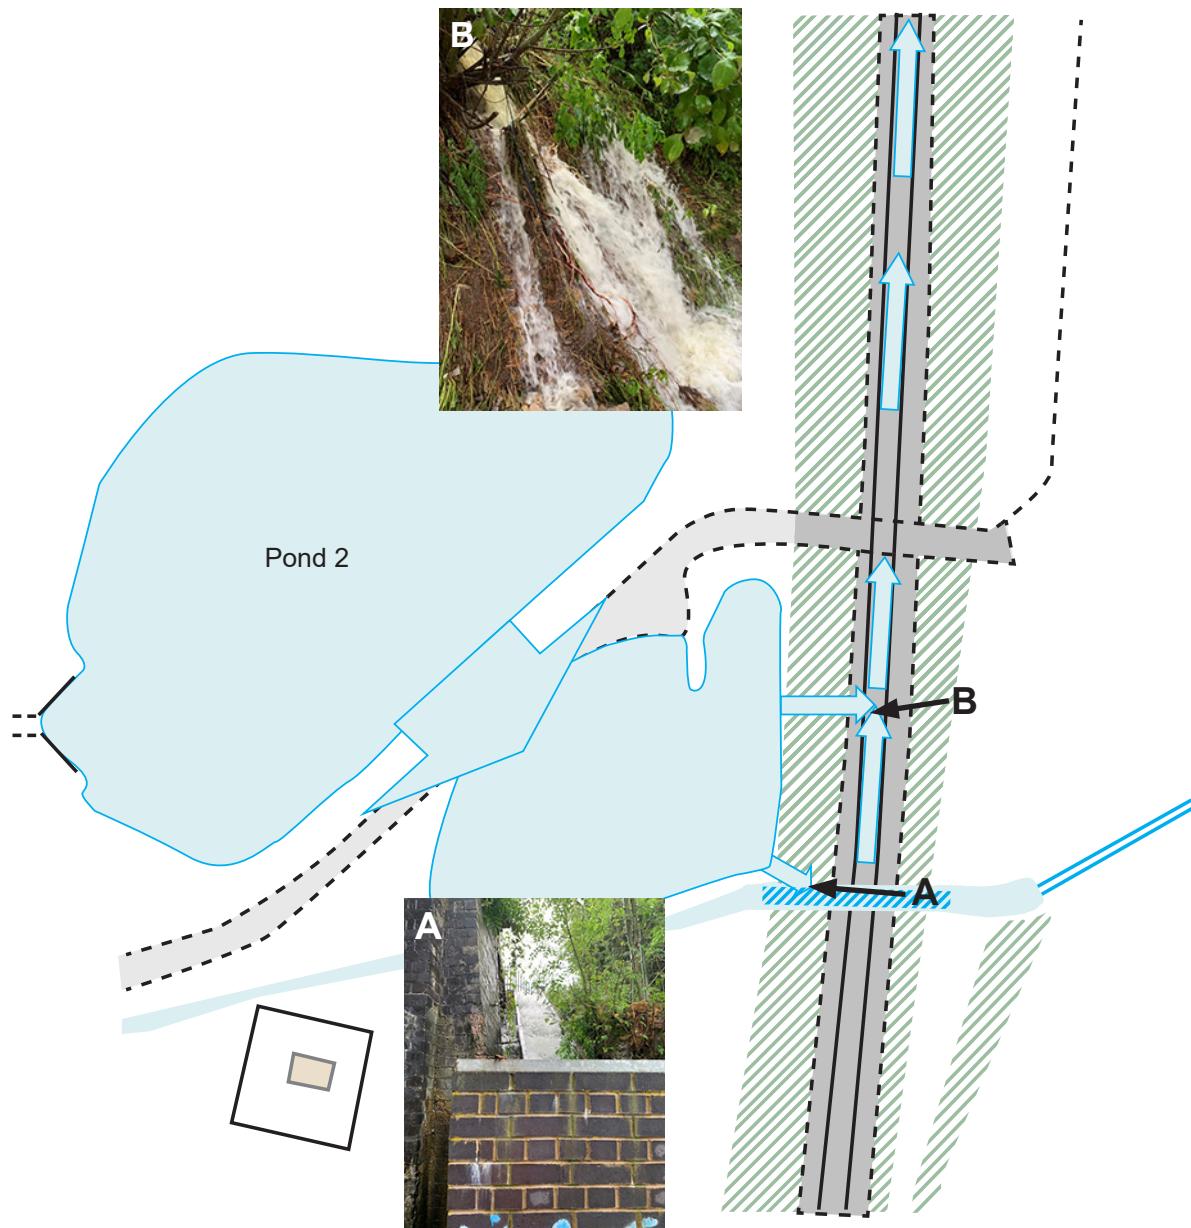
- 57 The adjacent flood storage ponds overfilled, causing excess water to pool in the field between the ponds and the crest of the cutting slope.
- 58 Contractors called to the site by Network Rail after the incident found a large volume of water had pooled in the field above the cutting slope. This water was coming from pond 2, pooling in the field, and then flowing onto the railway where the cutting slope had failed, and also at the northern side of the aqueduct (figure 9).

*Figure 9: The flow of water from pond 2, through the field and onto the railway. Inset image A shows flood water flowing down the stepped flume on the northern side of the aqueduct. Inset image B shows flood water flowing onto the foot of the cutting slope.*

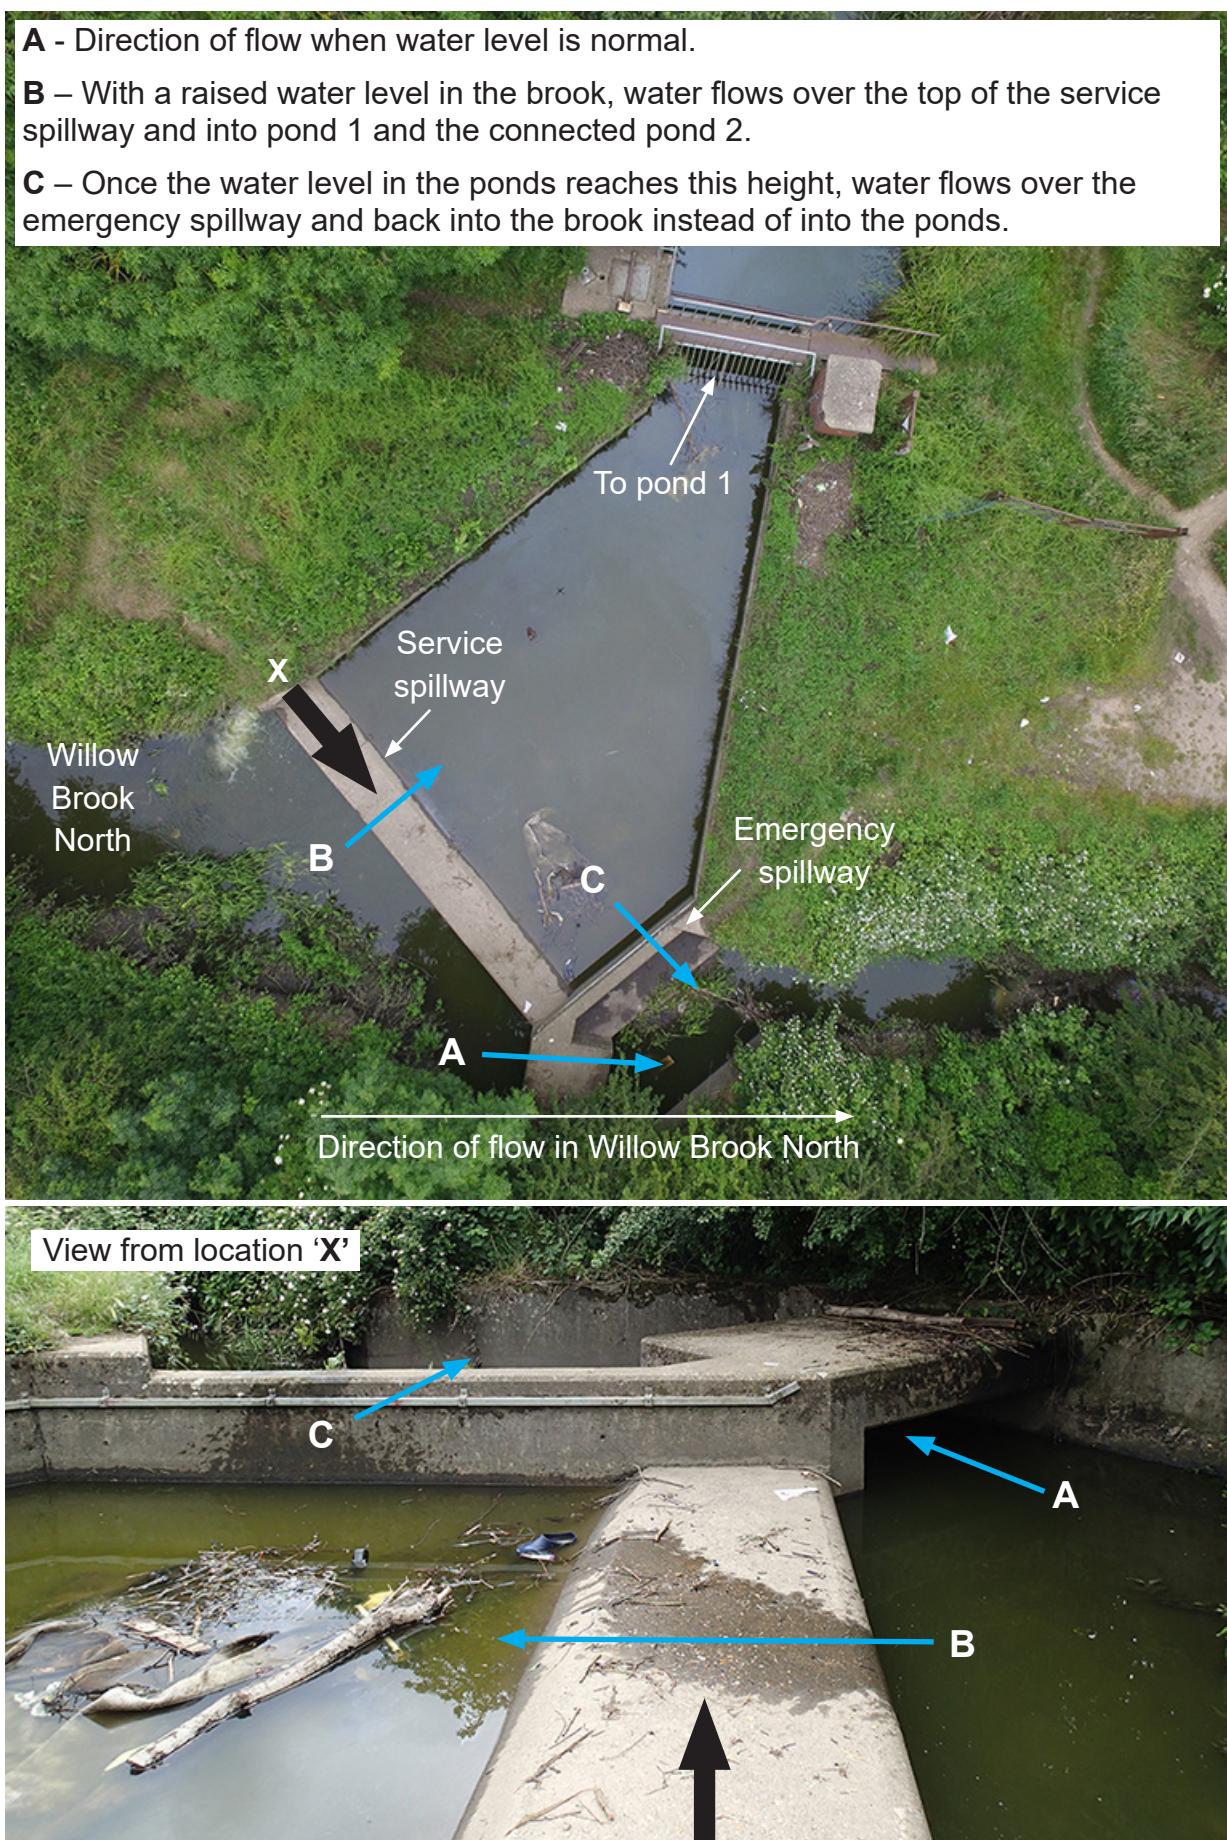
- 60 The water flowing in Willow Brook North was restricted by debris that had collected at the entrance to the bridge carrying Pen Green Lane over it (figure 5). This caused water in the brook to back up to the spillways located about 25 metres upstream of the bridge (figure 5). The spillways control the flow of water between Willow Brook North and the flood storage ponds as described in figure 10. When the water backed up, it raised the water level in the brook, which in turn diverted more water over the service spillway and into the ponds.

Figure 10: The spillways connecting the brook and pond 1

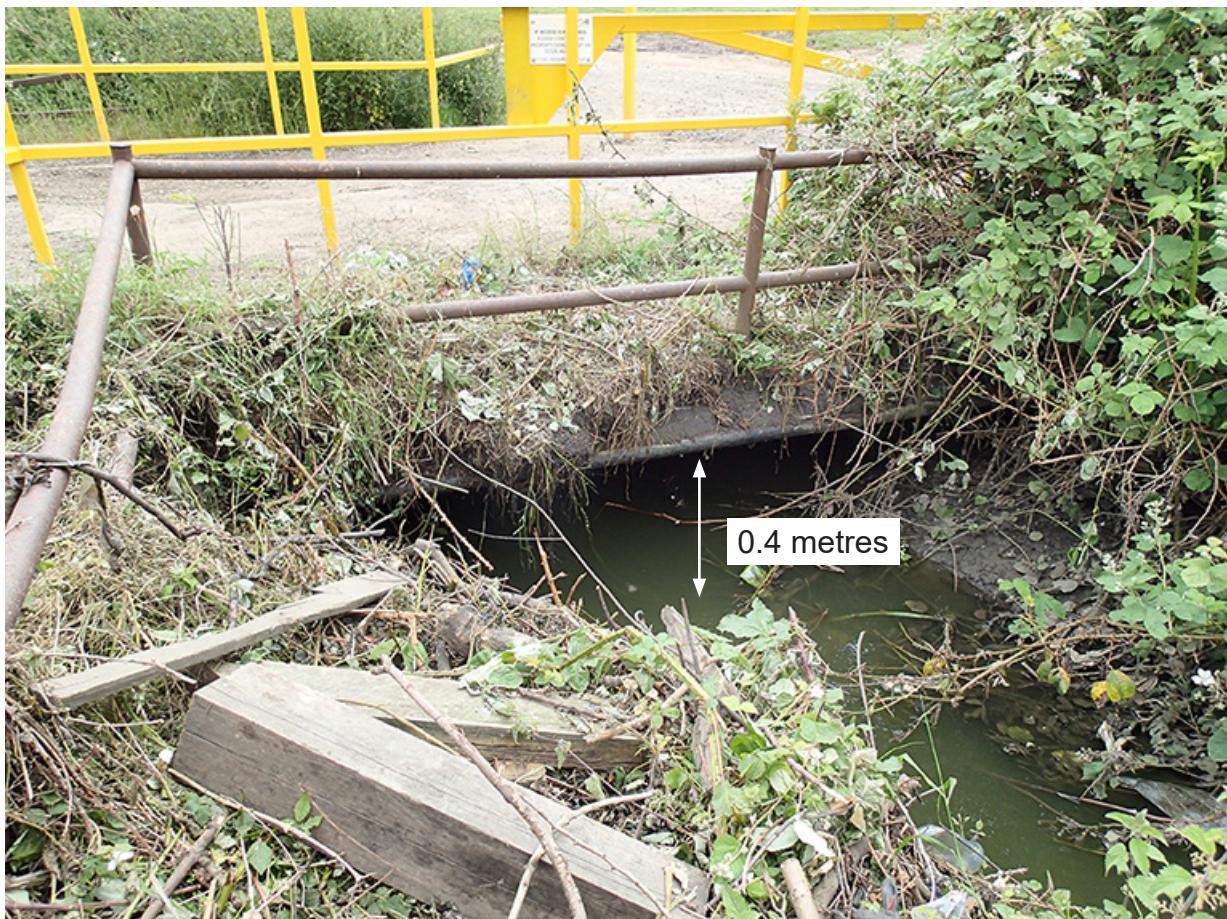
- 61 There is a clearance of around 0.4 metres between the bridge carrying Pen Green Lane over the brook and the typical water level in the brook when there has been no rainfall for several days (figure 11). Following rainfall, the water level in the brook quickly rises, reducing this clearance and increasing the likelihood of debris becoming trapped at the water's entrance to the bridge.

Figure 11: Typical clearance between the underneath of the bridge and the brook when there has been no rainfall for several days

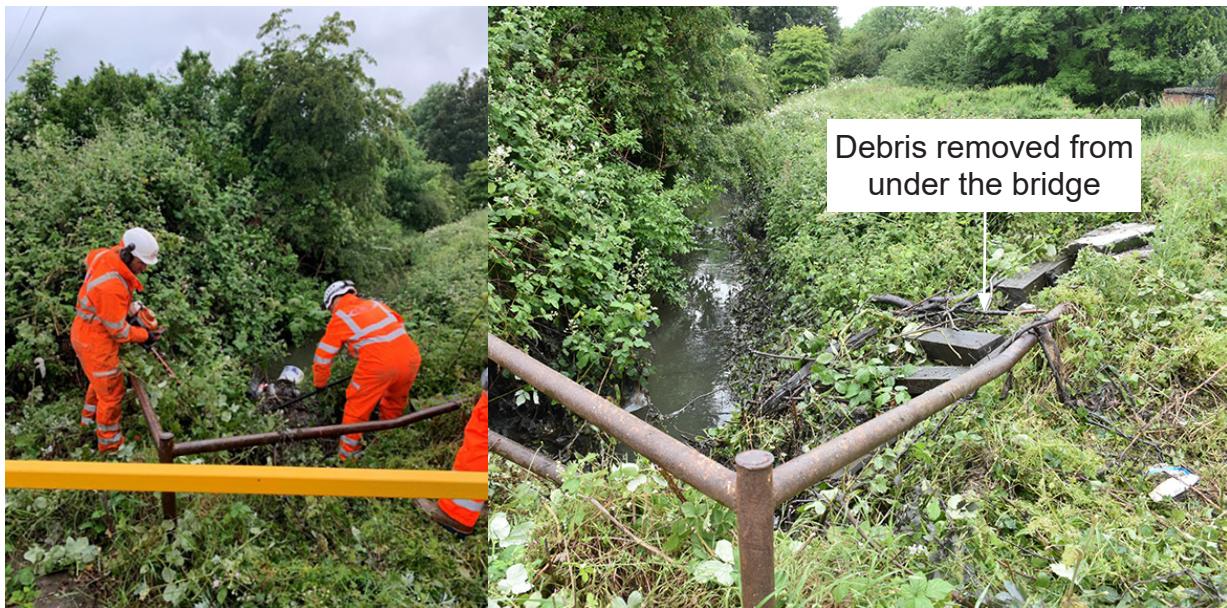
- 62 The contract staff called to site by Network Rail after the incident found a large amount of debris, mostly vegetation and large pieces of wood, trapped at the entrance to the bridge (figure 12). They removed the debris, which allowed the brook to flow freely through to the aqueduct. To reduce the likelihood of further flooding downstream, they also removed debris that had collected on the trash screen at the entrance to the aqueduct.

*Figure 12: Left image: The contractors called to the site by Network Rail removing debris from the watercourse under and before the bridge (image courtesy of CML). Right image: The debris removed from the watercourse.*

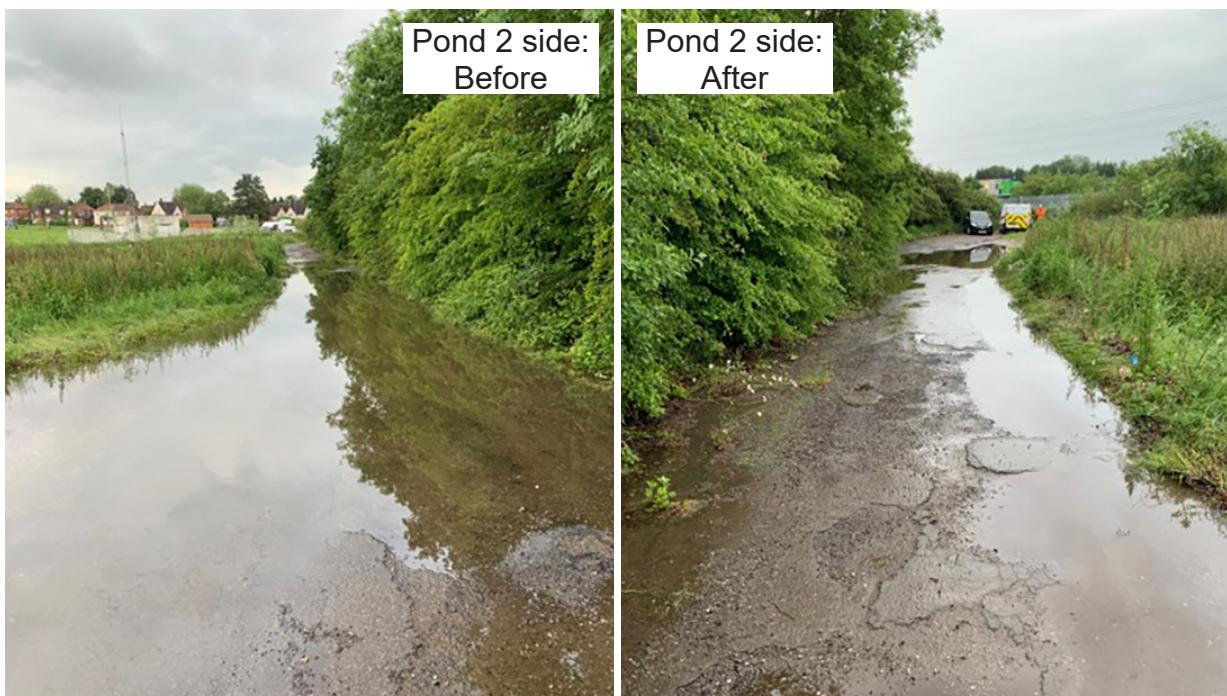
- 63 With the brook now flowing freely from the spillways to, and over, the aqueduct, the contract staff reported that the water level in the ponds soon began to fall as this allowed water to flow back out of the ponds, over the service spillway, and into the brook instead. This was evidenced by the water level in the ponds falling so that water no longer covered the path adjacent to the eastern bank of pond 2 (figure 5), which had been flooded when the contract staff had first arrived on site (figure 13). It also meant the water level in the ponds could continue to fall back to the level of the service spillway, which was the approximate water level in the ponds noted later by RAIB when on site at 21:00 hrs.

*Figure 13: The drop in the water level on the path. Left image shows the path next to pond 2 before blockages were cleared and right image (looking in opposite direction) shows the path after the blockages were cleared (images courtesy of CML).*

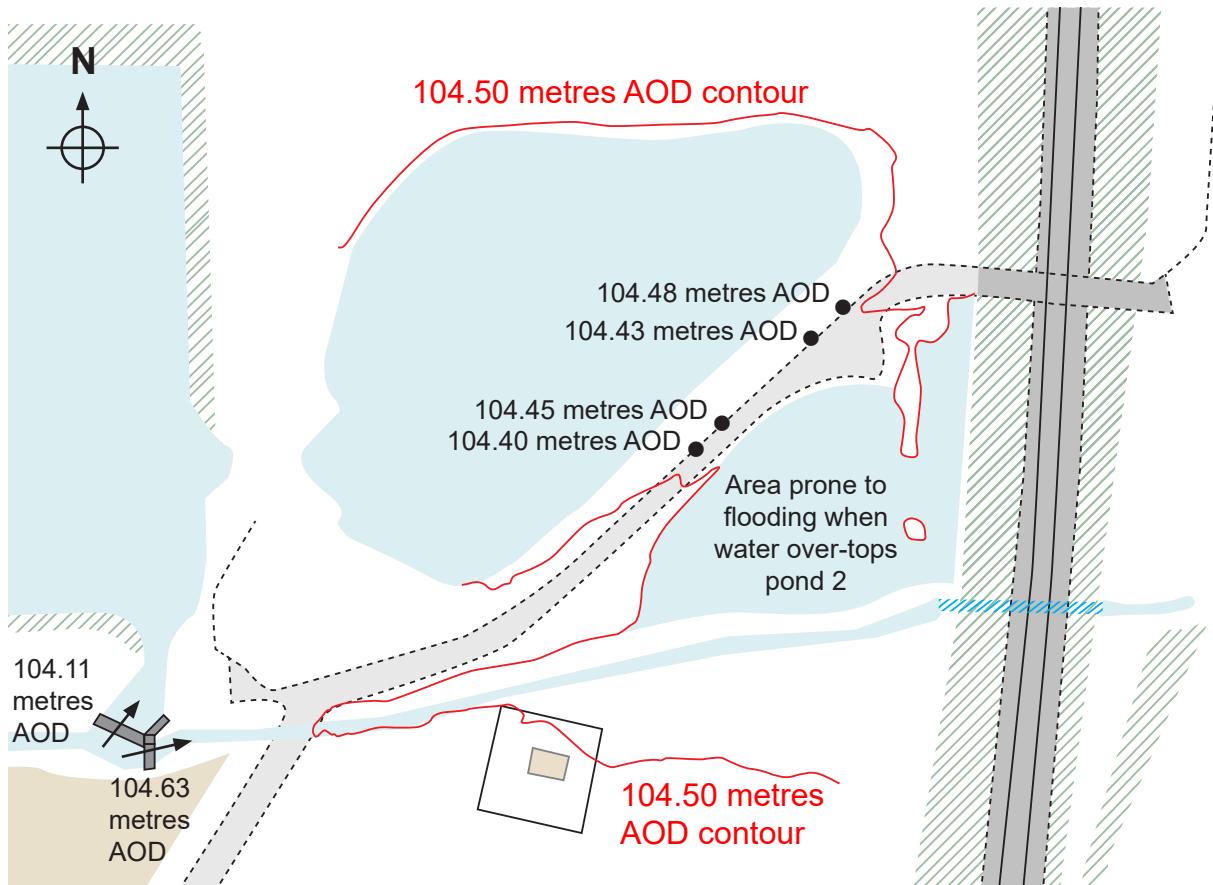
- 65 Both surveys showed that the eastern bank of pond 2, which runs alongside Pen Green Lane, was the lowest point on the perimeter of the two ponds (figure 14). Along a 40 metre long section of this bank, the lowest level was recorded as 104.40 metres above ordnance datum (AOD), with typical levels over this section measured between 104.43 and 104.48 metres AOD.

Figure 14: The levels as recorded by the surveys for the spillways and ground showing the low point on the eastern bank of pond 2

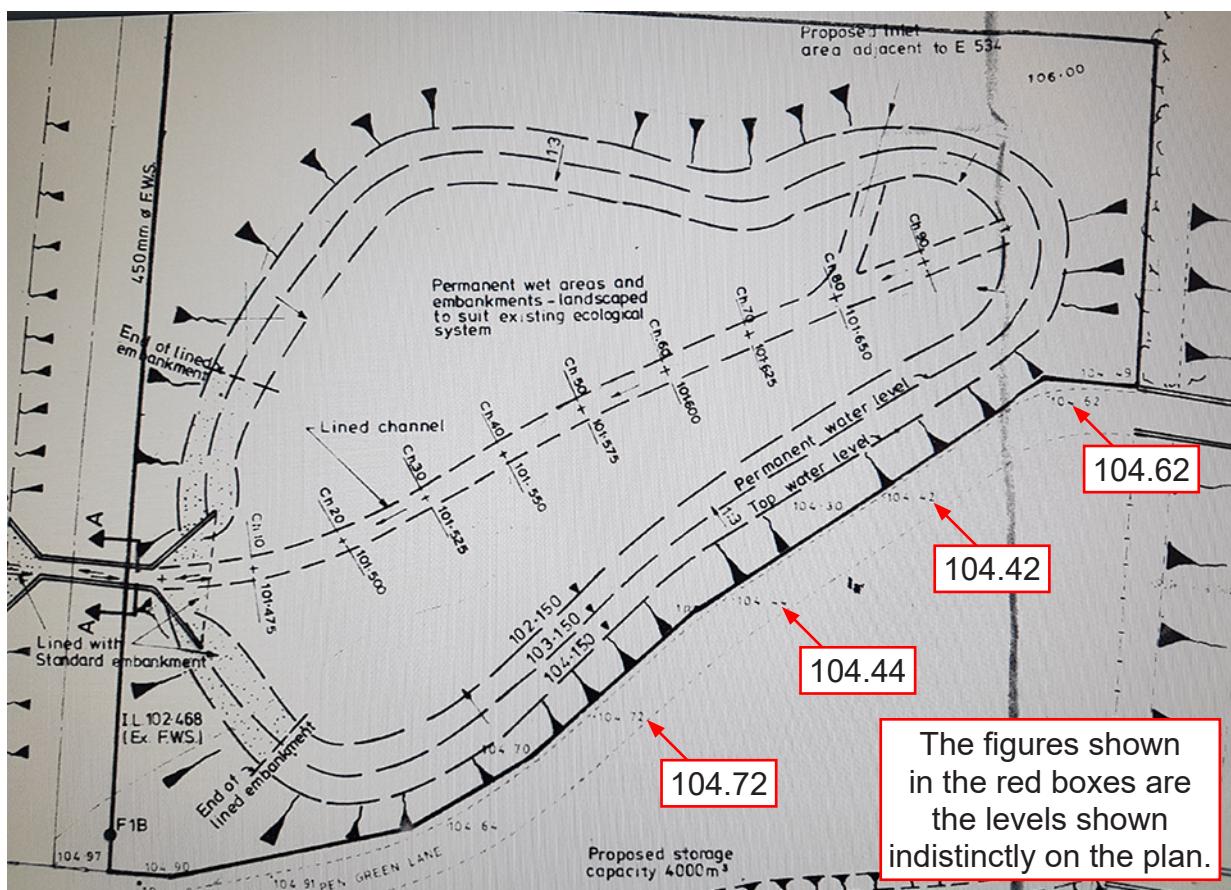
*Figure 15: The plan from the planning application for pond 2*

- 69 The plan also showed levels of 104.42 and 104.44 metres AOD recorded for the eastern bank of pond 2, indicating this bank was designed to be lower than the level of the emergency spillway. This made the emergency spillway ineffective in controlling the maximum water level in the ponds. Instead, the maximum water level in the ponds was controlled by water over-topping the eastern bank and flowing into the adjacent field at the crest of the cutting slope. Anglian Water staff with over 15 years' experience of this location reported to RAIB that they had never seen the water level in the ponds reach the point where water had passed over the emergency spillway.

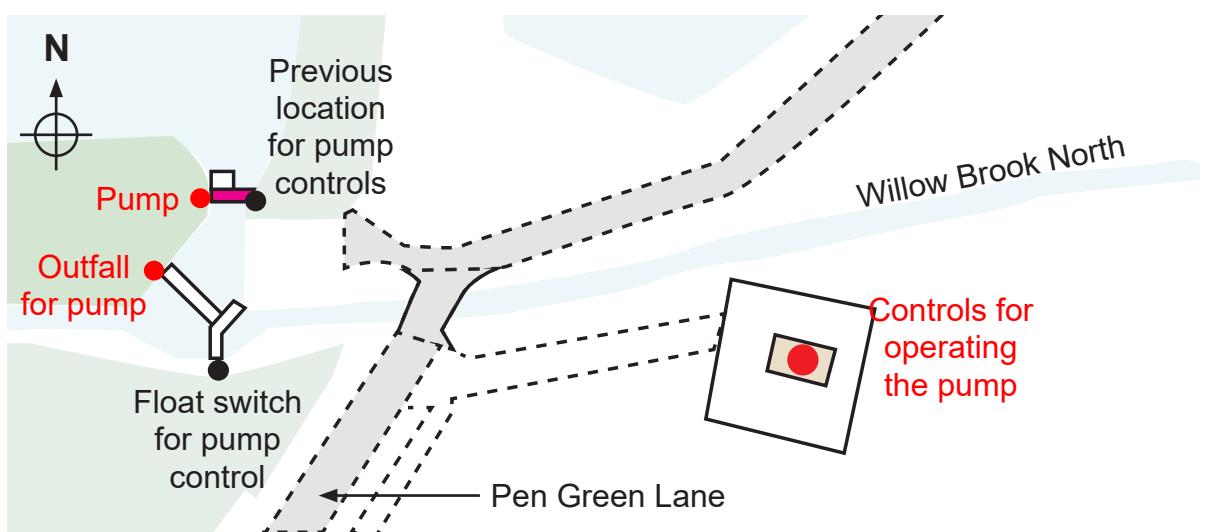
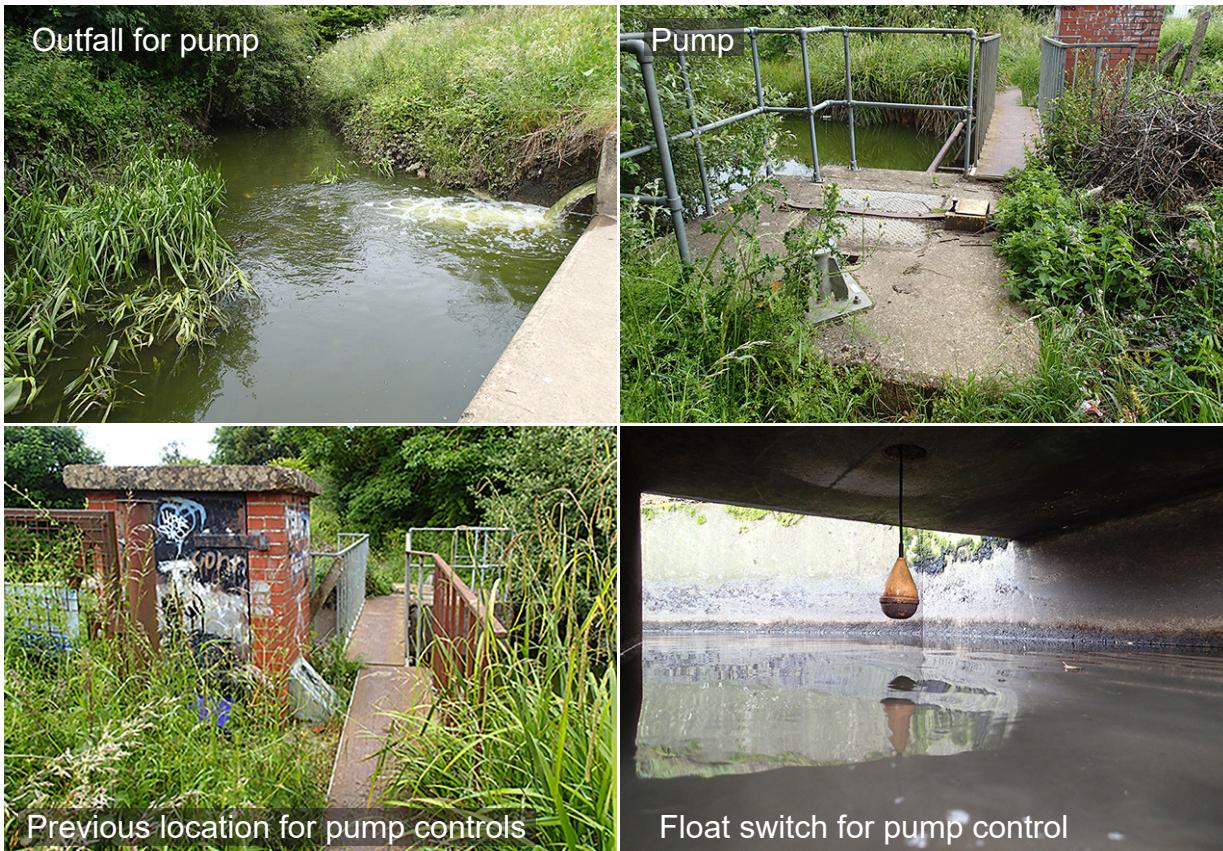
- 71 The pump is installed next to the trash screen by the entrance to pond 1, with its outlet into the brook located just before the service spillway (figure 16). Anglian Water is responsible for the pump and its operation. When pond 1 was constructed a pump system was installed and its operation was automated, with sensors that measured the water levels in the brook and pond 1 to determine when the pump should run. However, the system was frequently vandalised and so Anglian Water moved the controls for the pump to its nearby sewage pumping station (figure 16). This change resulted in the pump becoming manually controlled. RAIB has not been able to establish the exact date of this change. However, documentation related to flood management in the area that was issued in 2006, refers to the pump being manually controlled.

Figure 16: The pumping system at the spillways

- 72 Anglian Water has reported to RAIB that it does not have any formal arrangements in place for the manual operation of the pump, such as when it should be used or what the water level in the ponds should be reduced to. Instead, the pump is manually operated by a field maintenance technician employed by Anglian Water who uses his experience to decide when to run the pump.

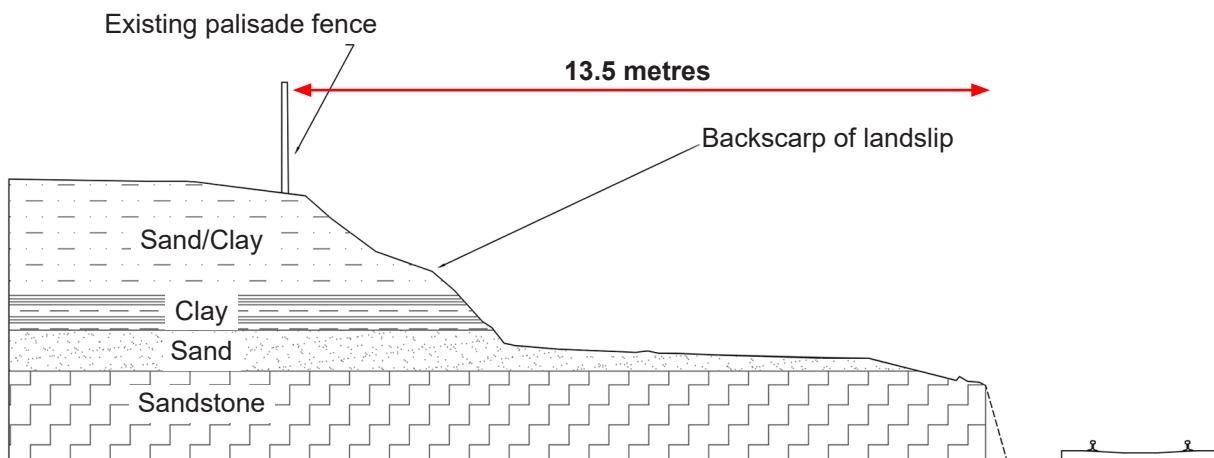
- 80 The geology of the cutting slope comprises a sandstone rock base with layers of sand and clay above it (figure 17). The cutting slope was damaged by flood water in 1999 (paragraph 43). At the time, the earthwork engineer who attended reported that the failure was due to material washing off the cutting slope onto the track, but the earthwork itself was stable. This allowed the railway to reopen within four hours of the landslip first being reported. Photographs taken by Network Rail in 2004, during an earthwork examination, show material from the cutting slope was partially filling the cess and contaminating the track ballast. No records can be found to indicate that any work took place on the cutting slope after the landslip in 1999, until it was repaired in 2009 (paragraph 45).

Figure 17: The geology of the failed cutting slope

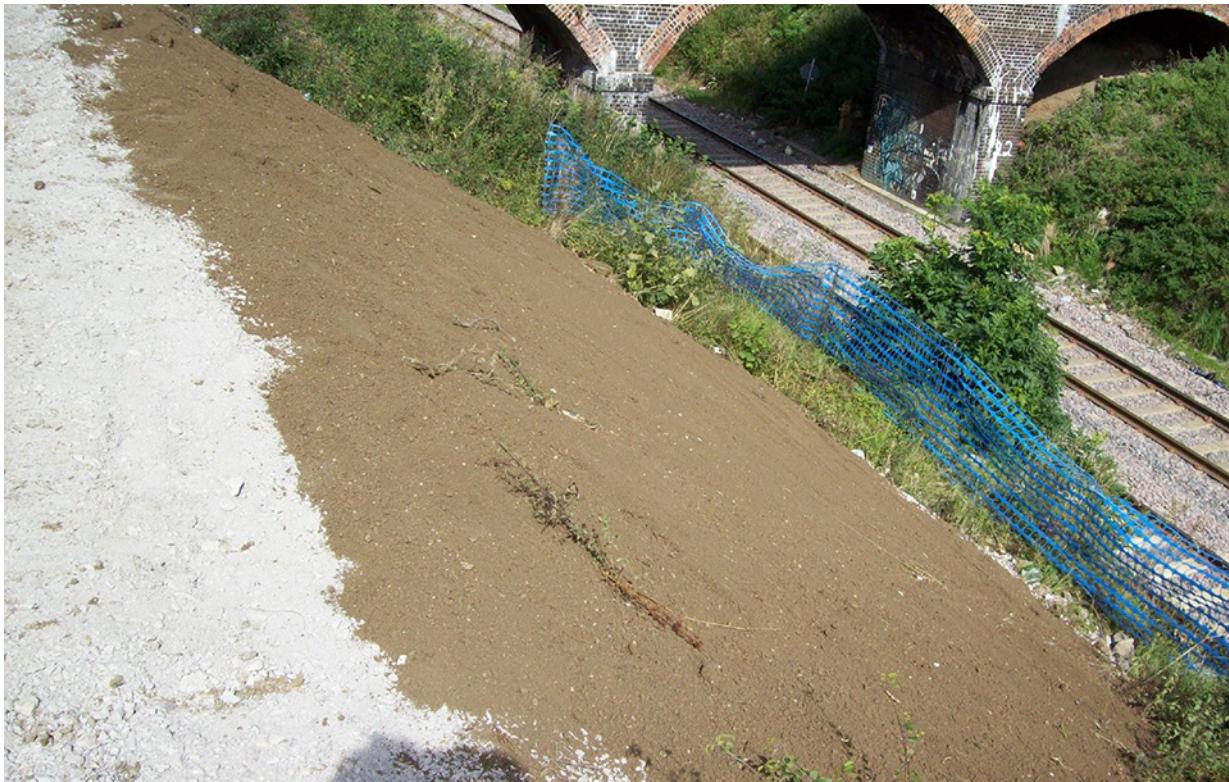
- 79 The repair to the cutting slope that was undertaken in 2009 (paragraph 45) was not appropriate for the flood water scenario that occurred in this incident. It was not designed to cope with large volumes of water accumulating at the crest of the cutting slope. Instead the 2009 repair was designed alongside some other changes aimed at minimising the accumulation of water at the cutting crest by better management of flooding at and around the entrance to the aqueduct.

Figure 19: The repaired cutting slope in 2009 (image courtesy of Network Rail)

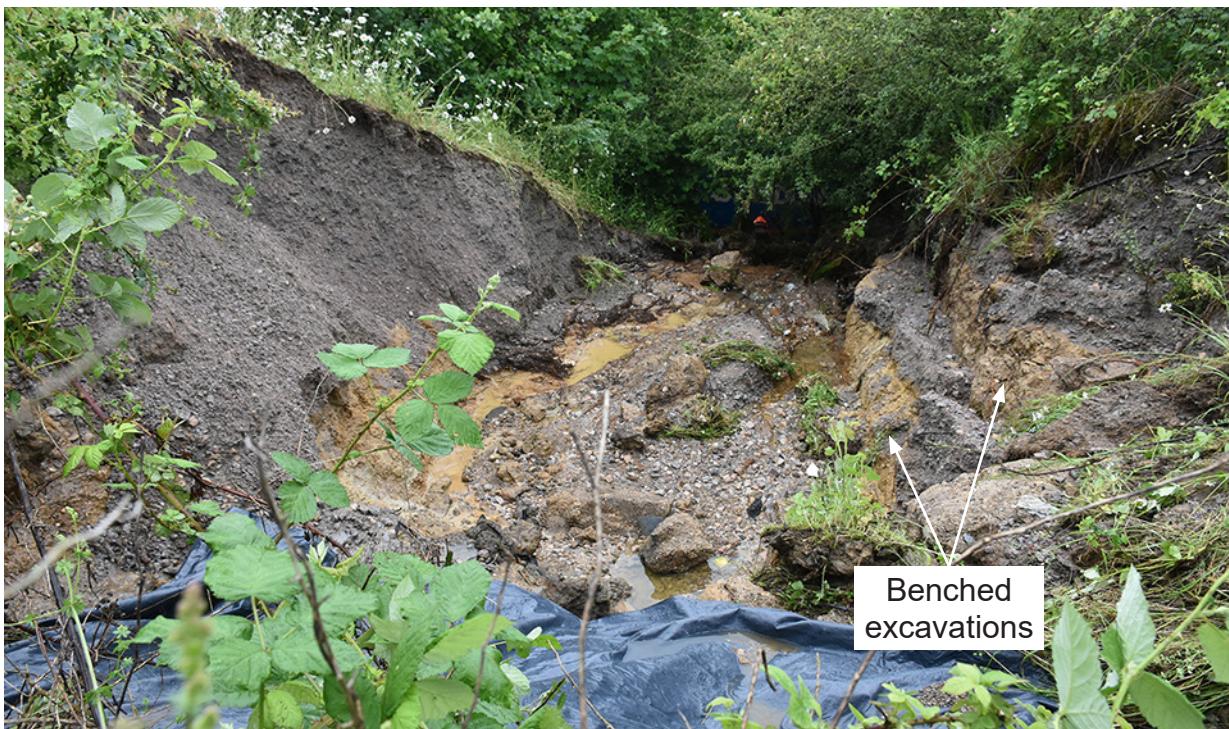
- 86 Once the sandy gravel was washed out from the cutting slope during this incident, it flowed underneath and through the gaps in the underframes of the vehicles at the rear of train 1D43 (figure 3). Afterwards, the void left in the cutting slope revealed the benched excavations made when the 2009 repair was carried out (figure 20), showing that the flood water had only washed away the fill material.

Figure 20: The void left in the cutting slope showing the benched excavations from the 2009 repair, viewed from the top of the cutting slope looking towards the railway

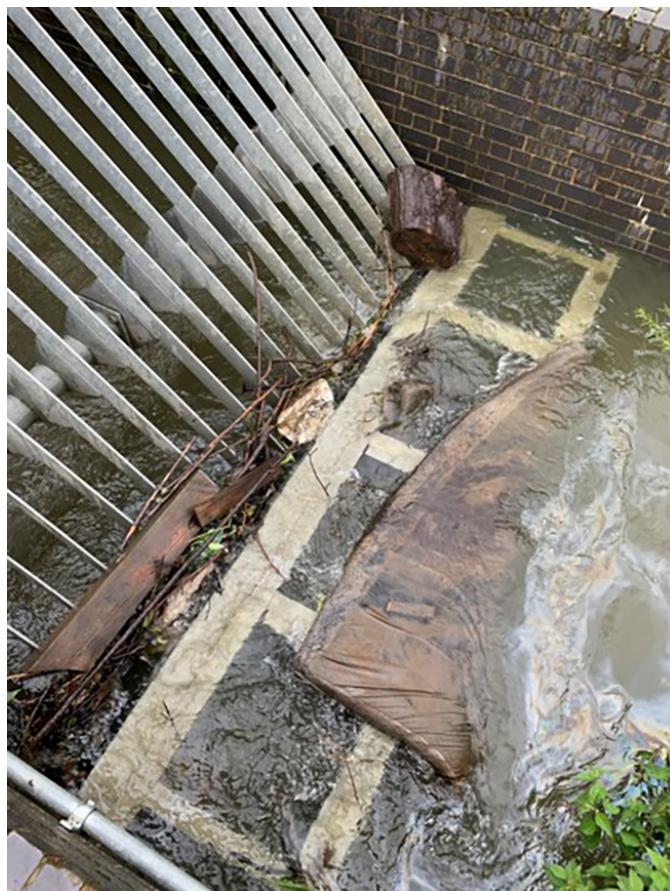
- 104 Anglian Water and Network Rail reported that the effectiveness of the flood management system at Pen Green Lane was also affected by high levels of antisocial behaviour. The automated pumping system stopped working due to frequent vandalism. The location also suffers from significant amounts of rubbish and items being thrown into the channels of Willow Brook North, causing blockages in the channels which reduce the flow of water. Debris also collects to form blockages at restrictions, such as under bridges or at trash screens, which also affects the flow of water in the brook. During checks on 13 June, the Network Rail mobile operations manager found and removed debris from the aqueduct's trash screen in the morning. It was still clear when checked again in the early afternoon (paragraphs 20 and 22) but after the incident, Network Rail's contractors found more debris had collected at the trash screen and was affecting the flow of water onto the aqueduct (figure 23).

*Figure 23: Debris in the aqueduct's trash screen after the incident (image courtesy of CML)*

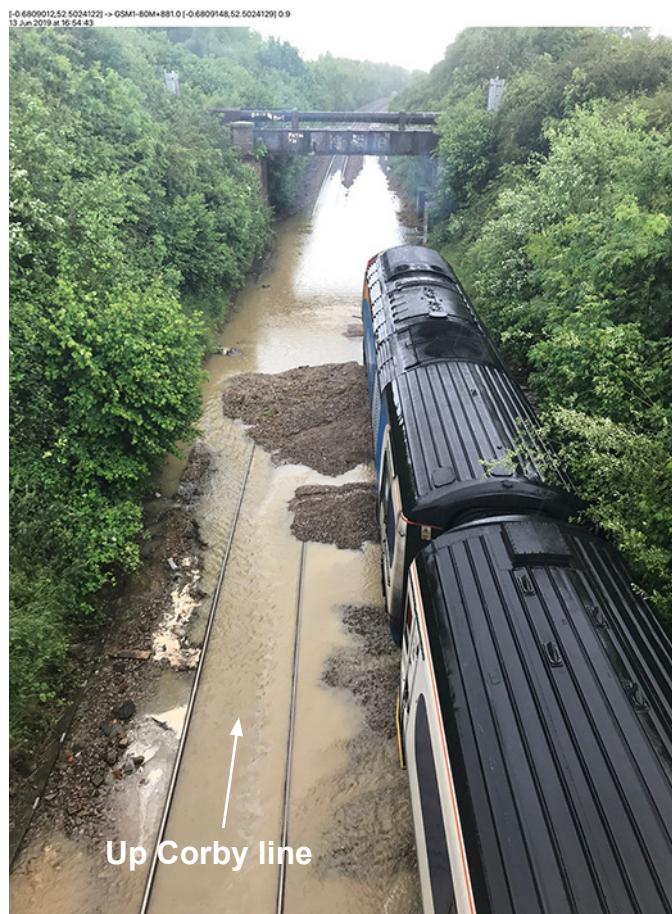
*Figure 24: Flood water and sandy gravel blocking the up line (image courtesy of Network Rail)*

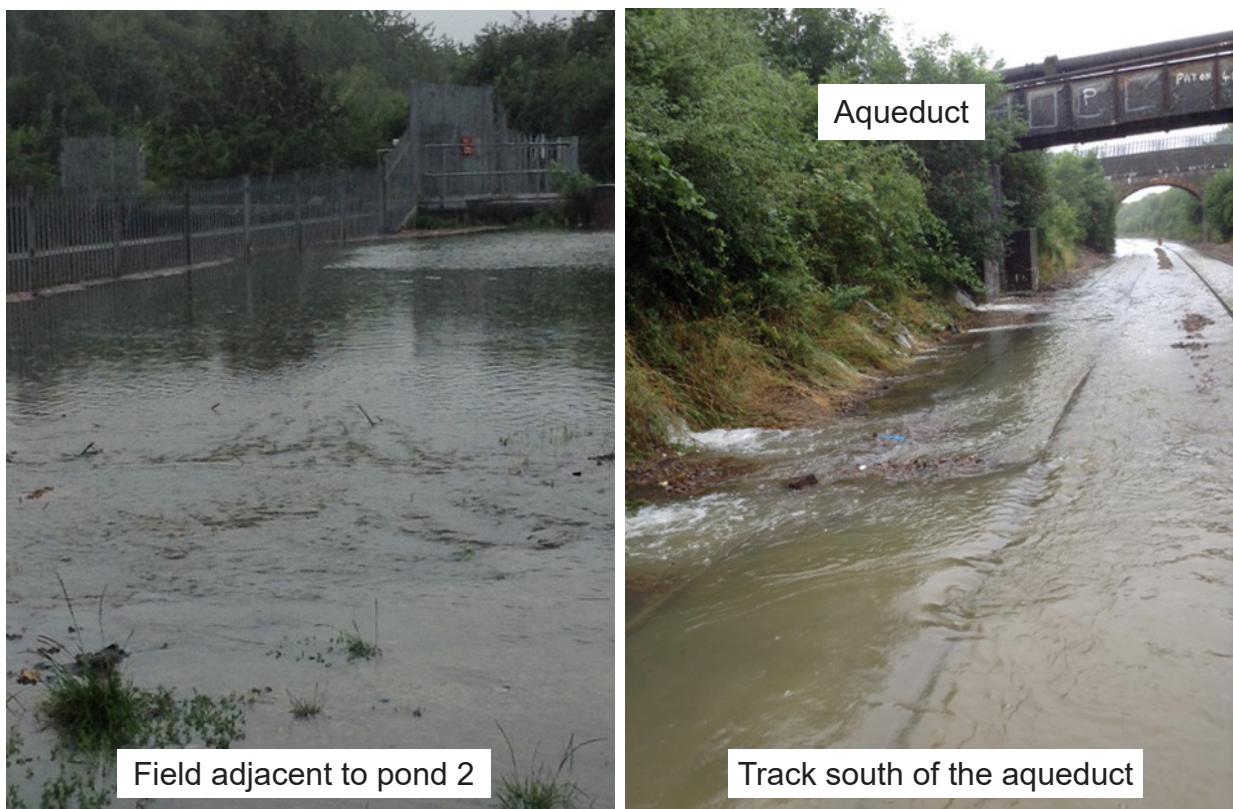
- 146 The effectiveness of the repair was demonstrated on 28 July when there was further flooding at Pen Green Lane after heavy rainfall. This time the cutting slope between the aqueduct and the bridge was protected by the piling. However, the new barrier diverted much of the flood water to the southern side of the aqueduct. Here, the flood water washed out material from the cutting slope and onto the track in three different places (figure 28). Although Network Rail had protected its infrastructure in one place, lack of capacity in the local flood management system resulted in the problem being moved to another location. This showed that Network Rail cannot solve the problem of flooding on the railway at Pen Green Lane on its own, and that it needs to work with the other organisations to improve the effectiveness of the flood management system at Pen Green Lane. The 28 July flooding event also demonstrated the need for effective liaison between Network Rail geotechnical staff and drainage staff when developing geotechnical solutions to problems involving drainage issues.

Figure 28: Images of the flooding on 28 July (courtesy of Network Rail)
