Rail Accident Investigation Branch

# Rail Accident Report

## Loss of brake control on a sleeper train approaching Edinburgh 1 August 2019

Report 05/2020  
May 2020

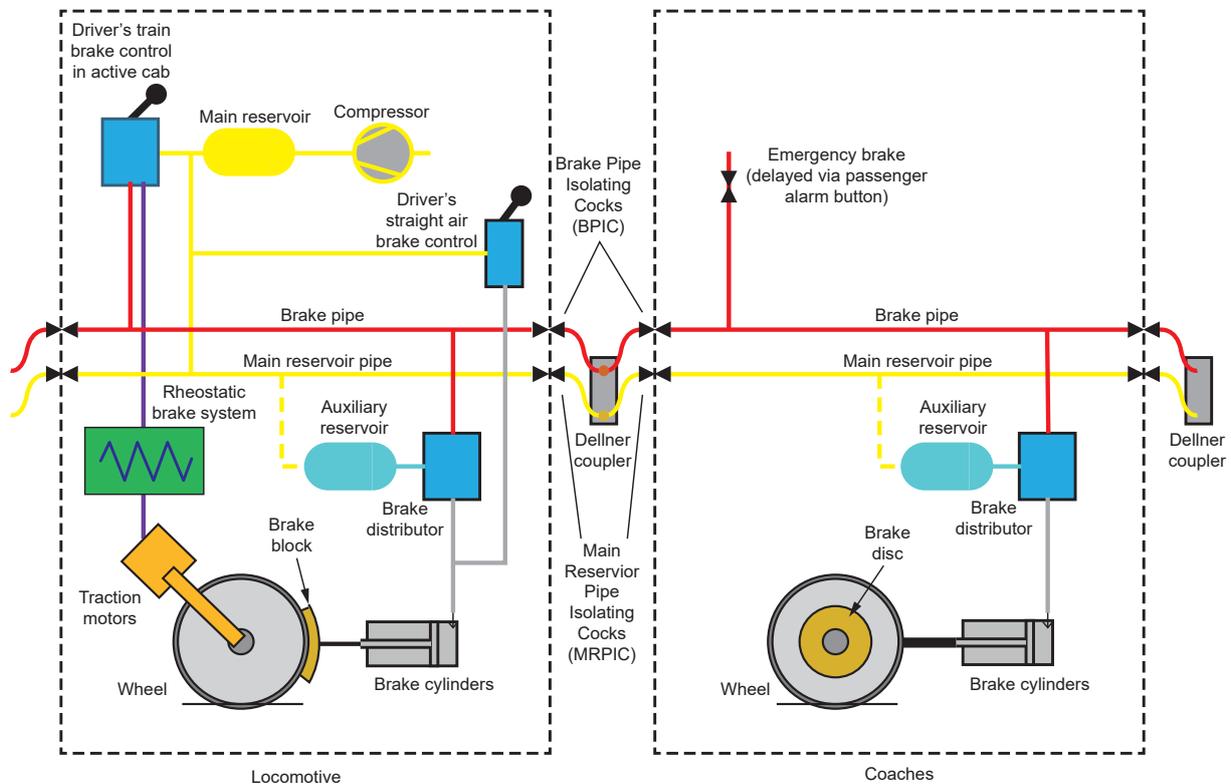
Figure 7: Simplified diagram of train brake systems (omitting other air-related systems)

- 27 Figure 7 shows a simplified diagram of the brake systems on the locomotive and the Mark 5 sleeper coaches. The locomotive controls the brakes on all the coaches using a conventional two pipe air system. A 'main reservoir pipe' and a 'brake pipe' run the length of the train, with the air connections passing through the couplers between each vehicle. Main reservoir and brake pipe isolating cocks (MRPIC and BPIC) are provided on the vehicle sides of every coupler. The main reservoir pipe keeps the auxiliary reservoirs on each vehicle topped up, using air from the locomotive main reservoir and compressor. The air in the auxiliary reservoirs provides the energy to apply the brakes on each vehicle. The driver's train brake control adjusts the air pressure in the brake pipe, with 5 bar pressure commanding brake release and a reduction from 5 bar commanding a proportionate brake application.

- 28 Each vehicle has a brake distributor that controls the flow of air from its own auxiliary reservoir to the brake cylinders on that vehicle when the brake pipe pressure falls below 5 bar. A reduction in the brake pipe pressure results in an increase in the pressure to the brake cylinders on all the vehicles, and thus the amount of friction braking applied. A brake pipe pressure reduction to 3.5 bar or lower causes a full application of the brakes on all vehicles. Gauges in the cab show the driver the air pressures in the brake pipe and the main reservoir pipe, as measured on the locomotive, and in the locomotive brake cylinders.

52 The BPIC on the leading end of the leading coach was found to be closed when the train came to a stop (paragraph 47). The effect of this was to disable control of the brakes on the coaches from the locomotive. The braking performance of the train, as recorded by the on-train data recorders (OTDR) on both the locomotive and the coaches, was consistent with the BPIC being closed for the entire journey from Carstairs to Edinburgh. This meant that the driver only had control of the friction and rheostatic brakes on the locomotive. The rheostatic brake shut down towards the end of the journey, and only the friction brakes on the locomotive remained available to stop the train (paragraph 88).

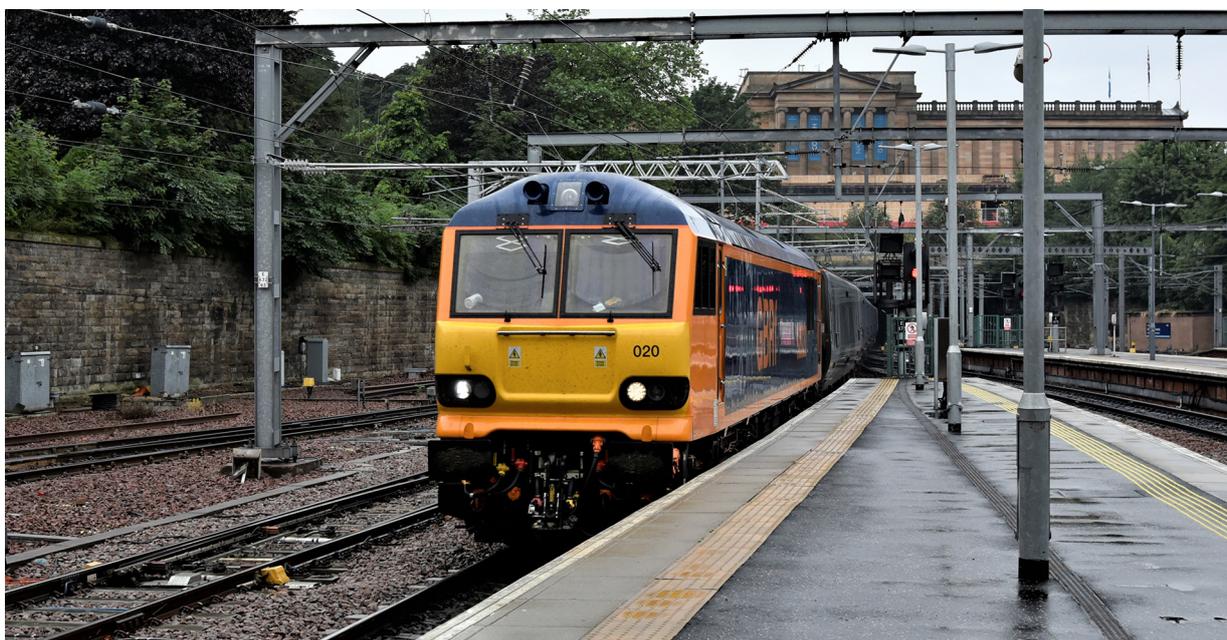
Figure 9: The train entering platform 11 during the incident (Courtesy of Peter Fitton)

- 46 The speed had reduced to 30 mph (48 km/h) by the time the train entered platform 11 (figure 9), and to 23 mph (37 km/h) by the time it passed the east end of platform 7. As the train was passing through platform 11, the train manager realised that there was a problem and operated the passenger alarm button in his office to try to stop the train. The passenger alarm button alerts the train driver to an emergency and applies the train brakes after a ten second delay (paragraph 29). When nothing seemed to be happening, because of the ten second delay, the train manager operated a second passenger alarm button in the passenger area outside his office, and he then felt the brakes apply sharply, bringing the train to a stop at 07:28 hrs. By this time the front of the train was in Calton South tunnel, with the rear between platform 7 and the tunnel (figure 10).

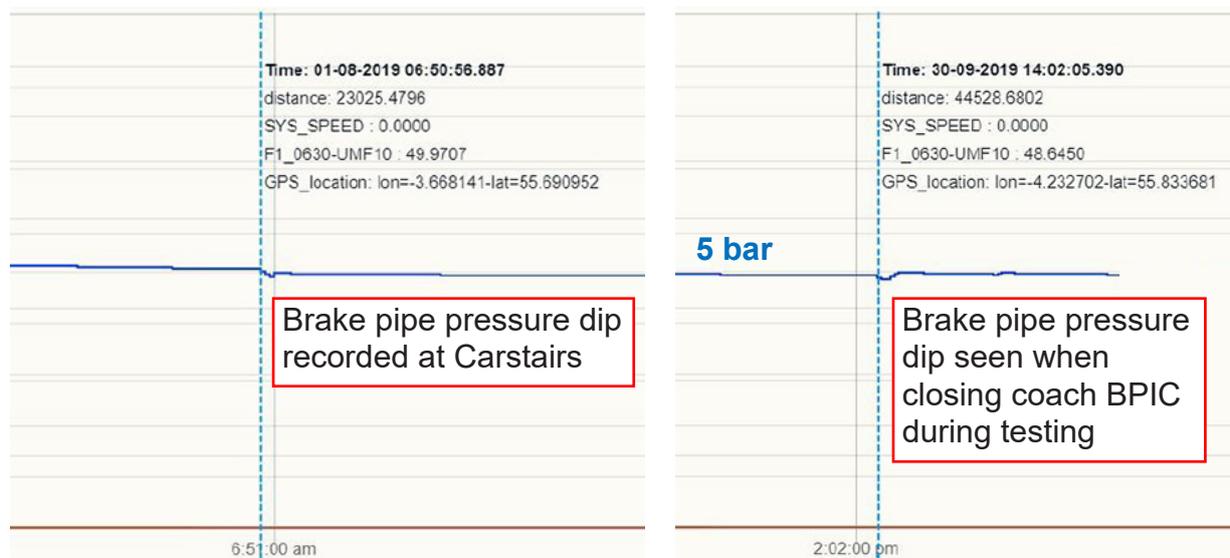
Figure 11: Comparison of brake pipe pressure dip at Carstairs and during BPIC operation testing

- 58 At 06:50:57 hrs, the locomotive's OTDR shows a small dip in the locomotive brake pipe pressure, which then recovers very quickly. This is consistent with the dip in pressure expected when the BPIC on the coach is closed, with that on the locomotive remaining open. The coaches' BPIC has a small vent on the non-coach side, which opens to atmosphere when the valve is in the closed position. The purpose of this is to release pressure in inter-vehicle connections ready for uncoupling.

- 59 The effect of closing only the coach BPIC was to seal 5 bar pressure in the brake pipe linking the coaches, and to vent the locomotive side. However, because the locomotive was still coupled with its BPIC open, the locomotive quickly detected the fall in brake pipe pressure and charged the brake pipe back to 5 bar. The rate of recharging was much faster than the vent could release the pressure, and so the brake pipe quickly returned to 5 bar. Figure 11 shows the brake pipe pressure record from the locomotive's OTDR, showing the short dip in the brake pipe pressure. It also shows a similar dip resulting from a post incident test operation of the coach BPIC at Polmadie depot. RAIB has concluded from this testing that it is almost certain that the brake pipe pressure dip seen at Carstairs indicates when the BPIC on the coach was closed.

- 60 The timing of the brake pipe pressure dip indicates that the BPIC was almost certainly operated part way through the period when both the driver and the shunter were struggling with the second ETS plug. This was at least one minute before they finally connected it and started to leave the track. This means that it is very unlikely that either the driver or the shunter operated the BPIC deliberately to provide some personal protection to prevent the train from moving when accessing the track, or to remove such protection when leaving the track. Neither the driver nor the shunter recall operating the BPIC when on track, and neither recalls seeing the other operate it. The absence of a reason to interact with the BPIC at the time indicated by the OTDR, combined with the lack of awareness of it being operated, leads RAIB to conclude that, although the possibility of it being turned by hand cannot be totally discounted, it was almost certainly operated inadvertently by either the shunter or the driver.

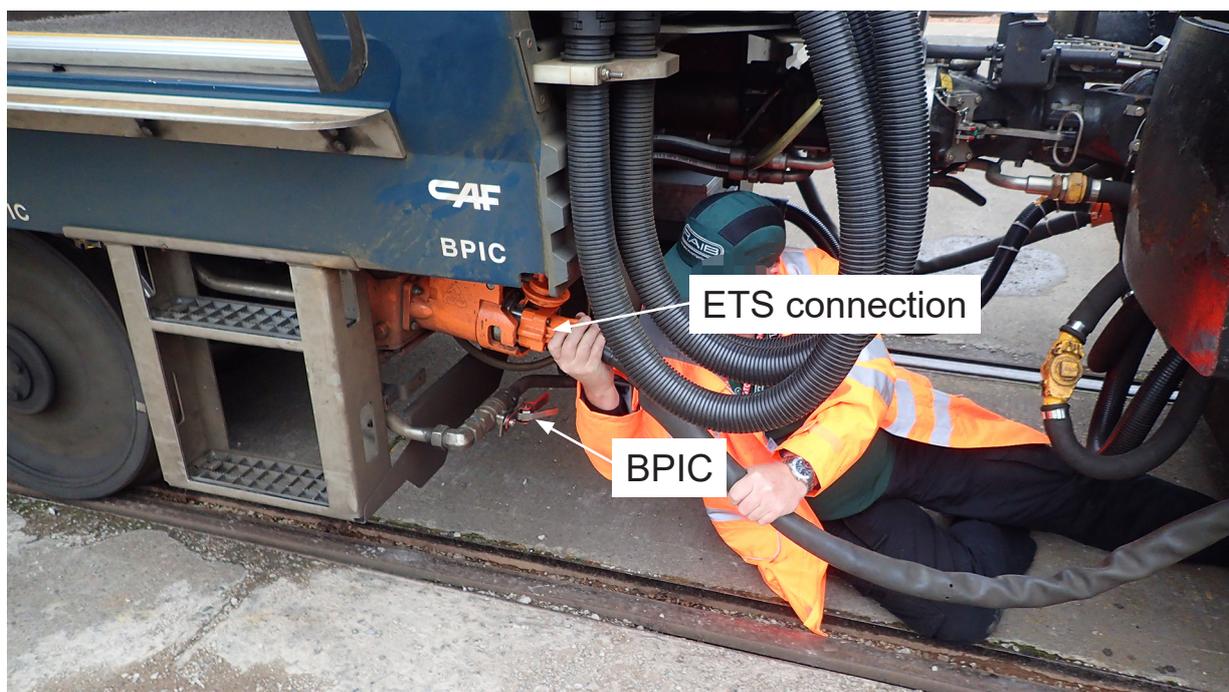
Figure 12: Location of the BPIC, showing proximity to ETS connection

- 66 When the shunter first went to help the driver, he was between the running rails, in a position similar to that shown in figure 12.<sup>6</sup> The driver was attempting to connect the ETS plug while crouching outside the rails facing towards it, in a position similar to that recommended in the rolling stock ergonomic assessments. The shunter later moved out from between the rails to a position crouching beside the driver and close to the steps. The work with the ETS plug was being undertaken above and very close to the BPIC. It is very likely that the BPIC was either leaned on or brushed against by either the driver or the shunter, caught on clothing, or knocked by the loose ETS plug. Although the BPIC was open, it is possible that its handle might not have been turned sufficiently for the latch to have engaged prior to coupling the locomotive, thus making the valve more susceptible to inadvertent closure.

- 67 Venting through the closed BPIC would have been accompanied by the sound of escaping air. However, the vent on the coach BPIC is much smaller than that on the locomotive BPIC, and also smaller than that fitted to Mark 2 and 3 coaches, the previous vehicles used on the sleeper service. As a result, the Mark 5 BPIC vent makes much less noise than the staff would normally have experienced with other coaches and locomotives. Neither the driver nor the shunter recalled hearing the BPIC vent, over the sound of the adjacent locomotive, and so were not alerted to the BPIC being closed.

- 68 RAIB notes that, although a flying ballast protection plate is provided, this only protects the BPIC on one side and the valve's position means that it is exposed to impact from objects approaching from the other side, such as fallen vegetation or flying ballast. The handle and its latch appear to be less robust than the latched type handles normally used on UK rolling stock (figure 13), and therefore may be more susceptible to inadvertent operation. Latched BPIC handles were recommended by the Railway Inspectorate report on a collision at Darlington on 16 February 1977, which was caused by a BPIC being knocked closed by debris on the track.

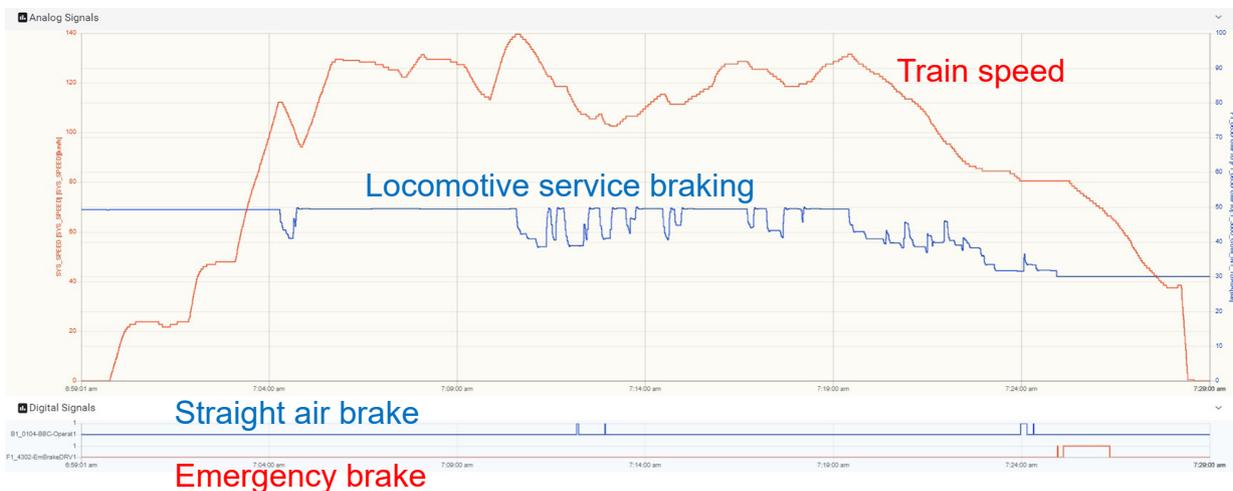
Figure 14: Speed and braking data from the locomotive OTDR

- 83 Although the coach brakes were isolated by the closed BPIC, the brakes on the locomotive were fully operational and under the driver's control. The locomotive braking is designed to primarily be provided by the rheostatic brake, to reduce brake block wear. The rheostatic brake is intended to replicate the retardation available from the locomotive's friction brake during normal operation, so that if the rheostatic brake is unavailable for any reason, the friction brake takes over. This means that the entire train of eight coaches was being retarded by the locomotive's rheostatic brake. The effectiveness of the rheostatic brake masked the non-operational coach brakes during the running brake test, so the driver did not perceive a problem.

87 Figure 14 shows that the driver made two short applications of the locomotive's straight air brake during this initial period of service braking. Although this might suggest that the driver had some concern about his brakes, he stated that this was because the cab gauges were showing no brake cylinder pressure during braking, and he applied the straight air brake to get reassurance that the friction braking was working. The brake cylinder pressure gauges (paragraph 31) were not showing any friction brake application at the time because the rheostatic braking was providing the required braking. The driver allowed the train speed to rise after this, showing that he was not particularly concerned about the operation of the brakes.

88 At the overhead line neutral section near Curriehill station (paragraph 44), the main circuit breaker on the locomotive opened automatically as intended, but did not reclose, and the pantograph dropped about 25 seconds later. The OTDR data does not include the detail required to explain why this happened, or the detail of subsequent events within the locomotive's control system. However, it is likely that the locomotive's electrical converters shut down during this event, and consequently the rheostatic brake stopped working. That would have resulted in the locomotive's friction brake becoming active, thus continuing to retard the train.
