**CONTENTS****SPECIAL BULLETINS / INTERIM REPORTS**

**AAIB FIELD INVESTIGATIONS****COMMERCIAL AIR TRANSPORT****FIXED WING**

Airbus A320-216	EC-KLT	26-Aug-19	3
ERJ 190-200 LR (Embraer 195)	G-FBEJ	28-Feb-19	11

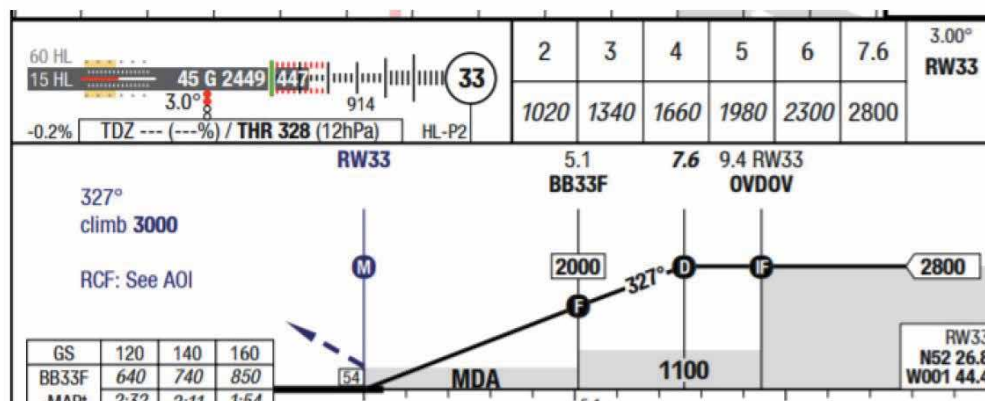
Figure 2

The investigation also highlighted a difference between the descent profile for the RNAV approach published in the UK AIP<sup>5</sup> and that published by the operator's chart provider<sup>6</sup>. Whilst the former had a platform altitude for the approach of 2,000 ft with final descent starting at 5.1 nm from the threshold, the operator's approach charts showed a continuous descent starting from 2,800 ft at 7.6 nm (Figure 2). This led to confusion by the pilots when initially they were cleared to 2,000 ft on the first approach, causing them to delay their descent and to ask ATC again for the descent instructions. This had served to compound the issue of the late configuration of the aircraft for the approach whilst trying to slow down, resulting in the aircraft not establishing on the correct approach profile and leading to the missed approach.

Extract from operator's chart for RNAV approach to Runway 33 at Birmingham

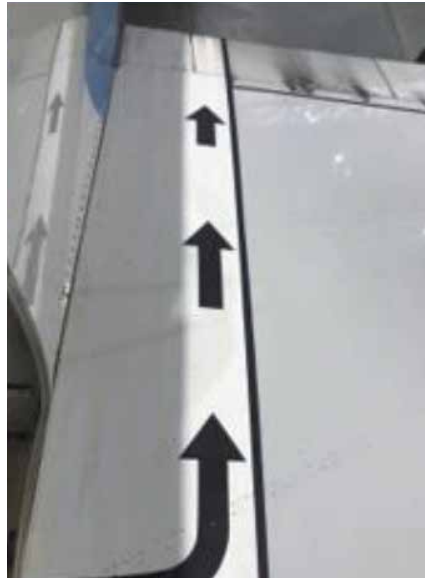
**Figure 1**

Overwing exit escape route markings on E195 (view towards wing trailing edge)

Despite the presence of a marked exit route on the wing with a non-slip surface, many passengers who exited via the overwing exits reported being uncertain where to go once out of the aircraft. None of them mentioned noticing the marked walkway on the wing. The evacuation took place during daylight hours with good visibility. As noted in the RAeS paper, overwing exit route markings are not always readily identifiable and may be even less so in darkness. Poor weather conditions or the presence of smoke could also hinder identification of an exit route.

It is apparent from this accident and the RAeS paper that the issue of ambiguous overwing escape route markings that resulted in previous AAIB Safety Recommendations 2002-42 and 2010-007 still exists. It is therefore appropriate that this matter is re-examined. The AAIB asked the EASA to review the issues identified relating to overwing escape route markings. The EASA indicated that while it considered all applicable certification requirements for the E195 relating to evacuation from overwing emergency exits had been met, it intended to consider introducing a new AMC to:

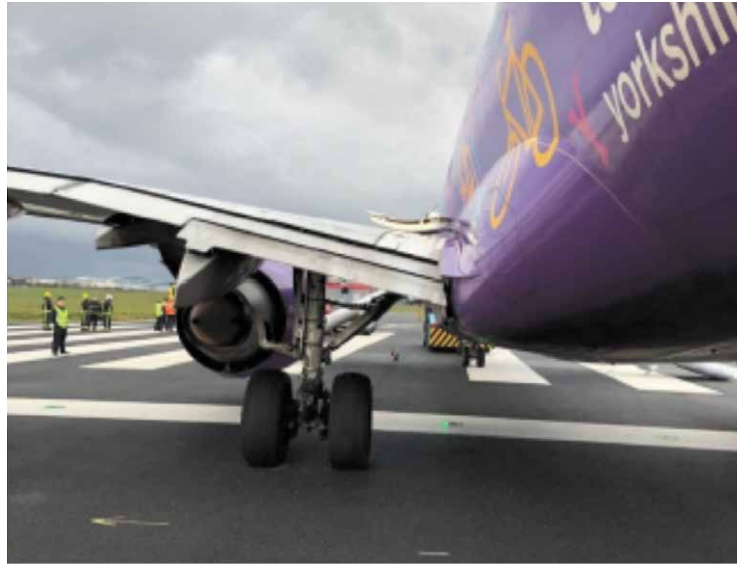
**Figure 3**

The FLAP 5 selection is made to facilitate passengers, exiting via the overwing exits, to get off the wing by sliding down the extended flaps. Figure 3 shows the drop to the ground from the left wing during the evacuation. The operator subsequently measured the height of the wing trailing edge above the ground when the flaps were not deployed and determined that it would be in excess of 2 m, depending on the aircraft weight and fuel load.

Drop to the ground from wing trailing edge with flaps in FLAP 1 setting

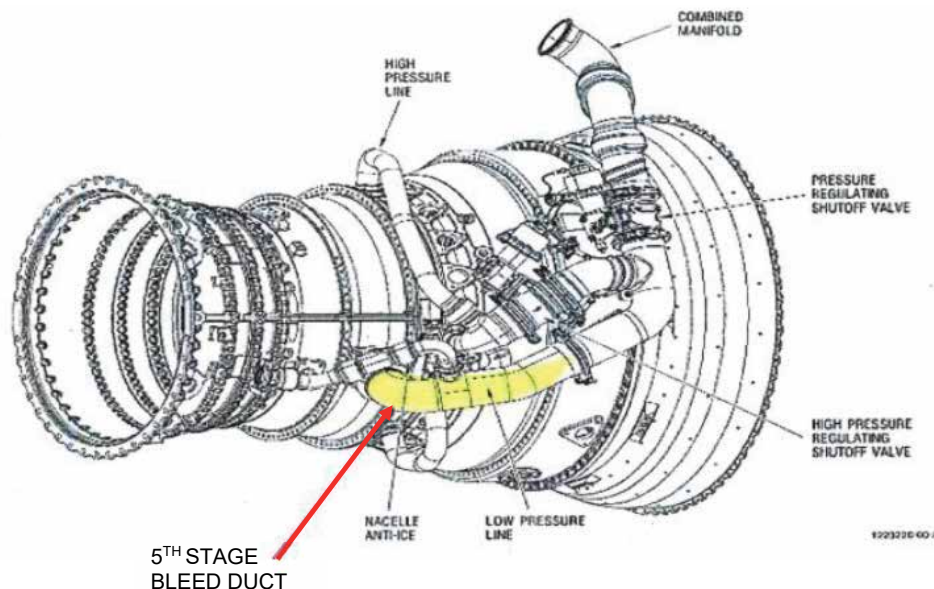
**Figure 6**

Engine schematic showing location of high pressure compressor fifth stage bleed duct

During the engine dry-out procedure following the compressor wash, the engines were run only at idle power. At idle power the engine power setting would have been insufficient for the engine bleed source to switch to the HPC fifth stage bleed. To dry out the fifth stage bleed ducts, the procedure recommended running the engine up to 65% N1. By not performing a high-power engine ground run, residual cleaning solution remained within the fifth stage bleed ducts.

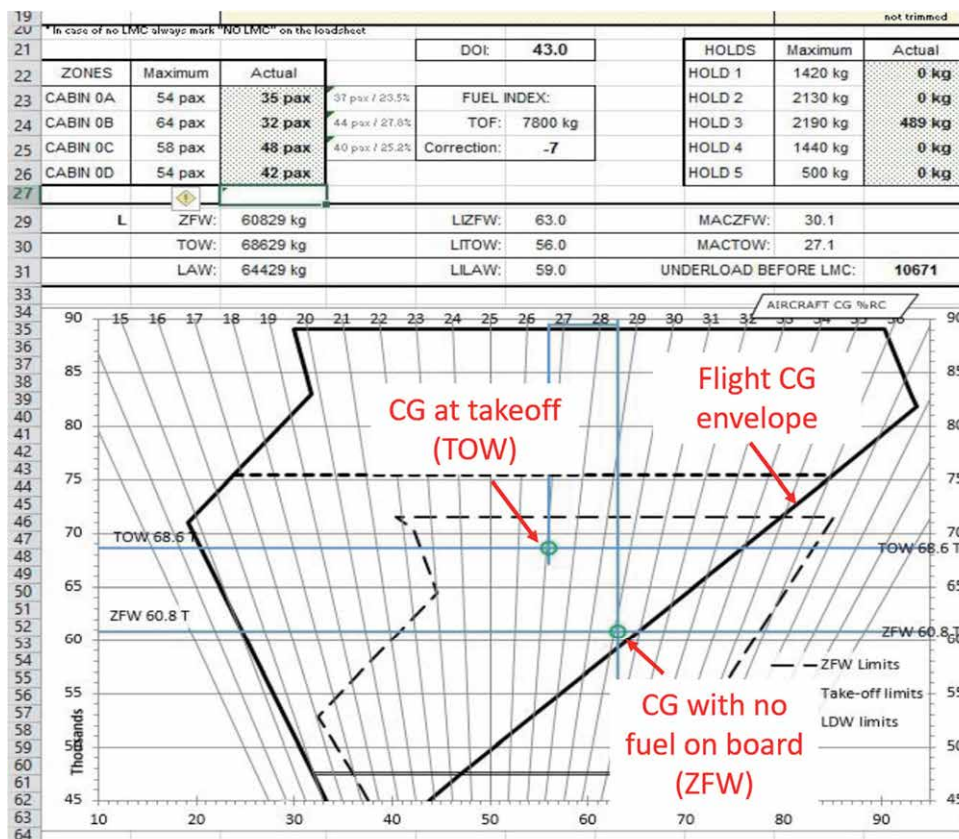
Figure 1

The Load and Trim Sheet as calculated but not as loaded

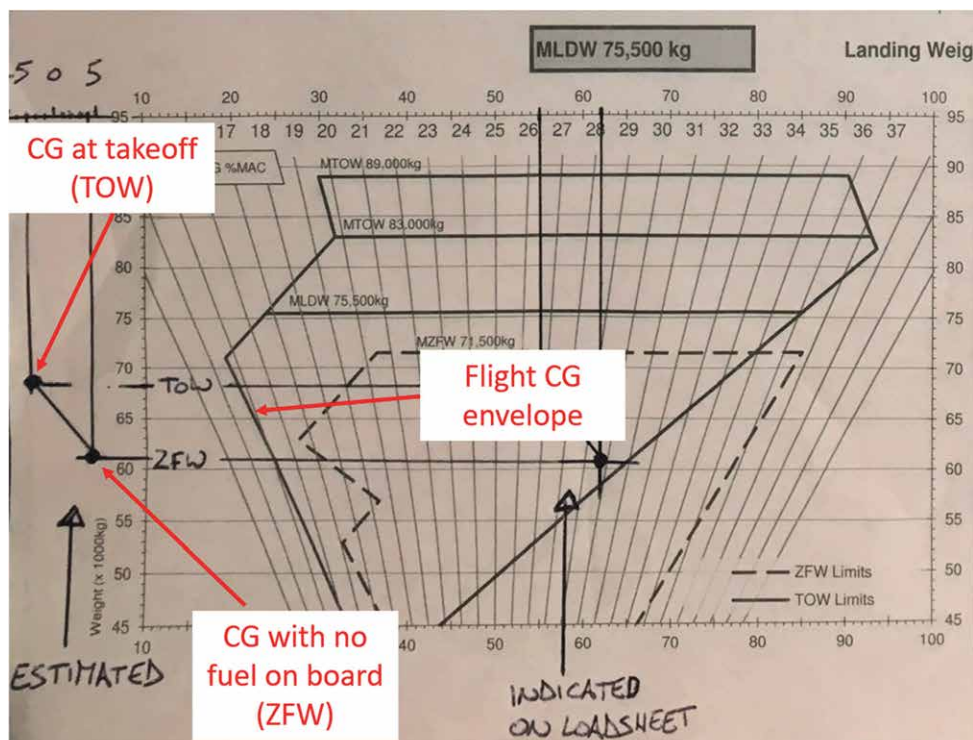
Figure 2

After the incident, the commander completed a Load and Trim sheet using the passenger seating allocation for the A320, but with the passengers seated in those seating positions in G-WUKG. The result, shown in Figure 2, shows that the total passenger weight was forward in the cabin placing the aircraft CG outside the permitted envelope.

The A321 Load and Trim Sheet that would have resulted on the incident flight
