Rail Accident Report

Train dispatch accident at Elstree & Borehamwood station 7 September 2018

Report 03/2019
May 2019

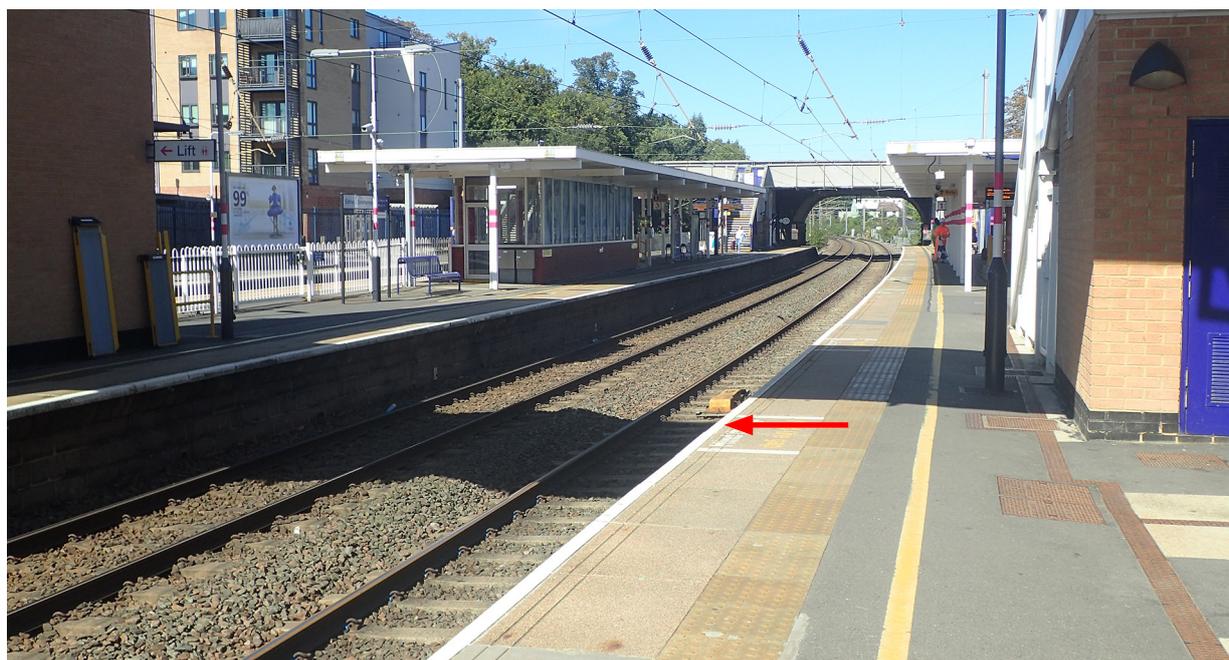
Figure 3: View looking north along platform 1 showing the location of the accident (red arrow)

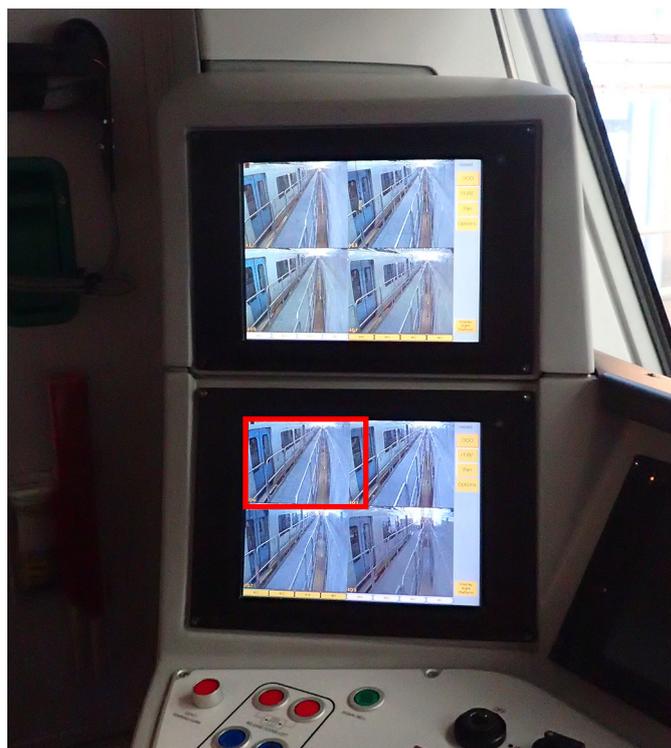
Figure 7: The screens displaying images from the externally mounted CCTV cameras. The red box shows the position of the image showing the fifth coach (involved in the accident). Images shown are not at Elstree and Borehamwood station.

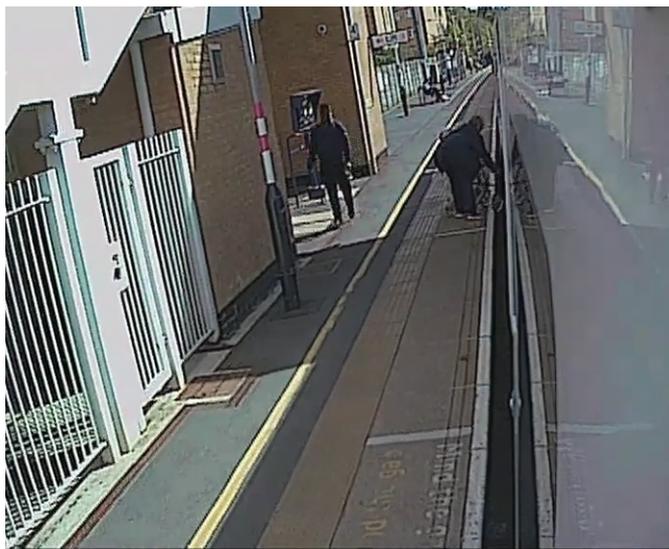
- 48 **The train driver was unaware of the passenger and her dog when he closed the doors and dispatched the train.**
- 49 Testing of the CCTV system carried out after the accident by Siemens (paragraph 36) indicated that it was working as expected. Siemens reported to the RAIB that there is no known system failure mode which could have provided false or misleading images to the driver. The RAIB's inspection of the recorded CCTV images found that the passenger was clearly visible, standing in close proximity to the train (figure 9).

Figure 9: The image of the passenger standing by the train as shown to the driver on the train's CCTV system. The image shown to the driver measured 104 mm horizontally by 87 mm vertically.

- 50 The driver stated that he recalled looking at the CCTV screens in the cab prior to applying power and departing Elstree and Borehamwood station, but he had no recollection of seeing the passenger or her dog in the monitors.
- 51 The investigation identified a number of factors, some or all of which may have played a part in the driver not seeing the passenger:
- a) the short time taken to check the platform-train interface during the dispatch process (paragraph 52);
 - b) reliance on the door interlock system (paragraph 57);
 - c) distraction (paragraph 60);
 - d) fatigue (paragraph 62); and
 - e) levels of human reliability in carrying out this task (paragraph 64).
