Rail Accident Investigation Branch

Rail Accident Report

**Near miss between a passenger train and lorry
at Mucking AHB level crossing, Essex
13 March 2019**

Report 16/2019
December 2019

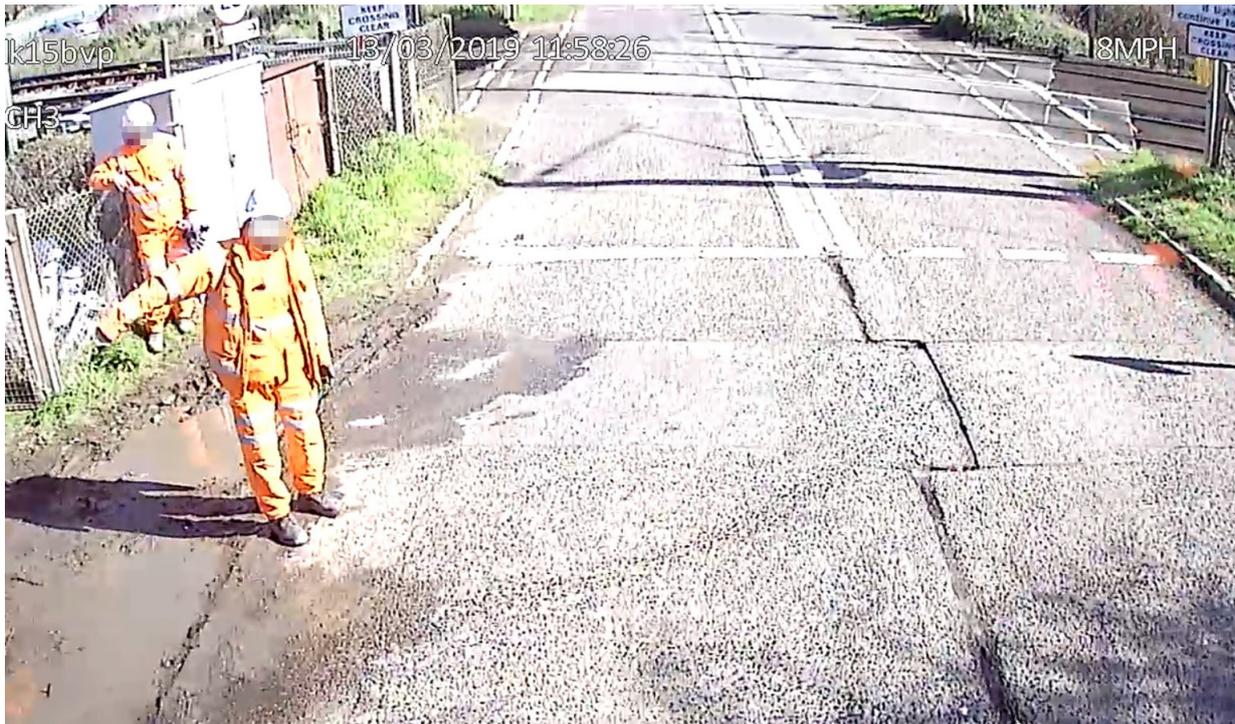
- 11 Euromix Concrete, a subsidiary of Tarmac Trading Ltd, owned the concrete delivery lorry involved in the incident and employed its driver. It supplied concrete to AmeyInabensa JV.

Figure 7: Lorry front camera view of banksman waving concrete delivery lorry forwards towards the level crossing (courtesy of Euromix Concrete)

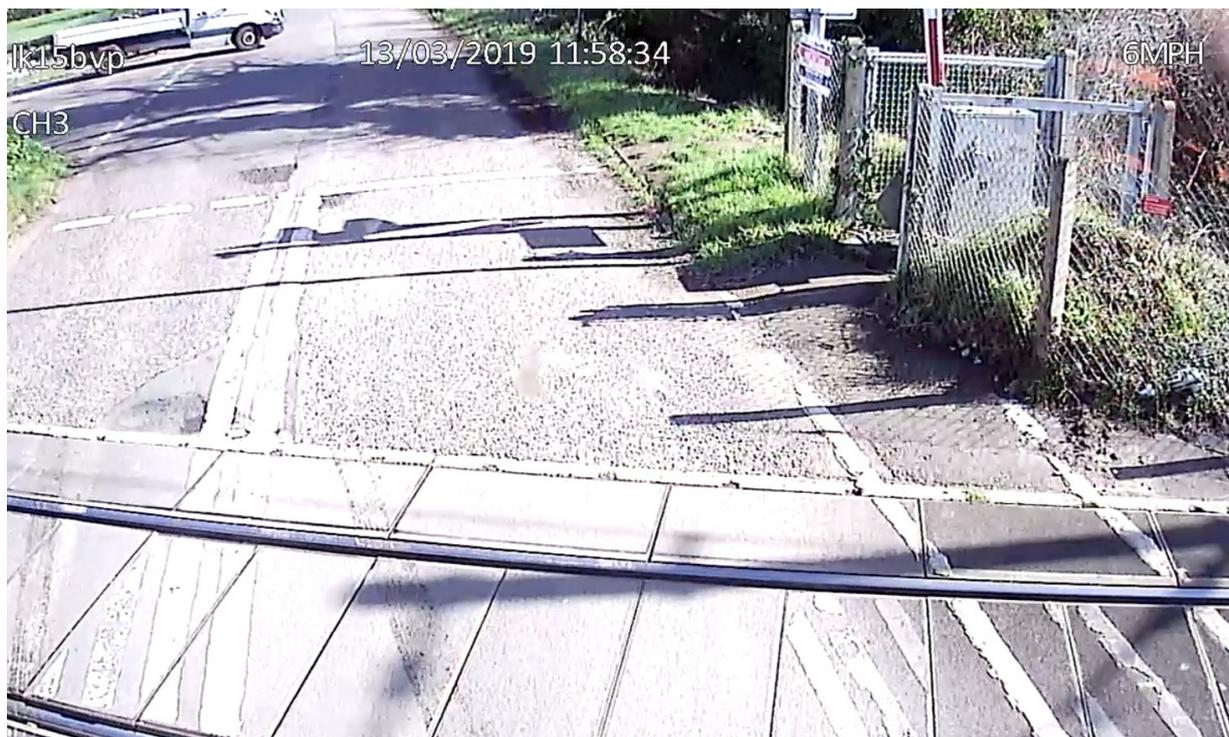
Figure 8: Lorry front camera view showing its position on the opposite carriageway ready for the reversing manoeuvre. The site pickup truck (visible at top of image) is reversing into a side road (courtesy of Euromix Concrete)

52 The lorry driver understood this to mean he should pass the site entrance before reversing into the site, so he continued to drive forwards onto the crossing to position the lorry for the reversing manoeuvre. He then stopped, and started to reverse. He stated that it would not have been possible to turn the lorry on the other side of the crossing because there were vans and cars parked in the side road. Video evidence from the lorry shows the pickup truck being used by site staff reversing into the side road as the lorry drove onto the crossing, temporarily obstructing the road about 15 metres beyond the level crossing (figure 8).

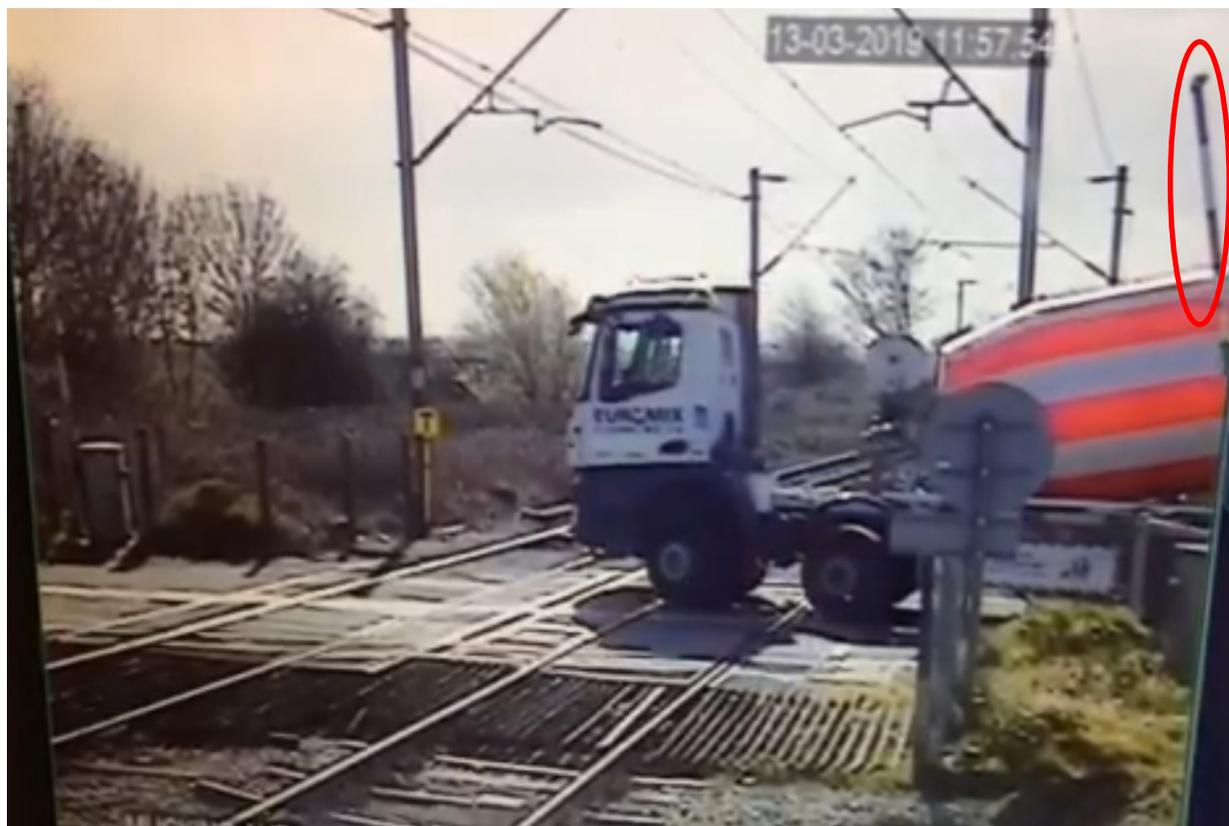
Figure 1: Extract from Ordnance Survey map showing location of incident

Figure 9: Level crossing camera view showing lorry stopped and about to start reversing manoeuvre. The crossing barrier (highlighted) has started to lower (courtesy of Network Rail)

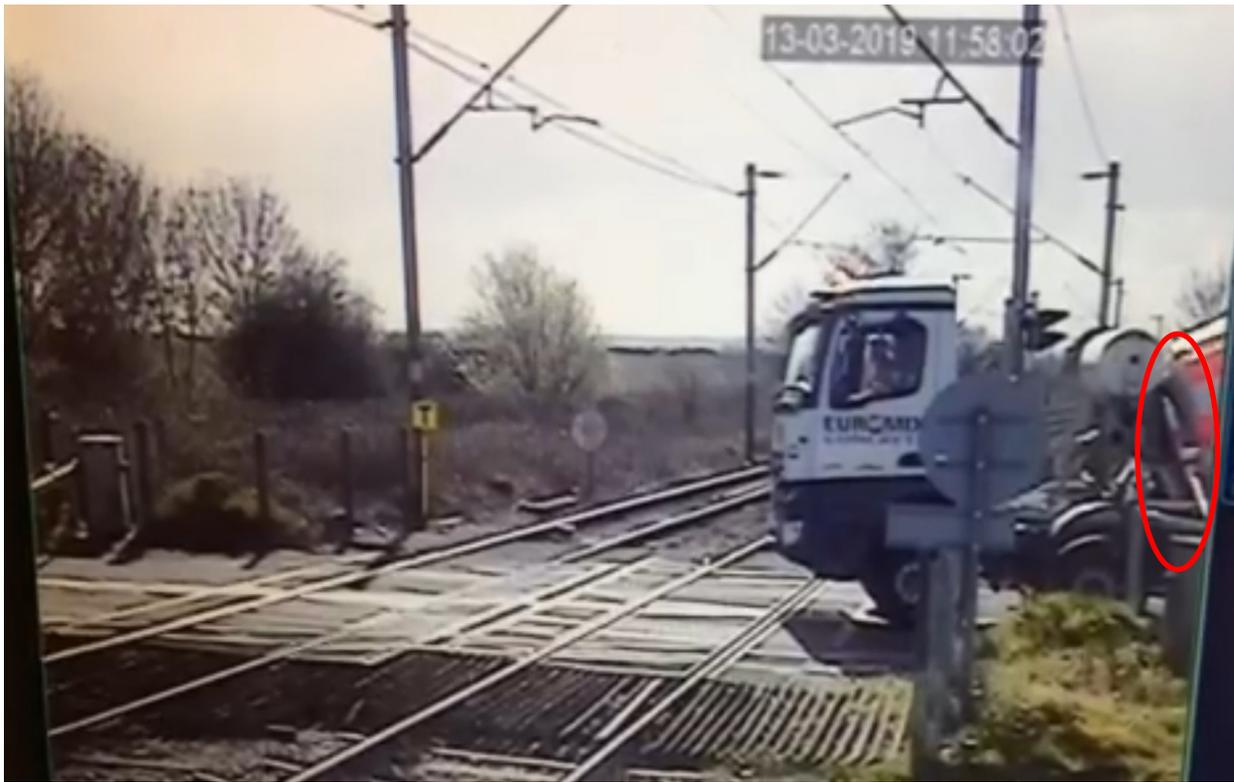
Figure 10: Level crossing camera view of the stationary lorry and partly lowered level crossing barrier (highlighted) caught by equipment on the back of the lorry. The approaching train is hidden by the lorry (courtesy of Network Rail)

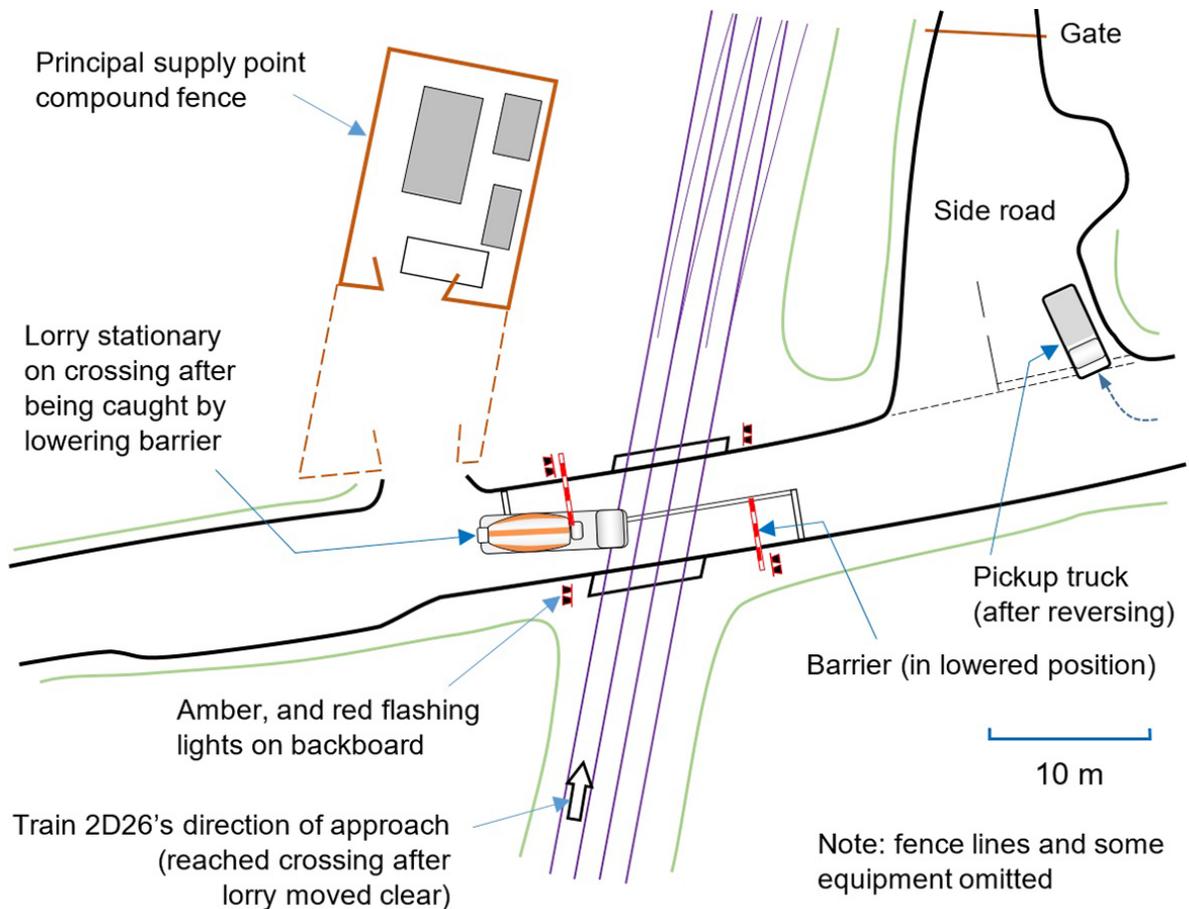
Figure 11: Diagram showing lorry's position when caught by the lowering barrier

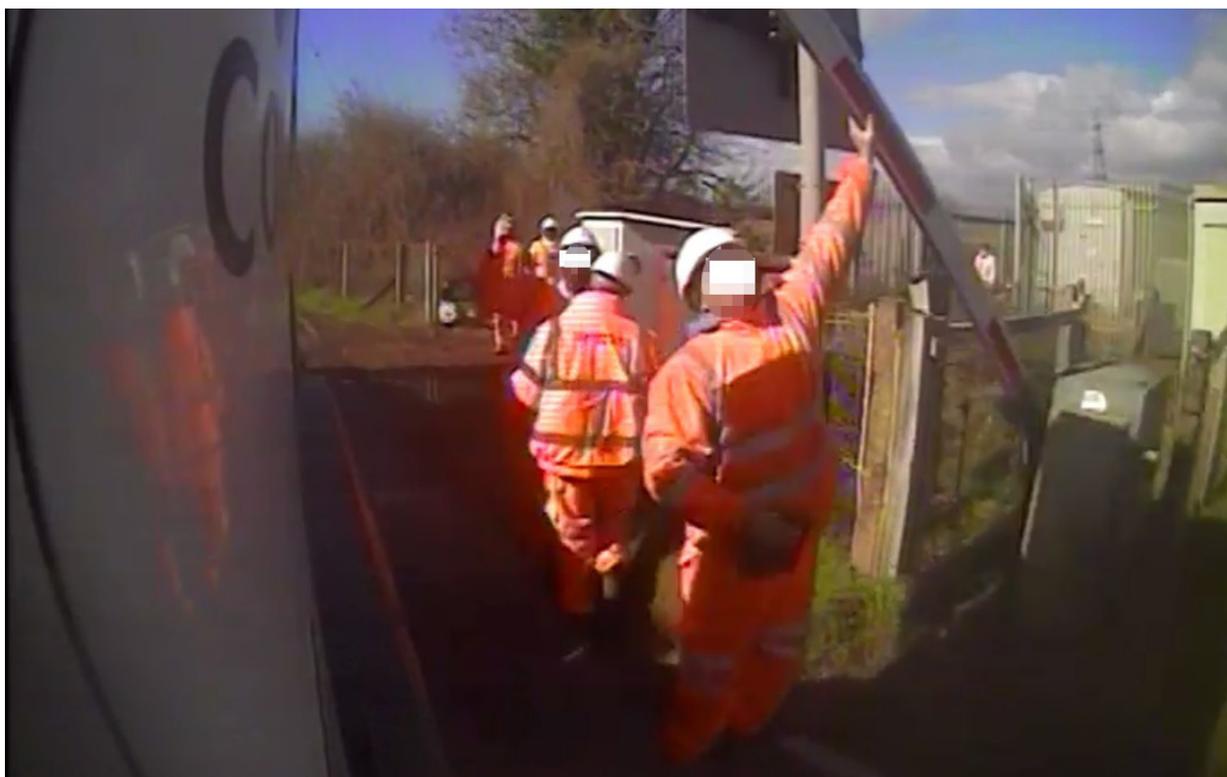
Figure 12: Level crossing barrier being lifted by site staff to free lorry (courtesy of Euromix Concrete)

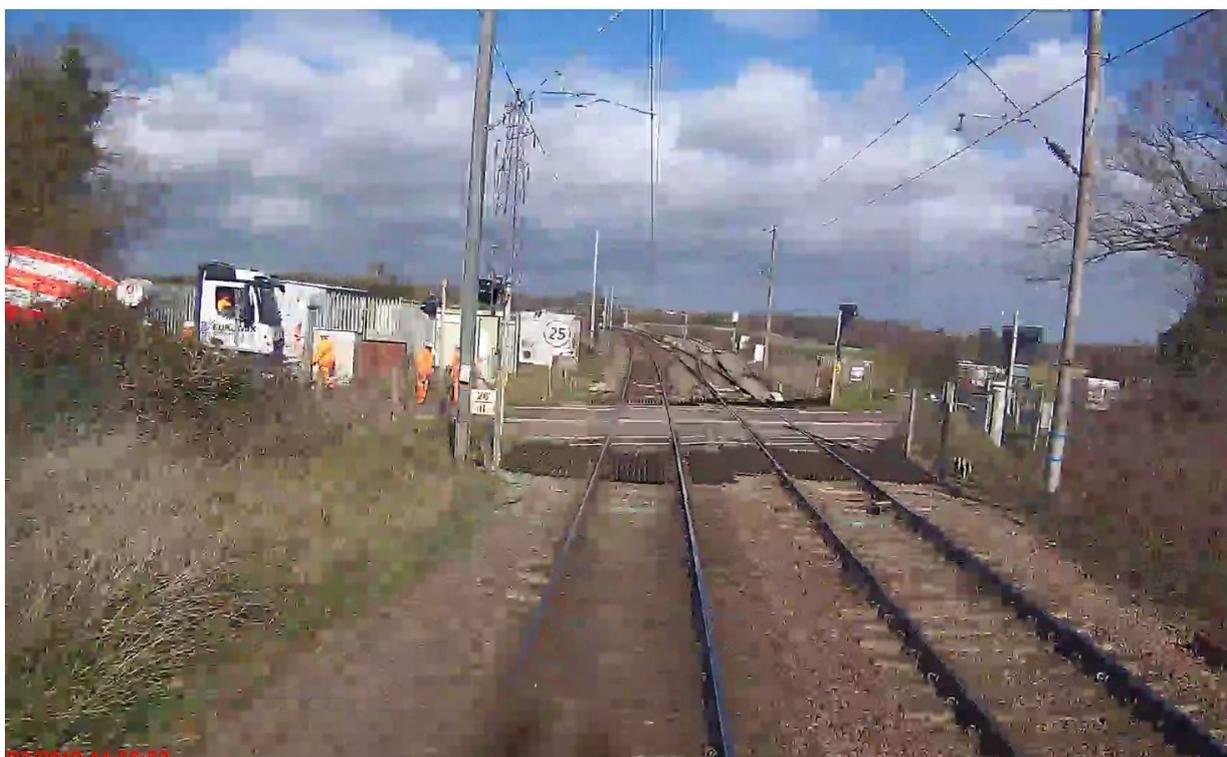
Figure 13: view from train 2D26 showing lorry reversing away from level crossing (courtesy of c2c)

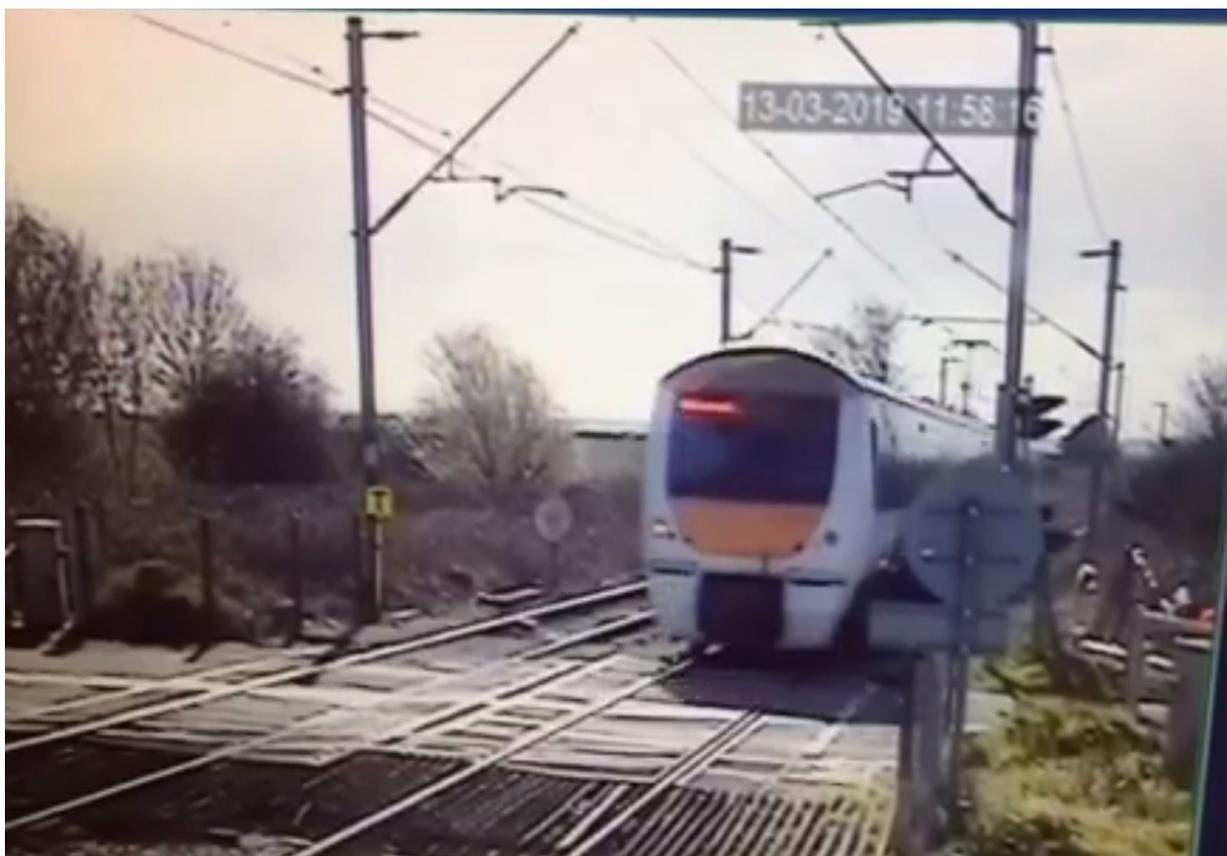
Figure 14: level crossing camera view of train 2D26 approaching at 57 mph (92 km/h) (courtesy of Network Rail)

- 43 The train driver did not apply the brake or sound the train's horn before passing the crossing, probably because the lorry was already reversing away from the railway when it first became visible. The train driver's view of the level crossing was restricted by the curve in the track (paragraph 6) until about 7 seconds before the train reached the crossing.
