Rail Accident Investigation Branch

Rail Accident Report

Freight train derailment at Willesden High Level Junction, north-west London 6 May 2019

Report 07/2020
August 2020

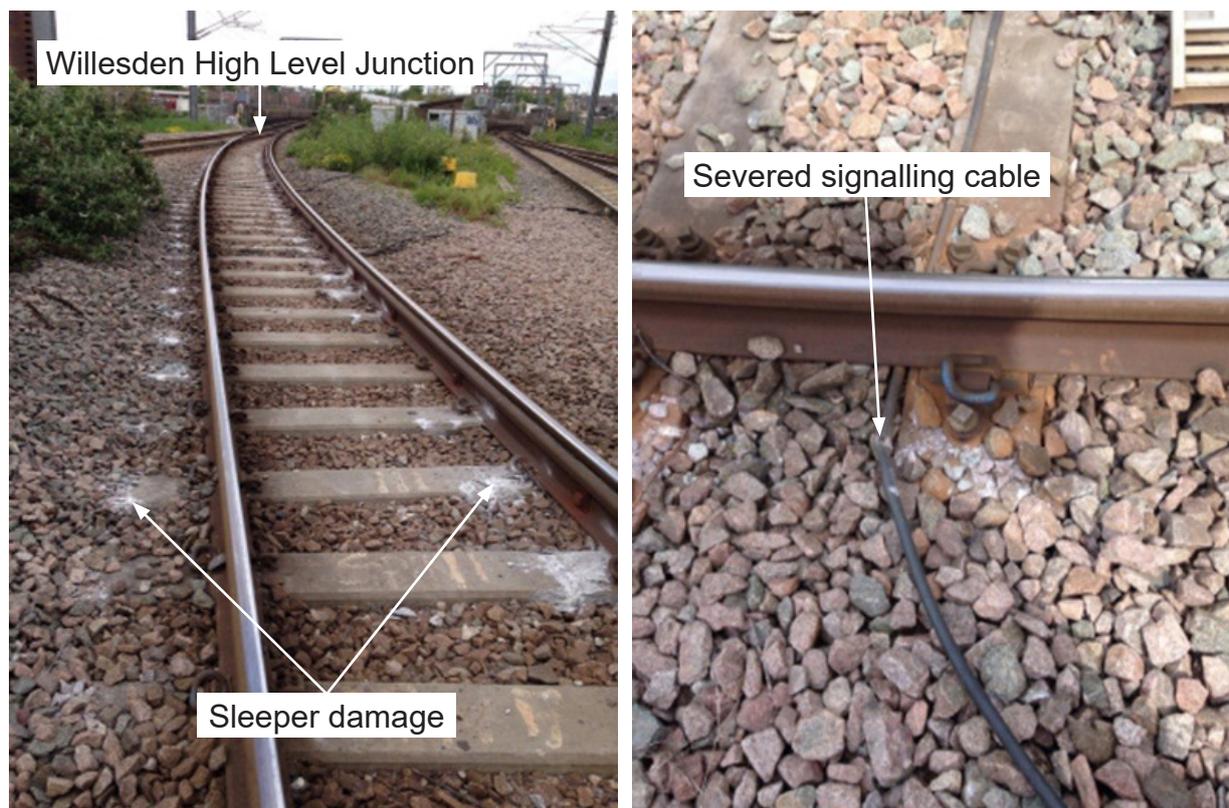
- 6 The derailment was not identified until around 14:00 hrs the following afternoon, when signalling technicians, attending to related lineside equipment faults, reported track damage and severed cables (figure 3).

Figure 3: Reported track damage (photographs courtesy of Network Rail)

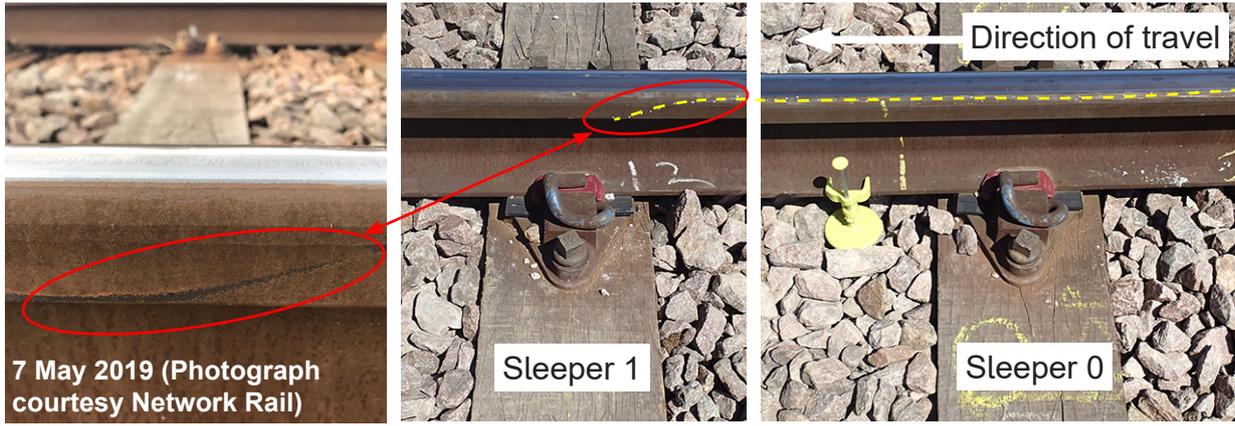
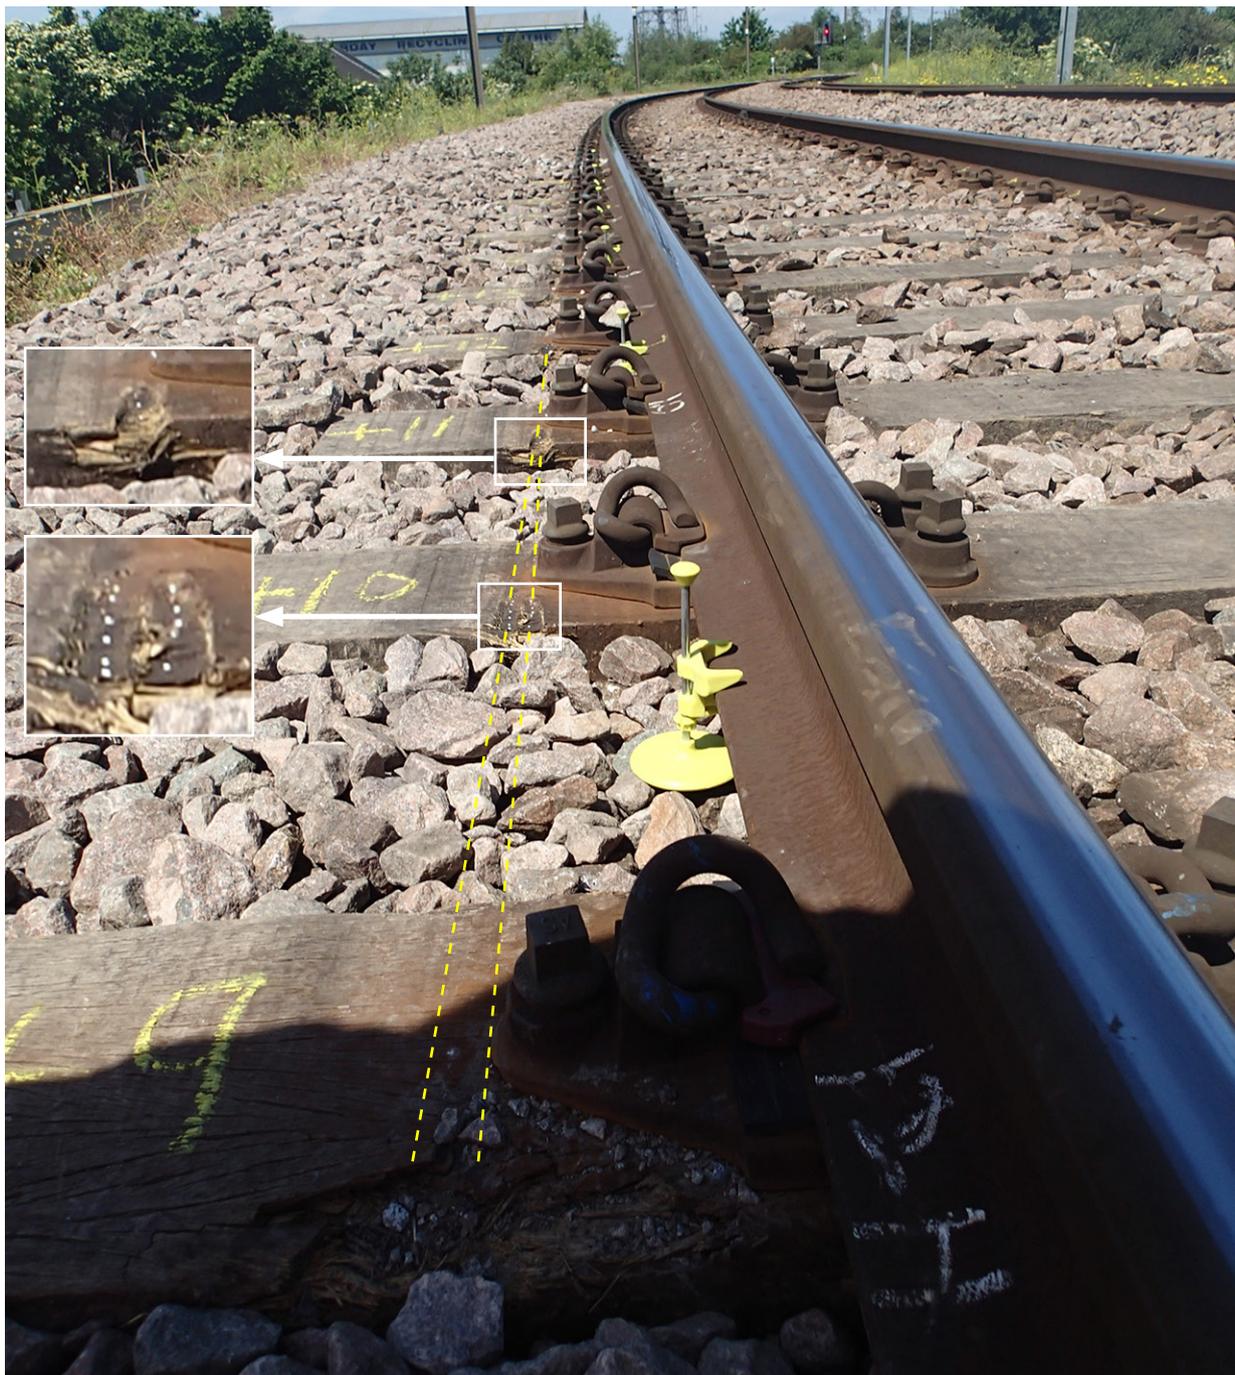
- 43 Witness marks showed that the mechanism of derailment was a flange of a left-hand wheel of wagon MPA 394228 climbing the railhead (a mechanism known as ‘flange climb’). There is a risk of derailment by flange climb when a wheel flange contacts the gauge face of the rail and the ratio of the lateral force of the wheel flange on the rail (Y) to the vertical wheel load (Q), known as the Y/Q derailment quotient, exceeds a critical limit value. Because of this, the lower the wheel load, or higher the lateral force, the greater the risk of derailment.

Figure 7: Marks showing evidence of derailed wheel flange running on the left-hand railhead, rail fasteners and sleeper ends (all photographs 23 May 2019, except as labelled)

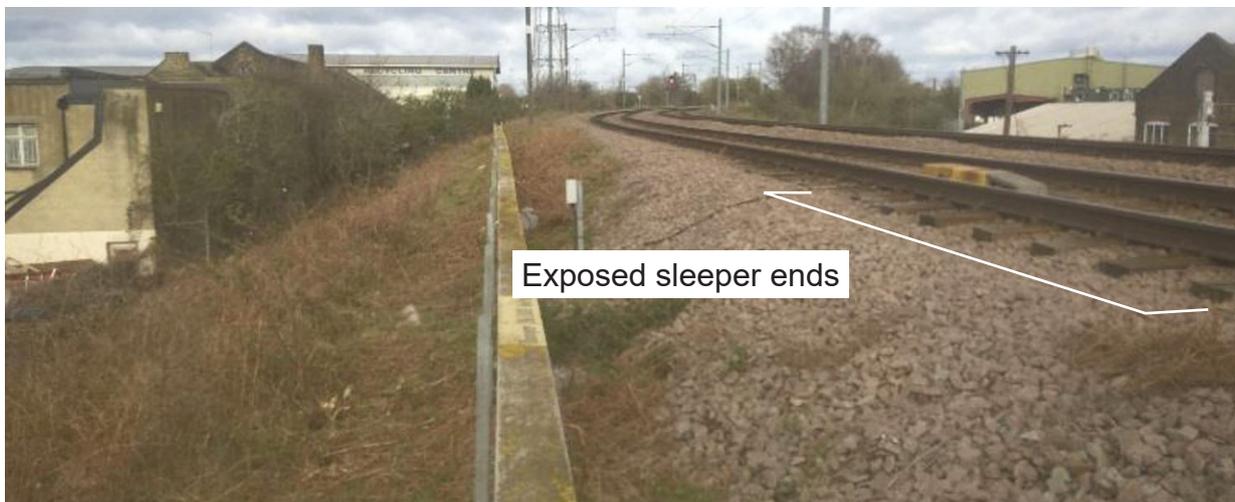
- section manager's visual inspections on 12 December 2018 and 14 March 2019, which both reported a lack of ballast on the up High Level line between 0 miles 9 chains and 0 miles 38 chains (paragraph 54)
- the cab ride by the Camden TSM on 6 April 2019, which reported the need for ballast between 0 miles 25 chains and 0 miles 27 chains (paragraph 55)
- the site visit by the Anglia AE(G) on 23 May 2016, which identified exposed sleeper ends and a reduced cess height (paragraph 58)
- the specialists who visited the location on 15 March 2019, and specifically commented on the lack of ballast around sleeper ends and the lowered cess in their report (paragraph 61 and figure 12).

Figure 12: The condition of the up-side cess and ballast around 0 miles 27 chains on the up High Level lines as photographed during the specialists' site visit of 15 March 2019 (photograph courtesy SNC-Lavalin)

- 95 These signs were consistent with ballast becoming mobile and able to escape from under the sleepers because of movements in the underlying embankment (paragraph 97). Work orders that had been raised to deliver new ballast to the site had been rescheduled (paragraph 54)²⁷ and, in the years before the derailment, no mechanised track maintenance work, such as tamping or stone blowing, had been arranged which would have helped reinstate support to the track.

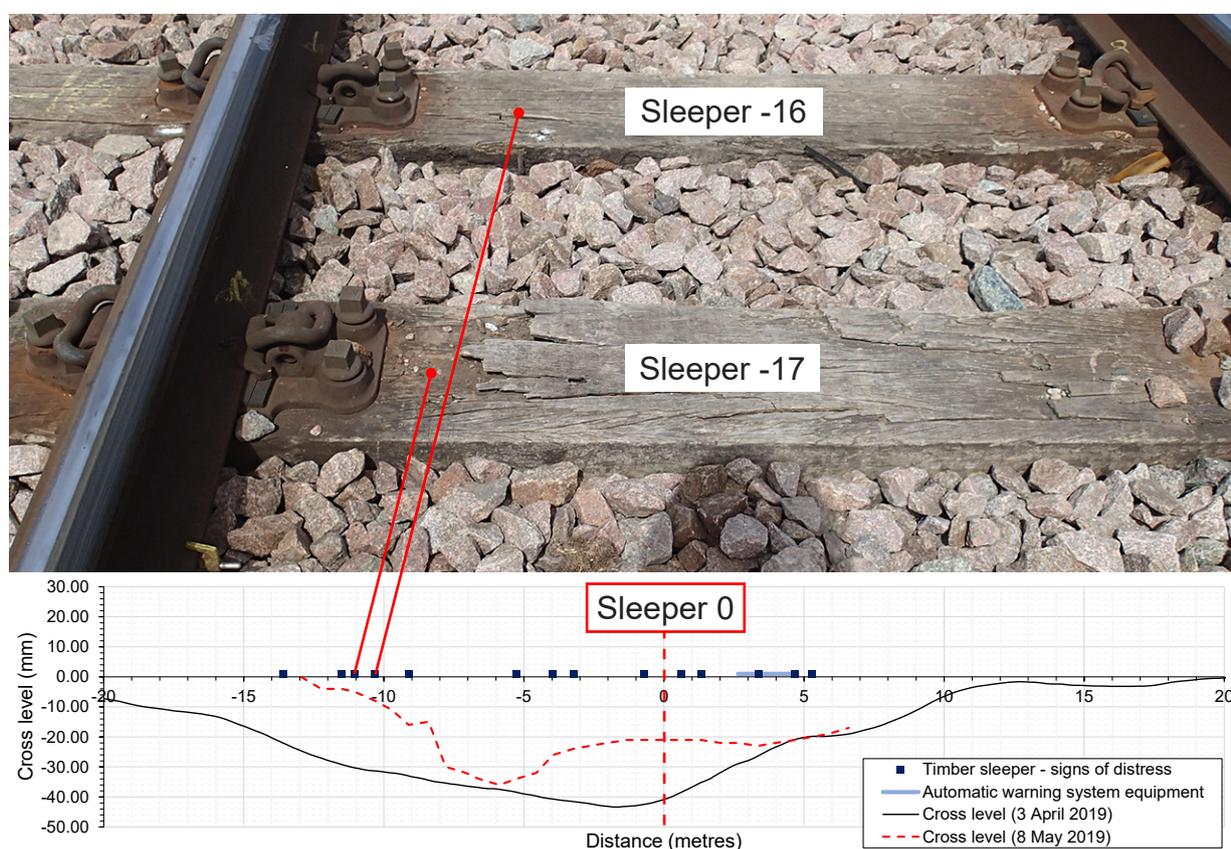
- 96 There were visible signs of distress on some of the timber sleepers close to the derailment location, suggesting they were likely to be more flexible and thus allow greater differences in cross-level on poor supporting ballast. RAIB compared the location of these sleepers, and the track-mounted automatic warning system equipment for signal NL 1048 (which is likely to have reduced sleeper flexibility), with the cross-level profiles measured by the Tottenham ATME, and those from the last pre-derailment track geometry measurement train run (figure 13). It noted a degree of correlation between the location of the distressed sleepers and the magnitude of the cross-level change. Therefore, it is possible that the condition of the sleepers contributed to a track twist being able to develop more rapidly.

Figure 13: Location of distressed sleepers and automatic warning system equipment close to 0 miles 27 chains compared to cross-level profiles measured on 3 April 2019 and 8 May 2019

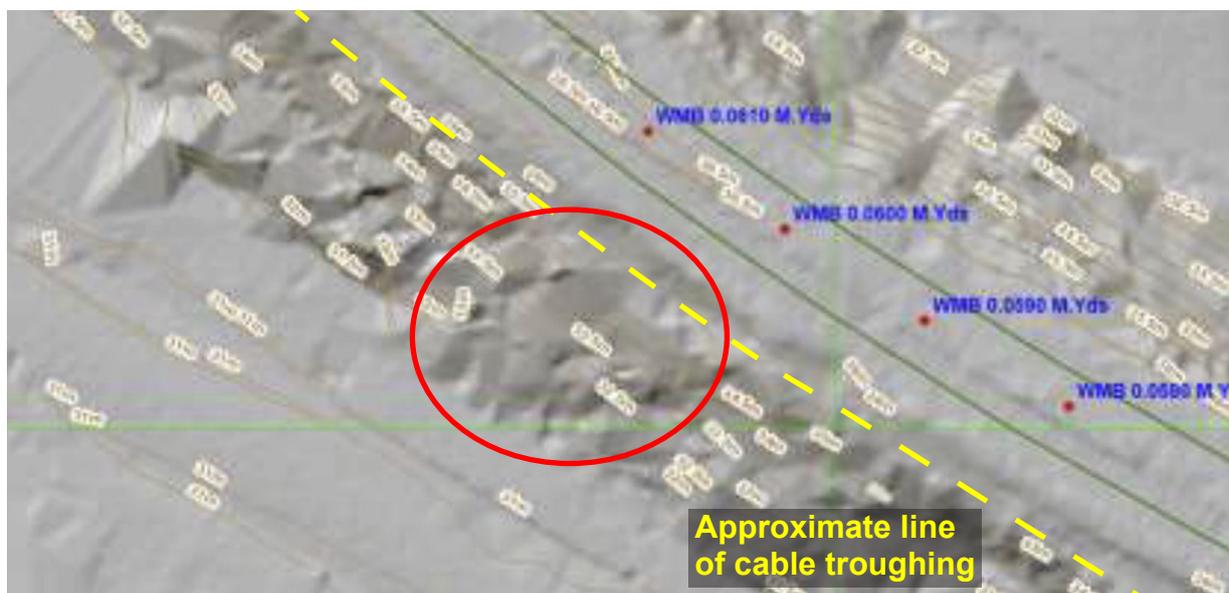
Figure 16: LiDAR survey of the embankment on Mitre Bridge Curve highlighting the flattened area on the up-side slope close to 0 miles 27 chains (image courtesy Network Rail)

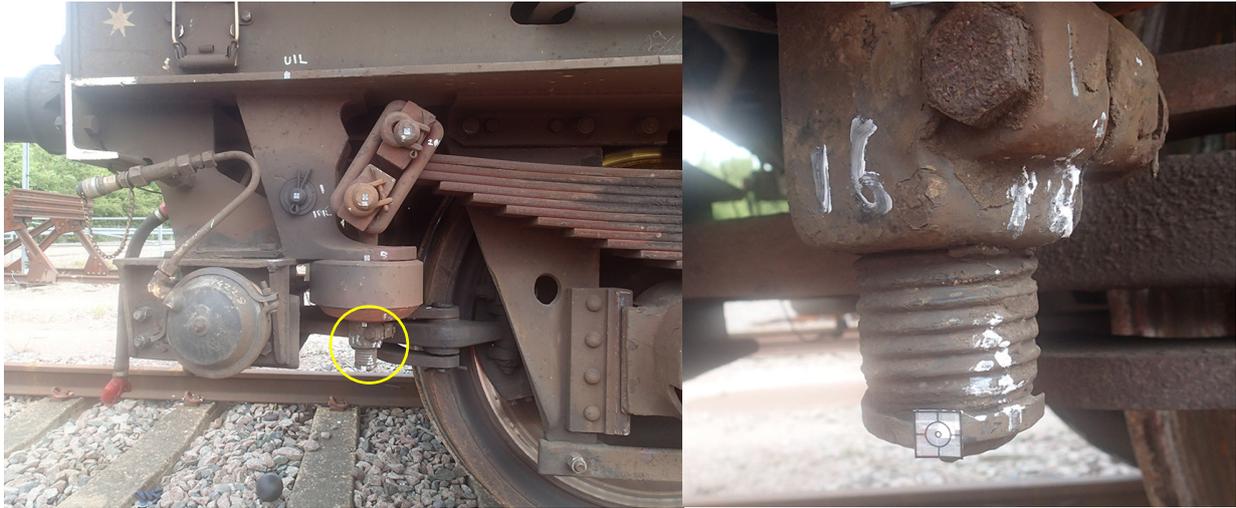
- 146 The condition of the split nuts and eye bolt threads on wagon MPA 394228 (figure 18) suggests that they had not been adjusted in recent years (possibly decades) and that the diagonal wheel load imbalance had existed for some time.

Figure 18: Typical split nut and eyebolt condition on wagon MPA 394228
