Rail Accident Investigation Branch

Rail Accident Report

Collision between mobile elevating work platforms at Rochford, Essex 25 January 2020

Report 08/2020
September 2020

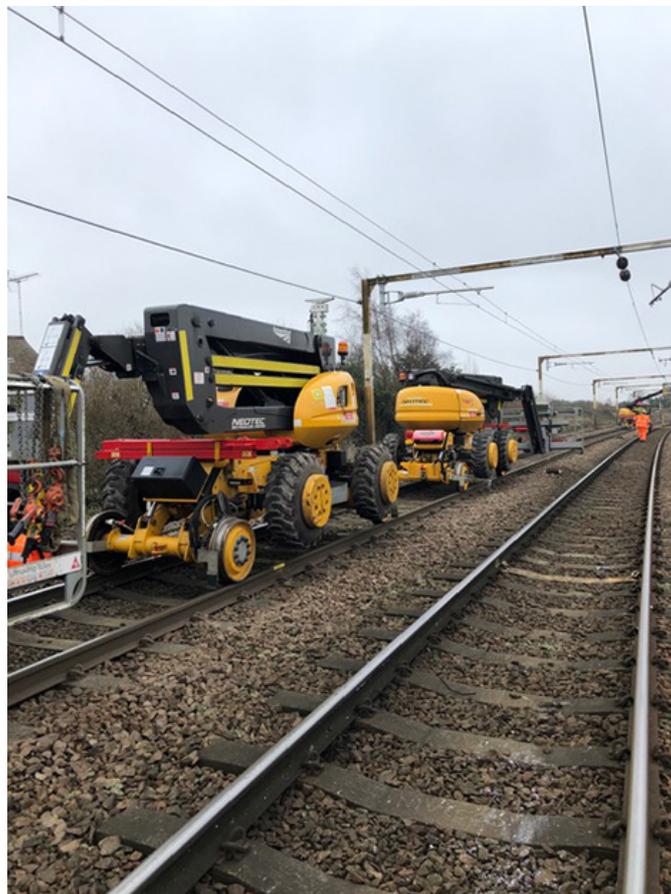
- 7 The accident occurred on the down line (the line normally used by trains travelling towards Southend), about 350 metres south from Rochford station, on a gentle right-hand curve. The track at this location is level (figure 3).

Figure 3: MEWP 10 after its collision with MEWP 3. MEWP 2 is not shown as it had moved away to continue its work (image courtesy of Network Rail).

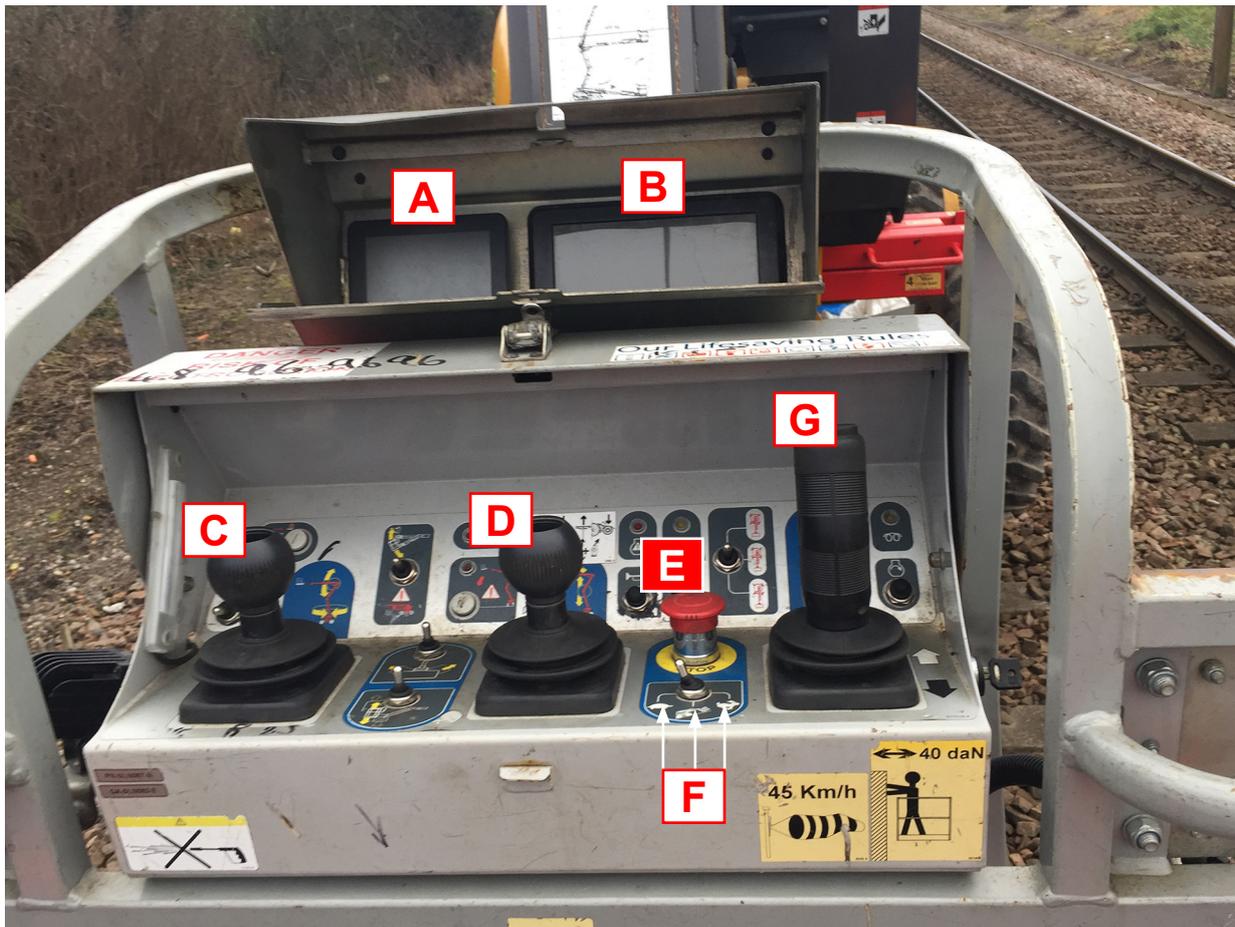
46 A mobile elevating work platform, commonly referred to as a MEWP, is a vehicle with a platform (known as a basket) attached to a central jib which can elevate the basket to give access to structures and equipment. The Skyrailer 440 (figure 4) is capable of operating on both road and rail, and is fitted with rail wheels which are directly driven and braked, independently of the road wheels. The basket, which can turn through 180 degrees, incorporates a control console (figure 7) with two monitors. The left-hand monitor (A) shows the machine configuration and the speedometer, and the other (B) is a CCTV monitor showing images from a camera on the front of the MEWP (see figure 4). The console has three joysticks which control the horizontal slewing of the basket (C), the height of the basket (D), and the forward and reverse movement of the machine, including braking (G). The joystick controlling the speed and braking has a button which must be depressed while holding the joystick to allow movement to take place. The operator must also have their foot inserted in the 'deadmans' control (figure 8) while the joystick is being used. Releasing the joystick or removing pressure on the footplate will initiate a hydrostatic brake application. Emergency braking can be applied by pushing the red plunger (figure 7, E).

Figure 7: The control console on MEWP 10 after the accident

- 47 The speed ranges in which the MEWP can be operated are selected by a three-position switch (F). 'Tortoise' or 'work' mode (left position) has a maximum speed of 5 mph (8 km/h). The centre position is the on-tracking or low loading mode. 'Hare' or 'travel' mode (right position) allows the machine to travel at a maximum speed of 10 mph (16 km/h). The basket must be in the lowered central position to allow the machine operator to use the machine in 'hare' mode.

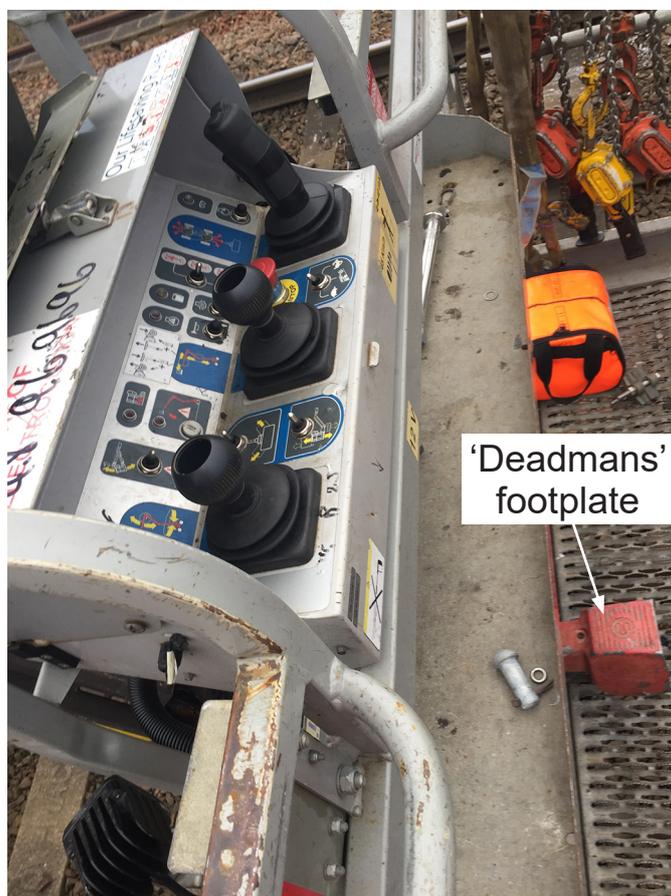
Figure 8: The control console and 'deadmans' foot control on MEWP 10

- 69 The machine operator stated that when he became '*aware of his surroundings*' and the close proximity of MEWP 3, he released the forward pressure on the joystick (but could not recall if he completely let go of it), and may also have removed his foot from the footplate control (figure 8), both of which would have applied the hydrostatic brakes.

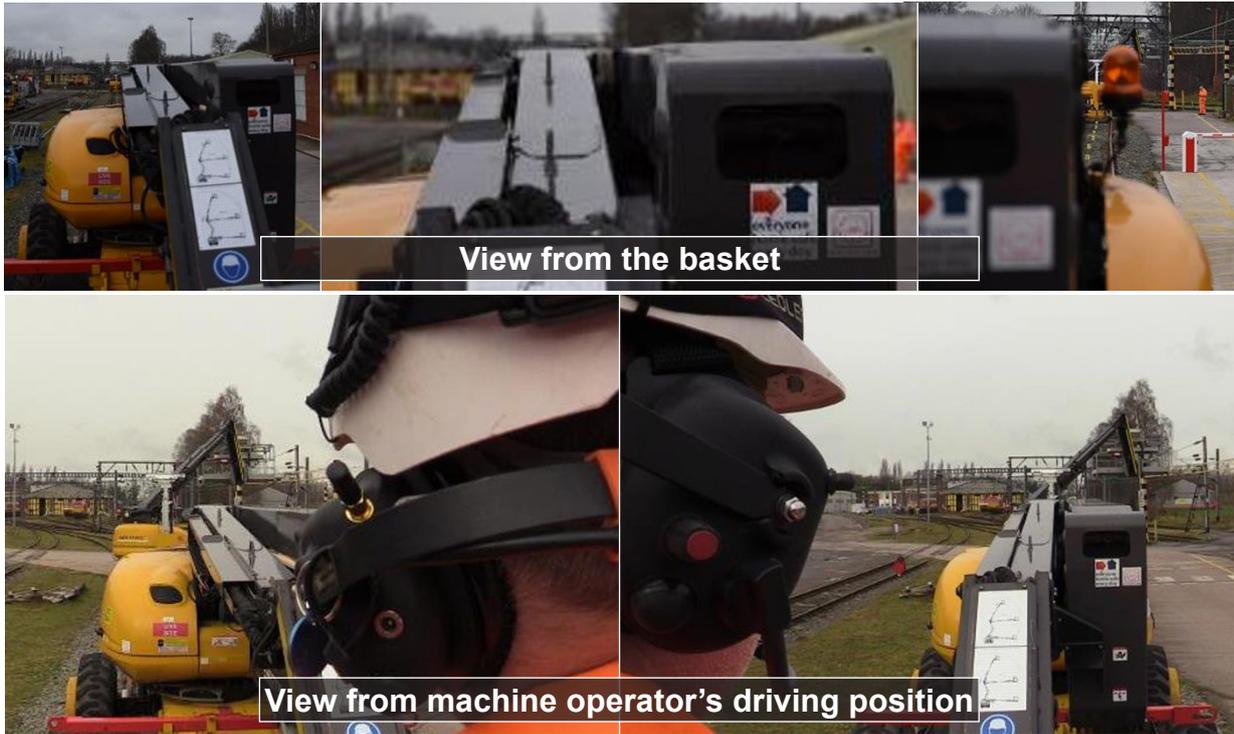
Figure 9: The view from the basket and eye level view from the machine operator's perspective on MEWP (10)

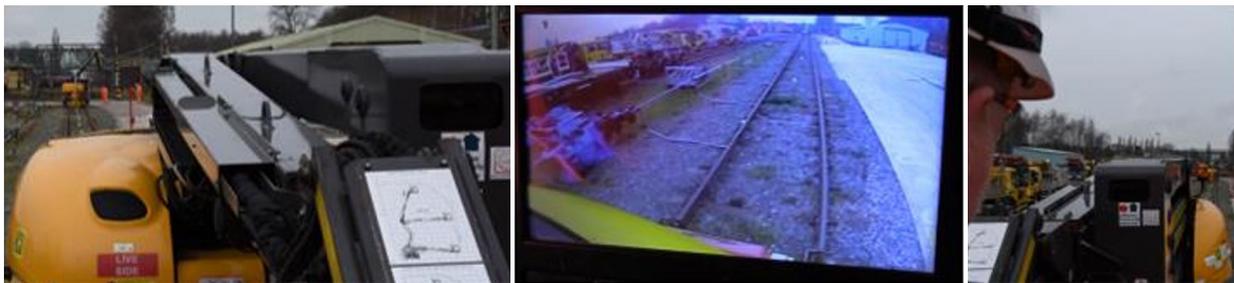
Figure 10: Images taken from MEWP 10, 107 metres from stationary MEWP 3, showing the view from the basket (left), CCTV monitor view (middle) and eye level view (right) from the machine operator's perspective on MEWP 10

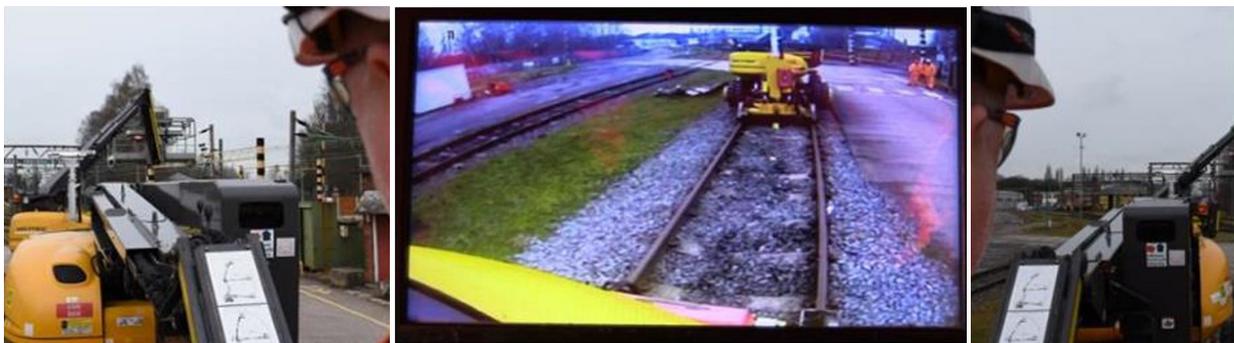
Figure 11: Images taken from MEWP 10, 15 metres from stationary MEWP 3, showing the view from the machine operator's eye level (left), CCTV monitor view (middle) and machine operator eye level view (right) from MEWP 10

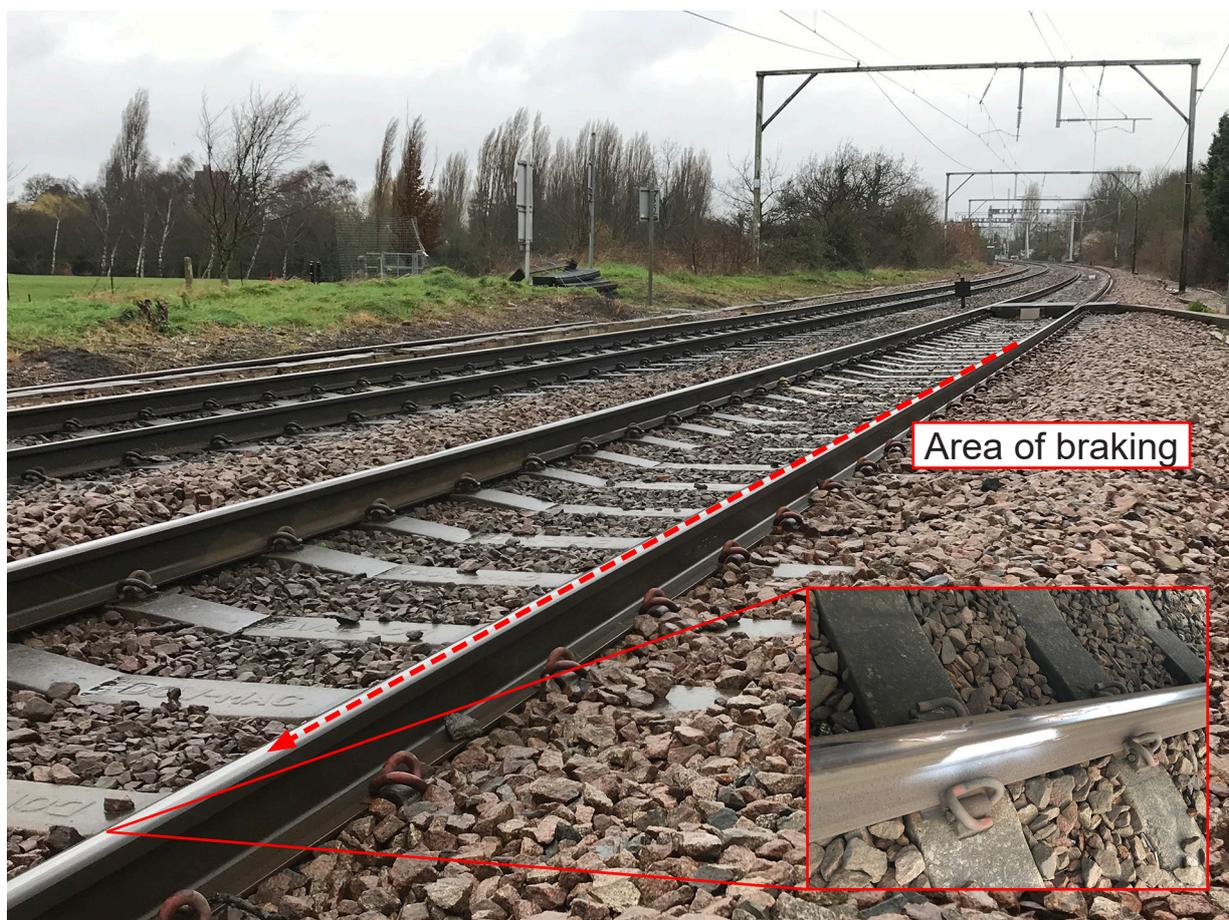
35 At 10:57 hrs, MEWP 10 collided with MEWP 3. Just before impact, the machine operator applied the brakes by releasing the MEWP's speed controller (figures 7 and 8). This produced a slight reduction in the speed of the MEWP before the collision, from 10 mph (16 km/h) to 9 mph (14 km/h). The machine operator of MEWP 3 (wearing headphones) and the linesman, who were working in the basket, did not hear any warnings (figure 6f).

Figure 12: image showing the location of the railhead markings and impact point (inset image courtesy of Network Rail)

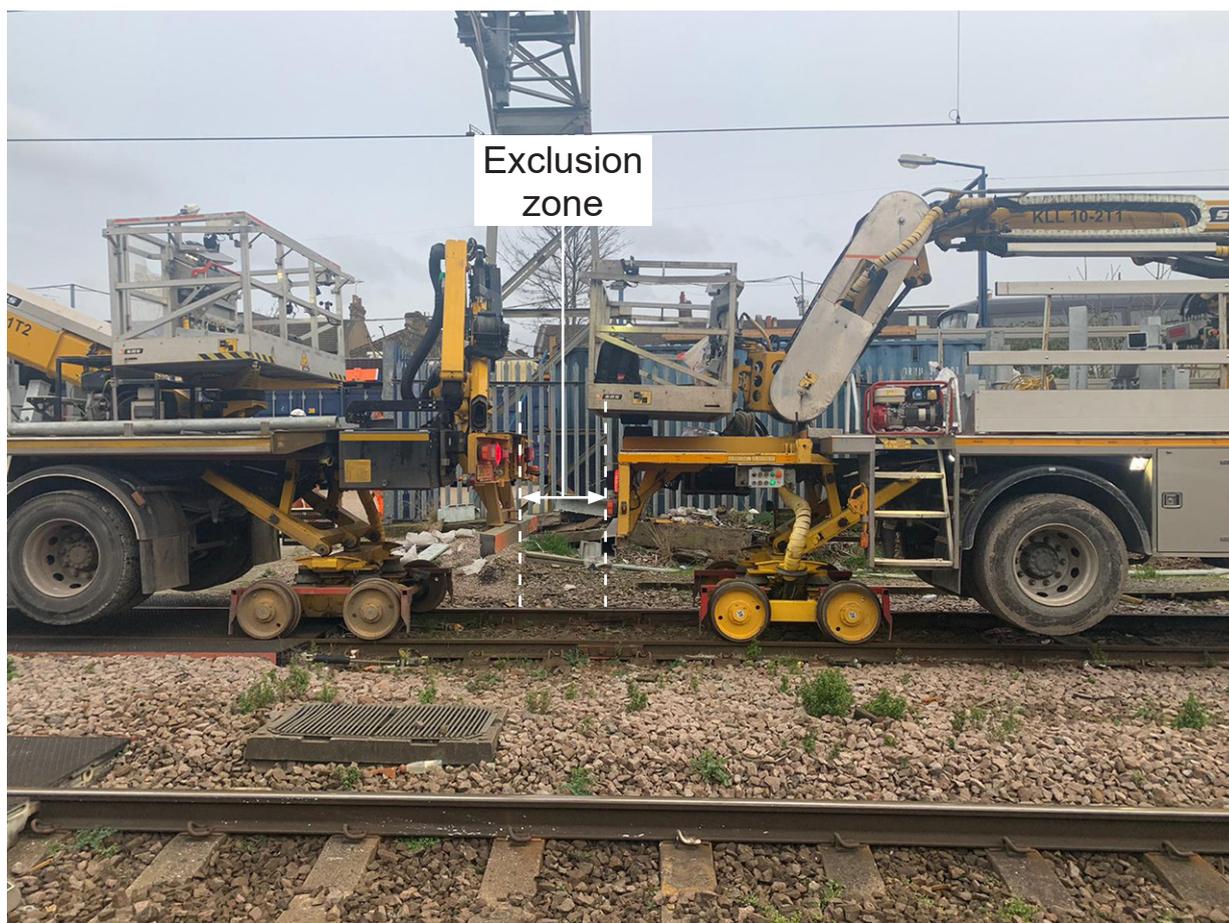
- 147 While the work was taking place, the machine operator for the forward road-rail vehicle asked the COSS of the lineside team and a trackman to transfer parts from the rear vehicle. Both staff then entered the area between the two vehicles (figure 14), believing that the machine controllers for both vehicles were aware of what was happening. At the same time the machine operator in the elevated basket of the rear vehicle told his machine controller that he needed to move his vehicle forward to gain a safer working position. The machine controller stated that he checked the zone between the vehicles before this movement took place and saw no-one. The machine operator then moved the vehicle forward at the same time as sounding the horn, unaware that the COSS was still between the two machines. The COSS was crushed by the movement.

Figure 14: Image showing where the COSS was injured at Manor Park
