Rail Accident Report

Fatal accident at Tyseley depot 14 December 2019

Report 09/2020
v2 - March 2022

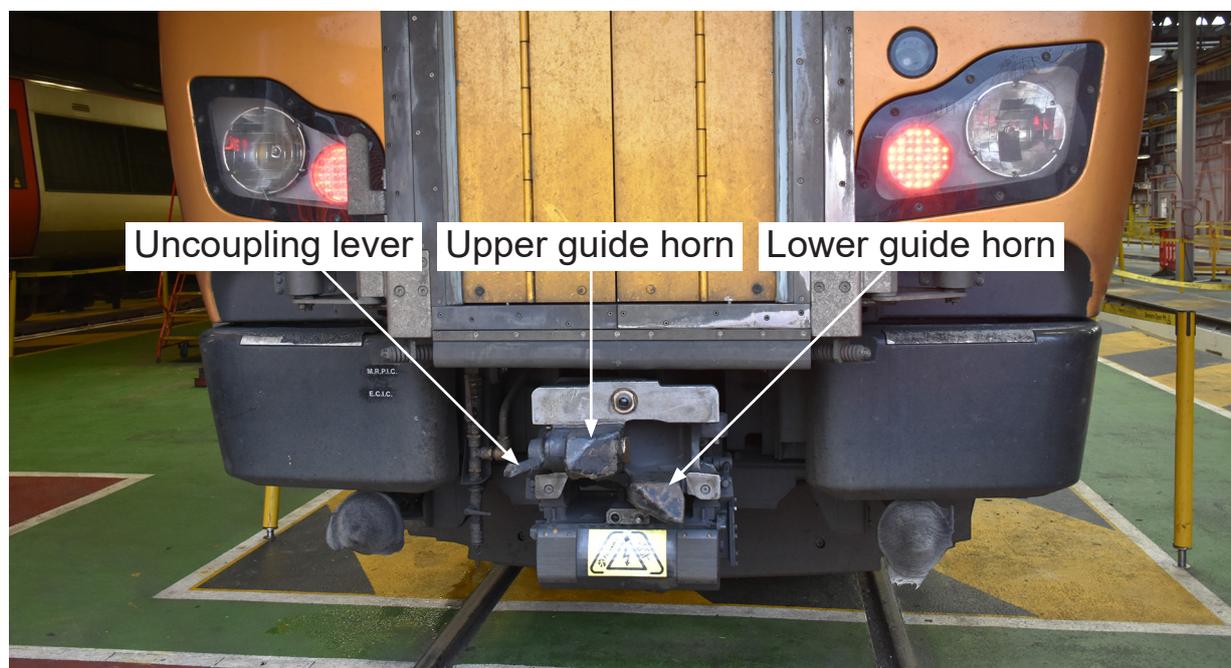
Figure 5: BSI autocoupler fitted to Class 172 unit

- 33 Although BSI autocouplers are generally reliable, units sometimes fail to couple correctly, generally due to misalignment between the autocouplers. In this event, drivers are trained to make a second attempt and to investigate the cause only if this also fails.
- 34 The gangway on a Class 172/3 unit is mounted immediately above the autocoupler. Gangways are pressed together by springs when the trains are coupled, and folding doors are then opened to allow passage between the units.

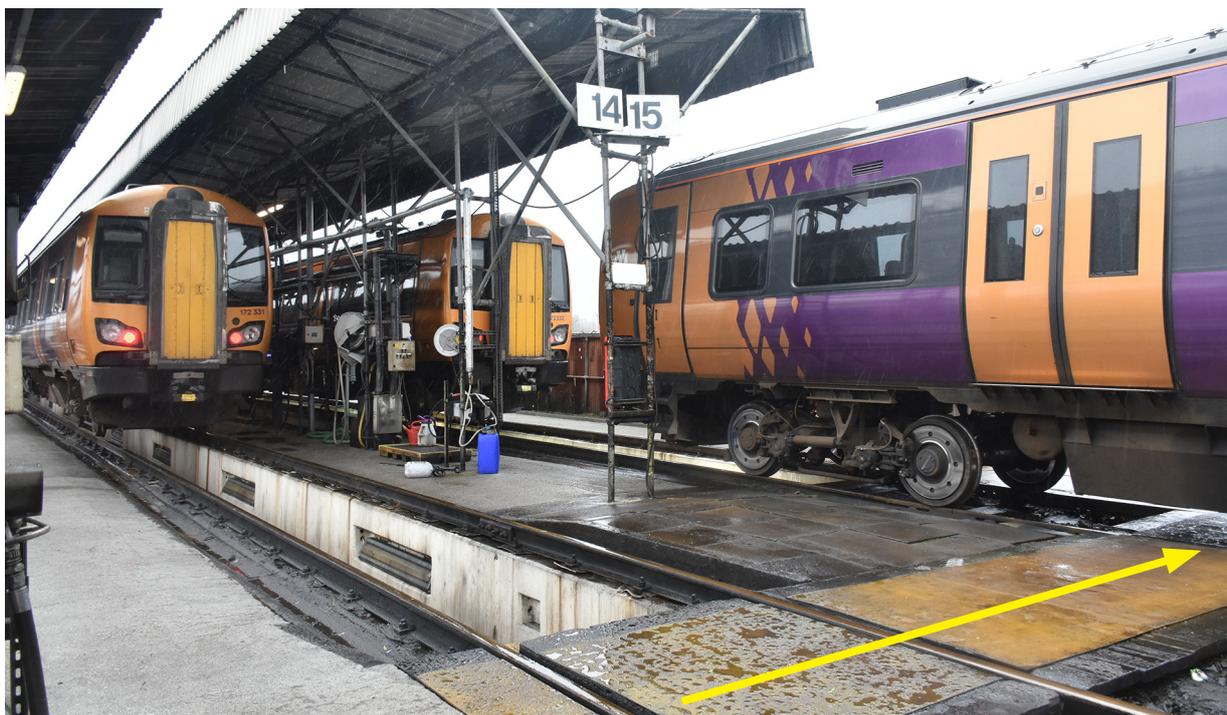
64 Unit 172344 (paragraph 23) arrived at Tyseley depot at approximately 19:15 hrs on the night of the accident. The North End Shunter directed the train onto number 15 siding. However, because another unit was already occupying the fuel pit, unit 172344 was stabled in a way that meant it obstructed the AWR which crossed number 15 siding (figures 8a and 9). Although a gap remained between unit 172344 and this other train, there is an inspection pit⁶ immediately to the south of the obstructed AWR which would have prevented Driver A from crossing there.

Figure 9: Trains positioned as at the time of the accident during the RAIB reconstruction. The obstructed walking route across number 15 siding is indicated.

- 65 Witness evidence indicated that trains were regularly stabled with only narrow gaps between them on number 15 siding. This was because of the need to avoid fouling the entrance to the sidings and to maximise depot capacity, which was often constrained (paragraph 119). Witness evidence also indicated that the obstruction of the authorised walking route across number 15 siding by trains was a regular occurrence. The depot operations manual (paragraph 38) did not prohibit this practice or provide any guidance about the need to keep authorised walking routes clear.

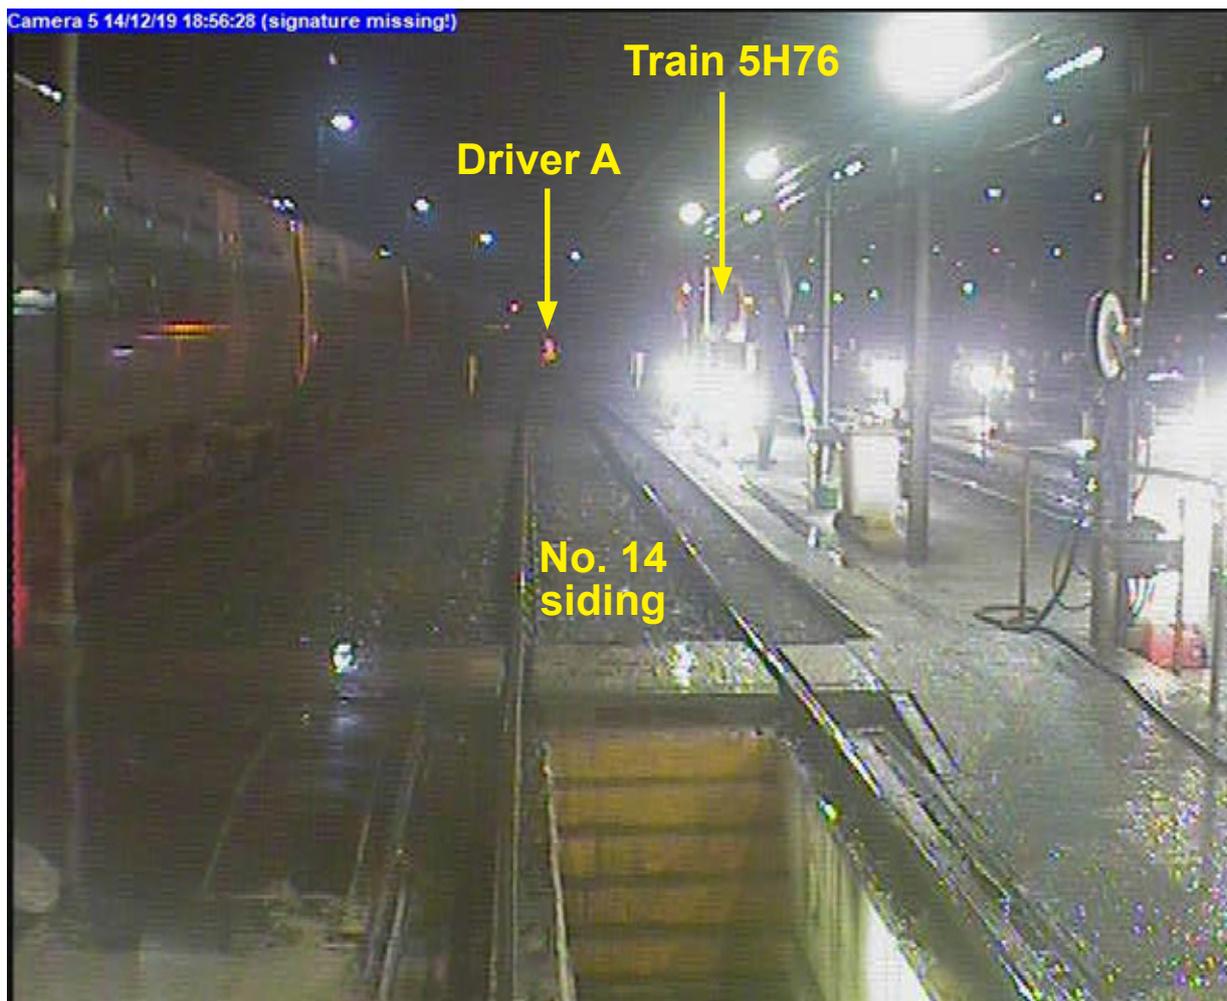
- 66 As he brought train 5H76 onto the depot and left the cab, Driver A would have had a clear view of the trains stabled on number 15 siding (figure 10), and he would have been able to see that a train was blocking his most direct route to the stairs. It is probably the case that his subsequent choice of route across the yard to the stairs was influenced by this knowledge.

Figure 10: CCTV still from camera mounted on the rear of a train stabled on number 14 siding within the fuel pit area. View is looking towards the north. Driver A is indicated, along with his train (5H76) stabled on number 13 siding.

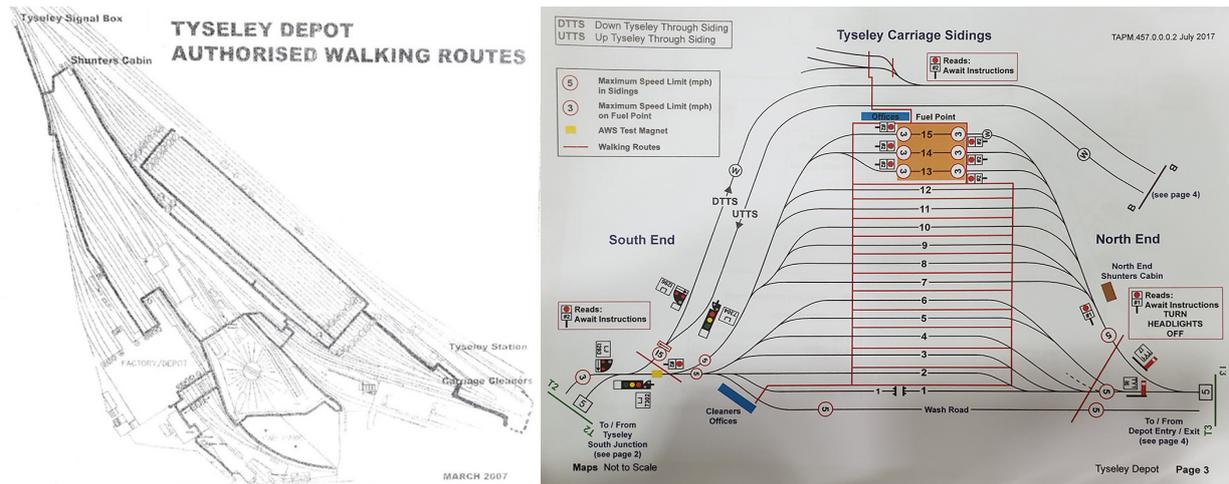
- 68 Driver A was familiar with Tyseley depot (paragraph 53) and his FDA assessments (paragraph 41) included a section in which the assessor was required to verify his knowledge of the AWRs encountered during the assessment. However, none of the FDA assessments of Driver A during the two-year cycle preceding the accident included Tyseley depot or any other maintenance depots. WMT managers stated that the assessment of a driver's knowledge of AWRs during an FDA would typically cover the walk from the Birmingham New Street driver's facility, through the public area of the station, and onto the platform to the train. This meant that a driver's knowledge of depot AWRs was normally only verified during the biennial assessment and re-certification day (paragraph 43).

Figure 11: Maps showing the AWR maps as displayed at Tyseley (left) and at Birmingham New Street (right)

- 71 Although not causal to the accident, RAIB noted that the path Driver B used to reach number 15 siding (paragraph 23) also did not involve the use of an AWR.

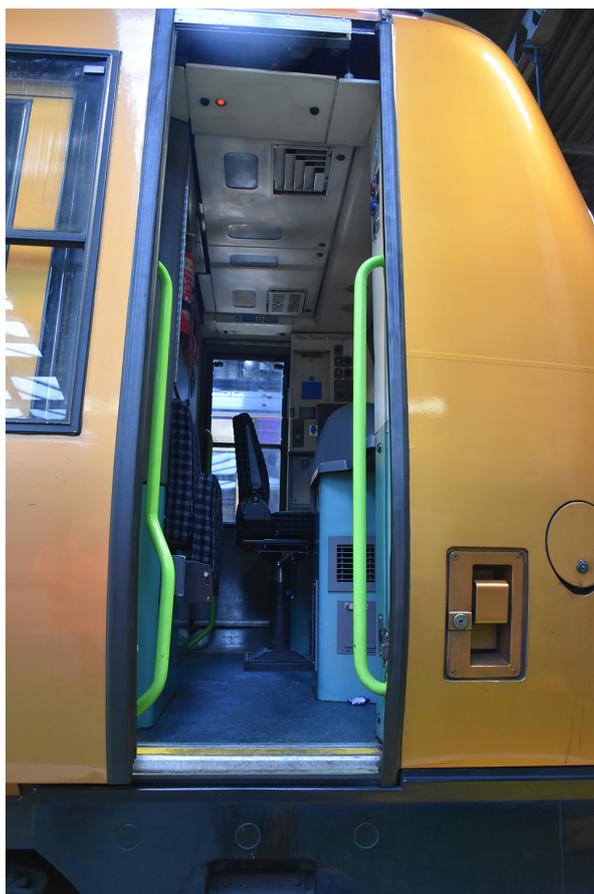
- 72 Driver A chose to leave train 5H76 by the non-driver's side cab door. Had he left the train by the driver's side door, he would have got down onto a wide and well-marked AWR which runs between numbers 12 and 13 sidings (paragraph 62). It is possible in this event that he would have continued to follow this walking route and crossed over the yard to reach the stairs via the south end of the fuel pit. This would have avoided him attempting to pass through the gap between the trains on number 15 siding.
- 73 There is no requirement that drivers should use a specific door when leaving trains. Observations by RAIB suggest that many drivers prefer to use the non-driver's side to enter or leave this type of train, as this avoids the obstruction presented by the fixed driver's seat (figure 12).

Figure 12: Class 170 cab, viewed looking in from non-driver's side

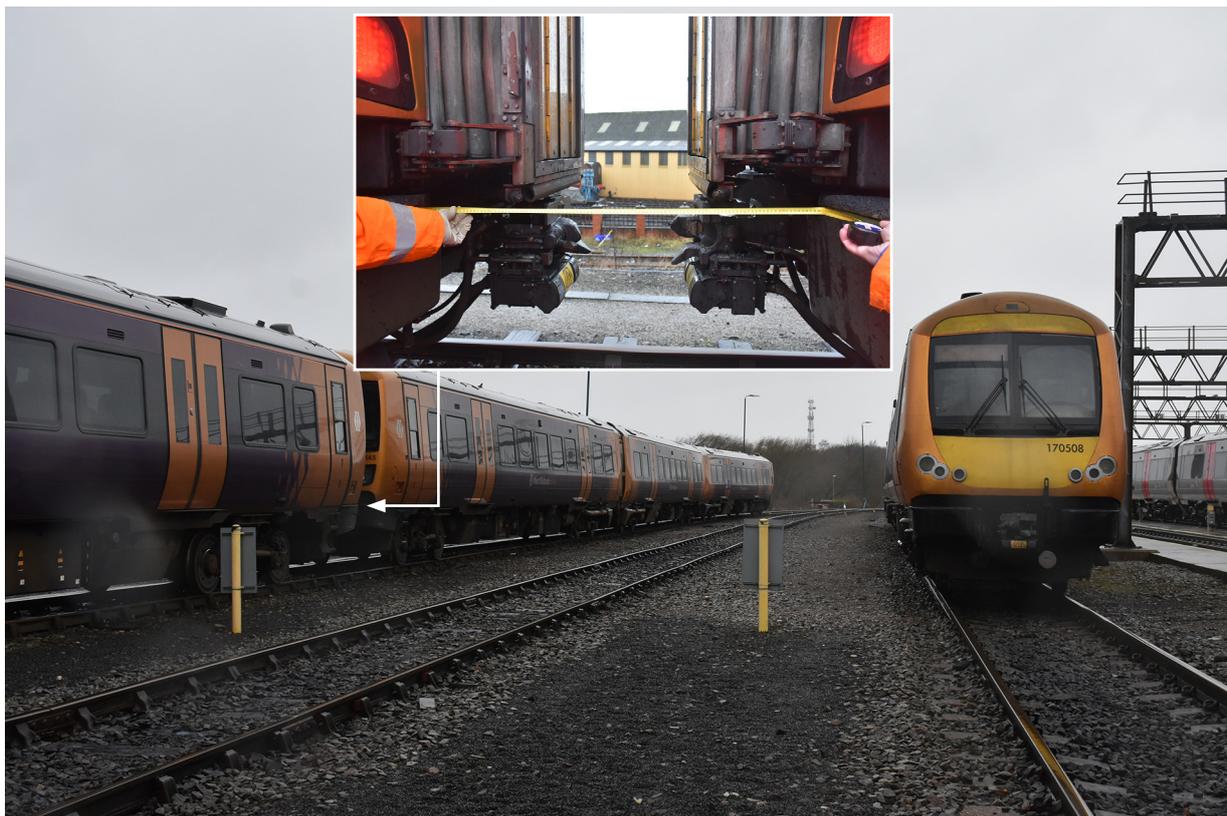
Figure 13: Trains on number 15 siding as positioned during the RAIB reconstruction. Inset shows the gap between the two Class 172 units

83 The reconstruction (which was carried out in daylight), showed that it was very unlikely that Driver A would have been able to see Driver B in the cab of unit 172343 after Driver A left train 5H76. Driver A's visibility of Driver B would probably have been further reduced on the night of the accident, because of the weather conditions and because the interior light in the cab of unit 172343 was not on at the time of the accident.

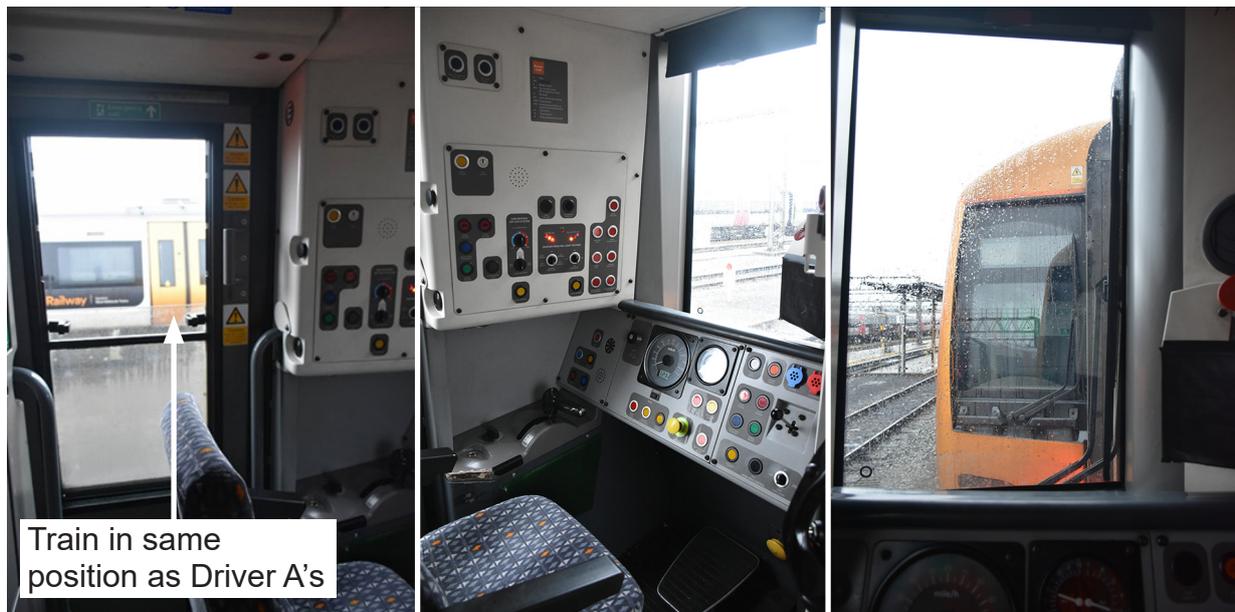
102 The RAIB reconstruction of the accident (paragraph 81) showed that Driver B would have been unable to see Driver A as the latter crossed from number 13 siding towards the gap between the two stabled trains. This is because a control panel in the Class 172 DMU cab (figure 14) would have obscured Driver B's view out of the cab in the relevant direction.

Figure 14: Views from Class 172 DMU cab, taken during the RAIB reconstruction. A train representing 5H76, from which Driver A alighted, is indicated. This train was positioned on number 13 siding.

103 The reconstruction showed that it was possible to see an individual standing directly in front of a Class 172 DMU from the cab of the unit, but only if the person occupying the cab was standing up and leaning as far forward as possible. There is no requirement for these actions to be carried out prior to coupling and CCTV evidence shows that Driver B did neither of these things as Driver A passed directly in front of the train.
