Rail Accident Investigation Branch

Rail Accident Report

**Track workers struck by a train at Margam,
Neath Port Talbot
3 July 2019**

Report 11/2020
November 2020

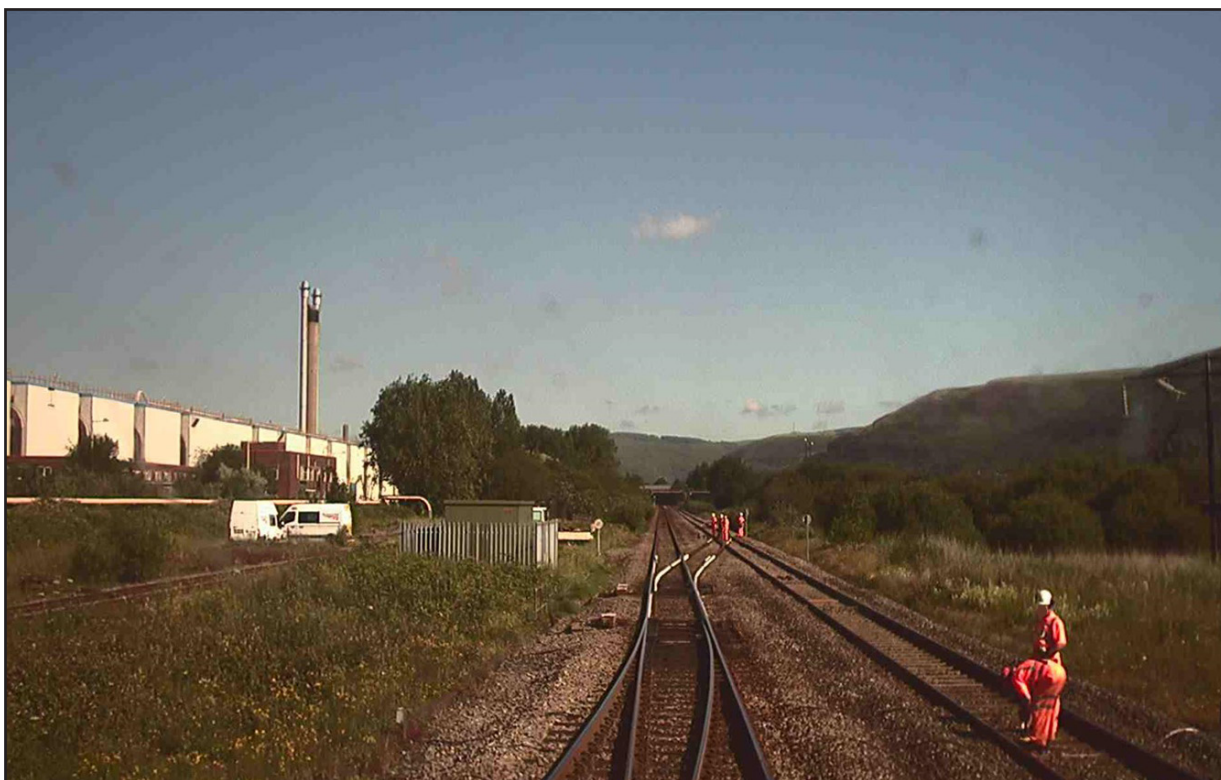
- 33 Around 08:50 hrs the six track workers split into two groups. One group, consisting of TW4 and TW6, started the additional task on the IRJs on the down main, up main and down relief crossover lines. The other group, consisting of TW1, TW2, TW3 and TW5, went to work on 9577B points (figure 3). TW5 stood clear of the line and acted as site lookout, with one of the others watching him and acting as *touch lookout* for the person with the power tool. During this period the two groups were around 100 metres apart, with TW4 and TW6 being the Cardiff side of 9577B points. TW4 and TW6 took it in turns to work while the other observed the nominated lookout TW5, who was with the other group at the points, for warning of approaching trains on the up main line.

Figure 3: Forward-facing CCTV image looking towards Port Talbot from a train on the down main line at approximately 09:24 hrs, showing the two groups working on the open up main line approximately 100 metres apart

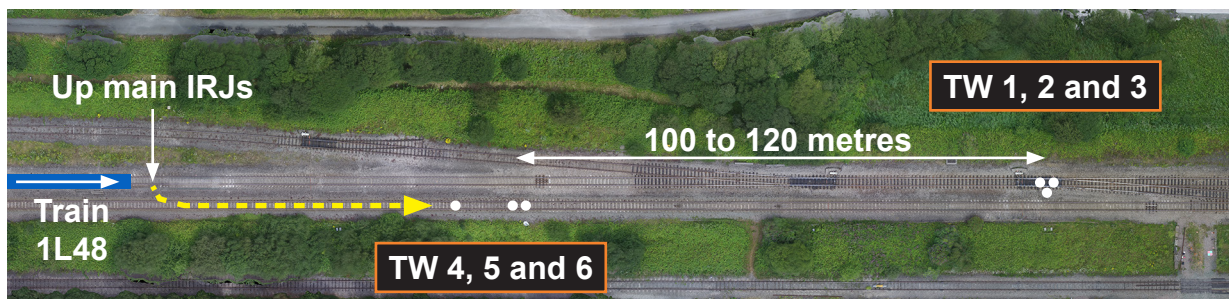
- 38 When they had completed their work on the IRJs, they crossed from the up main line to the down main line and walked back along the down main line towards the access point. They were walking facing the direction of traffic on that line, and therefore had no need to look out for trains approaching from behind them on the other line. Train 1L48 approached from behind them on the up main line travelling towards Cardiff. At this time they could see the other three track workers about 100 to 120 metres ahead, and they have stated that they were surprised to see them working on 9577B points on the up main line with a train so close (figures 4 and 5).

Figure 4: Position of workers immediately before the accident

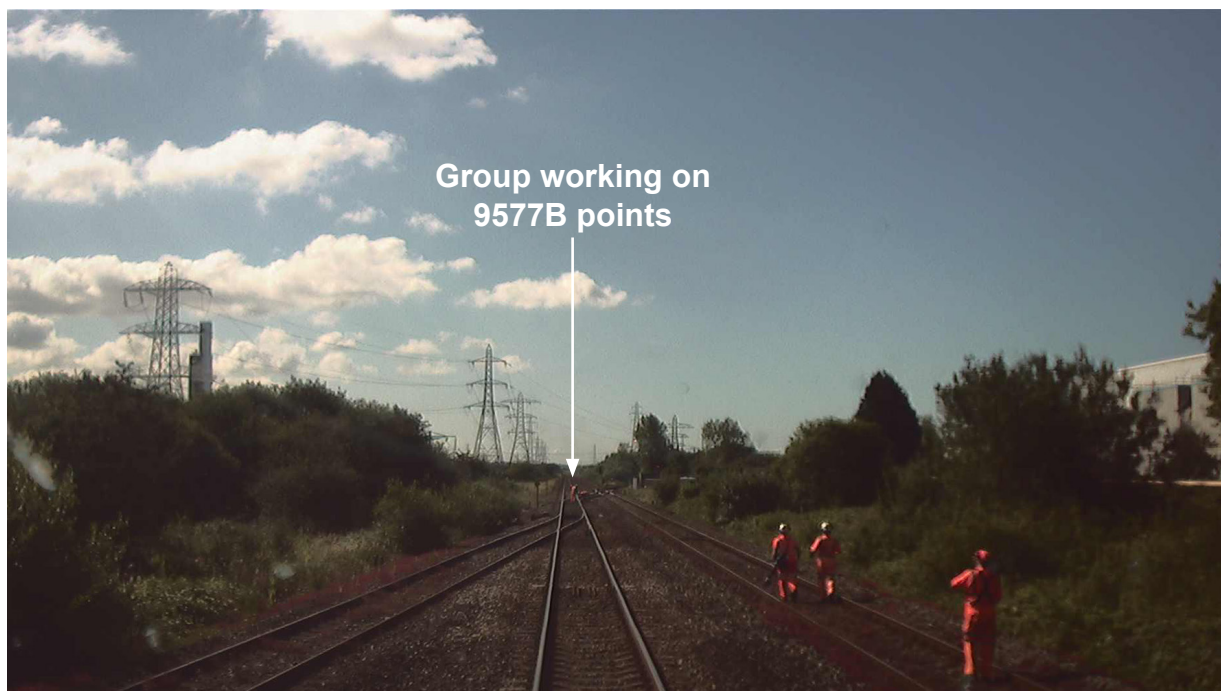
Figure 5: Image from forward-facing CCTV from train 1L48 as it was passing the group walking on the down main line

- 41 The lookout, TW5, who was with the group walking on the down line, stated that as the train passed him, he blew the horn he was carrying. The other two track workers in the group have stated that they began to shout and they all moved faster towards the three working on 9577B points (figure 5).
- 42 TW3, who was in the space between the up and down main lines, was using the impact wrench to loosen nuts, while one of the other two, both of whom were standing between the rails of the up main line, used a brush to lubricate the thread of the bolt. TW3 finished tightening a nut and was about to stand up when, less than a second later, the train struck TW1 and TW2. TW3 fell backwards out of the way. TW1 and TW2 were fatally injured. TW3 was severely traumatised.

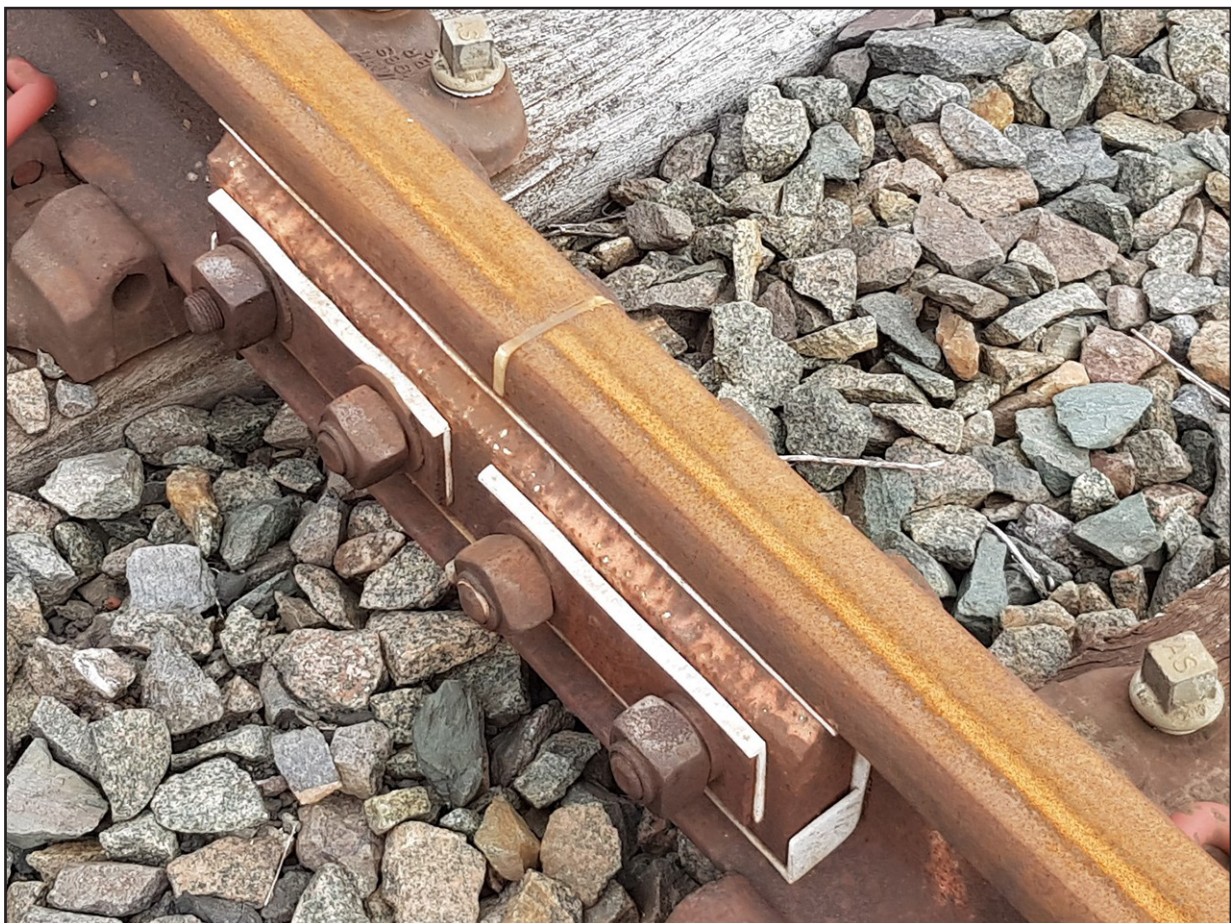
Figure 6: Insulated rail joint

71 It is important that the non-conducting property of an IRJ is maintained. Between the two abutting rail ends is an insulating spacer, and a common failure mode is for the rail ends to become deformed by the impact from passing wheels, leading to damage to the rail ends and the top of this spacer. This rail deformation is referred to as 'lipping'. If it is not checked, the two lipped rail ends may eventually make contact, at which point the electrical insulating property of the joint is lost. This will usually show up as a failure of one or both adjacent track circuits, meaning that the signals cannot be cleared for trains to pass.

- 72 If inspection of an IRJ shows that lipping is occurring, the joint can often be repaired by grinding away the deformed portion of the rail ends to restore the gap between them, grinding the top of the spacer to reduce its height, then adding a resin to build up the spacer again. The resin is then smoothed off to match the profile of the rails before it hardens. This operation is referred to by track maintenance staff as 'trimming' the IRJ.

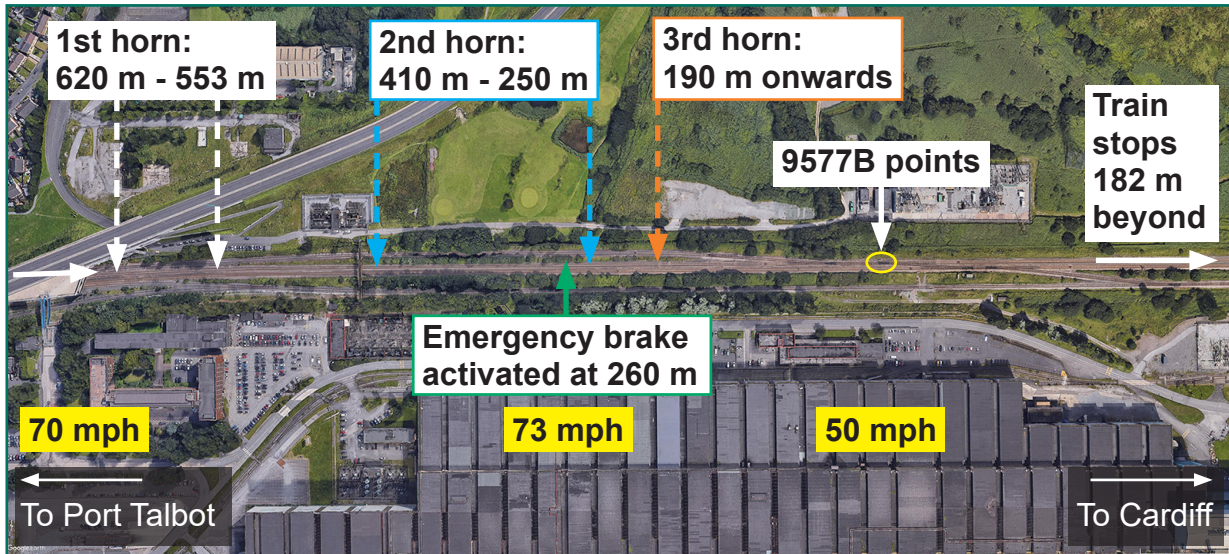
148 The train's data recorder shows that the driver sounded the train's warning horn three times on the approach to the group working on 9577B points (paragraph 40, figure 8). The driver sounded these repeated warnings, and applied the emergency brake during the second of them, because he saw no response from the group of three to the initial warning.

Figure 8: Driver actions and train speeds on the approach to 9577B points

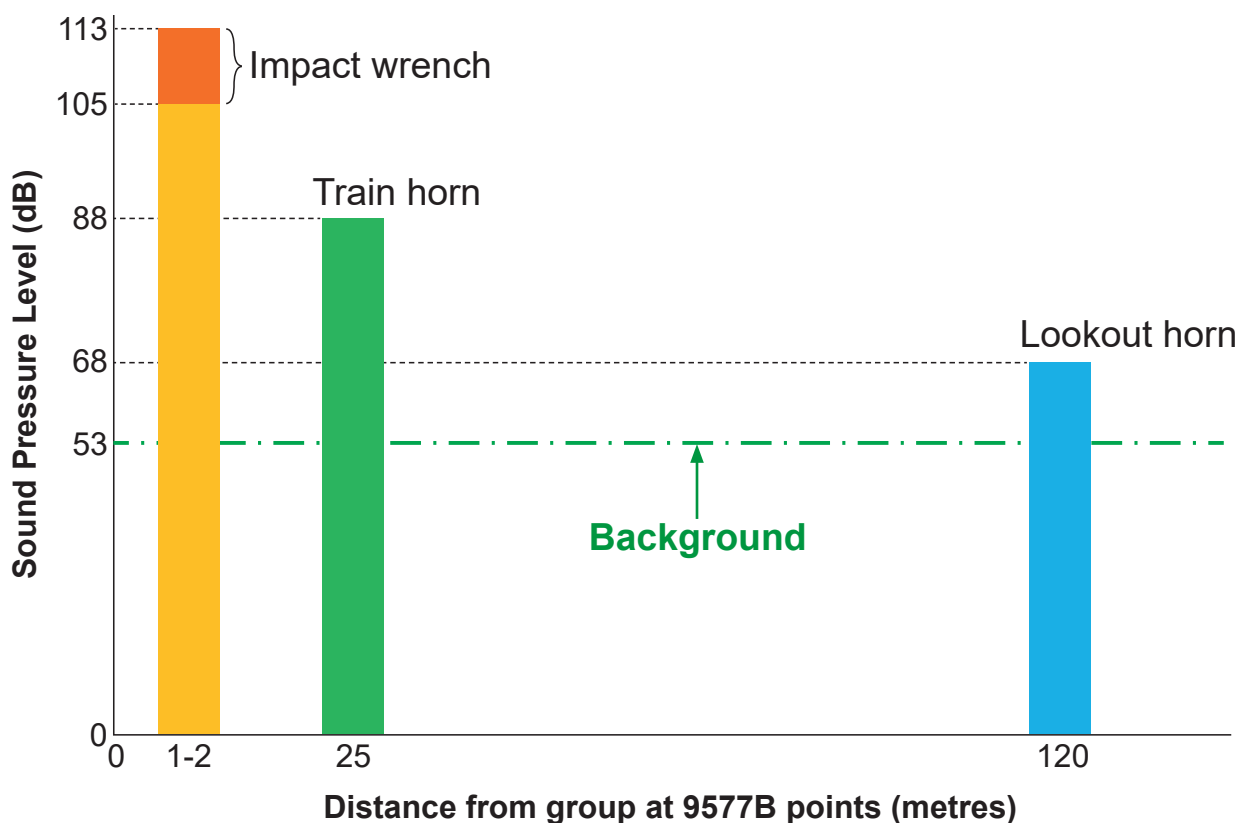
151 Measurements undertaken by RAIB of the sound pressure levels¹¹ from the impact wrench (measured in similar conditions to those at the time of the accident, but on a different day) showed that at distances of between 1 and 2 metres it produced a sound pressure level between 105 and 113 dB(C)¹² (figure 9). This was greater than the sound pressure level of the low tone warning from the approaching train horn (paragraph 40), which was measured as 88 dB(C) at 25 metres, the approximate distance the train was from the group around one second before it reached them. The sound pressure level of the lookout's warning horn was measured as 68 dB(A)¹³ at a distance of 120 metres, which is the approximate distance that the lookout was from the three track workers at the points.

Figure 9: Comparative sound pressure levels of different sources at distances relative to the group working at 9577B points
