AAIB
Air Accidents Investigation Branch

AAIB Bulletin

12/2020

Aircraft Type and Registration:	Bombardier BD-700-1A10 Global 6000, 9H-VJM
No & Type of Engines:	2 Rolls-Royce BR710A2-20 turbofan engines
Year of Manufacture:	2013 (Serial no: 9630)
Date & Time (UTC):	11 December 2019 at 0550 hrs
Location:	Liverpool Airport
Type of Flight:	Commercial Air Transport (Passenger)
Persons on Board:	Crew - 3 Passengers - 1
Injuries:	Crew - None Passengers - None
Nature of Damage:	None
Commander's Licence:	Airline Transport Pilot's Licence
Commander's Age:	53 years
Commander's Flying Experience:	11,506 hours (of which 3,864 were on type) Last 90 days - 104 hours Last 28 days - 48 hours
Information Source:	AAIB Field investigation

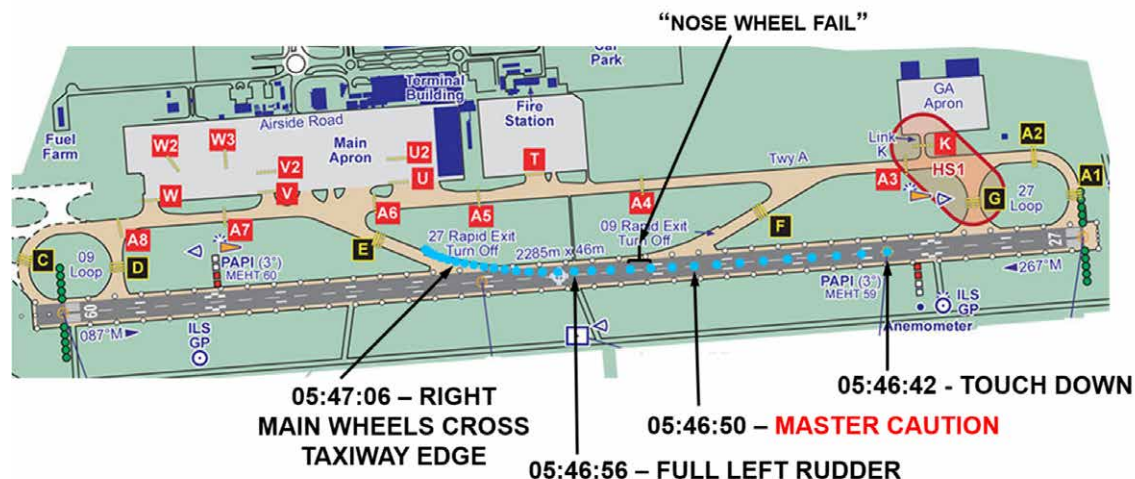
Figure 1

Liverpool Airport with the aircraft's ground track shown as blue dots (at one second intervals)

As the speed reduced, the aircraft turned more rapidly to the right and the commander was unable to keep the aircraft on the paved surface. The commander did not recall the speed at which the aircraft left the paved surface, but the co-pilot believed it was approximately 50 kt and he recalled seeing the NOSE STEER FAIL caution on the EICAS before the aircraft left the runway.

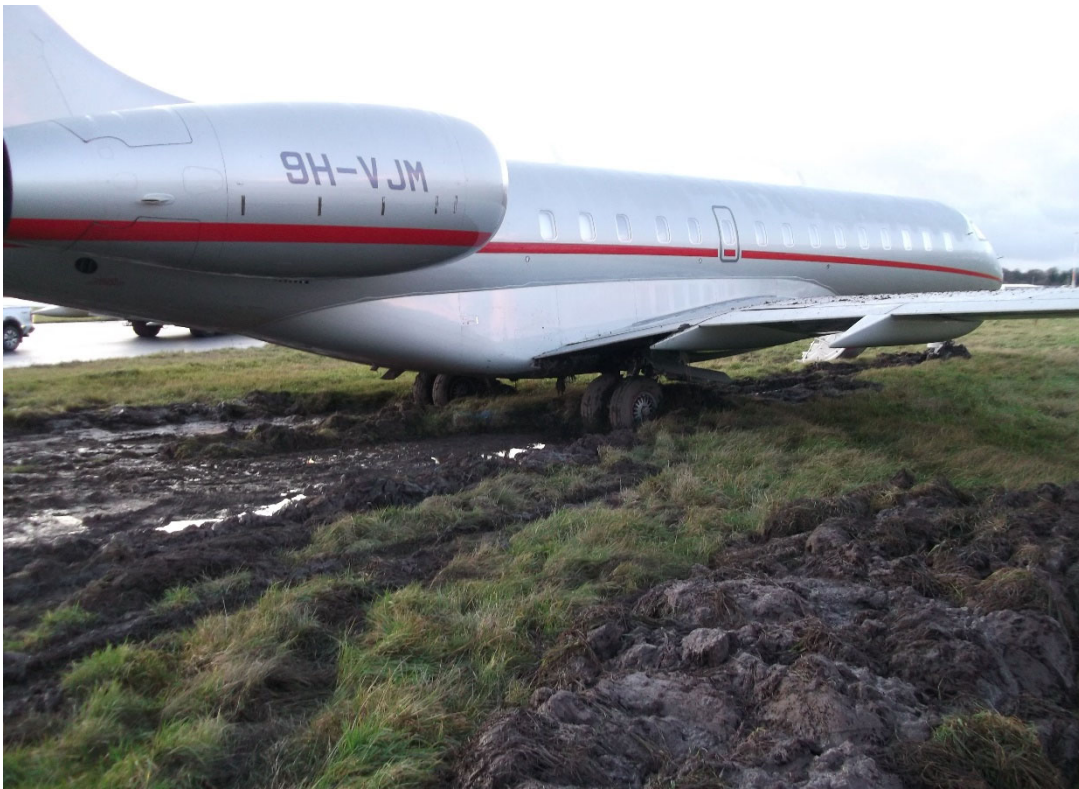
Figure 2

The aircraft had left the runway just before the start of runway rapid exit turnout (Exit E) to the right. It travelled approximately 30 m on the grassed area and its landing gear wheels sank into the topsoil and brought the aircraft to a stop. Mud and soil encased the lower parts of the landing gear (Figure 2). The flaps and slats were up, and mud and soil had been thrown upwards to become entrapped within the flap track mechanisms and fairings. Mud was also present on the wing leading edges and wheel bays and there were mud spatters on the engine intake rings.

9H-VJM on the soft ground

Despite departing the paved surface, examination of the aircraft found no pre-existent or resultant damage to the aircraft structure, landing gear, wheels, tyres and brakes. Although there was some evidence of mud spatter on both engine intake leading edges, the engines were undamaged.

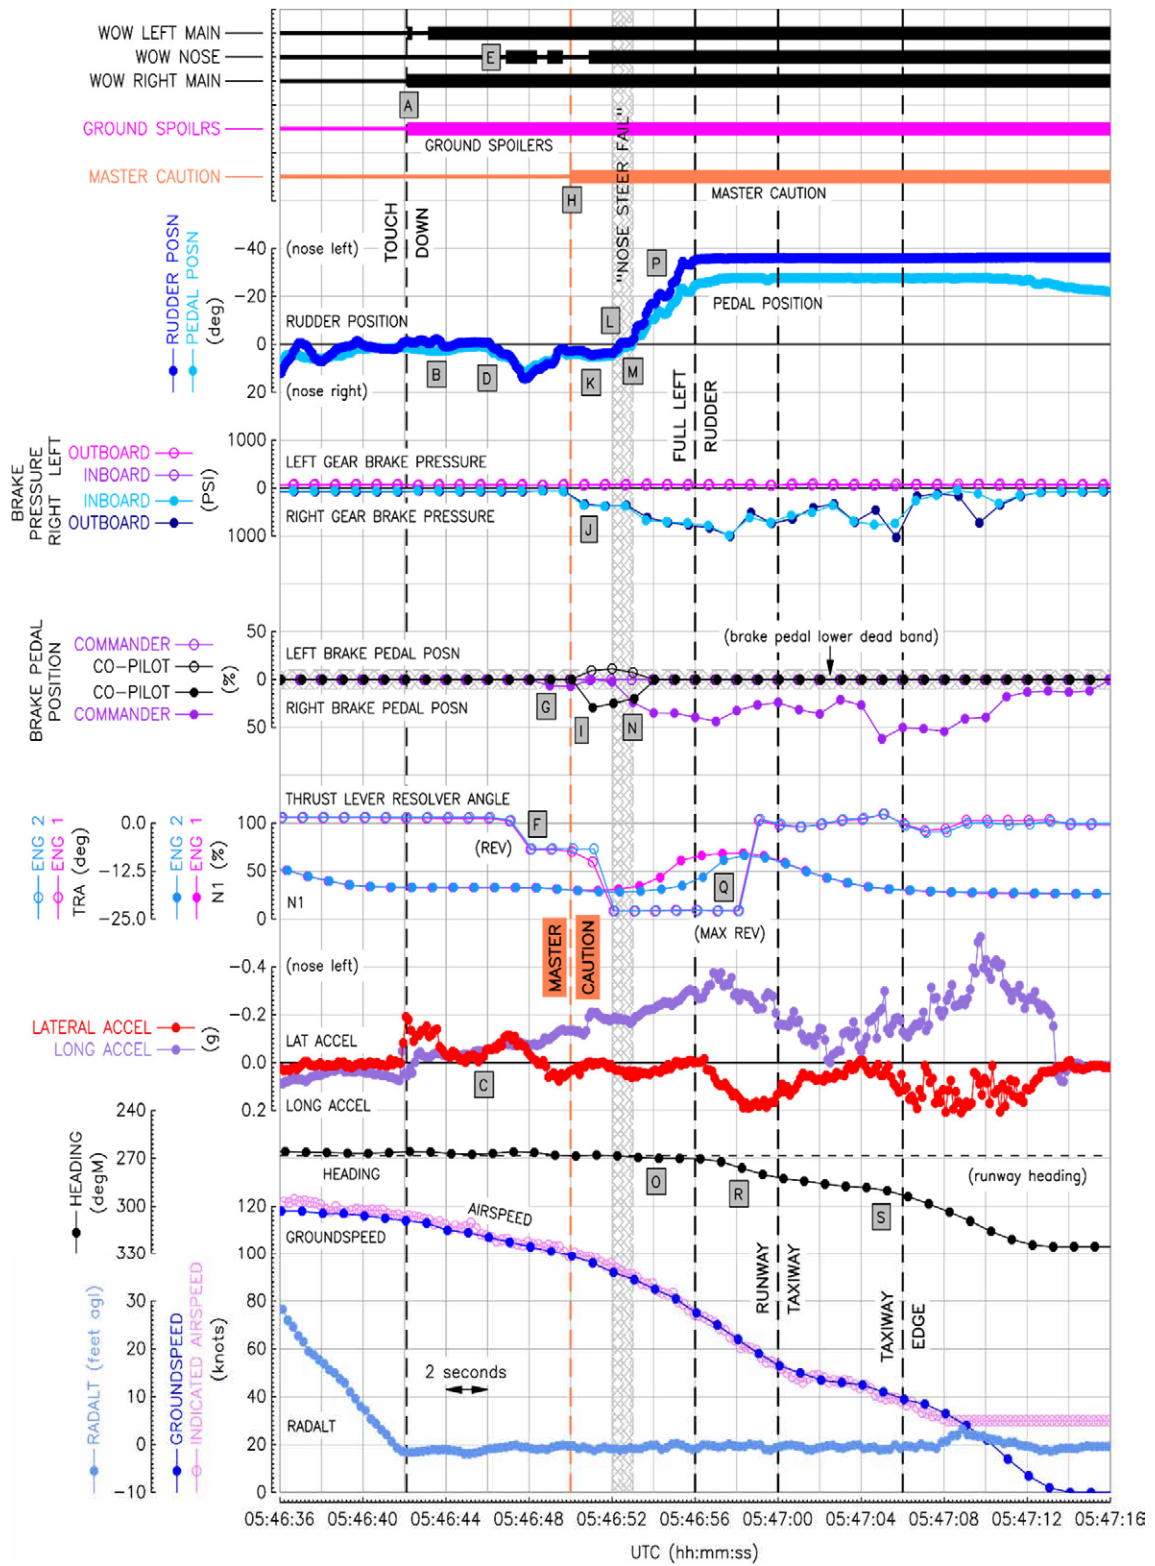
Figure 3
Recorded data for the landing

- Two seconds after the MASTER CAUTION is issued, the commander verbally announced a "NOSE STEER FAIL" (heard on the CVR recording) [L] just as the thrust levers were pulled back to MAX REV[ERSE]. A left rudder pedal input was made [M] (co-pilot still applying right brake) with a corresponding right brake pedal input by the commander [N].

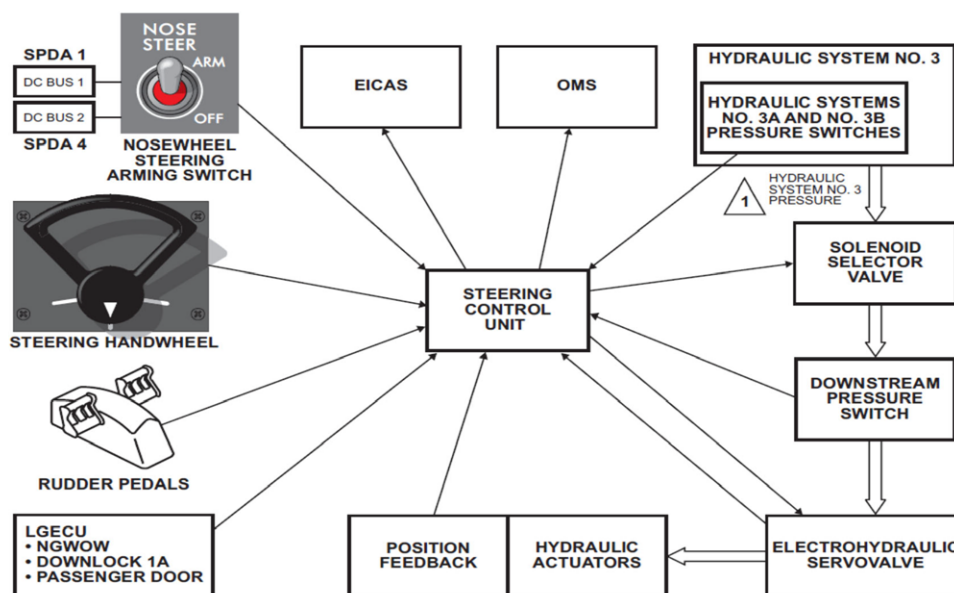
Figure 4
NWS schematic

The component testing of the NWS and associated components showed that the NWS had gone into free caster, as it was designed to do when a fault is detected. It is most likely the NWS fault was caused by either or both steering actuator LVDTs having low insulation resistance values. The handwheel faults detected on test are not considered to have caused any difficulty in controlling the aircraft and would not have caused the NWS to go into free caster.

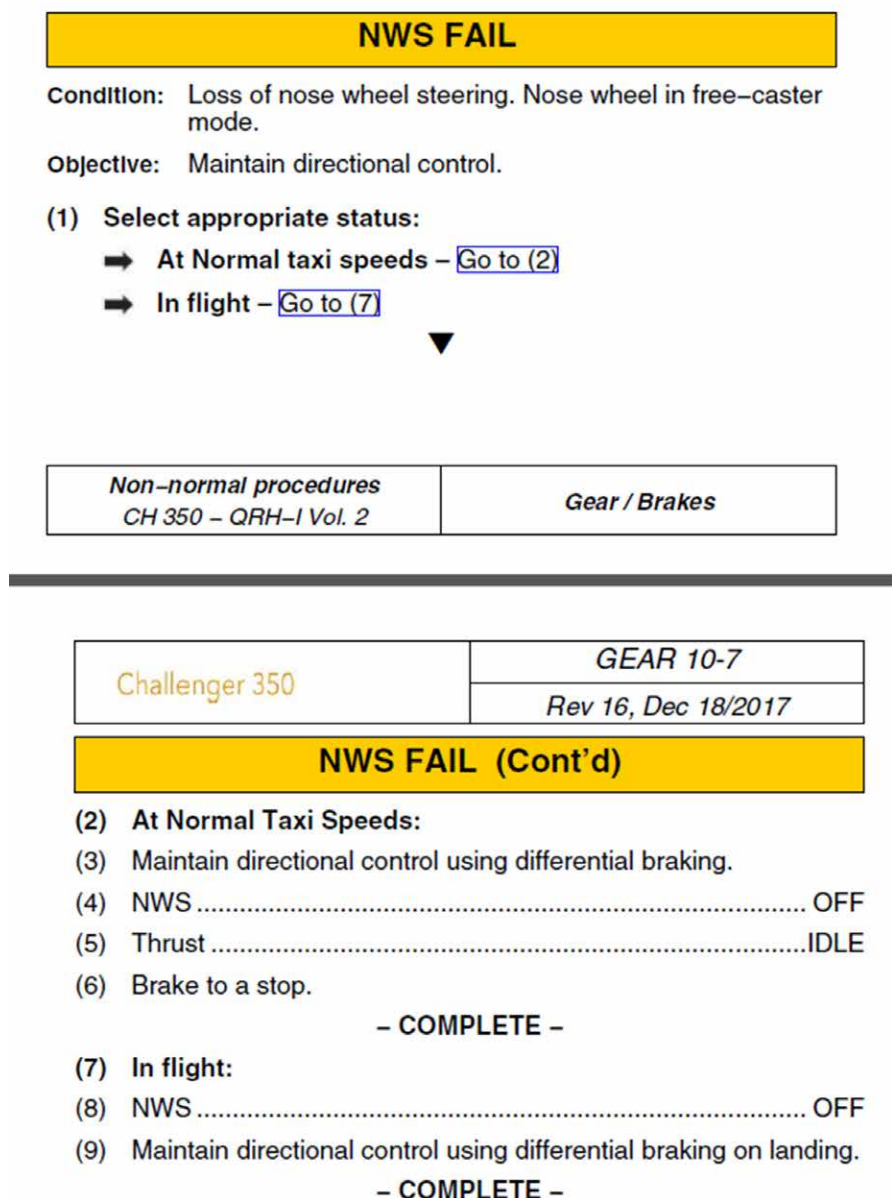
Other aircraft types produced by the manufacturer and which have similar NWS systems, specifically mention in the QRH and AFM procedures the need to use differential braking to steer in the event of NWS failure. An example of the procedure is at Figure 6.

Figure 6
NWS Procedure for Challenger 350

The manufacturer agreed that the disparity of information between aircraft types on differential braking was unsatisfactory and has undertaken to amend the QRH and Non-Normal Procedures of the AFM for the Global 6000 to provide direct guidance to flight crew on the use of differential braking.

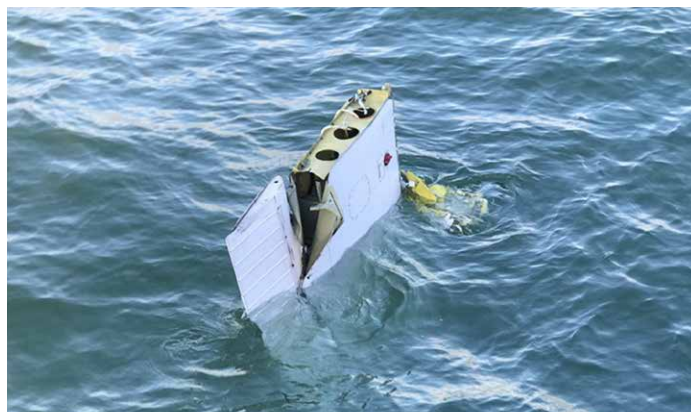
Figure 2

During the search for the aircraft, a lifeboat crew found the aircraft's right wing (Figure 2), part of the nose landing gear, a first aid kit and some personal effects floating in the sea approximately 3 miles north-west of Puffin Island. The wing was floating with its root up and photographs show that the leading edge had crumpled. An attempt by the lifeboat crew to recover the wing was abandoned when the wing came into contact with the lifeboat, puncturing the side. It was not found again and is thought to have later sunk. The other items were recovered back to shore.

Inboard end of the right wing found floating in the sea

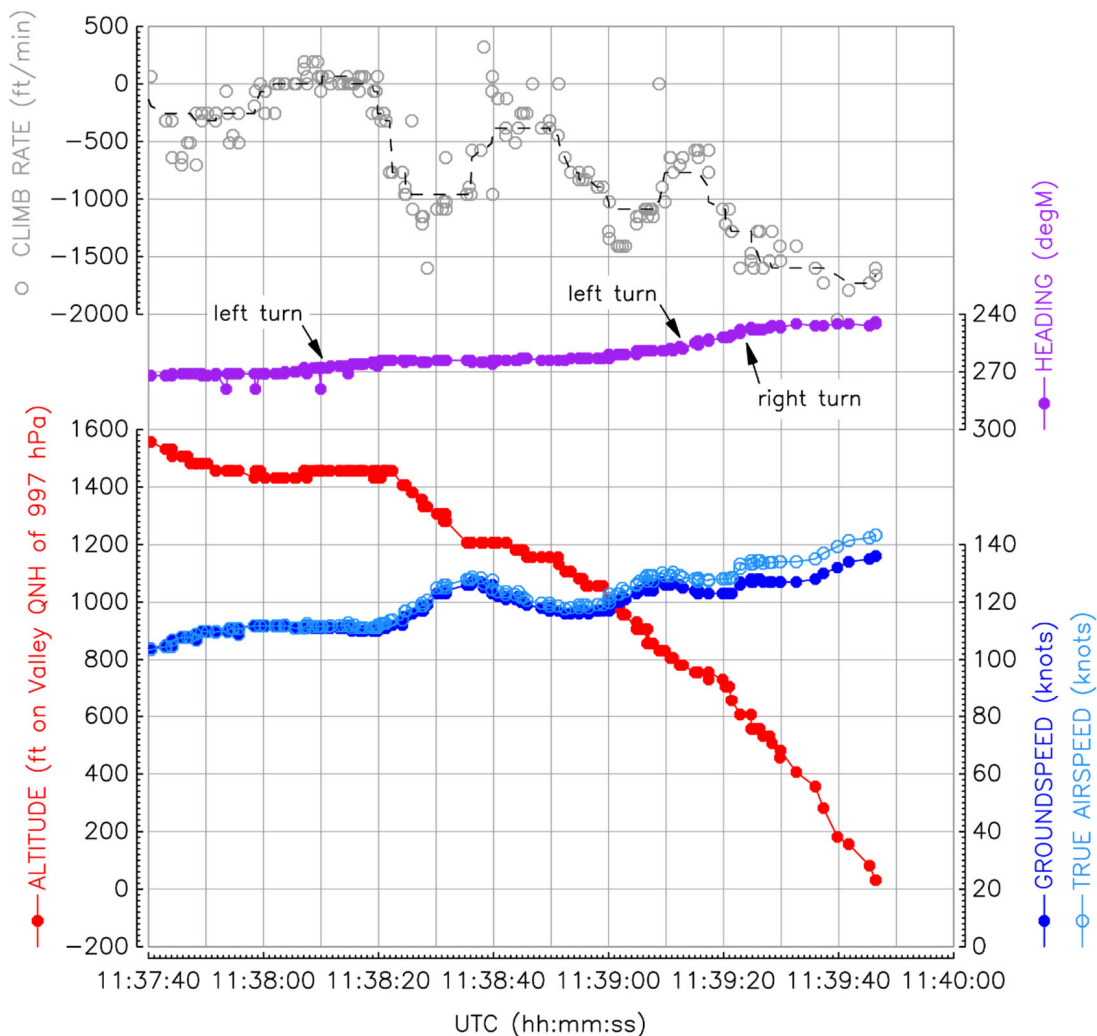
Figure 4

aircraft then descended again for about 90 seconds, initially at about 1,000 ft/min, during which it briefly levelling off at 1,200 ft. The last recorded point positioned the aircraft at a height of 5 ft over the sea on the Valley QNH of 997 hPa⁶. The descent profile shows the aircraft's rate of descent steadily increased, but fluctuated, reaching a peak of 1,700 ft/min, with a corresponding airspeed of about 140 KTAS. The data also shows that the aircraft turned slightly to the right by about 20° as it descended through 600 ft onto a final heading of about 245°M.

ADS-B data of the aircraft's descent from Great Orme coastline

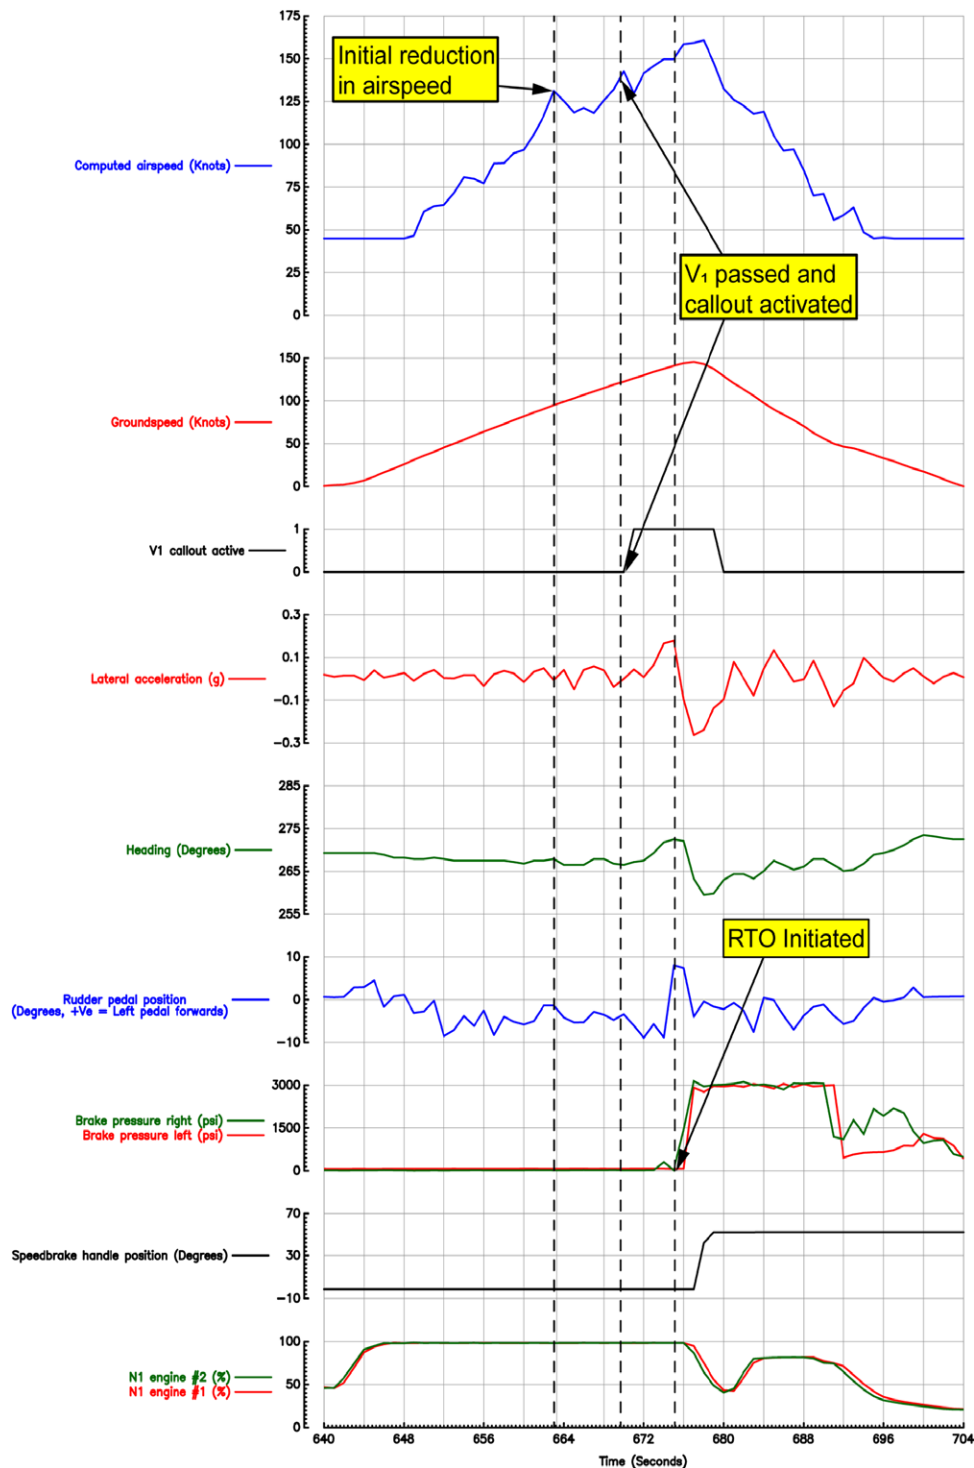
Between V_1 and the start of the RTO the aircraft turned right by approximately 8° . Once the RTO was initiated, the aircraft responded to the left pedal input and turned rapidly left through approximately 14° before recovering to the centreline of the runway. Around the start of the RTO there were substantial changes in lateral g commensurate with the rapid changes in heading.

Figure 2
Flight Data Monitoring Extract

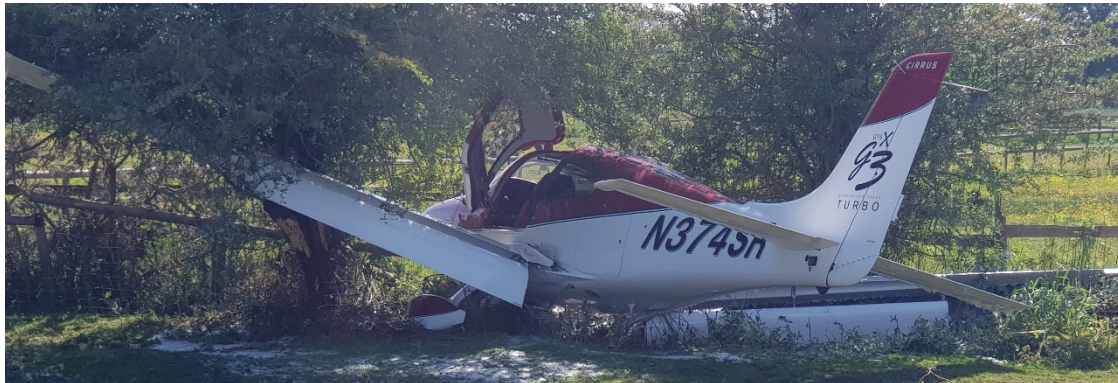
Figure 1

Despite the application of full braking, the aircraft overran the runway, went through the airfield boundary fence and crossed a public footpath before colliding with trees (Figure 1). N374SR sustained significant damage to wings and fuselage, but the pilot was able to vacate unaided and uninjured.

N374SR after colliding with trees in the runway overshoot
(photograph ©Surrey Police)

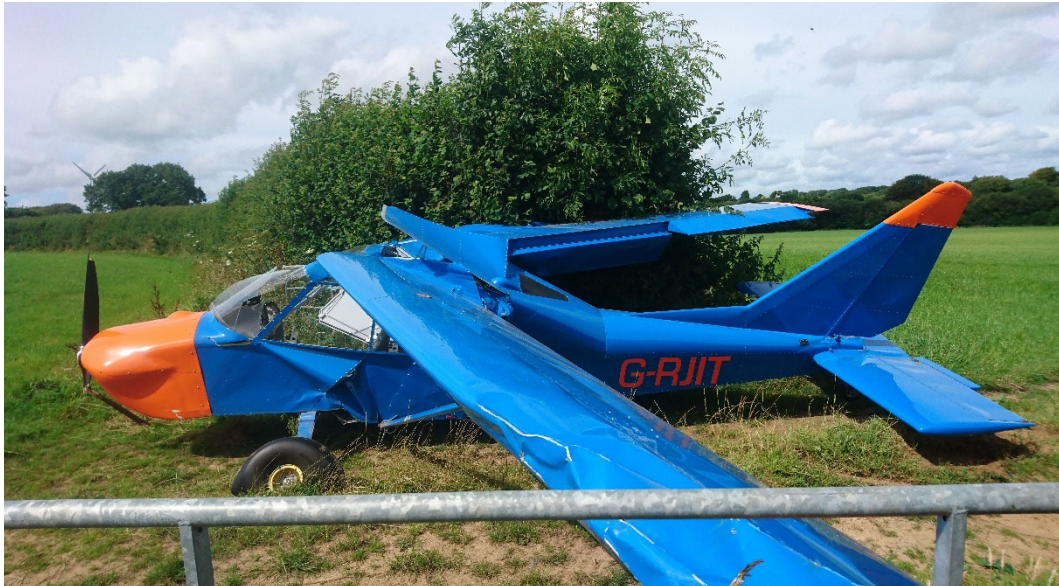
Figure 1

The left wing tip struck the gate, whilst the right wing was bent backwards by the impact with the gate-post and hedge. The landing gear, forward fuselage and wings absorbed most of the impact and sustained substantial damage (Figure 1). The pilot suffered a minor injury but was able to climb out of the aircraft unaided.

Final position of the aircraft showing significant damage to the fuselage and wings
