Defence  
Infrastructure  
Organisation

# Safety Alert

**Subject: Standby Generator - Battery Explosion**

**Number: SA 2020/56**

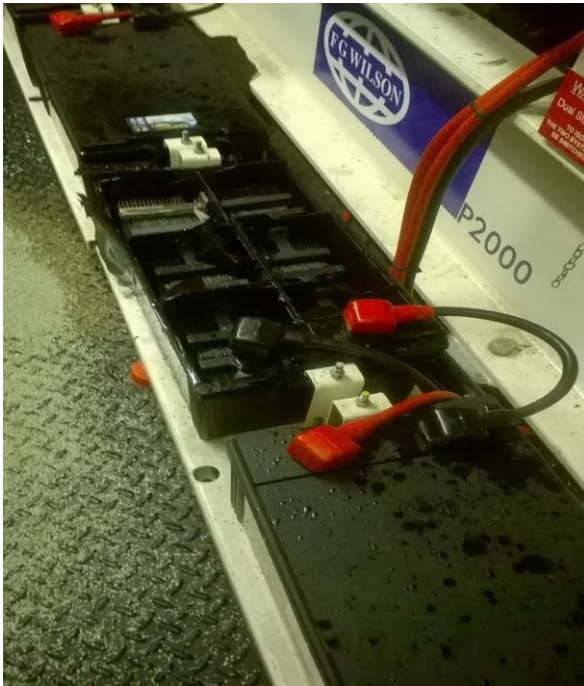
6. On investigation, it was found that one of the four left hand generator start batteries had exploded throwing debris and sulphuric acid across the plantroom. (See photographs at Annex A.)

11. The main contributing factor as to why the battery ruptured was probably due to accelerated water loss within the battery cell - although this type of battery is sealed thermal runaway can lead the battery to explode. As this is a sealed battery the loss of electrolyte cannot be determined when maintenance is undertaken and even if this was possible there is no facility provided to top up the cells.

Photograph – 01: A3 Generator Plantroom (Battery No 2). Point of Explosion.

17. The MMO, on direction from the DIO Regional Delivery Manager or Equivalent, shall initiate the following:
  - a. All automotive type batteries currently installed to standby generator plant are to be replaced with a battery suitable for standby generators on constant trickle charge and sized as per manufacturer's information.

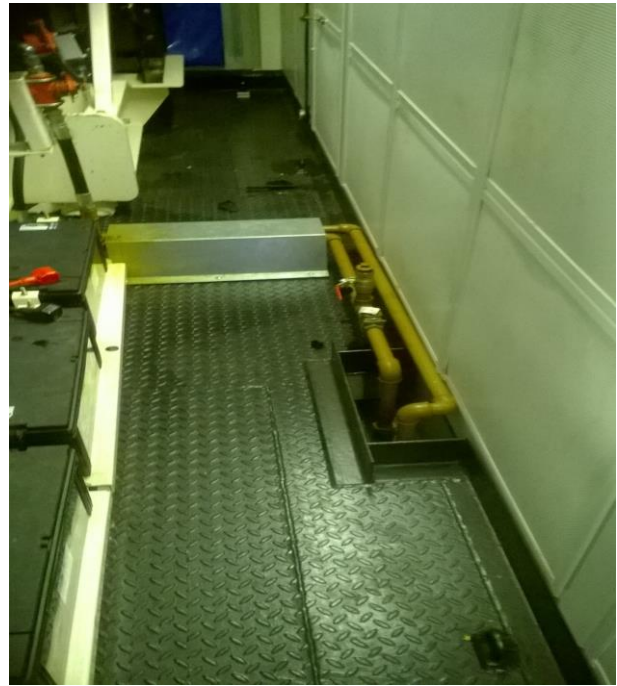
Photograph – 02 : Photograph shows extent debris was deposited within the generator room.  
Note: Plastic battery casing at front of generator opposite side approximately 4 Metres from discharge point.

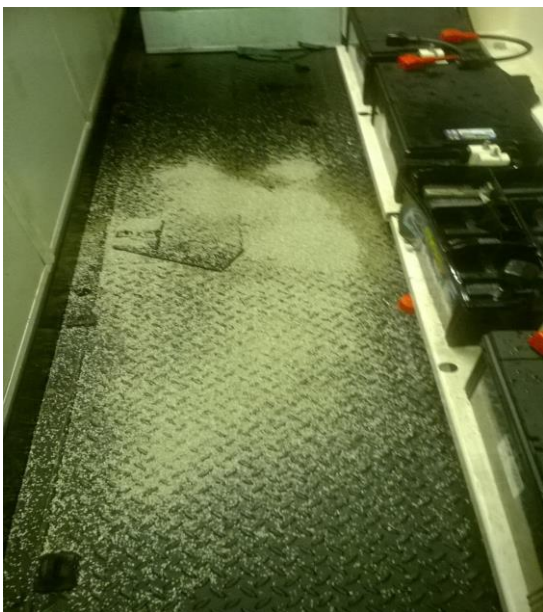
Photograph – 03 : Photograph shows extent debris was deposited within the generator room.  
Note: Plastic battery casing to side of generator adjacent to discharge point.
