Considerations on cracking of the Hammersmith Bridge pedestals

Prof. Norman A Fleck FREng FRS

6 November 2020

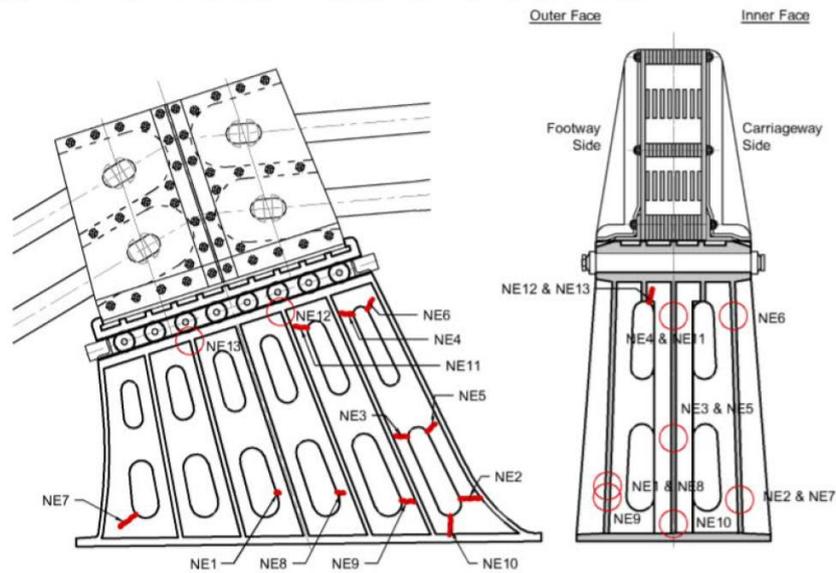
Figure 2.12: NE pedestal surface breaking defect and crack locations

13 distinct cracks exist in the NE pedestal, with none found in the SE pedestal. (MMD have suggested that “the condition and quality of the casting appeared to be better than that of the NE pedestal.”¹).

- (i) Cracks initiated in a zone of local tension due to loading *towards span*: NE1, NE2, NE3, NE 4, NE8, NE9, NE11
- (ii) Cracks initiated in a zone of local **compression** due to loading *towards span*: NE5, NE6, NE10
- (iii) Cracks initiated in a zone of local tension due to loading *towards anchorage*: NE7
- (iv) Cracks in the transverse diaphragms in a zone of tension due to loading towards span or anchorage: NE12, NE13.

Defect	Location	Detail
NE1	East Web	Approx. 30mm long
NE2	West Web	Approx. 200mm long
NE3	Centre Web	Approx. 100mm long
NE4	Centre Web	Approx. 100mm long
NE5	Centre Web	Approx. 80mm long
NE6	West Web	Approx. 80mm long
NE7	West Web	Approx. 205mm long
NE8	East Web	Approx. 50mm long
NE9	East Web	Approx. 70mm long
NE10	Centre Web	Approx. 160mm long
NE11	Centre Web	Approx. 95mm long
NE12	Diaphragm 5	Approx. 140mm long
NE13	Diaphragm 3	Approx. 125mm long

Defect	Type	Stressed state	Restrained force direction	Likely cause
NE1	Surface break	Tension ^[1]	Towards span	Manufacturing defect
NE2	Through thickness crack	Tension	Towards span	Tensile rupture
NE3	Through thickness crack	Tension	Towards span	Tensile rupture
NE4	Through thickness crack	Tension	Towards span	Tensile rupture
NE5	Through thickness crack	Compression	Towards span	Fatigue crack
NE6	Through thickness crack	Compression	Towards span	Fatigue crack
NE7	Through thickness crack	Tension	Towards anchorage	Tensile rupture
NE8	Surface break	Tension ^[1]	Towards span	Manufacturing defect
NE9	Surface break	Tension	Towards span	Manufacturing defect
NE10	Through thickness crack	Compression	Towards span	Fatigue crack
NE11	Through thickness crack	Tension	Towards span	Tensile rupture
NE12	Through thickness crack	Tension	Towards span/ anchorage	Tensile rupture
NE13	Through thickness crack	Tension	Towards span/ anchorage	Tensile rupture

Fig. 1: The 13 cracks in the North East (NE) pedestal. Taken from MMD report 417457 MMD-HSB-REP-PBI-000001 01 20 April 2020.

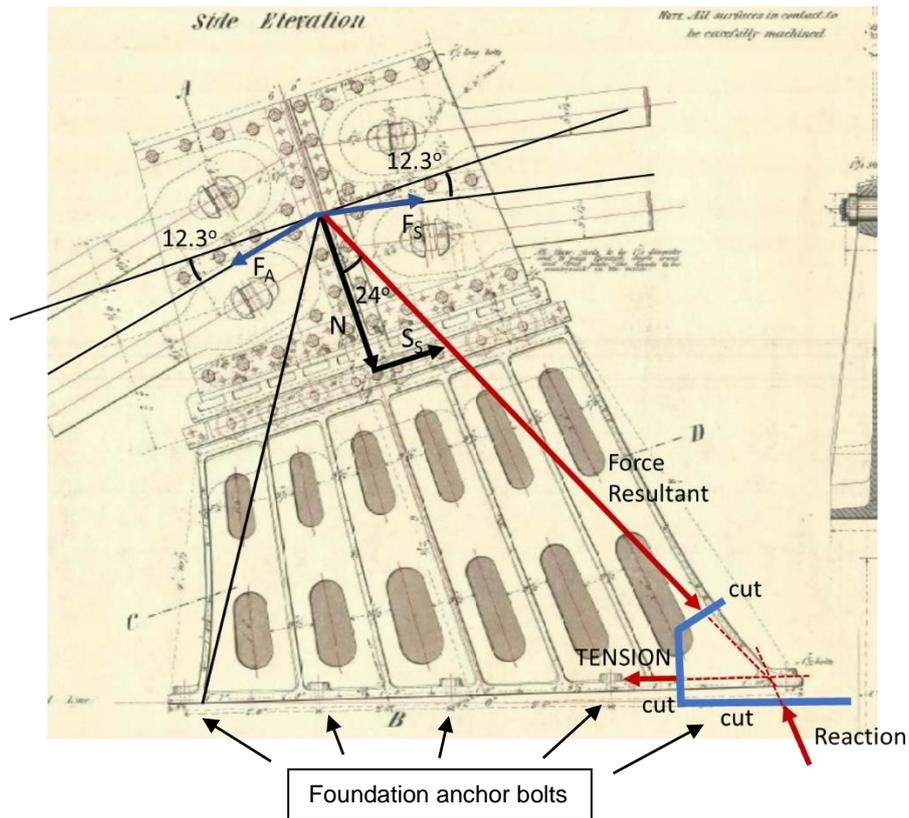
Crack NE10 advanced in August 2020 (an acoustic event recorded this), and it is important to develop an understanding for, and confidence in, the reason for this crack advance. The crack advance indicates the presence of local tension in this zone of the pedestal. The generally accepted working hypothesis is that local tension within the cracked region of the pedestal is associated with the development of a net suspension chain force (towards the river) due to a thermal relaxation of the anchor-chain tension associated with its thermal expansion. The net chain force develops because the rollers between deviation saddle and underlying pedestal are seized (by corrosion).

each side of the deviation saddle (due to temperature changes associated with summer peak temperatures) gives rise to a resultant force with a line of action that runs close to the toe of the pedestal – see Fig. 2. A small rotation of the pedestal about the toe will alleviate the tension imbalance in the chains: this is beneficial as it leads to a reduced level of stress in the pedestal. Likewise, any small displacement of the pedestal towards the river will relax the imbalance in chain tension.

It is difficult to envisage that a large shear component of restraining force from the foundation onto the tip of the pedestal can develop (not least as the pedestal is close to the embankment wall of the river – see Fig. 3). If a large shear force were to develop at the toe of the pedestal, then there is no clear reason why tension would develop in the vicinity of crack NE10. An alternative scenario is that a small rotation and/or slip of the pedestal takes up any clearance gap between the foundation anchor bolts and the pedestal base plate; this shear force induces tension in the pedestal the vicinity of crack NE10. This explanation is sketched in Fig. 2.

Fig. 2. The direction of the reaction force from foundation to pedestal dictates the level of tension at the location of the crack NE10 near the right-hand (river-side) toe of the pedestal. A free-body diagram of the forces on the right-hand toe of the pedestal due to a net chain force towards the river at high temperature (summer).

The placement of strain gauges and tilt gauges at judicious locations within the pedestal will give useful information on the stressing of the pedestal by temperature changes. Such instrumentation would also serve as a high-fidelity check of the MMD finite element model of pedestal behaviour as a function of chain temperature.
