Passenger train derailment at Bognor Regis station, West Sussex, 22 October 2020

Summary of the accident

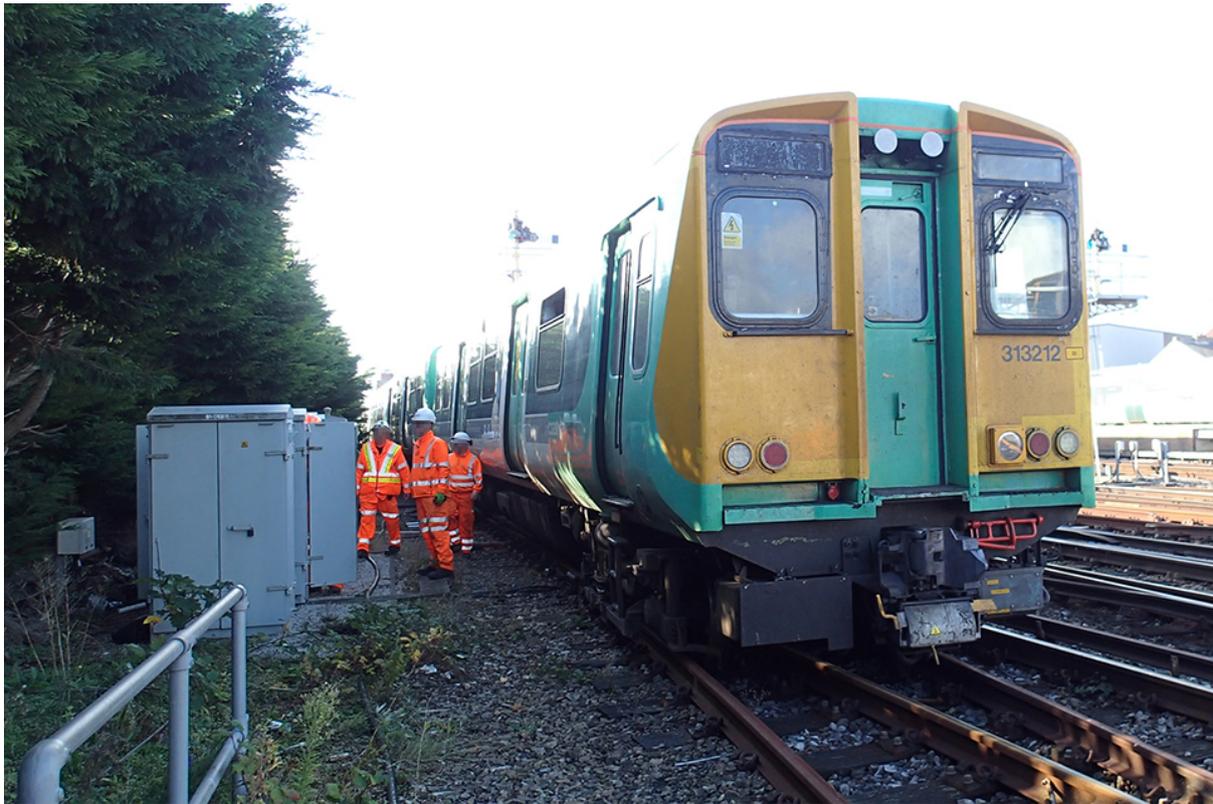
The derailed leading end of the train

The train, a three-car class 313 electric multiple unit, was travelling at approximately 5 mph (8 km/h) at the time of the accident. All four wheels of its leading bogie derailed on points, numbered 32B, a short distance beyond signal BR12, which is the platform 4 starting signal.

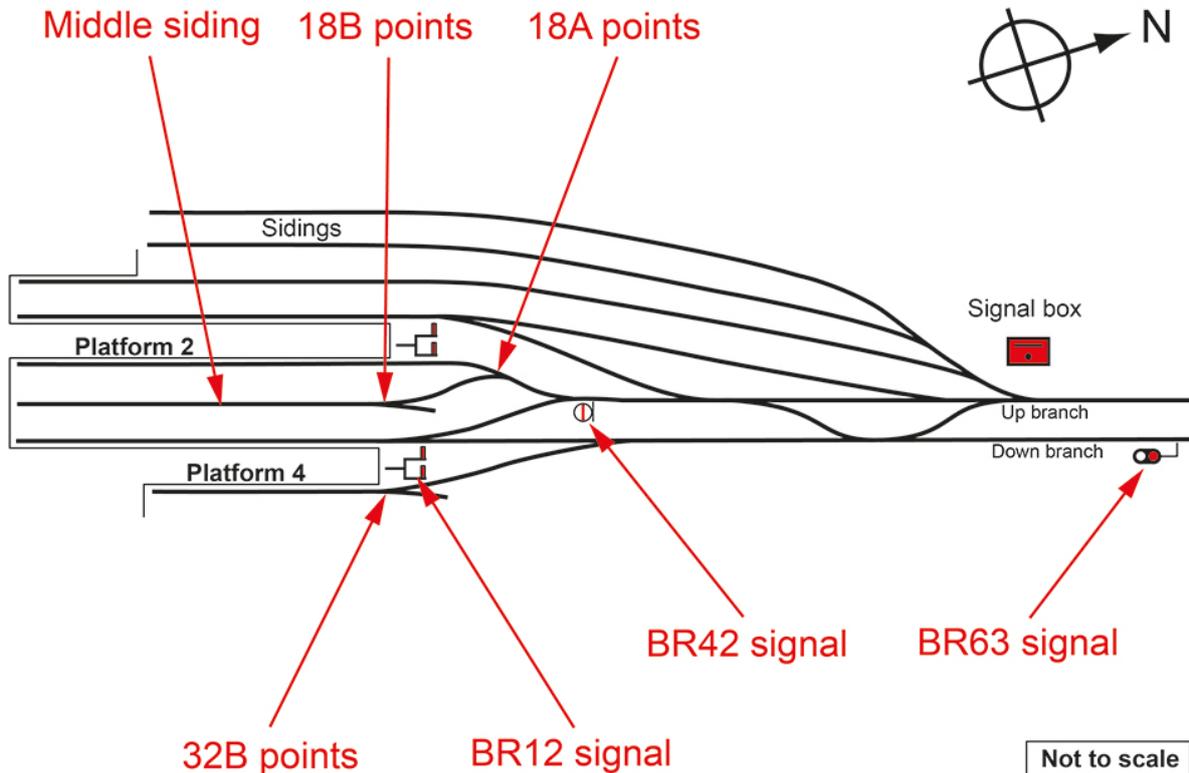
Simplified track diagram showing platforms 2 and 4, the middle siding, signals BR12, BR42 and BR63, and points 18A, 18B and 32B

The problem with 18 points meant that the train was instead directed into the middle siding. 18B points were damaged as a result of train 5P17 running through them when they were not properly set for this movement.

Points 18A, 18B and 32B are driven by electric motors, which are all powered by the same set of batteries. One of these batteries had failed so that, when the signaller tried to set the routes for trains 5P17 and 2P03, there was not enough energy available to set and lock the points in the reverse position. Train 5P17 was diverted into the middle siding because 18A points had not moved into the normal position, while train 2P03 derailed because 32B points had moved into an intermediate position, allowing the leading wheels to fall in between the rails. Neither train driver was able to see the position of the points clearly because it was dark at the time.

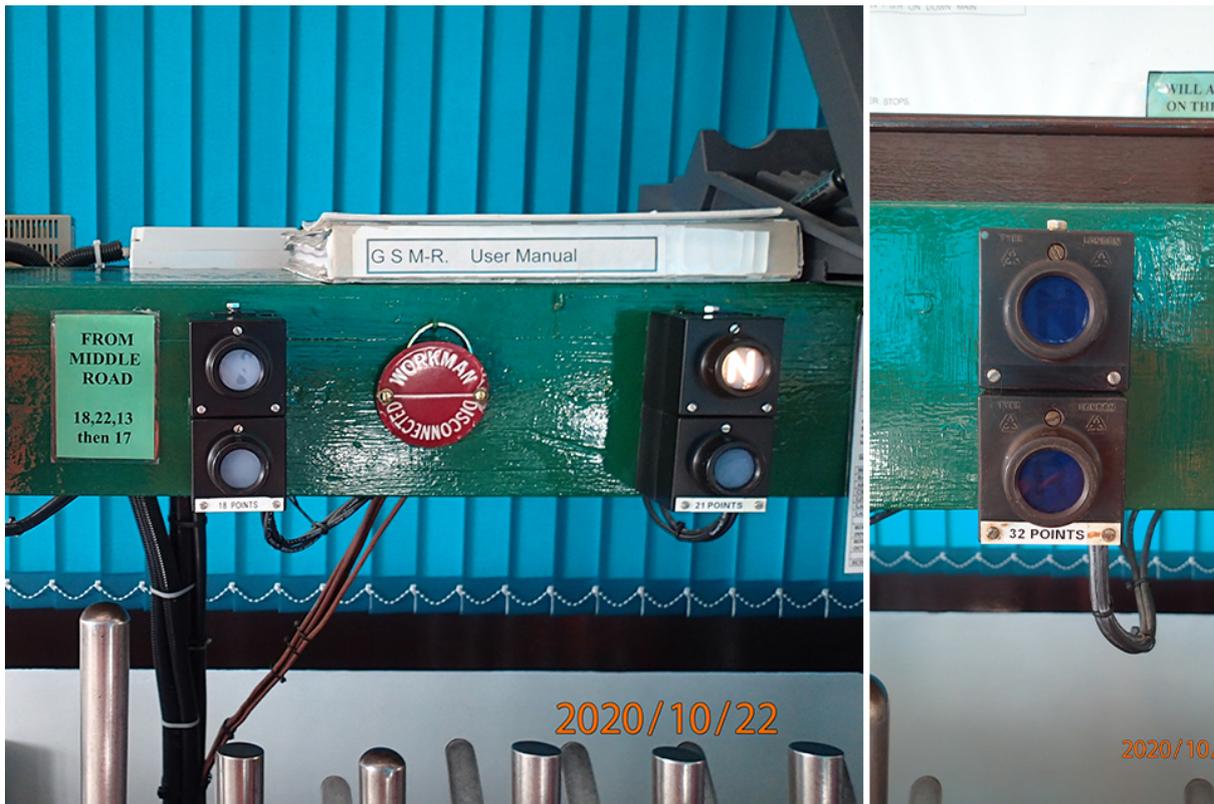
Above the lever frame in the signal box are indicator lights showing whether each set of points has been detected in either its normal or reverse position. After the accident, the indicators for both 18 and 32 points were found to be blank, meaning that neither of these sets of points were detected in a correct position. It is likely that these indicators were also blank before the movement of the two trains. However, the signaller did not notice this, partly because he was relying on the position of the levers, and partly because he was under increasing time pressure as well as probably being fatigued.

Indicators for 18, 21 and 32 points as observed after the accident. The indicators for 18 points (left) and 32 points (right) are blank, showing no detection of these points, whereas that for 21 points (middle) is lit with 'N' for normal position.

The signaller was not aware of the problem with the points because he had been relying on the position of levers in the signal box that are used to control the points, rather than checking that the points indicators were illuminated. An informal, locally-produced reference sheet in the signal box described all the lever movements that were necessary for a given train movement, and the signaller repeatedly consulted this sheet to check that he had carried out the correct actions. Because all the levers were in the correct positions according to the sheet, the signaller believed that the routes for each train were correctly set. However, the signaller did not recognise that, because the points at Bognor Regis involved in this accident are motorised, the position of the point levers only served as a reminder that he had commanded the points to move. The lever position does not necessarily reflect the actual position of the points on the ground, as it would if a mechanical linkage was in place and working correctly.

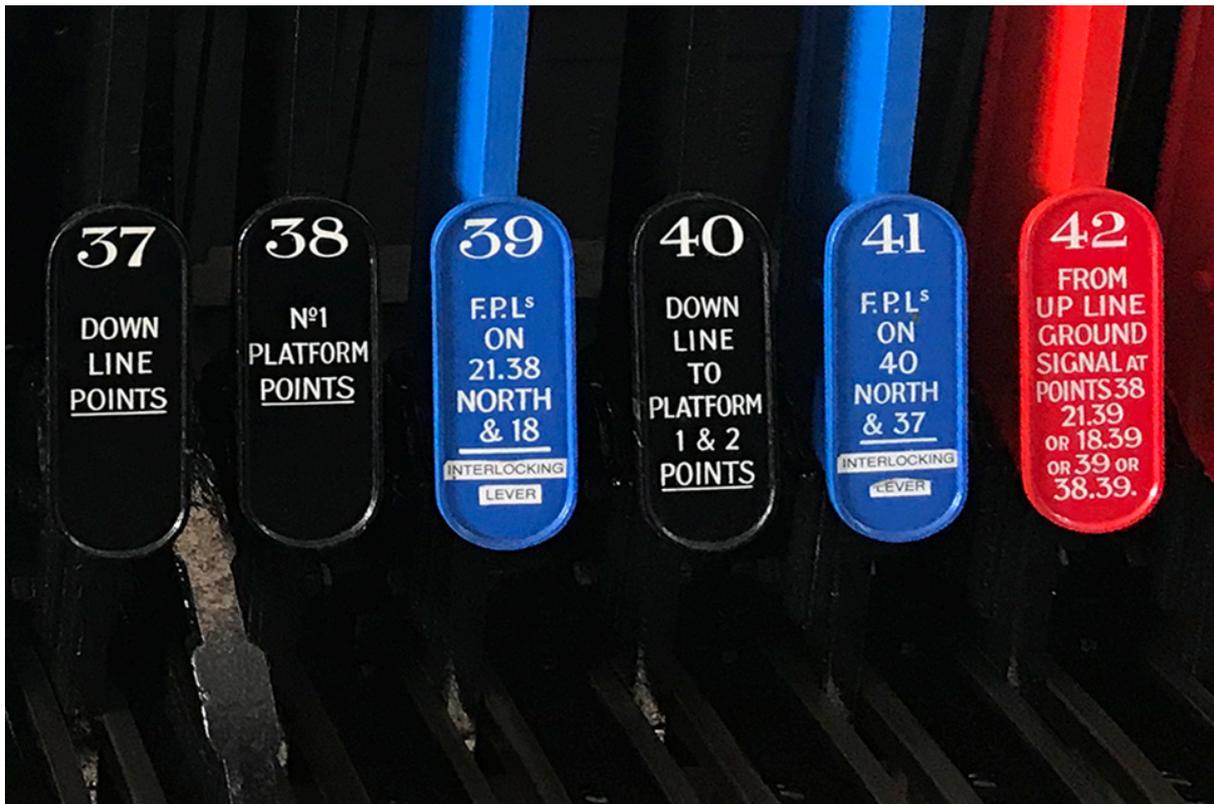
Many of the sets of points at Bognor Regis, including some of those involved in this accident, were converted from mechanical to motor operation between 2009 and 2012. When this work was carried out, the mechanical locking between the levers was not altered, and so the levers which formerly worked mechanical facing point locks still have to be pulled by the signaller, to release other levers which operate signals. Facing point locks are devices which secure facing points in the correct position.

Network Rail company standard NR/L2/SIG/11201/Mod A5-5 'Signalling Design Handbook: Signalling Control Centres', defines the requirements for levers in such a situation: they should have information on them describing their function (section 5.1); they should be described on the layout diagram in the signal box (section B1.4); and where they are worked to maintain the locking they should be painted white at the top and the colour associated with their original function at the bottom (section B1.9). At Bognor Regis, the former facing point lock levers were still painted all-over blue, badged with their previous function with small tape labels added, and were not described on the signal box diagram.

It was apparent from witness evidence that the function of the former facing point lock levers, and the reasons why they had to be worked, were not understood by some of the signallers at Bognor Regis. The obsolete labelling and lack of description of the levers may have contributed to this.

Example of the labelling on the blue facing point lock levers in Bognor Regis signal box.
