Preliminary assessment of the explosion resulting in damage and abandonment of the potting fishing vessel *Galwad-Y-Mor* (BRD116) 22 nautical miles north of Cromer, Norfolk on 15 December 2020

NARRATIVE

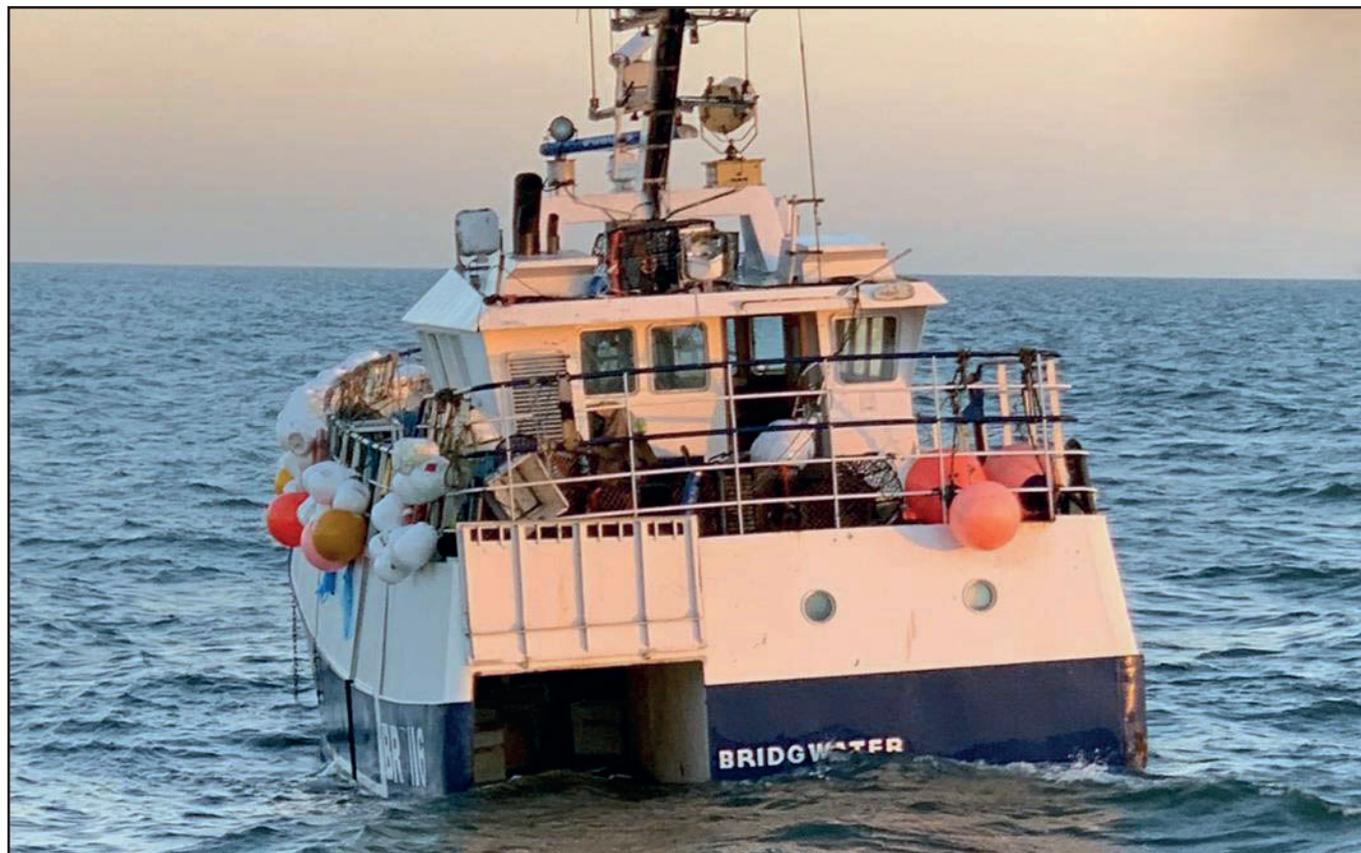
Although the liferaft had been manually activated, all crew members were initially rescued by the offshore support vessel, *Esvagt Njord*, then transferred ashore to hospital by helicopter and lifeboat. The abandoned *Galwad-Y-Mor*, which had settled low in the water (**Figure 2**), was towed to Grimsby by the tug, *GPS Avenger*, then lifted out of the water.

Figure 2: *Galwad-Y-Mor*, low in the water, after the abandonment

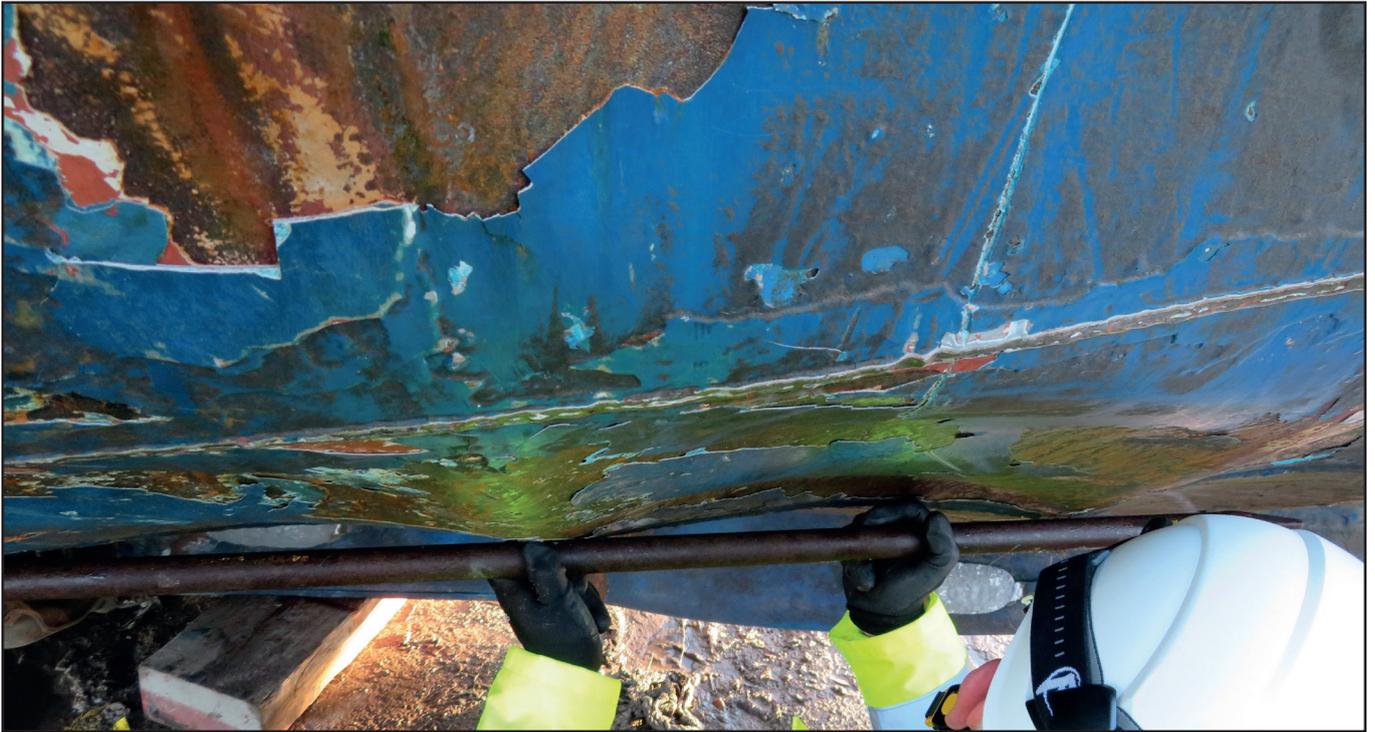
- Extensive shell plating indentation between frames (**Figure 3**)
- Shell plating ruptures and shearing of a seawater suction
- Main engine displaced from bedplate
- Widespread and significant levels of destruction of the wheelhouse (**Figure 4**) and other internal compartments
- Buckling of internal bulkheads and warping of decks
- Widespread damage to upper deck fittings.

Figure 3: Detail of shell plating damage showing coating loss and indentation between internal frames

While recovering crab pots using its hauler, *Galwad-Y-Mor* was extensively damaged and serious injuries were inflicted on the crew by an explosion. The explosion was in the water and external to the vessel. There was nothing that the crew could have done to prevent the accident. The source of the explosion has not been determined, but it was possible that old munitions on the seabed were disturbed as the vessel hauled its pots. Although extensively damaged and flooded, it is almost certain that *Galwad-Y-Mor* stayed afloat because the bulkheads either side of the engine room maintained their watertight integrity, containing the flood.

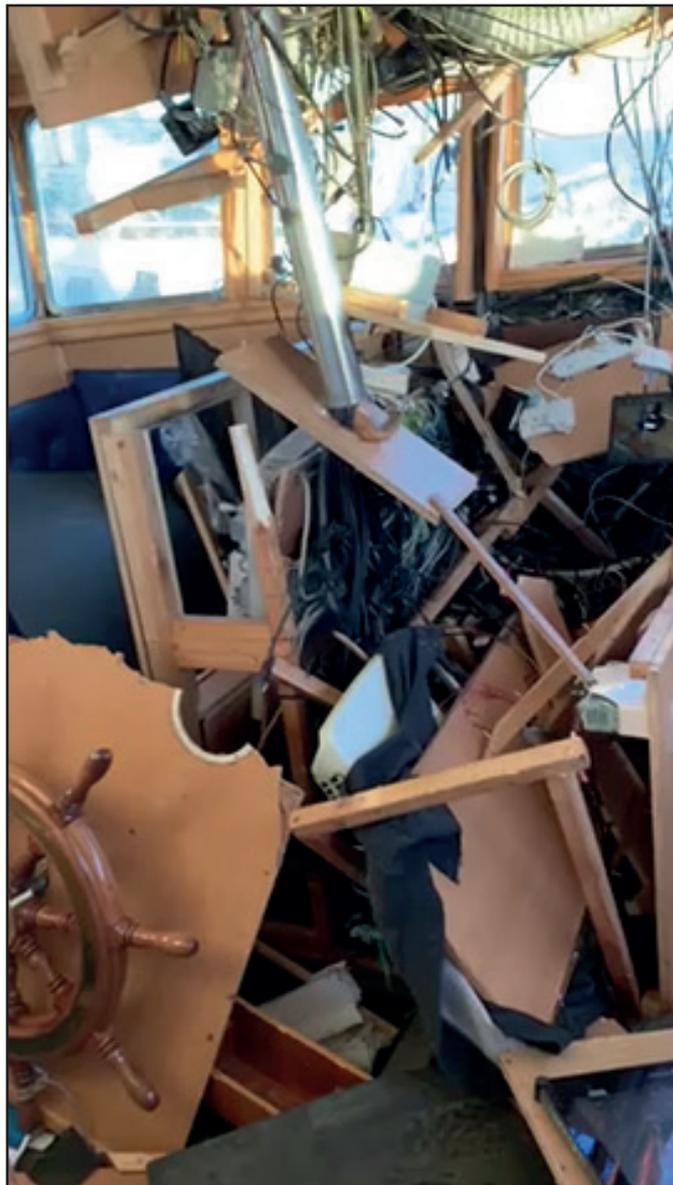
Figure 4: Wheelhouse destruction by shock damage
