Interim report on the investigation of the failure and snapback of the towline of *Svitzer Mercurius*, resulting in damage to wheelhouse windows and injury to the crew, Southampton Container Terminal, England on 22 December 2019

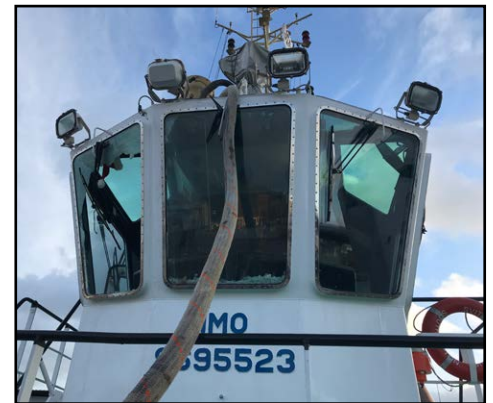
On Sunday 22 December 2019, the tug *Svitzer Mercurius* was secured to the stern of *CMA CGM Marco Polo* for berthing at Southampton Container Terminal. As the containership approached the berth starboard side to, the pilot instructed *Svitzer Mercurius*'s master to provide 100% astern thrust. As *Svitzer Mercurius*'s master applied full thrust the tug's towing winch brake began to slip and the pennant, securing the tug's towline to the ship, parted.

The towline recoiled and struck the tug's starboard forward wheelhouse window, shattering it. All of the crew in the wheelhouse were struck by flying glass. Fortunately, all the crew were wearing either sunglasses or spectacles, which prevented eye injuries. Some particles of glass also impacted with two aft wheelhouse windows, causing them to crack but not shatter.
