Rail Accident Investigation Branch

Rail Accident Report

Freight train derailment at Eastleigh, Hampshire 28 January 2020

Report 02/2021
March 2021

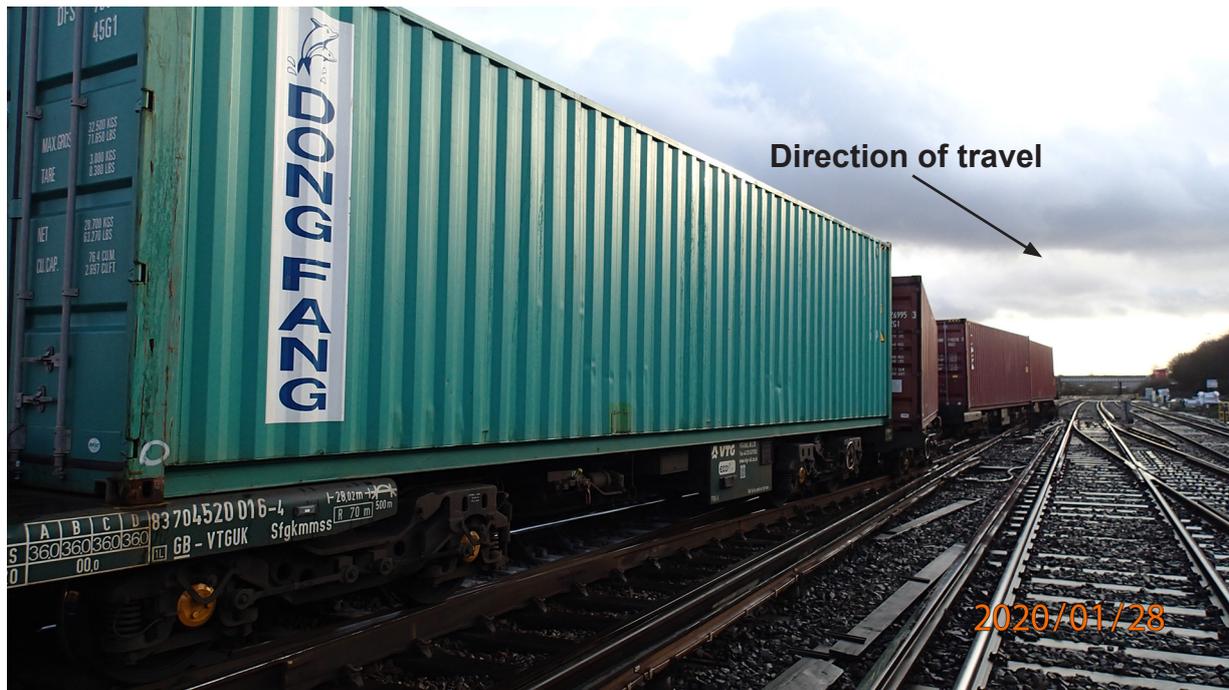
- 5 Significant damage was caused to the points at Eastleigh West Junction. The recovery of the train and infrastructure repairs caused the line to be closed for five days, and resulted in disruption to services for several weeks. The train suffered minor damage. Nobody was injured in the accident, although one member of infrastructure maintenance staff was almost struck by flying debris.

Figure 2: The derailed wagons following the accident

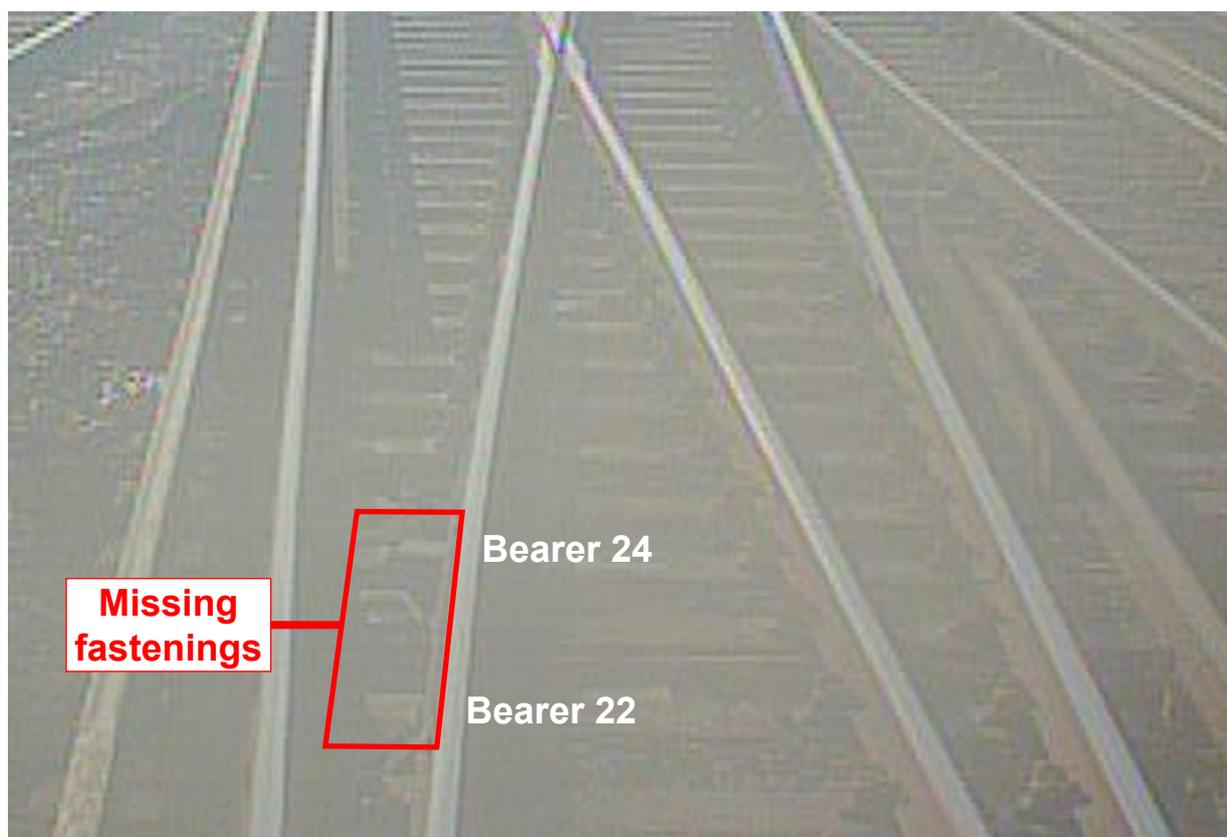
Figure 4: Forward facing CCTV from 2S27 showing three missing fastenings on bearers 22, 23 and 24 (image courtesy of South Western Railway)

- 41 Forward facing CCTV from train 2S27 confirmed that three of the nine fastenings found to have failed after the accident were missing prior to the passage of train 4O05 (paragraph 23). These were the fastenings to the left-hand side of the closure rail at bearers 22, 23 and 24 (figure 9).

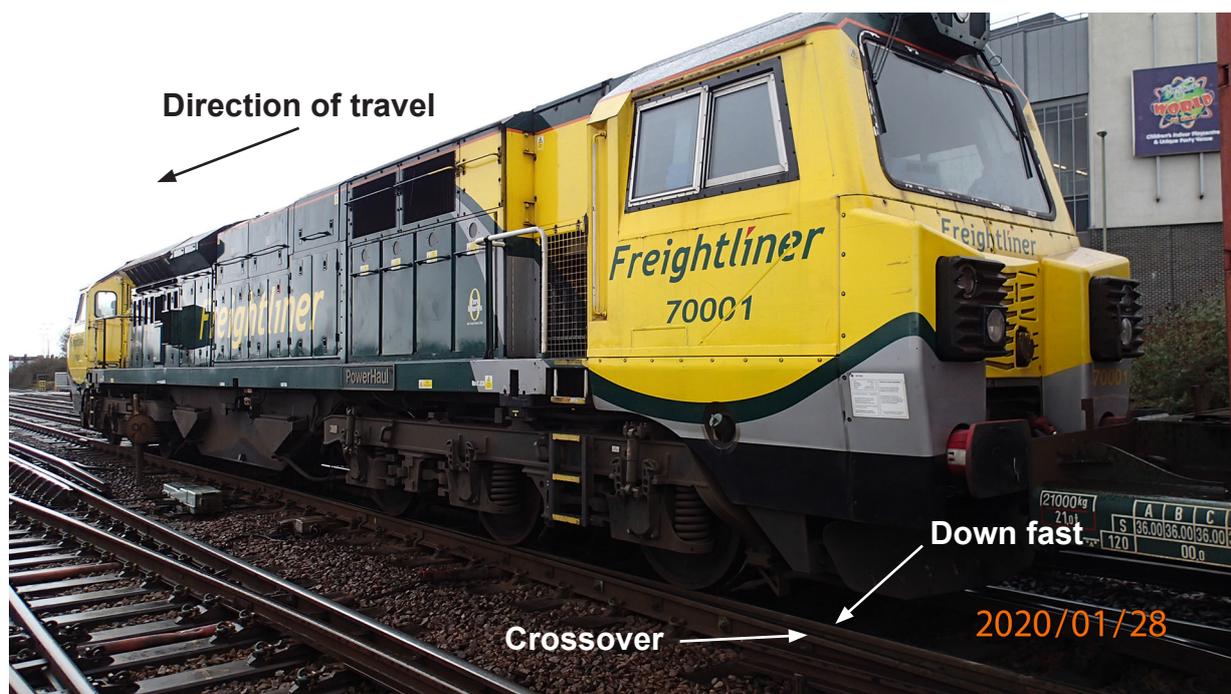
- 26 The locomotive continued to run derailed, causing damage to the track, before rereiling itself while traversing 450B points as it reached the down fast line (figure 6). The first three wagons and the fifth wagon of the train derailed on the section of track damaged by the locomotive. This caused further damage to the track.
- 27 The driver felt the train lurch as it passed over 450A points and made an emergency brake application. The train subsequently stopped with the locomotive around 90 metres beyond the point of derailment.

Figure 6: The locomotive following the derailment showing its final position with the rear bogie on the down fast

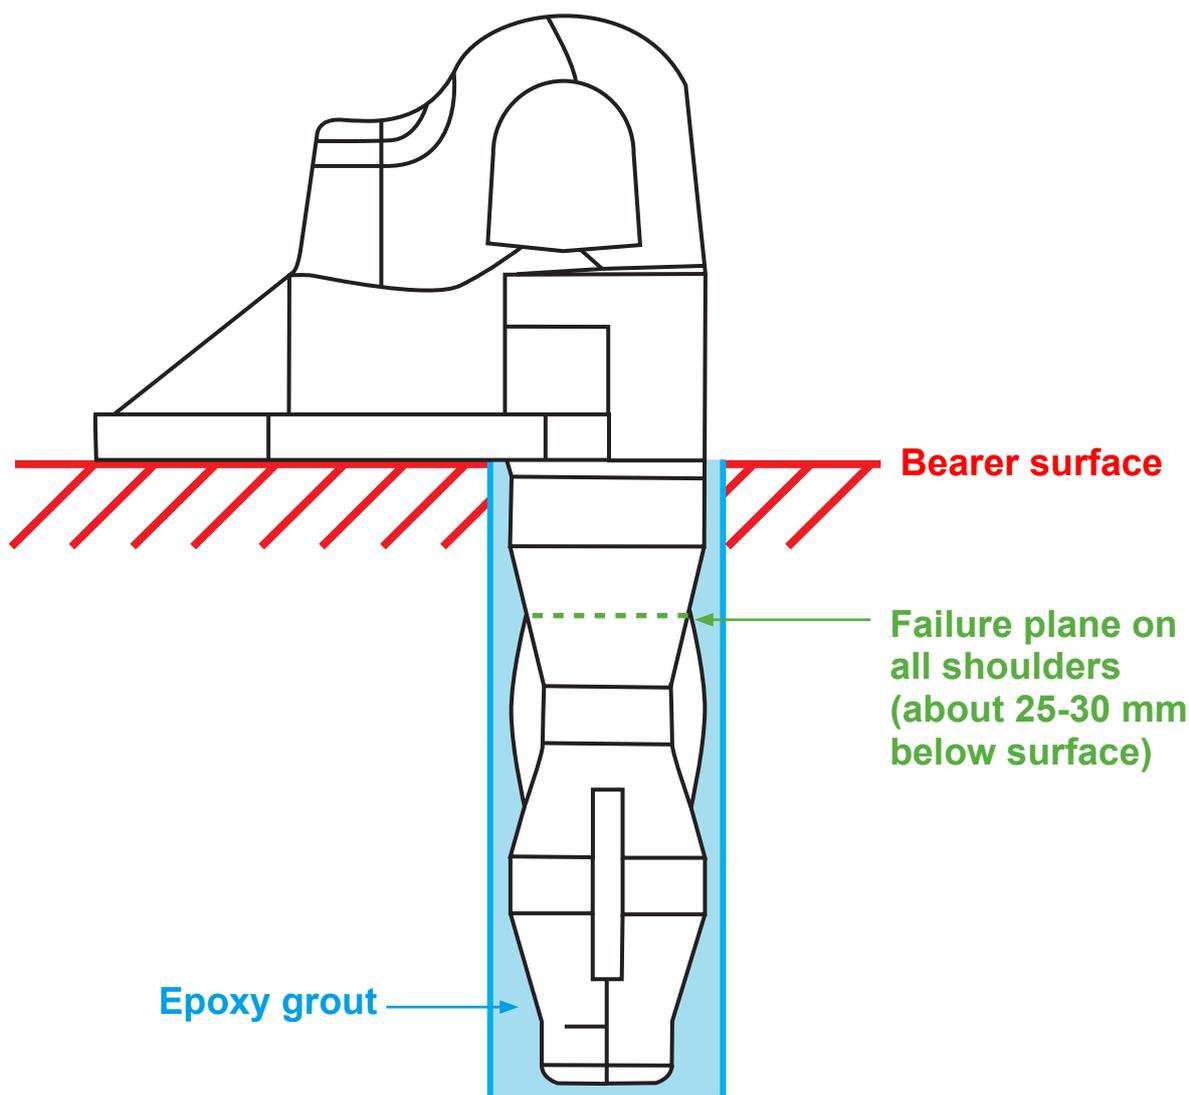
40 An examination of the fastenings which failed showed that they had all done so via a fracture through the stem of their cast iron shoulders, at a point approximately 30 mm below the surface of the bearer (figures 7 and 8). This is one of the narrowest parts of the stem in the direction of the failure.

Figure 7: Profile view of a cast iron shoulder indicating the typical plane of failure in green.

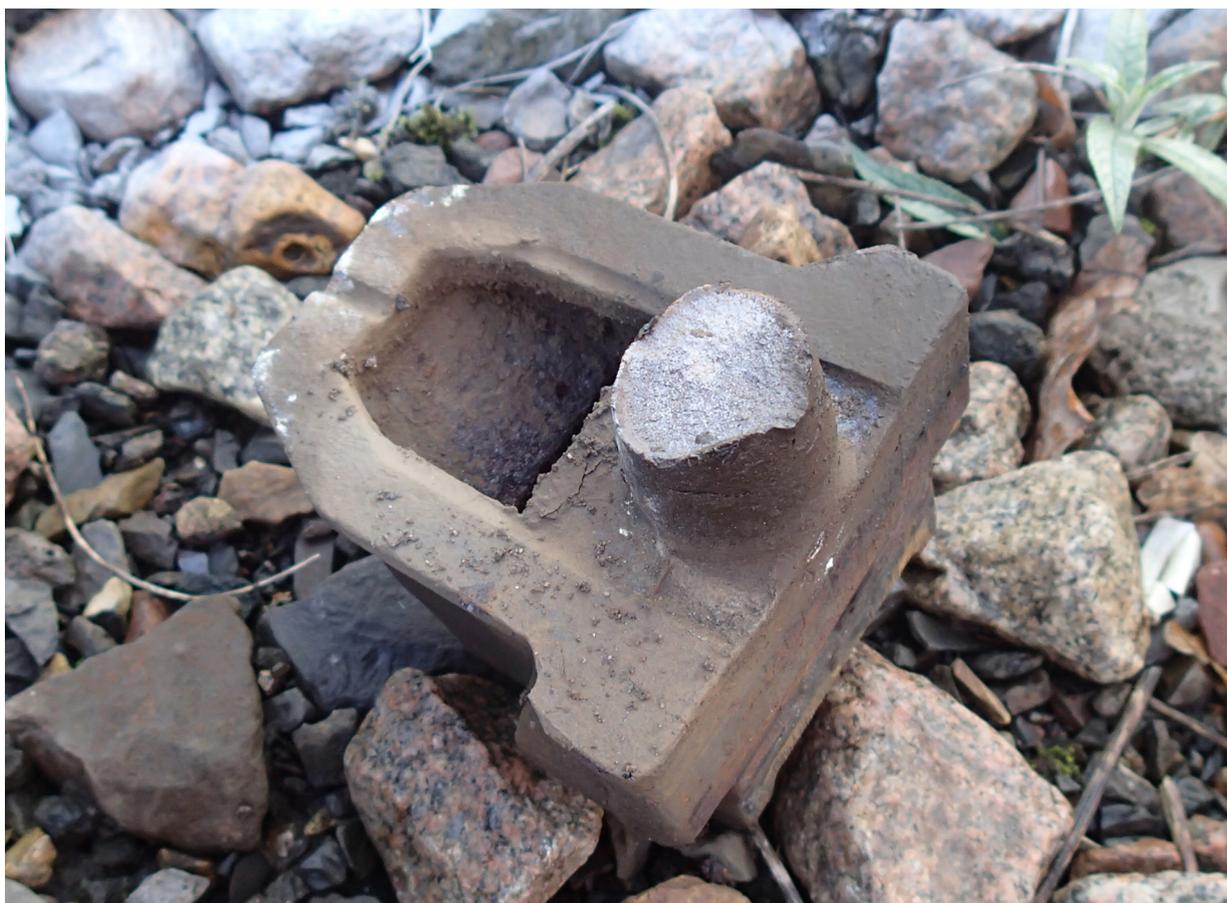
Figure 8: Photograph of one of the failed cast iron shoulders

- 47 Metallurgical analysis showed that the shoulders from 450A points that had failed in fatigue had done so prior to the derailment. While this analysis was not able to quantify exactly how long a period these failures had existed for, corrosion on the fracture faces suggested that some had been in a failed condition for at least several months prior to the derailment, while others had failed more recently. The fracturing of these shoulders would have reduced the capacity of the track fastening system to maintain the required track gauge.
- 48 This causal factor arose due to a combination of the following:
- The design of the track fastening system made the cast iron shoulder stem more prone to fatigue failure under high lateral forces (paragraph 50).
 - Routine maintenance inspections were not capable of detecting and addressing broken shoulder stems (paragraph 58).

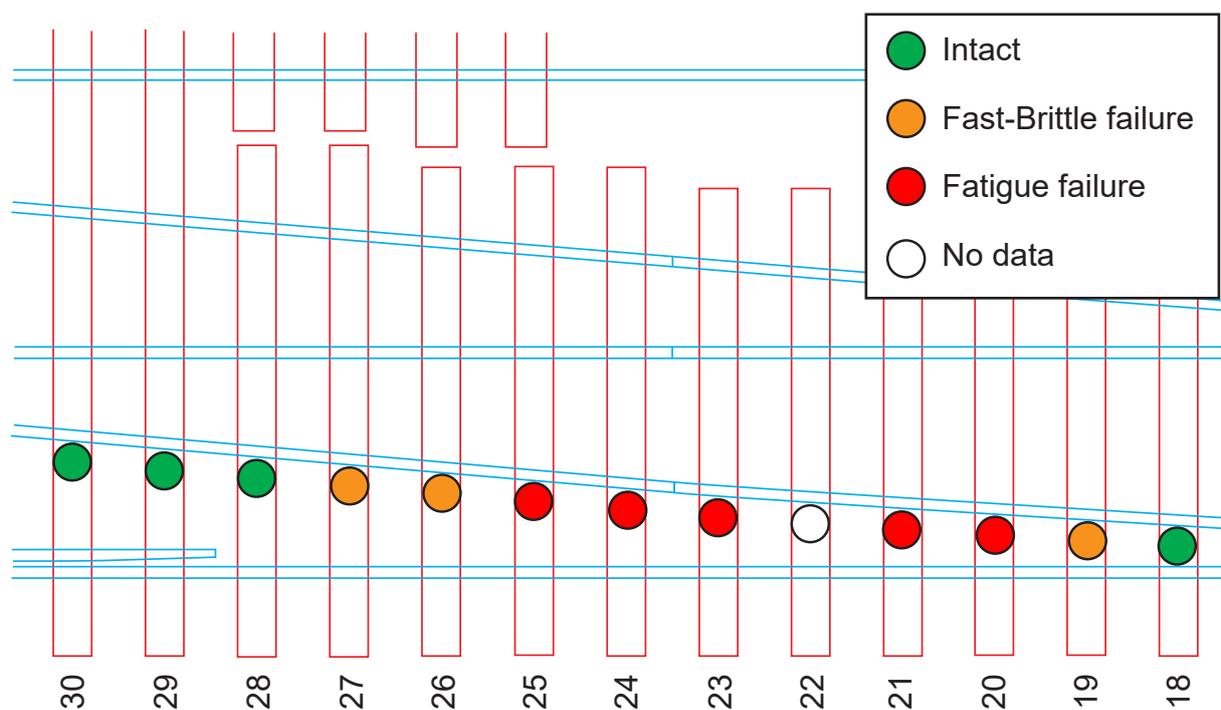
- 43 An independent metallurgical inspection was commissioned by Network Rail on a sample of four of the fractured shoulders from 450A points, and the four found on the ground nearby. This inspection, combined with other analysis commissioned by Network Rail, showed that three of the shoulders from 450A points had failed in a fast-brittle manner (see paragraph 81), whereas the others had been subject to a fatigue failure (see paragraph 47). It is probable, given the failure mode of the surrounding shoulders, that the missing shoulder from bearer 22 was also subject to a fatigue failure (figure 9). This meant that six consecutive shoulders, from bearers 20 to 25 inclusive, were probably fractured along the left-hand closure rail prior to the derailment.

Figure 9: Plan view of the area of derailment, highlighting the shoulders subject to a fatigue (red) or fast-brittle (orange) failure, or were intact (green). The shoulder on bearer 22 (white) could not be positively identified, but probably also failed in fatigue.

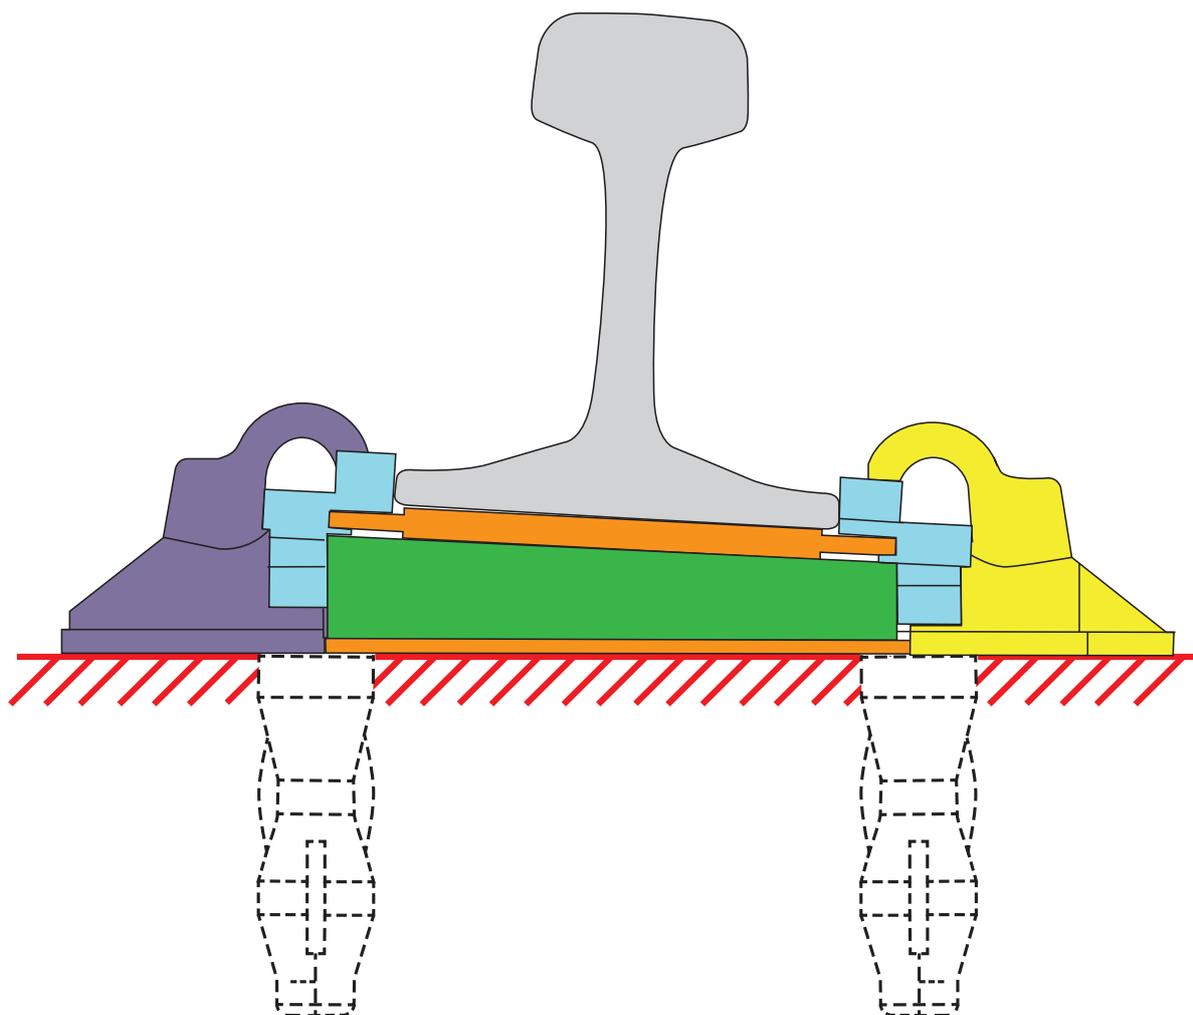
- 52 It is the need to accommodate these different elements that led BBRE to use an elevated type of shoulder as part of its modified track fastening system. In this design, the base of the rail abuts the insulator (blue in figure 10) on the outer shoulder (purple) at a nominal height of 48 mm above the top of the bearer. In comparison, this height would normally be around 10 mm on most railway sleepers used in the UK. This increase in height resulted in an elevated loading point and a significant increase in the bending forces applied to the shoulder stem under lateral loads.

Figure 10: Cross section of a BBRE RT60 layout highlighting the cast iron wedge (green) and elevated shoulder (purple).
