SAFETY FLYER TO THE FISHING INDUSTRY

Collision between the fishing vessel *Vertrouwen* and the recreational motor cruiser *James 2* resulting in the sinking of *James 2* and loss of 3 lives at Shoreham-by-Sea on 6 August 2017

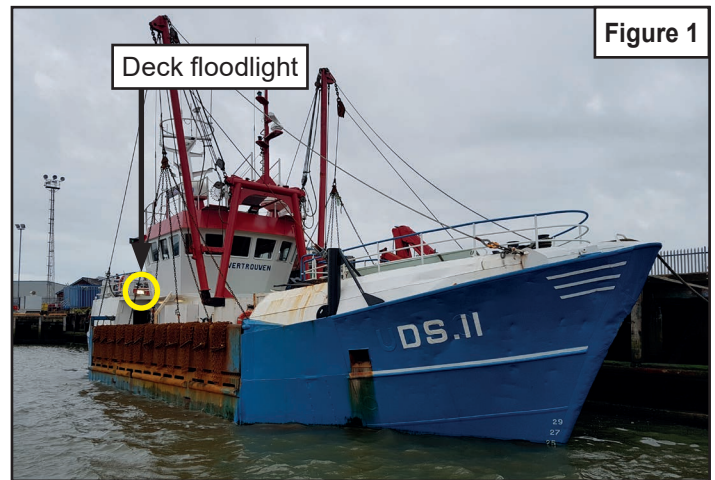
At 0026 on 6 August 2017, the 26.24m commercial fishing vessel *Vertrouwen* (**Figure 1**) collided with the 5.64m recreational motor cruiser *James 2* in Sussex Bay, 1.6 miles south-east of Shoreham harbour. Both vessels were undamaged by the impact but *James 2* was swamped by *Vertrouwen*'s wash and sank. Three of the men on board the motor cruiser drowned; a fourth was rescued from the water 5 hours later by a passing fishing vessel. *Vertrouwen* had just left port and was on passage to Grimsby; *James 2* was drifting with the wind and tide while the four men on board were rod fishing for mackerel.

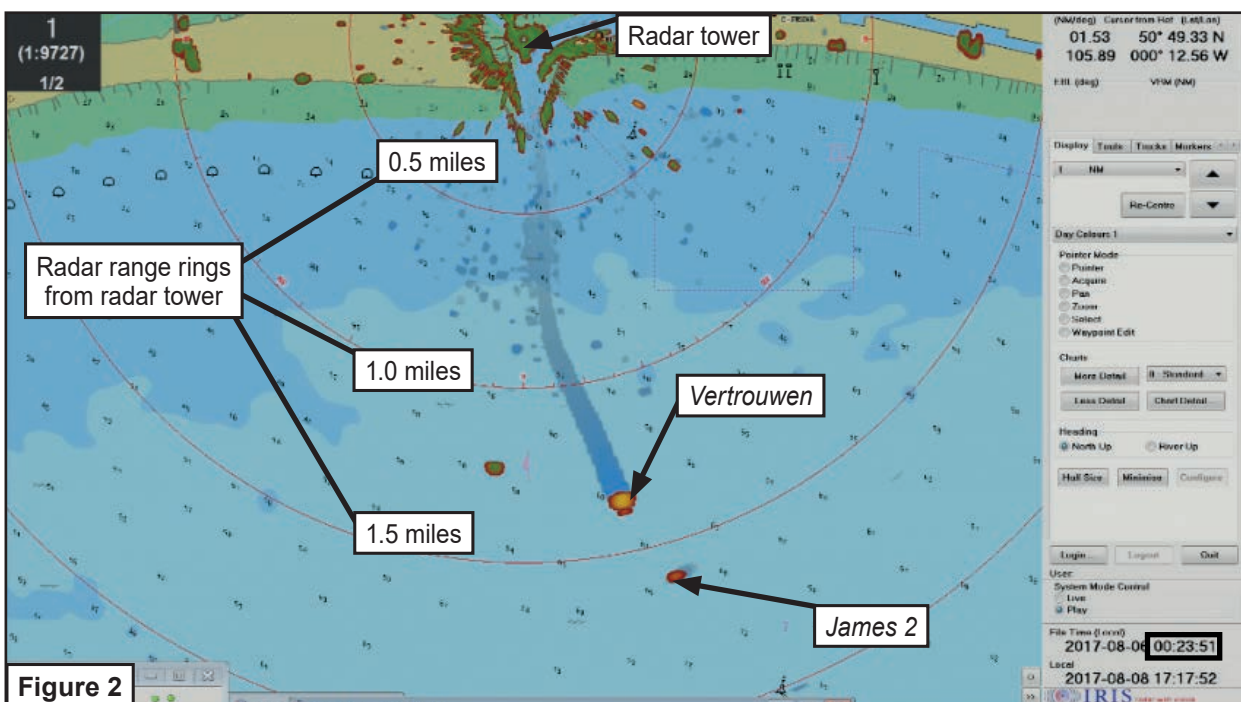
The collision occurred because *Vertrouwen*'s lone watchkeeper did not see *James 2* either visually or by radar and, by the time the sea anglers realised they were in danger of being run down, they were unable to get out of the way. That night, visibility was very good and the sea was calm, but *James 2* might not have been visible from *Vertrouwen*'s wheelhouse because the motor cruiser was not showing a masthead light and sternlight, or an all-round white light. *James 2* was almost stationary, but was presenting a strong echo on the port authority's radar (**Figure 2**) and *Vertrouwen* had two newly installed radars that were operating on the 6-mile range scale.

- *James 2* was presenting a good radar echo and should have been identifiable on *Vertrouwen*'s radar screens. However, *Vertrouwen*'s skipper was not systematically checking the radar picture. Further, *James 2* would have presented a small, stationary close by target that might have been hard to detect on a 6-mile range scale.

2. Radars are an effective aid to navigation that can supplement a visual lookout. However, to be effective, the selection of appropriate range scale and the use of target plotting are critical.

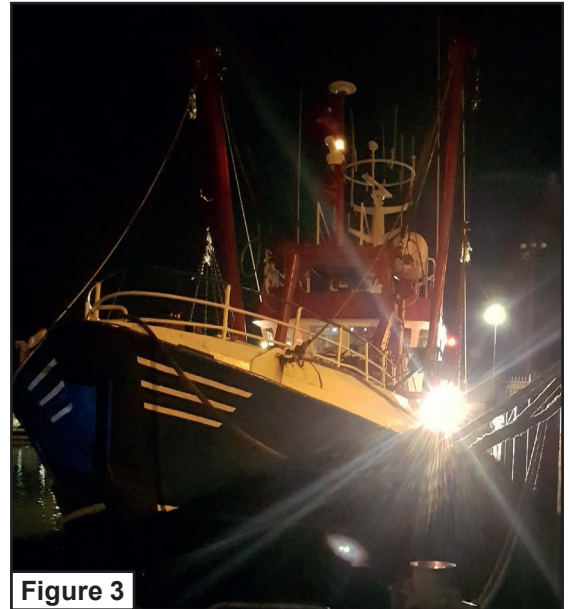
Figure 3

Vertrouwen was displaying the correct navigation lights for a vessel of its size, but in addition, its forward-facing dredge deck floodlights (**Figure 3**) on both sides of the vessel were switched on. Also, just prior to the collision, and for a while afterwards, the skipper was engaged with his mobile phone using social media. At the time of the collision he was using a laptop facing aft to compose his E-log departure report.

- The brightness of *Vertrouwen*'s illuminated deck floodlights would have impaired the lone watchkeeper's night vision and, when observed from ahead, would have made its navigation lights less distinguishable to other vessels.

3. At night, deck lights will create backscatter from deck equipment and housings that can impair a lookout's night vision. They can also mask navigation lights and so confuse observers from other vessels. Deck working lights should only be shown when absolutely necessary, and should be switched off at all other times.
