SAFETY DIGEST

**Lessons from Marine
Accident Reports
1/2021**

SAFETY DIGEST
Lessons from Marine Accident Reports
No 1/2021

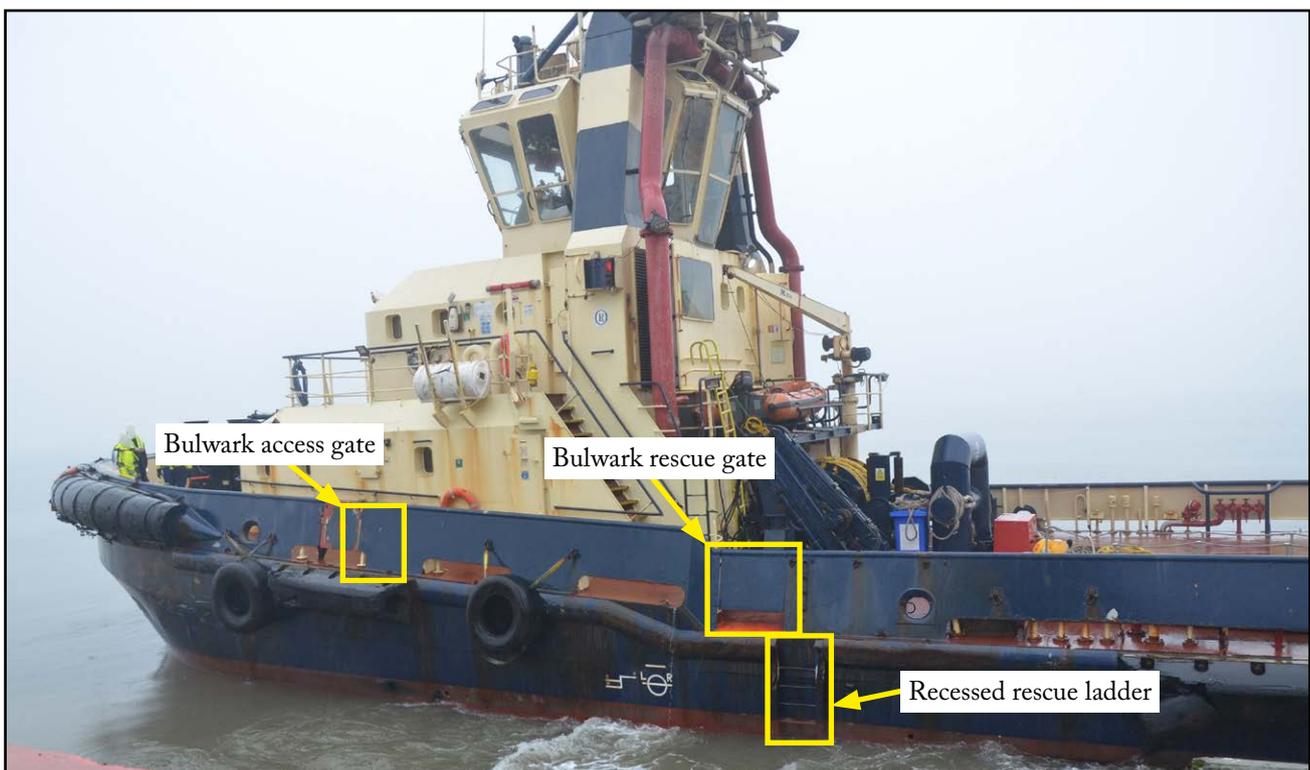
Figure 1: Tug and its access doors

It was subsequently found that it had become a standard practice to use the quay's fenders to step on and off tugs, and that the terminal had facilitated this by painting them with non-slip paint.

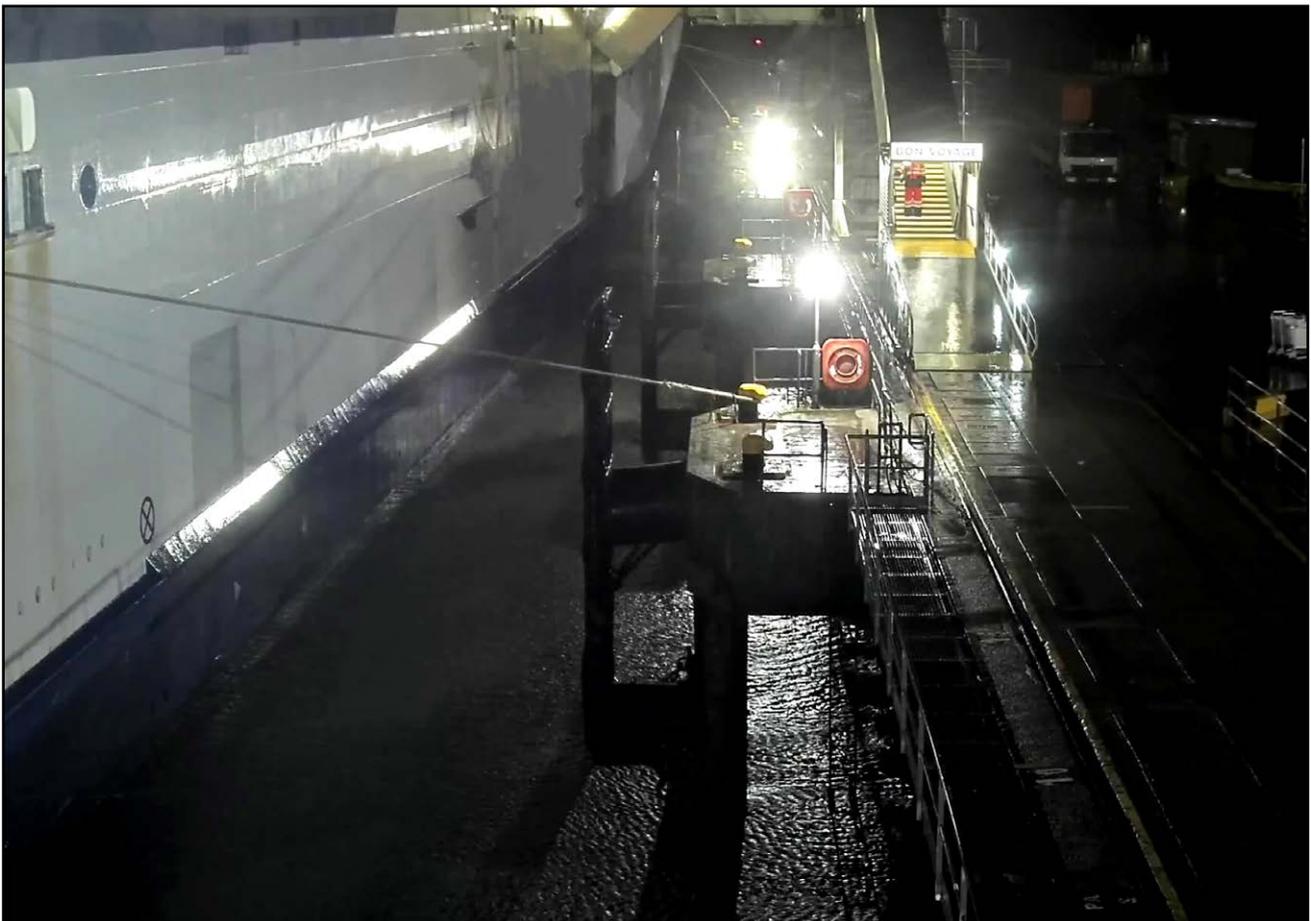
Figure 2: Spring paying out and gangway falling into water

3. The sliding gangway section had a minor defect that meant two doors had to be tied to the ship while the gangway was in place. As the ship moved away from the jetty, these ties prevented the gangway operator from disengaging the gangway and led to it falling into the water. Some seemingly minor defects can have major consequences – think carefully before putting off maintenance.

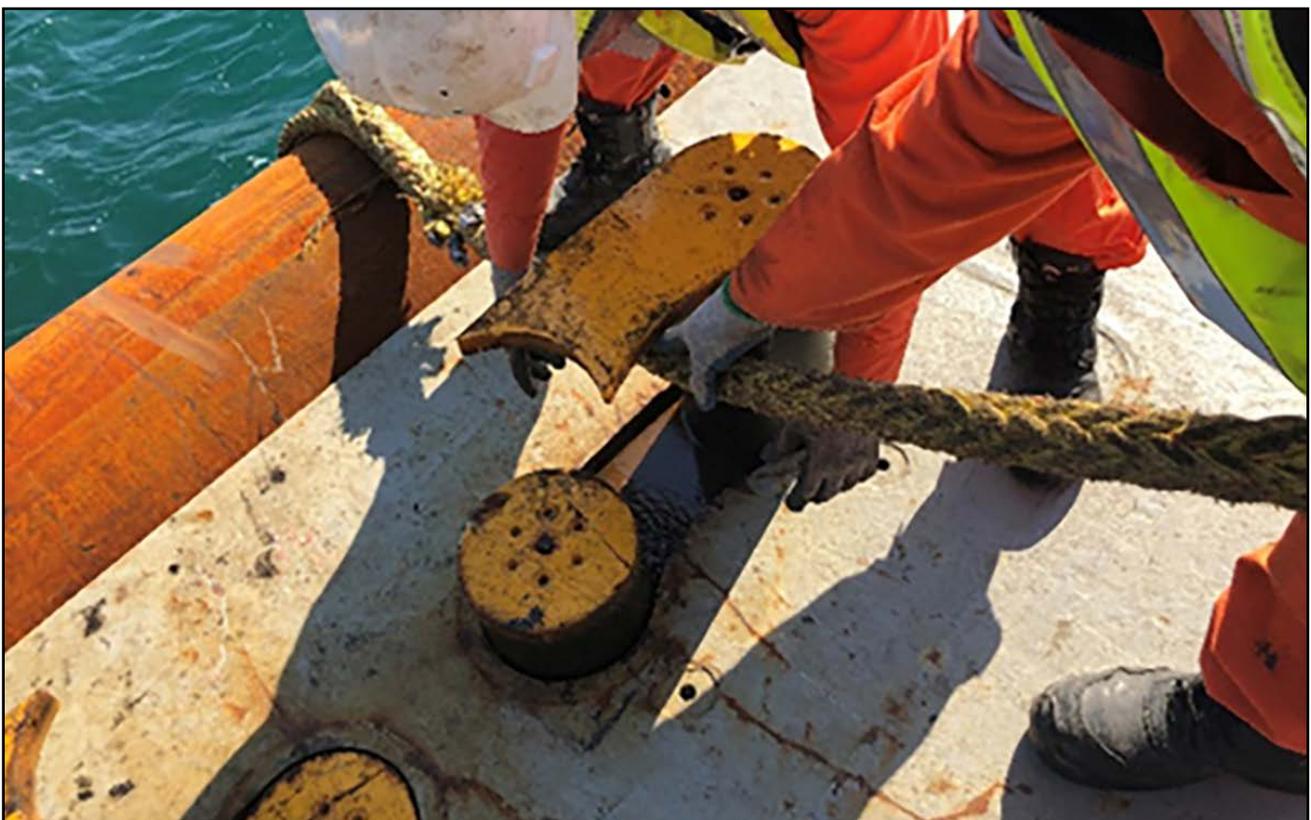
As the stretcher was being manhandled into place, it rapidly and unexpectedly came under tension, crushing the hand of one of the crewmen under the top plate of the hydraulic deck pin (Figure 2). The crewman suffered a serious hand injury requiring hospital treatment.

Figure 2: Reconstruction of the two crewman working on deck illustrating how the hand injury occurred

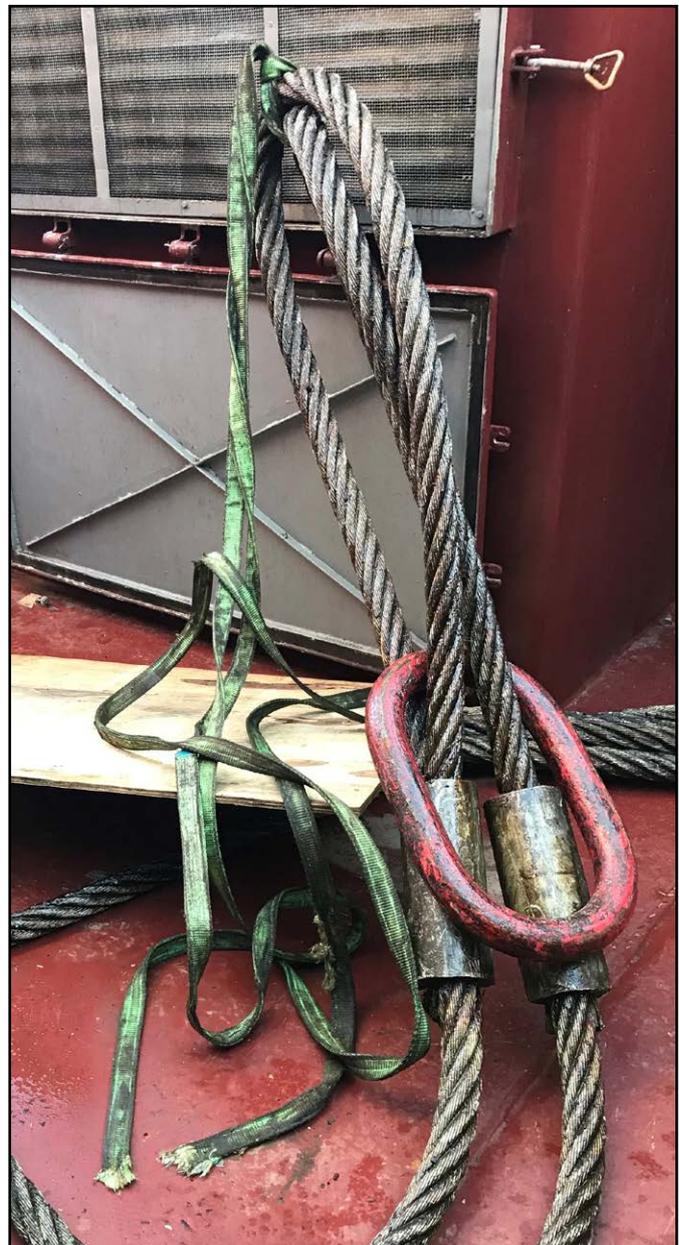
4. All fixed and loose lifting gear should be regularly inspected and documented. The purpose of inspections is to check that the gear is being maintained in a satisfactory condition for safety-related operational use. After the accident, it was discovered that the fibre sling in use was in a poor condition (Figure 2) and had not been recorded in the vessel's lifting gear log. Although the breaking load of the sling was sufficient to hoist the lifting gear, it should have been disposed of due to its poor condition.

Figure 2: The broken fibre sling, still attached to the lifting gear, after the accident

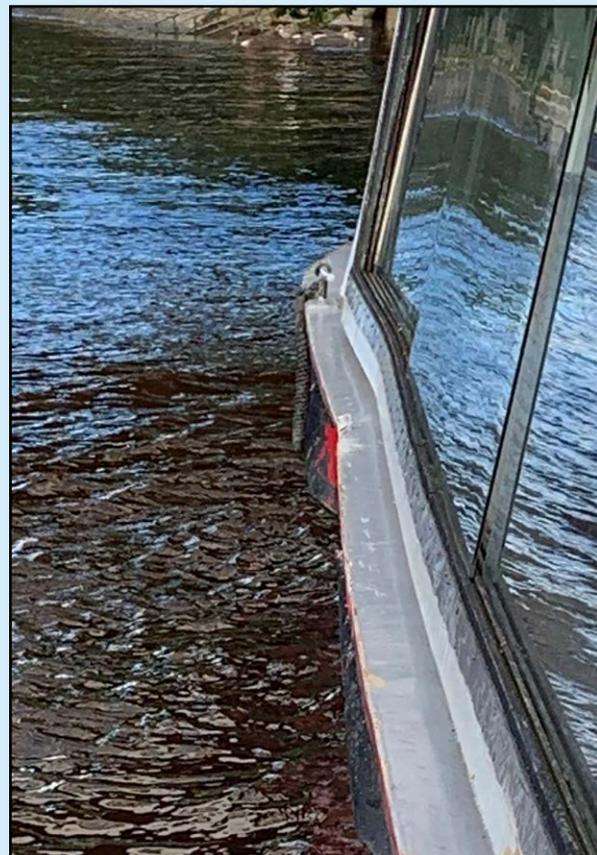
As the vessel's heading was being reversed close to the bridge, it was swept sideways towards one of the bridge's pillars by the combined effect of the strong stream and wind. The vessel's port side made heavy contact with the bridge, resulting in a dent on the fendering (see figure). Some passengers fell over and glasses were damaged in an internal bar area, however there was no injury.

Figure: Damage to the passenger vessel's port side after the contact with the bridge

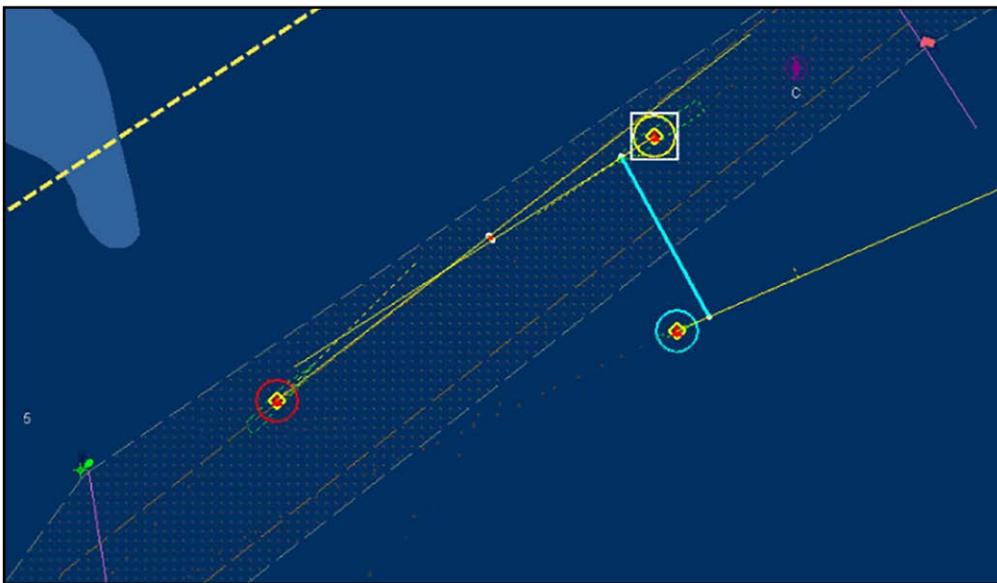
Soon afterwards the pilot on the inbound bulk carrier raised his concerns with VTS that the ferry's position appeared to be to the north of the channel and was likely to cause a risk of collision (Figure 2).

Figure 2: The bulk carrier pilot raises his concerns

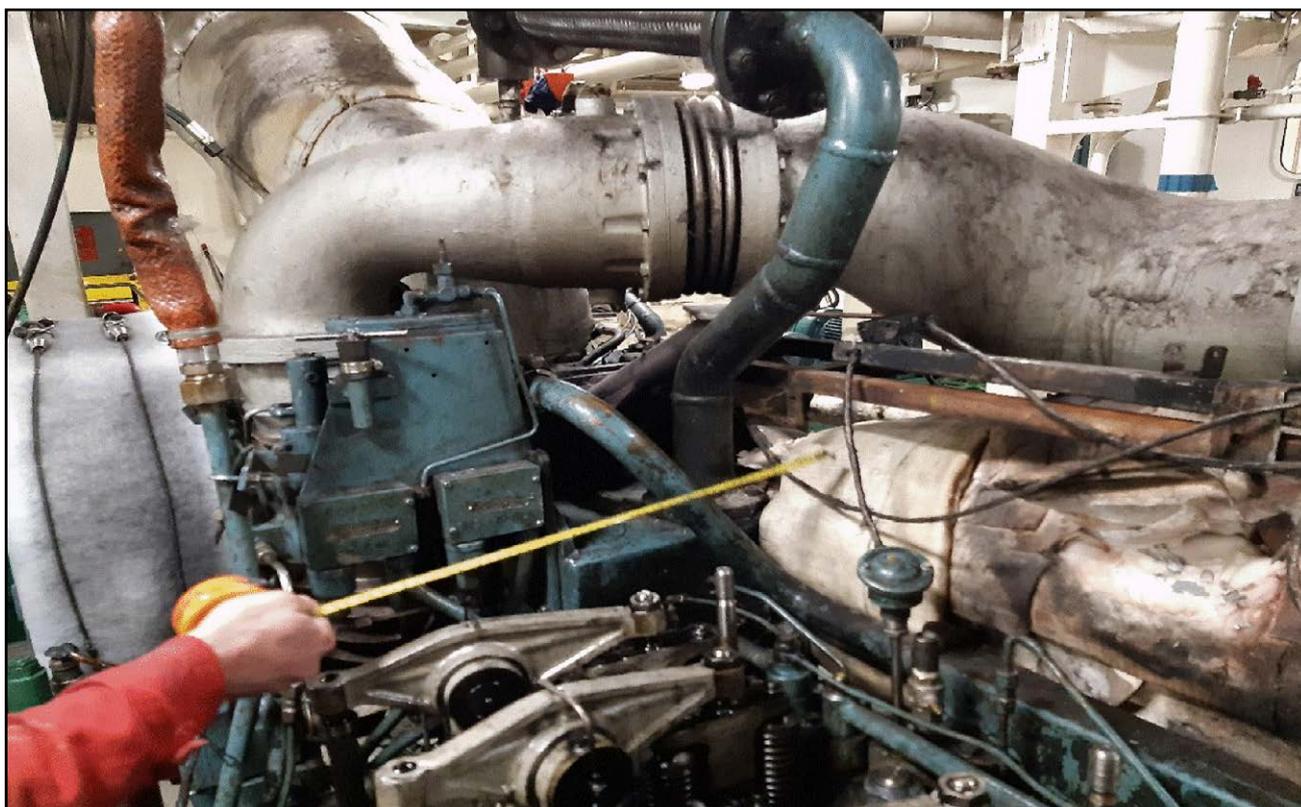
The company investigation later identified that during maintenance work on the main engine cooling system a pipe had been removed to allow a leak to be repaired by replacing a seal. This was not a planned task, and no risk assessment or method statement had been produced. When the pipe was removed, around 5 litres of water had drained from the top of the crank case breather box, and some oil residue inadvertently washed into the lagging. Main engine runs conducted alongside after the repair had not produced sufficient heat to ignite the oils. However, when the main engine was run under load at sea, the increased temperature produced was enough to cause a fire.

Figure: Location of lagging that ignited indicated

1. Whenever maintenance work is carried out around or near potential sources of heat, a risk assessment must be conducted to ensure unexpected results are considered. The working and adjacent areas should be protected from contamination – even if you expect only water to be present. If water can wash oils into places that can then become hot when machinery is running, a source of ignition can be created. In this case the crew were alert and the fire was small. This may not always be the case.
2. Even after AFFF is used, sufficient heat will cause flammable material to reignite once it gets hot enough. The crew involved in this incident were monitoring the site carefully and quickly extinguished the second fire. However, the only real solution would have been to remove the flammable material from the source of heat, which was subsequently done by removing and replacing the lagging.

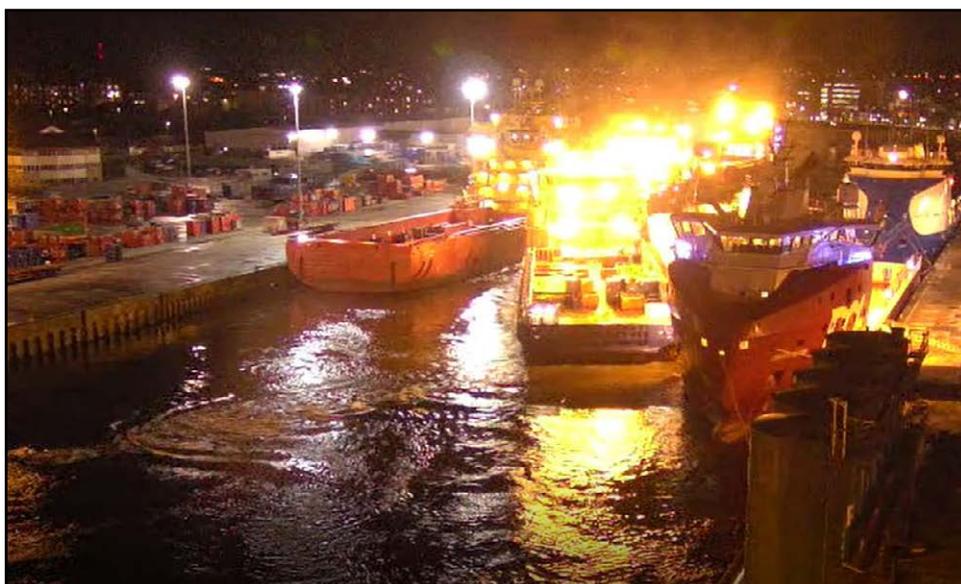
Figure 3: Loss of control and shear to port, with contact made with berthed vessels

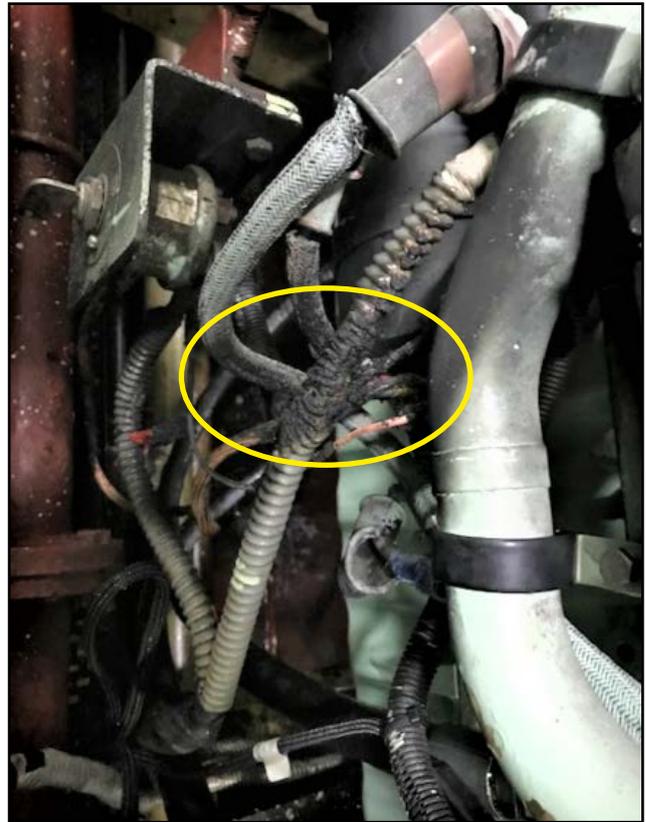
A subsequent examination of the heat damaged starter motor and cabling (see figure) identified that the electrical wiring had been incorrectly connected. On that particular engine model, some of the positive side cabling was coloured black instead of the

Figure: Heat damaged electrical cabling

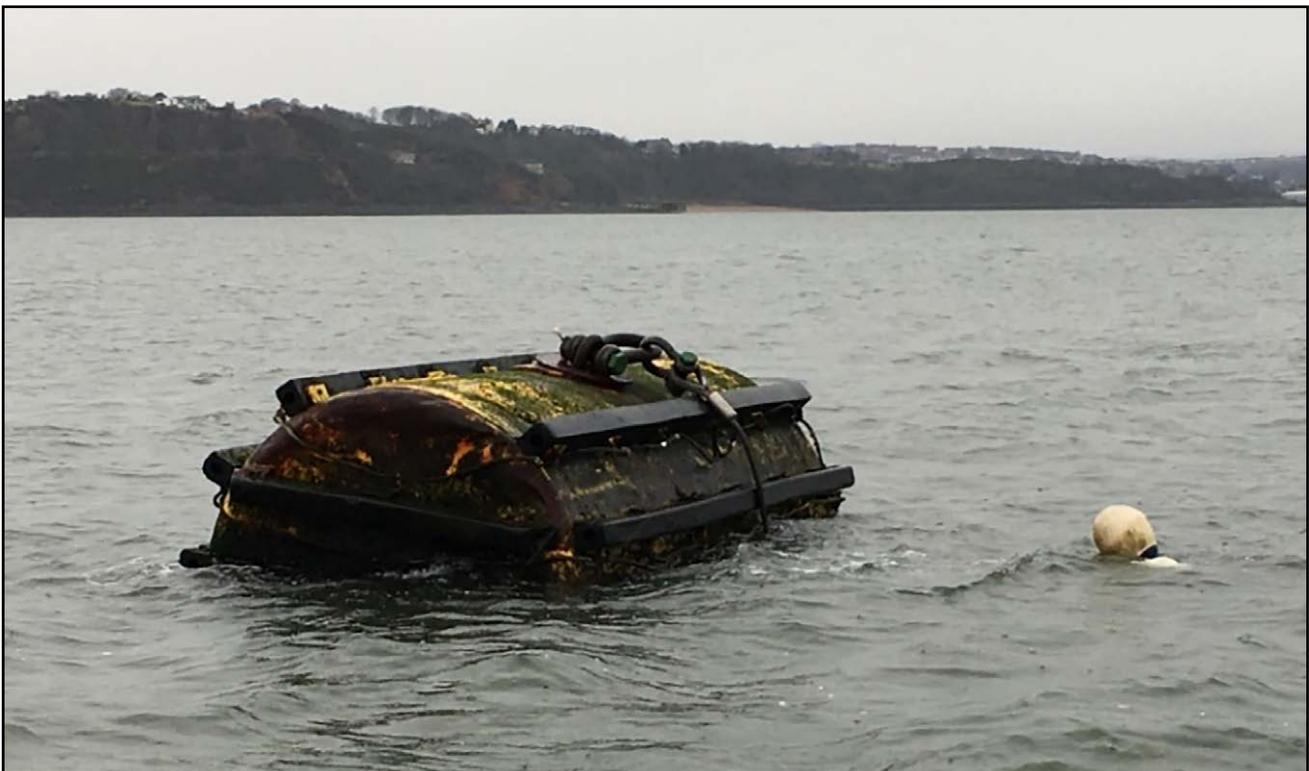
As the crew member finished rigging the searchlight, and the second crew member bent over to turn on the radar, the craft hit an unlit mooring buoy covered with heavy marine growth (Figure 1). The impact caused the bow to lift and roll to port, and the outboard engine skegs became caught on mooring pick-up lines attached to the buoy. The boat stopped instantly, propelling the forward crew member out of the boat and resulting in the crew member who was turning on the radar hitting his head on the handrail in front of him, causing a cut above his left eye.

Figure 1: Unlit mooring buoy, with significant marine growth

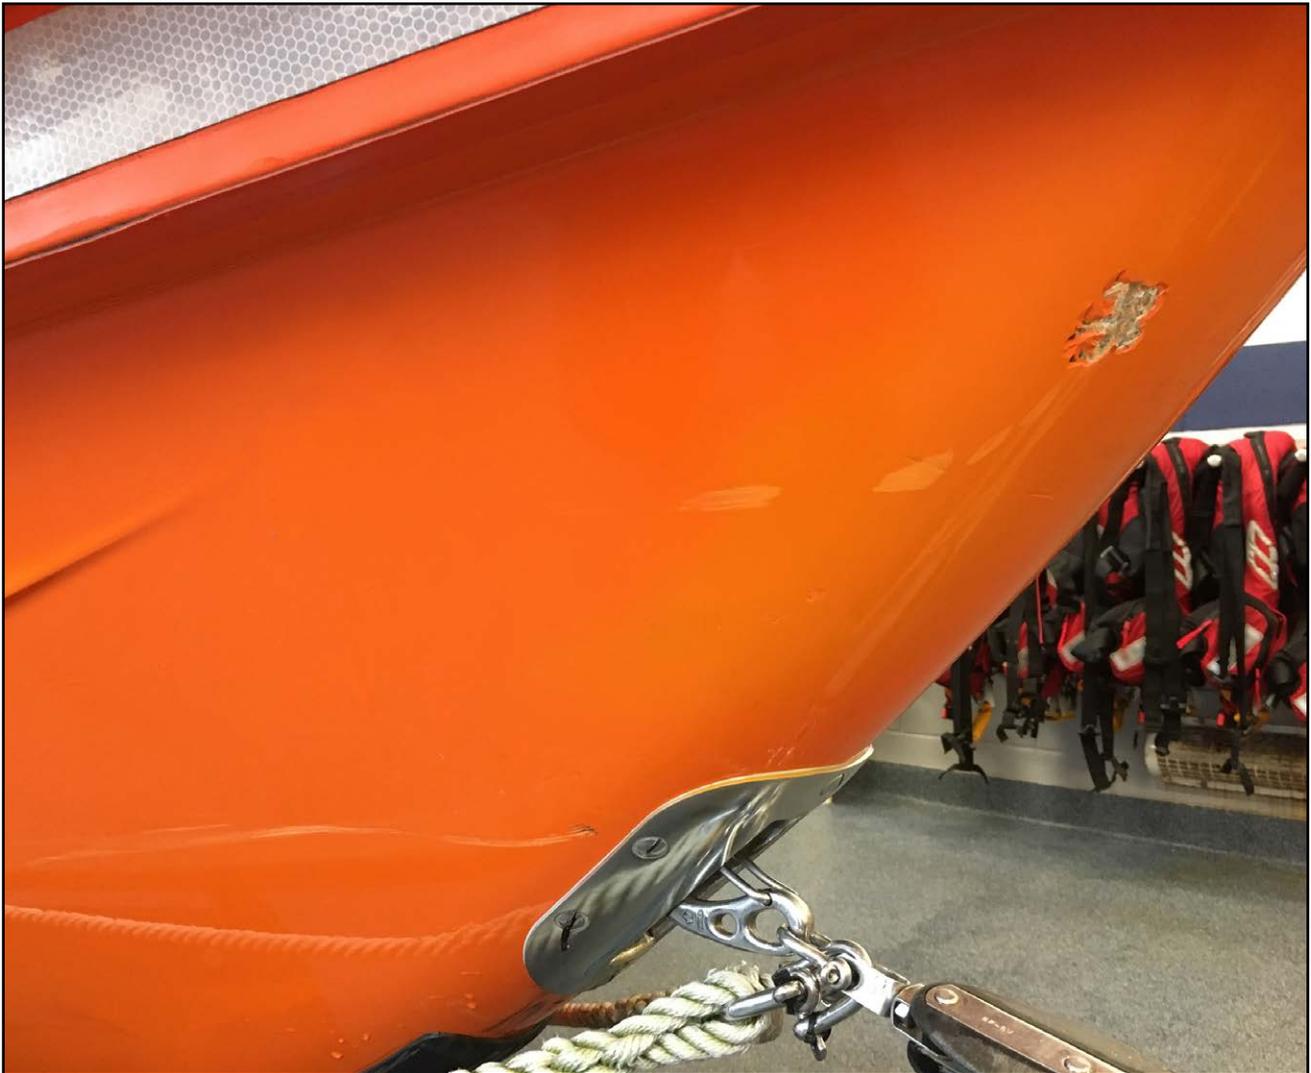
The craft returned to base and no serious injuries had been sustained. The boat was taken out of service for assessment, and after repairs to minor gelcoat damage (Figure 2) was returned to service.

Figure 2: Damage to gelcoat

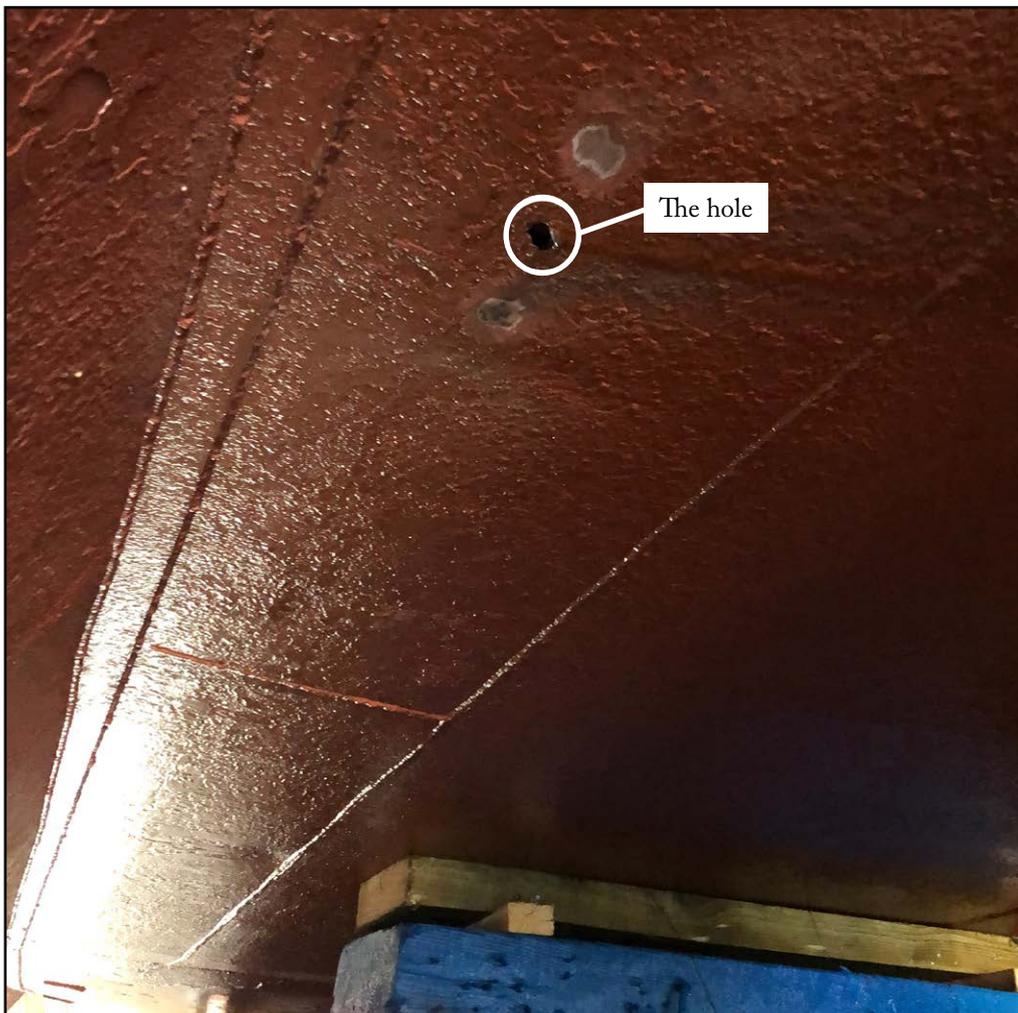
When the helicopter arrived, it lowered its powerful, petrol-driven salvage pump. Once this pump was set up and running, the situation was brought under control. As the water level reduced, the engineer was able to gain access to the fish hold's bilge well where the suctions were blocked by debris. The fishing boat then made its way safely back to harbour under its own power, escorted by the lifeboat. When the fishing boat was lifted out of the water, a 25mm diameter hole was found in the shell plating under the fish hold (see figure).

Figure: The 25mm hole in the fishing vessel's shell plating, observed when the vessel was lifted out of the water.

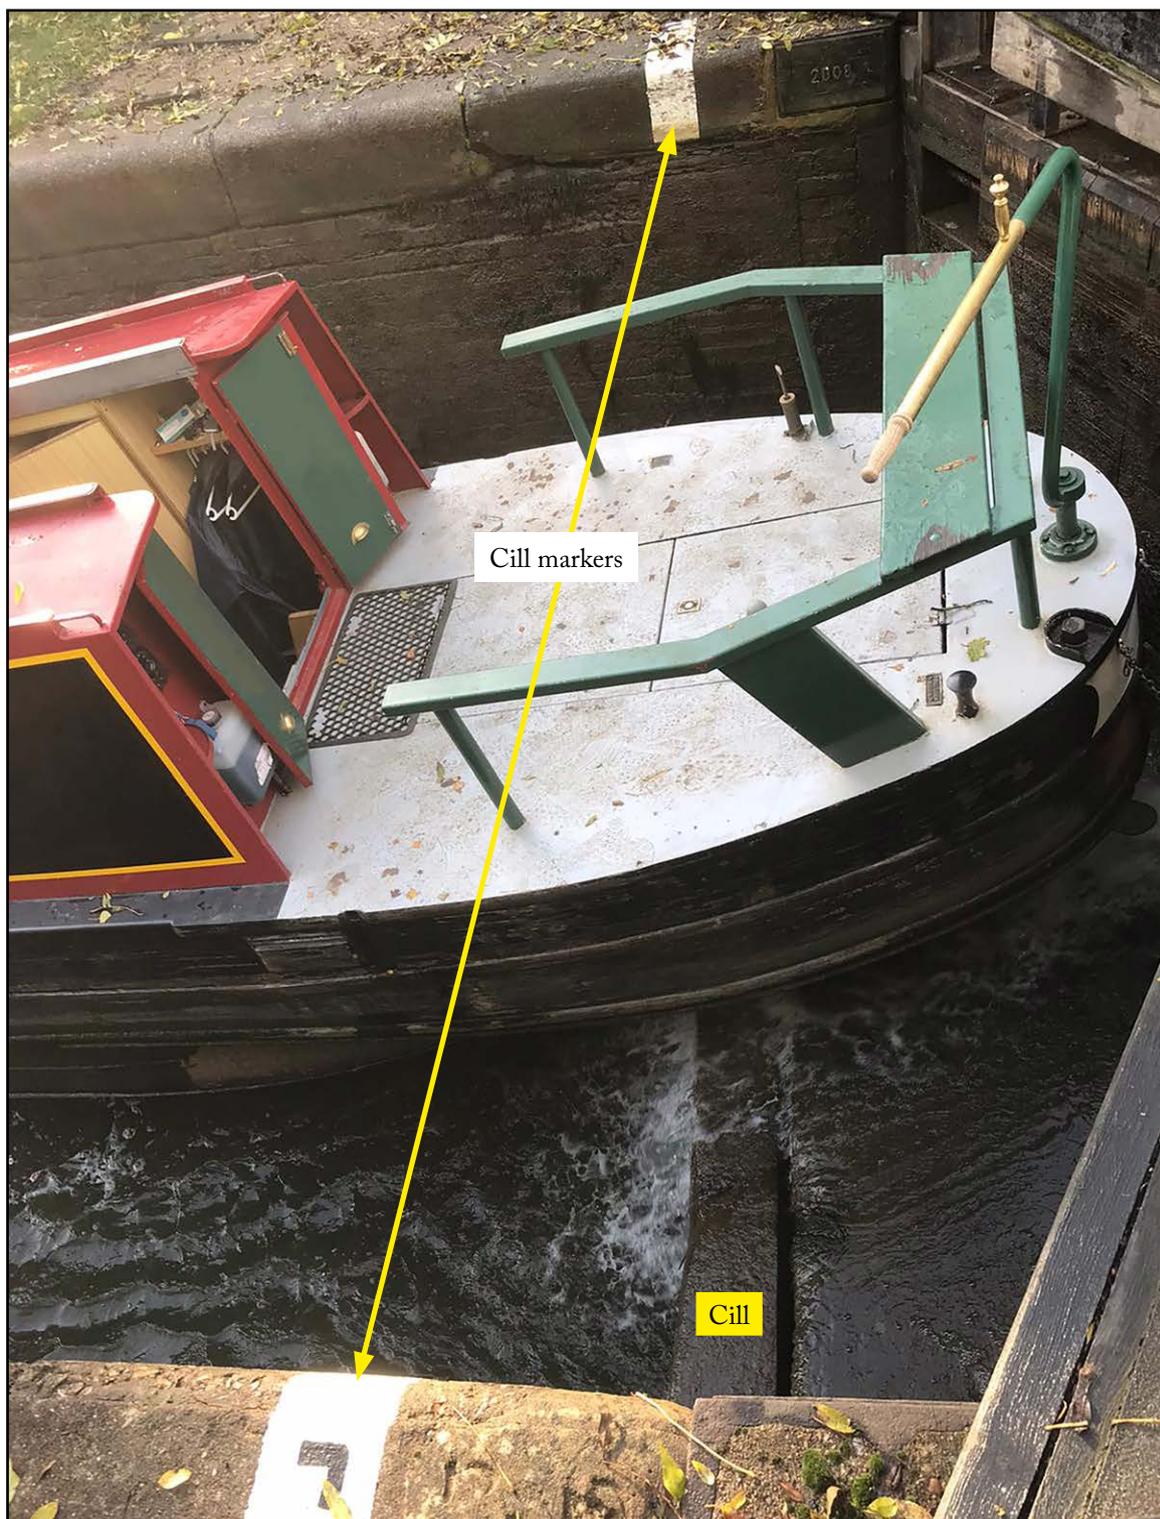
Figure 2: Hire boat's stern resting on the cill

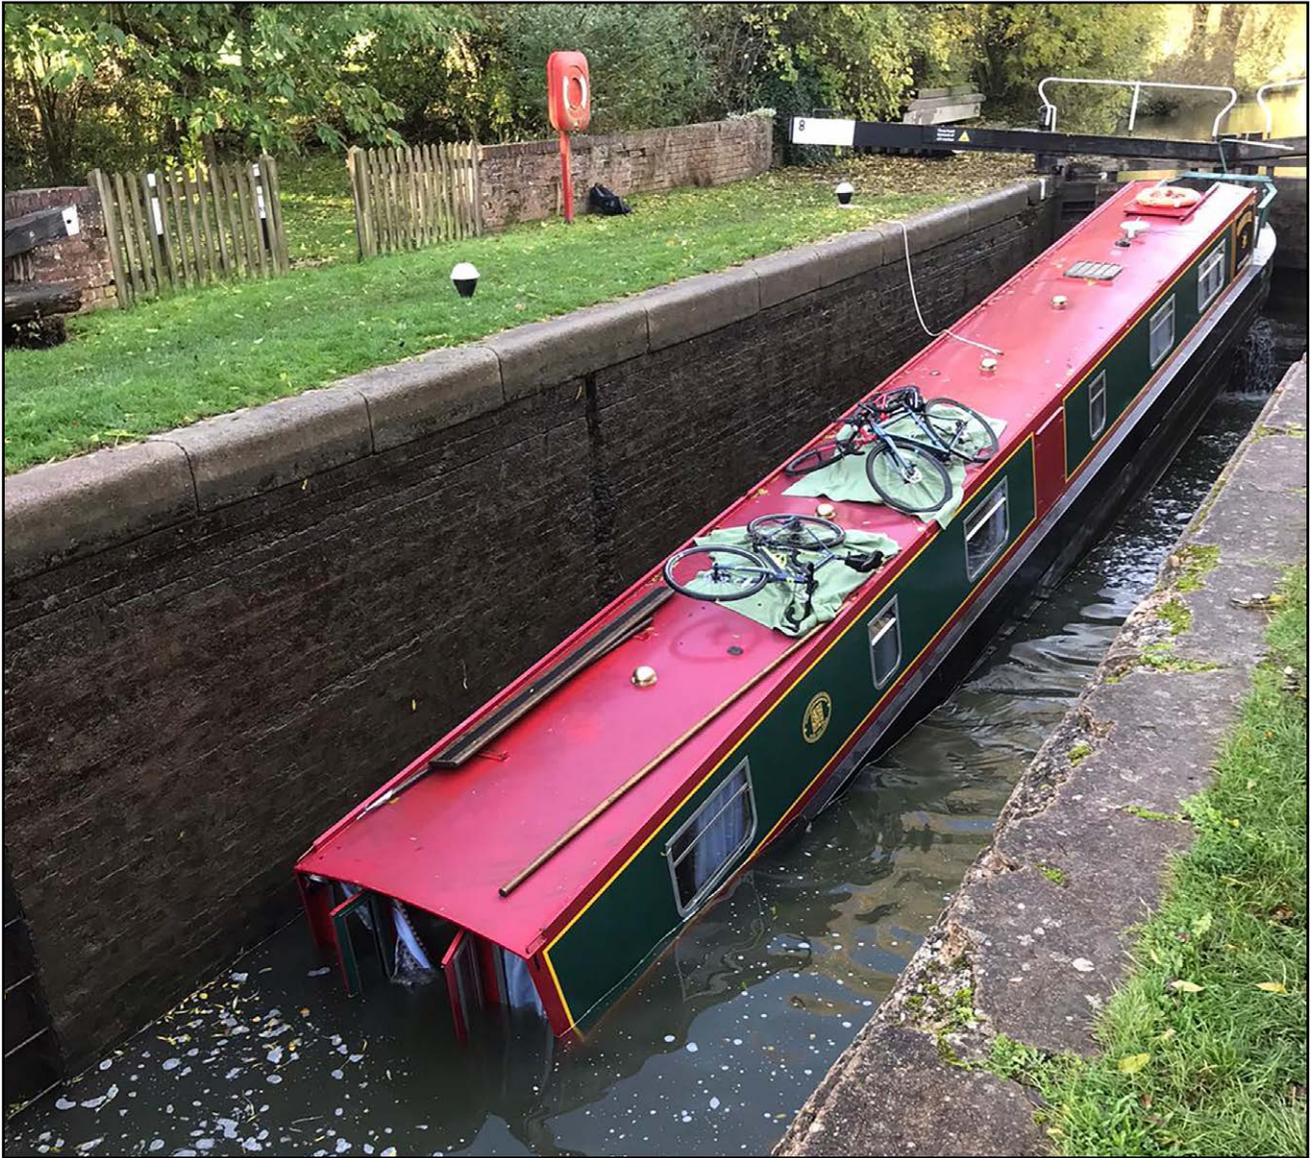
Figure 3: Hire boat's bow fully immersed

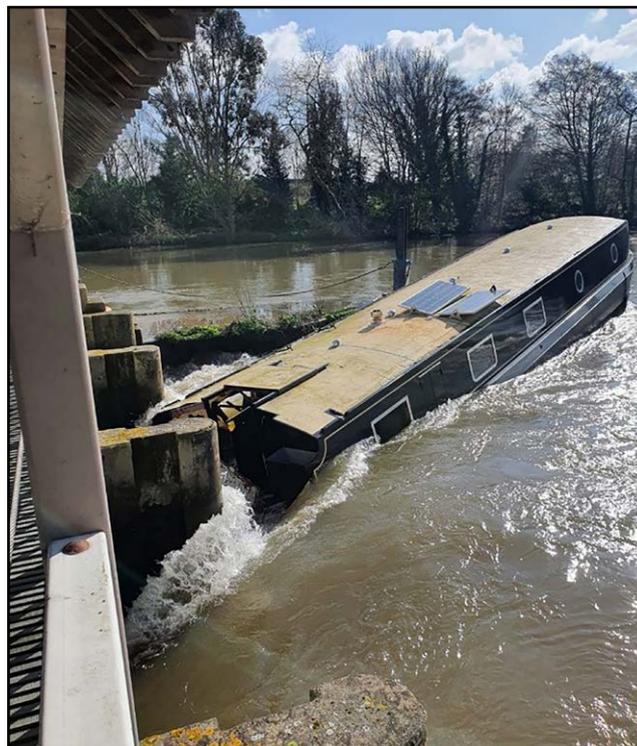
Figure 1: Narrowboat partially sunk on weir

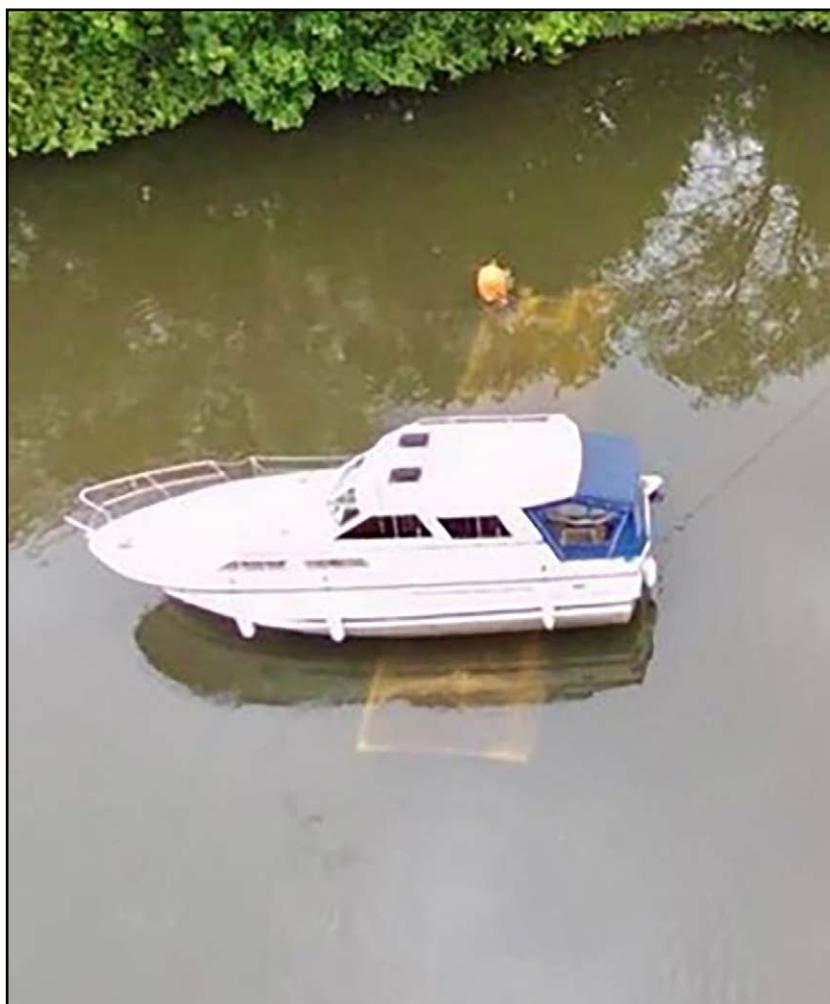
Figure 2: Motor cruiser grounded on submerged wreck
