AAIB Bulletin

4/2021

Published 8 April 2021.

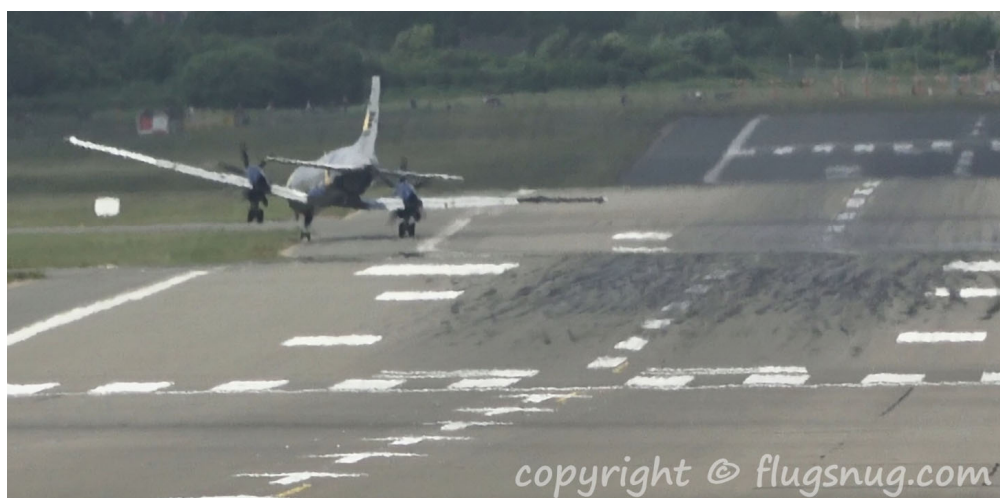
Figure 7

Image showing Point E from Figure 4 – SE-MAO leaves the paved surface

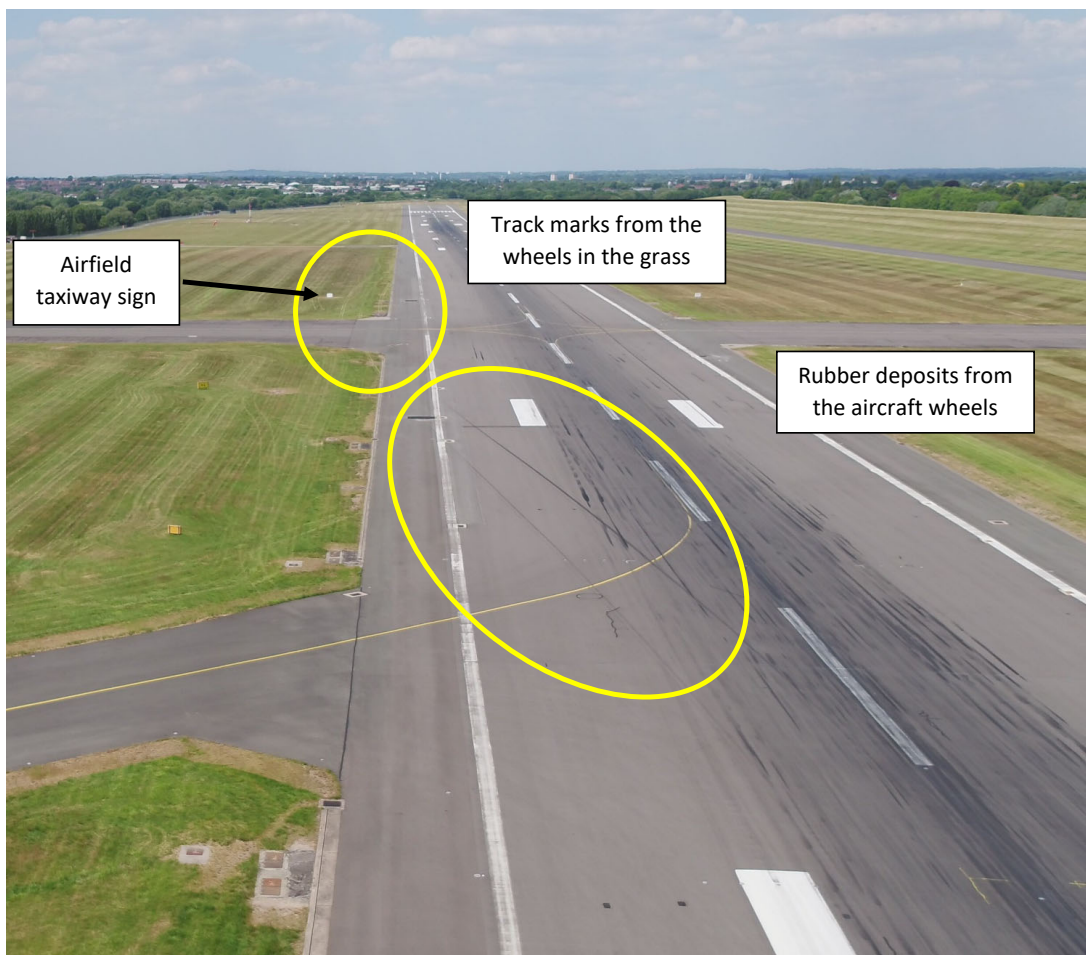
Using the images taken by the UAS it was possible to measure the distance from when the aircraft first left the paved runway surface until when the last wheel returned to the runway. The total distance was 450 m. Figure 11 shows the extent of the excursion, with the wheel tracks clearly visible in the grass.

UAS image of the runway and grass markings

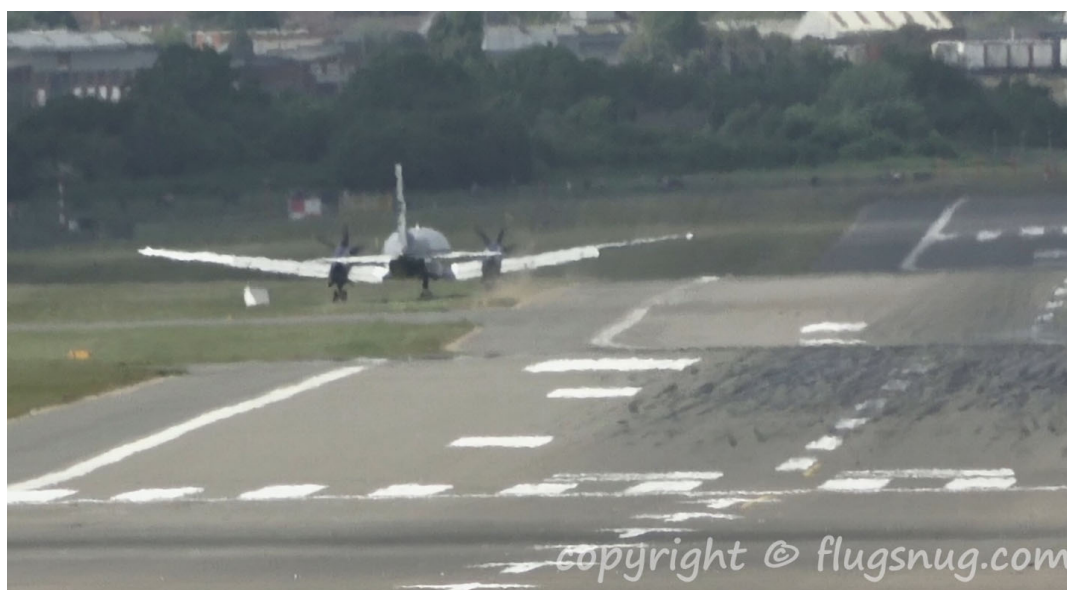
Figure 12

to the wing. Whilst all signs on the airport are designed to be frangible, it is likely that had the propeller hit the sign some damage would have occurred to the aircraft.

Image of the aircraft wing passing over the taxiway sign

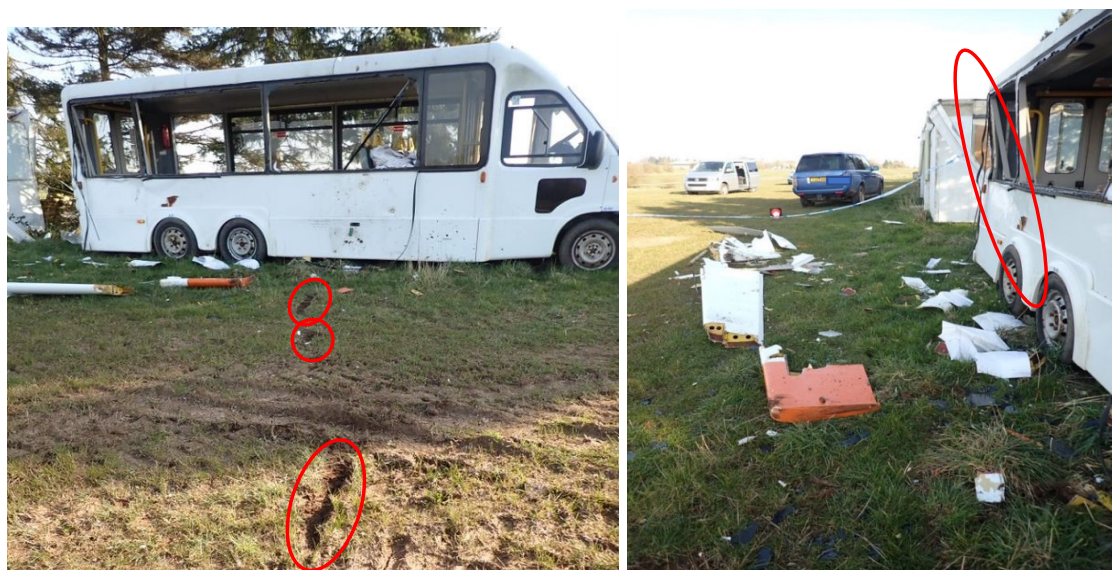
Figure 2

From the ground marks it was evident the aircraft was heading east towards the airfield at the time of the accident. The first impact marks were made by the right wing tip, which touched the ground three times before the leading edge of the wing hit a small bus parked along the treeline of the west field (Figure 2).

Ground impact marks, detached right wing and impact angle on the bus

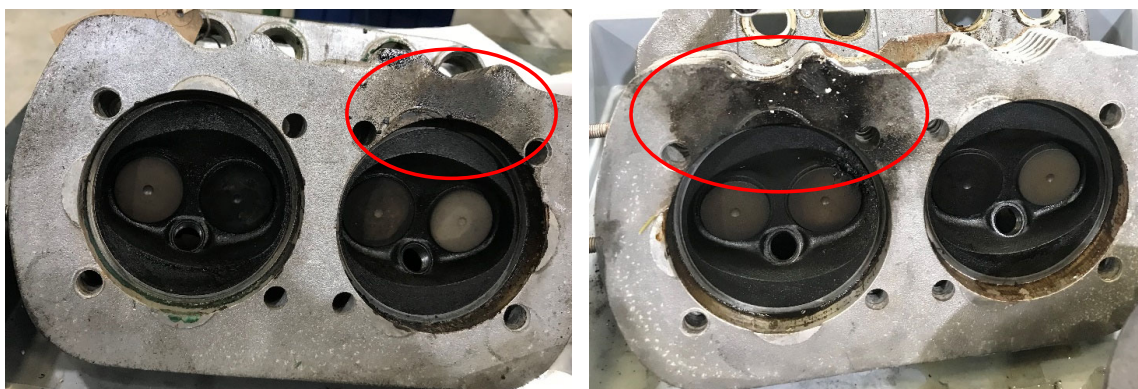
Figure 7

When the cylinder heads were unbolted from the crankcase, thin layers of black combustion deposits were found covering the piston crowns, combustion chambers and valve heads. There were signs of staining between Nos 3 and 4 cylinder heads and their respective cylinders (Figure 7). Records show that cylinder pressures were only 10% below their maximum when they were tested in December 2019.

No 3 and 4 cylinder heads showing signs of staining

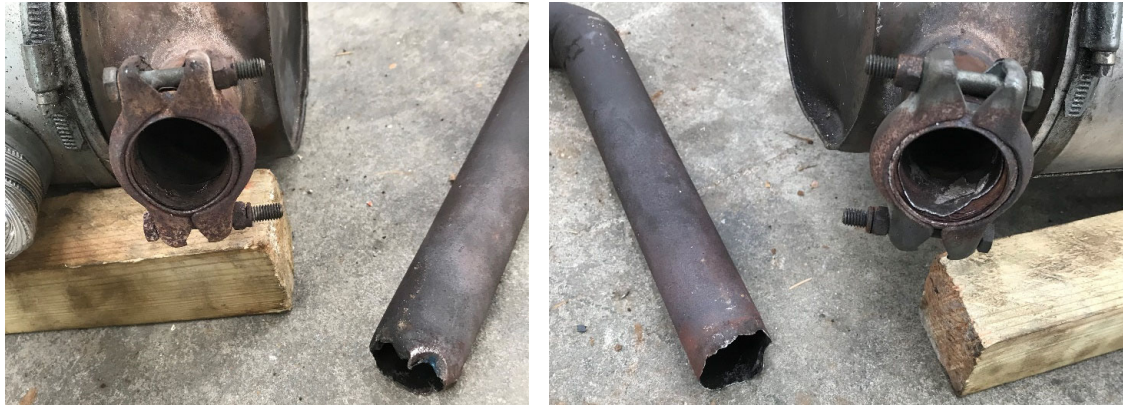
**Figure 9**

Forensic analysis found that although the exhaust down pipe from No 2 cylinder was corroded and the wall thickness had reduced, it had fractured during ground impact. The down pipe from No 1 cylinder was severely corroded and forensic analysis found that it had already failed some time before the accident. Both the pipe and its sealing ring showed traces of exhaust gas leakage. The evidence was very difficult to detect visually with the exhaust still fitted to the engine and in the engine bay. The signs of leakage were not easily discernable even with the system dismantled and required forensic examination to confirm that leaks had occurred.

No 1 and 2 cylinders' exhaust down pipes and silencer pipes showing failures

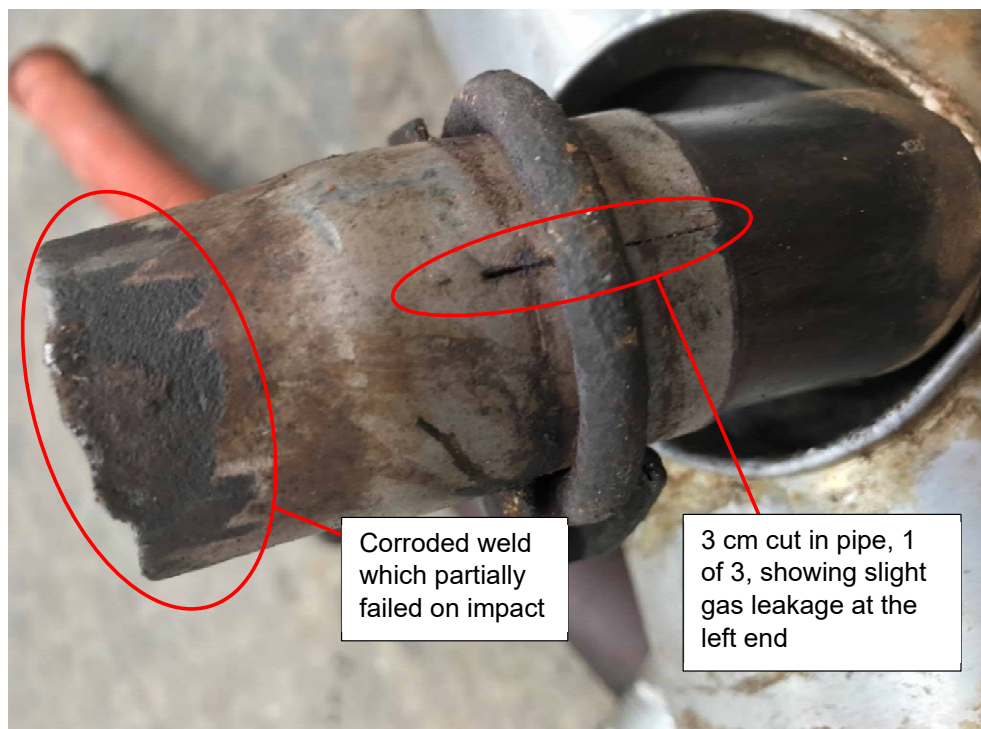
**Figure 10**

Whilst the partial failure of the exhaust tail pipe at the weld was due to ground impact, there was evidence that gas leakage had also occurred at the connection of the tail pipe to the silencer. The tail pipe had three, 3 cm cuts along the length of the pipe from the end to enable it to expand to fit over the silencer connection. A clamp was placed over the cut end of the pipe to secure it in place. As the pipe had not been fully pushed over the connection, the cuts were not completely blanked by the silencer pipe, which allowed gas to escape when the engine was running (Figure 10). The aircraft manufacturer stated that the tail pipe fitted was not an approved design.

Partially fractured tail pipe attached to the silencer

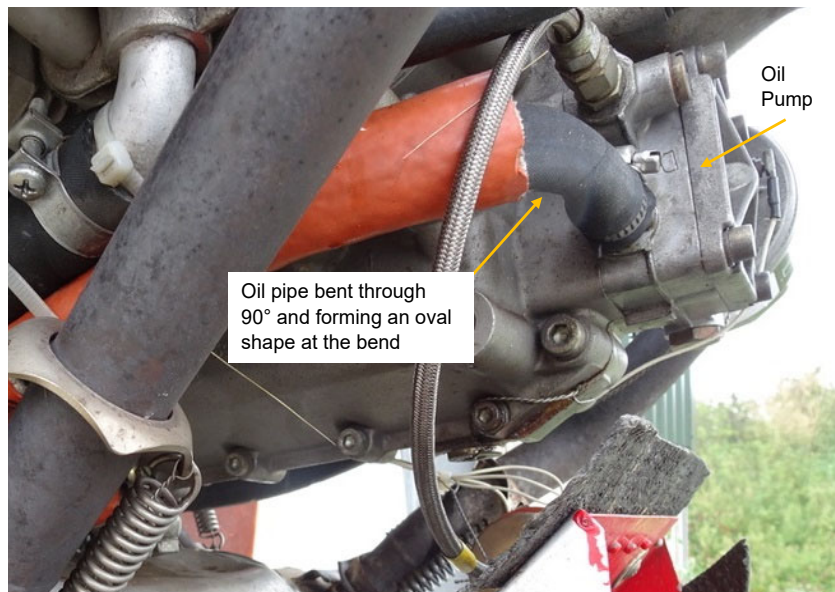
**Figure 2**

Before removing the engine, the owner noticed the cross-sectional shape of the pipe from the oil cooler had narrowed where it had been bent by 90° in order to connect it to the oil pump (Figure 2). On checking the Europa engine installation manual, the owner realised that an oil pipe with a pre-formed 90° bend was available, to avoid bending the pipe when connecting it to the pump. However, the owner also commented that later testing on a bench showed that this geometry only created an 'oval' cross-section in the pipe and did not 'kink' it. Further, the aircraft had flown with the pipe in this geometry for its Permit test flight and for a further flight as part of the owner's type conversion, with no indication of oil pressure problems at any stage.

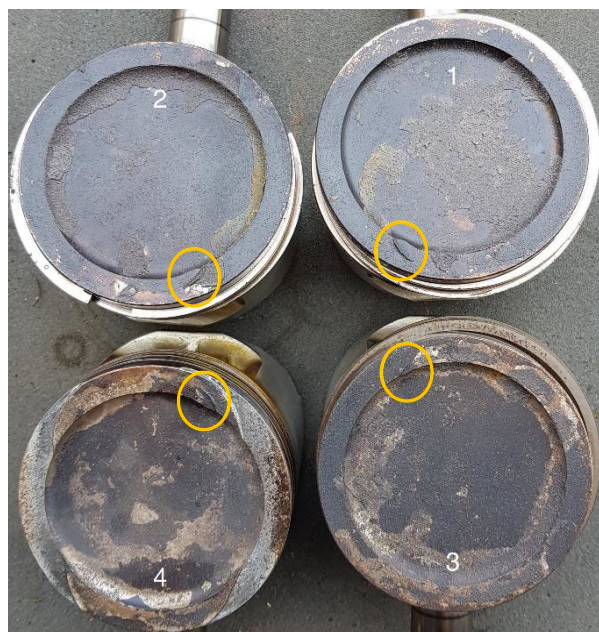
**Figure 3**

After removing the pistons from the engine, dents were found on the top surfaces (crown). The shape of the dents matched the edges of the cylinder inlet valves. None of the inlet valve stems were bent and the edges of the valves showed no signs of impact damage. The dents in the piston crowns were also coated with carbon deposits (Figure 3).

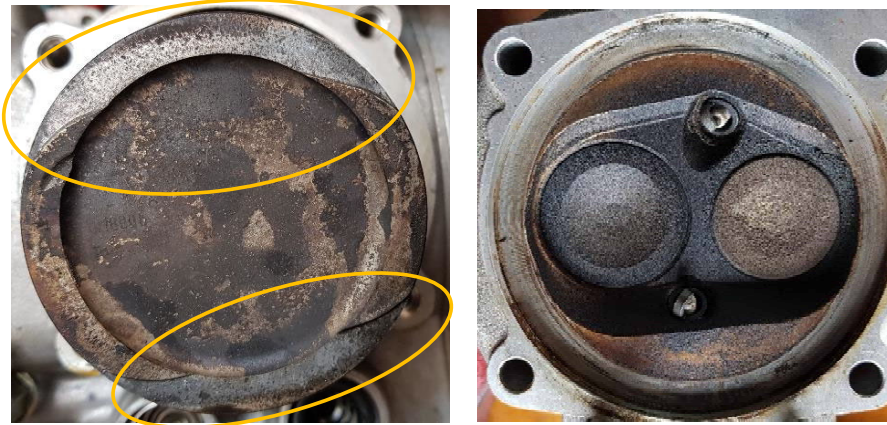
Figure 4

The No 4 piston had also been in contact with the cylinder head, creating cylinder head shaped dents in the crown (Figure 4).

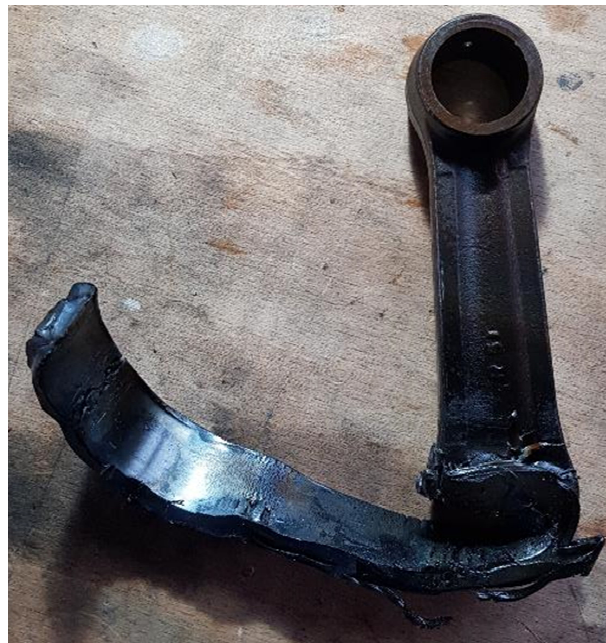
Figure 5

When the engine crankcase was opened, it was evident the No 4 piston connecting rod and bearing had failed at the attachment to the crankshaft (Figure 5). There were impact marks along the lower edges of the adjacent No 3 piston and cylinder.
