Rail Accident Investigation Branch

# Rail Accident Investigation: Interim Report

**Derailment of a passenger train at Carmont,  
Aberdeenshire  
12 August 2020**

Report IR1/2021  
April 2021

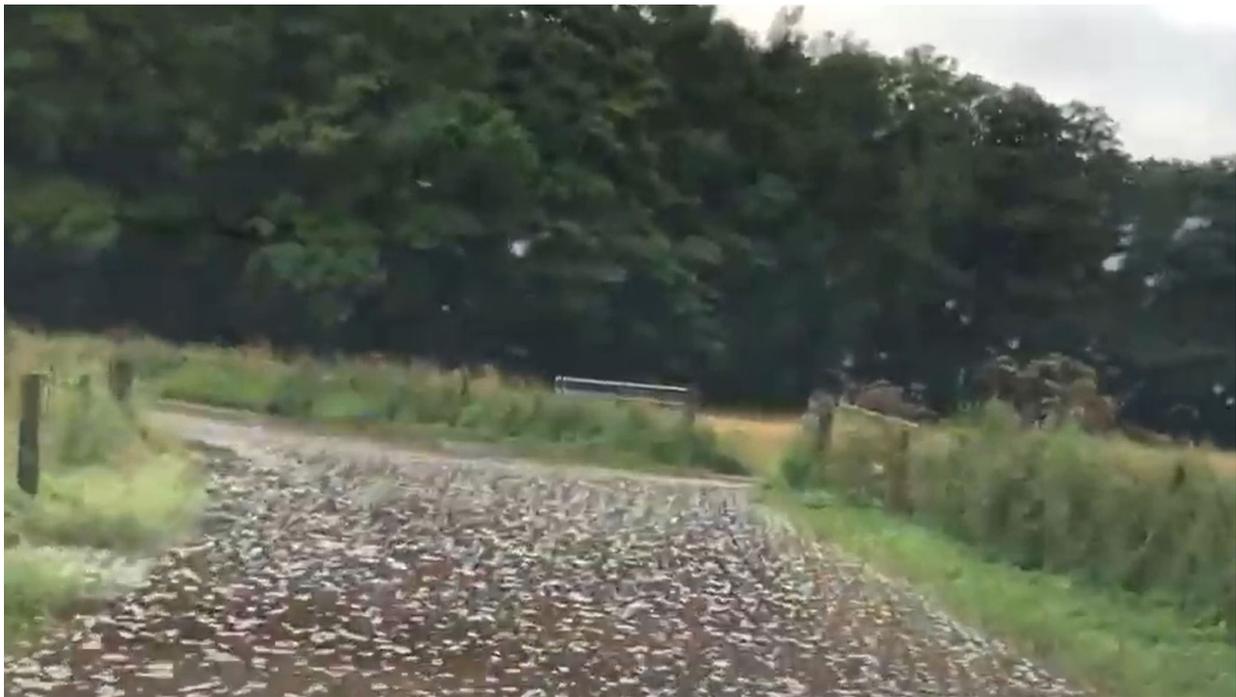
- 20 The 51.5 mm of rain which fell in this period at the accident site is almost 75% of the total monthly rainfall (70 mm) for Aberdeenshire in an average August. It caused significant flooding in the surrounding areas (figure 7).

Figure 7: Conditions on a road near Carmont at 08:39 hrs on 12 August 2020 (image courtesy of Chris Harvey)

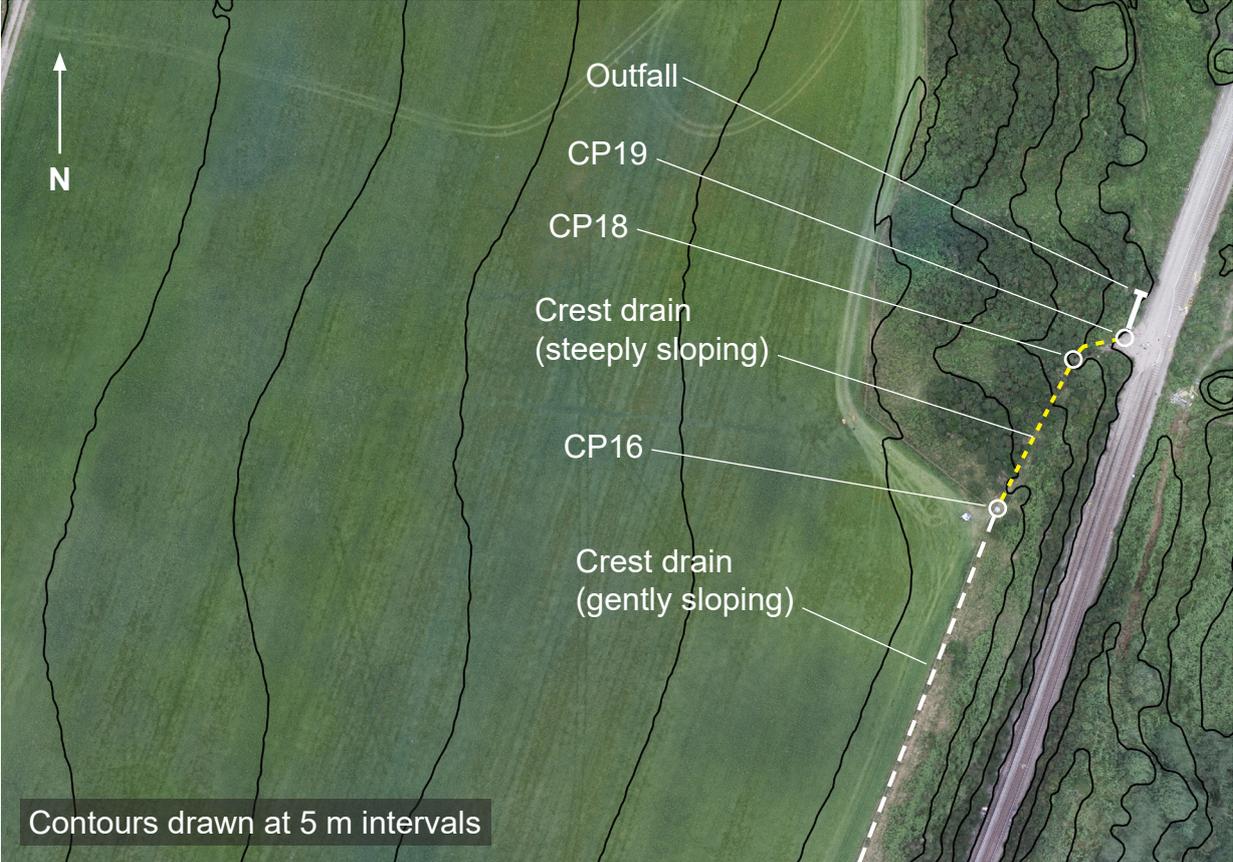
24 Most of the drain sloped gently towards its outfall as it ran along the edge of a field, which rose gently away from the top of the railway cutting. However, as the cutting depth began to reduce, the drain followed the crest and, at the north-west end of the cutting, sloped relatively steeply at an average gradient of about 33% (1 in 3) to track level. Catchpits (manholes) were provided at intervals along the pipe to allow inspection and maintenance of the pipe (figure 8).

Figure 8: Drainage and initial RAIB survey (contours influenced by vegetation). Only selected catchpits (marked CP with number) are shown.

25 A little above track level, the crest drain reached a catchpit, referred to as catchpit 18, located about 15 metres from the railway and near a bend in the pipe, where it changed direction and flowed towards catchpit 19 adjacent to the railway. Beyond catchpit 19, the drain turned to run parallel to the railway for a short distance, until it reached its outfall into a ditch at about track level. This track-side section of the new drain was installed alongside an existing clay pipe track drainage system, which included a catchpit and discharged into the same track-side ditch. The pipework of the crest drain and the track drain were not connected.

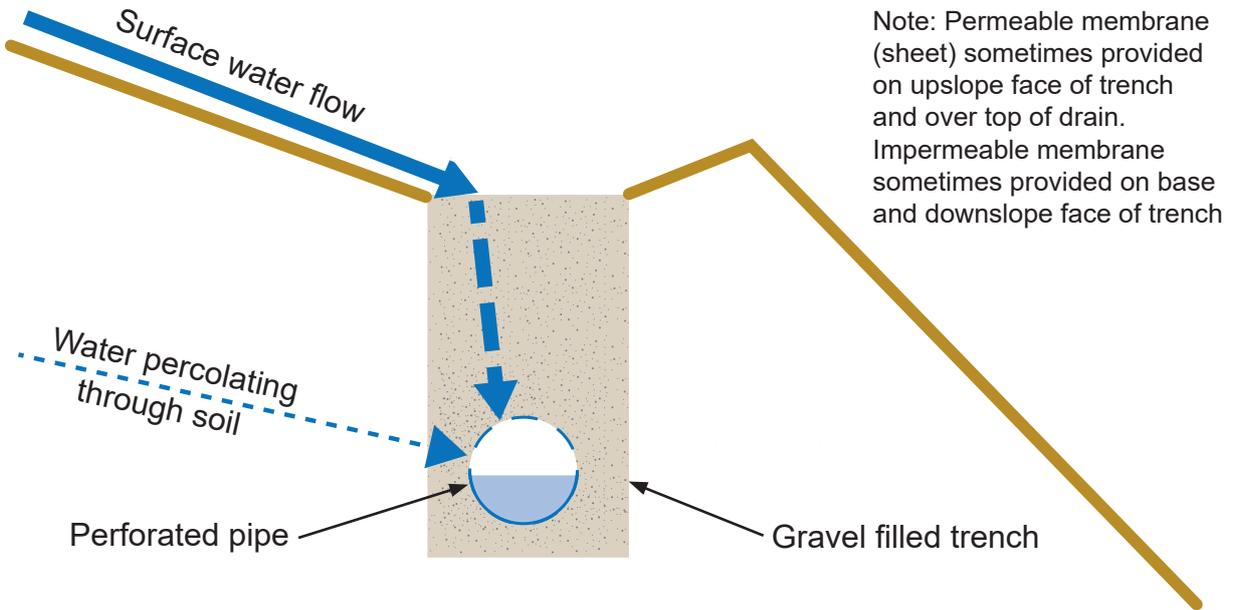
- 23 The new crest drain ran northwards for a distance of about 340 metres and comprised a 0.45 metre diameter perforated pipe buried in a gravel-filled trench, an arrangement often known as a 'french drain'. An inlet near the south end captured water from a small burn (stream), which runs along a hedge line towards the railway. The gravel-filled trench was intended to collect water which seeped through the gravel and into the pipe through the perforations (figure 9).

Figure 9: Gravel filled trench

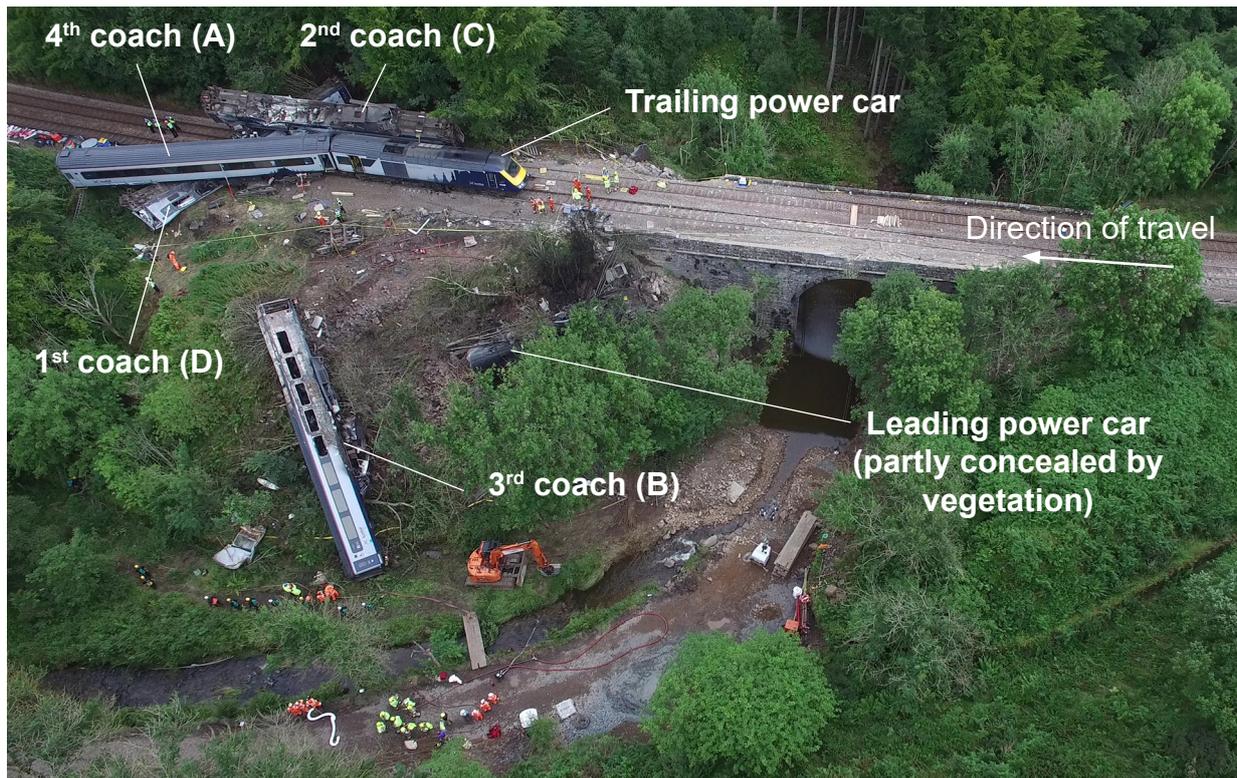
Figure 12: Derailed train

- 75 The leading power car and all four passenger coaches suffered substantial damage, with the extent of the damage reducing progressively towards the rear of the train.

- 76 On the leading power car, the driver's cab became completely detached when the vehicle collided with the bank, and the roof, right-hand body side, trailing end, bogies and underframe were substantially damaged.

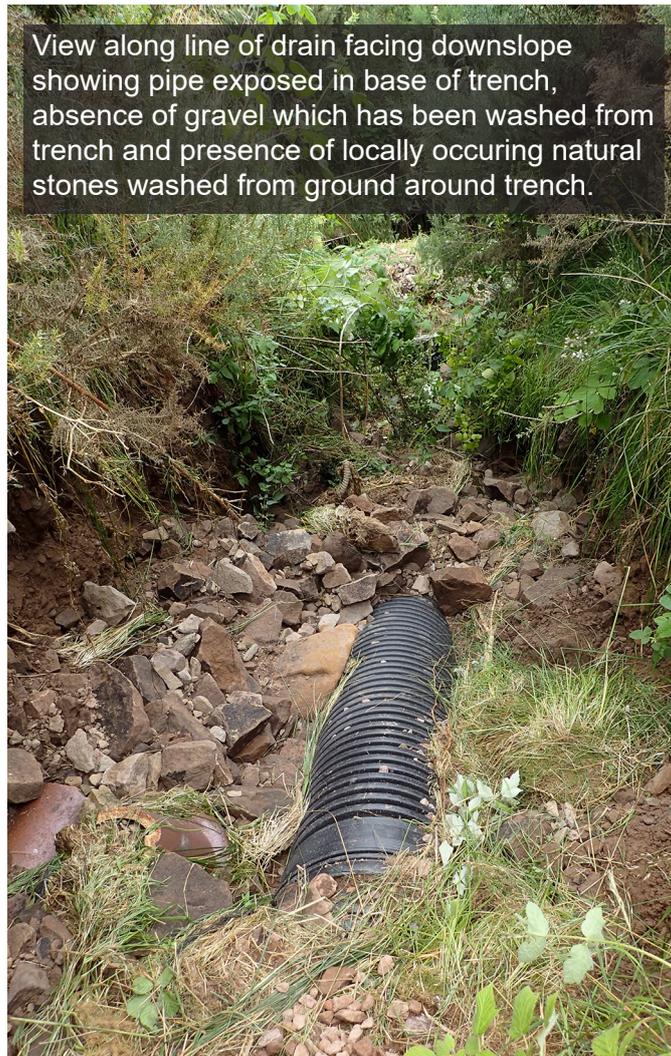
- 61 The washout was caused by unusually heavy rain (paragraph 19) which washed stone from the gravel-filled crest drain near catchpit 18, and from surrounding ground, onto the adjacent track leaving the perforated drainage pipe exposed. Local ground topography directed large amounts of surface water onto the steeply sloping drain in the area from which gravel was washed (figure 8). Although surface water flow alone can dislodge gravel, and stones of other sizes, RAIB is continuing to investigate whether other factors, such as the drainage system's design or the quality of installation, contributed to the displacement of material.

- 62 The topography of the area around the washout, as recorded by an RAIB aerial survey immediately after the accident, is shown in figure 8. Gravel was missing from the drain to a depth sufficient to expose the buried pipe partially or completely for a distance of about eight metres upslope of catchpit 18 (figure 13). Material was also missing for an additional six metres around and downslope of catchpit 18 (figure 14). Evidence of large surface water flows in this area was shown by detritus caught on a fence and by erosion of channels in the soil immediately upslope of the drain.

- 63 The colour and shape of the drain fill, as evidenced by gravel remaining in the drain, differed from stones occurring naturally in the surrounding area and represented a significant proportion of the debris on the track. The locally occurring material found on the track was probably washed from the surrounding soil and the slope close to the track. Stones similar to those found in the debris on the track were seen in natural soil exposed in the trench sides in areas where the gravel fill had been washed out.

*Figure 13: Drain with gravel washed out upslope of catchpit 18*

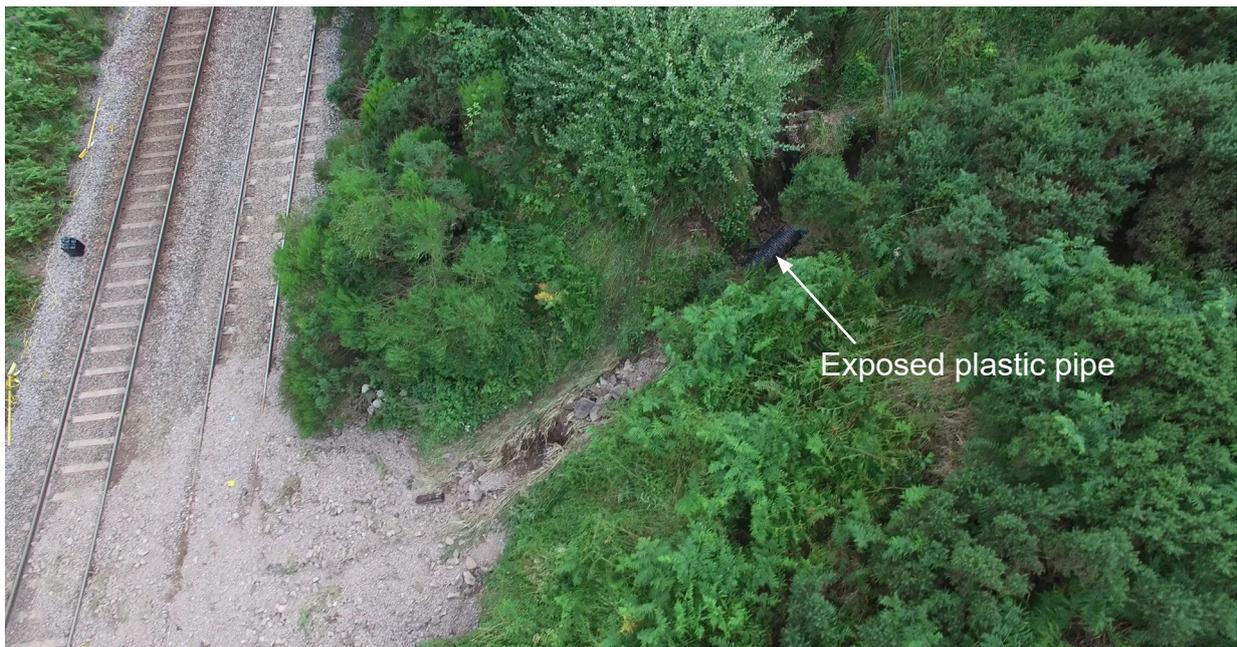
*Figure 14: Drain downslope of catchpit 18*

64 It is possible that surface water flows, before the day of the accident, had been sufficient to dislodge gravel from small areas of the gravel-filled drain, sufficient to be seen in the area affected, but with insufficient material washed down for this to be apparent at track level. The lack of an effective drainage inspection regime (paragraph 26) meant that any such indications of future problems upslope of catchpit 18 would not have been detected.
