# Banff SAL Buoy Interim Close-Out Report

Originator/Contractor/Supplier Company Name/ Logo Altera Production	Originator/Contractor/Supplier Company Document Number:				
	Discipline:	System:	Doc. Type:	SFI:	
	U	19	LA	-NA	
Document Number: <b>PJB-AIP-U-19-RA-000002-001</b>					
Project No: -NA Contract/PO No: 43030	Document Title: <b>Banff Field Single Anchor Loading (SAL) Buoy Interim Report</b>			Status: Final

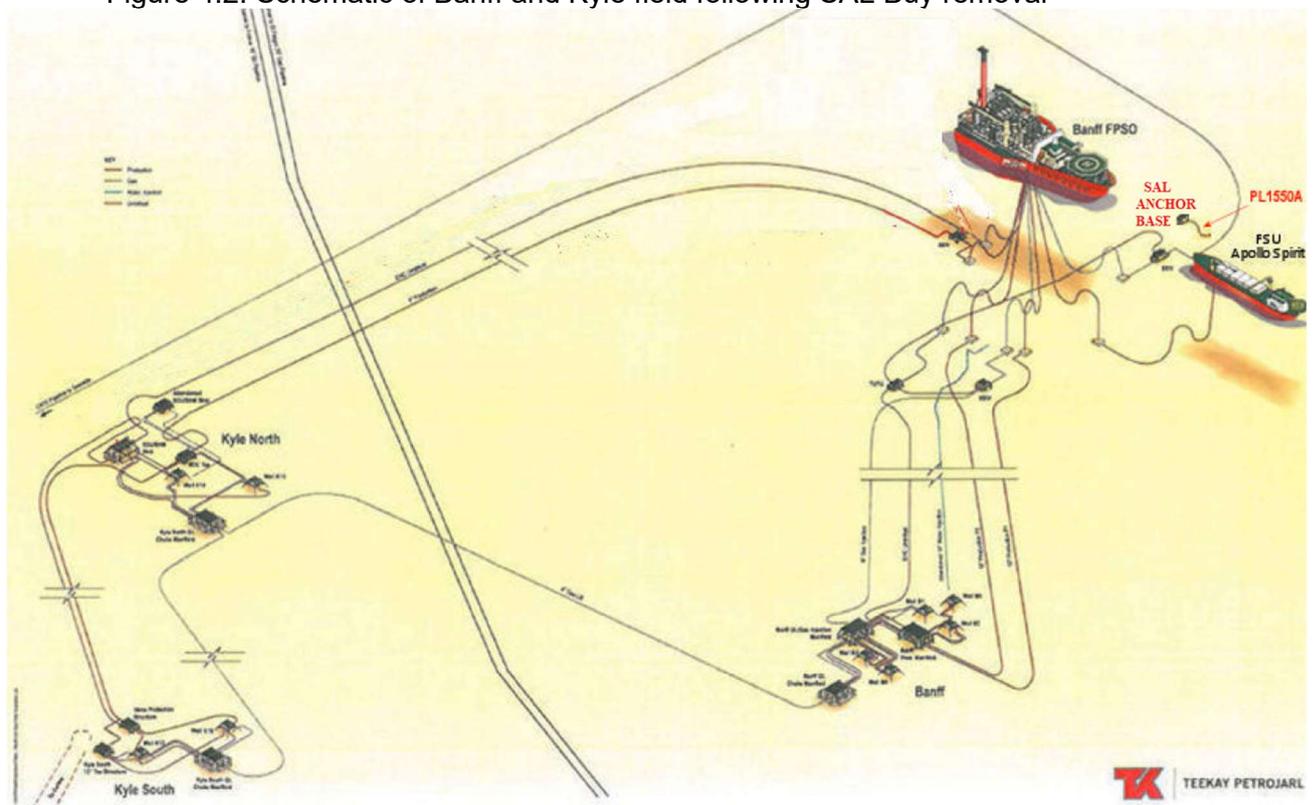
Figure 4.2: Schematic of Banff and Kyle field following SAL Buoy removal

The remaining infrastructure at the SAL Buoy location comprises of the SAL anchor base and 48m section of disused loading hose (Figure 4.2). The SAL anchor has since been marked with a special marker buoy as it is not over trawlable. The UK Hydrographic Office and Kingfisher have subsequently been notified of the marker buoy locations along with two other marker buoy positions at the former FPSO and FSU locations.

The anchor with disused loading hose will be removed as part Banff and Kyle Field decommissioning. Details on how the debris identification and removal from seabed will be undertaken as part of the wider field decommissioning will be outlined in subsequent Banff and Kyle Field Decommissioning Programmes. Final seabed clearance and certification will be obtained after decommissioning activities for the full Banff and Kyle Field have been completed.

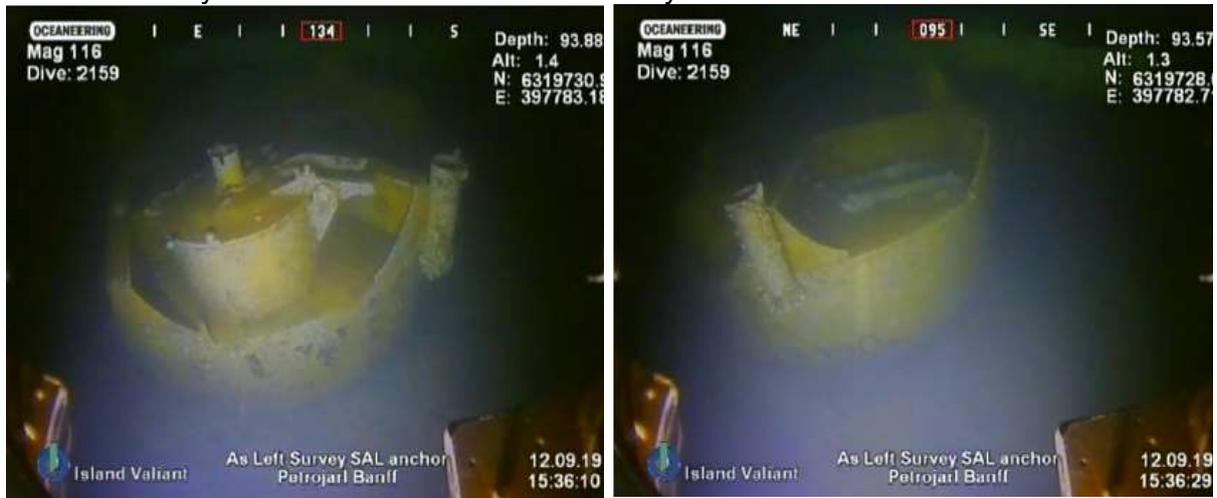
Figure 9.1: SAL buoy anchor

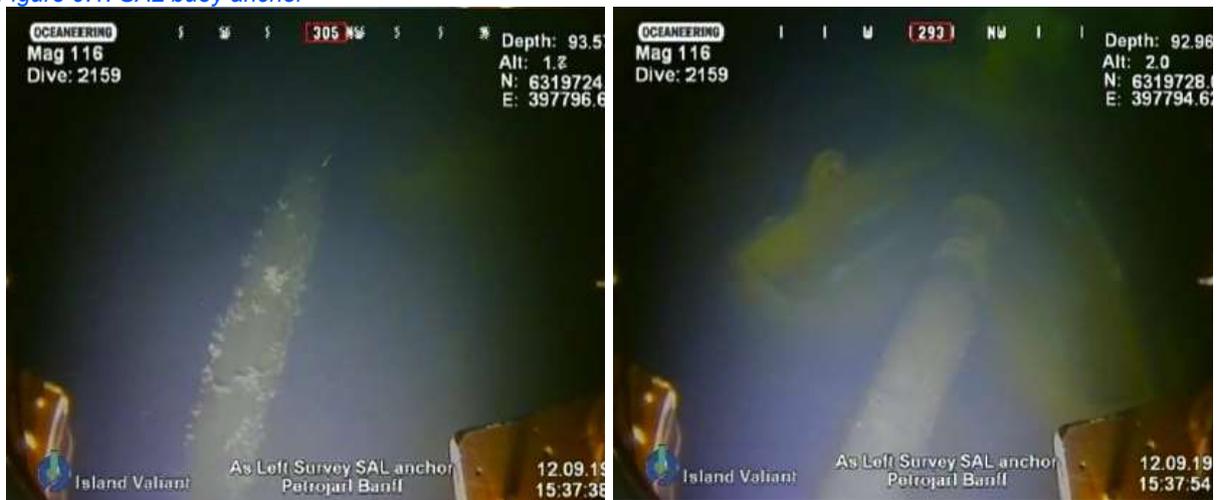
Figure 9.9-1: Bonded 12" hose towards flow assembly

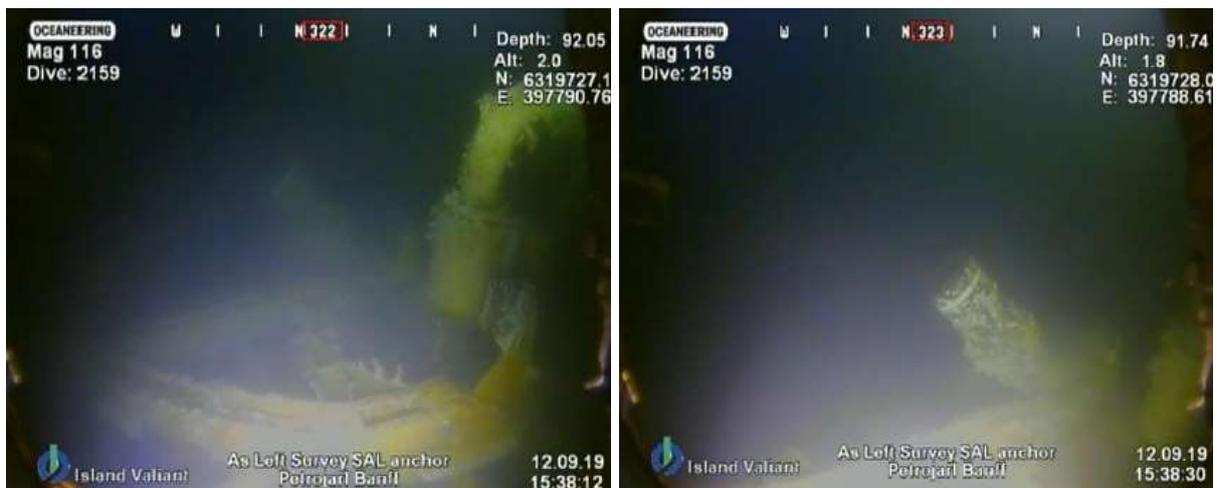
Figure 9.9-2: Flow assembly at SAL buoy anchor base and hose cut at flow assembly

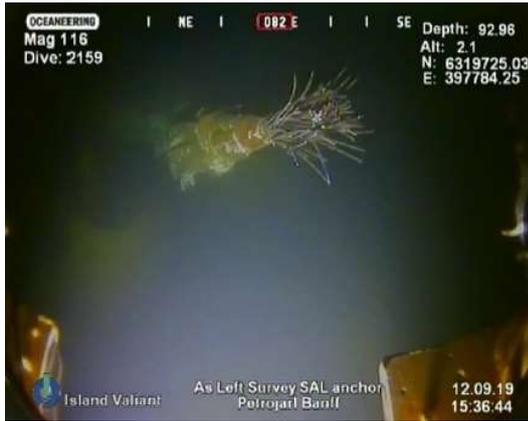
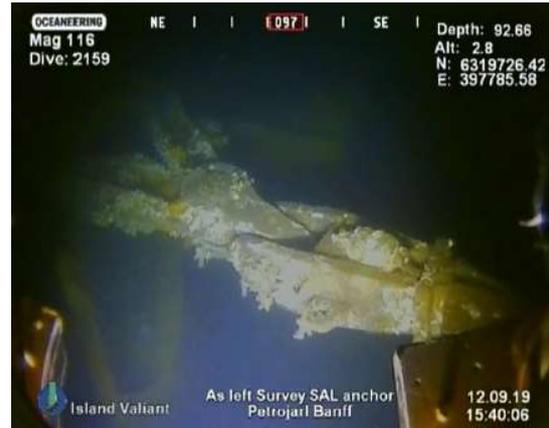
Figure 9.9-3: Mooring wire connection towards SAL anchor base

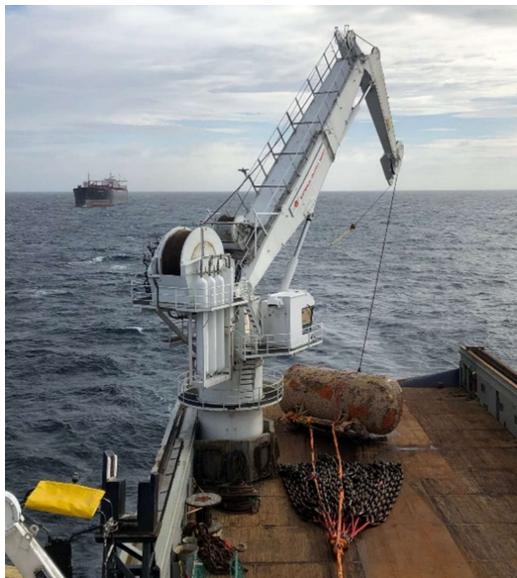
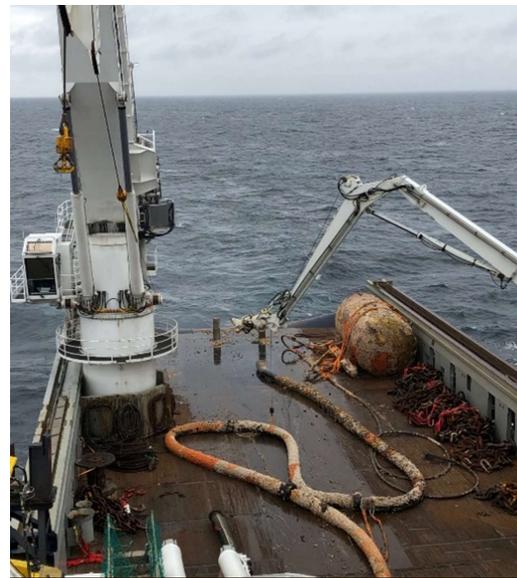
Figure 9.5: SAL buoy and loading hose retrieved to AHV deck
