Grenfell Tower

Summary Note

Ministry of Housing, Communities and Local Government

5186876-ATK-XX-XX-RP-SE-000009

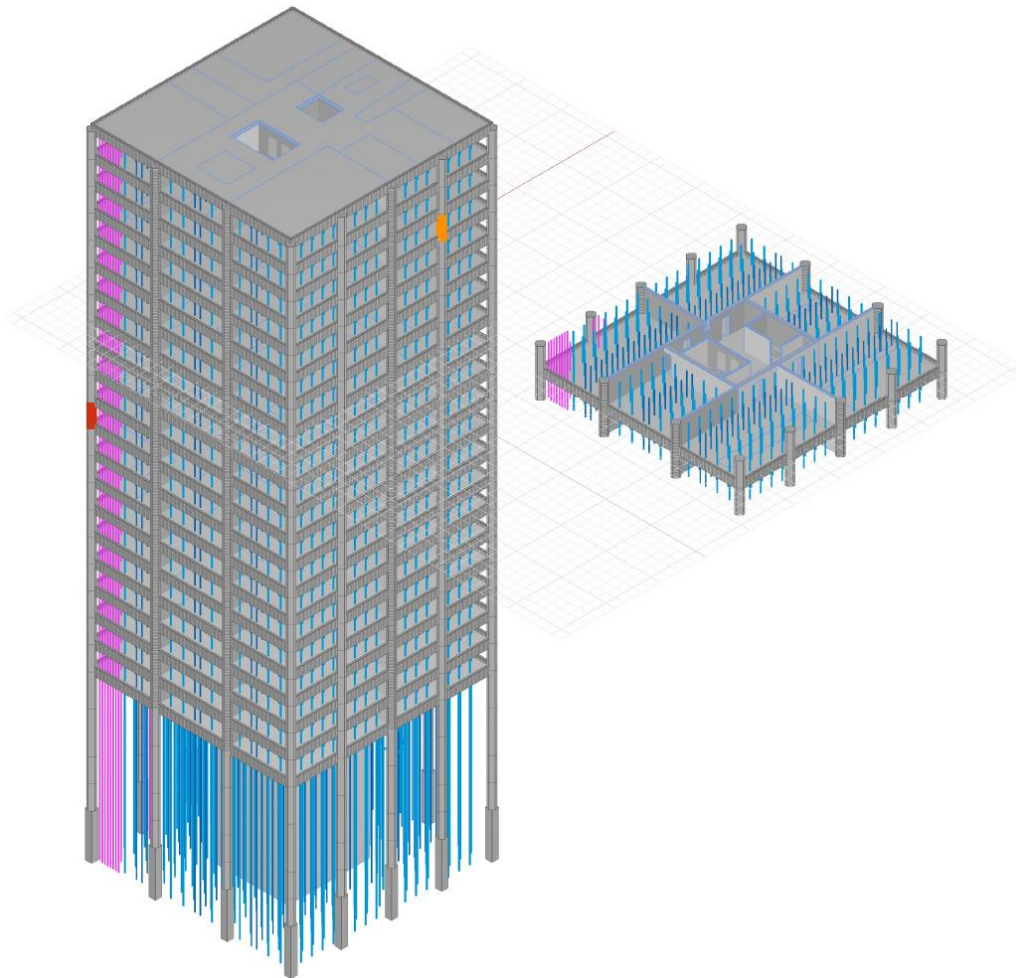
Figure 6 – Illustration of propping

Propping to the basement, as reflected in **Figure 6**, which shows the supplementary (Stage 3) propping system, only mitigates the risk of degradation in the medium term. Hence, although the building may be stable it cannot be considered safe, as the risk of further spalling potentially injuring site personnel remains. This risk increases the longer the damaged parts of the building remain standing and will also make the deconstruction of the Tower more difficult and dangerous.

In **Figure 6** the blue props represent the supplementary (Stage 3) propping and the pink props indicate the Stage 2 propping that has to be retained adjacent to the heavily damaged column in the northwest corner.

Two supplementary propping designs have been developed. One design has props from 4th floor to roof level and relies on the less damaged slabs supporting the damaged slabs. The second design has props from basement to roof level which carry more of the damaged slab loads to the foundations, but still rely in part on the less damaged slabs supporting the damaged slabs. The former will be employed if a decision is made by July 2021 to commence deconstruction (or partial deconstruction) of the building in May 2022 and will obviate the need to prop to the basement. However, for either supplementary propping solution the propping will need to have been completed by May 2022.
