Rail Accident Investigation Branch

Rail Accident Report

Wagon derailment at York station 18 January 2006

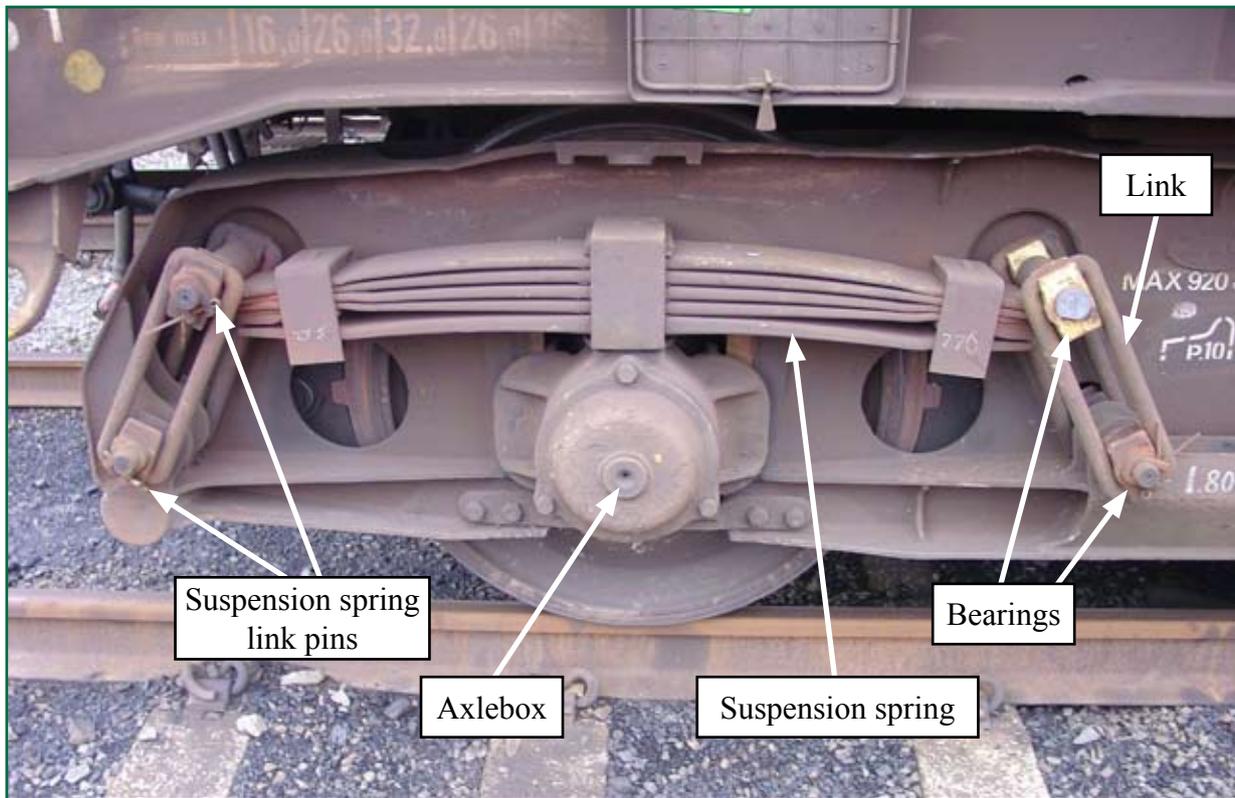
Figure 3: Bogie suspension

- 16 The wagon is fitted with bogies and has a maximum load per axle of 22.5 tonnes. The suspension is attached to the bogie frame via an assembly of links, link pins and bearings - see Figure 3. This type of bogie suspension is fitted to hundreds of wagons in the UK and is used extensively in other parts of Europe.

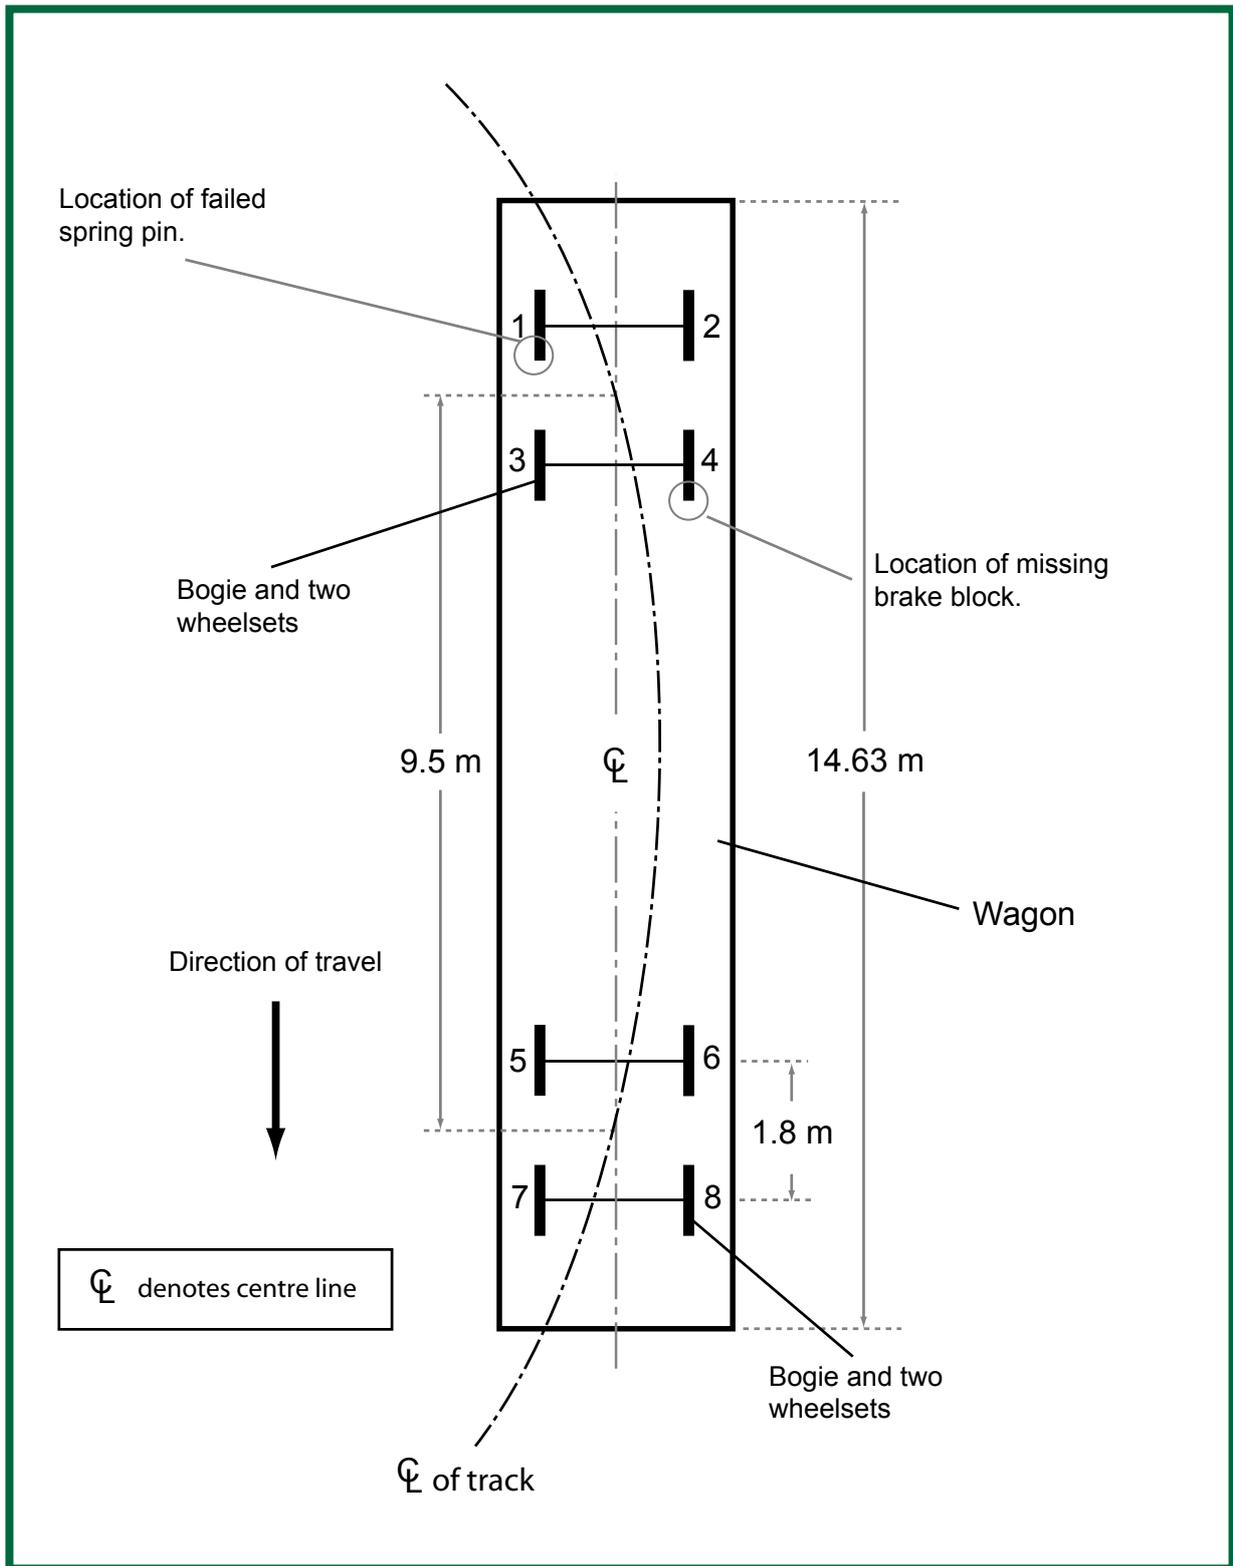
Figure 6: Plan view of wagon 7008990380 and the derailed wheelset

- 35 The driver re-examined the train with the Network Rail Mobile Operations Manager (MOM) who had arrived on site. They found a collapsed suspension at wheel one and a missing brake block at wheel four on bogie serial number 89 - see Figure 6.

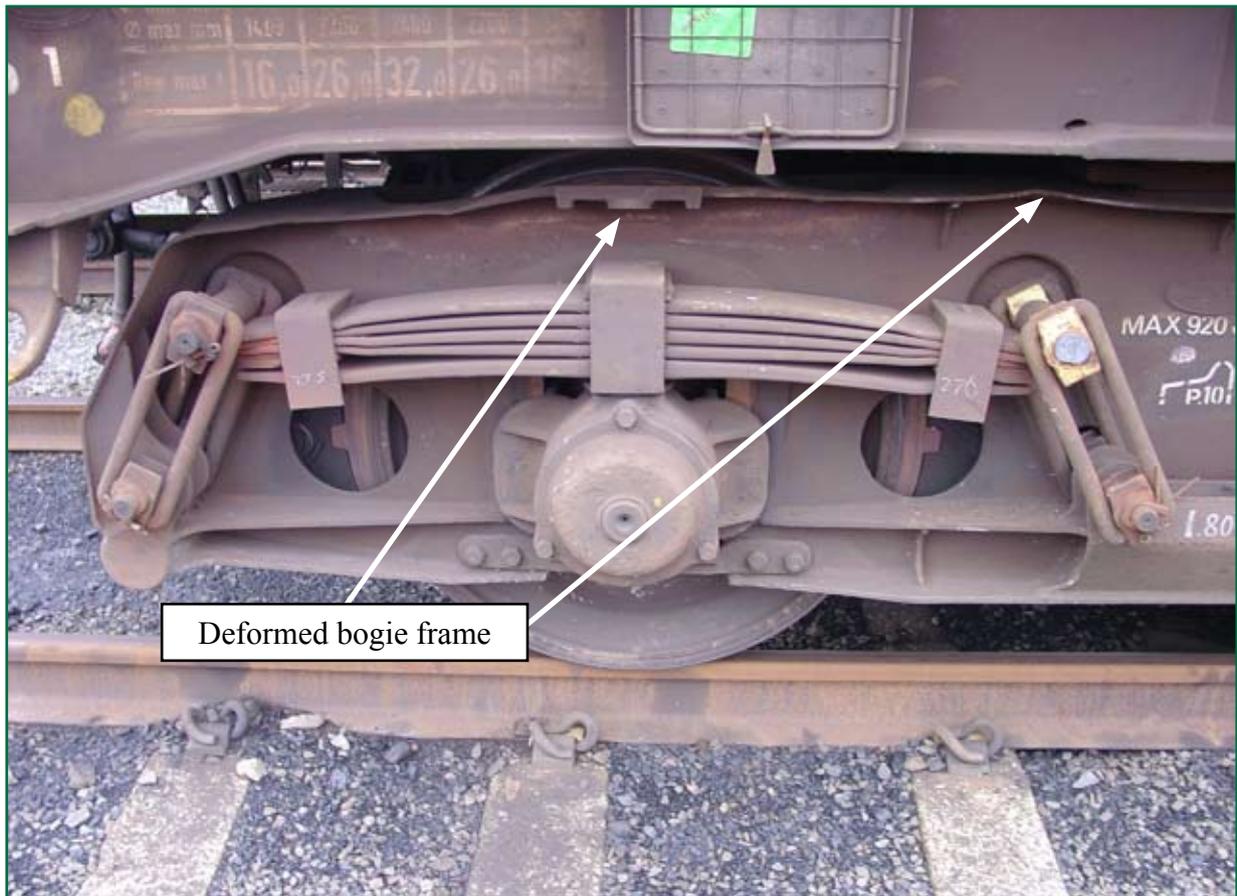
- 36 Damage to the wagon from the incident included: (i) deformation of the bogie frame due to impact by the suspension spring - see Figure 7; (ii) deformation of the bogie frame by the wagon structure due to excessive relative movement during derailed running – see Figure 8 and (iii) damage to wheel three from number 788 points check rail – see Figure 9.

Figure 7: Photograph of deformation of the bogie frame due to impact by suspension spring

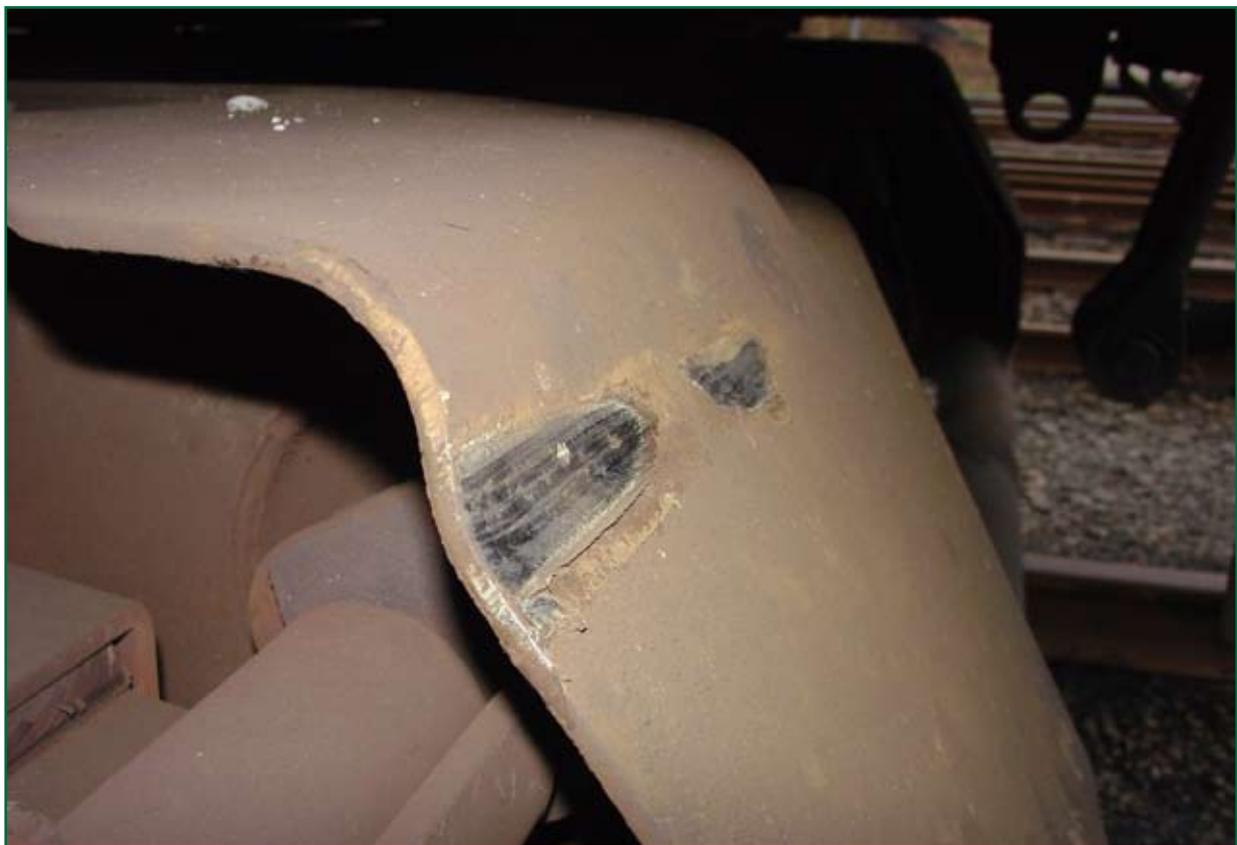
Figure 8: Photograph of deformation of the bogie frame by the wagon structure due to excessive relative movement during the incident

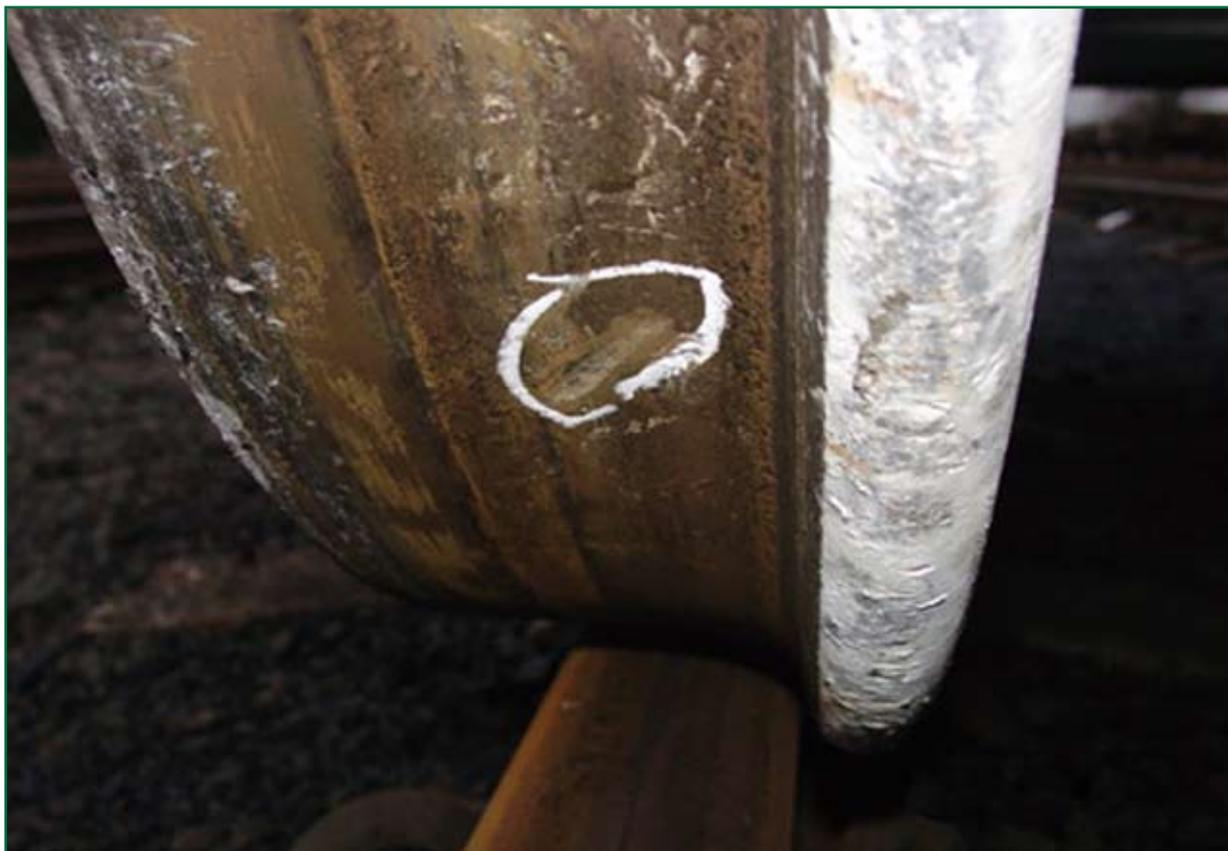
Figure 9: Damage to wheel three from number 788 points check rail

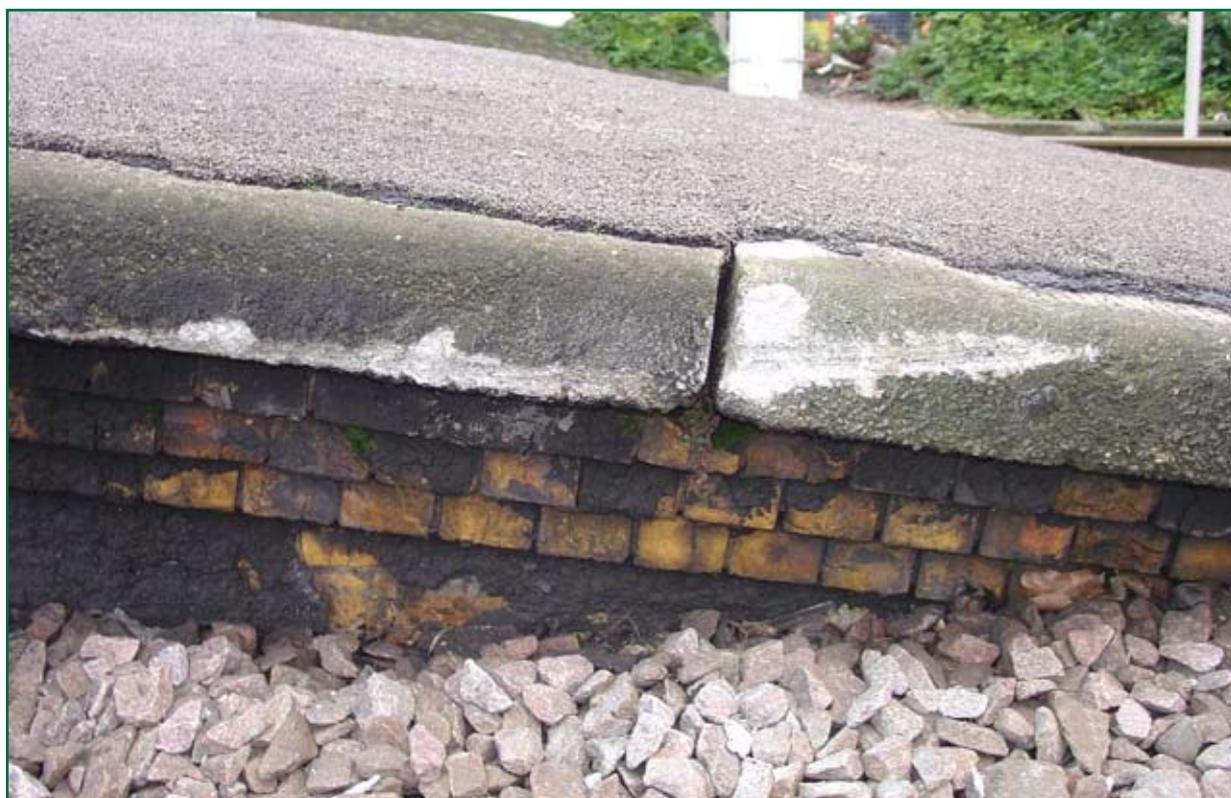
- 37 Infrastructure equipment damage extended over approximately 250 m and included: (i) approximately 400 *sleepers*; (ii) 20 *Pandrol* clips; (iii) 18 *bearers*; (iv) 8 track circuit cables; (v) *Train Protection and Warning System* (TPWS) equipment mounting bars and (vi) check rail and *fish plates* at number 788 points. The coping stone at platform three was misaligned and scored by impact with the bogie as shown in Figure 10.

Figure 10 Platform three coping stone misaligned by impact with bogie
