Aircraft type and registration: Cessna 402B G-BLTI (light twin engined fixed wing aircraft)

Date and time (GMT): 27 March 1985 at 1850 hrs

Location: East Midlands Airport

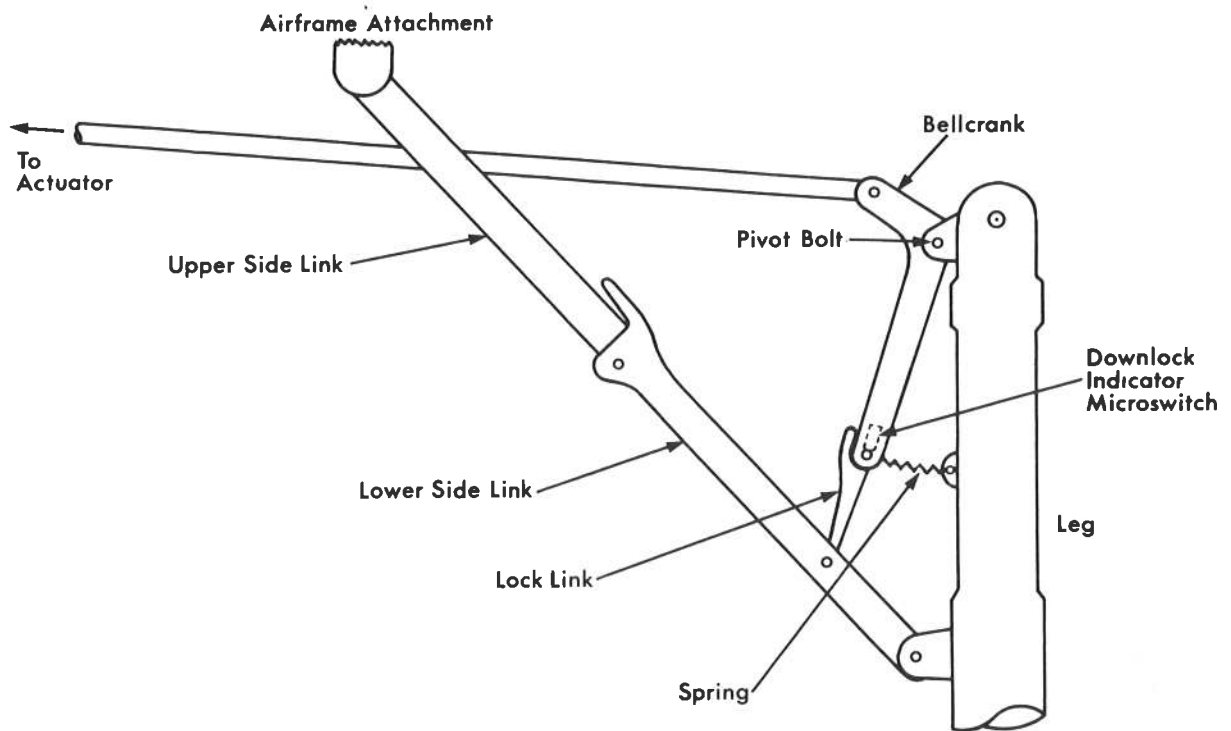
Fig.1 Main Landing Gear Schematic

Examination of the left landing gear (Fig 1) showed that the eye-end of the lock link had fractured, the bellcrank pivot bolt had sheared, and the forward pivot bolt attachment lug had fractured. Metallurgical examination of the fractures showed no evidence of a pre-accident failure or fatigue.

The landing gear mechanism was re-assembled using a new pivot bolt and eye-end and the lock link adjusted to the pre-accident setting. The landing gear was cycled a number of times and no fault was found. During the examination of the landing gear mechanism it was noted that the pivot points of the upper and lower side links of the left landing gear had a lot more play than those of the right landing gear.
