Boeing 747-286B, EP-IAH

AAIB Bulletin No: 5/2003

Ref: EW/ C2002/06/09

INCIDENT

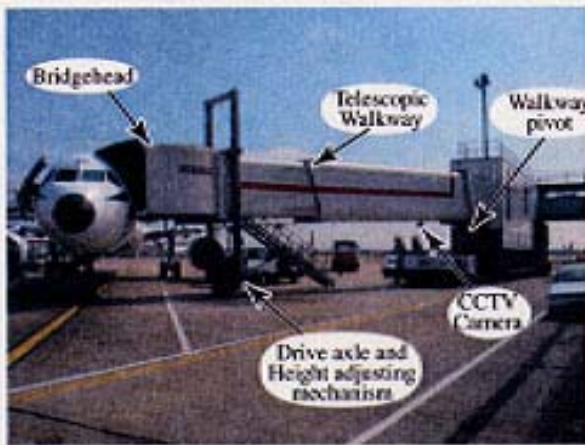
Plate 2 Older type apron-drive airbridge

Of the 'Apron-drive' airbridges in Terminals 2 & 3, where the controller involved in this incident worked, all of those in Terminal 2 and the majority in Terminal 3 are of one make and have been in service for several years (see Figure 1 Plates 2 & 2a). These are controlled from a console in the airbridge head and have the steerable drive axle and height adjusting mechanism just behind the airbridge head; the drive axle steering has limiting switches fitted in the mechanism. The control console faces forward, which gives the controller a direct view out of the front of the bridge towards an aircraft on the stand; there are no side windows. The drive and/or steering can be operated manually, from ground level, if power to the bridge is lost or disabled.

Airbridge movement across the apron is controlled by a joystick, which causes movement of the bridgehead in the same direction that the stick is deflected, and there are pushbutton controls for bridge head slew and height. There is an axle position indicator which shows, clearly, the orientation of the drive axle relative to the axis of the airbridge and the direction of 'forward' drive. There is a monitor with adjustable brightness and contrast, but no zoom, to view the image from an apron surveillance CCTV camera. This is mounted on the underside of the airbridge walkway, back near the pivot, and allows the controller to see any obstructions on the apron area around the drive axle and is used to position the airbridge wheels in their parking 'box' when it has been drawn back from an aircraft on the stand. This was the type of airbridge with which the controller involved in this incident was familiar.

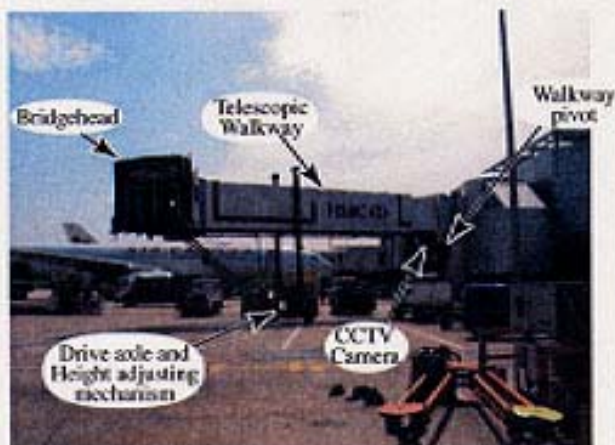
Plate 3 Latest type apron-drive airbridge

The other type of 'Apron-drive' airbridge, of which three have been introduced into Terminal 3 relatively recently, whilst not radically different in concept from the more numerous older type, has significant detail differences (see Figure 1 Plates 3 & 3a). It is, similarly controlled from a console in the airbridge head but on this type the control console is located in an alcove on the left hand side of the head, directly below a sideways facing window. Therefore, if the controller wishes to look towards an aircraft on the stand, they must either face the console and look over their right shoulder or stand, facing the aircraft, beside the console and operate the controls with their left hand. Airbridge movement across the apron is similarly controlled by a joystick which causes movement of the bridgehead in the same direction that the stick is deflected. There are pushbutton controls, similar to those in the other type, for bridge head slew and height.

This type has the steerable drive axle and height adjusting mechanism a considerable distance back down the walkway from the airbridge head which results in a different movement geometry compared to that of the older type. There are similar steering limiting switches fitted in the mechanism as in the other type; they are externally mounted and readily accessible for adjustment. There is also a proximity sensing system in the bridgehead which, in the final stages of its approach to the aircraft, limit the speed of the bridgehead, stop it at the correct point and prevent forward drive being engaged when in this position. The sensor system does, however, permit reverse drive to be applied to disengage from the aircraft.

On the 'new' airbridge type there is no drive axle steering position indicator on the console and to determine the axle orientation visually, the controller would normally use the apron surveillance CCTV camera image. This is displayed on a monitor which is not adjustable for zoom, contrast or brightness and is situated directly below the window which has no blind on it. When the airbridge is considerably extended (as it is when serving Door 2 Left on a Boeing 747) the image of the drive axle is small and indistinct. Moreover, the legend, either 'FRONT' or 'BACK', painted in white on a grey axle beam, is not easily discernible. It has been observed that, with bright sunlight shining in through the window, the image on the monitor is barely visible and the definition of details at the distance of the drive axle with the airbridge extended is extremely poor. The possibility exists for a controller to

Heathrow Airport Limited, in consultation with Thyssen, the airbridge manufacturer, should improve the ease of use and accuracy of the means by which airbridge controllers can assess the orientation of the drive axles of the type of airbridge installed at Stand M30 of Heathrow Terminal 3.

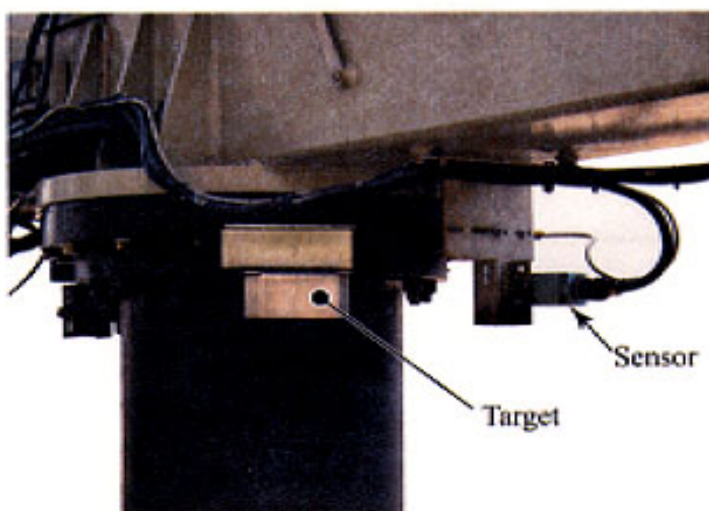
Figure 2b View showing accessibility of limit switches

Although the airbridge is fitted with a refined system for preventing a damaging approach of the bridgehead to an aircraft, this system is disabled whilst the airbridge is being driven in reverse. If the steering limit switches do not prevent the drive axle being turned to an orientation which, when reversing, will cause the bridgehead to move obliquely towards the fuselage of an aircraft on the stand when the airbridge is positioned most nearly parallel to the aircraft fuselage when serving a door, inadvertent damage to the aircraft will always be possible.

If steering limitation were to be used as an additional means of preventing airbridges from colliding with aircraft on the stand, the limits set would need to be unique to each stand. An examination of the geometry of Stand M30 showed that to avoid reversing into the side of an aircraft whilst retracting the airbridge from its furthest permitted extension, it would be necessary to limit the steering angle to the right to about 40° (see Figure 2 Diagram 1). On the adjacent stand, M32, the different relative alignments of the Stand centreline and airbridge pivot indicate that a much smaller steering angle to the right, of the order of 5°, would be all that was permissible.

Heathrow Airport Limited should consider determining and setting the steering limits of 'Apron-drive' type airbridges such that whilst the airbridge is being driven in reverse, it is not possible for the bridgehead to approach the fuselage side of a correctly positioned aircraft.
